**ANALYSING AND PREDICTING
FALSEWORK FAILURE IN HONG KONG**

A Doctoral Thesis submitted in partial
fulfillment of the requirements for the award of
Doctor of Philosophy of Loughborough University

February 2002

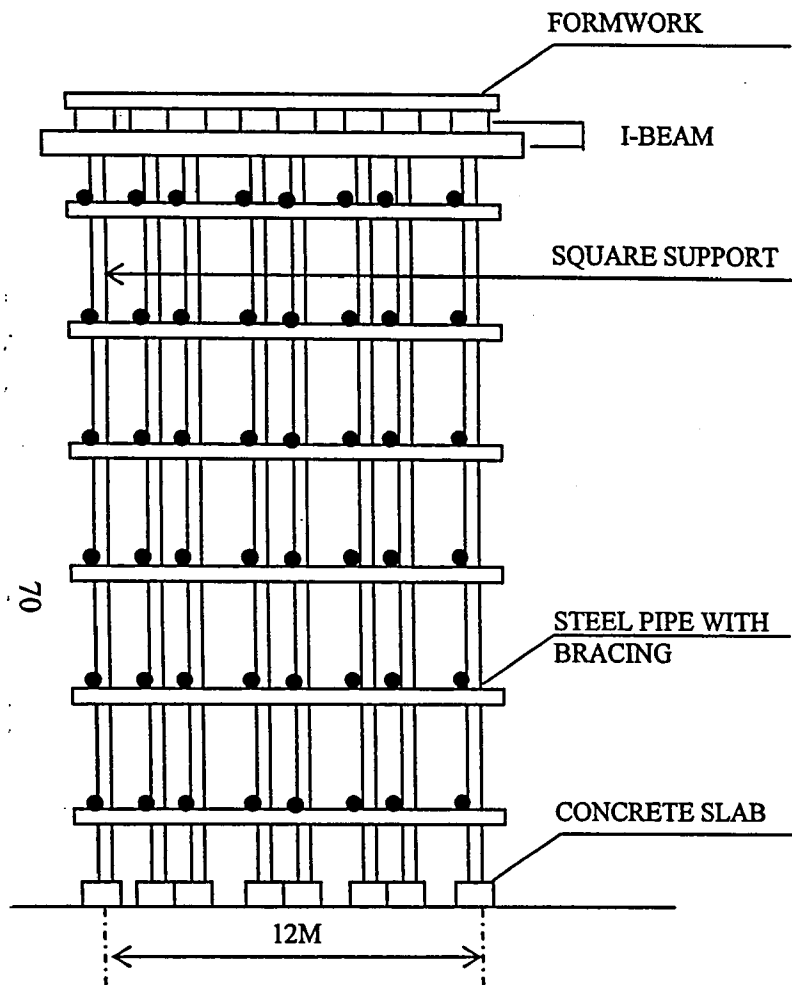
Figure 6.2:
CONDITIONS OF STAGE 1
FALSEWORK BEFORE COLLAPSE

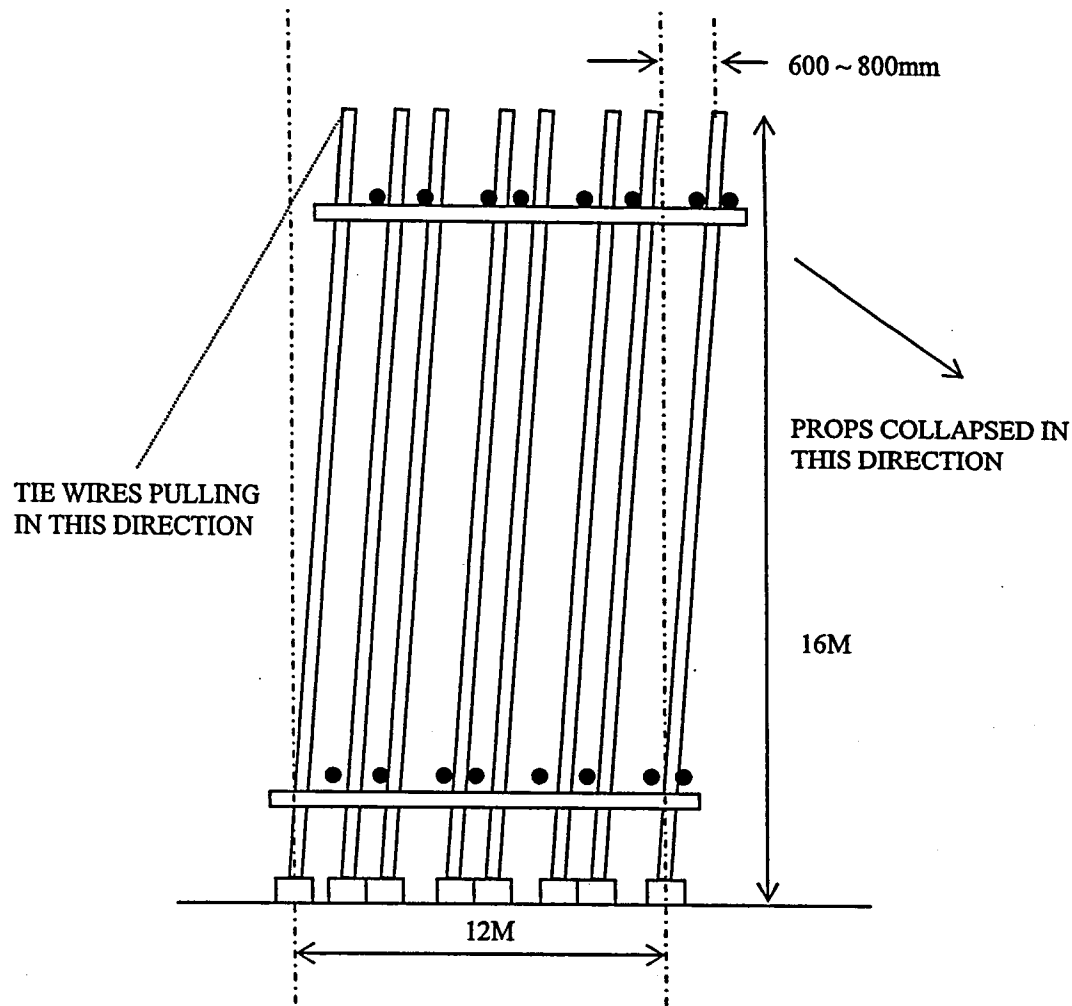
Figure 6.3:
STAGE 2 FALSEWORK LEANED TO
SOUTH

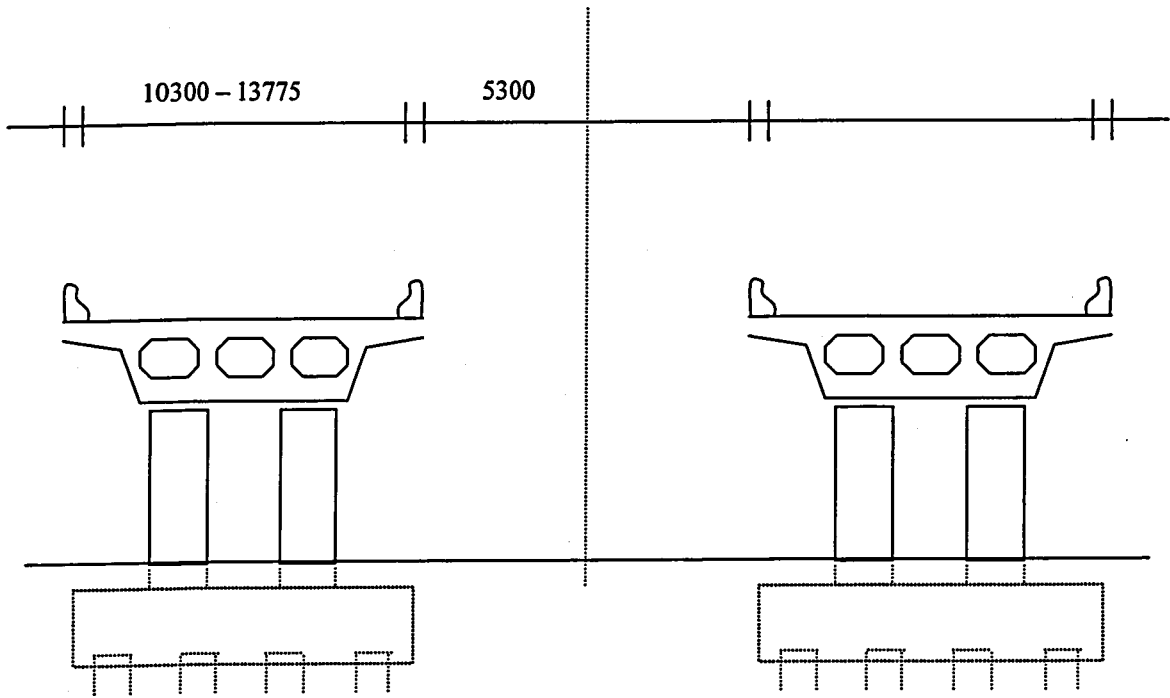
The fourth span, being the uppermost and with tubular scaffolding below, rotated about the continuous support and fell to the ground. The second span was retained by the much stronger steel frame structure which was erected to provide access below the deck during construction. The first span, which was at a greater distance away, had had similar damages as the second one. Fortunately and miraculously, no one was hurt during the collapse.

Figure 6.5: Section of the collapsed bridge, Taipei, Taiwan

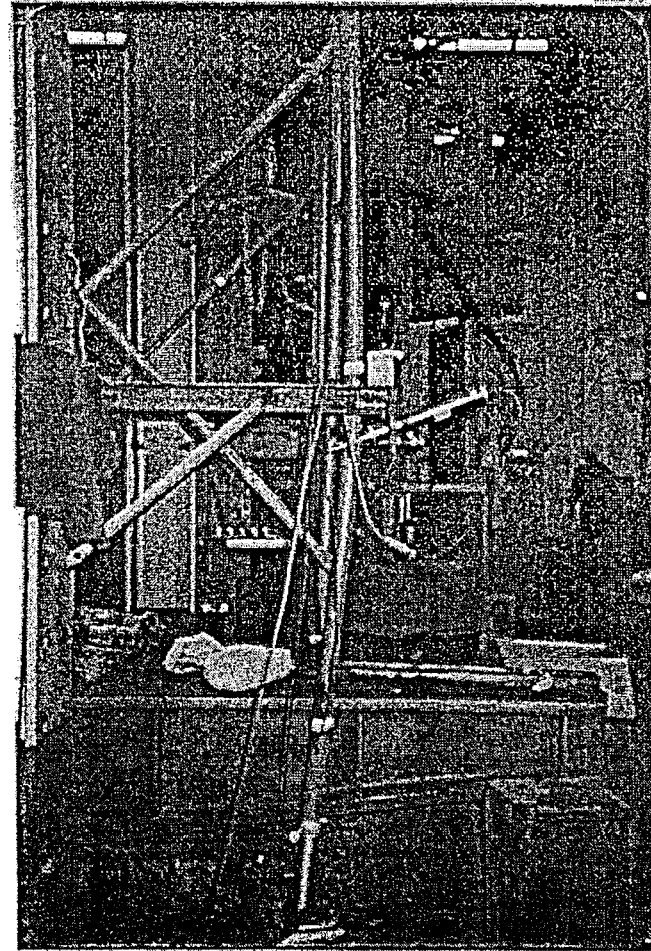
Photo 7.2 Failure of scaffold

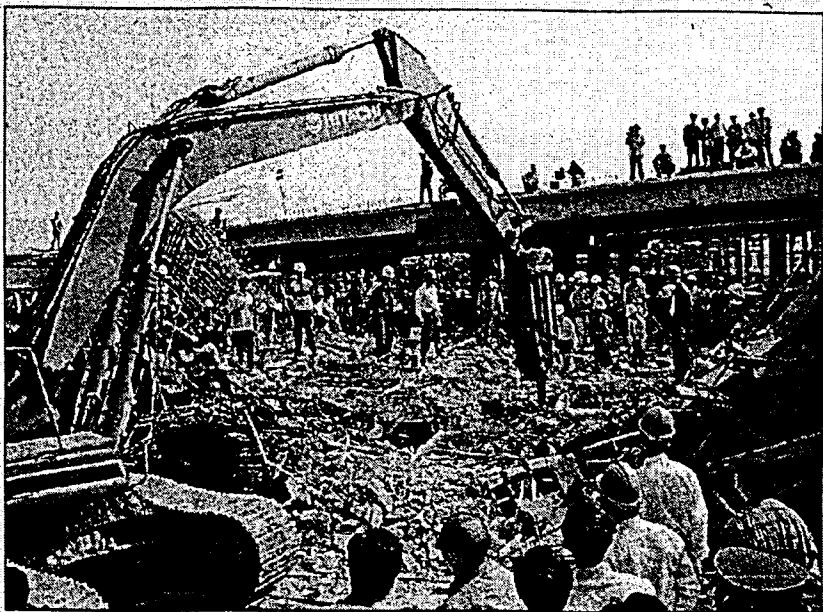
事故原因仍未有調查結論，但有關專家認為，事故原因和橋身負重過荷有關。專家指出，該橋八十公分厚的混凝土本應分兩次倒，等第一層厚四十公分的混凝土凝固後，橋樑鋼筋能承受部分重量，才能倒第二層混凝土。但調查顯示，施工過程中，八十公分的混凝土是一次過就傾倒下的，致使橋身過重，橋樑下支撐的木方斷裂，引致塌橋事故。

在廣州東圃高速公路塌橋意外現場，搶救隊調來液壓破碎機參加挖掘工作。

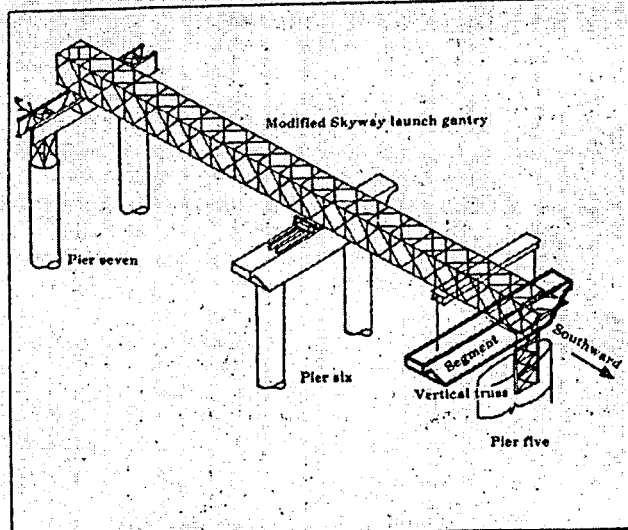
ABOVE: The first segment was being placed as the failure occurred. RIGHT: Section through pier five gantry support.

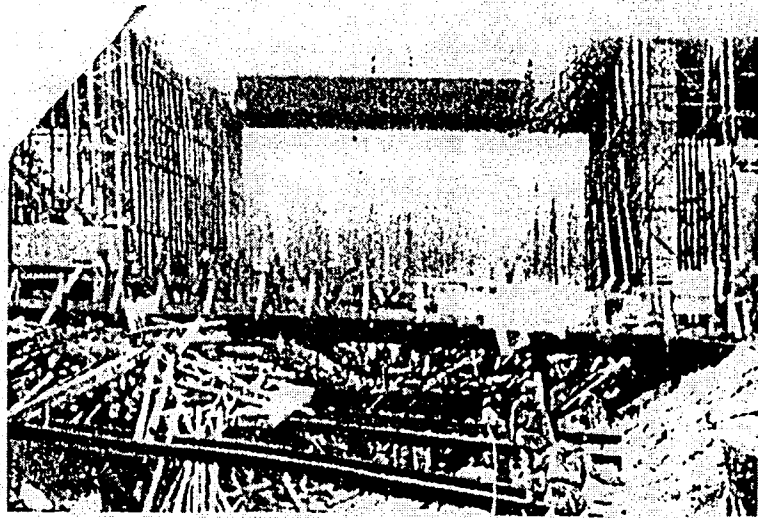
Failure in center span support frames during concreting may be cause.
