Lessons learned on the diagnosis of pathologies in concrete dams: 30 years of research and practice

Summary

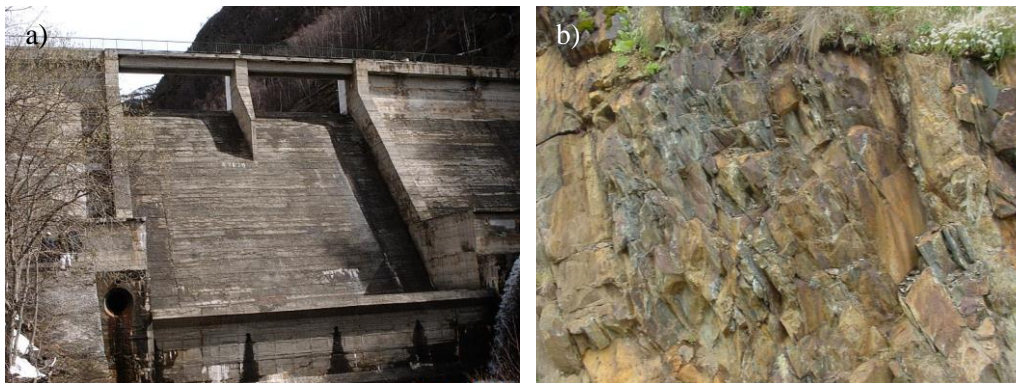
Case study I (Figure 1a) was selected due to the magnitude of the non-recoverable displacements and the singularity of the pathology - a combination of two expansive reactions with different kinetics. This concrete-made, gravity dam was built from 1968 to 1971 and presents a straight shape in the top view, with a crest length of 102.4 m and a height of 28.9 m. The dam is divided into 1 block (number 1) that is 12.4 m wide and 6 blocks that are 15.0 m wide (numbers 2 to 7). The dam presents one gallery and the reservoir has a capacity of 0.33 hm³. Slate and phyllites are the predominant surrounding geologic formation (Figure 1b), which is also the most likely source of the aggregates to produce the concrete used in the dam. This hypothesis was later confirmed by the historical construction records and by the microstructural analyses performed.

Figure 1. a) General view of the downstream face in 2005 and b) slates found near the dam.

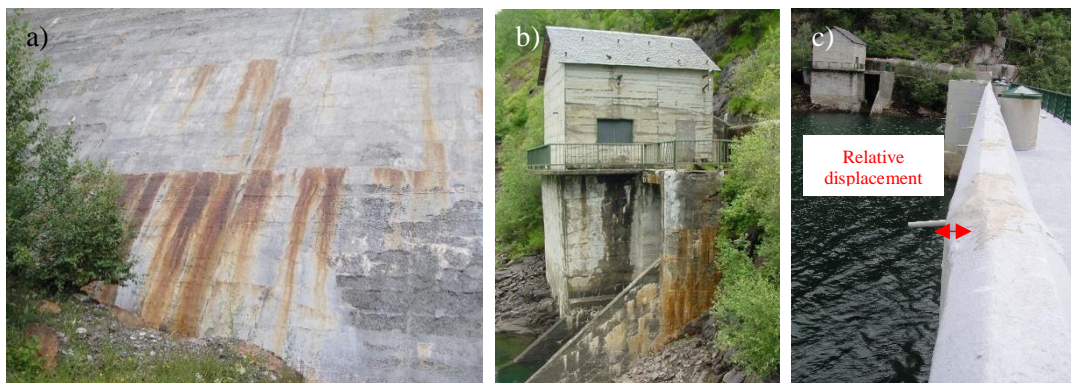
Several visual inspections conducted over the years indicated signs of damage in the dam (both externally and internally in the gallery). Externally, map cracking was clearly visible in the downstream face of the dam, combined with deposition of ochre shading precipitates (see Figure 2a) most likely related to the oxidation of iron sulfides from the aggregates used in the concrete. The same was also detected in nearby auxiliary structures, such as shown in Figure 2b.

Figure 2. a) Map cracking in the downstream face and ochre shading precipitate found in 2011, b) same signs in auxiliary structure inspected in 2004 and c) relative displacement between blocks.

Additional evidence of a pathology was detected in the crest, where fixed elements such as the safety railing suggested relative displacements between the blocks. This is clearly visible in the picture taken in 2011 from the crest of the downstream face (Figure 2c) despite the maintenance operations performed in previous years. Periodical visits to the gallery of the dam allowed assessing the state of the concrete inside the dam, which also exhibited cracking and deposition ochre shading precipitates, as shown in Figure 3. Upon entering the gallery, a strong sulfur-like odour is perceptible - an evidence of the presence of sulphides precipitates in combination with a potential biologic action.

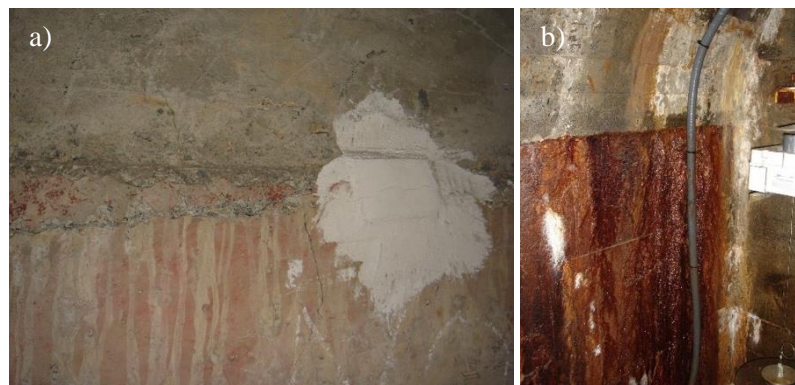
Figure 3. a) Cracking and b) ochre shading precipitate in the gallery.

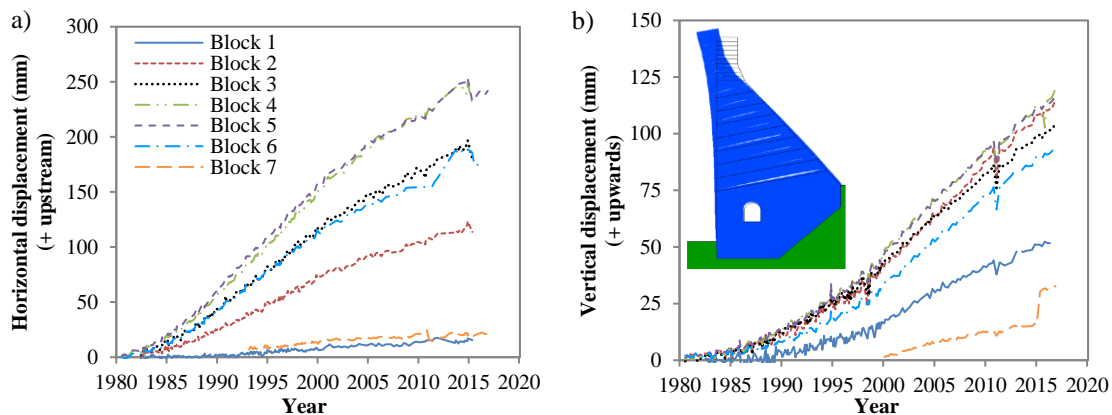
Figure 4 shows the evolution of the vertical and the horizontal displacements at the crest of the dam since 1981 for Blocks 1 to 7. The curves reveal significant, non-recoverable displacements in both directions. Horizontal displacements towards the upstream direction are approximately 2 times bigger than the upward vertical displacements. Until 2015, the former reaches 249 mm, whereas the latter approach 115 mm in blocks 4 and 5. Based on the authors' experience, such displacements are remarkably large for a dam with only 28.9 m of maximum height, equating to an average vertical strain of nearly 4‰. Notice that this strain is beyond the limit strain in compression typically allowed for concrete in structural design codes (e.g. Euro Code 2 that indicates 3.5‰ for normal strength concrete in the ultimate limit state).

Figure 4. Evolution of a) horizontal and b) vertical displacements including a schematic representation of the displacements [11].

However, a different trend is observed from 1993 to 2017. While horizontal displacements at the crest of Block 5 increased by almost threefold, vertical displacements increased by fivefold (see Figure 4). Additionally, in 2009, cracks in the vertical shafts and non-recoverable displacements (approximately 10 mm) in the gallery were also observed. This gallery is located at a low level, near the reservoir and close to the upstream face, where the availability of oxygen should be limited. Such evidence contradicts the expected due to the ISA, suggesting the presence of another deleterious phenomenon.

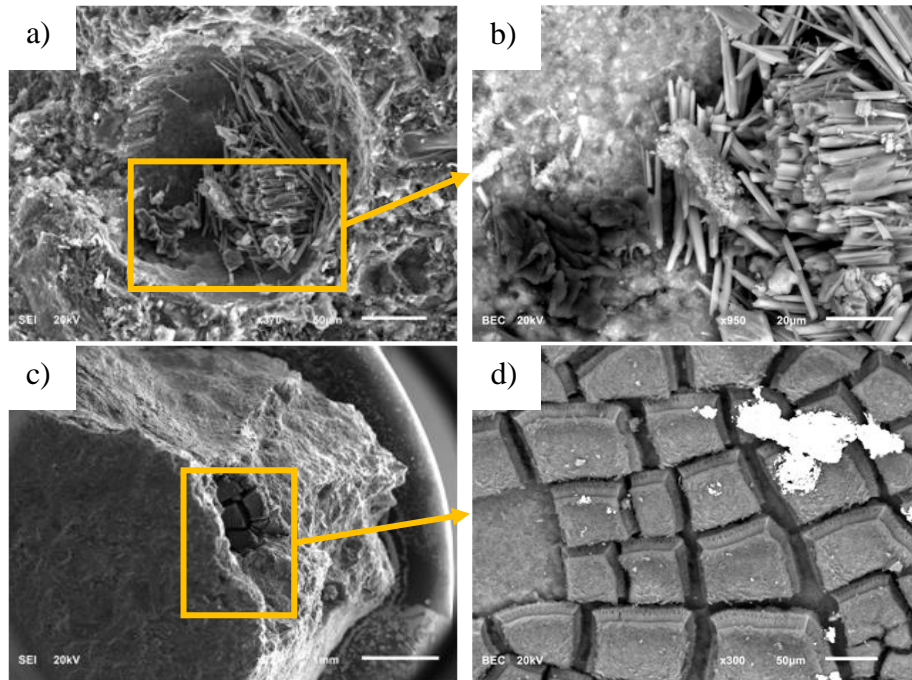
To verify this hypothesis, samples extracted from the dam in 2011 were characterized by scanning electron microscopy (SEM). As an example of some of the results obtained in this study, Figure 5 shows SEM images of two samples. Figure 5a and 5b show a pore of the concrete matrix with ettringite needles (confirmed by Energy Dispersive X-Ray Analysis - EDX), potentially a consequence of the ISA. Figure 5c and 5d show a region of the sample where alkali-silica gel from the AAR was found (confirmed by the EDX analyses). In several samples, the gel was covering the ettringite needles, thus suggesting that the ettringite was formed prior to the gel. These findings support the hypothesis described above, suggesting that the bulk of the ettringite

formation due to the ISA came first and was succeeded by the gel formation in the AAR. This hypothesis was also confirmed through numerical simulations [15].

Figure 5. SEM from samples of concrete from the dam: a) pore, b) detail of the pore with ettringite, c) area with alkali-silica gel and d) detail of the area confirming the presence of the gel.

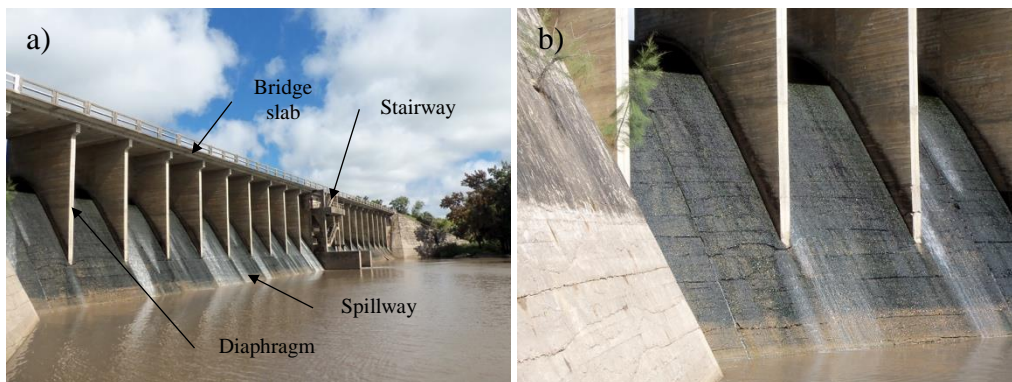
Figure 6. a) General view of the downstream face and b) detail of the horizontal cracking in the spillway and retaining walls.

At the time of the study, the spillway exhibited horizontal cracks along the construction joints in the downstream (see Figure 6b) and visible area of the upstream faces. These cracks were already reported in 1989 and 1996, being described as non-continuous since no water egress was identified. Map cracking was also observed at the upstream face (see Figure 7a) and the walls of the dykes (see Figure 7b).

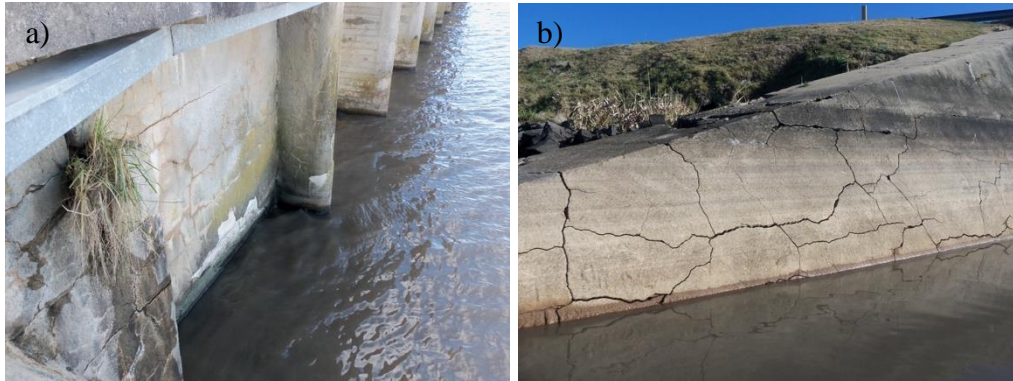
Figure 7. a) Map cracking in the upstream face and b) at the walls of the dykes.

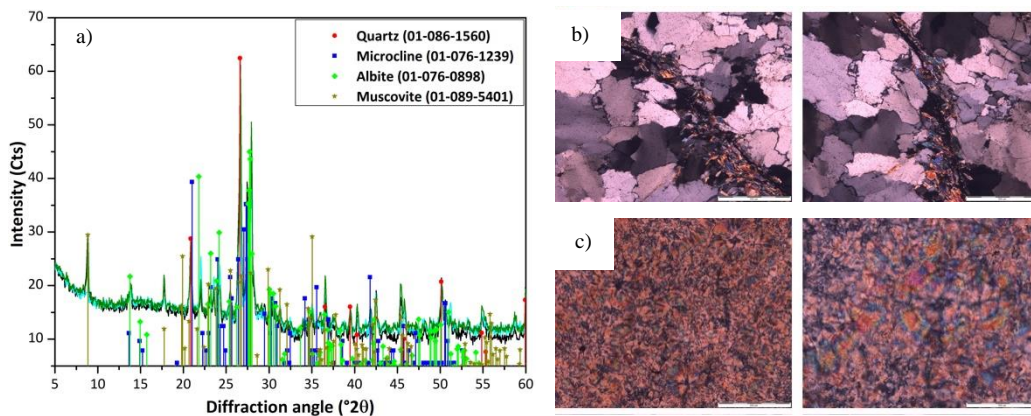
Among the 16 aggregate samples analysed with XRD, 12 were identified as quartzitic rocks given that quartz was the main crystalline phase. Feldspar was also detected as a minor phase in 11 of the quartzitic samples but it was not possible to identify the specific type of feldspar. The other aggregate samples were quartzitic schists with a large presence of feldspars (albite) and variable quantities of mica (muscovite). No other crystalline phases were identified. Figure 8a shows the XRD patterns of the quartzitic schists. The analyses of five thin sections with the optical microscope confirms the presence of quartz, albite and mica. Undulate extinctions, which are a characteristic feature from quartzitic samples with small size crystals and dislocations, were also identified (see Figure 8c). Additionally, one sample exhibited a fibrous structure that is typical of chalcedony with microcrystalline grains (see Figure 8b). Also, some of the samples with feldspars contained clayey phyllosilicates, which is a sign of alteration.

Figure 8. a) XRD patterns of the quartzitic schists, b) quartzitic aggregate sample with the presence of chalcedony and c) undulate extinction characteristic from quartz.

All the above indicates that the aggregates selected are not adequate to produce concrete, suggesting a potential reactivity with the alkalis of the cement. Even though amorphous silica was not observed, other characteristics described in the literature as signs of possible alkali-silica reactivity were detected. Moreover, the reactivity of the aggregates was confirmed through accelerated mortar bar tests [16]. Further detail on the tests and the results obtained may be found in [1].

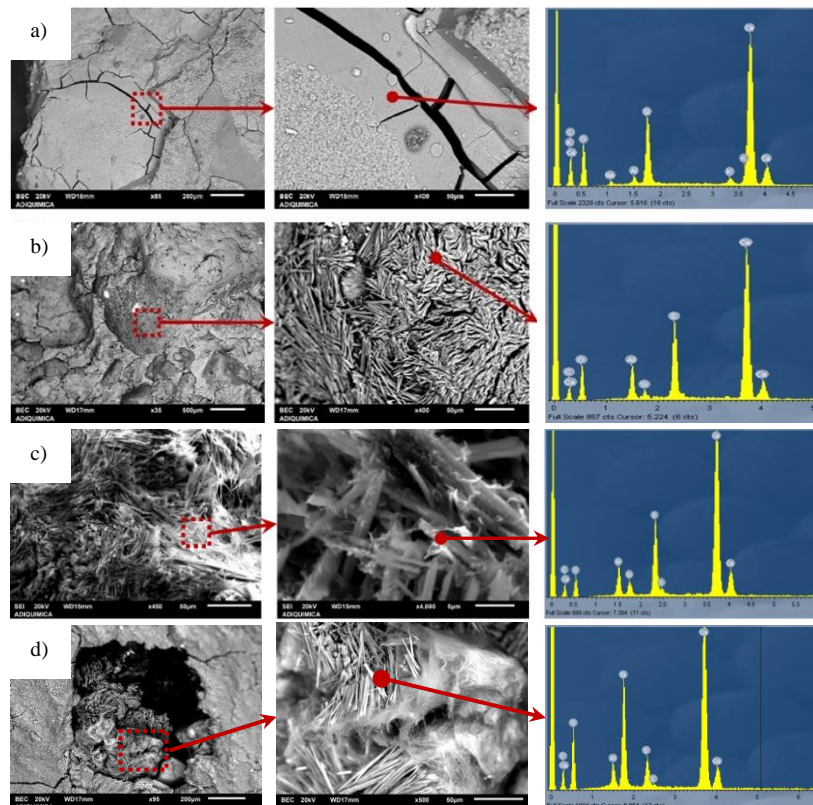
Abundant AAR gel was found in the SEM and EDX analyses of all samples (see Figure 9a). The high relative intensities of potassium and calcium peaks suggest the reaction was in an advanced stage since the concentration of these ions in the gel tends to increase as the reaction progresses [18]. In some cases, the gel appeared together with ettringite, which was dispersed in the cement paste and precipitated in pores (see Figure 9b). In some samples, ettringite needles are covered by different neoformed products whose morphology and composition suggest a product of the ASR in an initial stage of the reaction (see Figure 9c). Ettringite was also found in the form of long, well-defined needles inside pores (see Figure 9d).

Figure 9 SEM images of mortar samples: a) AAR products, b) ettringite, c) ettringite covered by AAR products and d) long ettringite needles inside a pore.

The high content of ettringite and its distribution throughout the matrix suggest a delayed ettringite formation (DEF). Previous studies reporting DEF show similar SEM images [19,20].

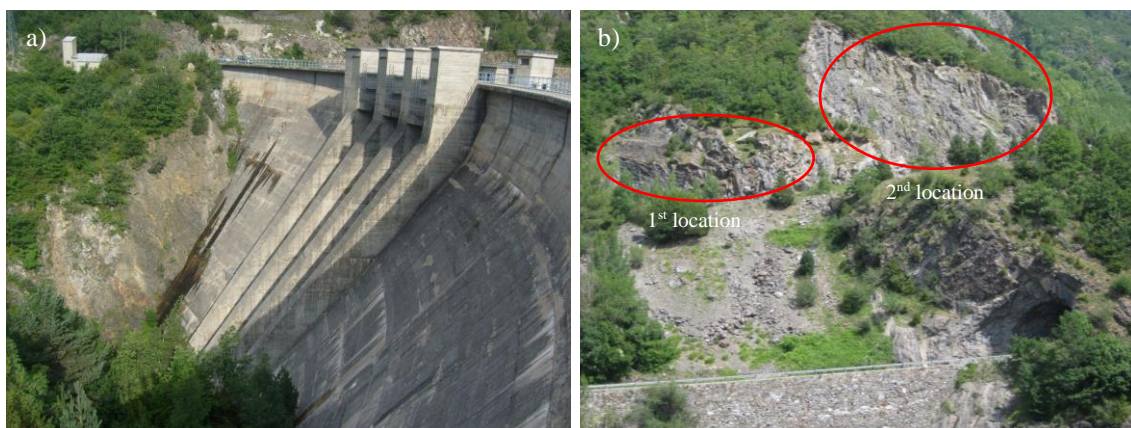
Case study III was selected given the peculiarities of the internal sulfate attack in the dam, which is not generalized in the downstream face but localized in certain areas where a specific type of aggregate was used. This study corresponds to an arch-gravity dam (see Figure 10a) built in 1969 that is 72,6 m high and whose crest is 195 m long. The dam is divided into 12 blocks containing 4 main longitudinal galleries connected by an additional perimeter gallery. The reservoir has a capacity of 3 hm³. The dam is in an area with sedimentary and metamorphic rocks such as slate and limestone (in some cases with calcite veins or quartz). The historical records indicate that the concrete was produced with aggregates from the area, extracted from 2 different locations of the same quarry (see Figure 10b).

Figure 10. a) General view of the downstream face in 2008 and b) view of the quarry and locations for the extraction of aggregates.

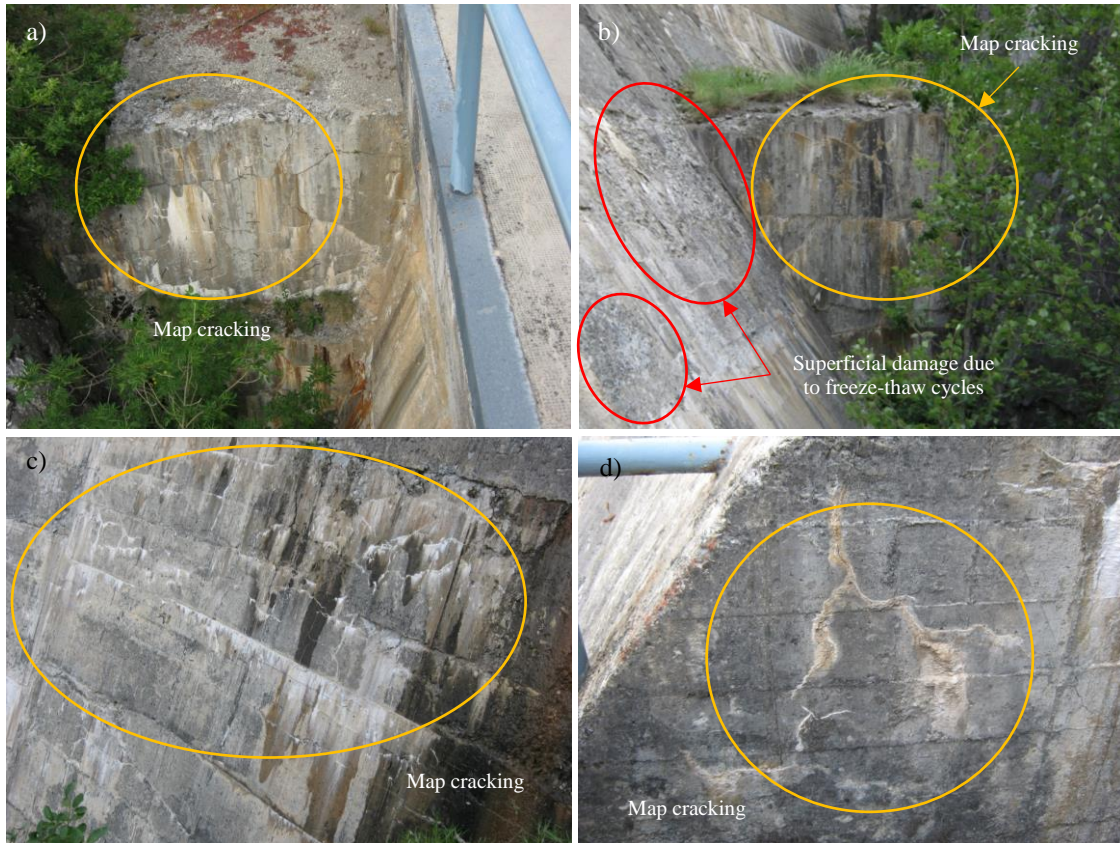
In the visual inspection, degradation due to different phenomena was observed in the downstream face. On one hand, superficial damage due to freeze-thaw cycles was detected, as shown in Figure 11b. On the other hand, map cracking and ochre shading precipitates appeared in the blocks near the abutment (Figure 11a and 11b), both in the downstream face (Figure 11c) and in the entrance to the upper gallery (Figure 11d).

Figure 11. Map cracking localized in specific areas of the dam: a) block beside the right abutment, b) block beside the left abutment, c) downstream face and d) entrance to the upper gallery.

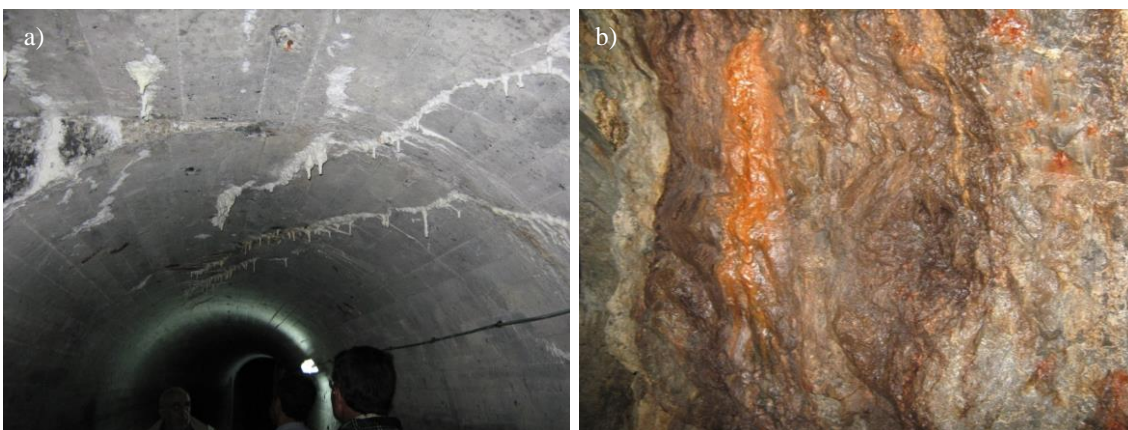
Inside the dam, oblique cracks were observed in the upper gallery (level 1350 m) near the left abutment, as shown in Figure 12a. In the second gallery (level 1330 m), inside the right abutment, the rock exhibits signs of oxidized iron sulfides (see Figure 12b). This phenomenon was also detected in the two lower galleries (at levels 1311 m and 1292 m).

Figure 12. a) Oblique cracks in an upper gallery near the left abutment (level 1350 m) and b) state of the rock in the right abutment seen from the second gallery (level 1330 m).

In the upper gallery near the left abutment, the dam exhibits oblique cracks that are usually associated with torsion forces. Torsion may occur in a block of the dam due to differential displacements within the block or due to the interaction with the abutments or other blocks that exhibit different behaviour. The fact that the expansions due to ISA are localized in certain areas of the blocks (hatched region in Figure 14) supports this argument. Furthermore, in the case of the cracks located in the upper gallery, the block between joints J12 and J13 presented clear signs of ISA (see Figure 12b) and could, consequently, contribute to a torsion effect of adjacent blocks.

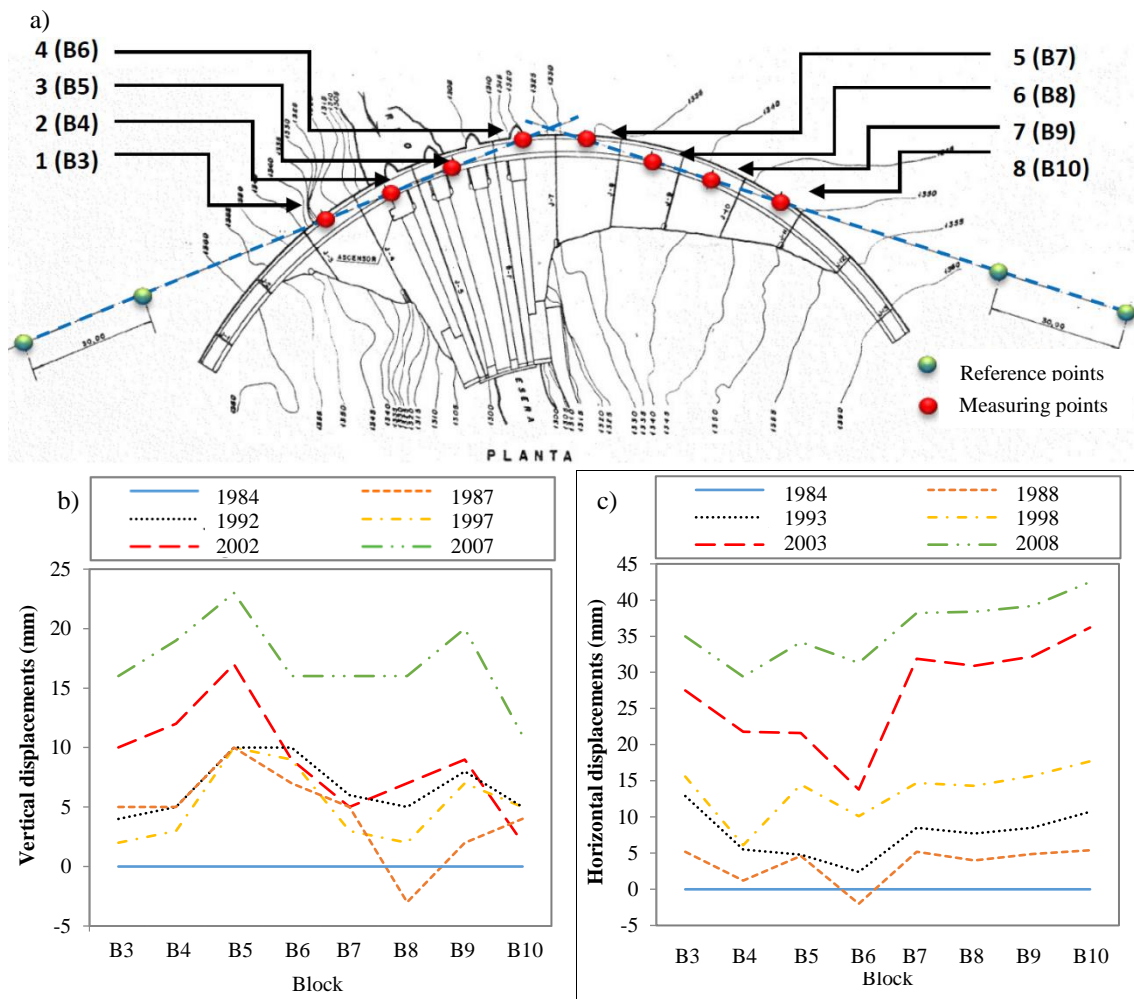
Figure 13. a) Location of points of measurement and blocks [11] and b) vertical and c) horizontal displacements per block at the crest of the dam.

The curves indicate that the displacements of the dam are non-recoverable, reaching vertical values of 23 mm in B5 and horizontal values of 42.5 mm in B10. Notice that displacements caused by expansive reactions are usually symmetric when plotted as in Figure 13 (if the dam is symmetric) and proportional to the height of the dam (see case study I). In other words, the central blocks usually present the largest displacements with regards to the blocks near the abutment, which contradicts the behaviour observed in this case study. Consequently, the curves in Figure 13 suggest that, in this case, the dam presents a non-uniform response either due to the material or the interaction with the soil.

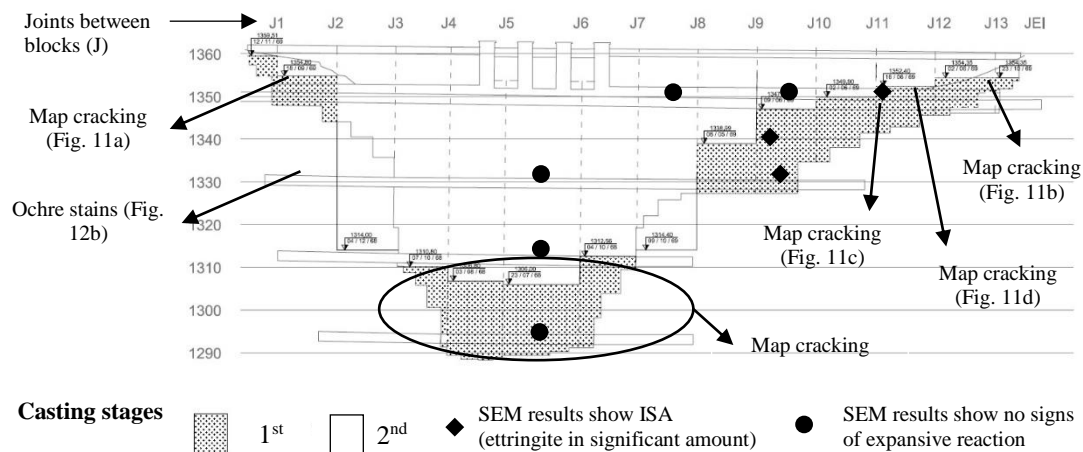
This dam is an example of the importance of reviewing “clinical history” to reach a successful diagnosis (see Table 1). Historical records indicate that the aggregates used in the concrete were obtained from two locations at the quarry near the dam (see locations in Figure 10b). Figure 14 depicts the areas of the dam constructed with aggregate from each location and the position of the most significant damage found in the visual inspection conducted in 2008. The aggregates extracted from the first quarry location shown in Figure 10b were used to produce the concrete for the first stage of construction (hatched areas in Figure 14). Aggregates from the second quarry location shown in Figure 10b were used in the following construction stages (white area in Figure 14). Interestingly, all signs of damage were detected in areas corresponding to the initial stage of construction.

Figure 14. Stages of construction depending on aggregates used.

Therefore, it is possible that the aggregates used during the first stage of construction were potentially more reactive and led to expansive reactions in the concrete. This hypothesis was supported by the current state of the rocks in the quarry, which exhibited signs of oxidation of iron sulphides in the first location, whereas rocks in the second location remained unaltered. An experimental program was conducted on concrete samples extracted from the dam using SEM and EDX to verify the presence of an expansive reaction. Figure 14 shows the location of the extraction points classified as without (marked with the symbol ●) or with (marked with the symbol ◆) signs of expansive reaction based on the microstructural and mineralogical analysis. All samples with signs of expansion were in the region within the 1st construction stage, having iron sulfides in the form of pyrite and a significant amount of secondary ettringite either filling cracks and pores or on the surface.

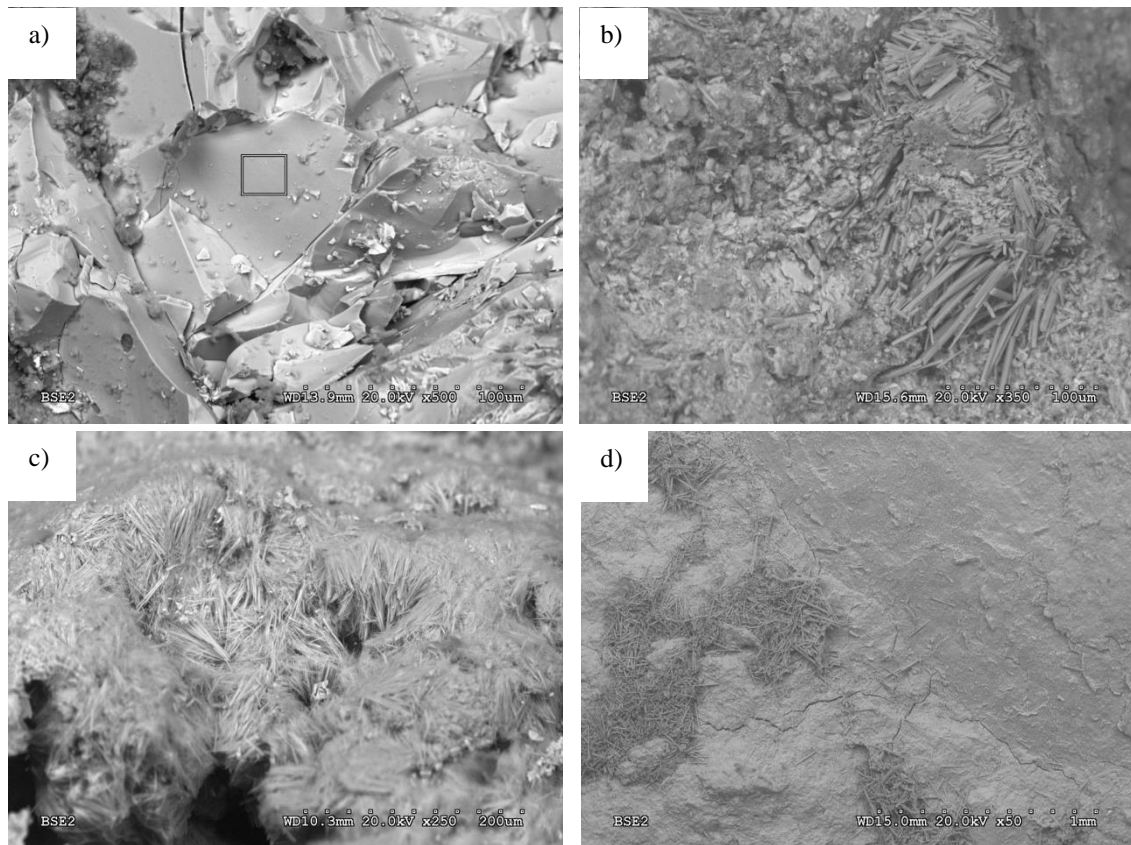
Figure 15a shows iron sulfides in a sample located in the second gallery (level 1330 m) between J9 and J10, near the left abutment (see Figure 14). The microanalysis with EDX confirmed this was pyrite. Figure 15b shows ettringite needles found in the same sample. Figure 15c corresponds to a sample obtained from the upper gallery (level 1351 m, see Figure 14) also in the area cast during the 1st stage and shows a significant amount of ettringite needles. Figure 15d was obtained from a sample that exhibited a halo around the aggregate associated to a possible AAR. The SEM and EDX analyses confirmed the presence of AAR gel and ettringite needles. The limited formation of gel suggests an incipient AAR.

Figure 15. a) Iron sulfides, namely pyrite, b) c) ettringite needles and d) ettringite needles and AAR gel.

Such outcome confirms an ISA in the concrete corresponding to the first stage of construction due to the iron sulfides contained in the aggregates used at that stage, which justifies the unusual characteristics of some of the signs of damage (e.g. map cracking localized in certain areas downstream face and the non-symmetry displacement of the dam).

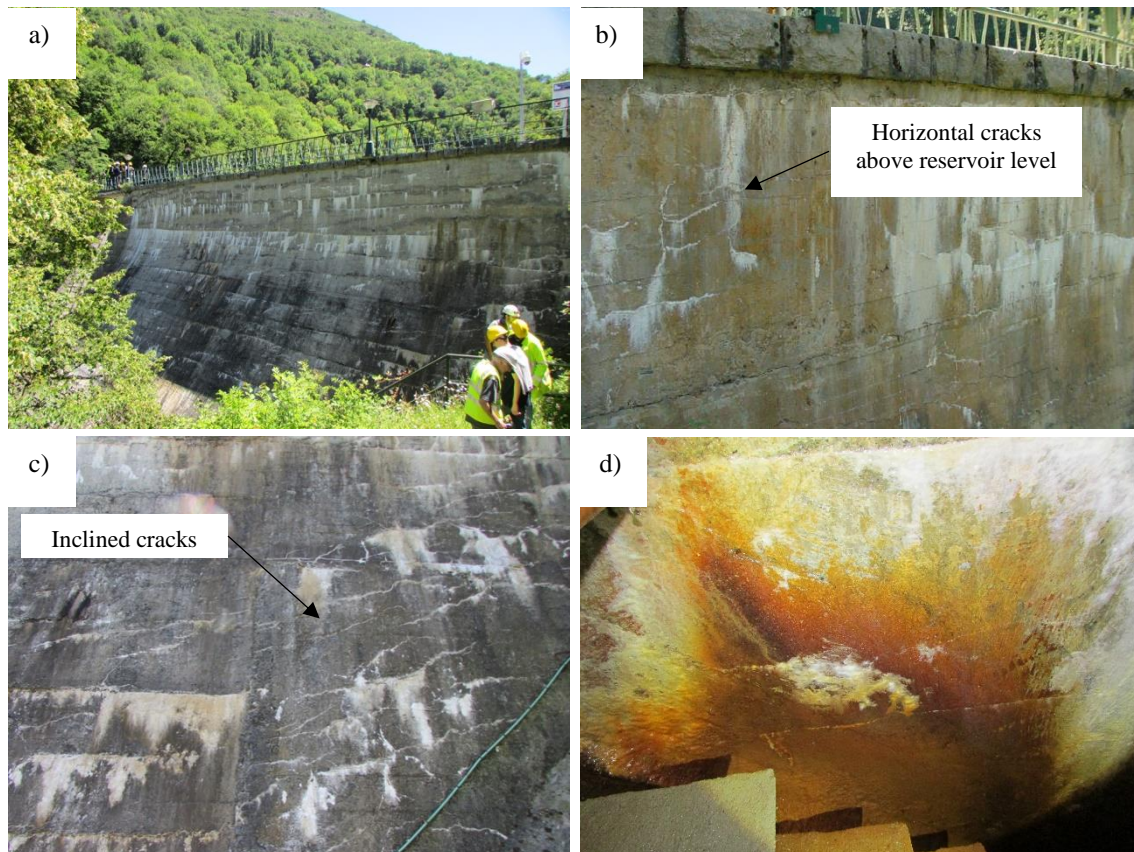
Figure 16. a) General view of the downstream face, b) map cracking at the downstream face, c) inclined to crack near the abutment, d) stains associated with oxidization of iron sulphides at gallery wall.

Field inspections conducted over the years revealed map cracking in the downstream face and auxiliary elements of the dam. Either horizontal (see Figure 16b) or slightly inclined cracks were observed near the crest of the dam, at the downstream face. The inclination of these cracks increases near the abutments, as shown in Figure 16c. Despite the application of a waterproofing layer during maintenance operations, a photograph taken in 1984 confirmed the existence of these cracks also in the upstream face above the water level. The white precipitates in the cracks (Figures 16b and 16c) indicate the accumulation of calcium carbonate. In the gallery of the dam, horizontal cracks were also detected on both walls (on the downstream and upstream sides). Additionally, the concrete walls exhibited stains commonly associated with the oxidization of iron sulphides, as shown in Figure 16d.

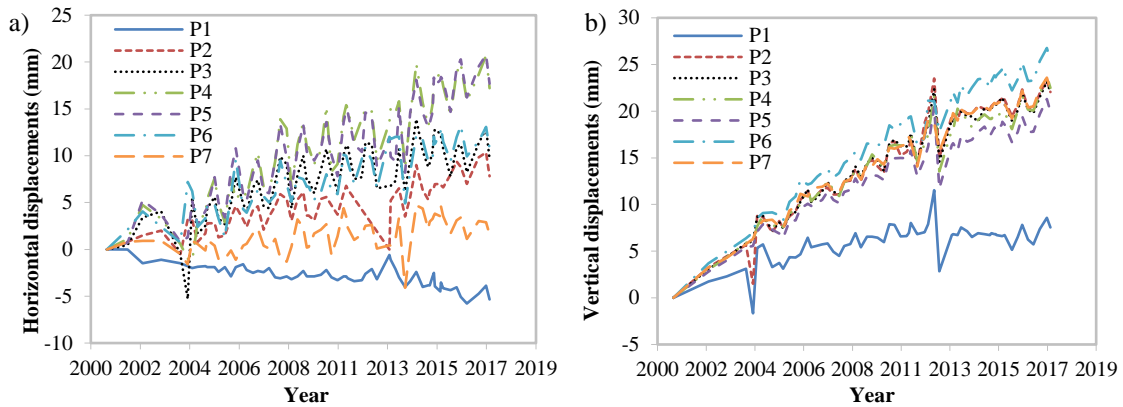
Figure 17 shows the displacements measured at the crest of the dam from 2000 to 2017 (previous measurements were not available). The analysis of the data reveals non-recoverable movements, beyond the cyclic variations due to thermal effects or the level of the reservoir. The central blocks of the dam (Blocks 4 and 5) accumulated horizontal displacements towards upstream of 20 mm in the period (monitoring points P4 and P5 in Figure 17a, respectively). The opposite behaviour is detected for the blocks located near the abutments that presented either displacement with small variations around 0 mm (monitoring point P7 near left abutment) or towards downstream (P1 near the right abutment). Figure 17b indicates that all monitoring points, except for P1, register a non-recoverable upward movement of the blocks. This elevation ranges from 20 to 25 mm in the period considered. Considerable smaller vertical displacements are observed in P1, near the right abutment. This may be attributed to the smaller size of the block combined with the influence of the restraint applied by the rock.

Figure 17. a) Horizontal and b) vertical displacements registered in the period 2000-2017.

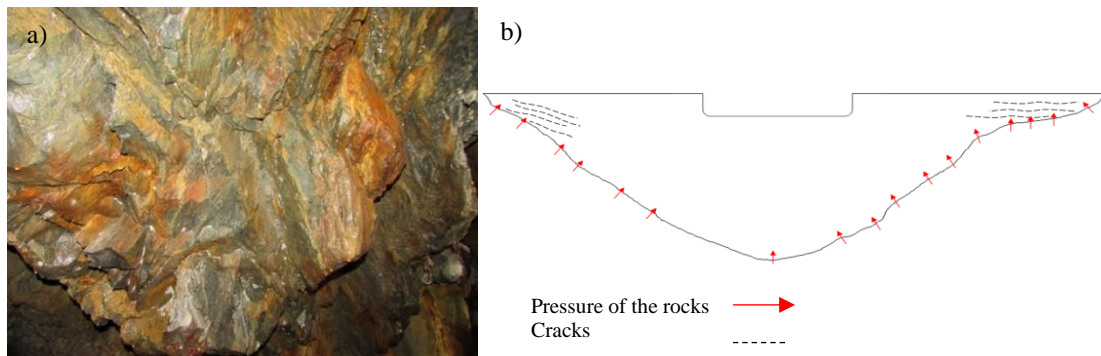
Several pieces of evidence described previously are consistent with an ISA, including map cracking, oxidization of iron sulphides and non-recoverable displacements towards upstream. The study of the historical records indicates that the aggregates used in the concrete were extracted from the local area, which according to the geological maps is predominantly constituted by slate and limestone. Moreover, during the field inspection of the gallery, rocks located in the left abutment exhibited signs of oxidization (see Figure 18a).

Figure 18. Detail of a) rock on left abutment and b) effect of the pressure of the abutments on the dam.
