Supplementary information files for In-situ comparison of high-order detonations and low-order deflagration methodologies for underwater unexploded ordnance (UXO) disposal

Underwater Noise Trial Denmark

EOD Report Annex A

Mine Foxtrot – High Order

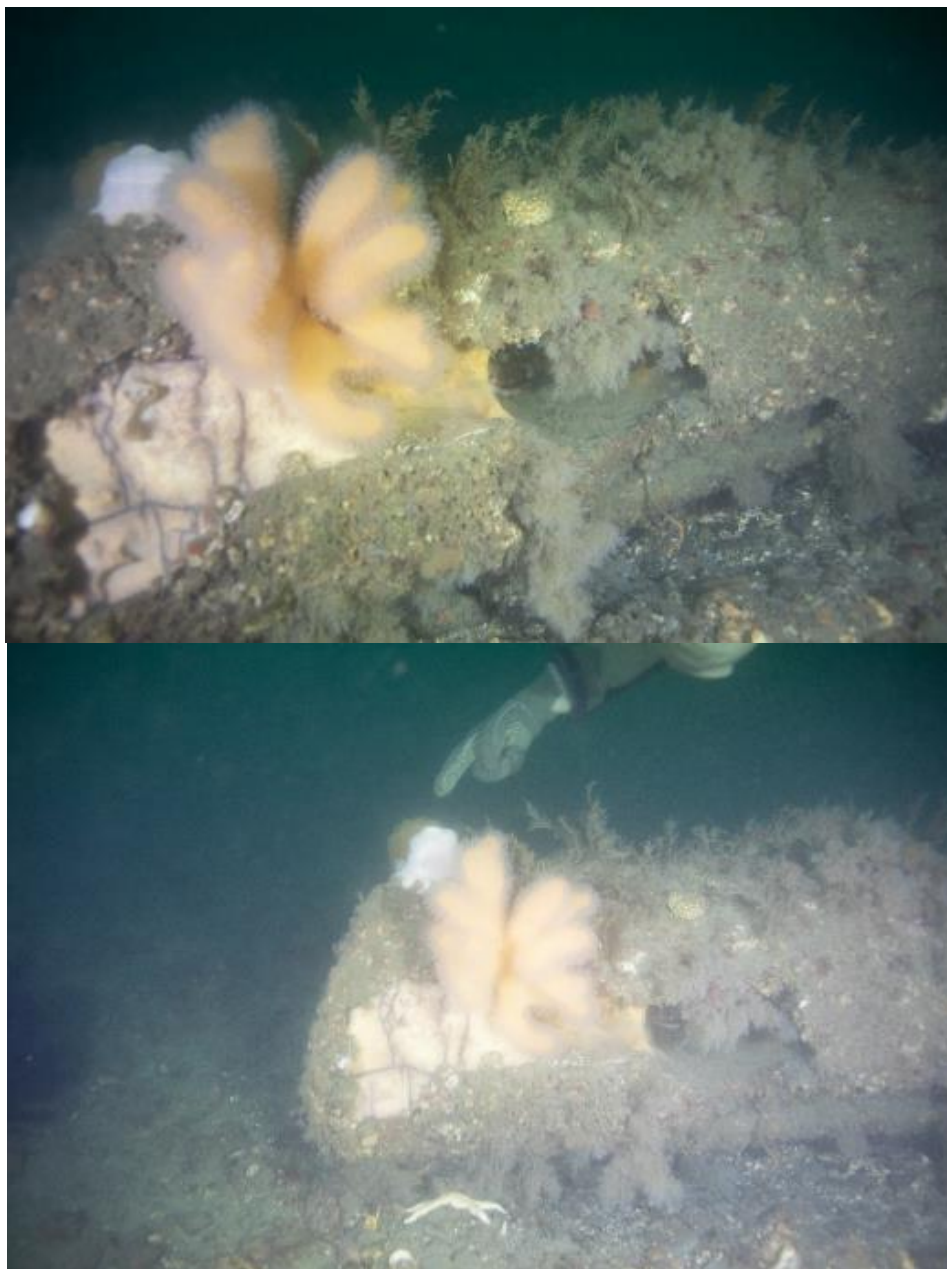
Figure 1: Mine Foxtrot Heavily Encrusted with Marine Growth. Mine Charge Case Corroded, Exposing a Brown Amatol Explosive Fill.

2.1 Mine Foxtrot was heavily encrusted with marine growth and the explosive section badly corroded with the exposed explosive filling being identified as Amatol. The diver estimated that approximately 60% of the explosive charge remained (Figure1)

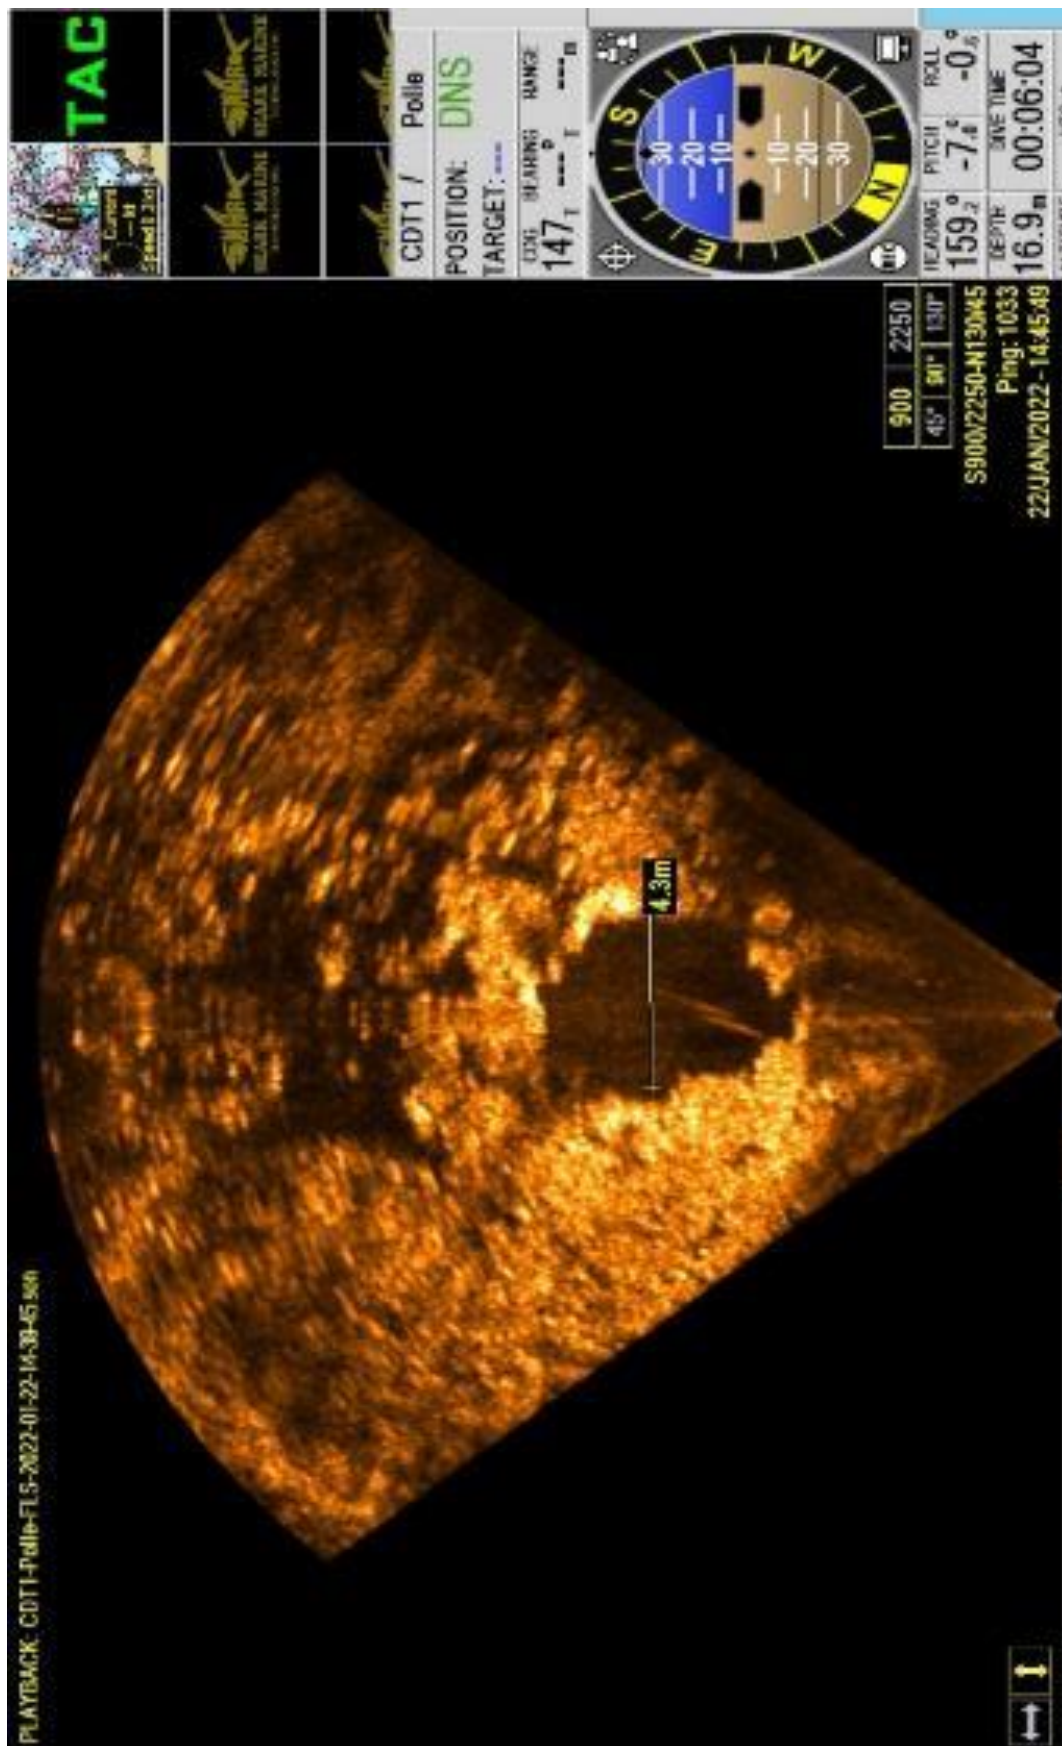
5.2 A diver survey with a Shark Marine held sonar recorded a significant crater (Figure 2), estimated to be over 4m in diameter and approx 1m deep.

5.3 Although the mine was in a very poor condition the crater size is conducive to a detonation of the estimated remaining charge weight of approximately 200Kg plus the 10Kg countermining charge. This indicated that whilst the Amatol explosive had been subjected to long term erosion and water absorption, it proved viable when subjected to the shock of the countermining charge.

Figure 2: - Shark Marine Sonar Image showing Foxtrot Blast Crater

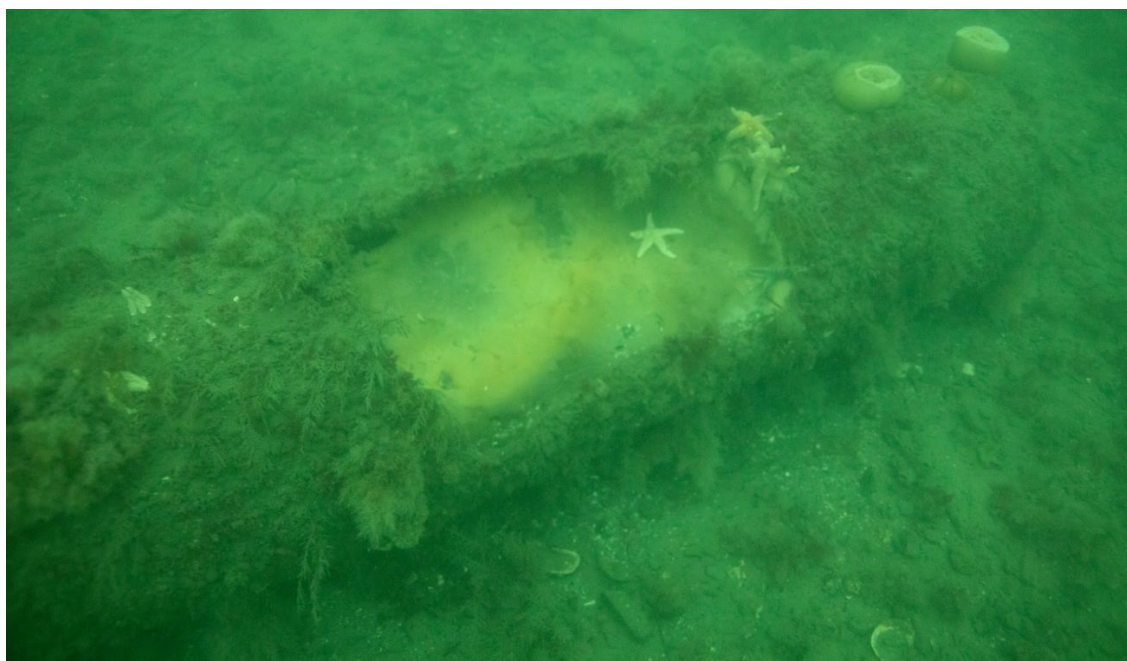
2.2 The explosive charge section was open to the environment which enabled the explosive content to be identified by its colour as Amatol. (Figure 1). The exposed explosive was estimated by the diver to have been reduced to approximately 80% of its original charge weight due to water ingress and erosion.

2.3 The mine's open condition presented a potentially difficult target for low order, because the gasses generated by deflagration could vent immediately instead of increasing the internal pressure in the mine body. This in turn was likely to quench the deflagration process and its subsequent disruptive effect.

Figure 1: Mine Golf Survey Recce showing exposed Amatol

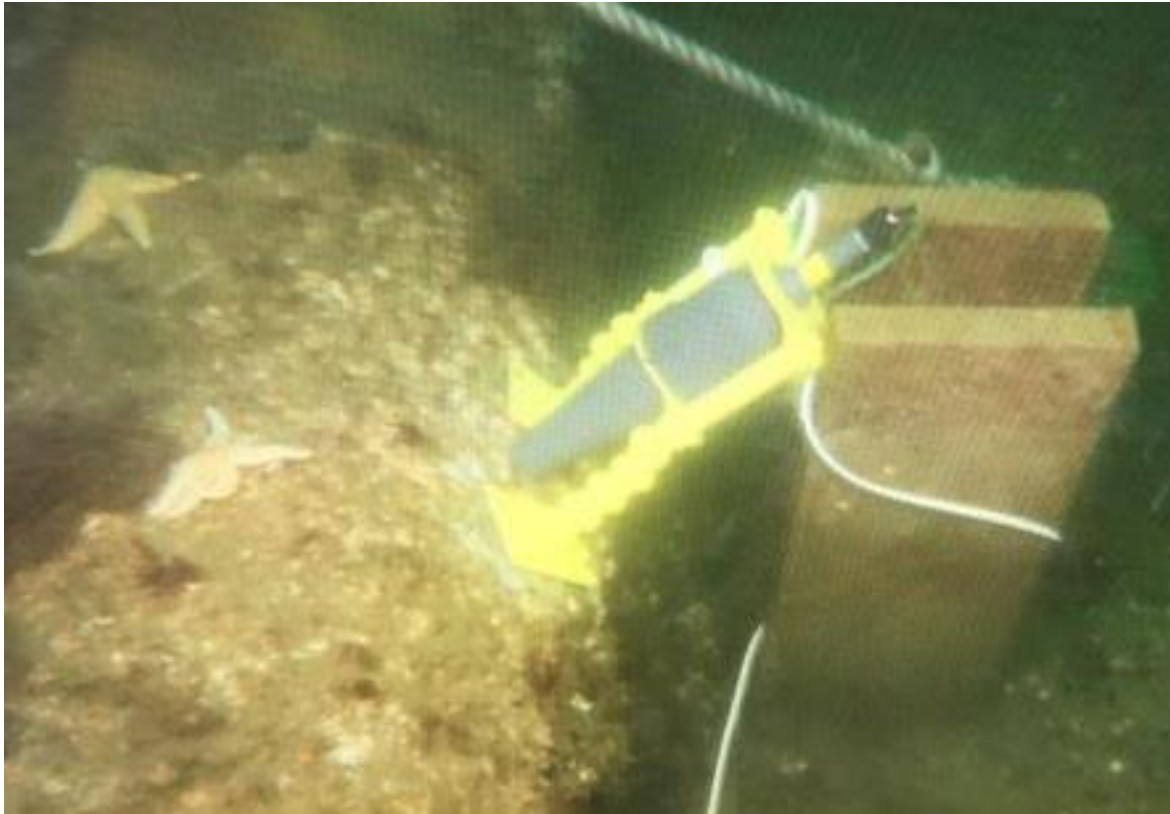
Figure 2: Mine Golf with Pluton Shaped Charge in Position Perpendicular, in the Centre of the Charge Case.

4.1 A Pluton 65mm modular shaped charge loaded with 250g Plastic Explosive and a low density, incendiary projectile was used with a fixed air stand-off capsule. The Pluton was positioned by a diver, perpendicular to the centre of mine charge section. It was secured initially with magnets, but subsequently had to be supported due to the amount of marine growth. The charge was initiated using an electric detonator & firing cable to the surface.

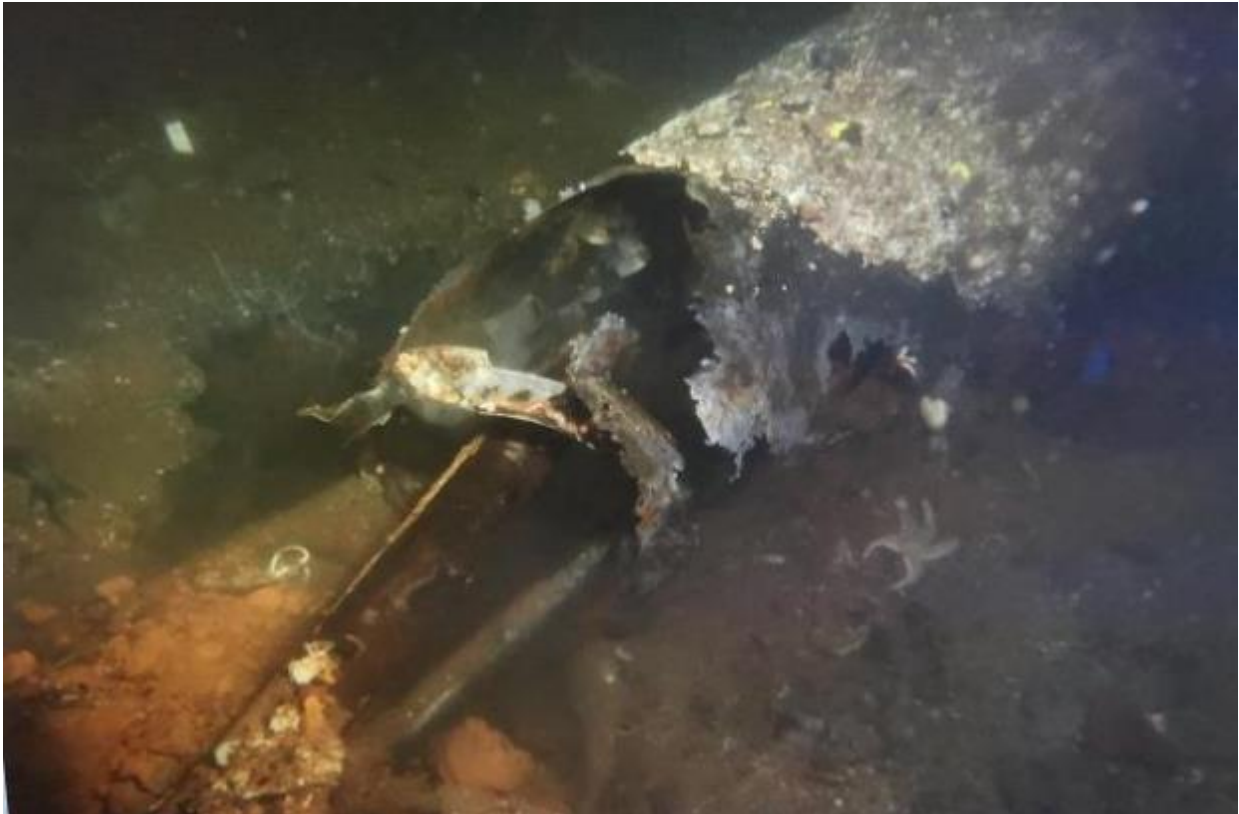
5.3 The remaining explosive section had been disrupted to the point where it was almost empty. A percentage of shattered explosives estimated at less than 10% of original NEQ, remained in the forward part of the mine (Figure 5). The original solid Amatol explosive main charge had been reduced in mass and volume by the process of deflagration and any that

remained, shattered into a loose, low-density mix of powder, granules, and lumps. This explosive residue was scattered in and around the remaining mine-carcass further reducing the original hazard.

Figure 3: Deflagrated main Charge Case showing that most of the Amatol main Charge has either burned or shattered and ejected.

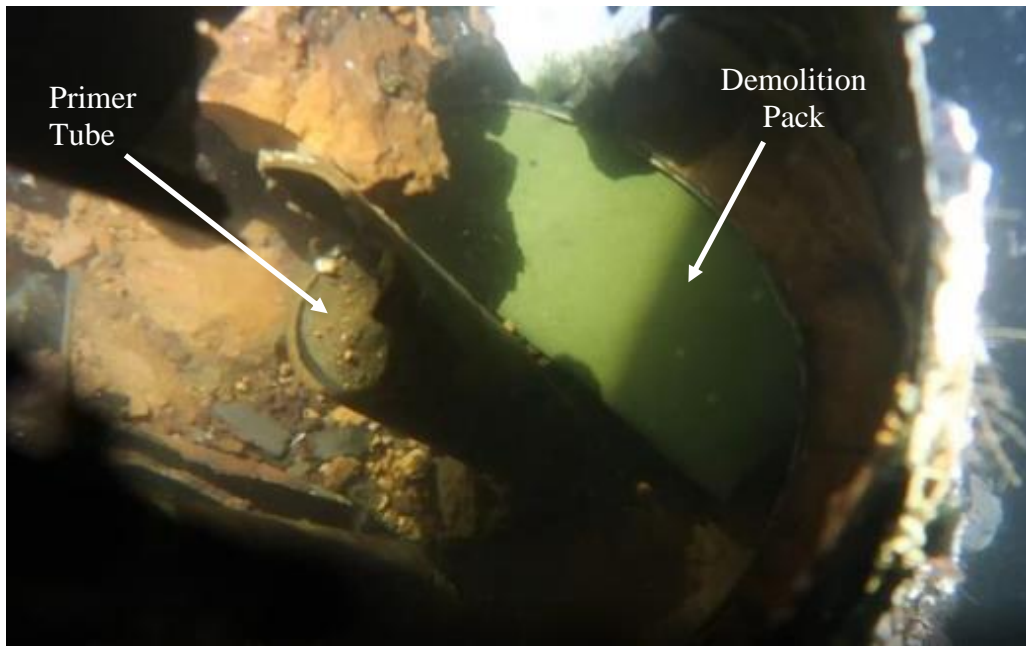
5.5 The Primer Tube had been severed, mid-point in-line with the projectile impact (Figure 4). This also meant that the detonator located in the rear of the primer tube was no longer explosively connected to the forward end of the mine. The severance of the primer tube is also significant because the Tetryl primers, contained in the bakerite tube were likely to have been in good condition and more sensitive to shock than Amatol.

Figure 4: The Bakelite Primer Tube visible Centre has been severed by the deflagration process. The Green Area is the end of the 10Kg Clear-up Demolition Charge.

5.6 In Summary, the disruption by deflagration of the original main charge (344Kg) had been reduced by an estimated 90%. This includes severing the primer tube and its separation from the explosive fill. The remaining explosive residue was so dispersed, that the risk of accidental initiation was not considered credible. The remaining mine components were now easily accessible for recovery or disposal operations using a specialist commercial ROV. However, it was Danish Navy EOD policy to countermine the remaining components with their standard 10Kg demolition charge. (Figures 4 & 5).

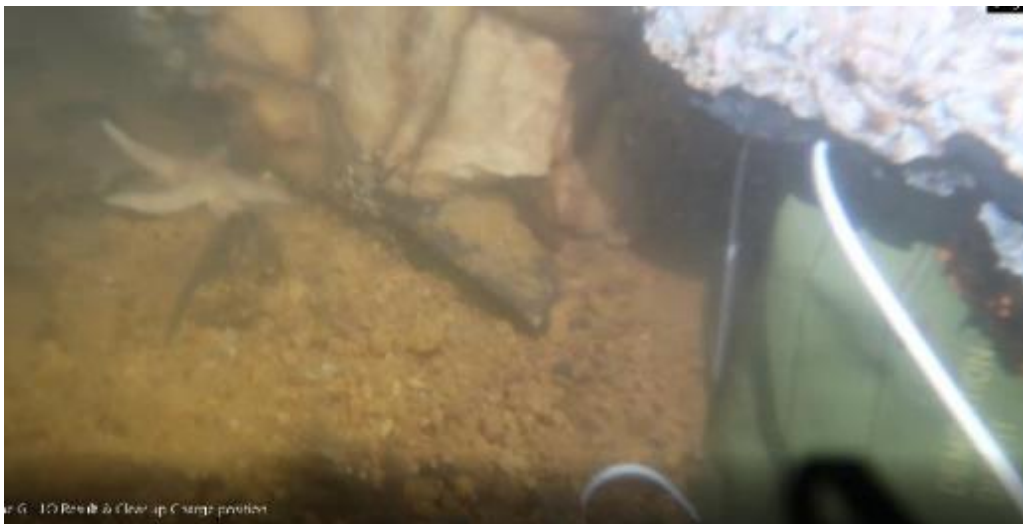
Figure 5: A small percentage of the original 430Kg charge remained in the nose of the mine.

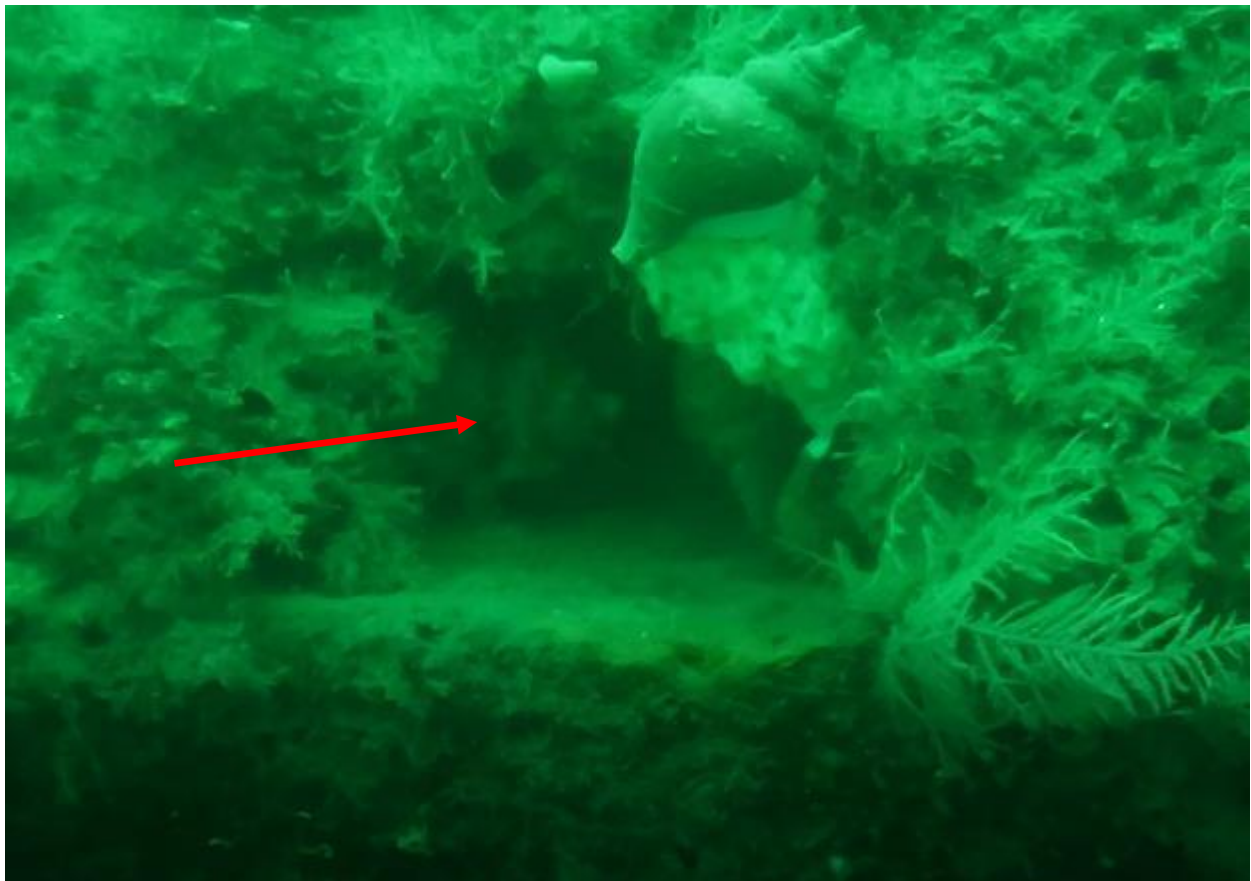
2.1 Assessment of the diver video survey shows that the mine case was covered in marine growth and very badly corroded. The mine charge section was open along most of its length (Figure 2) and estimated that the remaining explosive charge was approx 50% - 60% of the original 340Kg charge weight. The mechanism section and buoyancy section were also very badly corroded. The hydrostatic switch located in a square pocket (Figure 1) tends to confirm the original mine identification as that of an A Mk 1- 4.

Figure 1: Mine Mike - Hydrostatic Switch.

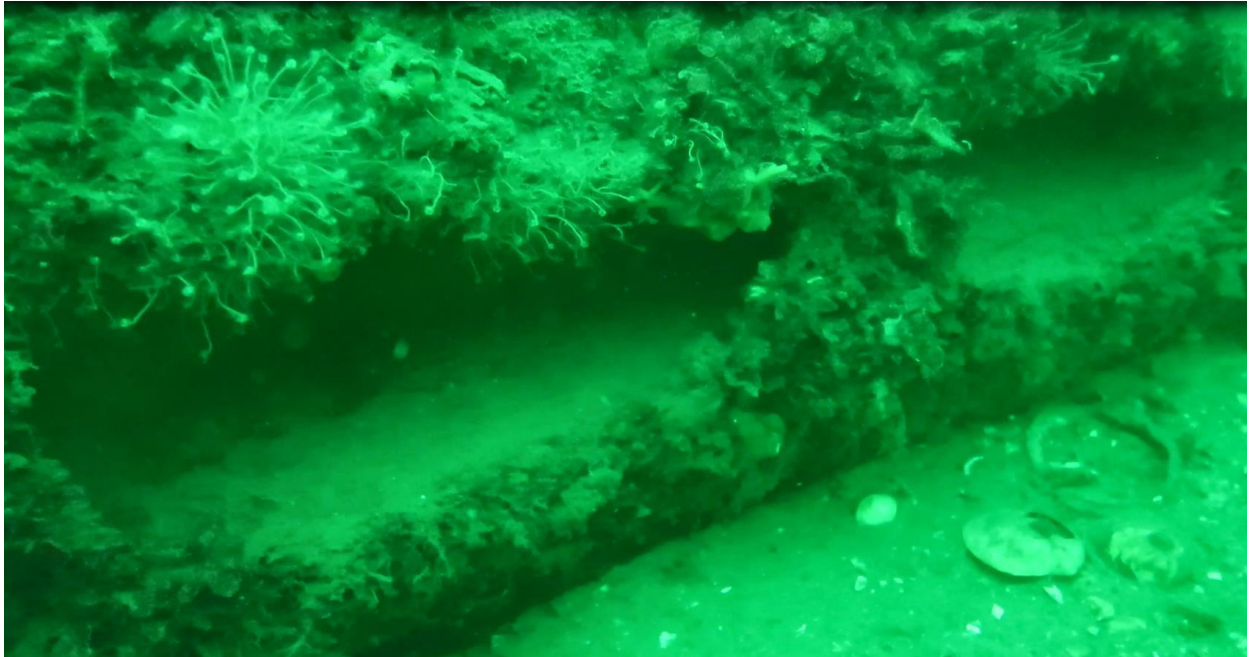
Figure 2: Mine Mike Initial Survey showing extent of mine corrosion.

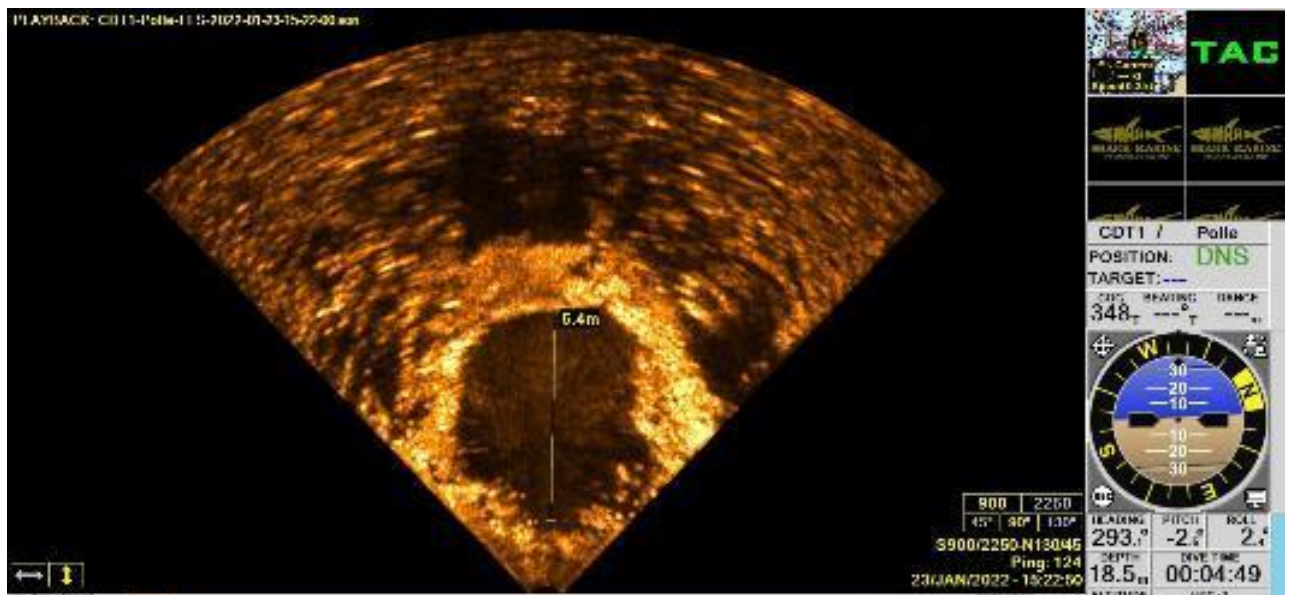
4.1 The mine detonated with a large water plume visible at the surface and the blast shockwave felt and heard on board the Diving Vessel. A diver survey with and a held sonar recorded a significant crater as detailed in the video capture (Figure 3).

4.2 Although the mine was in a very poor condition the crater size is conducive to a detonation of the estimated remaining charge weight of approximately 170Kg plus the 10Kg countermining charge. This indicated that whilst the Amatol explosive had been subjected to long term water absorption and considerable erosion, it remained a viable explosive when subjected to sufficient shock.

Figure 3: Mine Mike Post Blast Sonar Survey showing Crater Size Diameter of approx 6m.

5.2 The resultant crater size of mine Mike (6m) (NEQ 170Kg) was larger than that of mine Foxtrot (4.3m) despite the higher NEQ of 260Kg. As the degree of mine burial and depth of water are similar, this anomaly is thought to be a result of either a different seabed type, explosive power or countermining charge positioning and direction of shock wave.

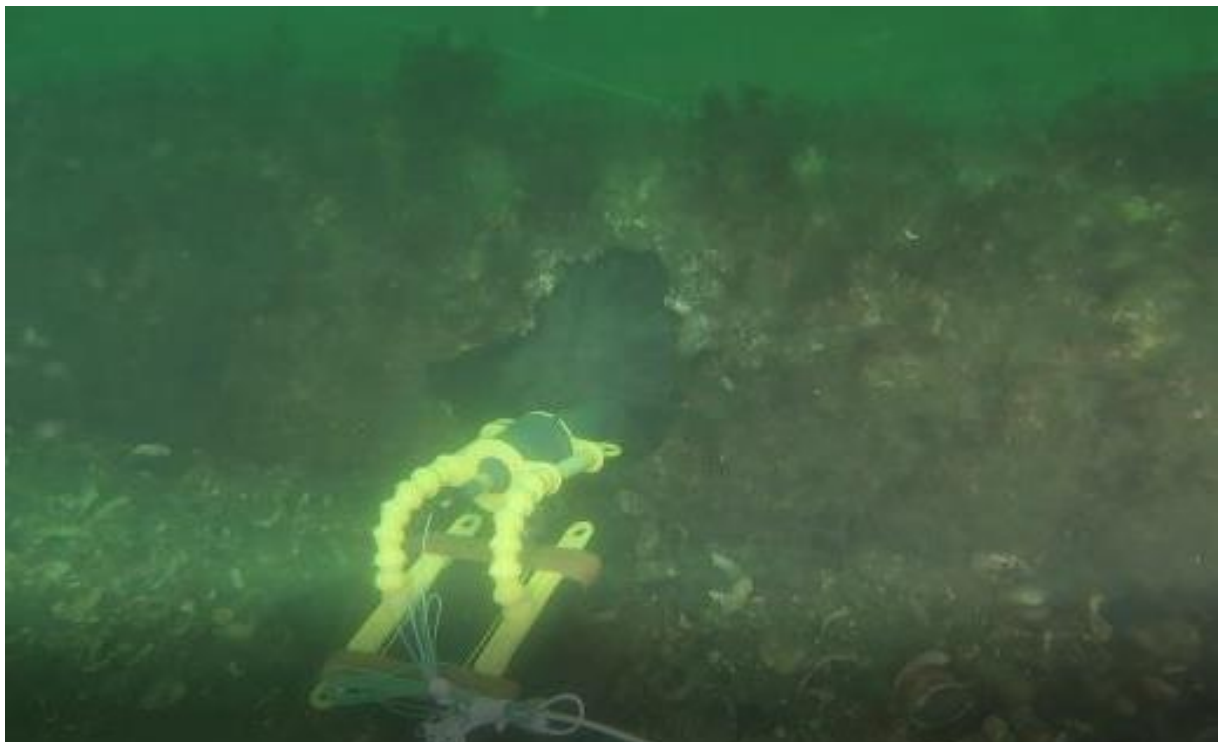
Figure 1: Mine November with Pluton Charge positioned for Low Order.

4.1 A Pluton 65mm modular shaped charge loaded with 250g Plastic Explosive and a low density, incendiary projectile with an air stand-off capsule was positioned by diver on a weighted weapon stand (Figure 1) and fired using an electric detonator & firing cable to the surface.

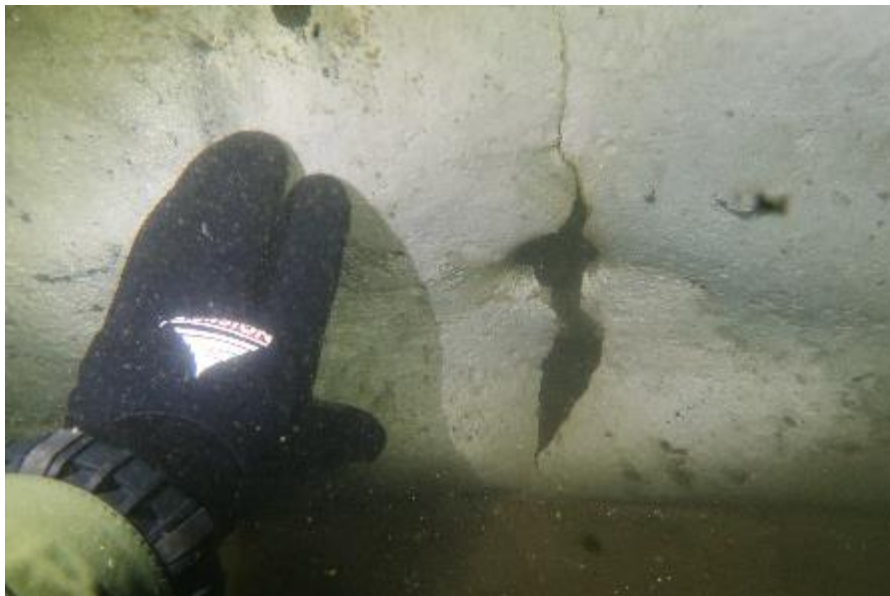
5.2 On examination, the mine case proved to have been in reasonably good condition with minimal exposure to seawater. Most of the marine growth had been removed by the shockwave with the explosive injection point clearly visible (Figure 2).

Figure 2: Mine November - Pluton Injection Point and Minor Overpressure Damage

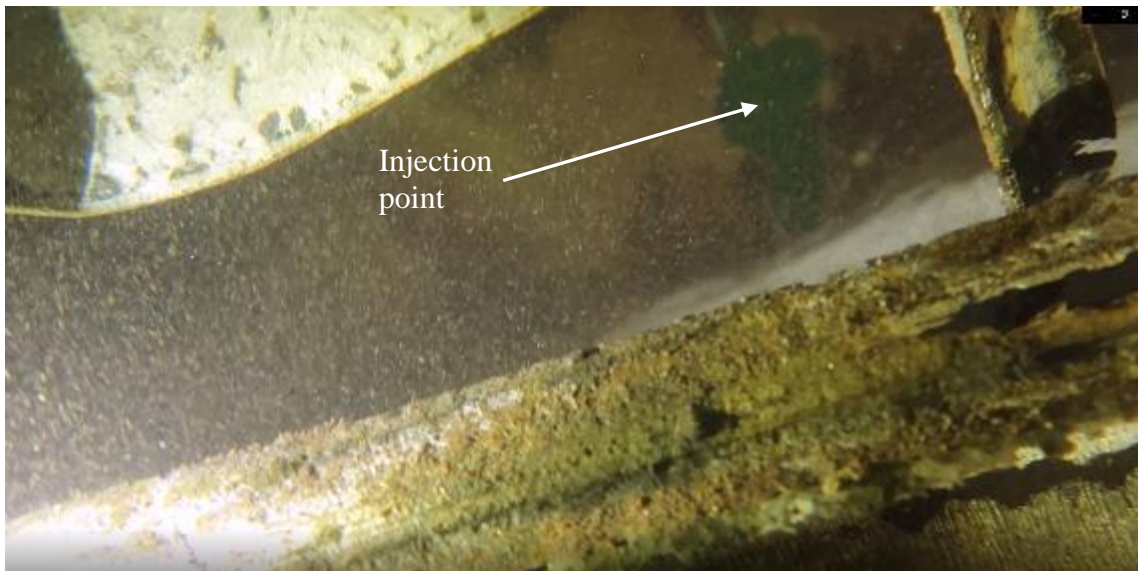
Figure 3: Inside of the Explosive Section Showing the Reverse Side of the Injection Point

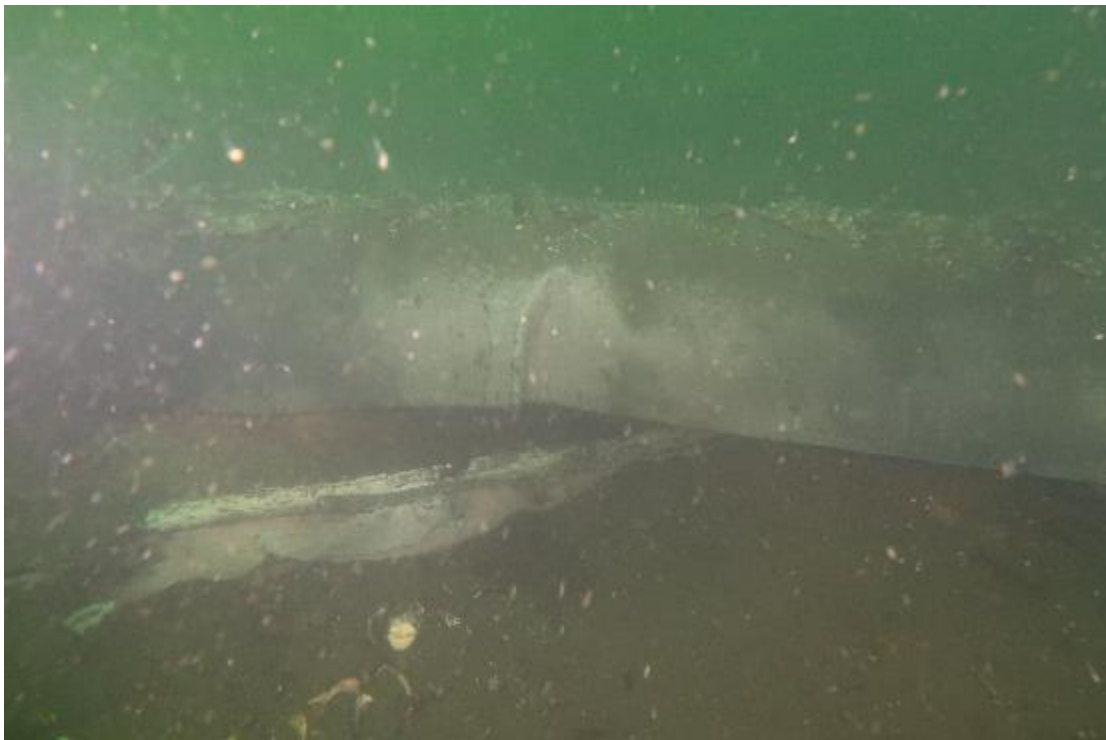
5.3 On the opposite side of the injection point, there was clear evidence of explosive deflagration and internal pressure build up. The mine charge section had split along the entire length of the welded seam, further indicating that the mine case had been in good condition.

Figure 4: Mine November – Deflagration Internal Overpressure split the mine charge section open along its entire length

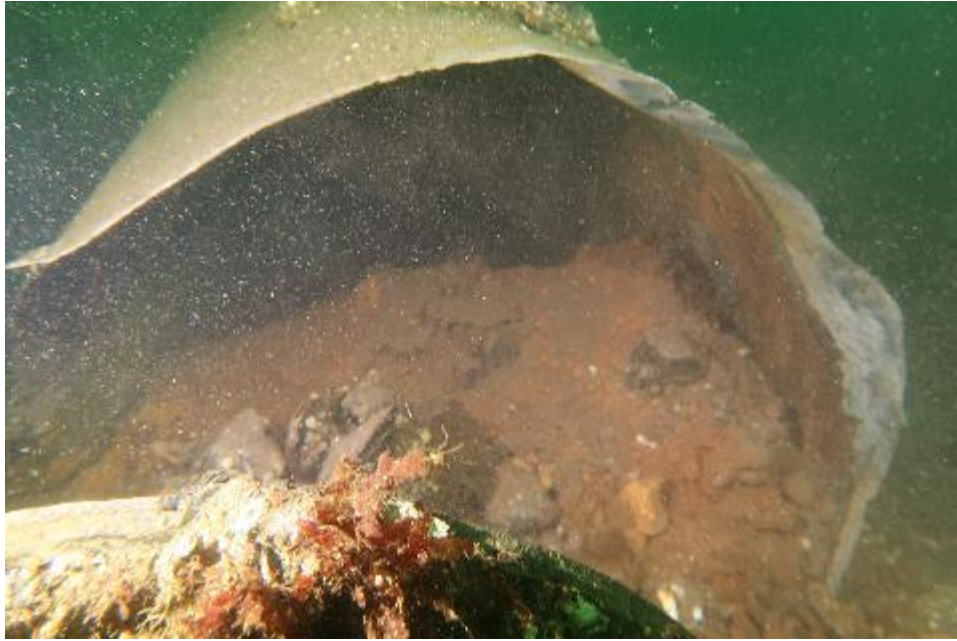
5.5 The mine mechanism section end plate was ejected by internal over pressure, forcing explosive fill and mechanism components out of the mine case (Figure 5).

Figure 5: Mine November – end plate ejected by internal overpressure

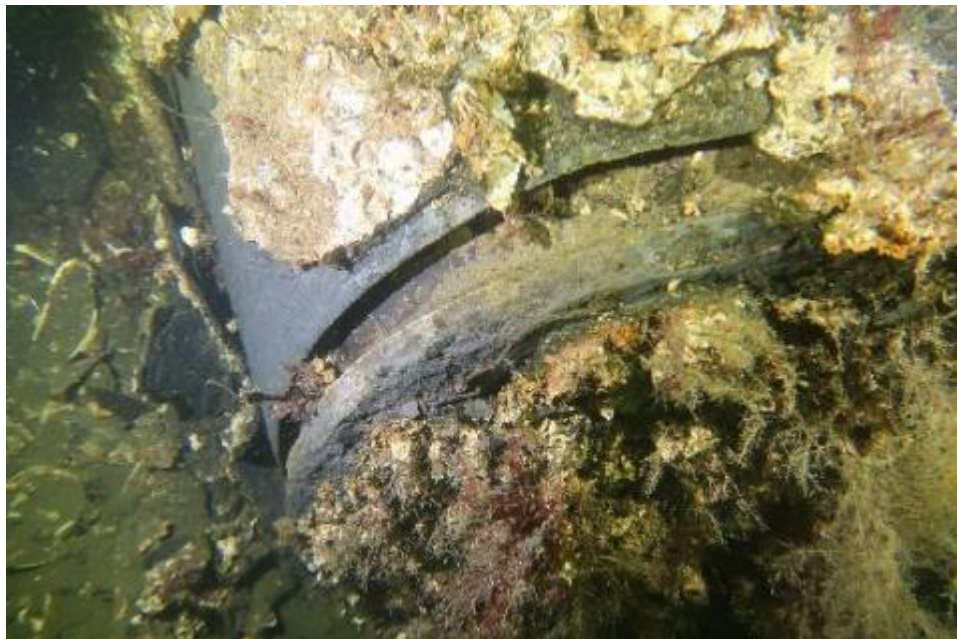
Figure 6: Mine November – Deflagration Internal Overpressure split the mine charge

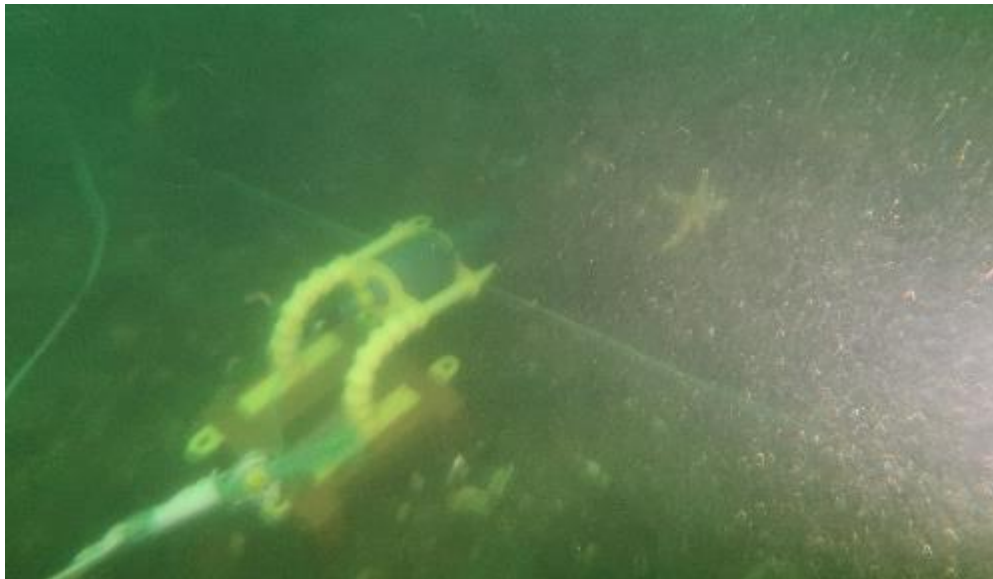
Figure 1: Pluton Charge Positioned against Mine Lima

4.1 A Pluton 65mm modular shaped charge loaded with 250g Plastic Explosive and a low density, incendiary projectile with an air stand-off was positioned by diver on a weighted weapon stand (Figure 1) and fired using an electric detonator & firing cable to the surface.

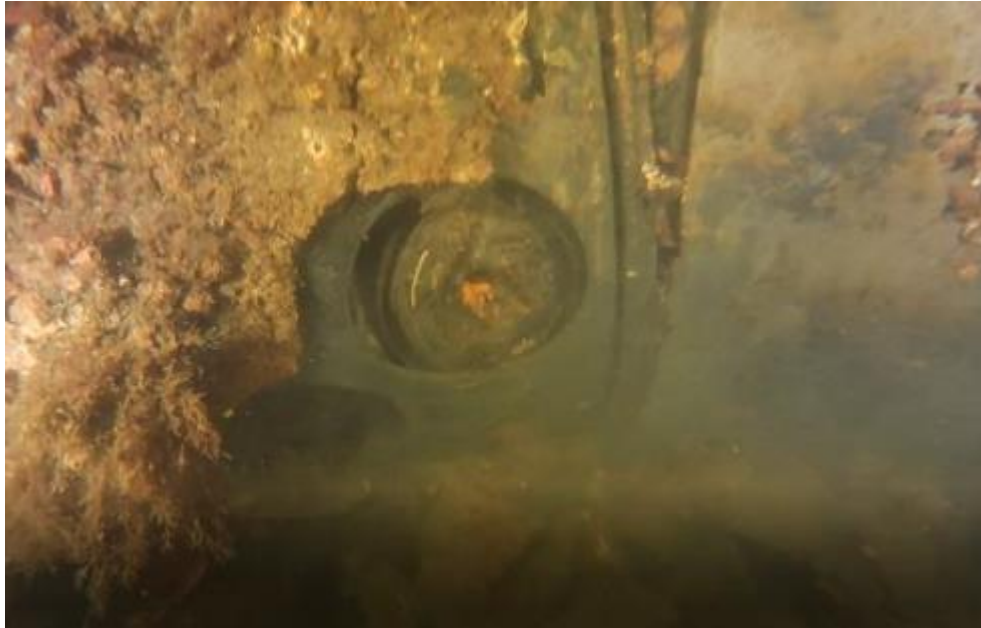
5.2 On close examination of the post blast video, much of the marine growth and corroded metal had been shocked loose and certain features were now visible. Notably a detonator hydrostat and an inspection bung. These features are clear indication that the mine is an A Mk 6 rather than an A Mk 1-4 which meant that the explosive charge weight was actually 430Kg.

Figure 2: A Mk 6 Detonator hydrostat and inspection bung

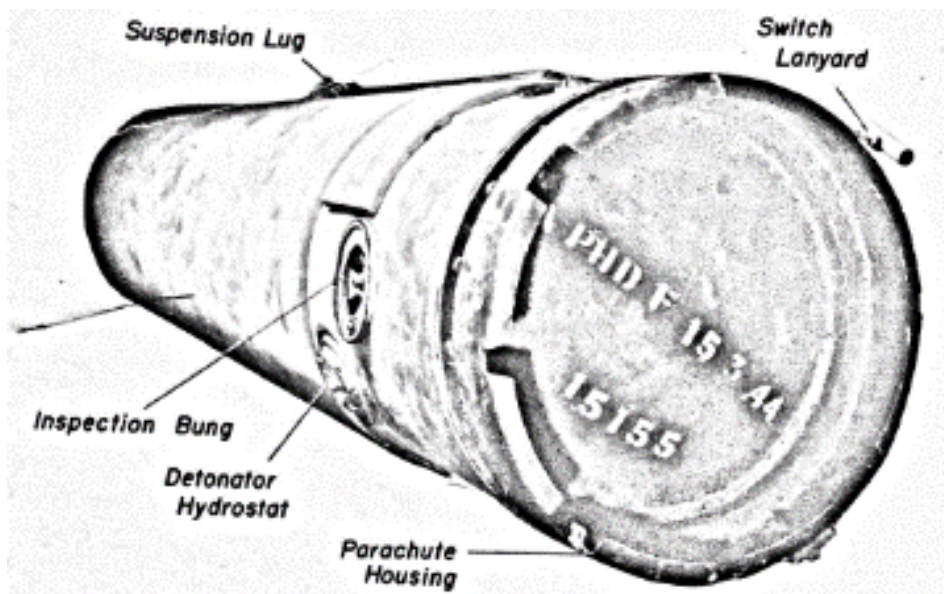
Figure 3: A Mk 6 – Main features

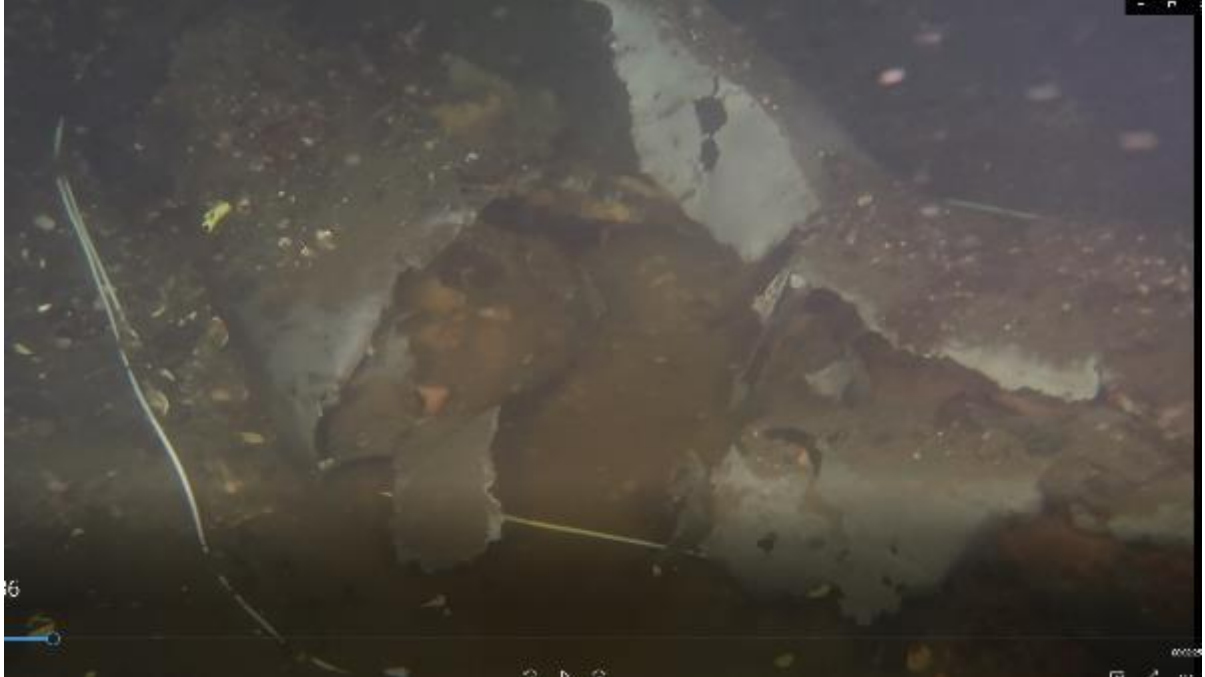
5.3 The mine charge case had almost been cut in half (Figure 3) with much of the Amatol burned or ejected during the process of deflagration. The remaining steel mine case showed evidence of severe corrosion which had weakened the mine case and reduced the disruptive effect.

Figure 3: A Mk 6 – Main charge Section completely burst open and almost cut in half.

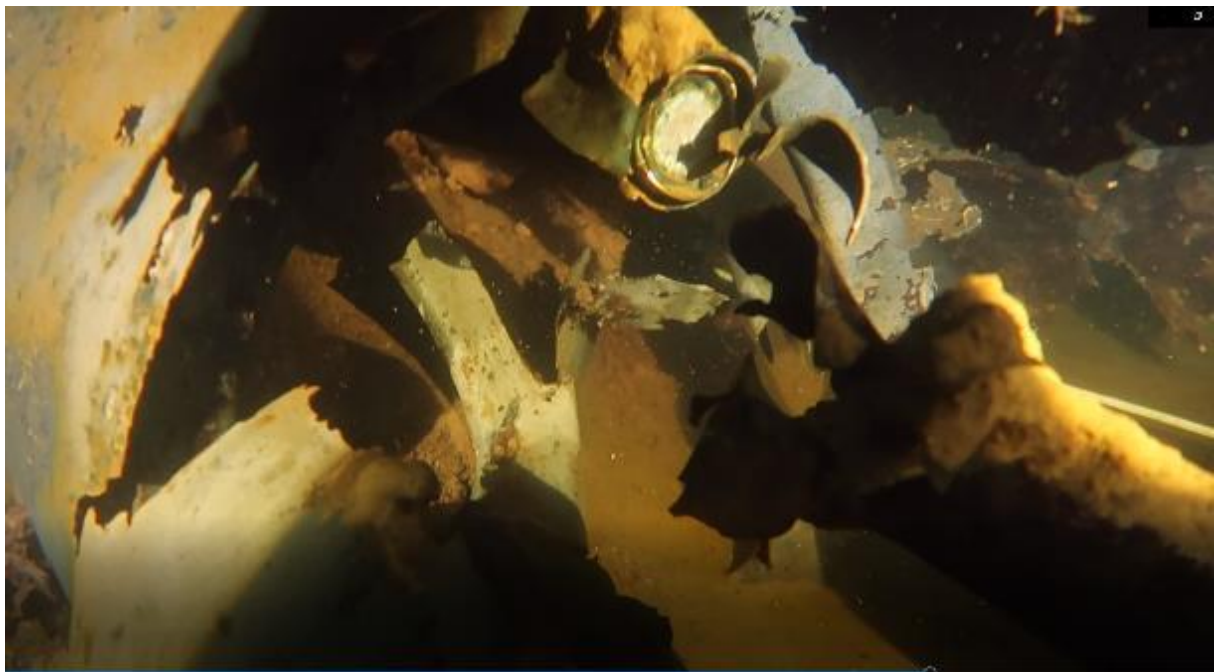
Figure 4:

5.4 The primer tube had been severed (Figure 4) and there was evidence of shattered explosive residue in the nose and close to the mechanism housing.

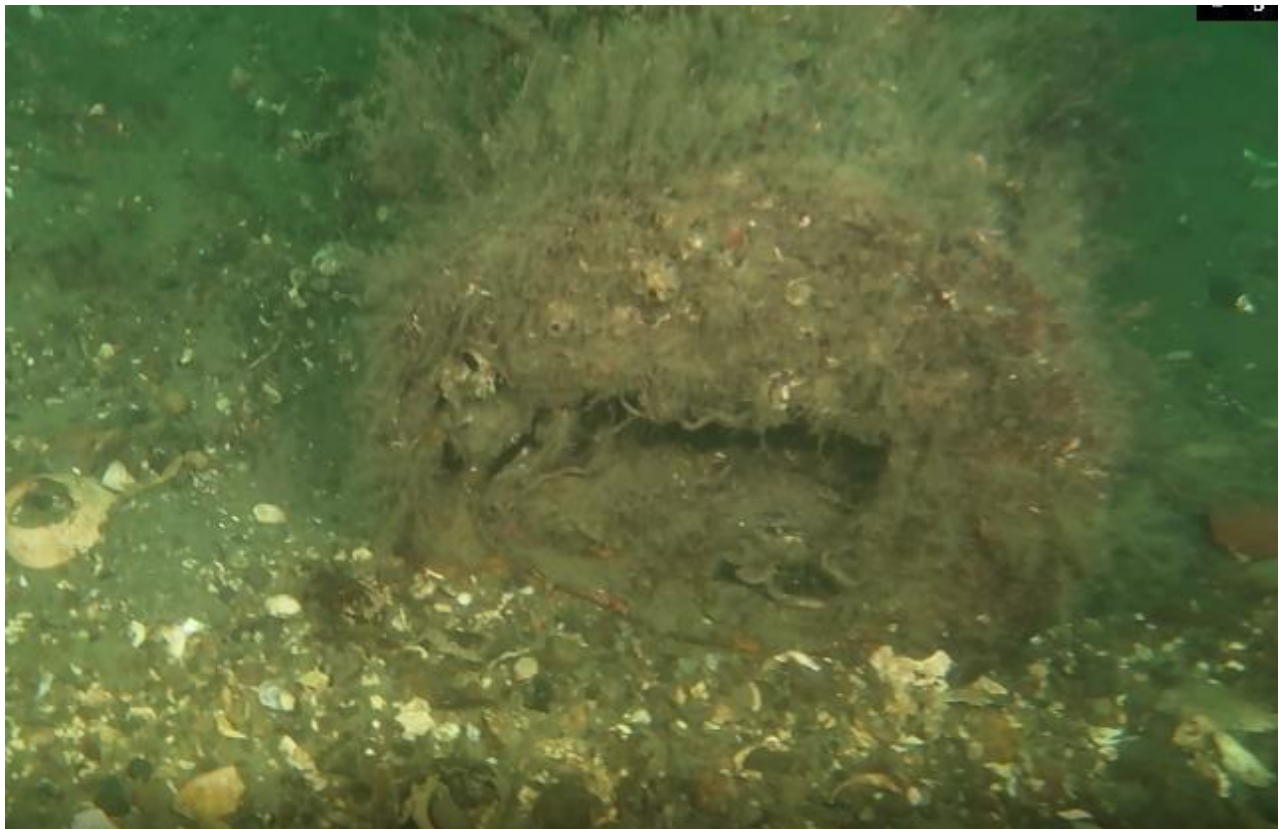
2.2 The end of the mechanism section was open to the environment (Figure 1), and there were small areas of corrosion on the charge section (Figure 2), indicating that the explosive fill had been exposed to salt water, but there was no indication that the total NEQ had been reduced by tidal erosion and it was not possible to identify the type of explosive in the main charge.

Figure 1: Mine Juliet showing damage to the end of the mechanism section

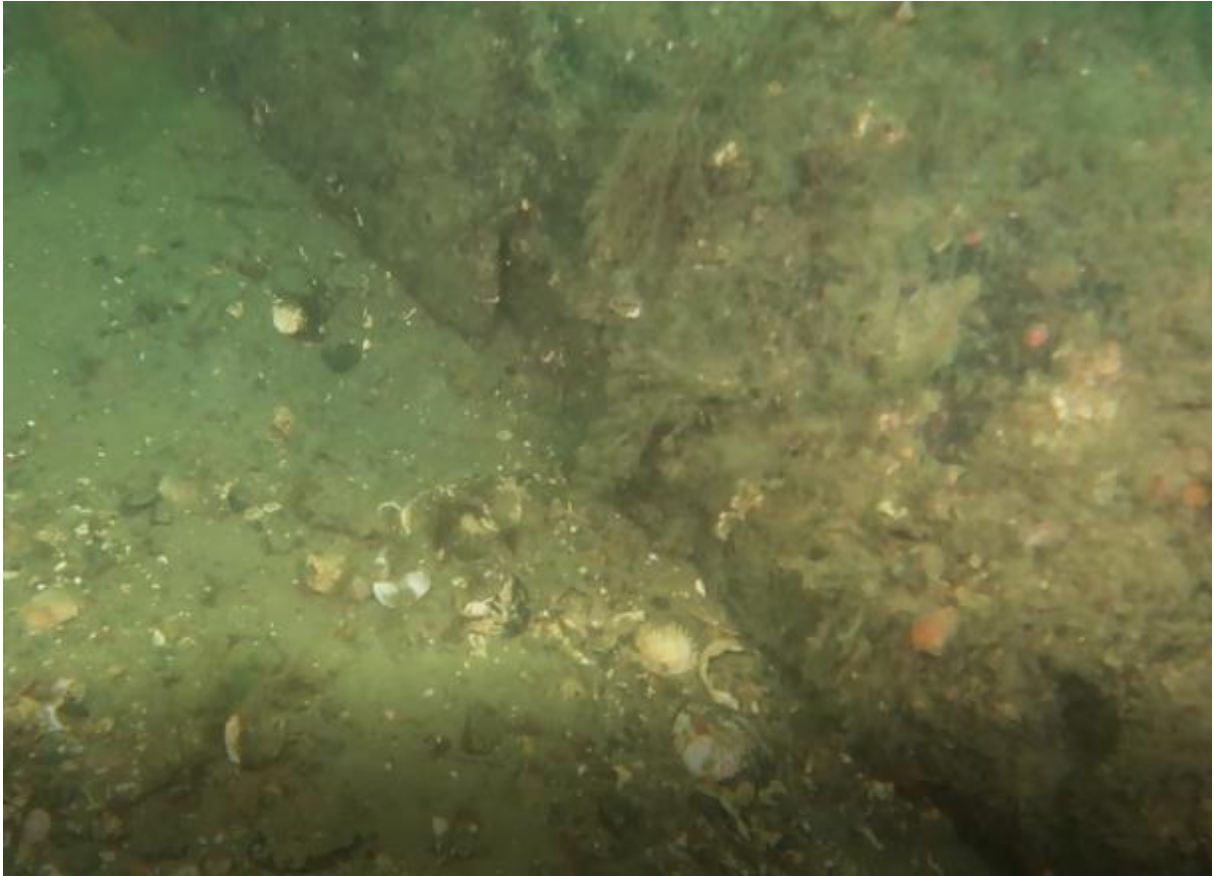
Figure 2: Small areas of corrosion visible in the mine charge section.

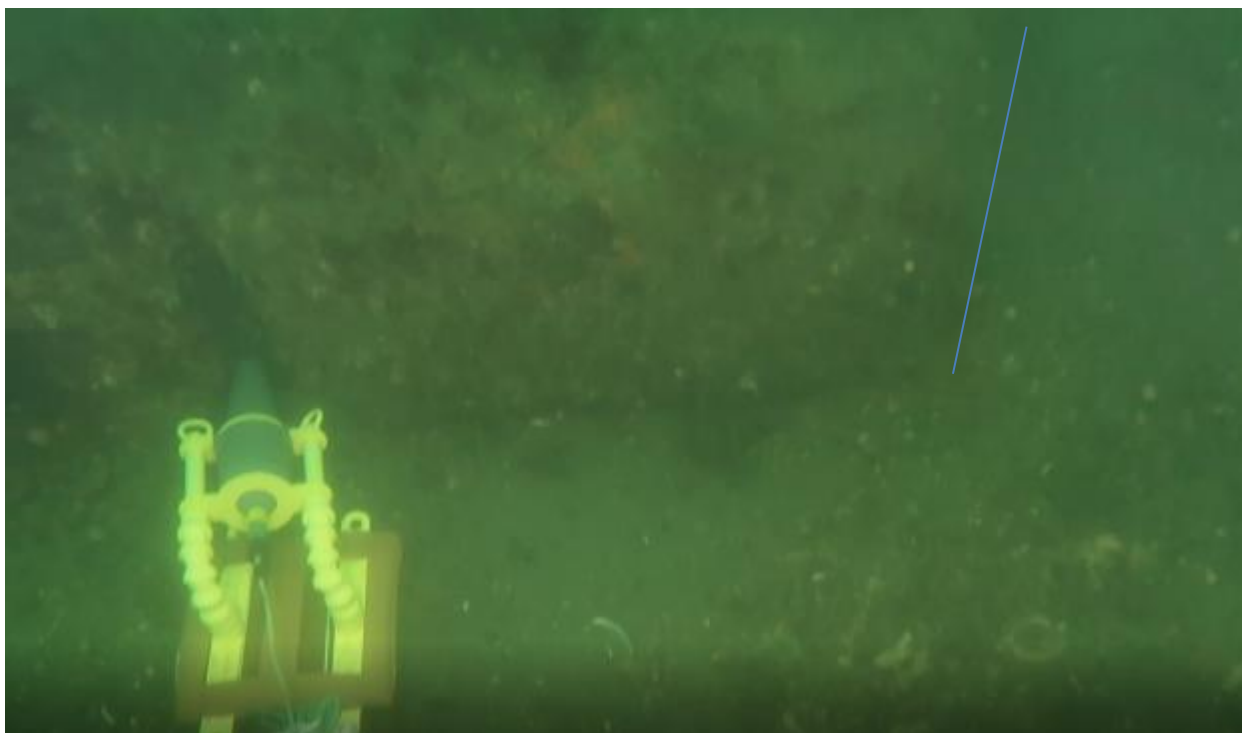
4.2 The single Pluton charge positioning (Figure 3) can be seen to be approximately 500mm back from the nose of the mine which is not the optimum position for an A Mk 1-4 type mine, due to the nose section having an air-filled buoyancy chamber. A better position is further to the rear in the centre of the explosive section. The charge was initiated using an electric detonator & firing cable to the surface.

Figure 3: Mine Juliet with Pluton Shaped Charge was Position approx 500mm back from the Nose (highlighted).
