Supplementary information files for In-situ comparison of high-order detonations and low-order deflagration methodologies for underwater unexploded ordnance (UXO) disposal

Underwater Noise Trial Denmark

EOD Report Annex A

Mine Foxtrot – High Order

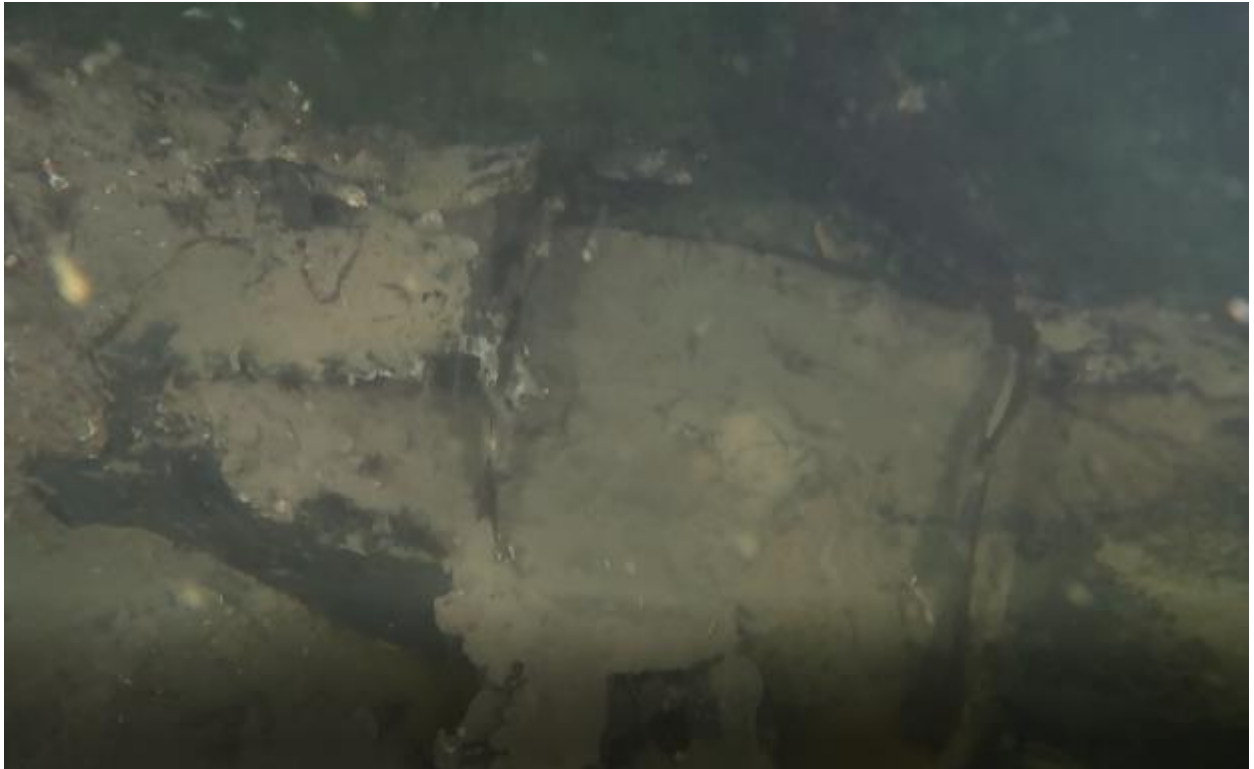
5.3 Despite the wet condition of the explosives and sub-optimal charge placement, the effects of deflagration had still burst opened the main explosive section, which was almost empty. Explosive residue was scattered in a similar manner to that witnessed in the other mines.

5.4 The percentage of explosives that burned during deflagration is difficult to assess but is likely to be less than that of Amatol. The Minol explosive residue looks to have been reduced to a soft powder similar in texture to silt or mud and was already being dispersed by tidal action, evident by its visible spread around the mine carcass.

Figure 3: Deflagrated main Charge Case showing the grey Minol main Charge has either burned or been reduced to soft powder.

5.5 The mine having been severely shocked and in an open condition was easily accessible for further EOD action by diver or ROV. Remote movement for example would effectively wash out any explosive residue and make access to other components a simple evolution.
