Experiences and lessons from the operation of Monrovia sewerage system

E K O Akowuah
Experiences and lessons from the operation of Monrovia sewerage system
INTRODUCTION

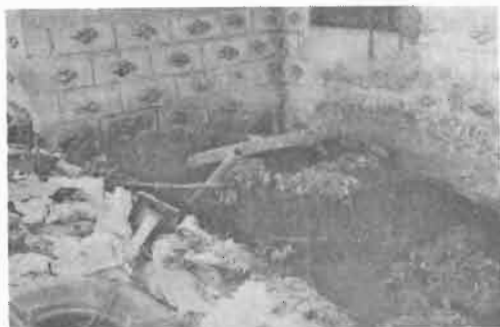
- (i) Chronic lack of maintenance action for the removal of grit and sand from sewers: The maintenance crews had never been equipped with tools for sand removal and therefore sand had continued to accumulate in the sewers throughout the 30 years history of the system.

Figure 1. Raw sewage spilling from a manhole forms a rivulet running to an open drain in the Sonnewein sector of Monrovia. The manhole is on a sewer permanently blocked by sand and grit.

- (i) A sewer-cleaning truck with equipment for water-jetting and vacuum-suction was purchased to be used to implement a programme for removing sand and grit from the sewer network. A team of operators was also trained to use the equipment.
