39th WEDC International Conference, Kumasi, Ghana, 2016

**Performance of Iron removal plants on groundwater:
field assessment in Central Uganda**

K. Okurut, P. Kimera & A. N. Bamutaze (Uganda)

REFEREED PAPER 2386

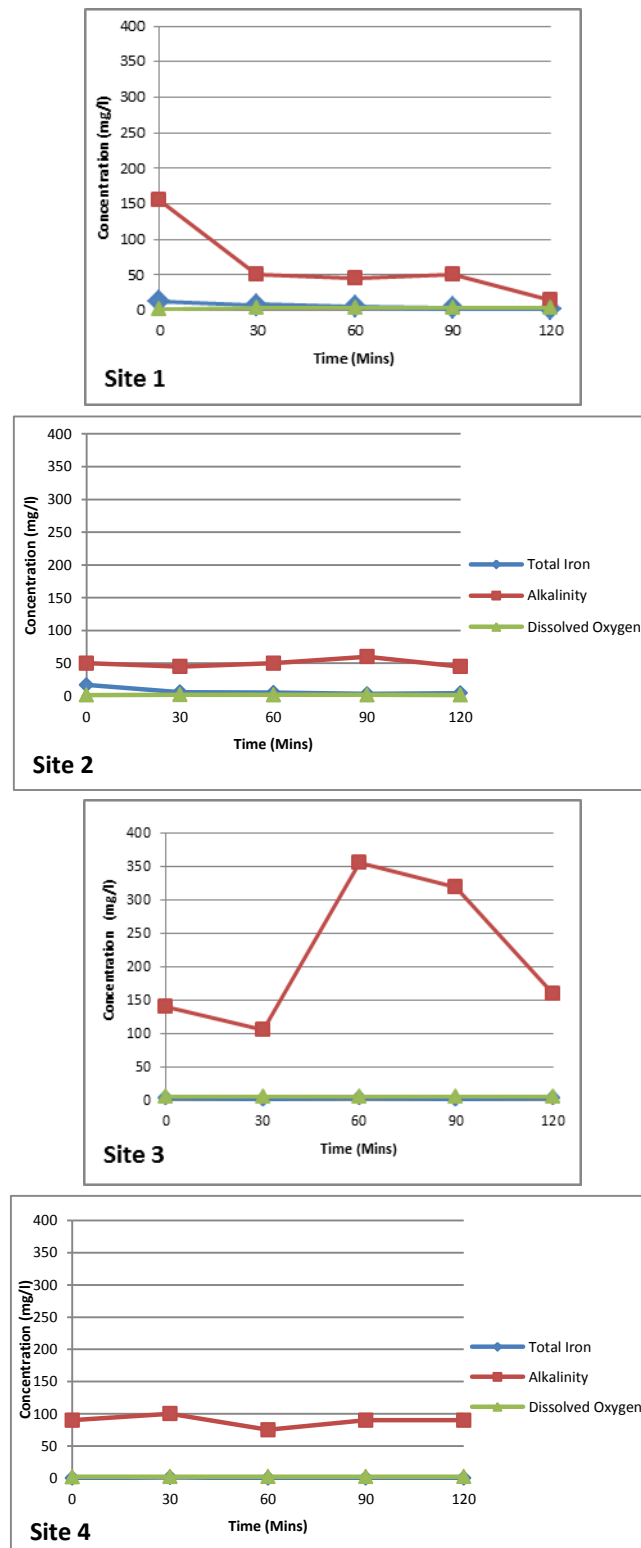
The study showed that the sampled boreholes are with pH levels (5.72 ± 0.15), typical of groundwater sources and not being too low ($\text{pH} < 3$) to be aggressive. Also the temperature variability between sampling times and also between the sources ($23.0 - 25.1^\circ\text{C}$) is not that much implying minimal impact from surficial or ambient conditions. The groundwater from the sampled boreholes is with relatively high levels of dissolved oxygen ($> 2\text{mg/l}$) which renders it a fresh water source. The sampled boreholes are generally with a high pH buffering capacity as indicated by the high alkalinity levels ($> 40\text{mg/l}$) (Figure 1) leading to resistance to significant pH change.

With regard to boreholes in Mpigi (Sites 1 & 2), there was a general decrease in pH, alkalinity and Total Iron with time. The quality of the water sampled out of the boreholes with time is indicative of the water flowing through the aquifer. However, it suffices to note that the quality variations are also dependent on the amounts of water pumped out of the aquifer prior to the sampling times. In Kamwenge, quality of the water in the borehole at Site 3 exhibited an increase in pH, dissolved oxygen and alkalinity with time. However, the Total Iron and alkalinity levels were with a decreasing and increasing trend most likely due to the quantities of water being pumped out of the aquifer prior to the sampling times. The borehole at Site 4 in Kamwenge (Not closed the previous night prior to the field measurements) illustrates that continuous pumping of the borehole resulted in improved quality of the water with time giving a better indication of the water quality within the aquifer. It suffices to note that in this particular borehole, the initial measured Total Iron levels were low compared to the rest of the boreholes which likely led to a decrease to undetected levels in the subsequent sampling times. Interviews with the operator also revealed that the down-hole-pump system of the borehole at Site 4 had been replaced with PVC pipes that explain the low levels of Total Iron concentration in this particular borehole.

The source at Site 3 in Kamwenge district showed low values of Total Iron concentration of 1.9 ± 0.38 , but high alkalinity during the two hours of continuous pumping. Communities in water scarce areas would still consider Total Iron concentrations of less than 2mg/l as acceptable (MWE 2013) but this particular source at Site 3 is abandoned and people instead collect water from a river that is too risky with reported deaths. A local leader explained that women stopped using the borehole because the water makes them pale with very rough skin to the extent that their husbands do not want to share with them beds. They may try to use lotion but cannot always afford and, to save their marriage, they prefer to risk the lives of their children who collect water from the river. Compared to borehole at Site 4 where the source was improved by replacing GI pipes of the down-hole-pipes with PVC pipes, the improved source recorded a Total Iron concentration of less than 2mg/l and alkalinity of $89.00 \pm 4.0\text{mg/l}$ but is under continuous usage with no complaints. This finding reveals that a water source may have multiple problems that need to be fully investigated and identified differently, to develop appropriate solutions for each case. Fader (2011) recommended that IRP should not be installed in an application that still has its iron pipes and components.

Figure 1. Quality of water sampled from the unimproved IRP boreholes, taken every 30 minutes of continuous pumping

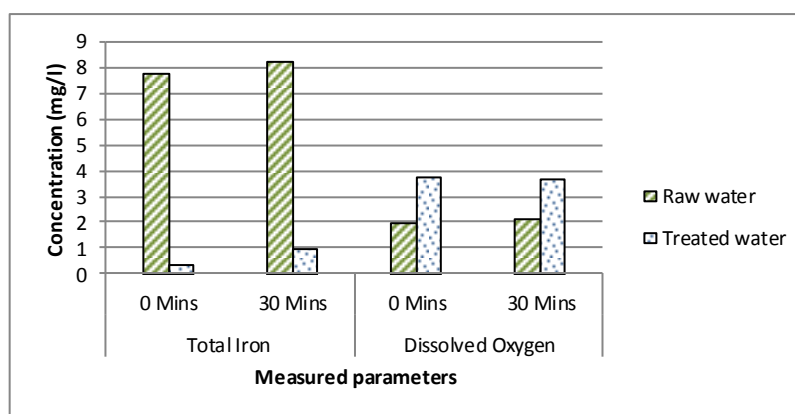
The school management has proved that the IRP can work well with proper operation and maintenance and they have gone ahead to install and oversee another plant for a community at Site 5 in Kibanda Sub County. The school management has also trained the local leaders of the community on how to manage the improved IRP U2 borehole to ensure it serves the purpose. The efficacy of the IRP improved water source that was constructed by the school at Site 5 was assessed. The results show that the plant can reduce the Total Iron concentration and also increase the amount of dissolved oxygen in the treated water (Figure 2).

Figure 2. Quality of water sampled from the IRP improved borehole at Site 5 in Rakai district

Measurements of the selected physicochemical parameters taken over a 30 minutes interval showed relatively small variability with a sharp increase in alkalinity of 105mg/l to 175mg/l in the raw water. Values of the measured parameters in the treated water are with increased dissolved oxygen levels and reduced total iron levels given the nature of the treatment unit operations and processes. A slight increase in Total Iron concentration in the raw water sample after 30 minutes can be explained by the recharging of the aquifer. While the increase in Total Iron of the treated water after 30 minutes could be due to the influence of the volume of water exposed to free air in the aeration unit prior to sampling. This is also noted with the slight decrease in dissolved oxygen after 30 minutes as more oxidation process occurs in the treated water. Further study will optimize the efficacy during continuous pumping process of the IRP and its general performance to enhance the sustainability of the improved water source.
