Diagnosing the Cause of Incipient Anodes in Repaired Reinforced Concrete Structures

C Christodoulou¹, C Goodier², S Austin², J Webb¹, G K Glass³

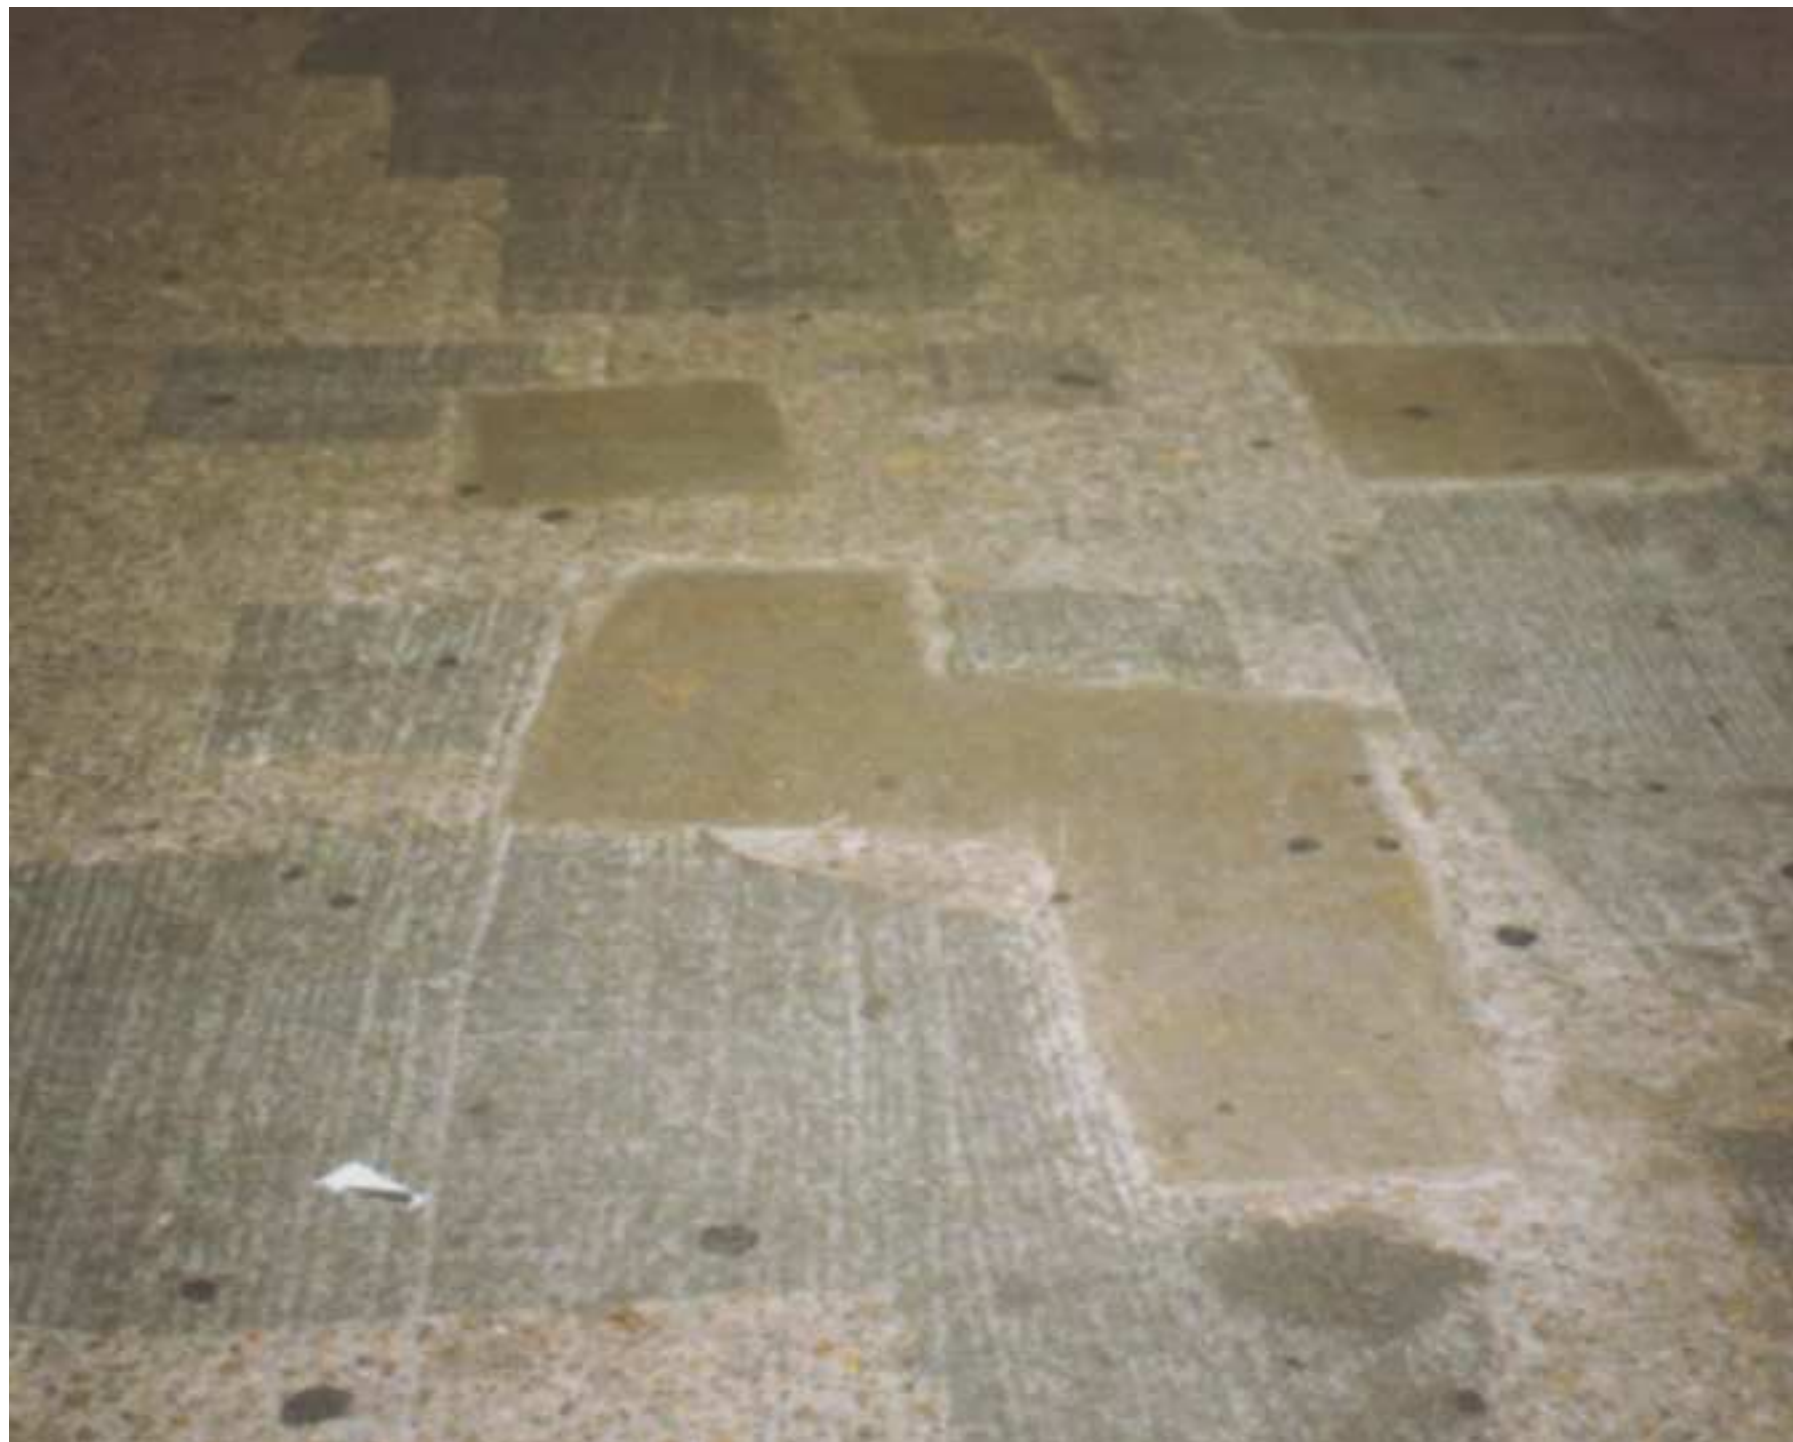
Figure 1: A concrete deck showing the quilt-like appearance associated with the incipient anode phenomenon arising from successive repair contracts.

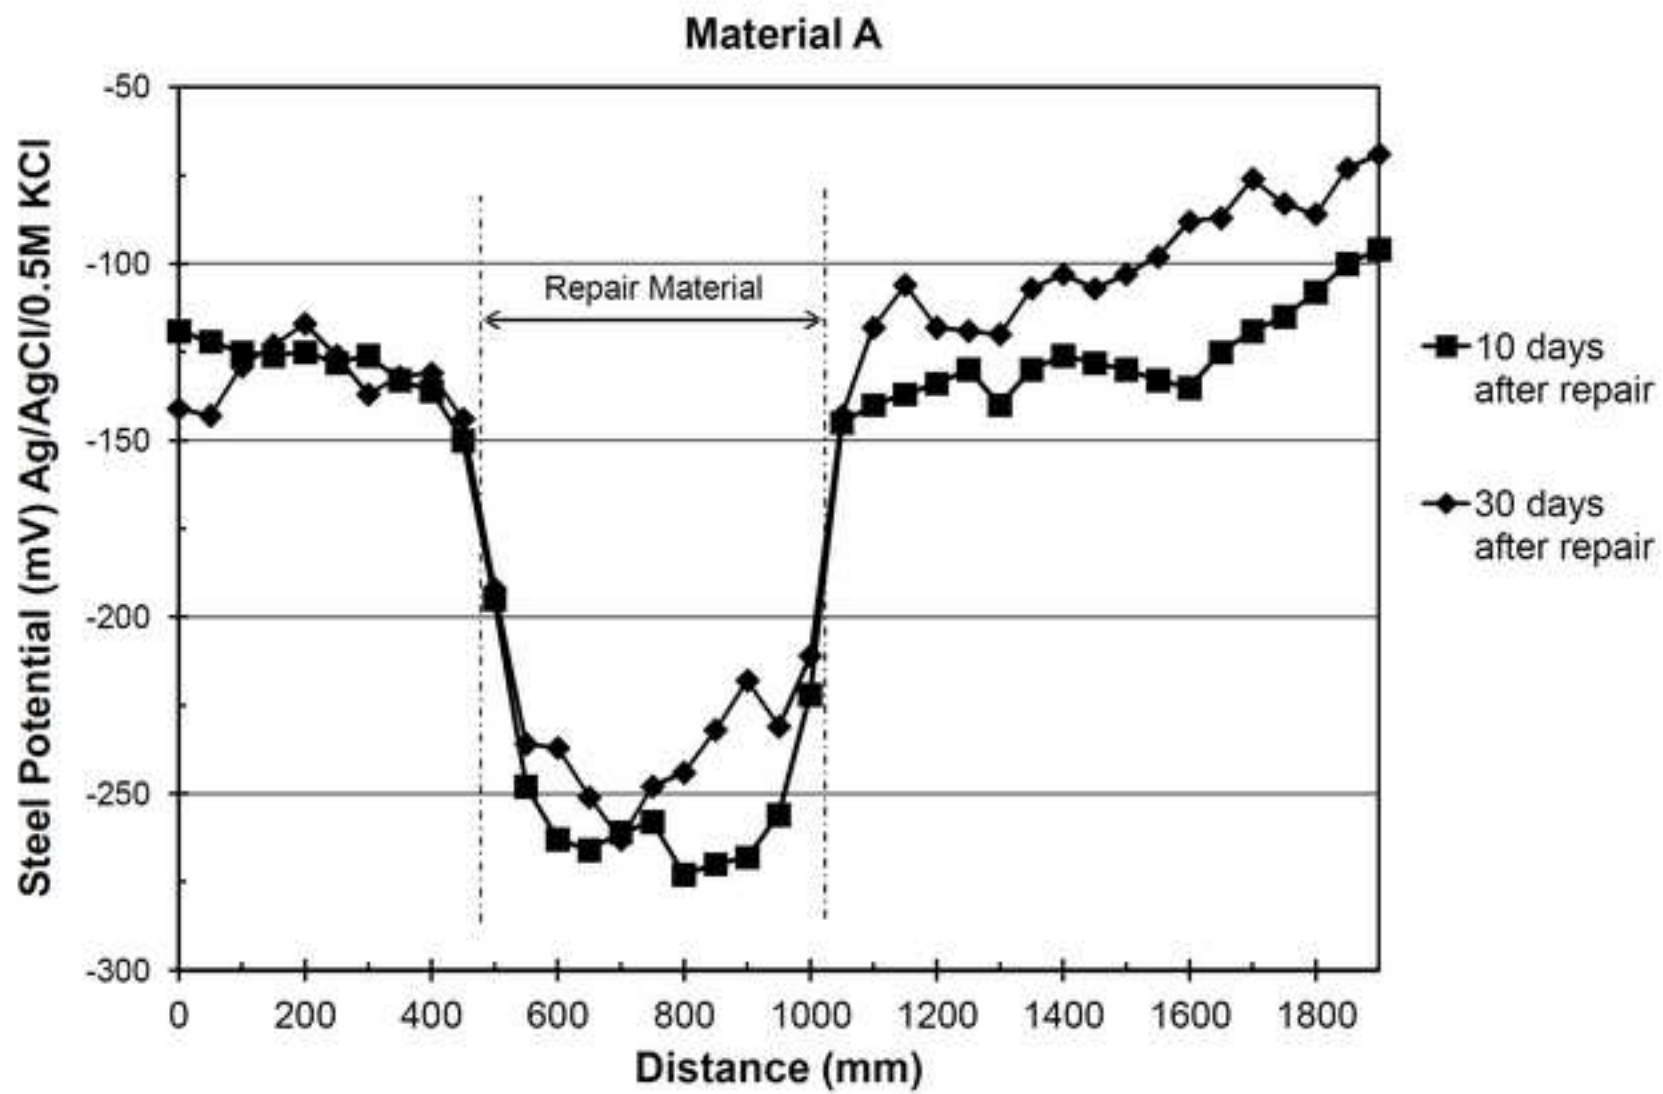
The steel potential after 30 days as a function of distance across a concrete surface that included a repair with material A is shown in Figure 2. It is clear that the potentials of the steel within the repaired area are substantially more negative than the potential of the steel in the parent concrete.

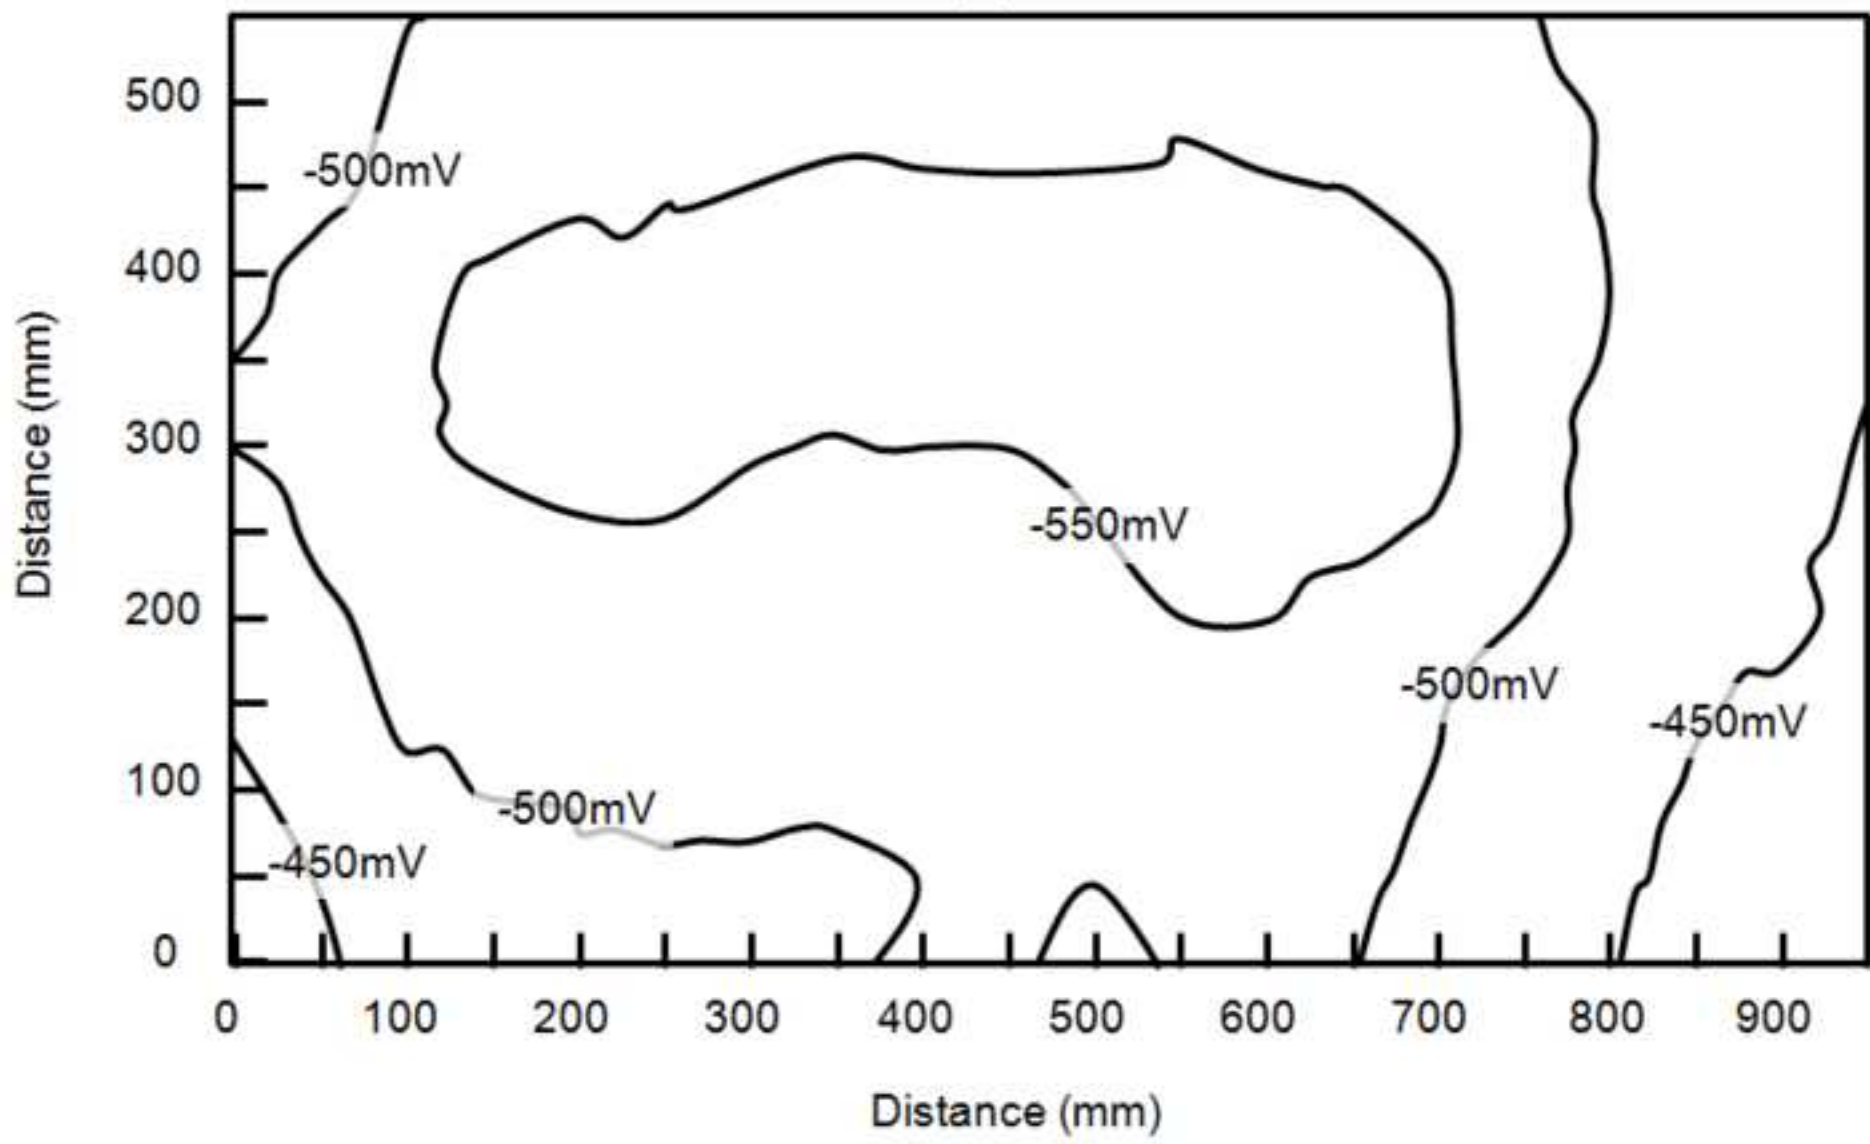
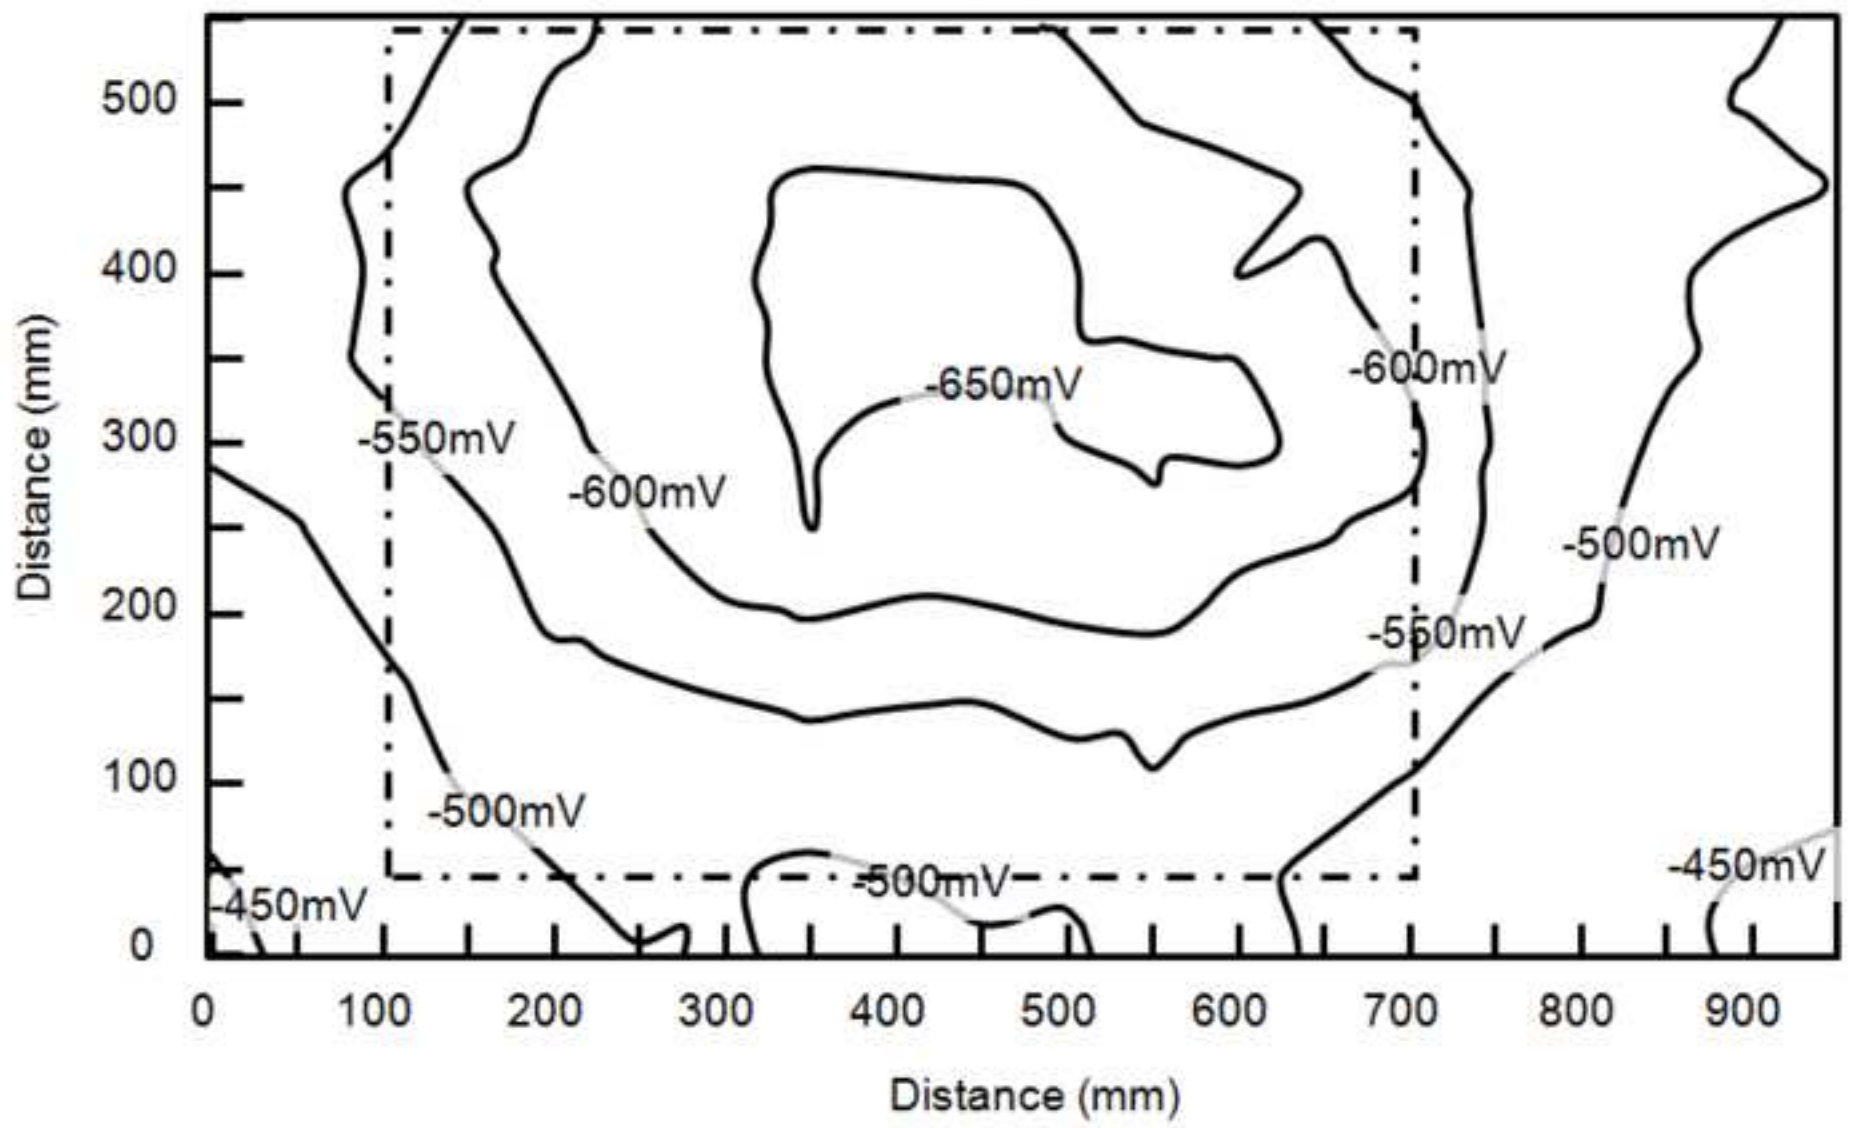
Contour plots showing potential mapping results both before and after repairing an area of corrosion damage with material A are given in Figure 3. The repair material had cured for 30 days when the data for the post repair contour plot was recorded. It is evident that, before the repair (Figure 3(a)), the potential in the area of the corroding steel was about 100 mV

more negative than the potential in the adjacent parent concrete. 30 Days after the repair this difference increased to approximately 200 mV.

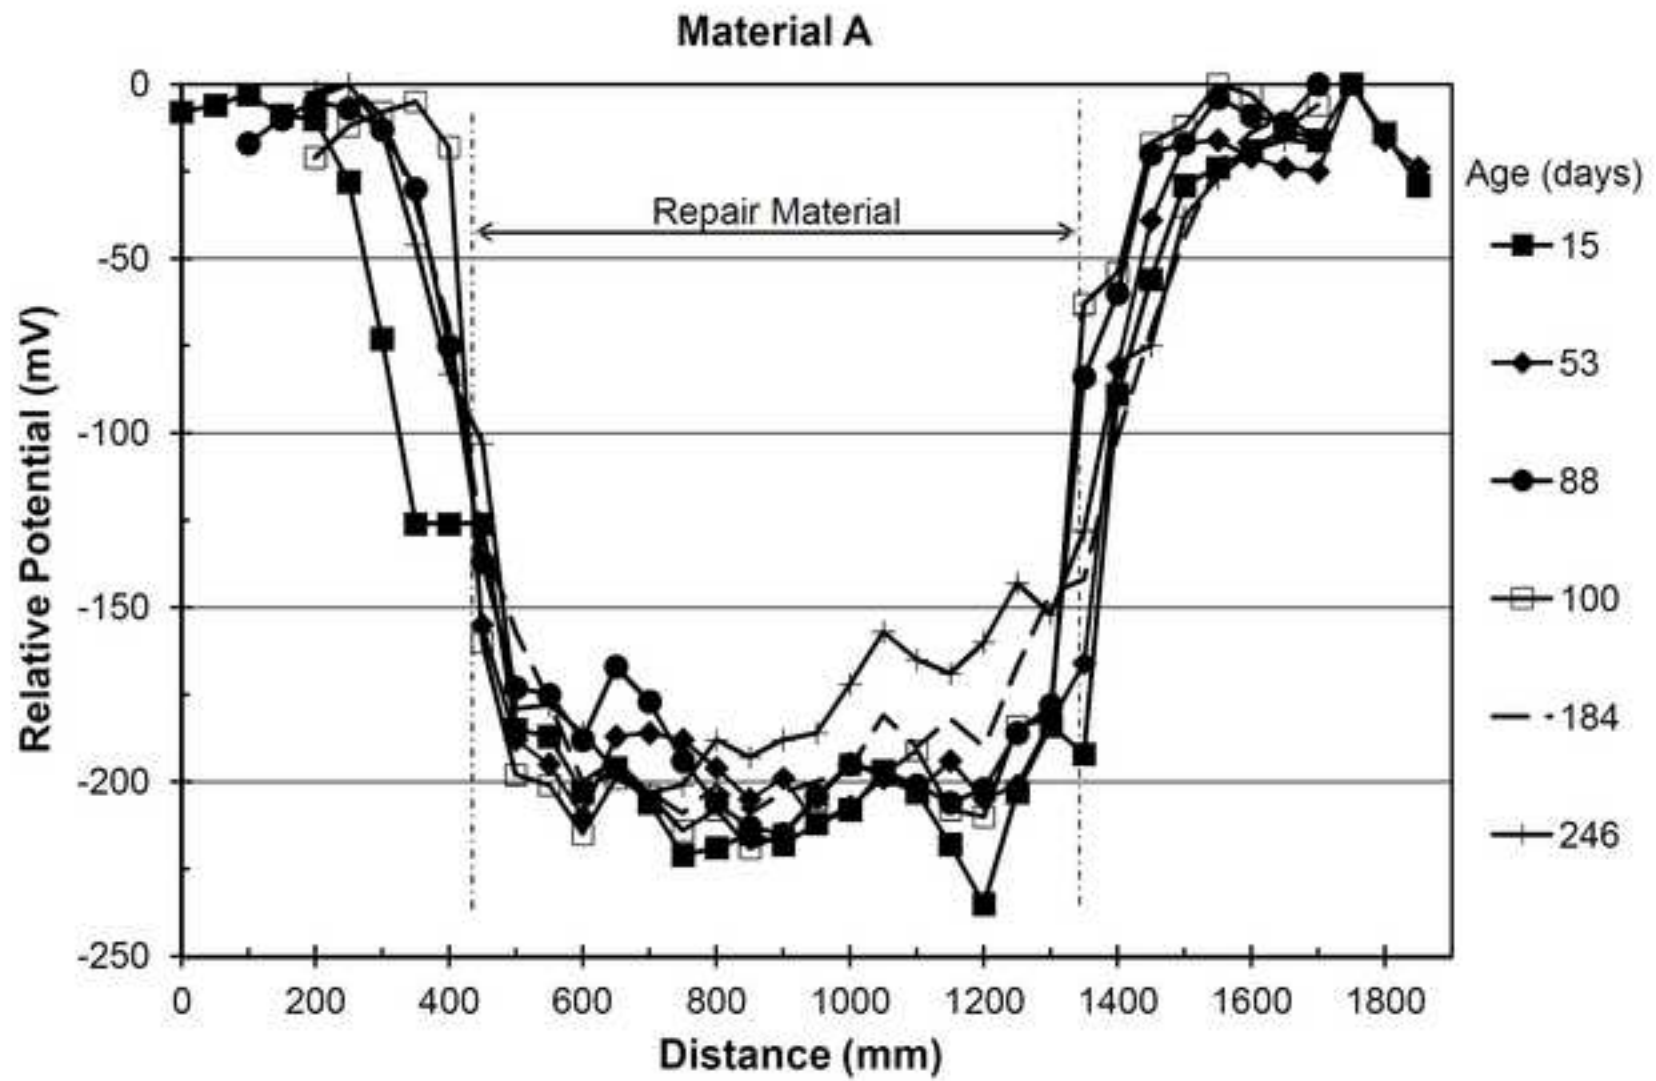
Figure 4 shows the change in the potential difference between an area repaired with material A and the adjacent parent concrete over a period of 246 days. The early age results (15 days) show that the potentials within the patch repair were about 200 mV more negative than the potentials in the parent concrete. This difference reduced with time but the changes were relatively small. After 246 days the potential difference was somewhere between 150 and 200 mV. The potentials were measured in a variety of naturally occurring conditions including a very wet day on day 88.

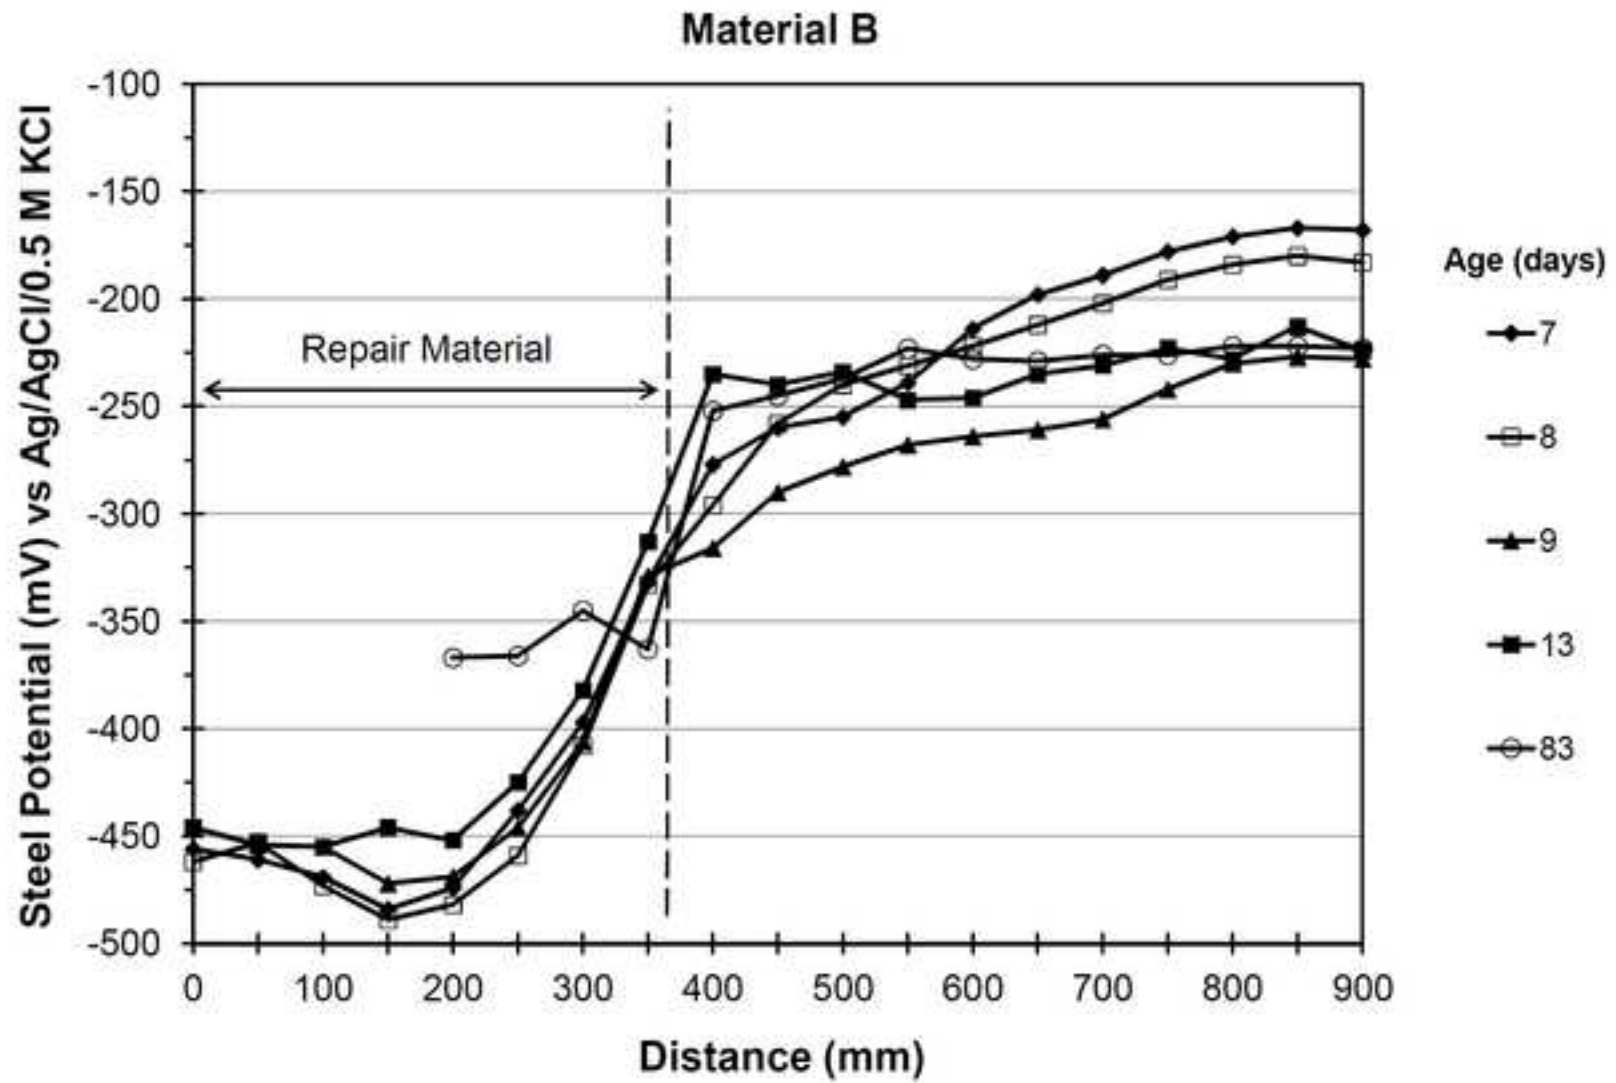
The potential data obtained on patch repairs on the bridge structure illustrated similar behaviour to that obtained on the car park. Figure 5 shows data obtained at an area repaired with material B. The potentials of the steel within the repair material were about 200 mV more negative than the potentials of the steel in the adjacent parent concrete at the start. After 83 days the change was still greater than 100 mV.

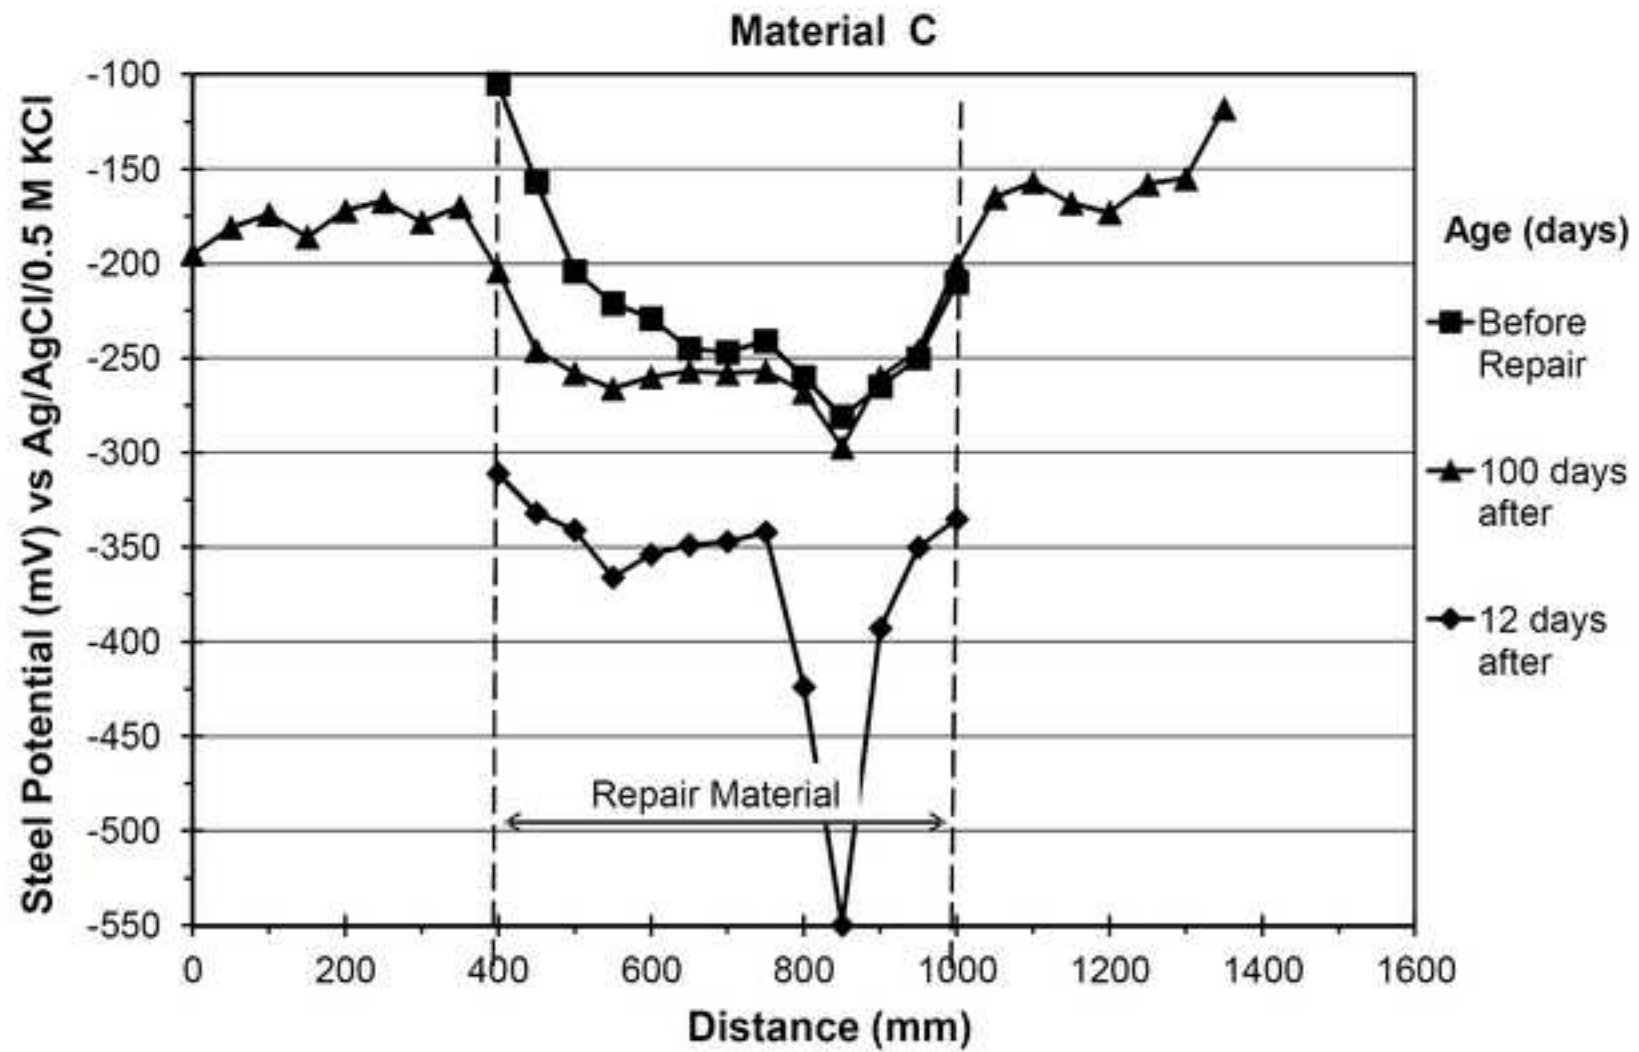
Figure 6 shows the steel potentials within the repair area measured before and after repair with material C. The data again shows that the potential of the steel within the repair area may be depressed to values that are more negative than the values observed in the parent concrete.

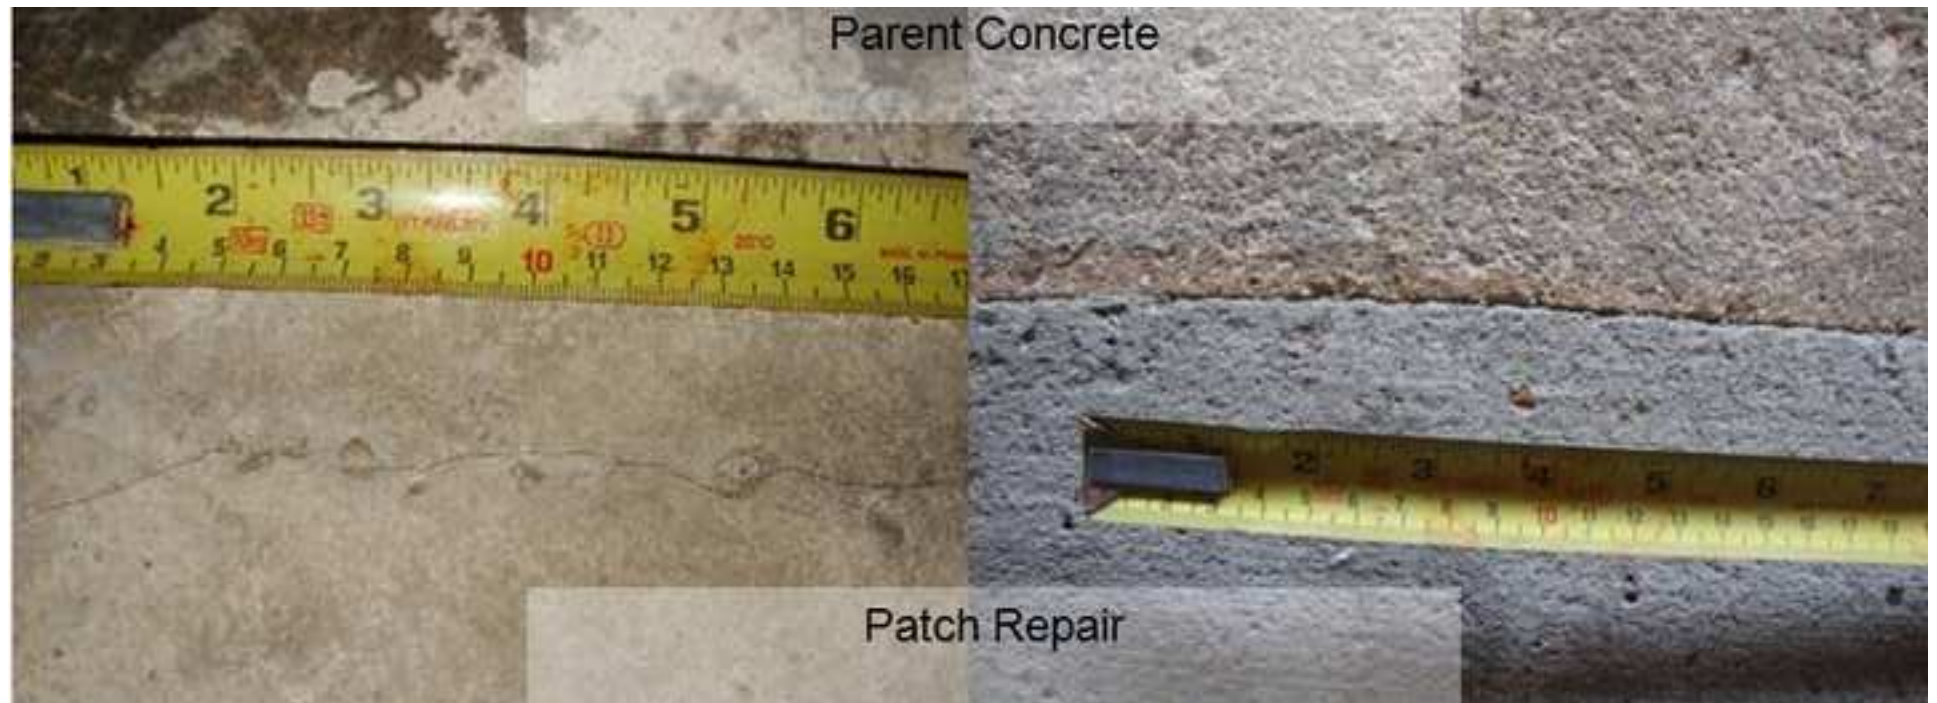
In some areas repaired with the pourable materials A and C, cracks were observed at the visible interface between the parent concrete and the repair material (Figure 7). The full extent of a crack is usually concealed due to the trowel finish of the repair that extends over to the parent concrete. It was only uncovered following surface preparation by mechanically

shot-blasting in preparation for an applied coating. For the spray applied material B, no cracks were identified.

Thus, the interface between repair material and parent concrete may provide a path for chlorides to penetrate preferentially into the substrate. The extent of this effect will be dependent on surface preparation, application techniques, curing, material properties and compatibility with the parent concrete. The presence of visible cracks may be obscured by trowel finishing the repair.

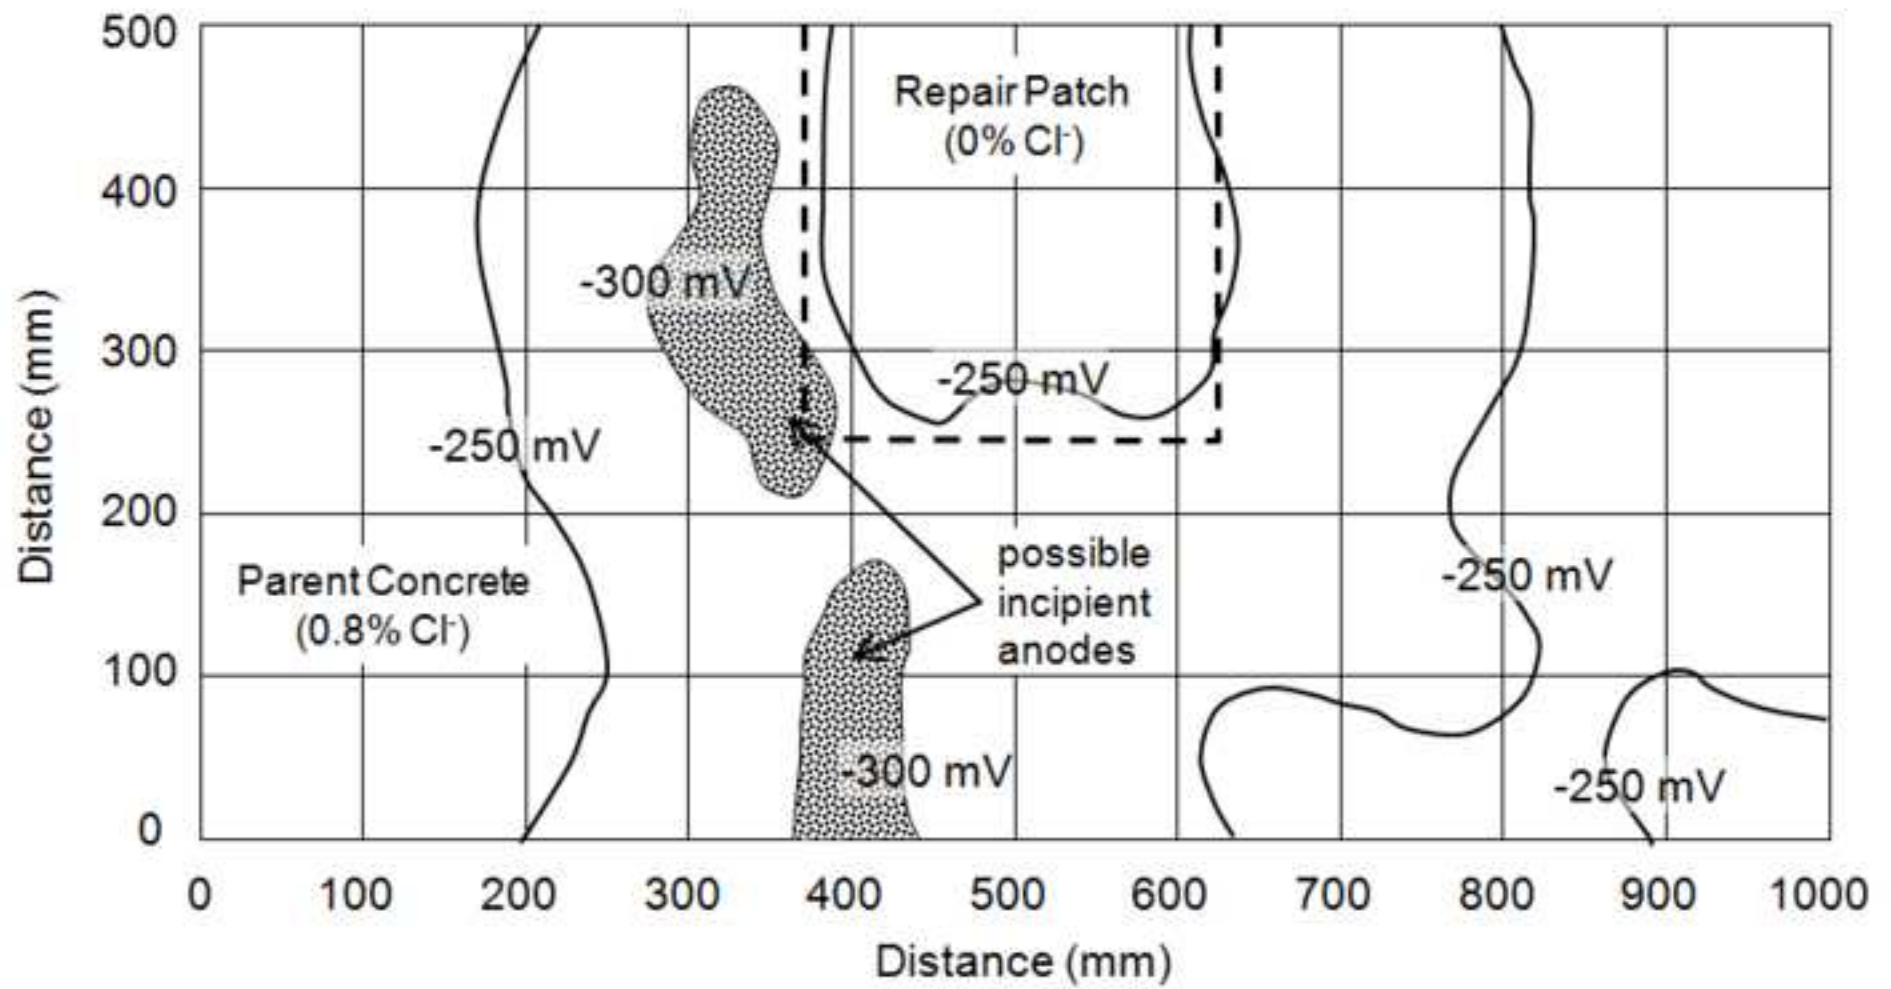
Case 2 represents the situation where the repair results in the removal of the corrosion site that used to be an anode. Previously published laboratory data [3] has shown that this situation may occur. Figure 9 reproduces the best data available supporting the widely held diagnosis (challenged in this current work) that macrocell activity causes incipient anode formation. To obtain this data a concrete slab was cast and then repaired under laboratory conditions. The parent concrete was not aged in the same way that concrete on a structure is aged and a proprietary repair material conforming to existing standards was not used to repair the damage.

Figure 9 shows that the potential of the steel in the repaired area did not differ substantially from the potential of the steel in the parent concrete. Two possible areas of incipient anode formation were identified. Only one of these was located adjacent to the repair area. A macrocell was also present between steel in different areas of the parent concrete in Figure 9. This data does not show that the incipient anodes were stimulated by the formation of a new macrocell. The parent concrete already contained passive steel that was as positive as the steel in the repaired area. The data suggests that the residual chloride content was sufficient on its own to cause corrosion at at least one of the identified areas of incipient anode formation.
