THE CORROSION BEHAVIOUR OF Fe-Cr-Ni ALLOYS
IN COMPLEX HIGH TEMPERATURE GASEOUS ATMOSPHERES
CONTAINING THE REACTANTS OXYGEN, SULPHUR
AND CARBON

A Doctoral Thesis submitted in partial fulfilment
of the requirements for the award of
Doctor of Philosophy
of the Loughborough University of Technology, U.K.,
based on research carried out at the
Commission of the European Communities Joint Research Centre,
Petten, Netherlands.

VOLUME 2

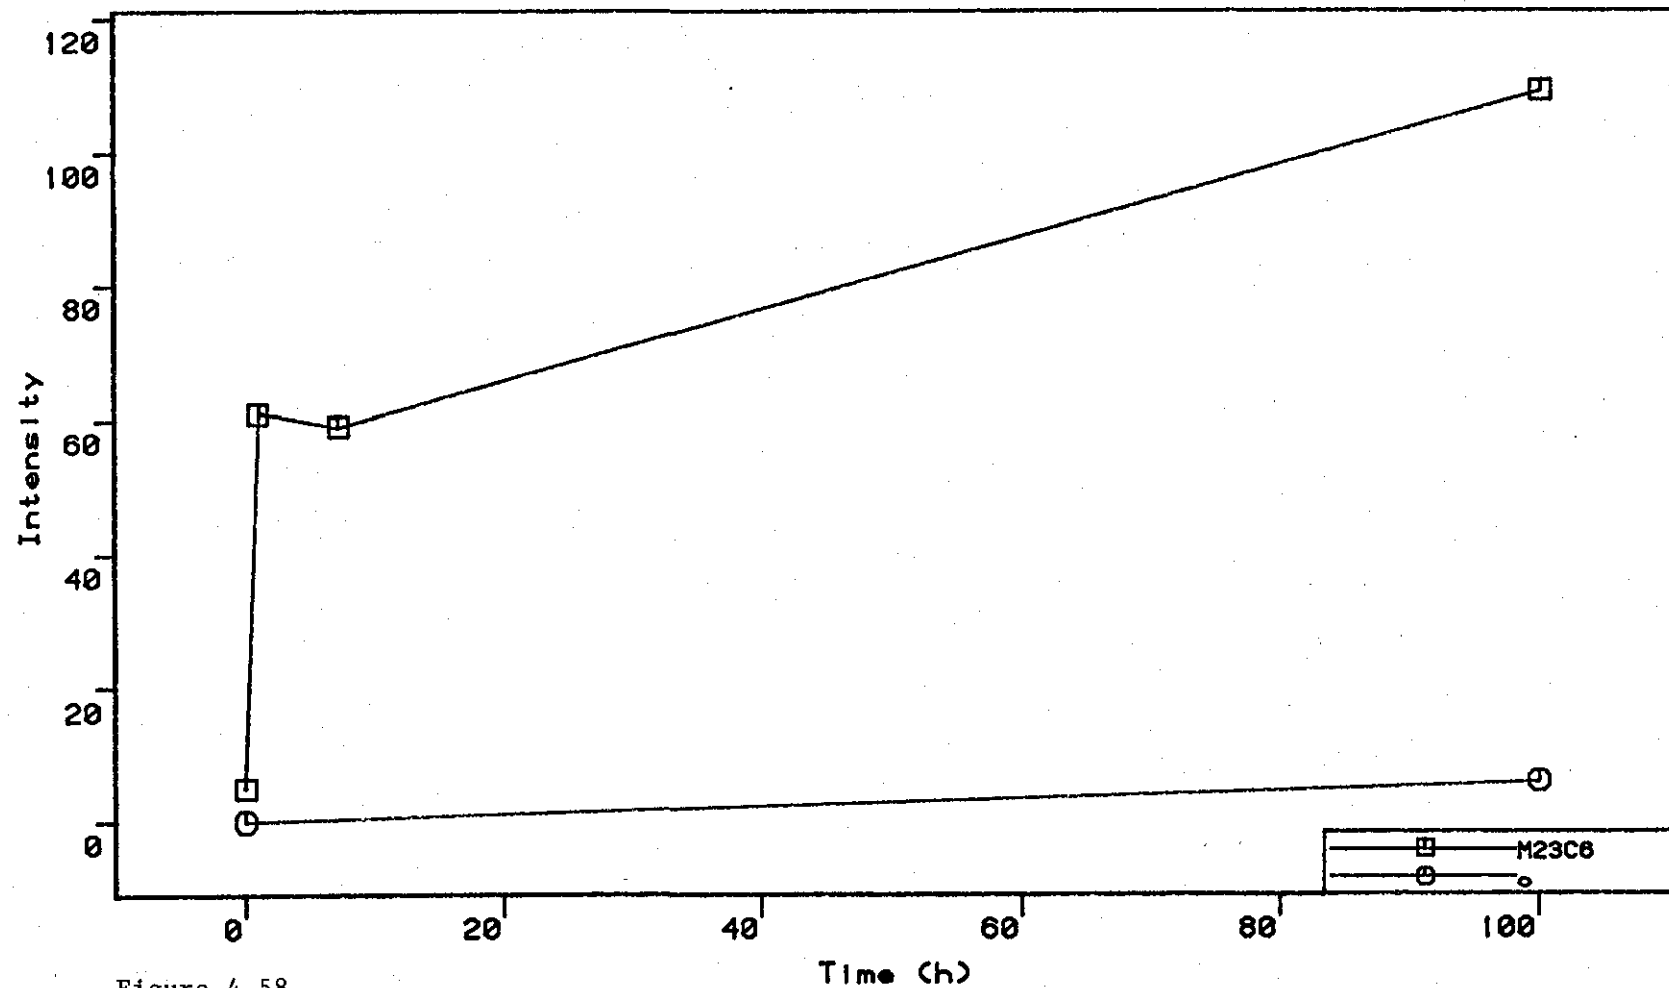
Figure 4.58

Plots of the X-ray diffraction peak intensity of the phases extracted from AISI 314 against annealing time in argon at 800°C.

Thus in summary the alloy in the as-received condition consisted of austenite with a few $M_{23}C_6$ precipitates at grain boundaries. As time progressed at 800°C, aging processes led initially to the amount of $M_{23}C_6$ precipitates increasing followed by the formation of the σ phase.

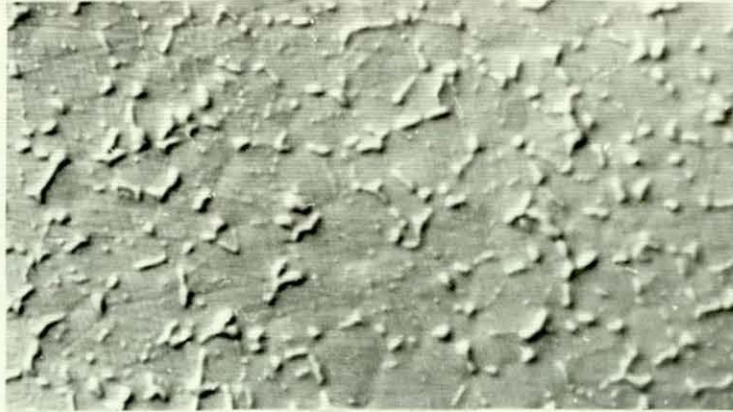
AISI 314 Aging at 800 deg. C

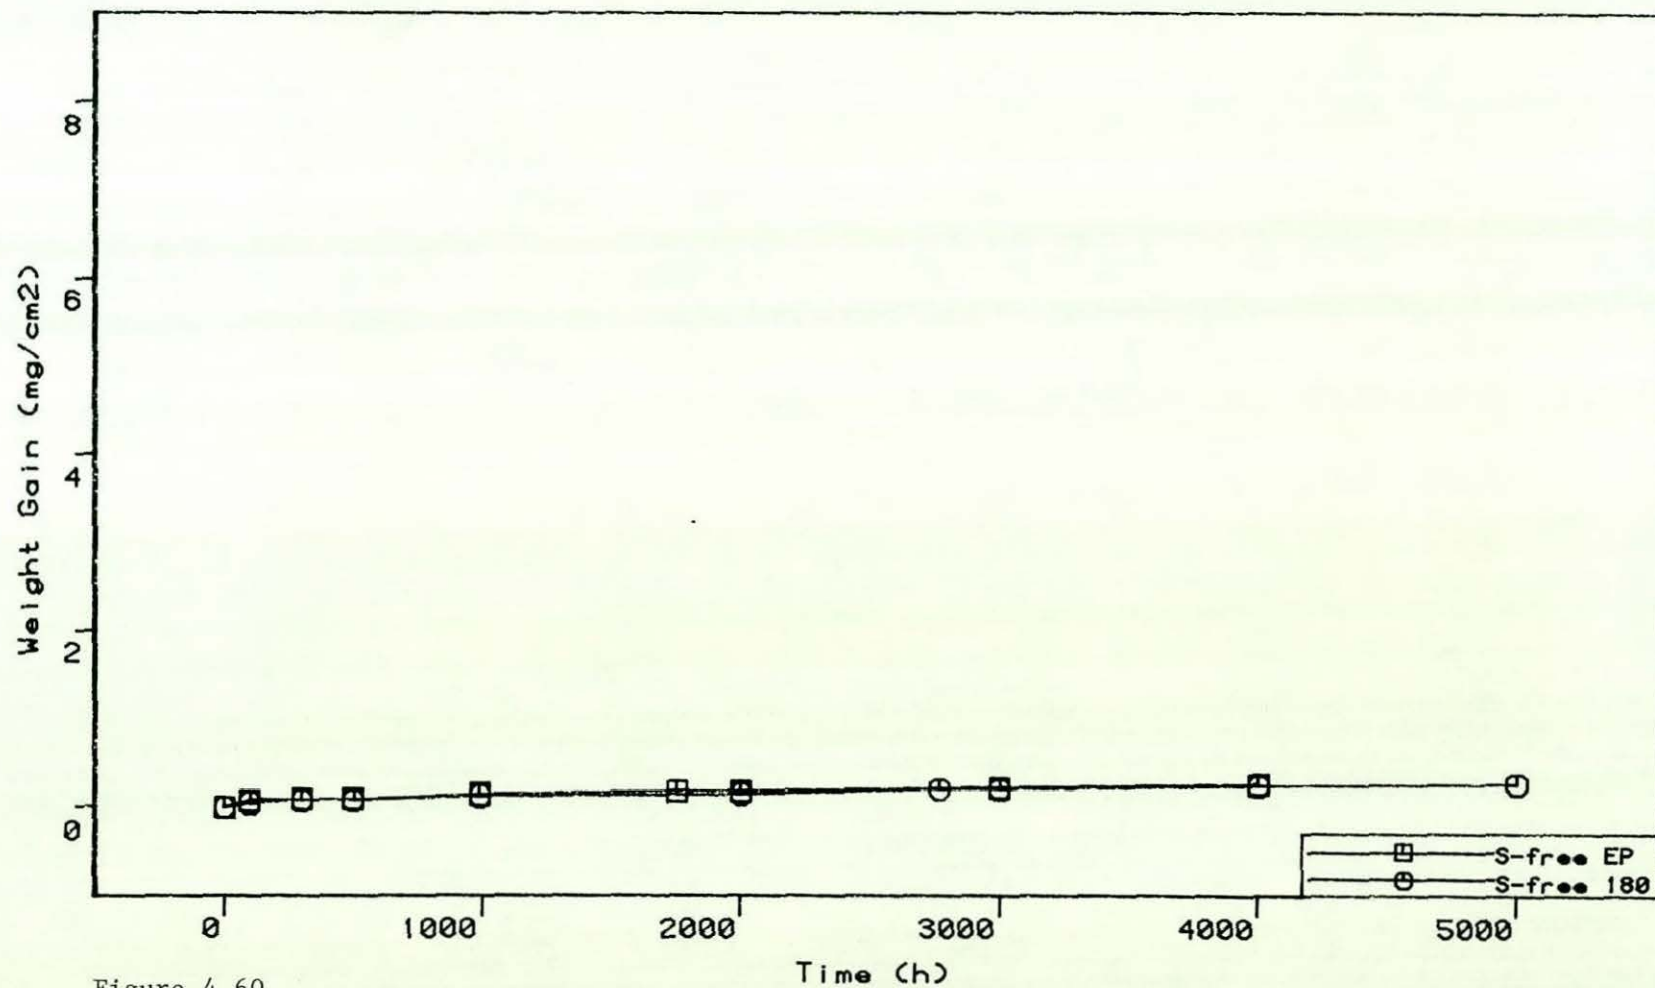
Figure 4.60

Kinetic data for AISI 314 exposed to the sulphur-free gas at 800°C.

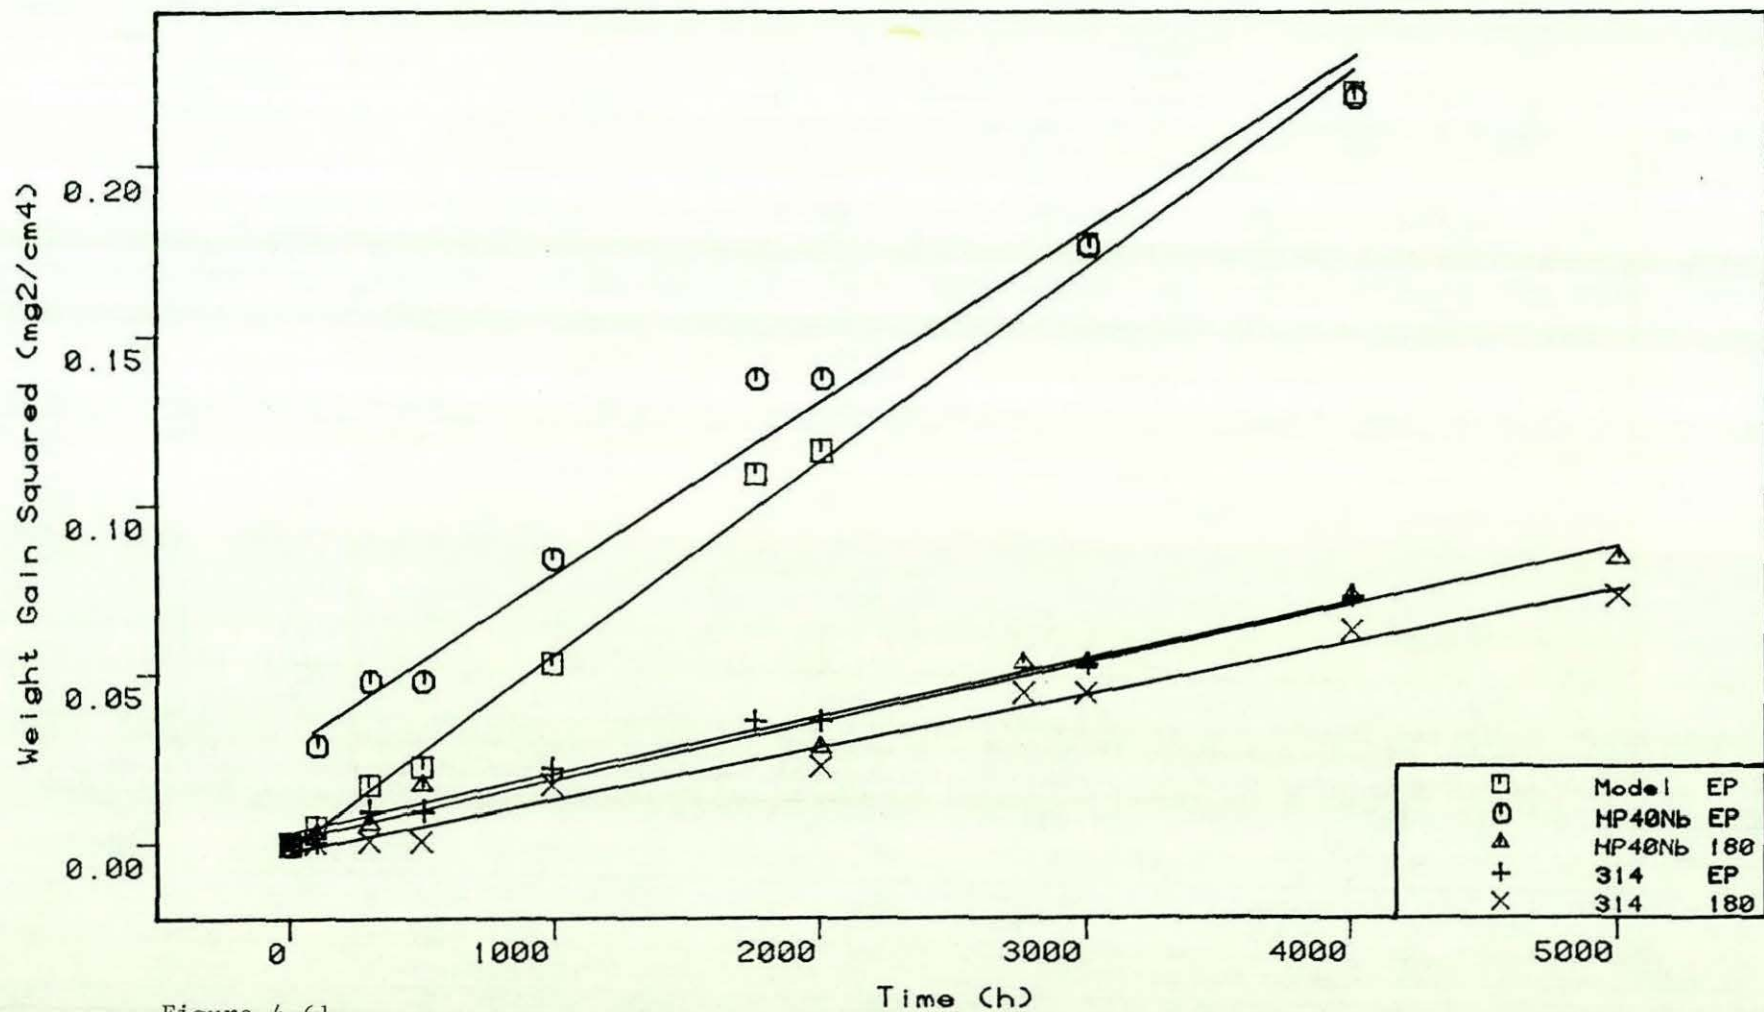
Figure 4.61

Plots of weight gain squared against time, which compare the corrosion behaviour of AISI 314 with the Model 25Cr-35Ni-Fe alloy and HP40Nb in the sulphur-free gas at 800°C .

Replotting these data as weight-gain squared against time, figure 4.61, showed that the corrosion kinetics were parabolic, with the rate approximately equal to that of the HP40Nb alloy in the 180 grit condition. The reaction rate constants are given in table 4.12. Data for the HP40Nb and Model 25Cr-35Ni-Fe alloy in the electropolished (EP) condition are also presented for comparison purposes to illustrate the very low corrosion rates of the AISI 314 material, figure 4.61.

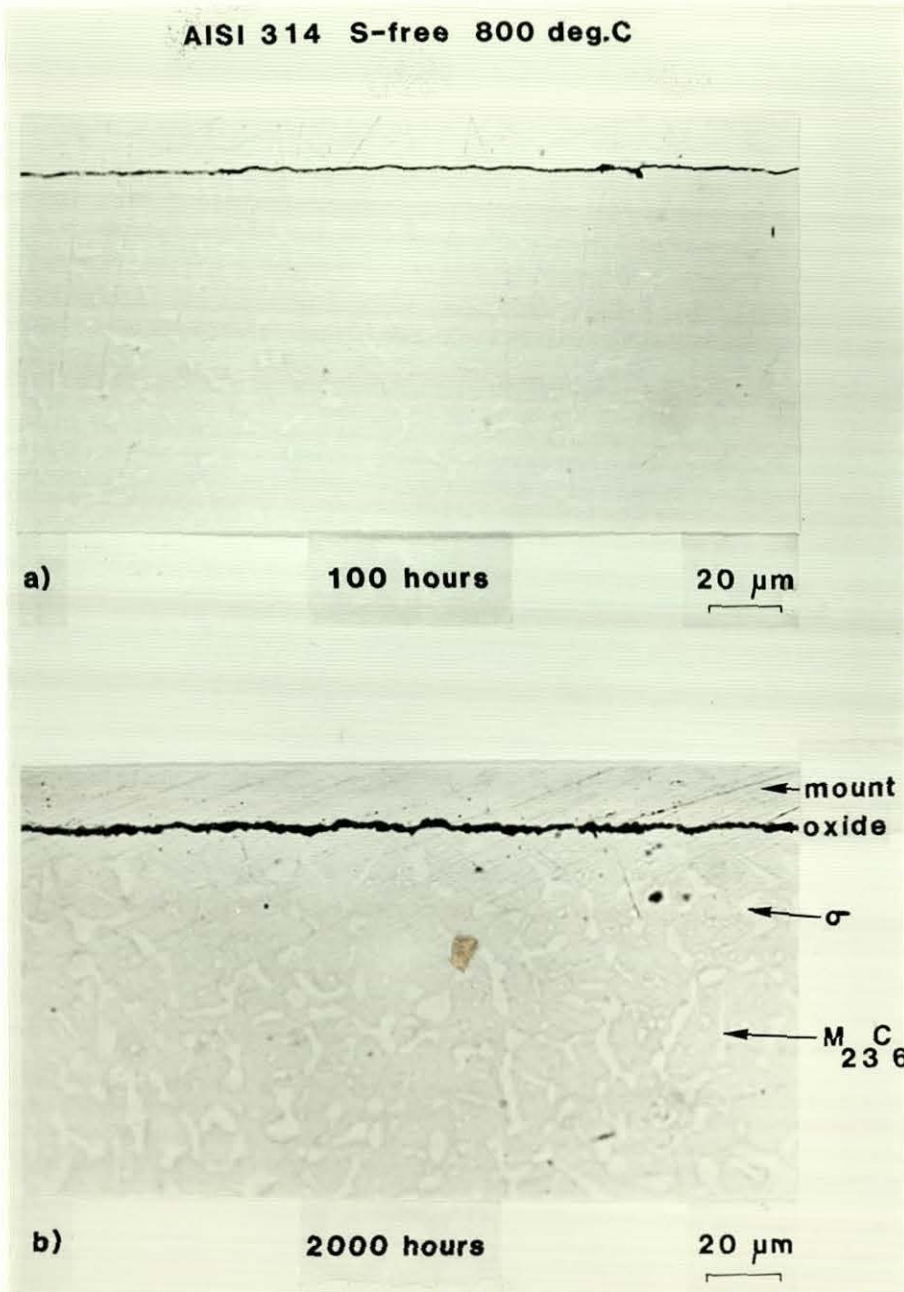
Figure 4.62

Cross-sectional metallographic examination of AISI 314 exposed to the sulphur-free gas at 800°C.

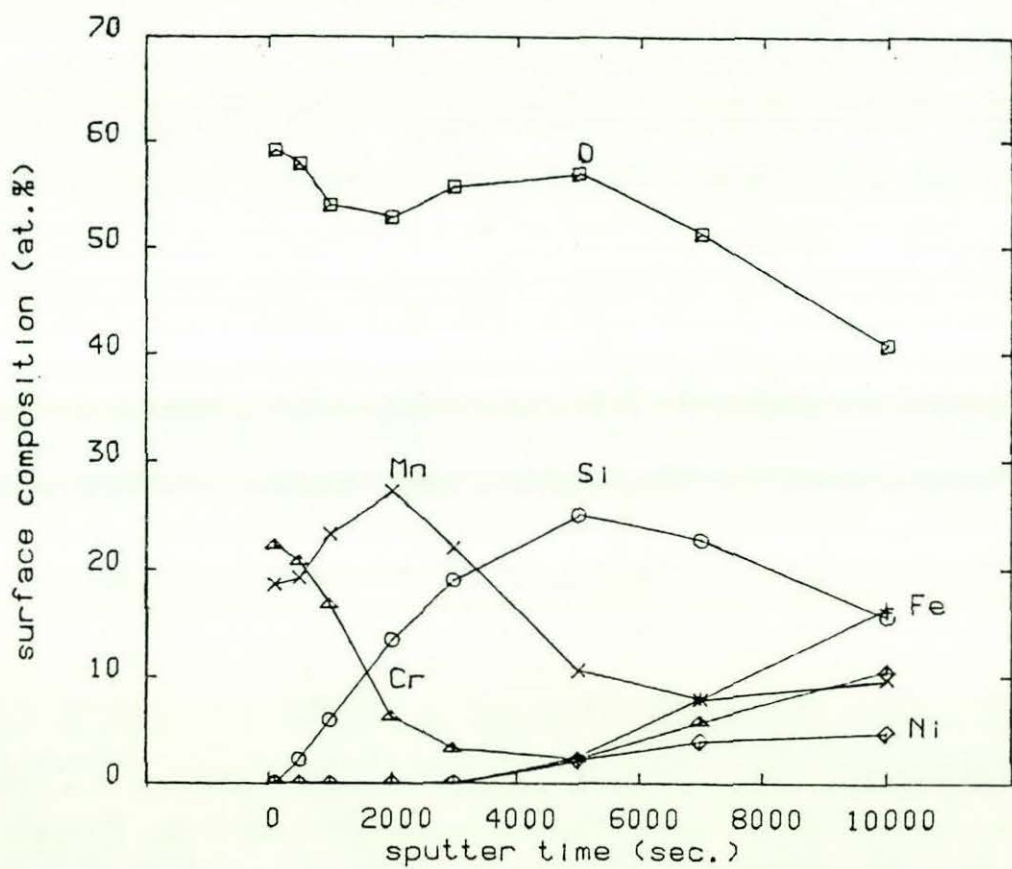
Figure 4.64

ESCA-AUGER analysis of the scale formed on AISI 314 exposed to the sulphur-free gas at 800°C for 2000 hours (surface worked '180 grit' condition).

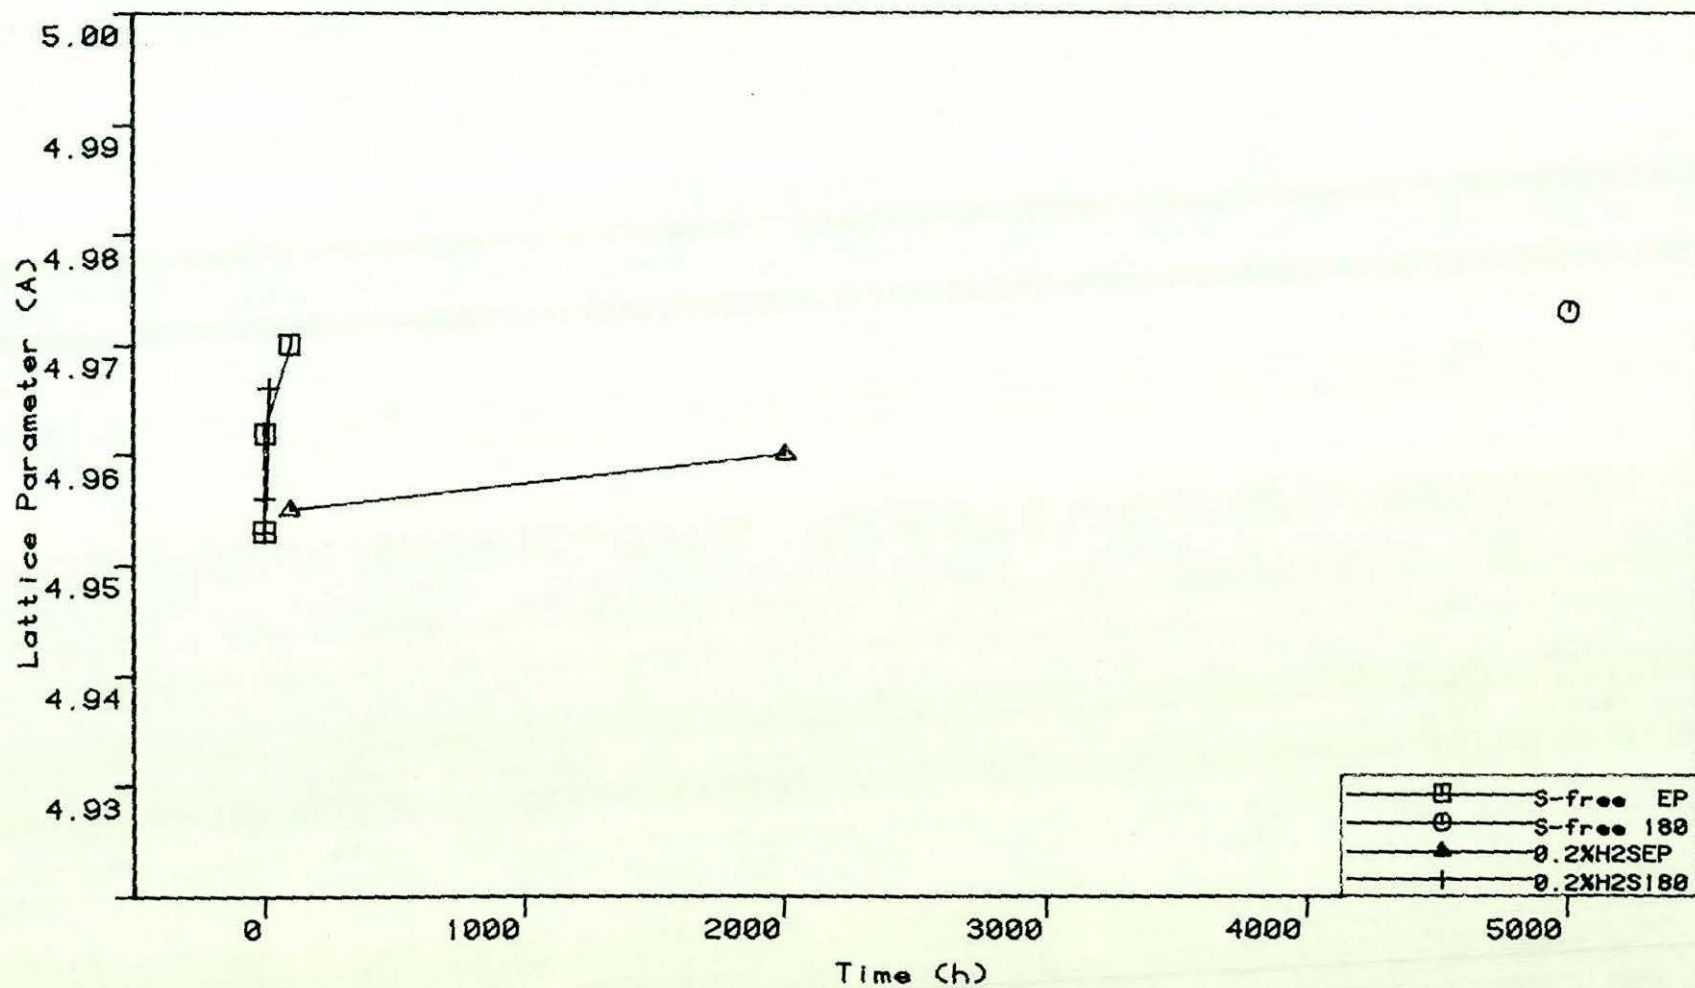
Figure 4.65

Plots of Cr_2O_3 lattice parameter against time for the scale formed on AISI 314 exposed to the sulphur-free and 0.2% H_2S gases at 800°C.

Surface SEM examination showed that in general the scale had now become even coarser, figure 4.68c. At corners of the specimen, where quite often most of the spallation had occurred, large sulphide particles had formed, figure 4.68d. These were identified by X-ray diffraction using surface reflection as M_3S_4 , table 4.15. The rest of the surface was identified as M_3O_3 and Cr_2O_3 , table 4.15. The lattice parameter of the spinel indicated that it was FeCr_2O_4 , figure 4.63. The Cr_2O_3 lattice parameter however was still approximately equivalent to that of pure Cr_2O_3 , figure 4.65.

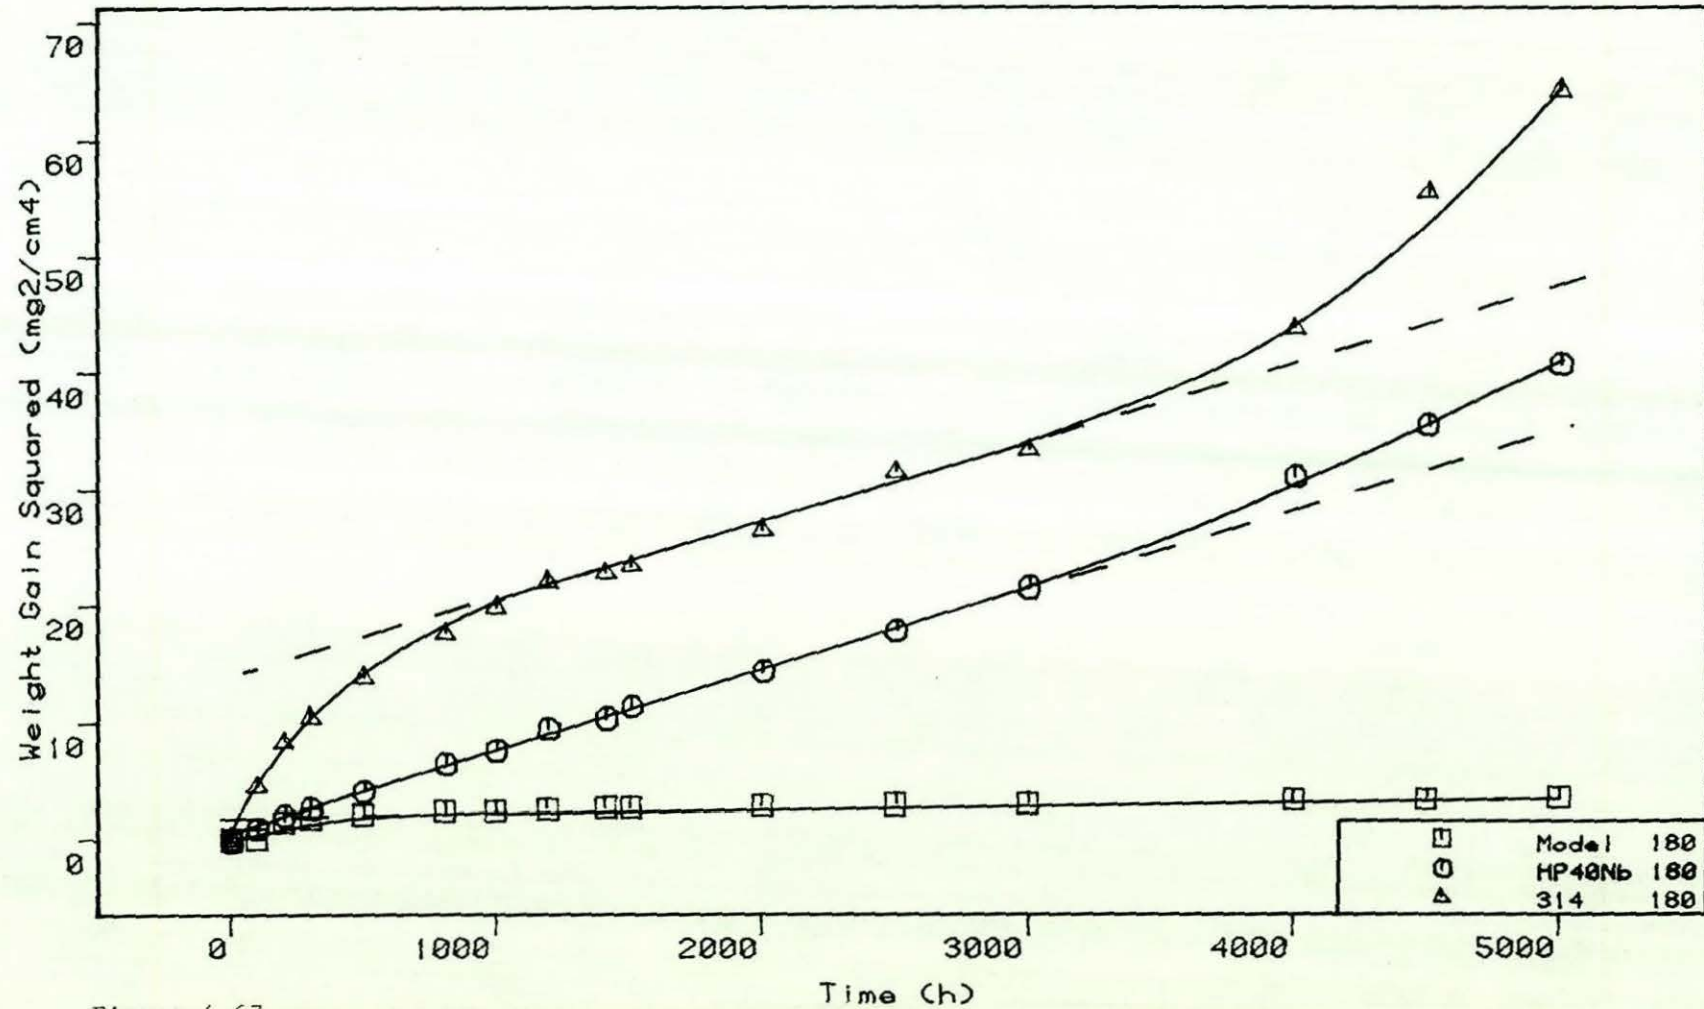
Figure 4.67

Plots of weight gain squared against time, which compare the corrosion behaviour of AISI 314 with the Model 25Cr-35Ni-Fe alloy and HP40Nb in the 0.2% H₂S gas at 800°C. (180 grit condition).

Replotting the kinetic data as weight gain squared against time showed that the corrosion process commenced at a high rate and subsequently slowed down until after approximately 1000 hours it became parabolic, figure 4.67. The corrosion rate remained parabolic until after 3000 hours a significant increase in the rate occurred, indicating the onset of breakaway corrosion. Whilst in the parabolic range the corrosion rate was very similar to the HP40Nb alloy (table 4.12), however once breakaway commenced the upturn in the rate for AISI 314 was much more pronounced, figure 4.67. The Model 25Cr-35Ni-Fe alloy is also included in the figure for comparison purposes.

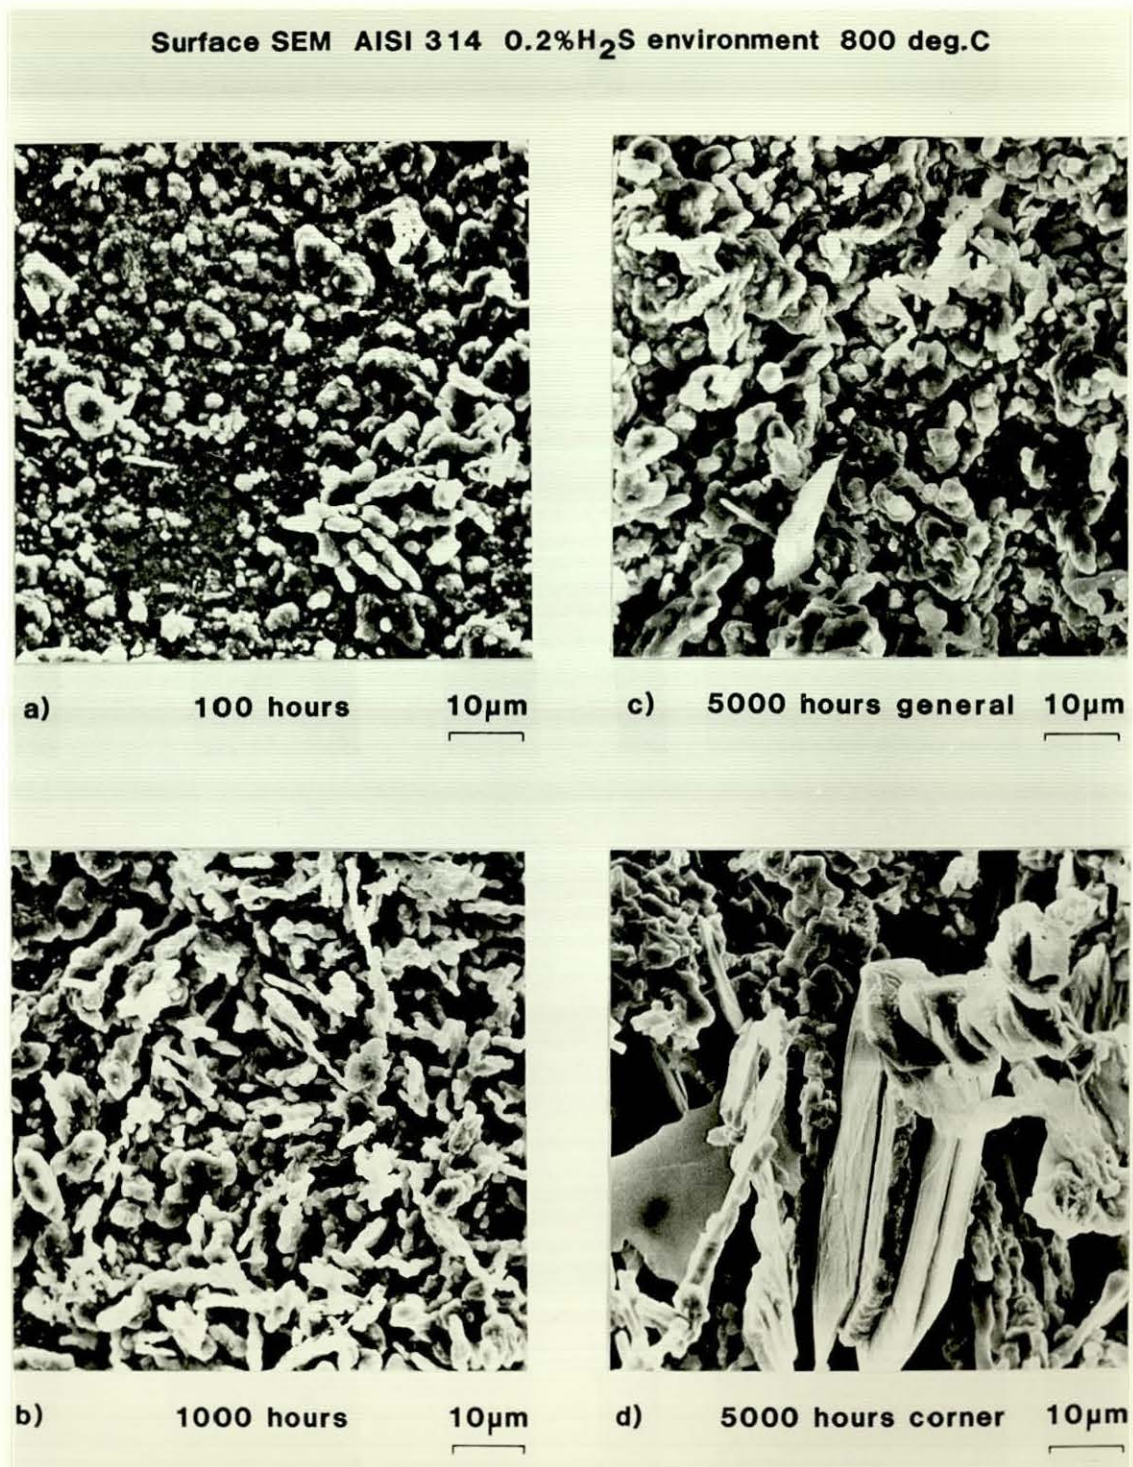
Figure 4.68

Surface SEM examination of AISI 314 exposed to the 0.2 % H_2S gas at 800°C, 180 grit condition.

Some spallation of the scale started to occur. SEM examination showed that the surface of the scale was very filamentary, figure 4.68a. Cross-sectional examination using the Pepperhoff technique revealed that the scale consisted of two layers : an outer filamentary looking layer (10 μm thick) and a slightly thinner uneven inner layer (5 μm thick), figure 4.69a. A few isolated metallic particles were also visible between the two layers. Although the two layers were predominantly oxide both contained a number of sulphide particles. Spherical sulphide precipitates were also present in the alloy substrate.

After 1000 hours surface SEM examination revealed that the outer layer had become coarser, figure 4.68b. An appreciable amount of spallation was also continuing to occur. The outer layer which was still attached to the specimen was removed, ground to a powder and examined by ESCA-AUGER analysis. This showed that it still consisted of predominantly Cr-rich oxides with small amounts of Fe, Mn and S also present, figure 4.71.

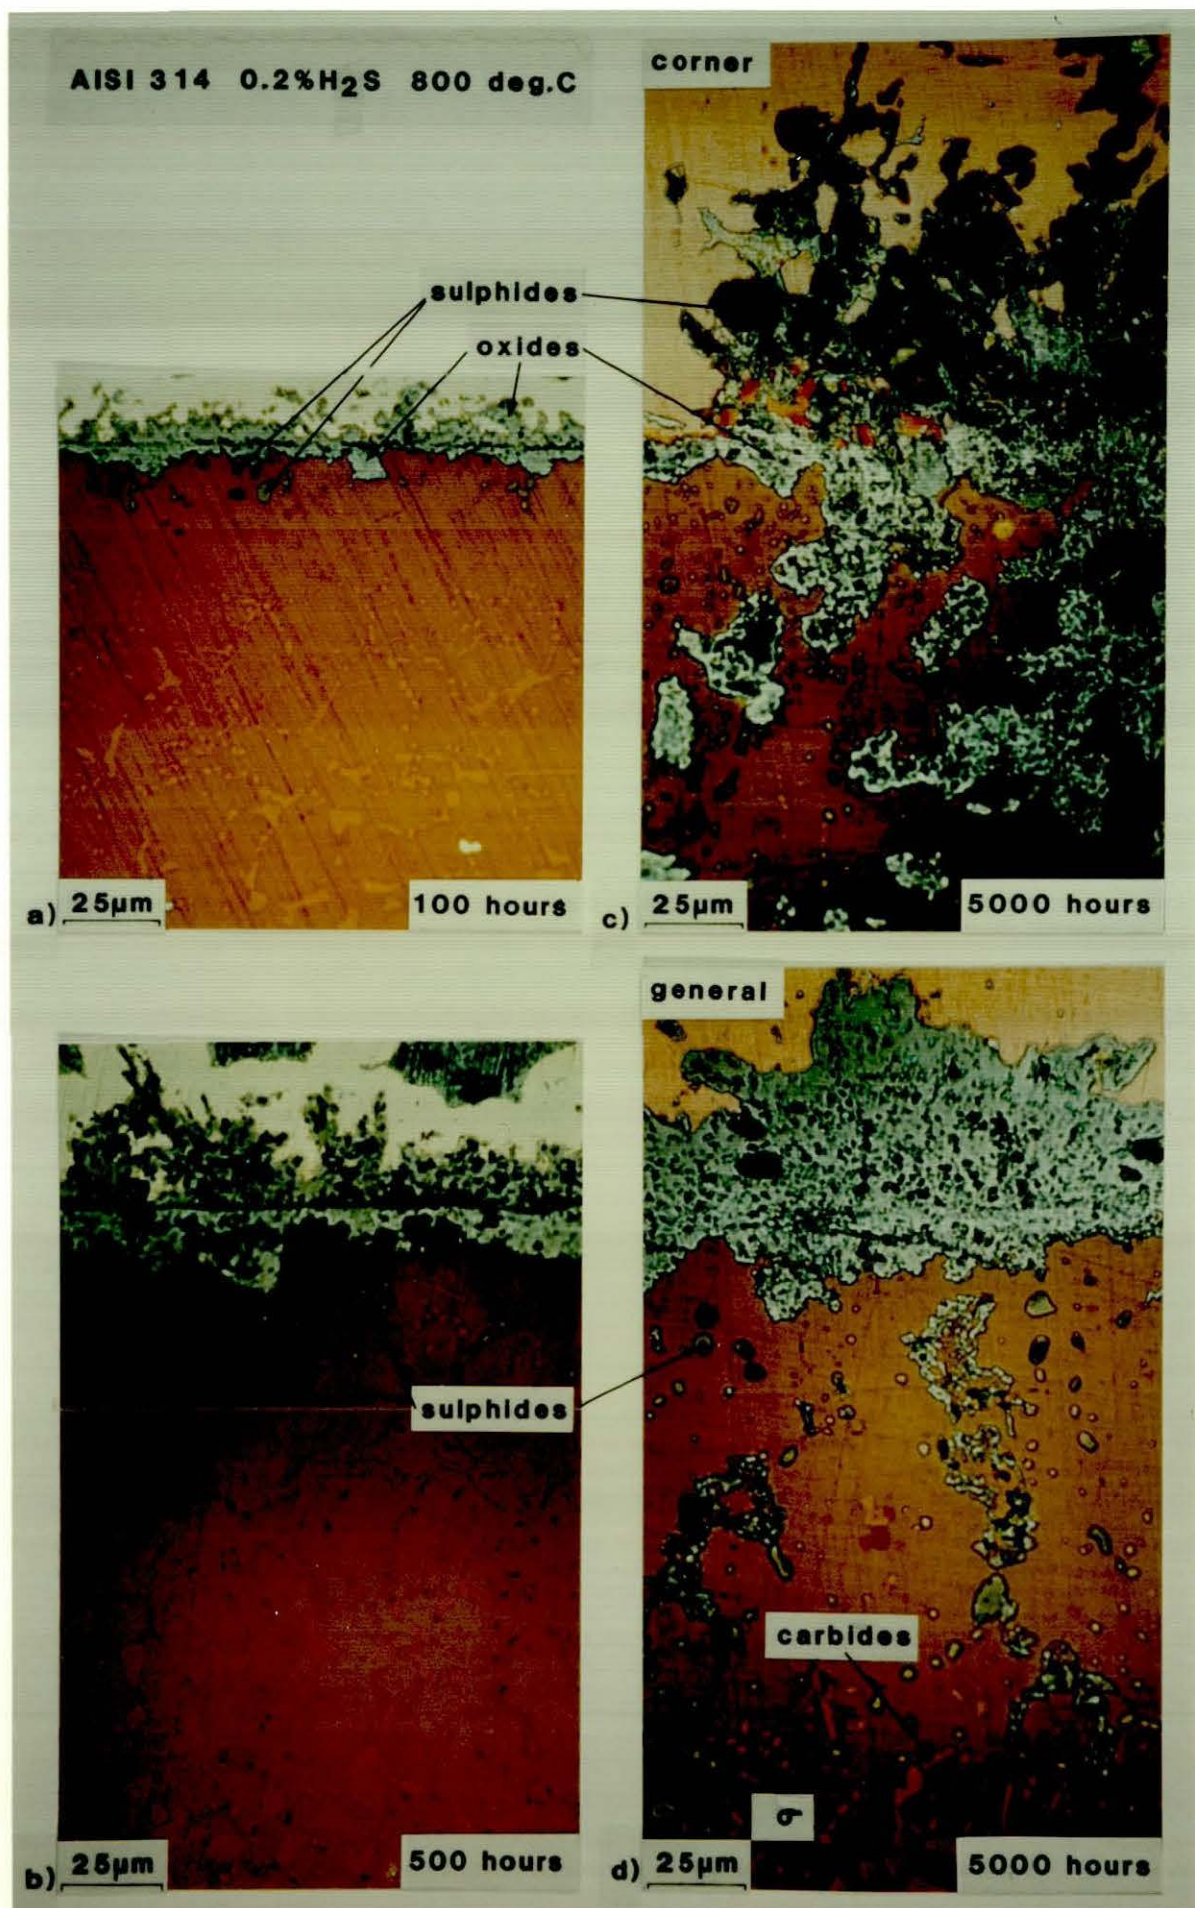
Figure 4.69
Cross-sectional examination using the Pepperhoff technique for AISI 314
exposed to the 0.2 % H_2S environment at 800°C, 180 grit condition.

Cross-sectional examination after 500 hours showed that both the outer (20 μm) and inner (14 μm) layers were thicker but otherwise the corrosion morphology was very similar to that after 100 hours, figure 4.69b. The internal spherical sulphide precipitates had however become larger but fewer in number and penetrated deeper into the alloy substrate.

The corrosion attack was much more severe at the corners of the specimens, figure 4.72 and 4.69c. Rather voluminous looking M_3S_4 sulphide lamellae were now present in place of the outer oxide layer. The internal oxide layer remained, but a vast amount of localized internal oxidation had taken place.

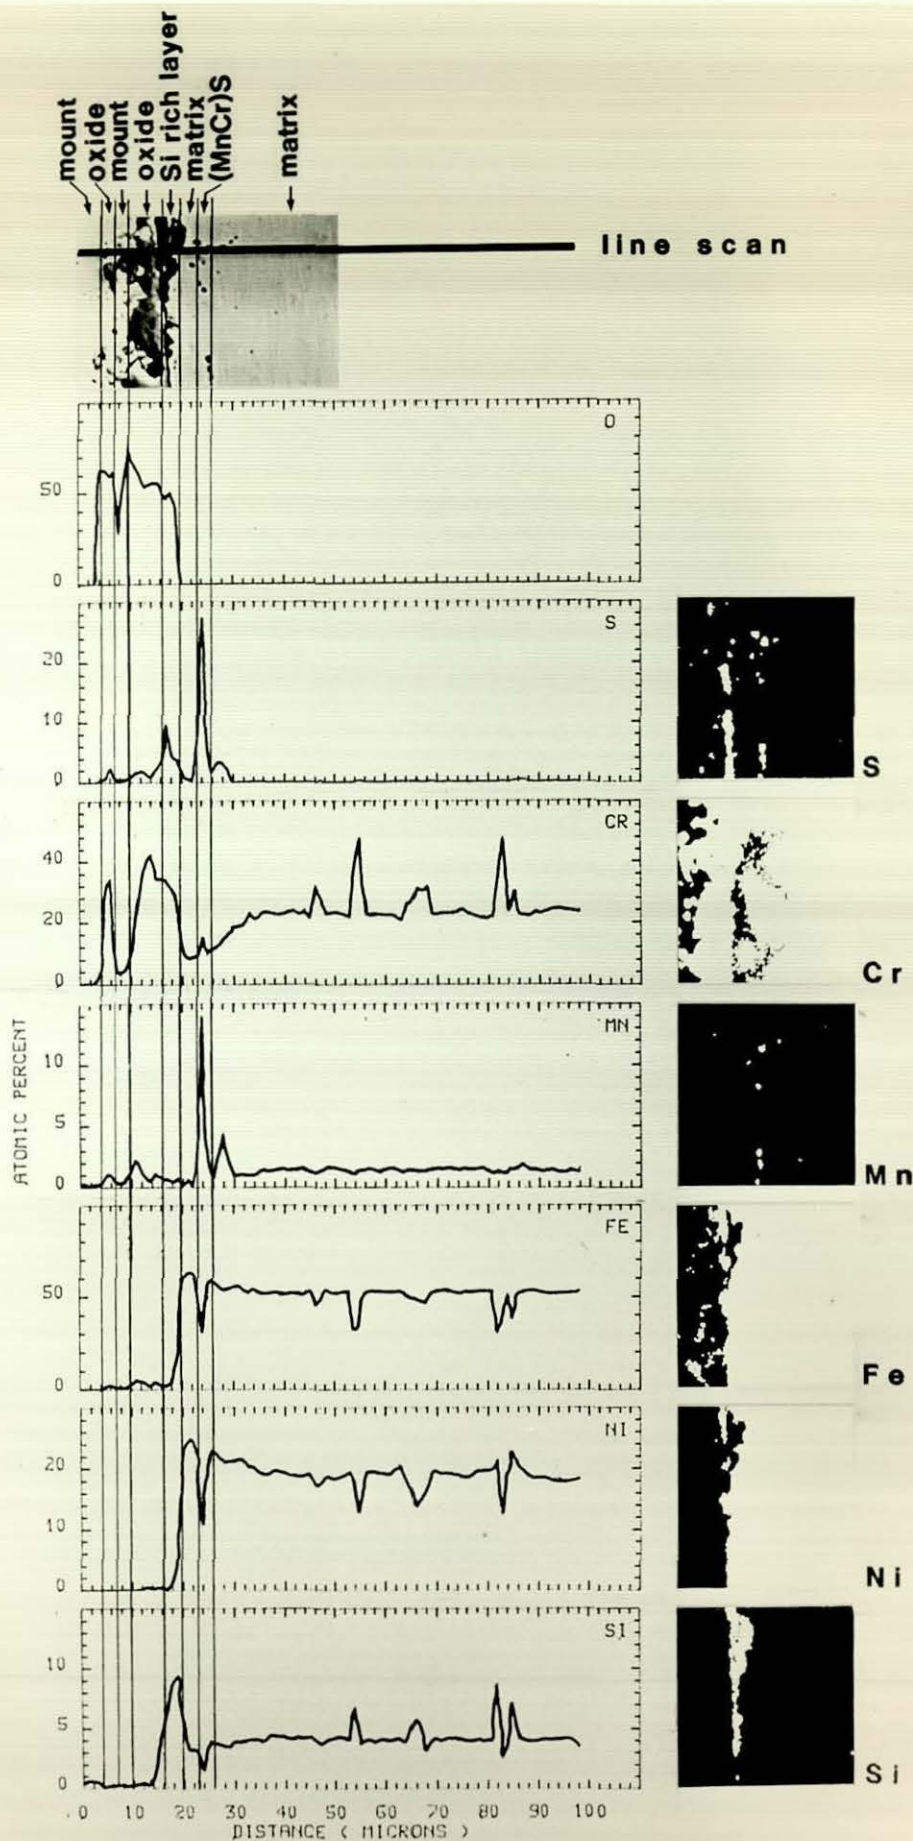
Figure 4.70

EPMA line scan and elemental concentration maps on AISI 314 exposed for 100 hours to the 0.2 % H_2S environment at 800°C, 180 grit condition.

An EPMA line scan taken through the two layers indicated that the outer oxide layer contained predominantly chromium and oxygen with approximately 5 % Fe, 2 % Mn and 4 % S also present, figure 4.70. X-ray mapping indicated that the Fe tended to be concentrated in localized regions. The inner layer was rich in both Si and Cr and contained considerably more S (up to 10 %) than the external layer. The alloy substrate beneath the scale at this stage contained 12 % Cr. The spherical sulphide precipitates present in the Cr depleted alloy substrate were found to be rich in Mn and Cr but had no fixed composition. No carbides or σ -phase were present in the Cr-depleted zone.

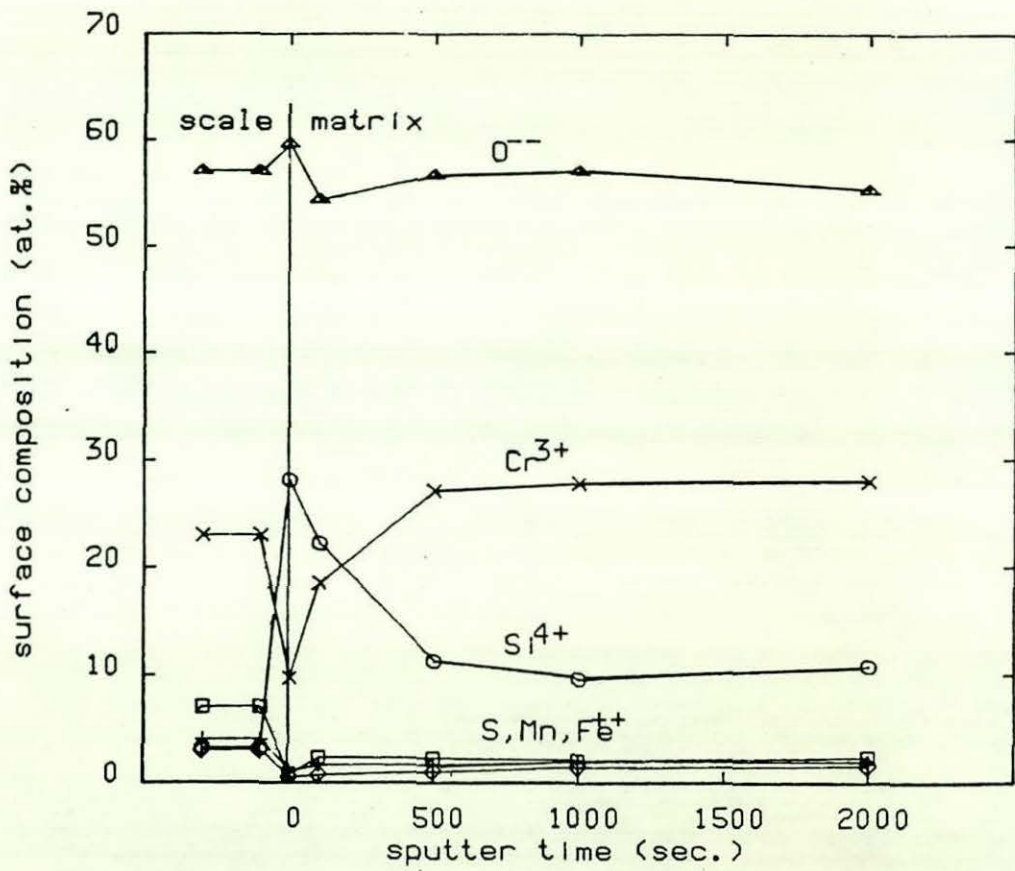
Figure 4.71

ESCA-AUGER analysis of the outer and inner layers of scale formed on AISI 314 exposed to the 0.2 % H_2S gas at 800°C for 1000 hours, 180 grit condition.

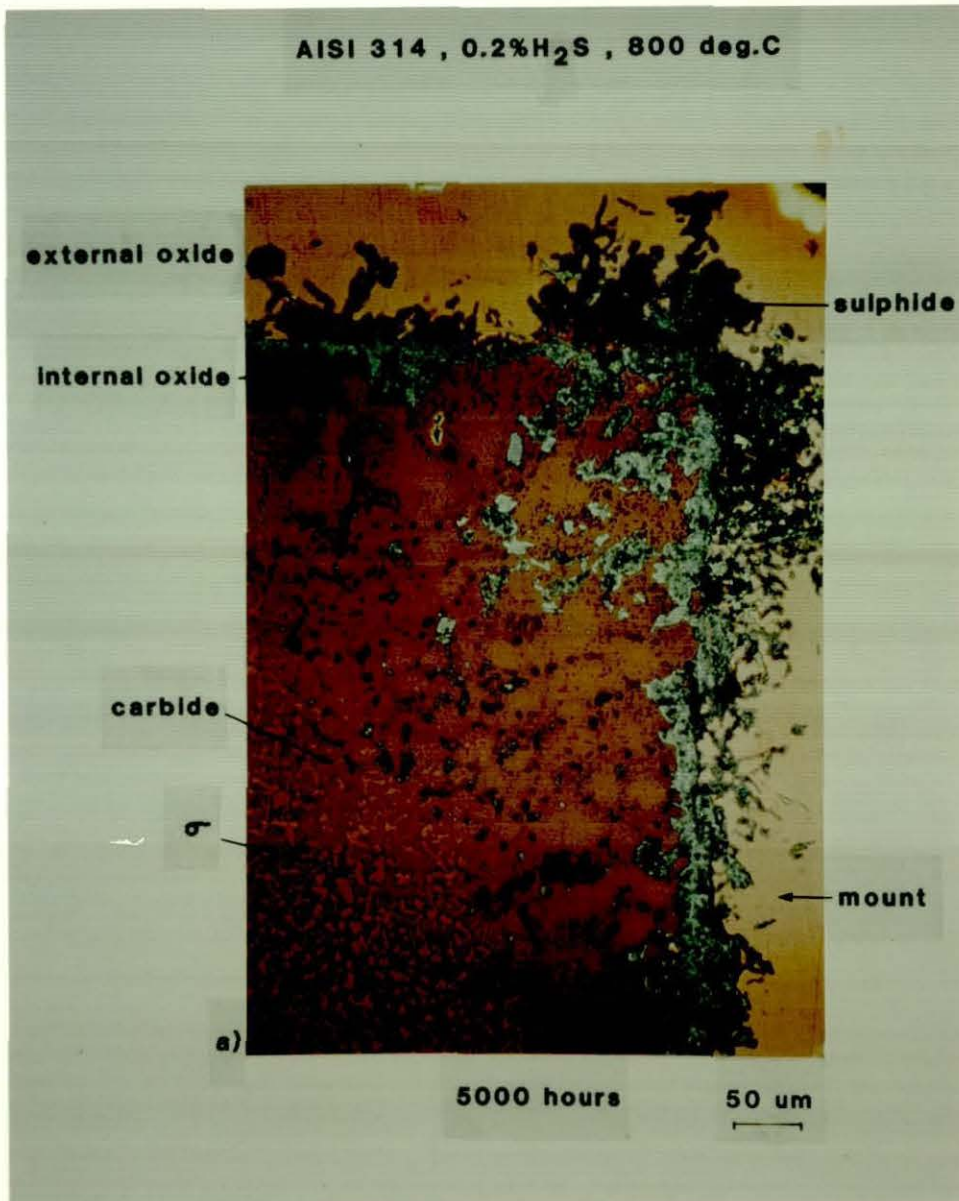
Figure 4.72

Cross-sectional examination using the Pepperhoff technique for AISI 314, exposed to the 0.2 % H_2S at 800°C for 5000 hours, 180 grit condition.

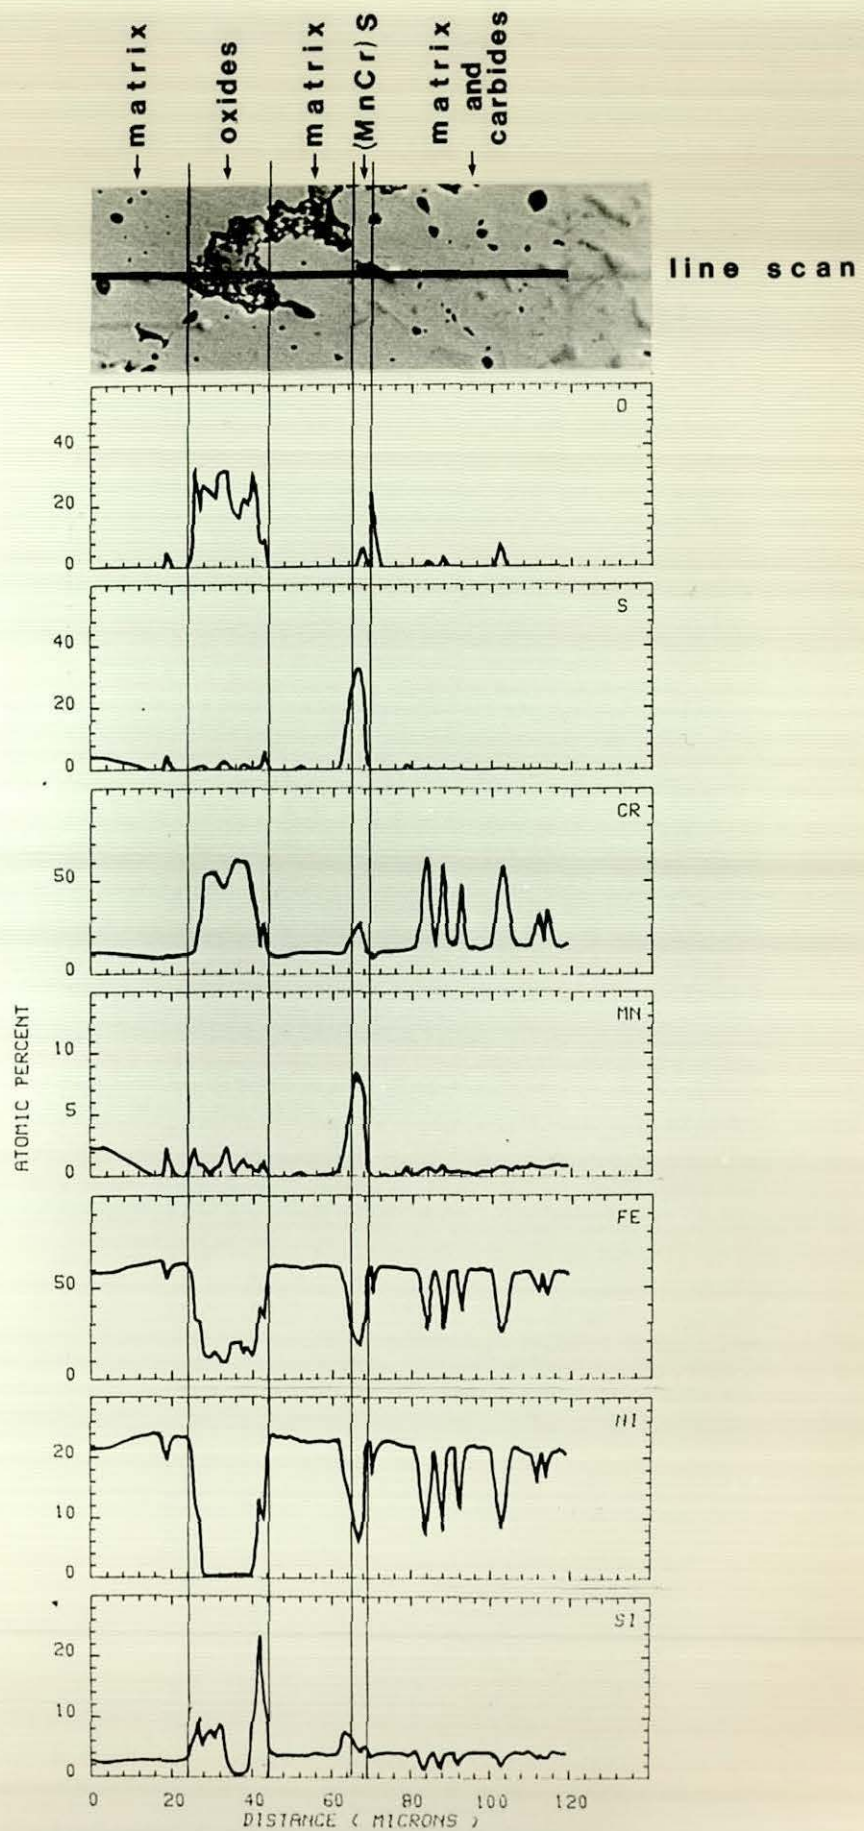
Figure 4.74
Continuation of the line scan shown in Figure 4.73.
