THE CORROSION BEHAVIOUR OF Fe-Cr-Ni ALLOYS
IN COMPLEX HIGH TEMPERATURE GASEOUS ATMOSPHERES
CONTAINING THE REACTANTS OXYGEN, SULPHUR
AND CARBON

A Doctoral Thesis submitted in partial fulfilment
of the requirements for the award of
Doctor of Philosophy
of the Loughborough University of Technology, U.K.,
based on research carried out at the
Commission of the European Communities Joint Research Centre,
Petten, Netherlands.

VOLUME 2

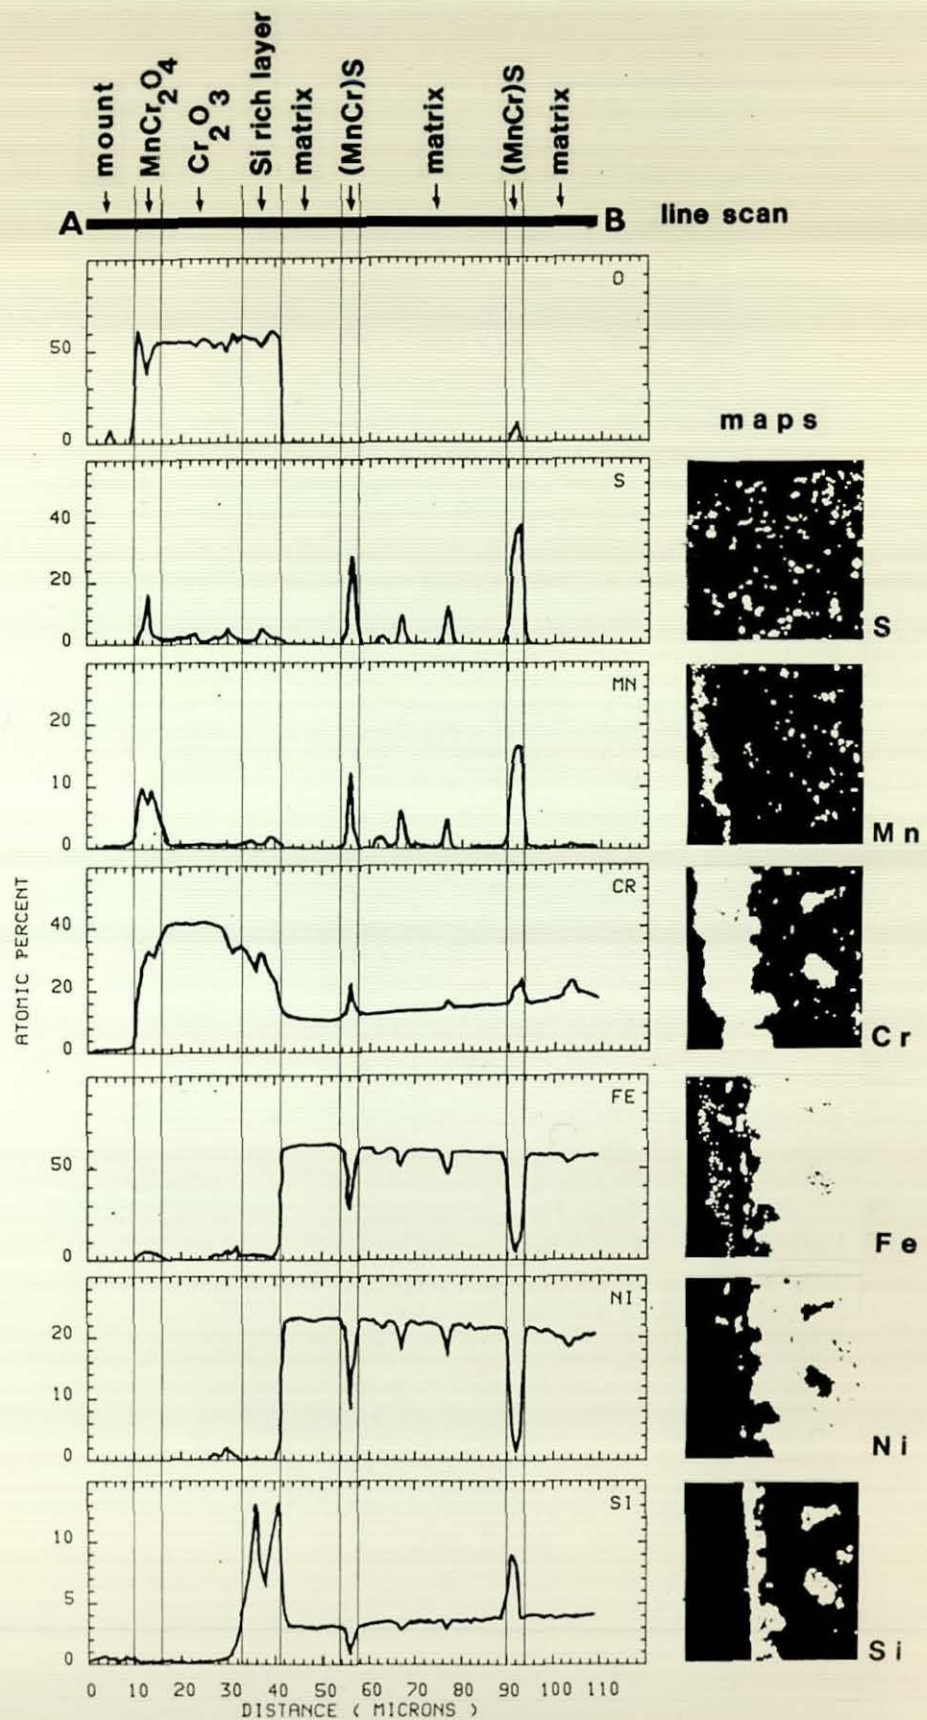
Figure 4.76

EPMA line scan, corresponding to line AB on Figure 4.75b, and elemental concentration maps on AISI 314 exposed for 2000 hours to the 0.2 % H_2S gas at 800°C, electropolished condition.

A line scan AB taken through a typical area of the scale is shown in figure 4.76. This confirmed that the scale consisted of three layers; an outermost $(MnFe)Cr_2O_4$ layer, an intermediate Cr_2O_3 layer and an inner layer rich in Si and Cr. The line scan and elemental mapping also showed that all three of these layers contained a significant amount of sulphur. After 2000 hours the alloy substrate beneath the inner layer contained only approximately 10 % Cr, figure 4.76. If the corrosion process was continued for longer exposure times this low level of Cr

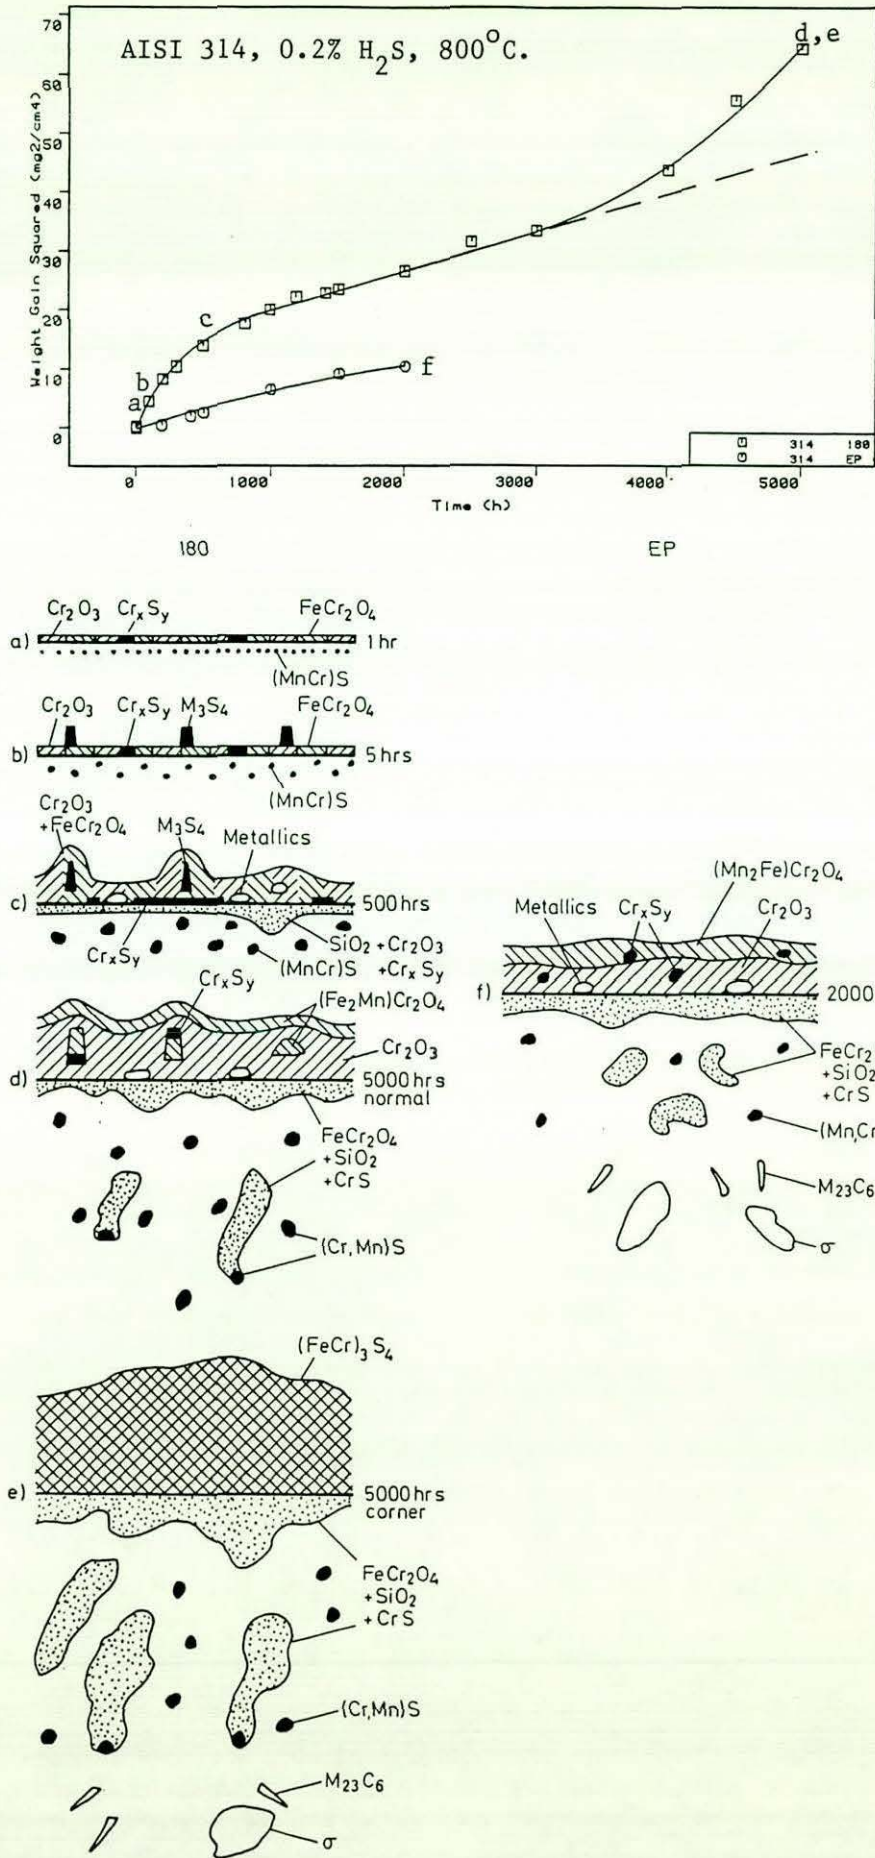
Figure 4.78

Schematic diagram summarising the corrosion behaviour of AISI 314 in the 0.2 % H₂S gas at 800°C.

In some places, such as corners, the external scale had spalled off and the Cr level of the substrate was now insufficient to form a new Cr_2O_3 outer layer. This resulted firstly a large amount of internal attack and secondly the formation of an FeCr-rich sulphide outer layer, figure 4.78e.

The weight uptake of the electropolished material was slightly lower. Examination after 2000 hours showed that the corrosion morphology was very similar to the 180 grit condition, figure 4.78f. The main difference was that a smaller volume of internal sulphide precipitates were present and that the M_3O_4 spinel contained a higher Mn to Fe ratio than the 180 grit material. This spinel was concentrated in an outer layer on top of the Cr_2O_3 layer. Thus it was concluded that because less Mn was consumed by the internal sulphides, more was available for external oxidation.

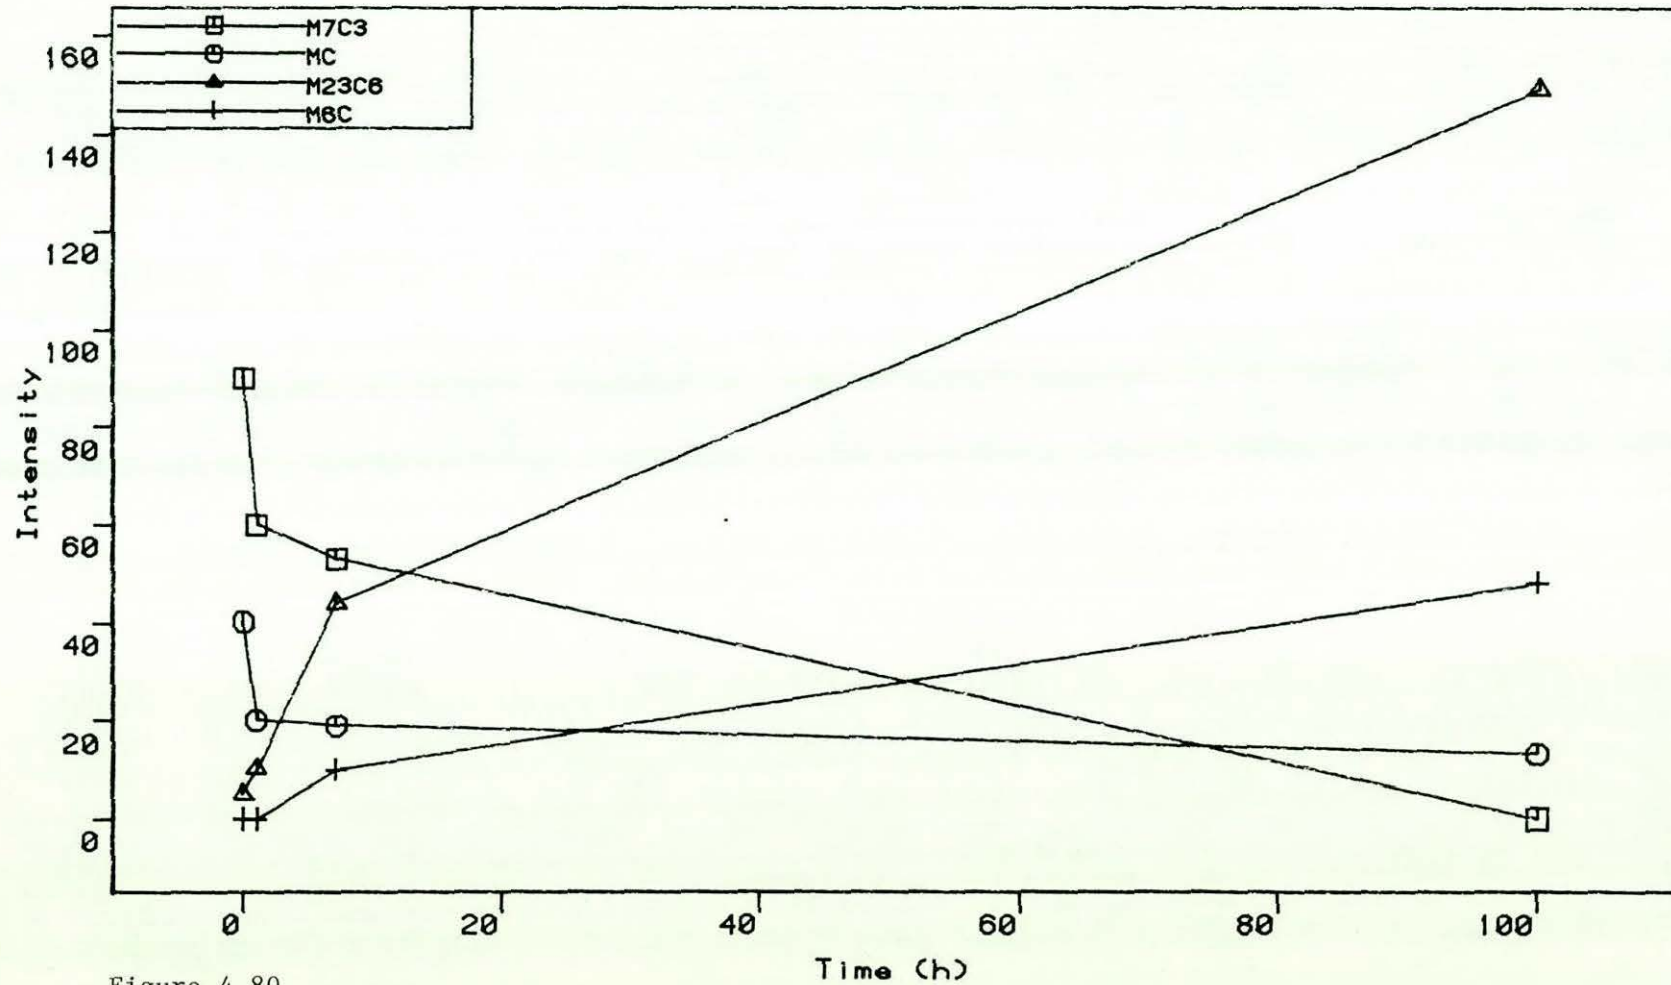
Figure 4.80

Plots of the X-ray diffraction peak intensity of the phases extracted from HP40Al against annealing time in argon at 800°C.

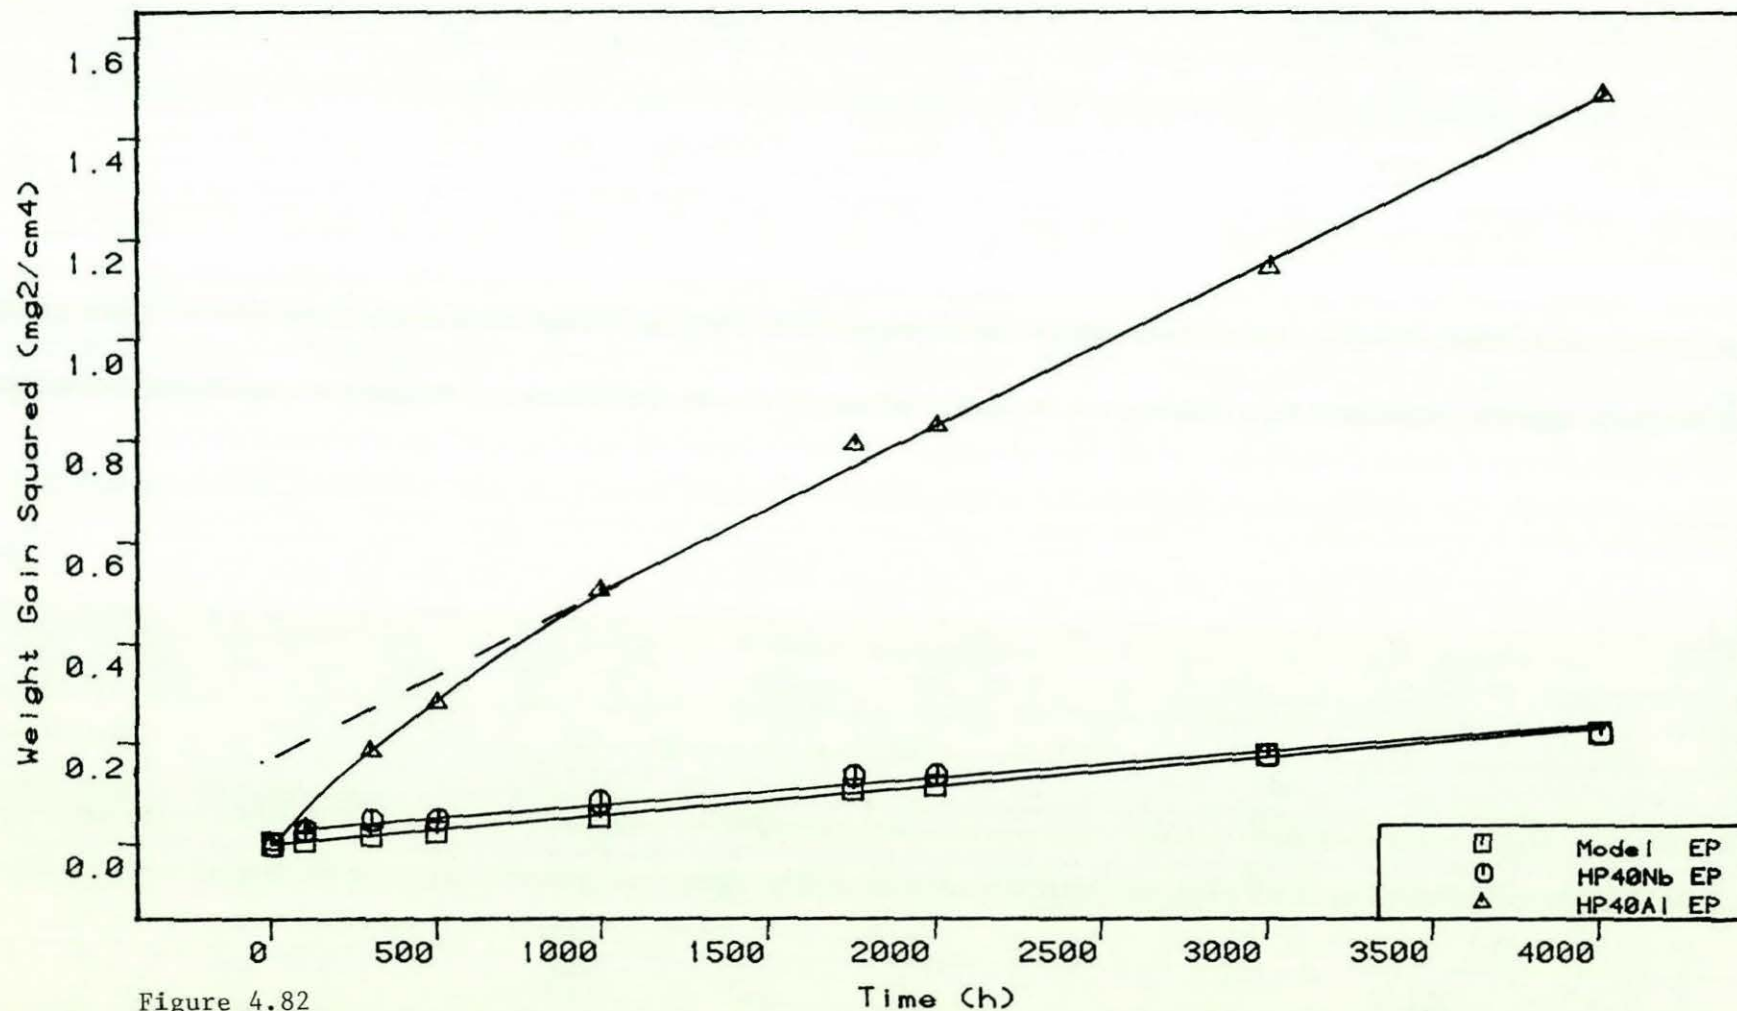
Figure 4.82

Plots of weight gain squared against time, which compare the corrosion behaviour of HP40Al with the Model 25Cr-35Ni-Fe alloy and HP40Nb in the sulphur-free gas at 800°C .

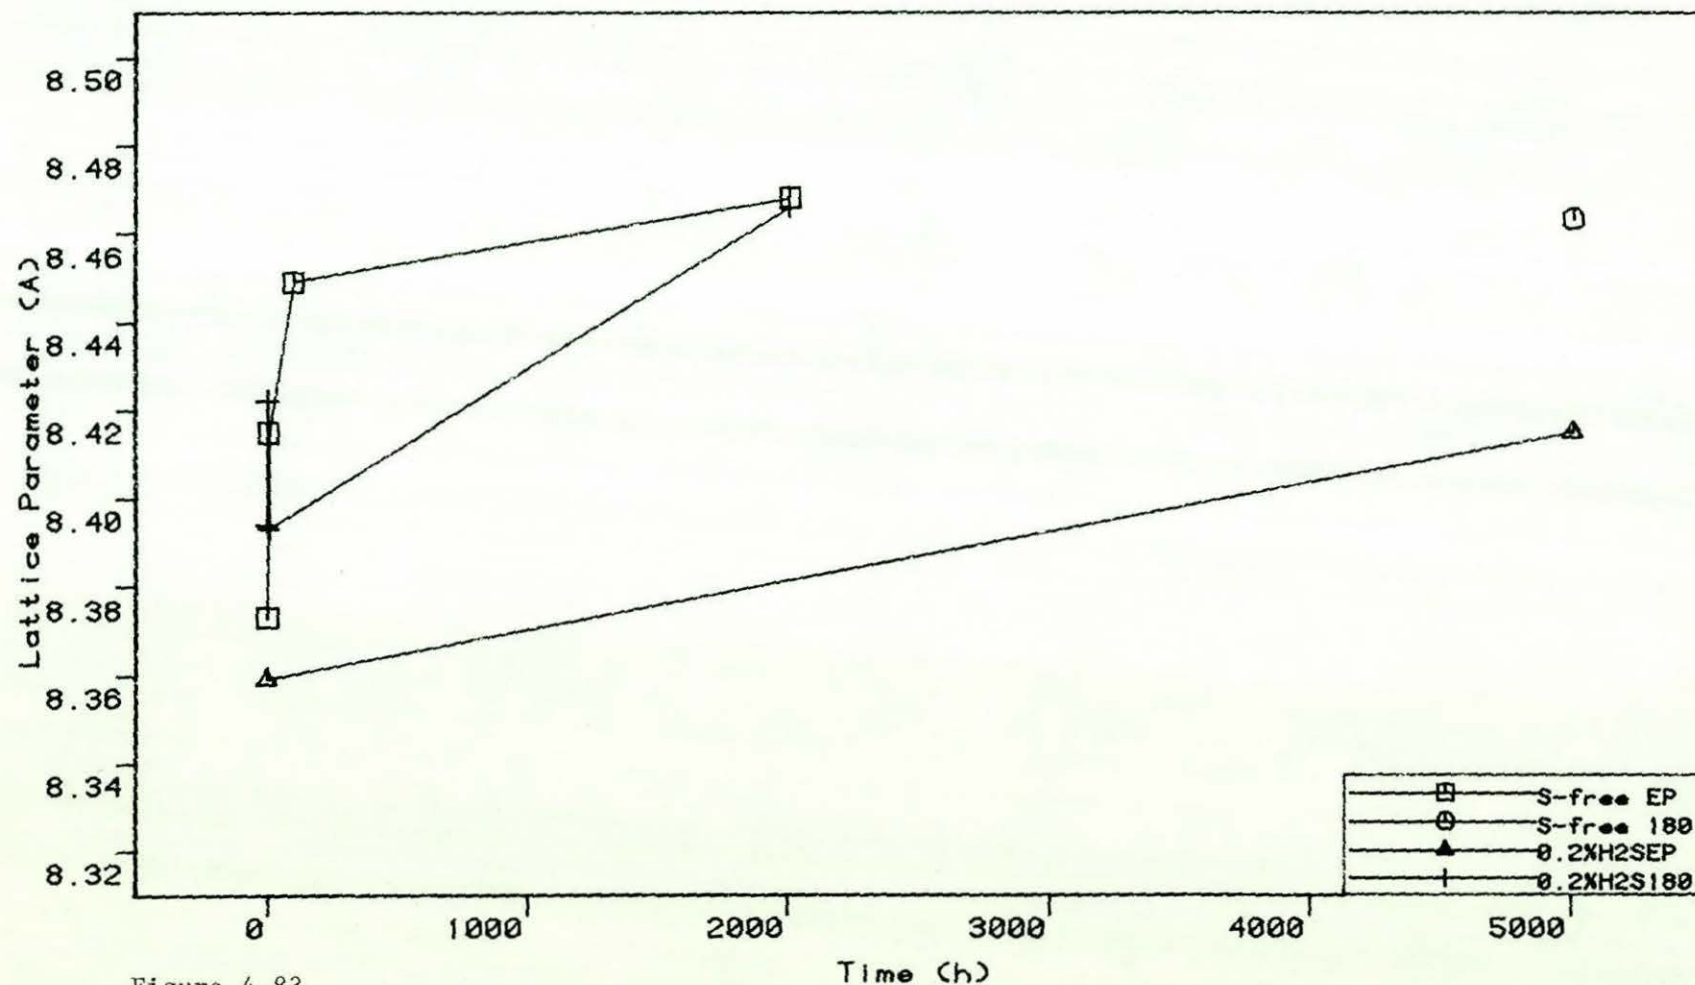
Figure 4.83

Plots of oxide spinel lattice parameter against time for the scale formed on HP40Al exposed to the sulphur-free and 0.2% H_2S gases at $800^{\circ}C$.

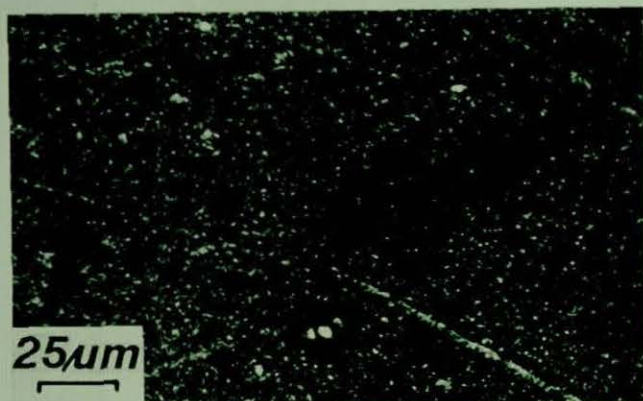
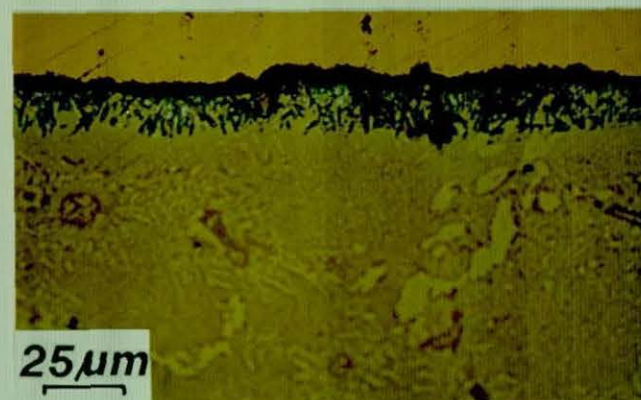
Figure 4.85

Surface SEM and cross-sectional examination using the Pepperhoff technique comparing the corrosion products formed on the Model 25Cr-35Ni-Fe alloy, HP40Nb and HP40Al alloys after exposure to the sulphur-free gas at 800°C for 2000 hours. Electropolished condition.

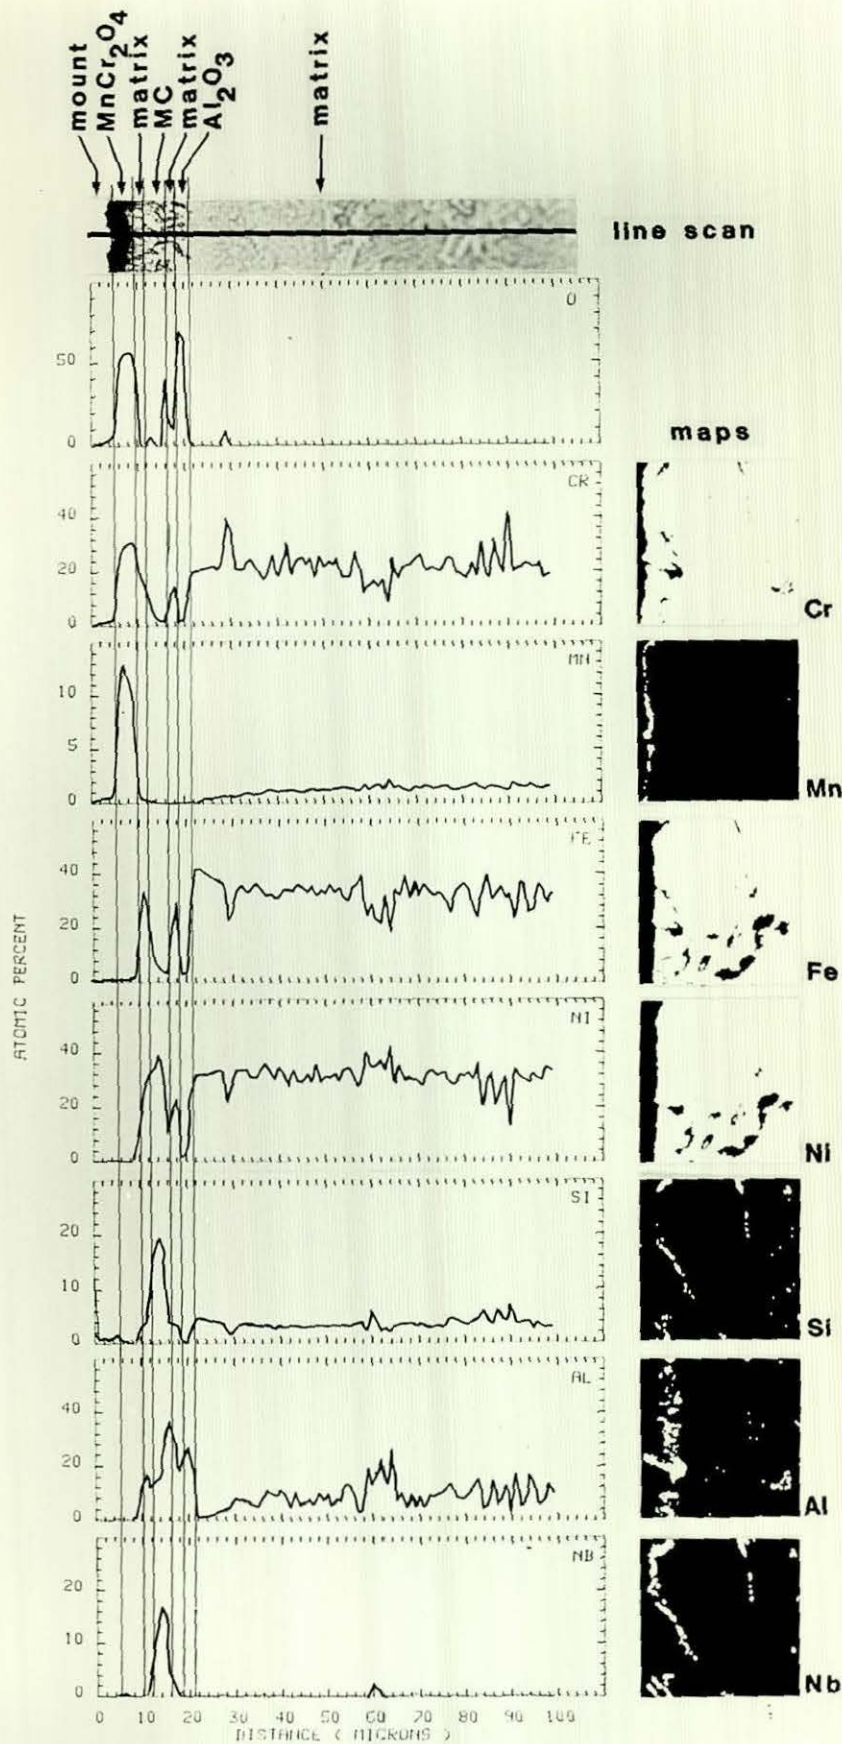
Figure 4.86

EPMA line scan and elemental concentration maps on HP40Al exposed for 2000 hours in the sulphur-free gas at 800°C (electropolished condition).

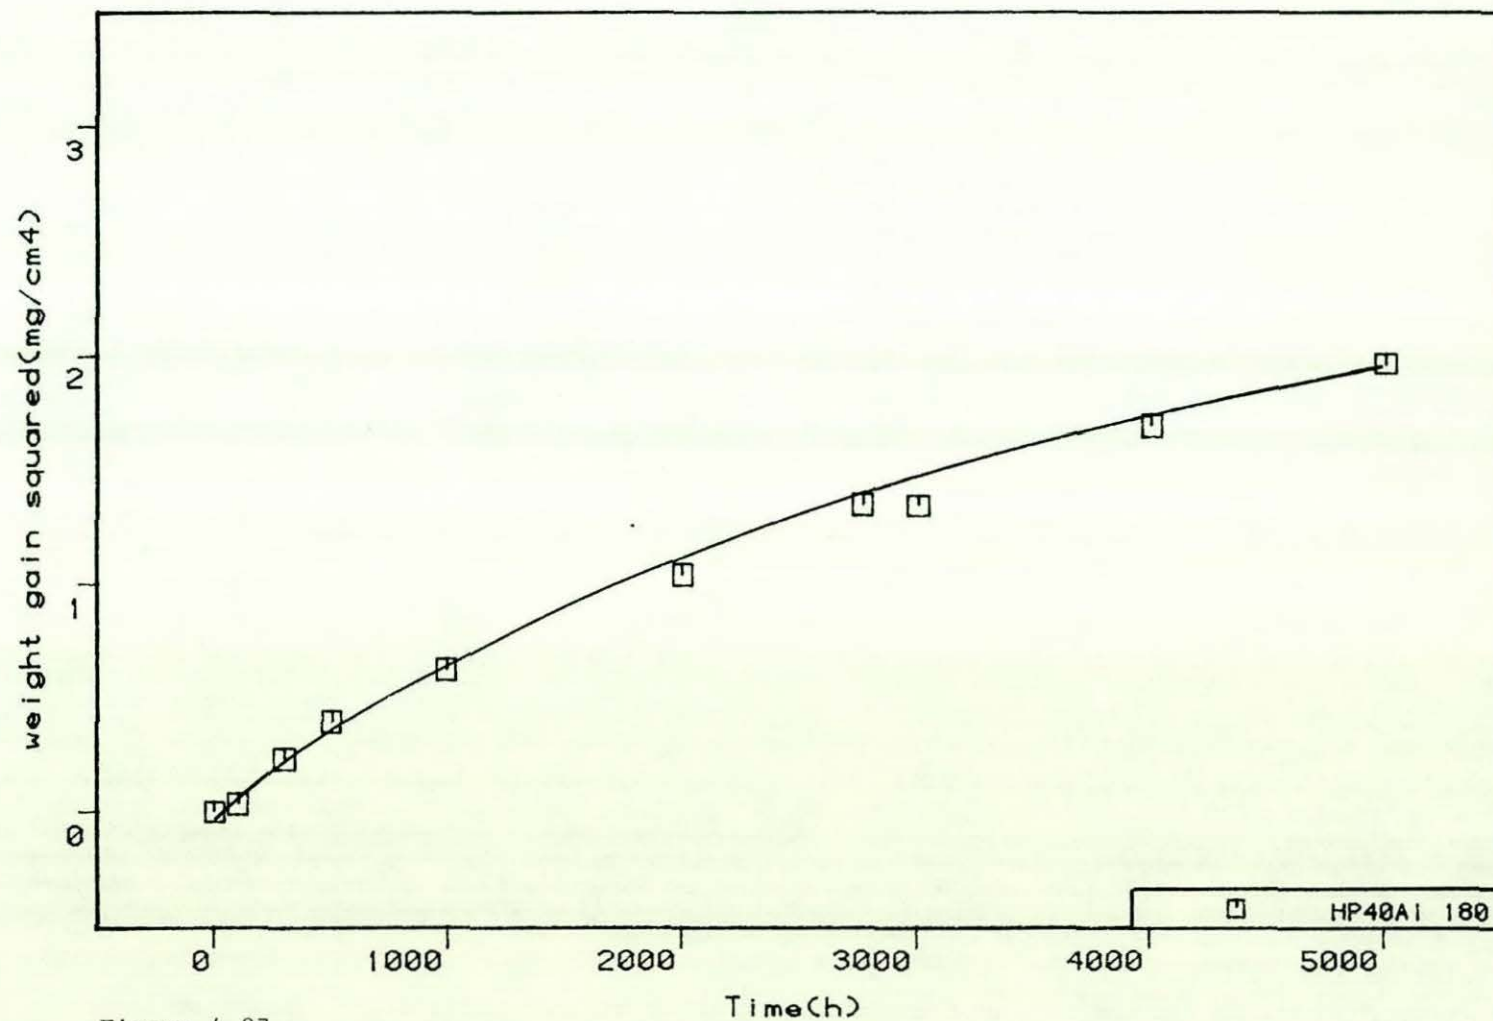
Figure 4.87

Plot of weight gain squared against time for HP40Al exposed to the sulphur-free gas at 800°C, 180 grit condition.

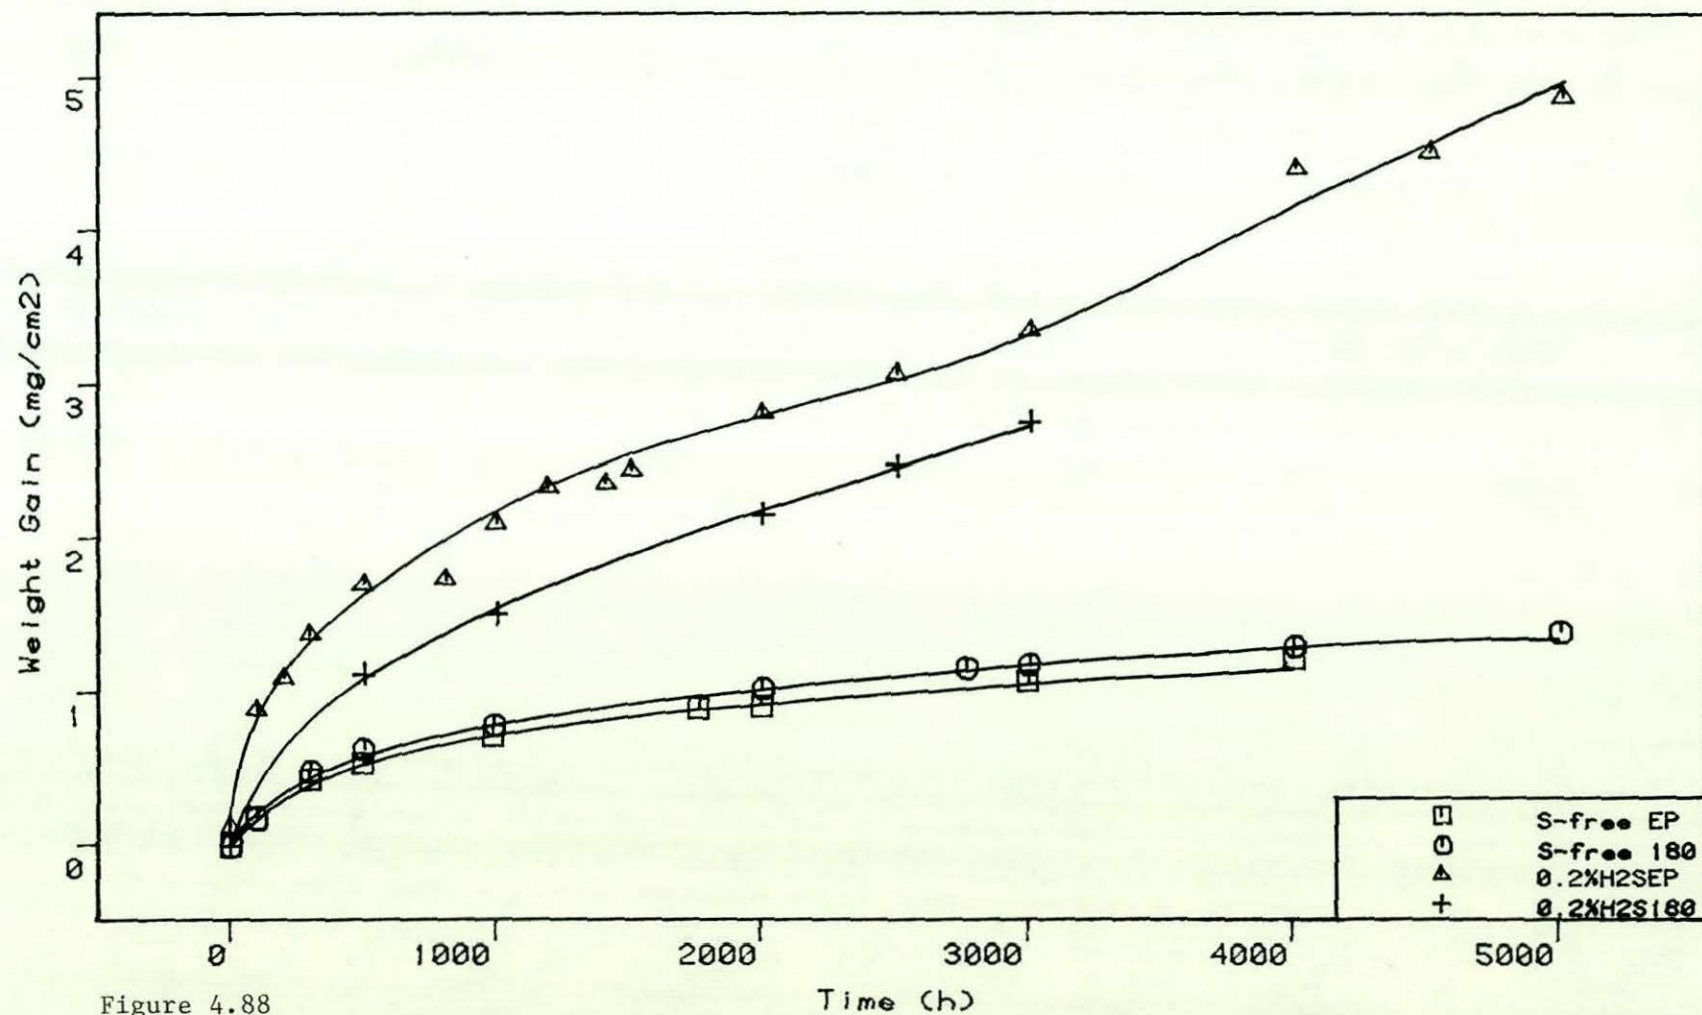
Figure 4.88

Kinetic data for HP40Al exposed to the sulphur-free and 0.2% H₂S gases at 800°C.

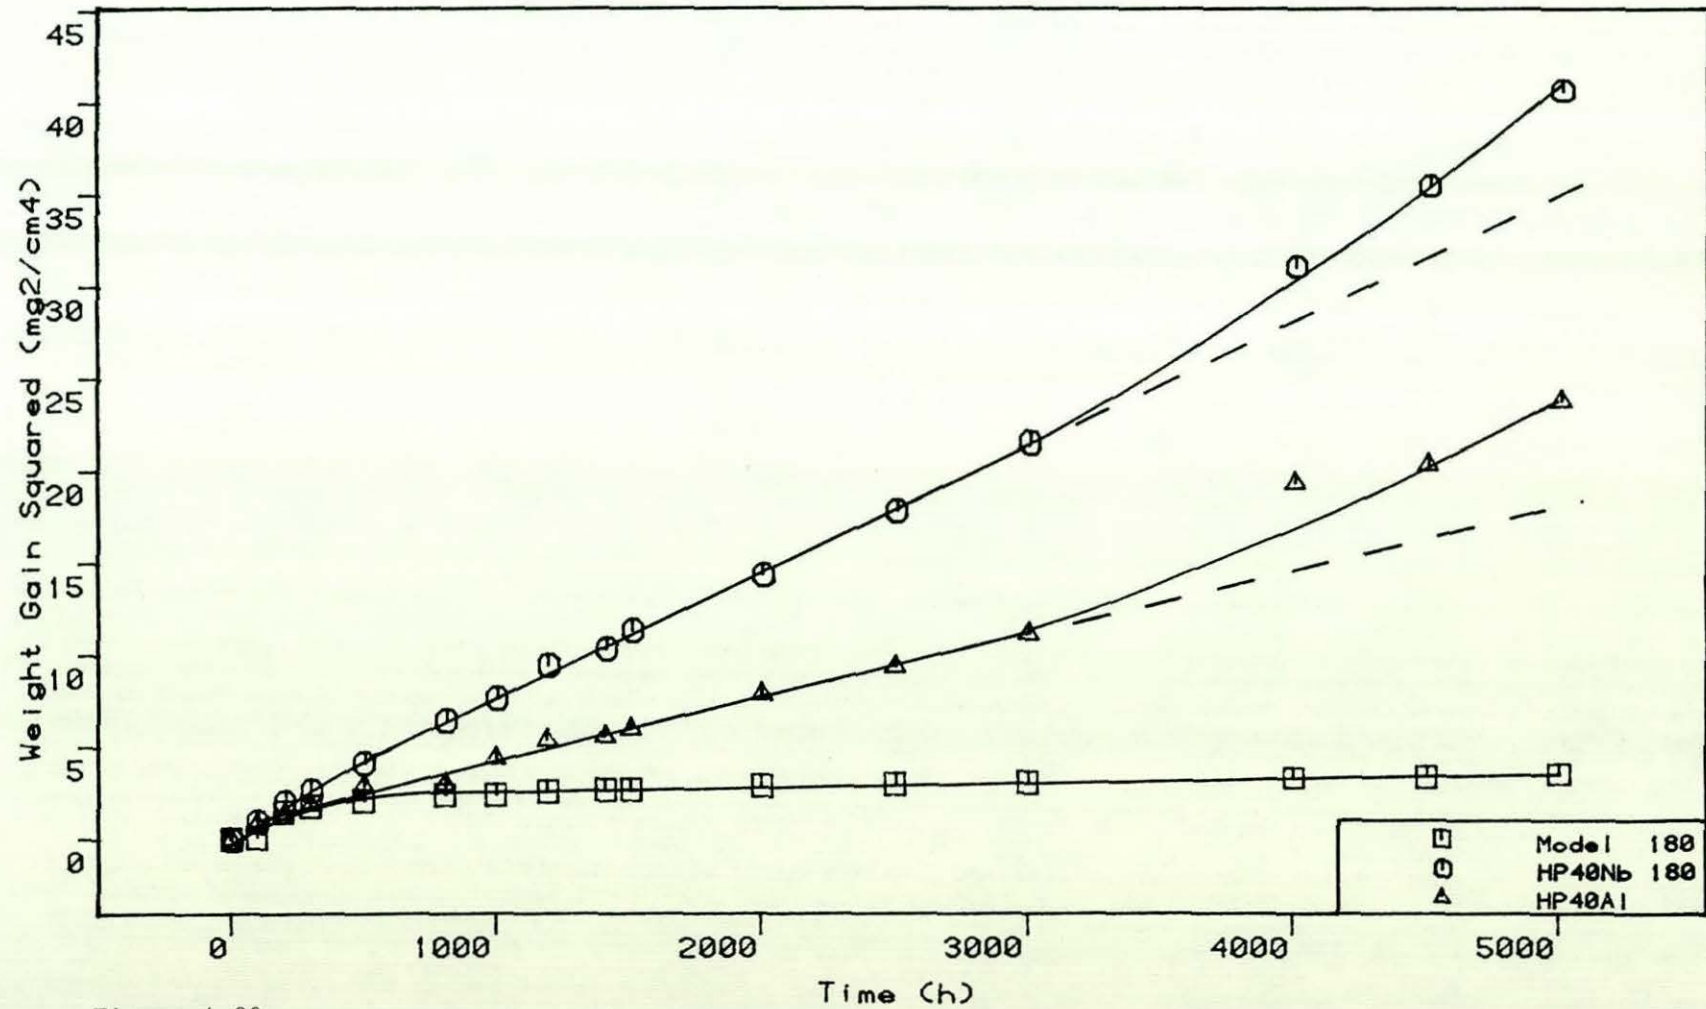
Figure 4.89

Plots of weight gain squared against time which compare the corrosion behaviour of HP40Al with the Model 25Cr-35Ni-Fe alloy and HP40Nb in the 0.2% H₂S gas at 800°C.

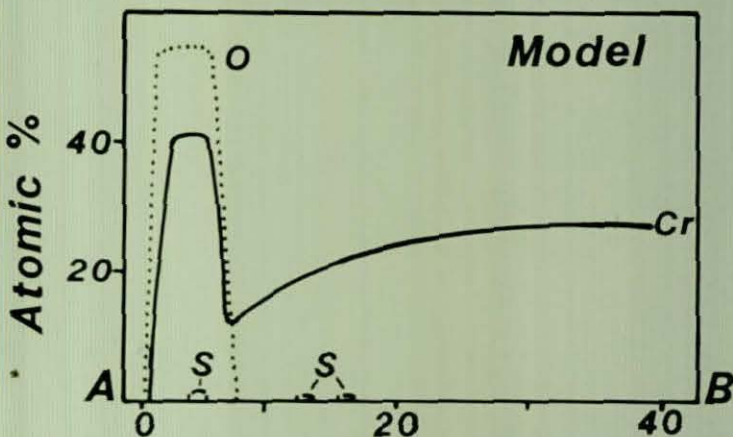
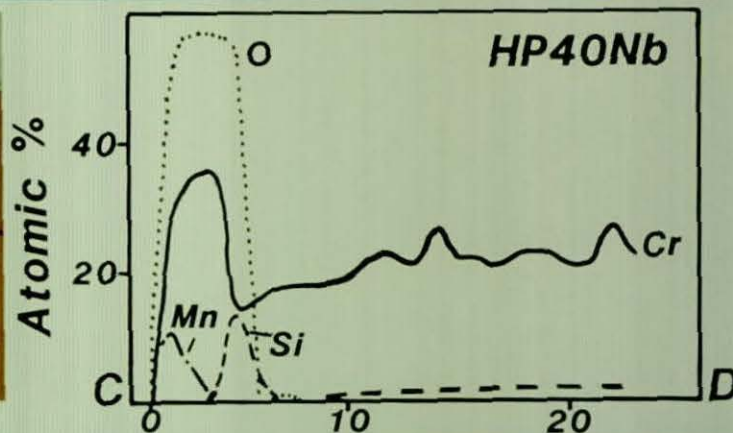
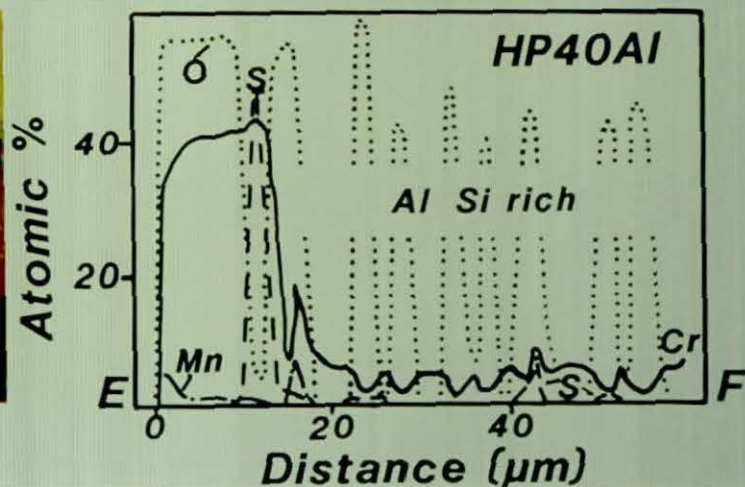
Figure 4.91

Cross-sectional examination using the Pepperhoff technique and EPMA analysis for the Model 25Cr-35Ni-Fe alloy, HP40Nb and HP40Al alloys after exposure to the 0.2 % H₂S gas at 800°C for 2000 hours. Electropolished condition.

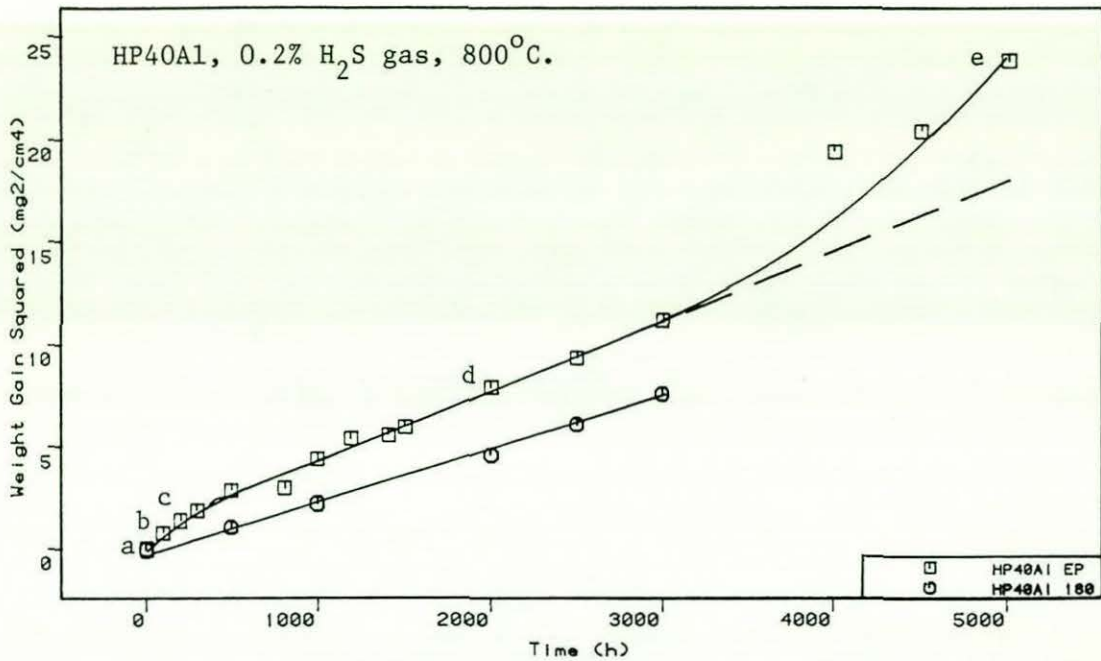
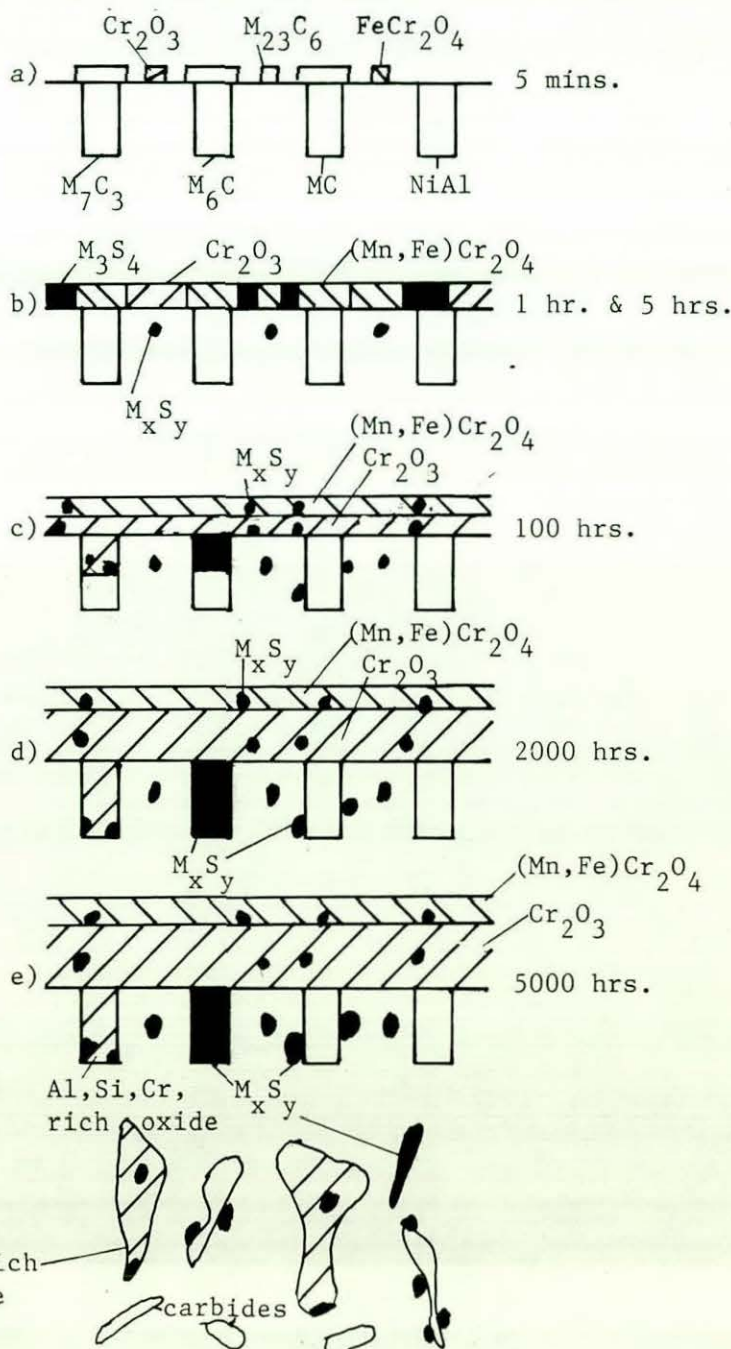
Figure 4.95

Schematic diagram summarizing the corrosion behaviour of HP40Al in the 0.2 % H₂S gas at 800°C.

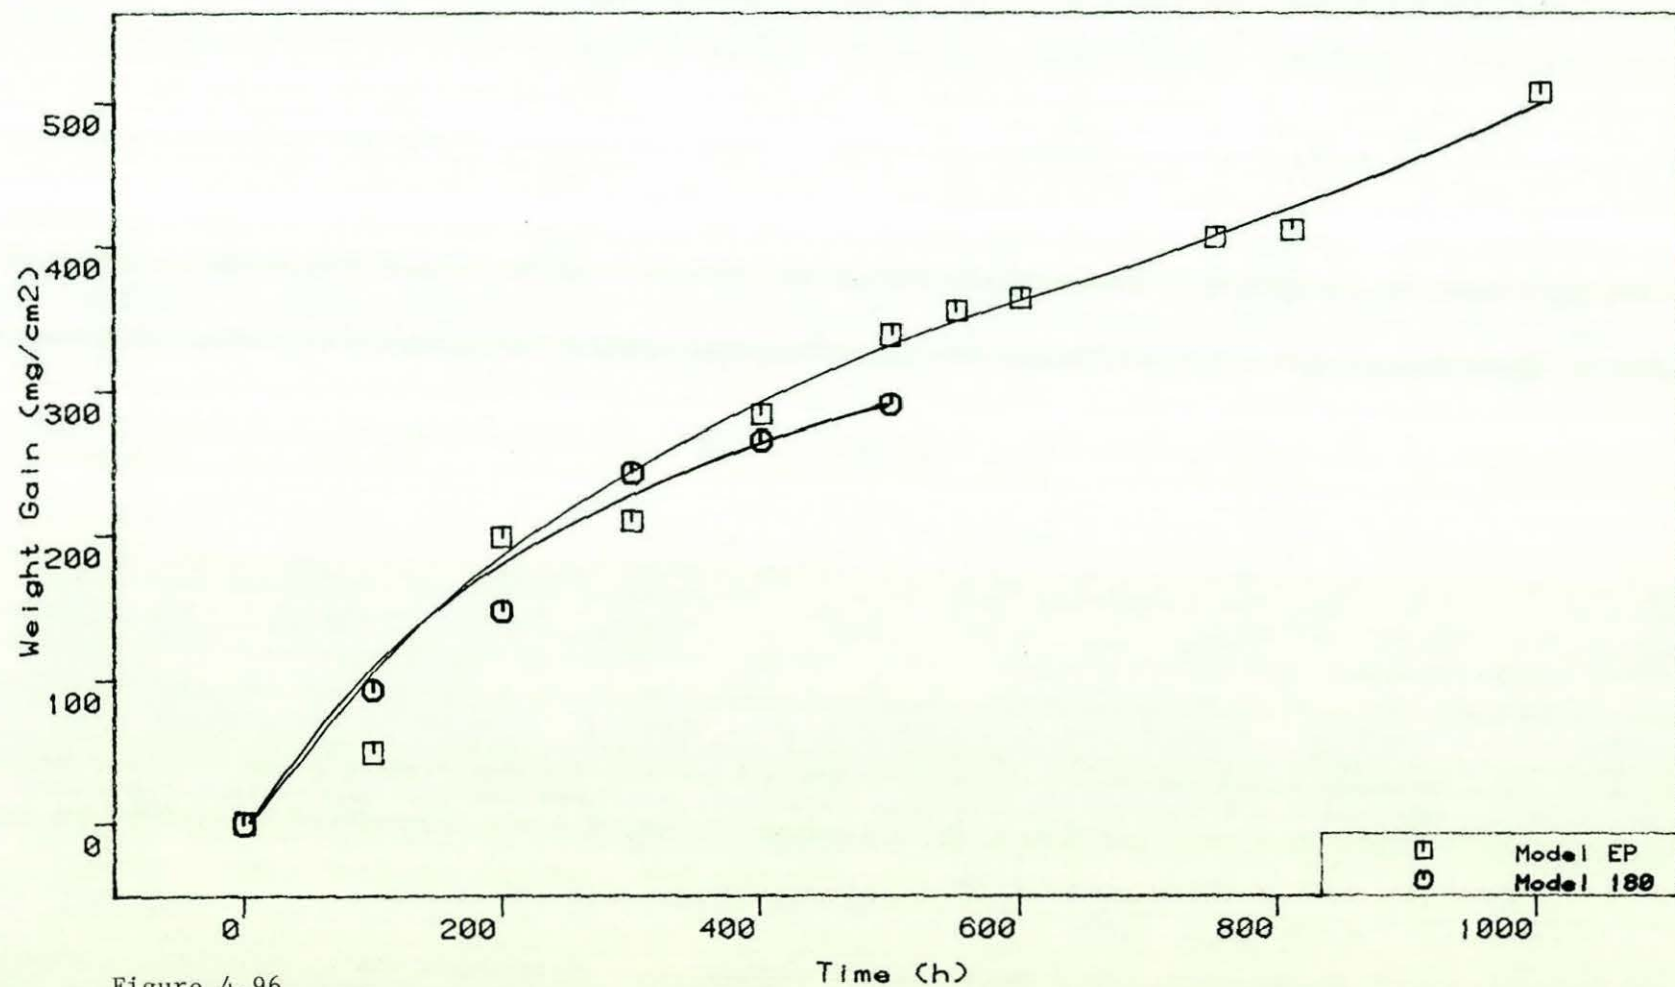
Figure 4.96

Corrosion kinetics for the Model 25Cr-35Ni-Fe alloy in the 0.6% H_2S gas at 800°C .

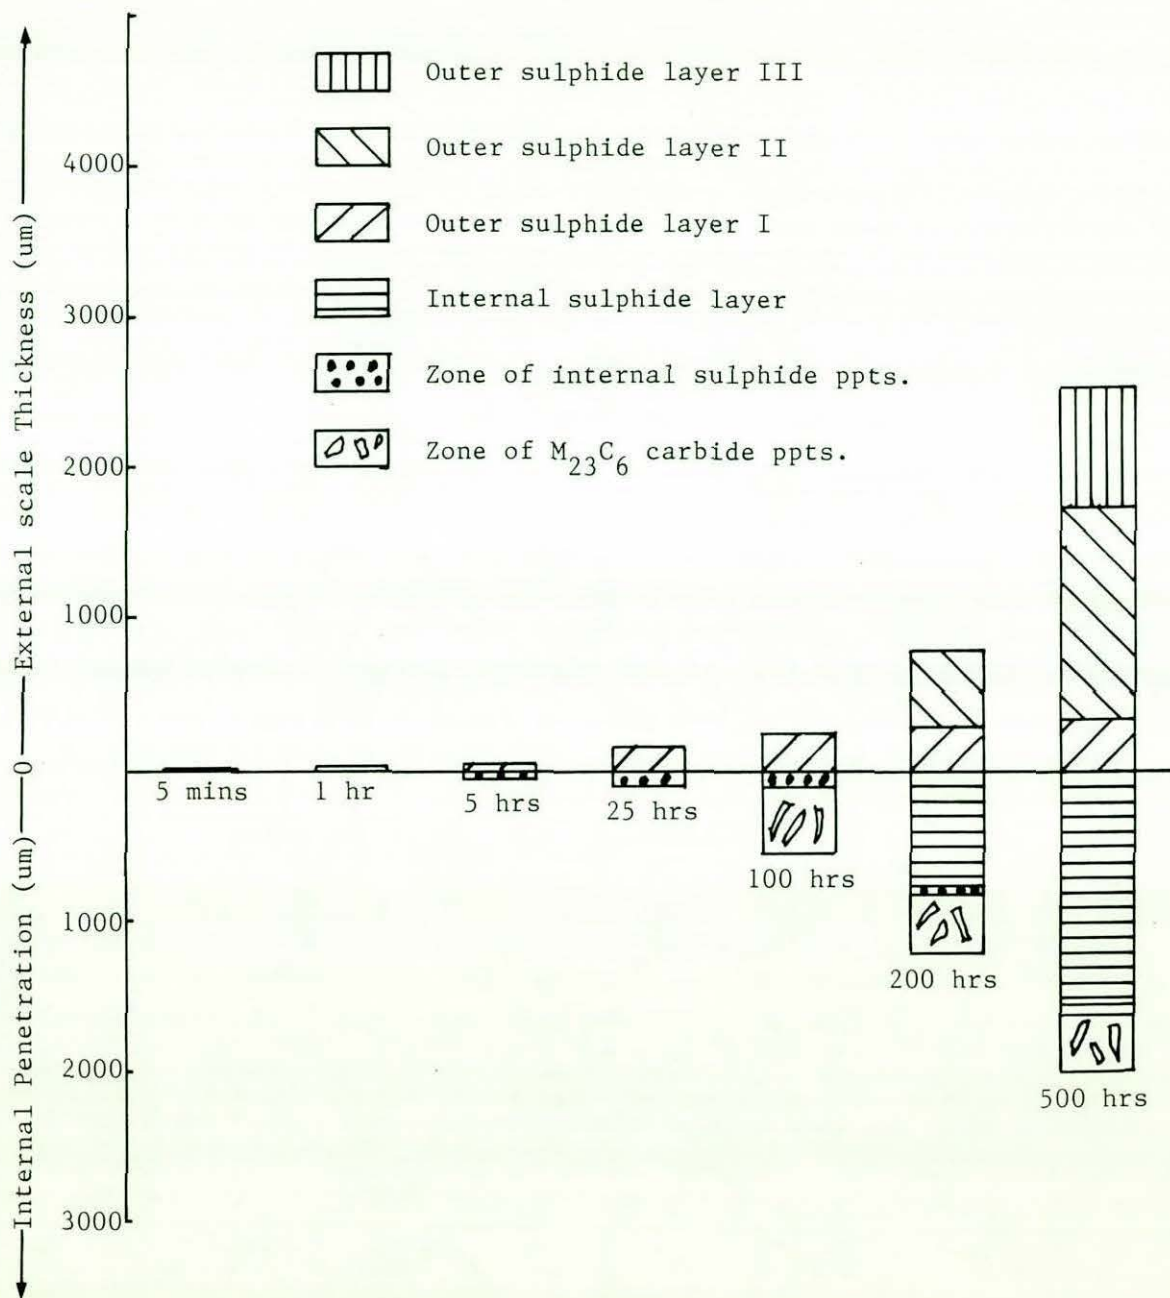
Figure 4.98

Diagram depicting the thickness of the various corrosion layers formed on the Model 25Cr-35Ni-Fe alloy during exposure to the 0.6 % H_2S gas at 800°C.
