THE CORROSION BEHAVIOUR OF Fe-Cr-Ni ALLOYS
IN COMPLEX HIGH TEMPERATURE GASEOUS ATMOSPHERES
CONTAINING THE REACTANTS OXYGEN, SULPHUR
AND CARBON

A Doctoral Thesis submitted in partial fulfilment
of the requirements for the award of
Doctor of Philosophy
of the Loughborough University of Technology, U.K.,
based on research carried out at the
Commission of the European Communities Joint Research Centre,
Petten, Netherlands.

VOLUME 2

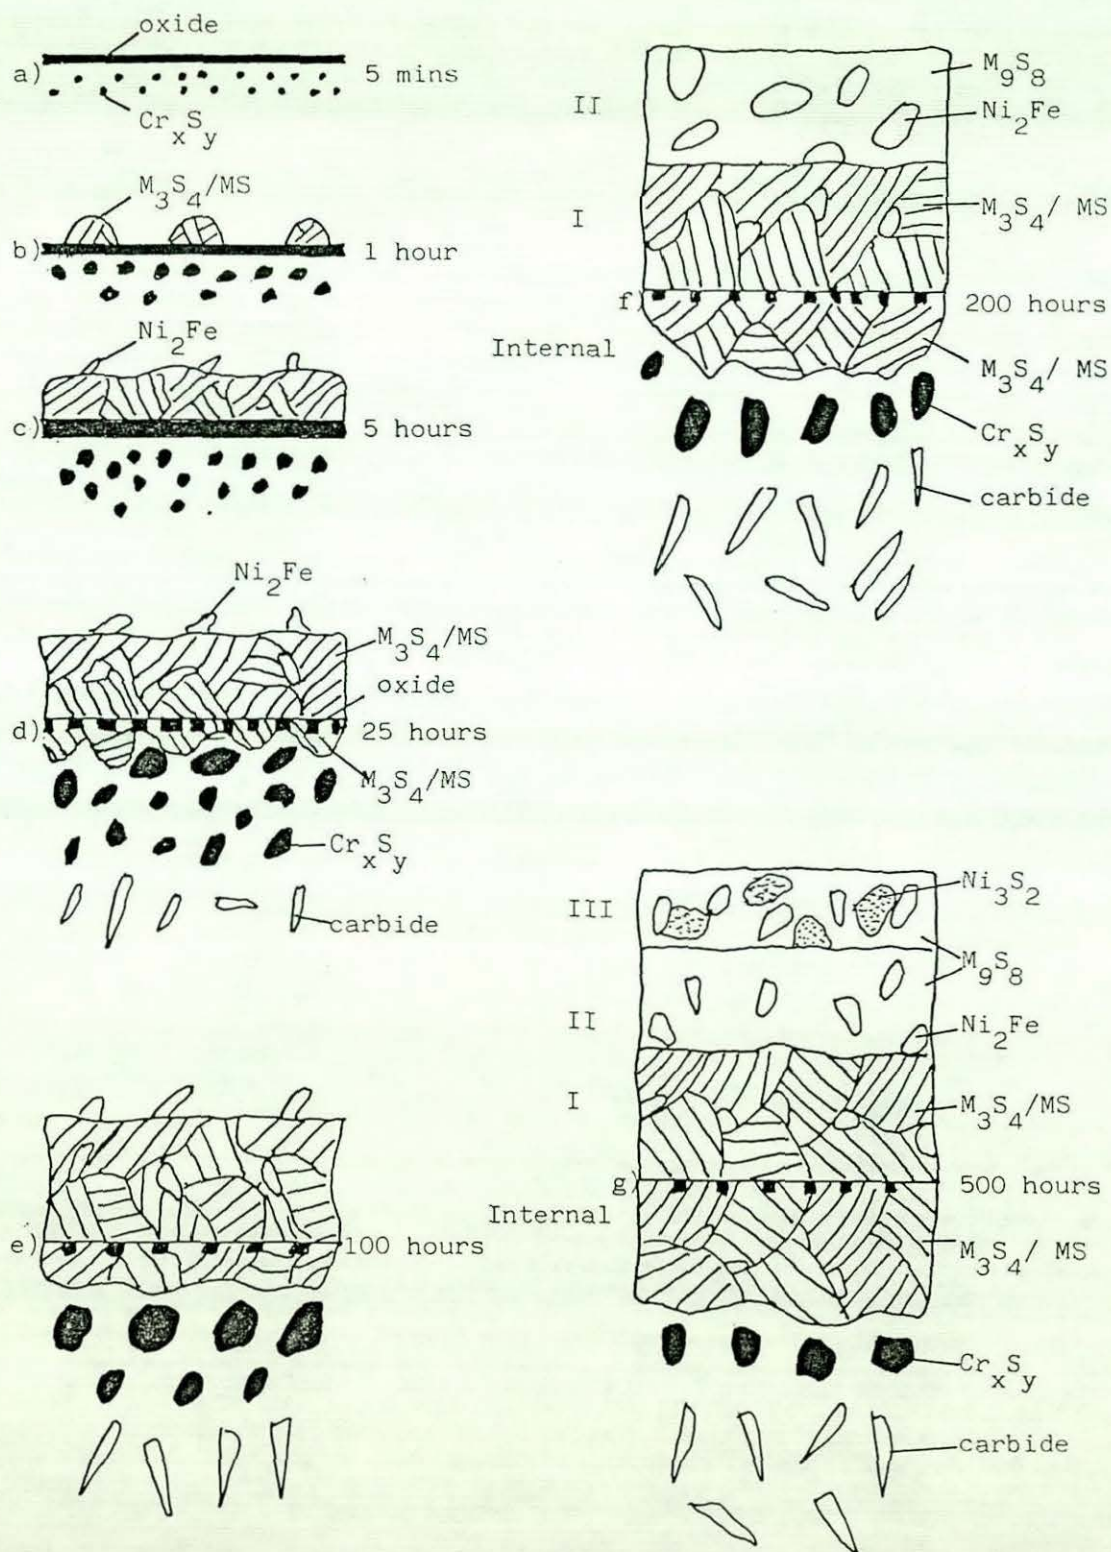
Figure 4.99

Summary figure showing the corrosion morphology of the model alloy in the 0.6% H_2S gas.

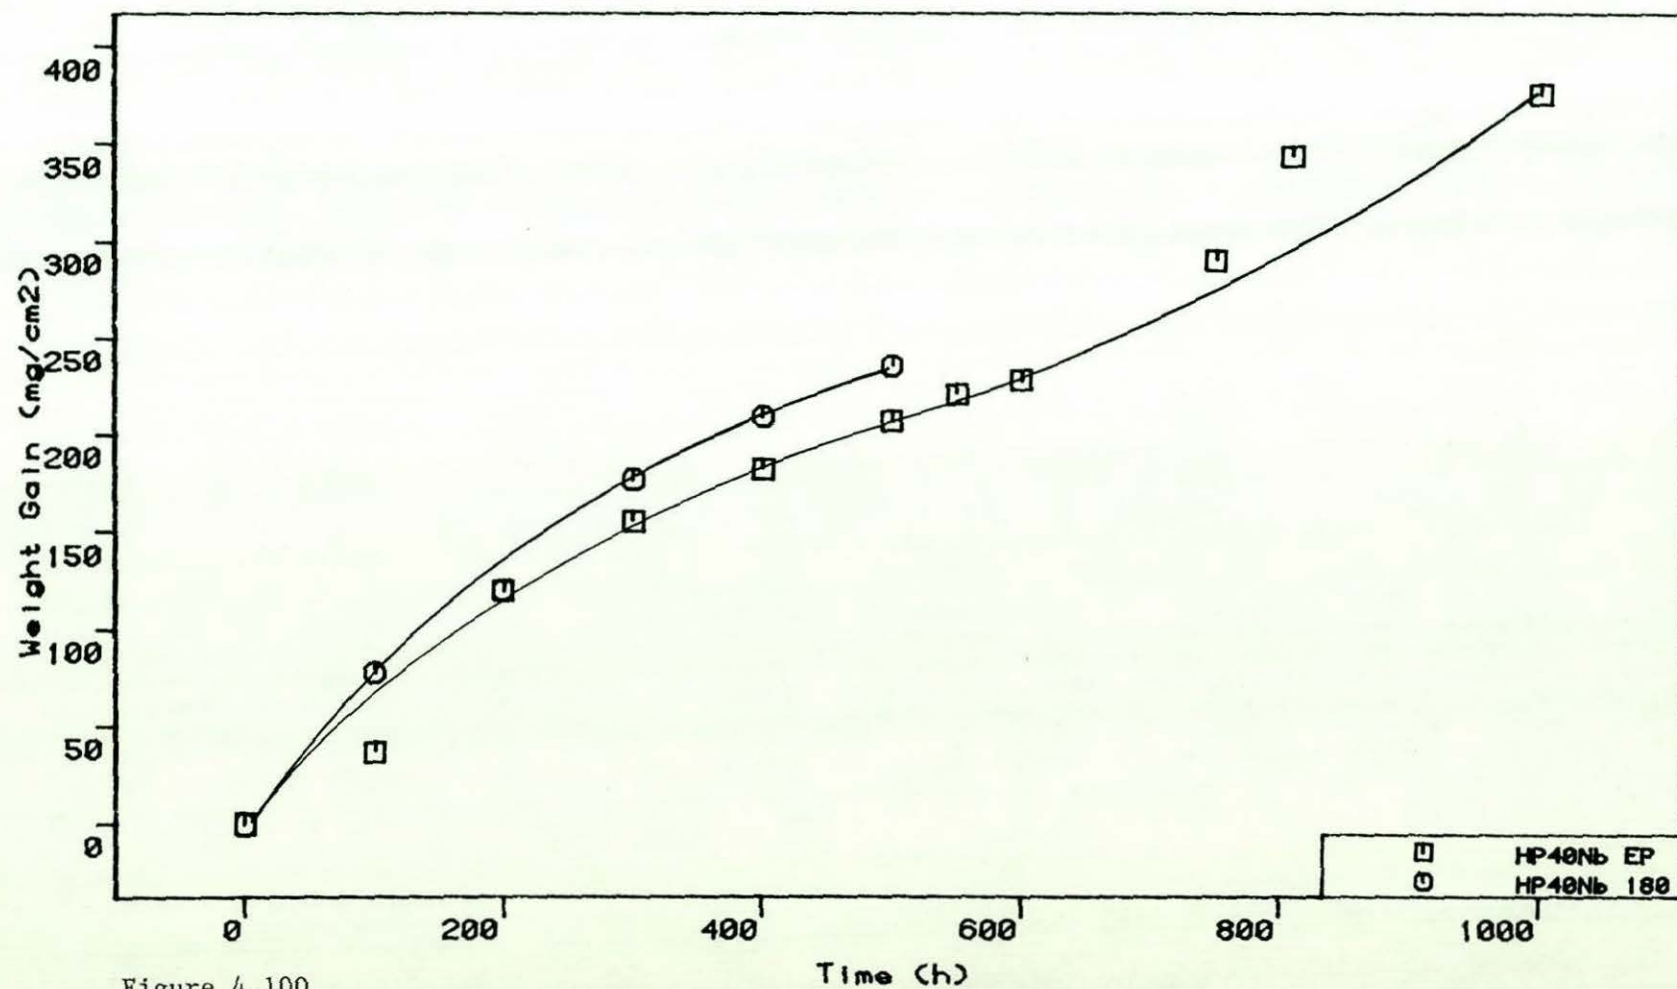
Figure 4.100
Corrosion kinetics for HP40Nb in the 0.6 % H₂S gas at 800°C.

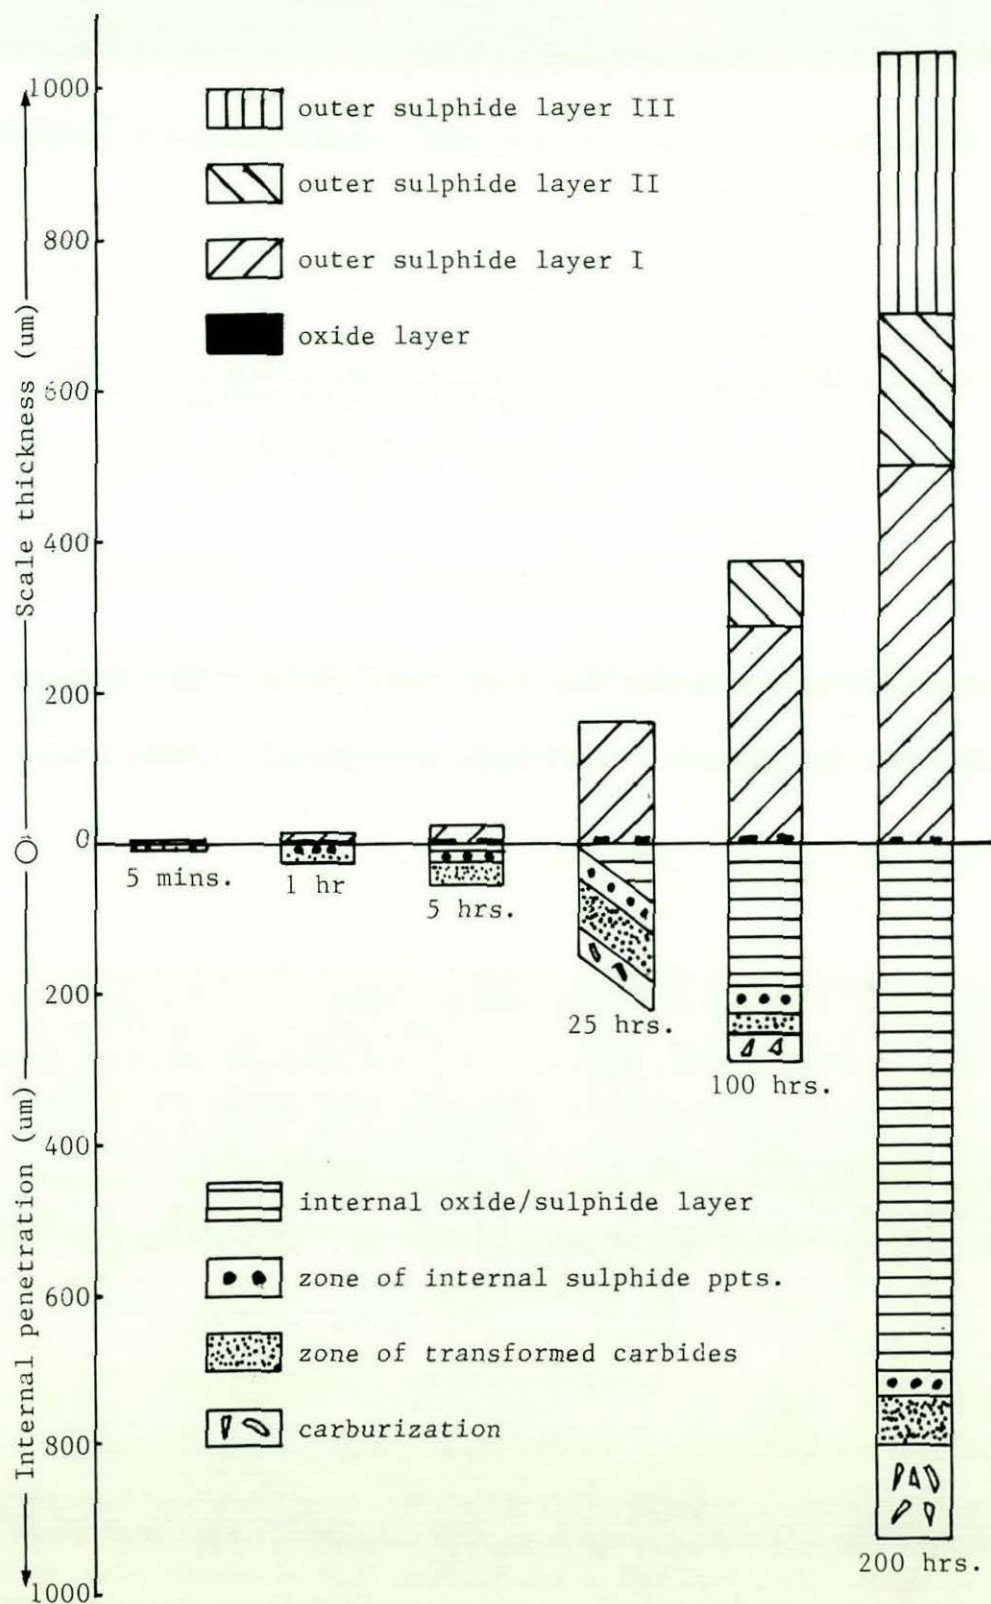
Figure 4.102

Diagram depicting the thickness of the various corrosion layers formed on the HP40Nb during exposure to the 0.6 % H₂S gas at 800°C.

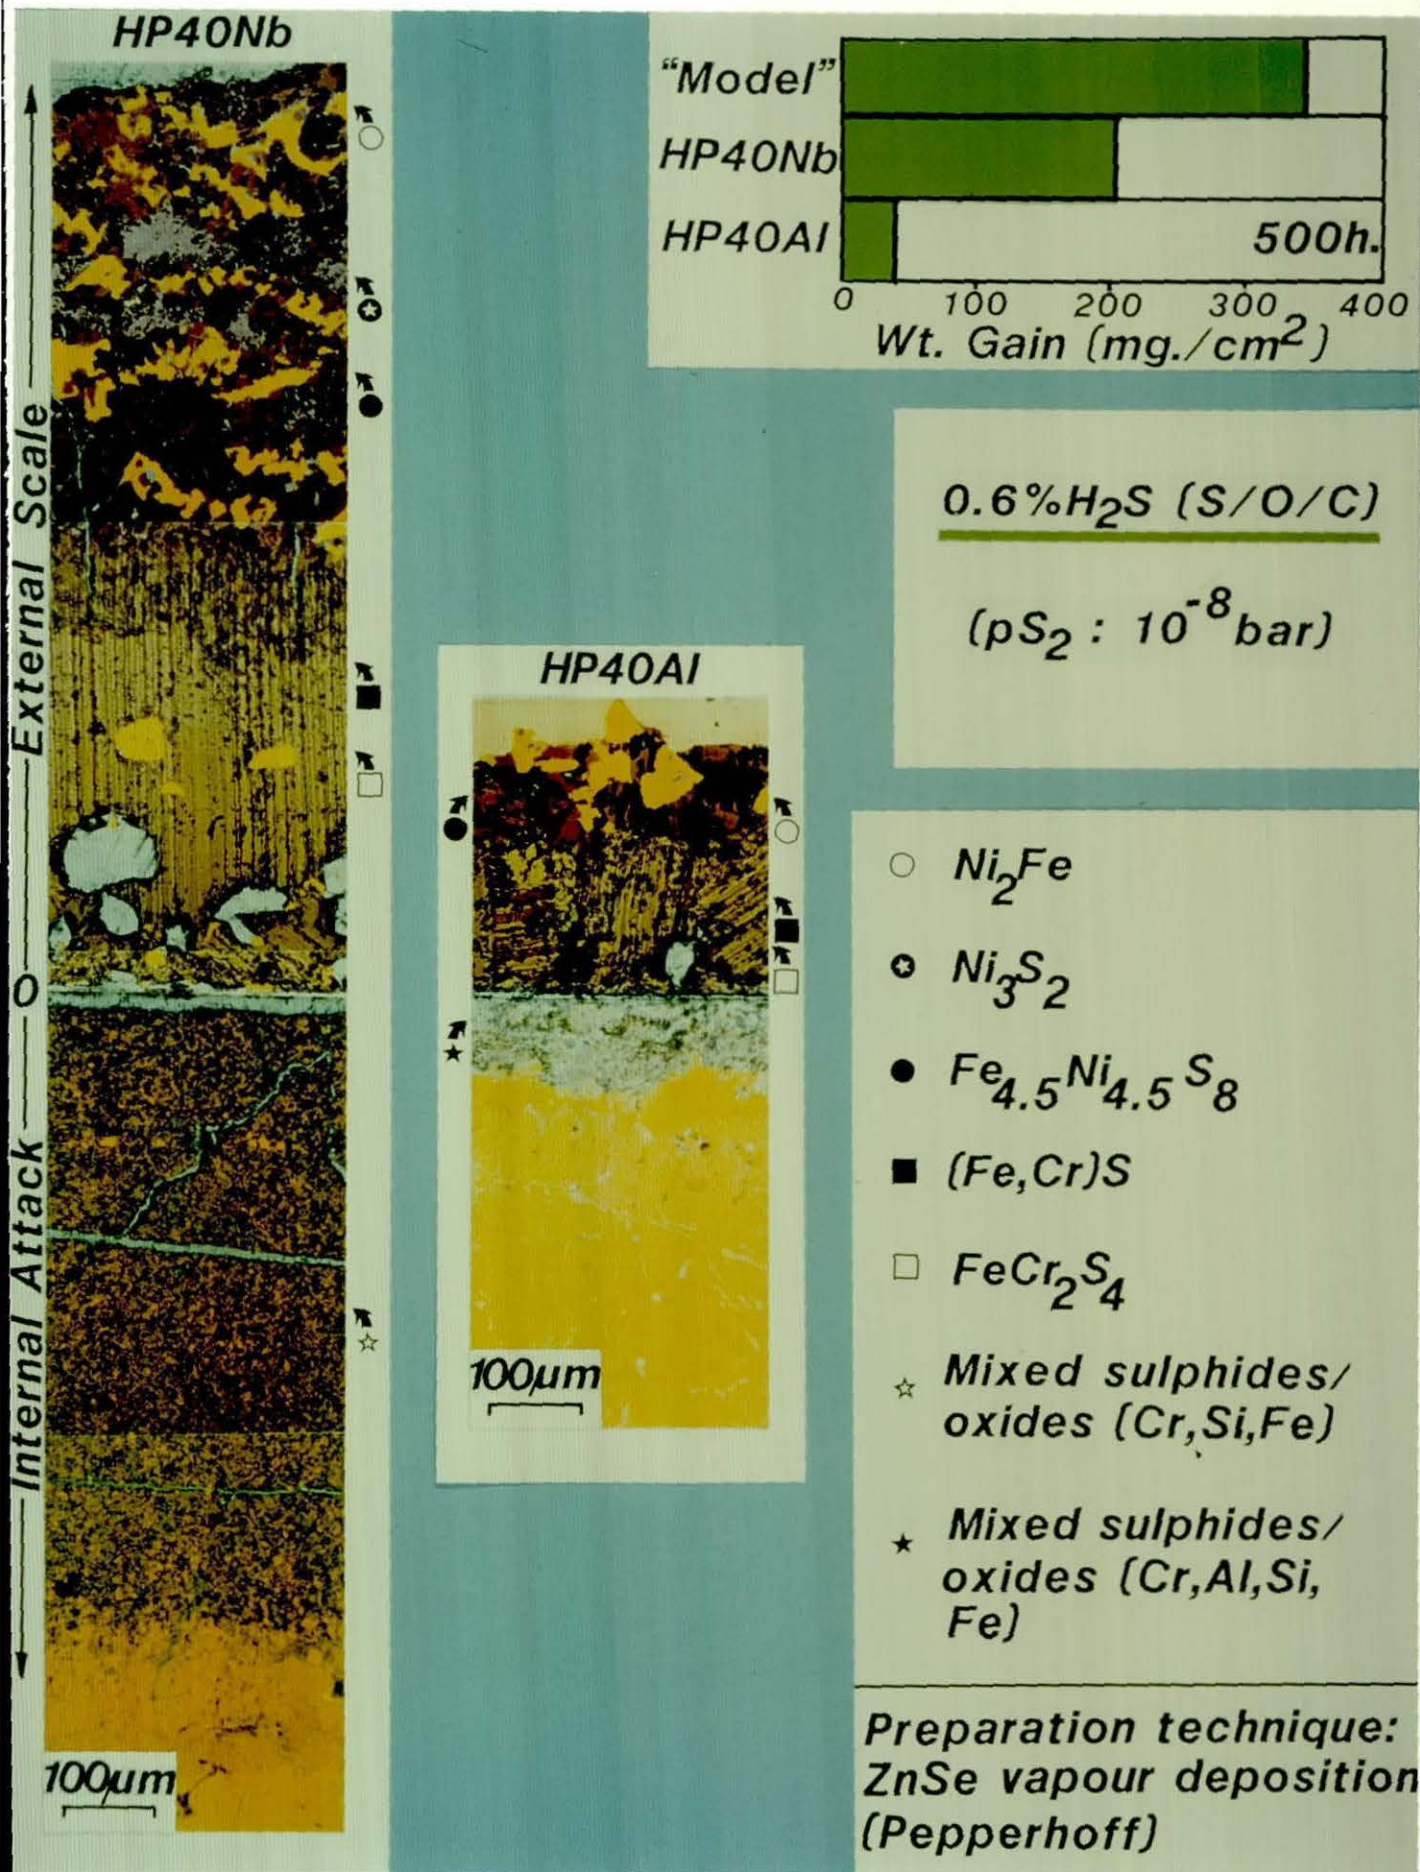
Figure 4.103

Cross-sectional examination using the Pepperhoff technique to compare the corrosion behaviour of the HP40Nb and HP40Al alloys after exposure to the 0.6 % H₂S gas for 500 hours.

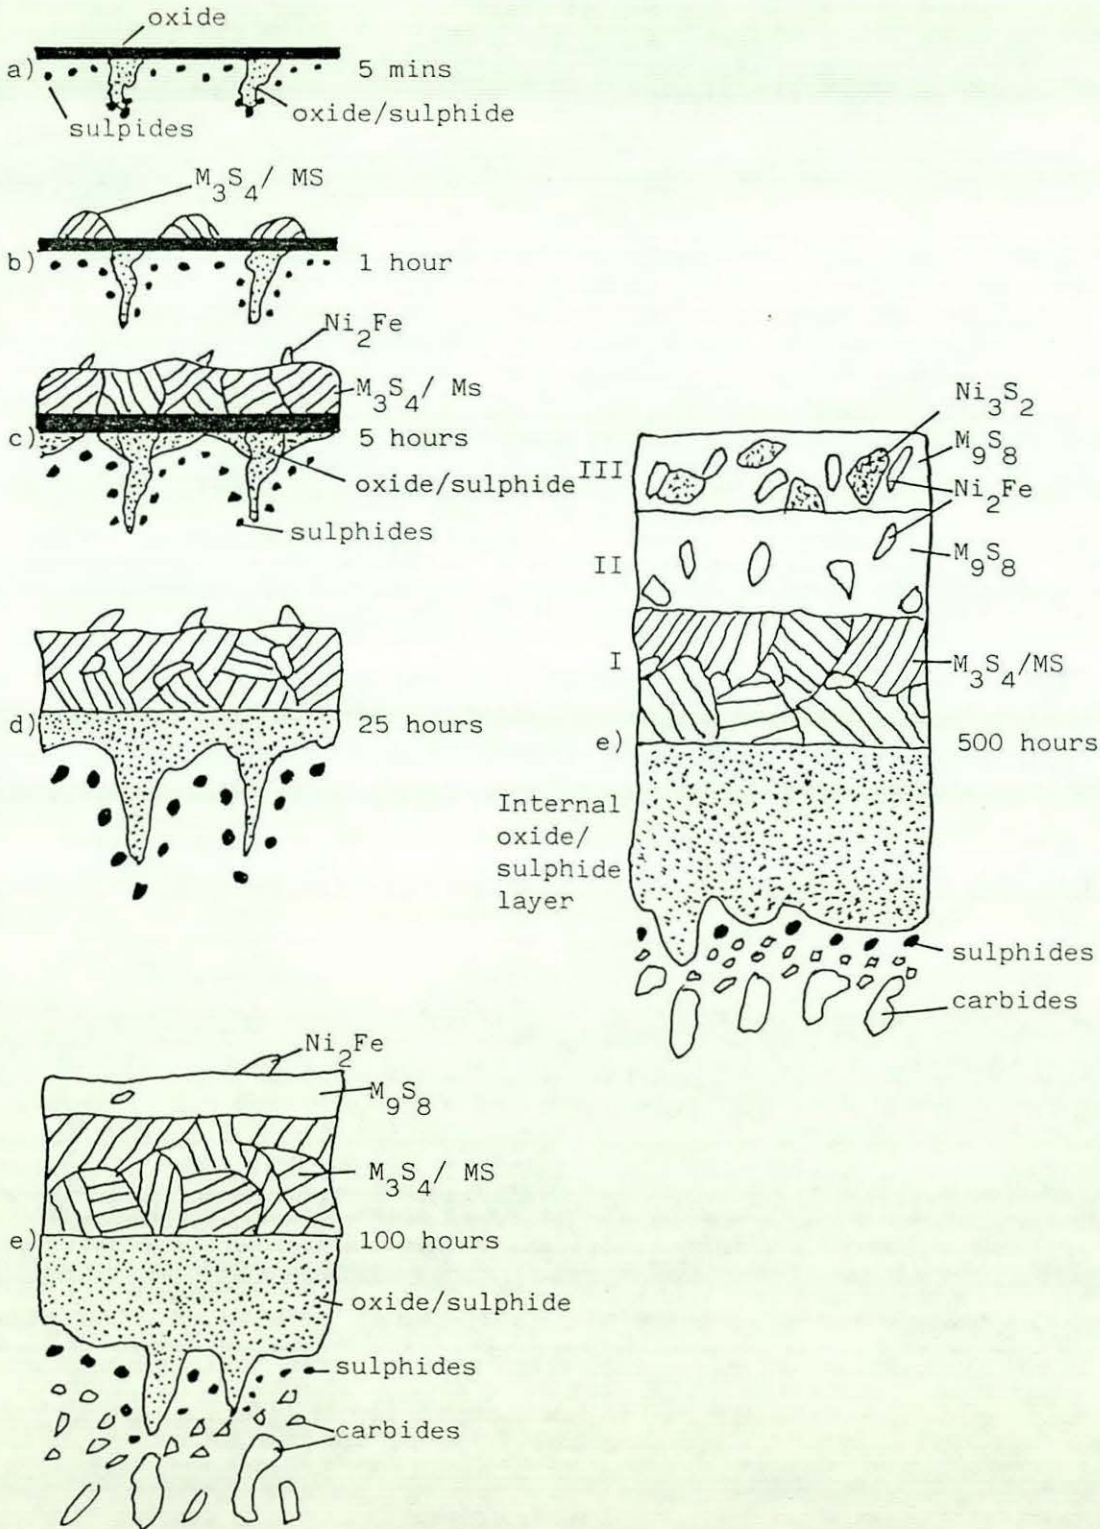
Figure 4.104

Summary figure showing the corrosion behaviour of HP40Nb in the 0.6% H_2S gas at 800° C .

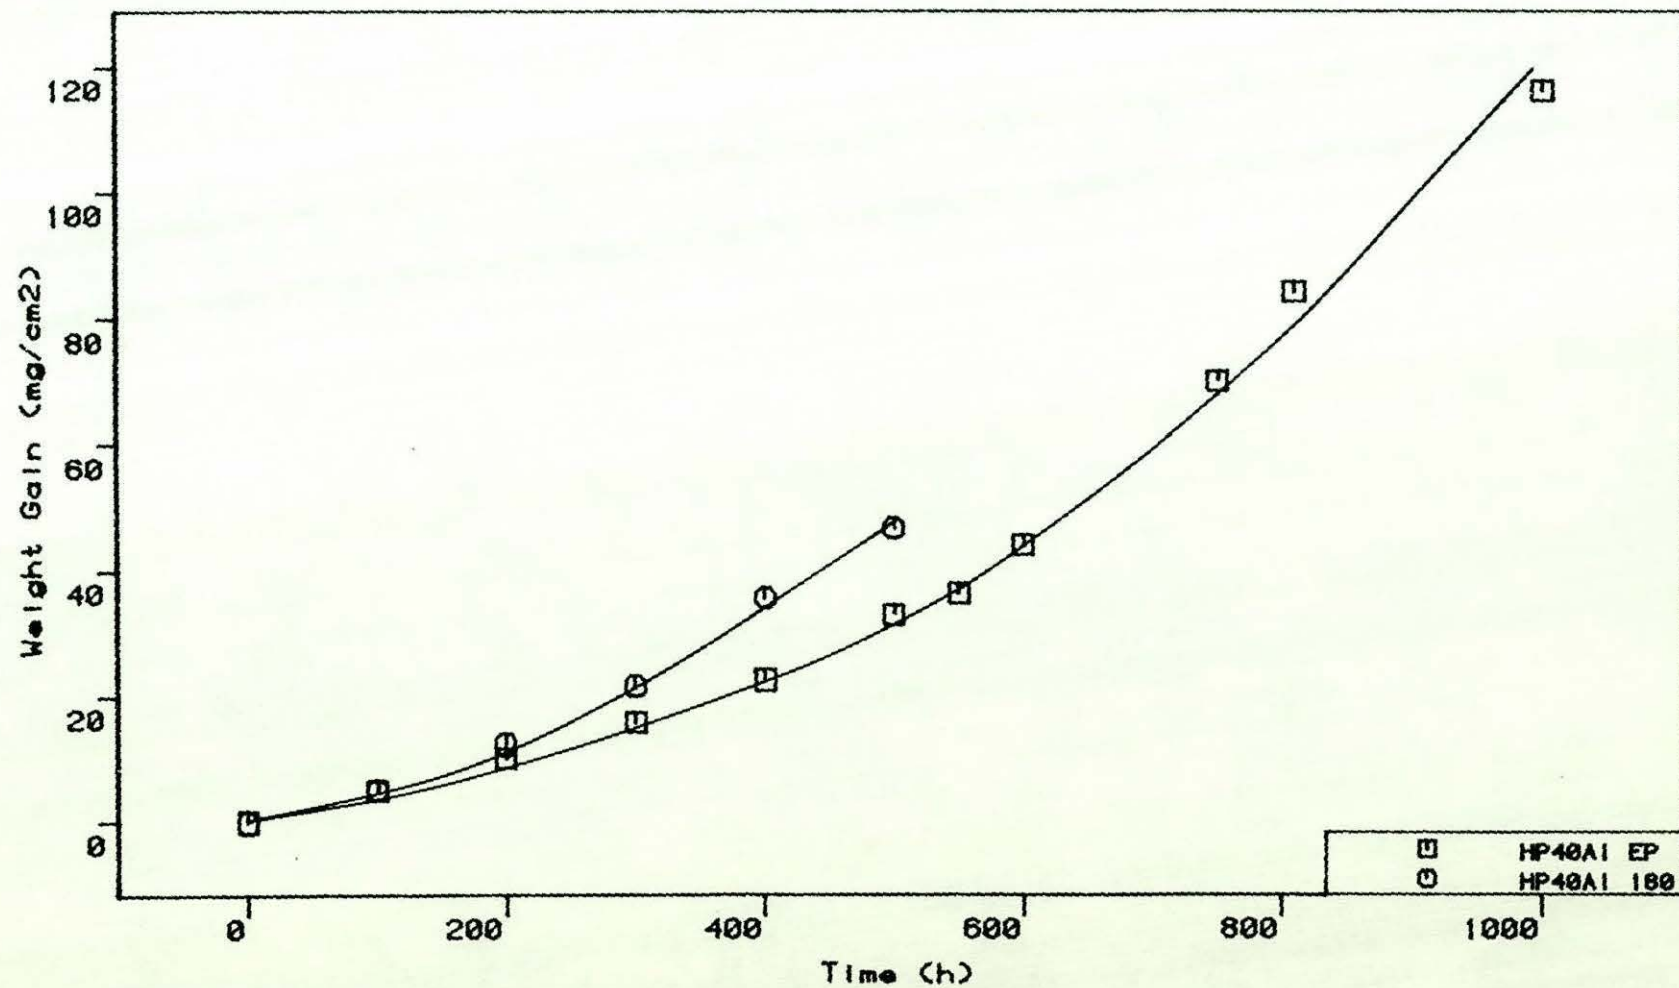
Figure 4.105

Corrosion kinetics for HP40Al in the 0.6 % H₂S gas at 800°C.

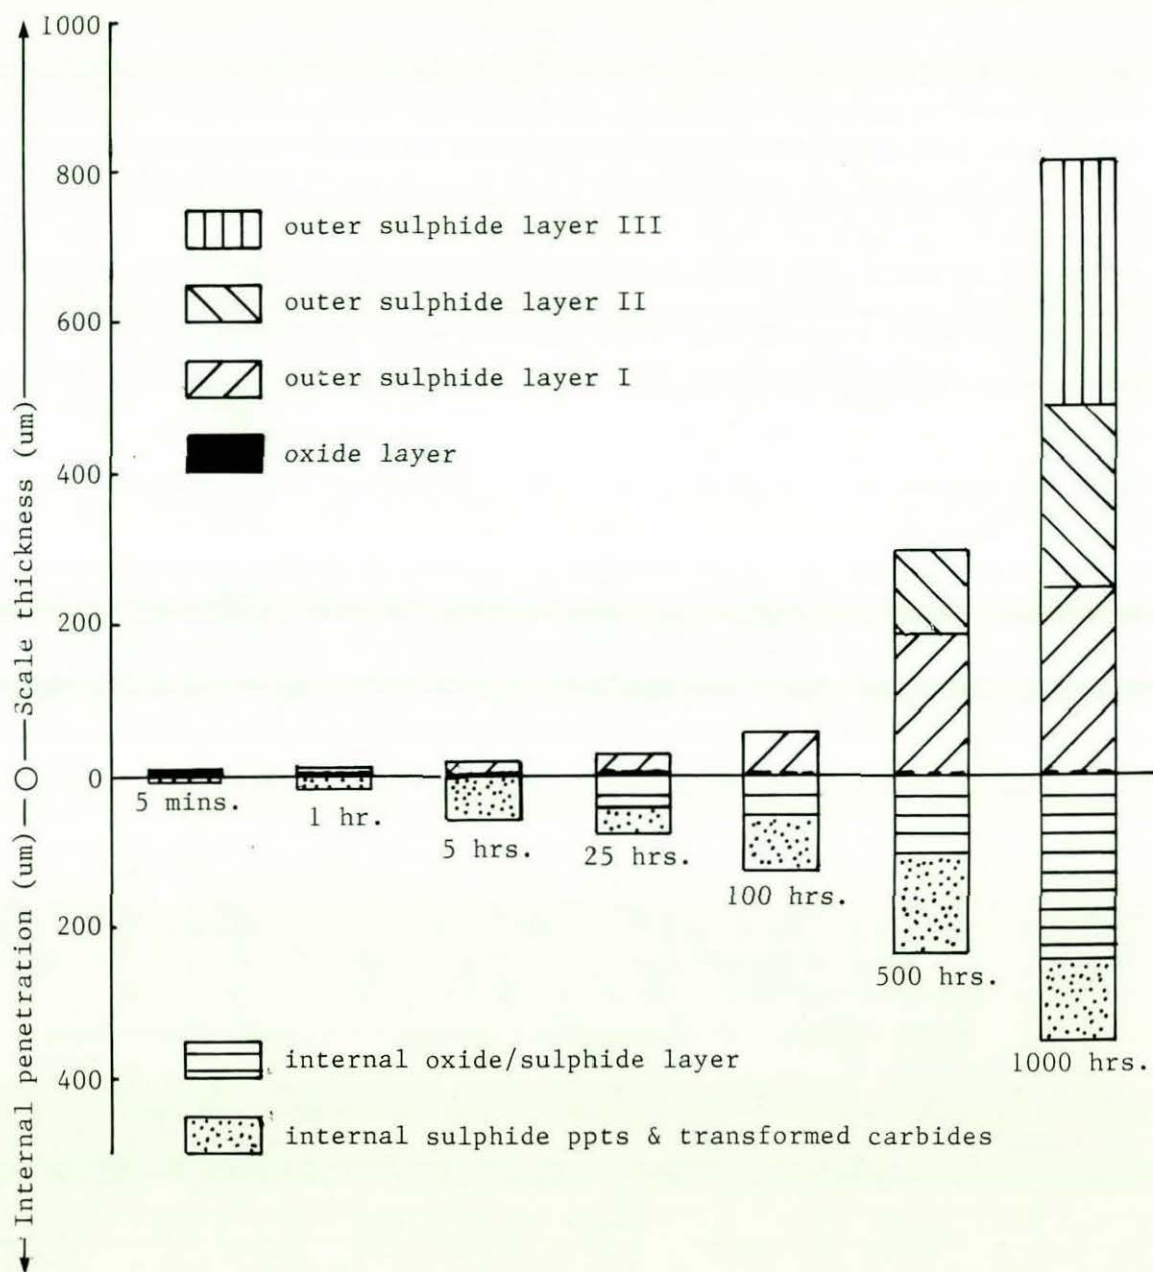
Figure 4.107

Diagram depicting the thickness of the various corrosion layers formed on the HP40Al alloy during exposure to the 0.6 % H_2S gas at $800^\circ C$.

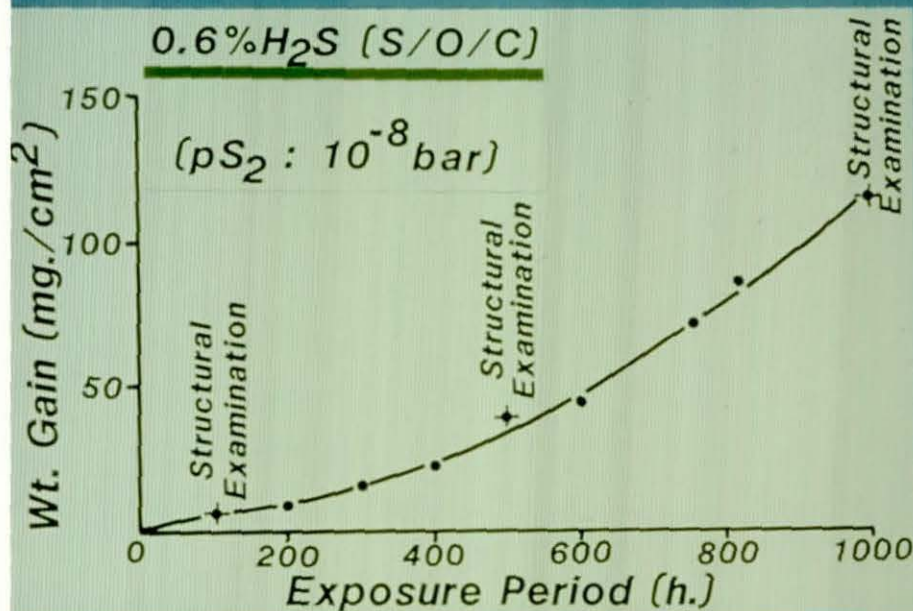
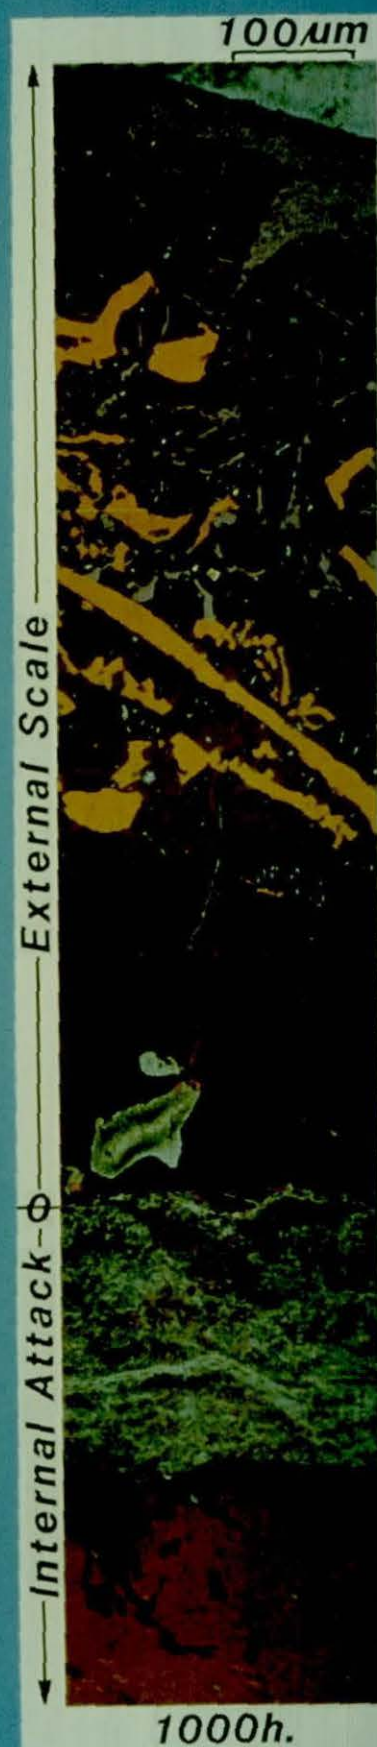
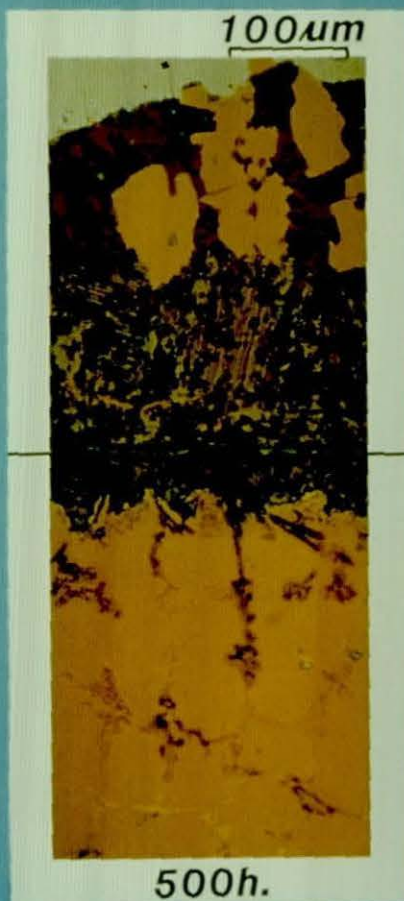
Figure 4.108

Cross-sectional examination using the Pepperhoff technique for HP40Al exposed to the 0.6 % H₂S gas at 800°C.

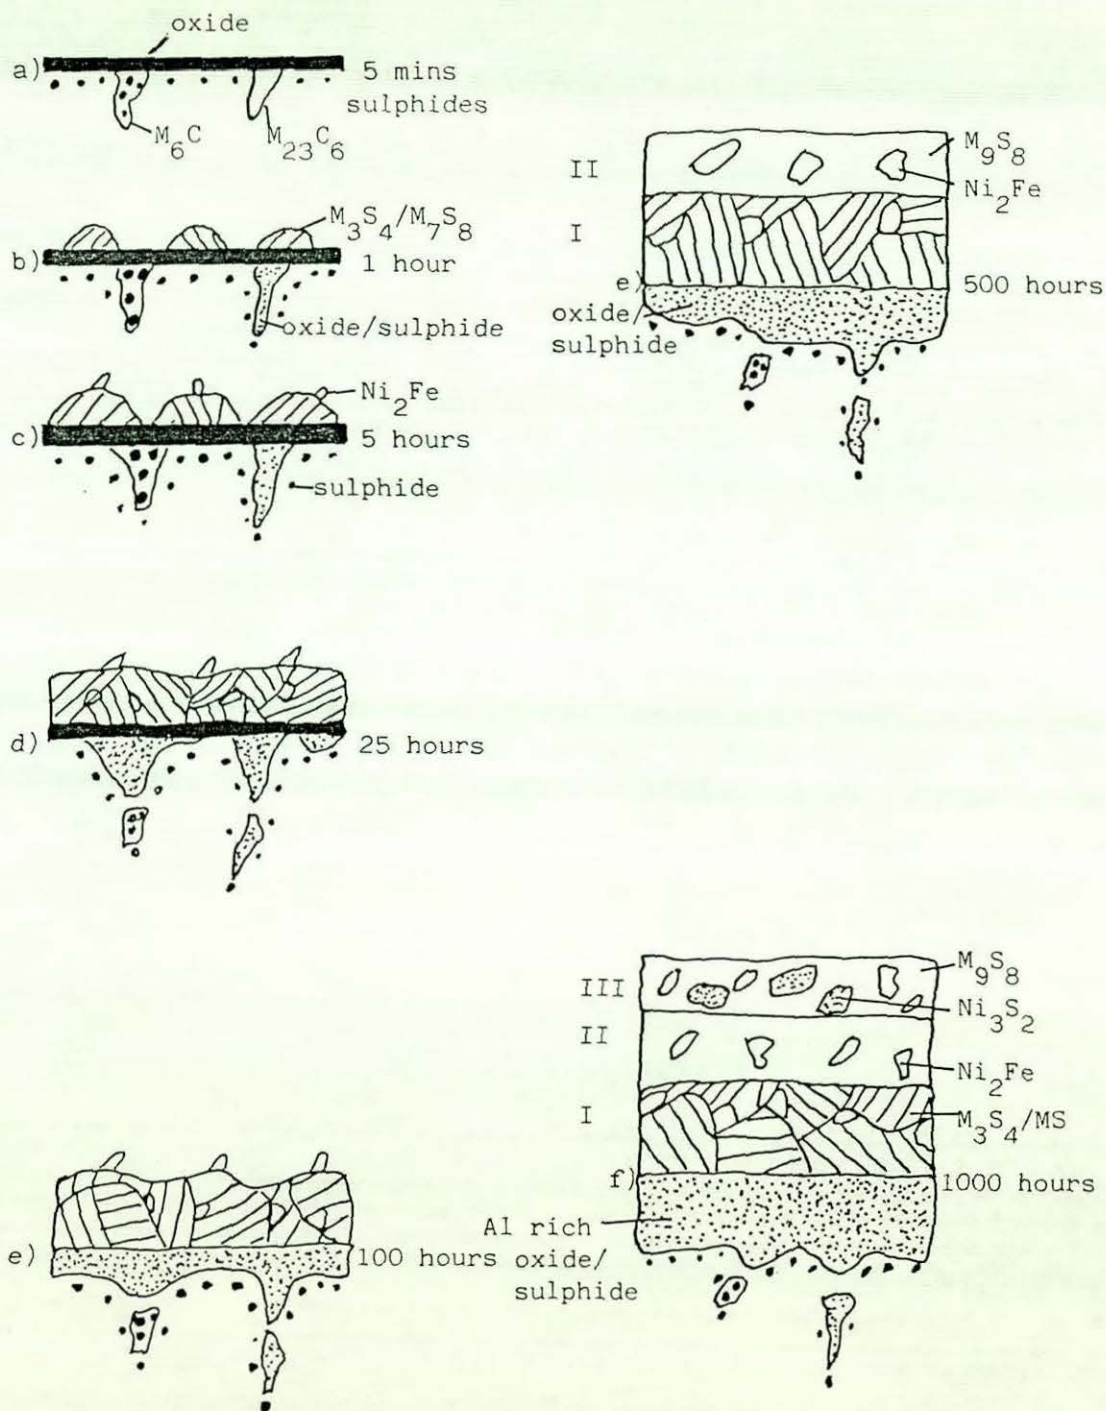
Figure 4.112

Summary figure showing the corrosion behaviour of HP40Al in the 0.6% H_2S gas at $800^\circ C$.

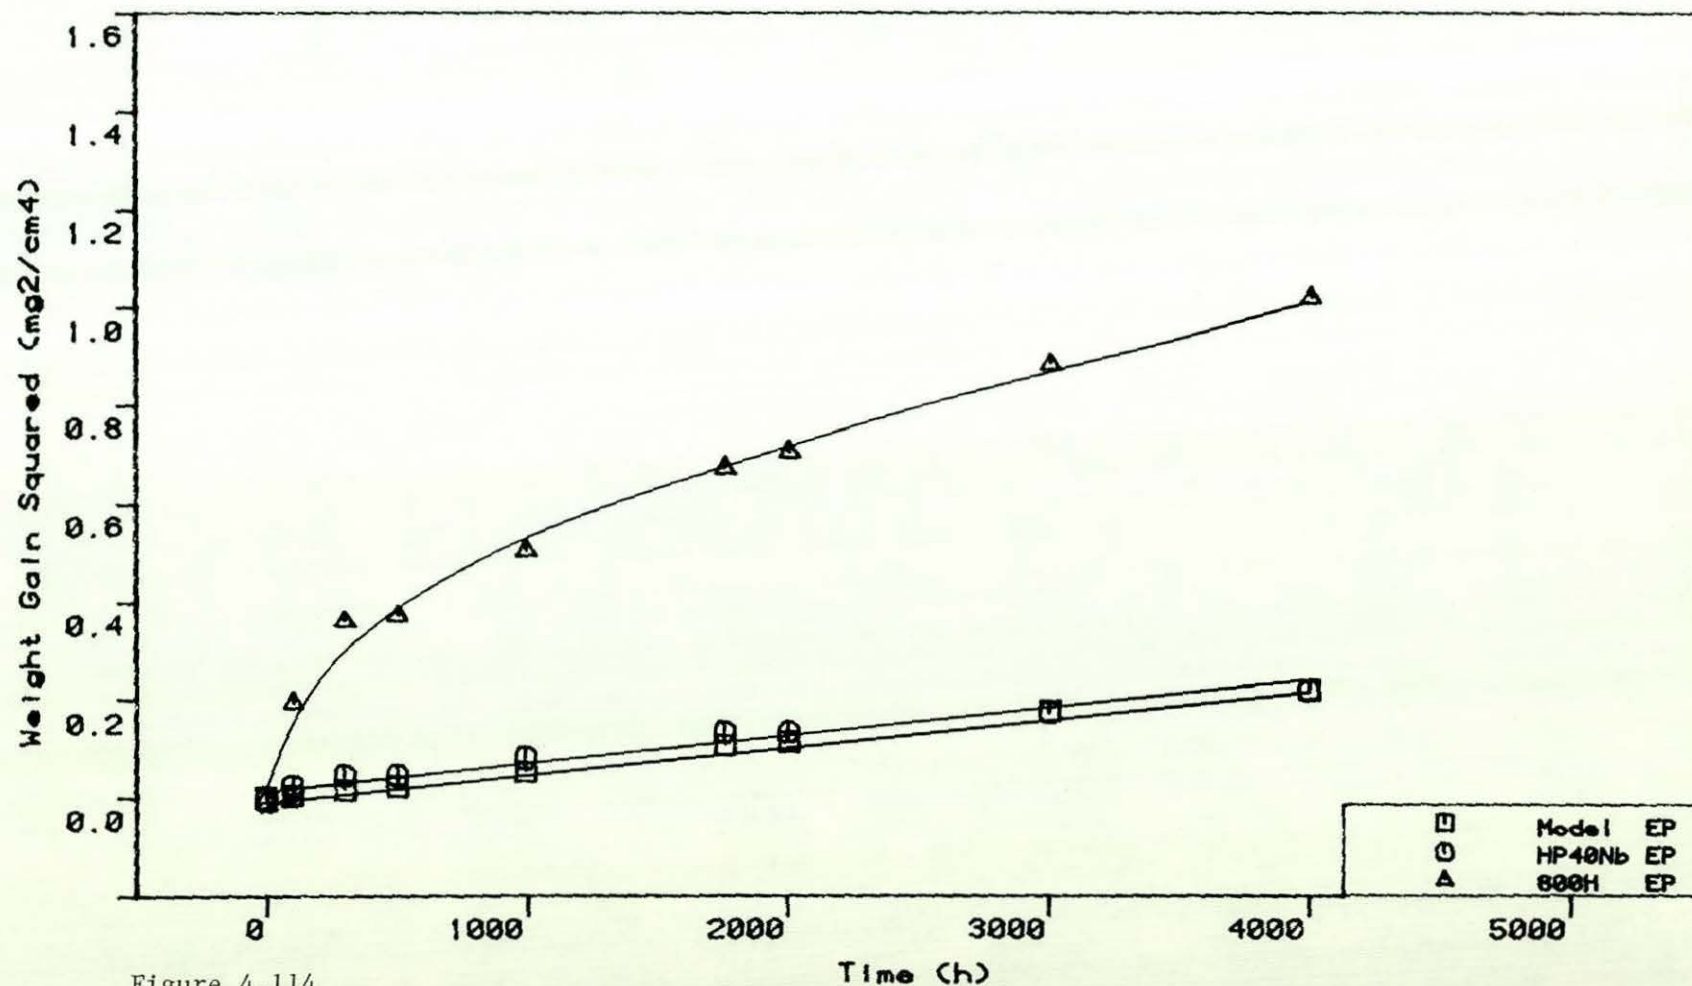
Figure 4.114

Plots of weight gain squared against time for the Alloy 800H and the Model 25Cr-35Ni-Fe alloy in the sulphur-free gas at 800°C , electropolished condition.

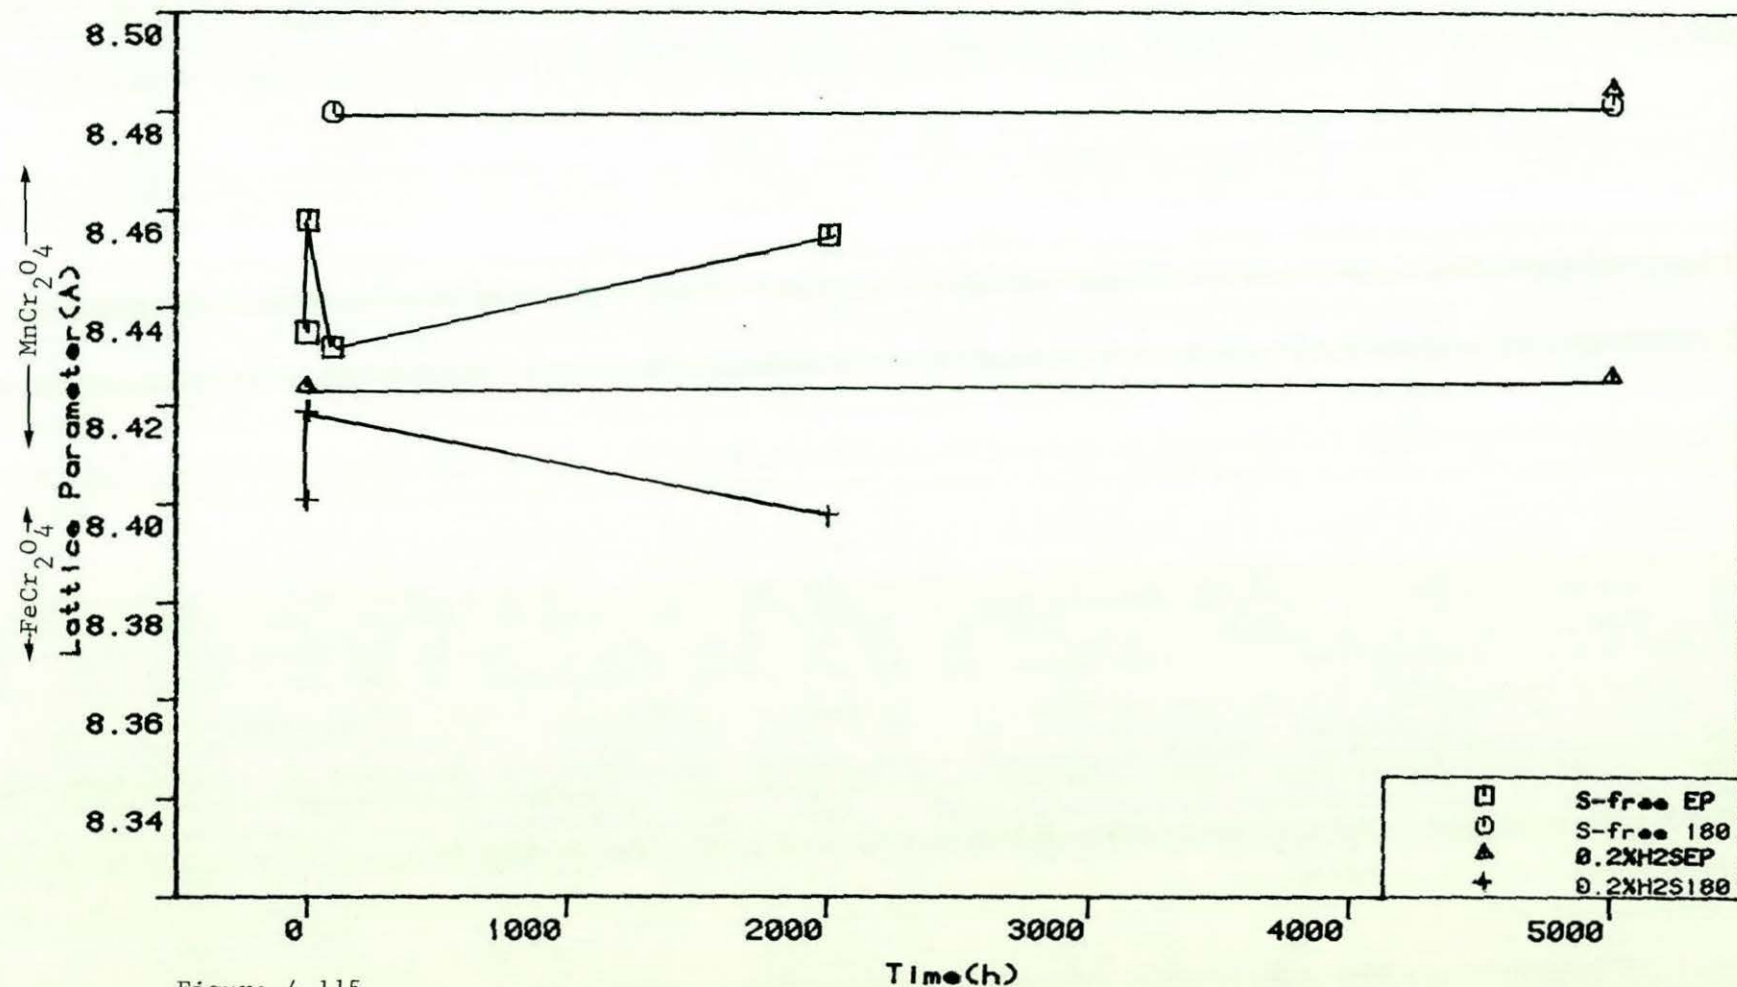
Figure 4.115

Plots of oxide spinel lattice parameter against time for Alloy 800H exposed to the sulphur-free and 0.2% H₂S gases at 800°C.

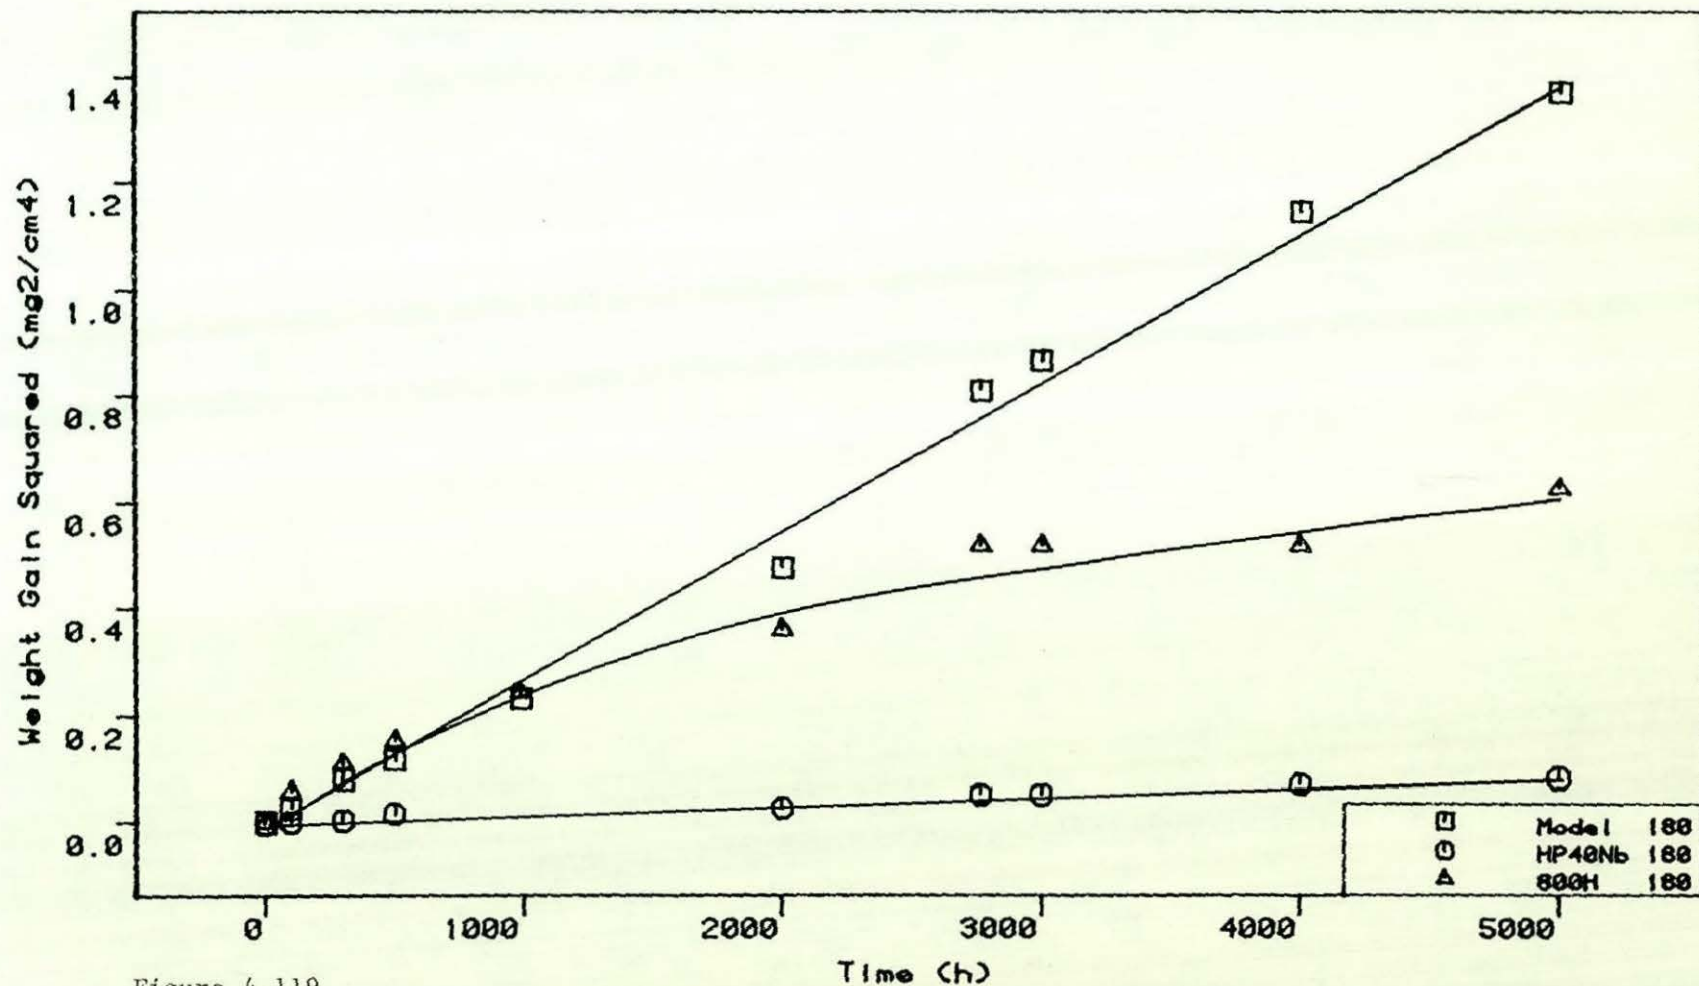
Figure 4.119

Plots of weight gain squared against time for Alloy 800H, Model 25Cr-35Ni-Fe and HP40Nb exposed to the sulphur-free gas at 800°C , 180 grit condition.
