THE CORROSION BEHAVIOUR OF Fe-Cr-Ni ALLOYS
IN COMPLEX HIGH TEMPERATURE GASEOUS ATMOSPHERES
CONTAINING THE REACTANTS OXYGEN, SULPHUR
AND CARBON

A Doctoral Thesis submitted in partial fulfilment
of the requirements for the award of
Doctor of Philosophy
of the Loughborough University of Technology, U.K.,
based on research carried out at the
Commission of the European Communities Joint Research Centre,
Petten, Netherlands.

VOLUME 2

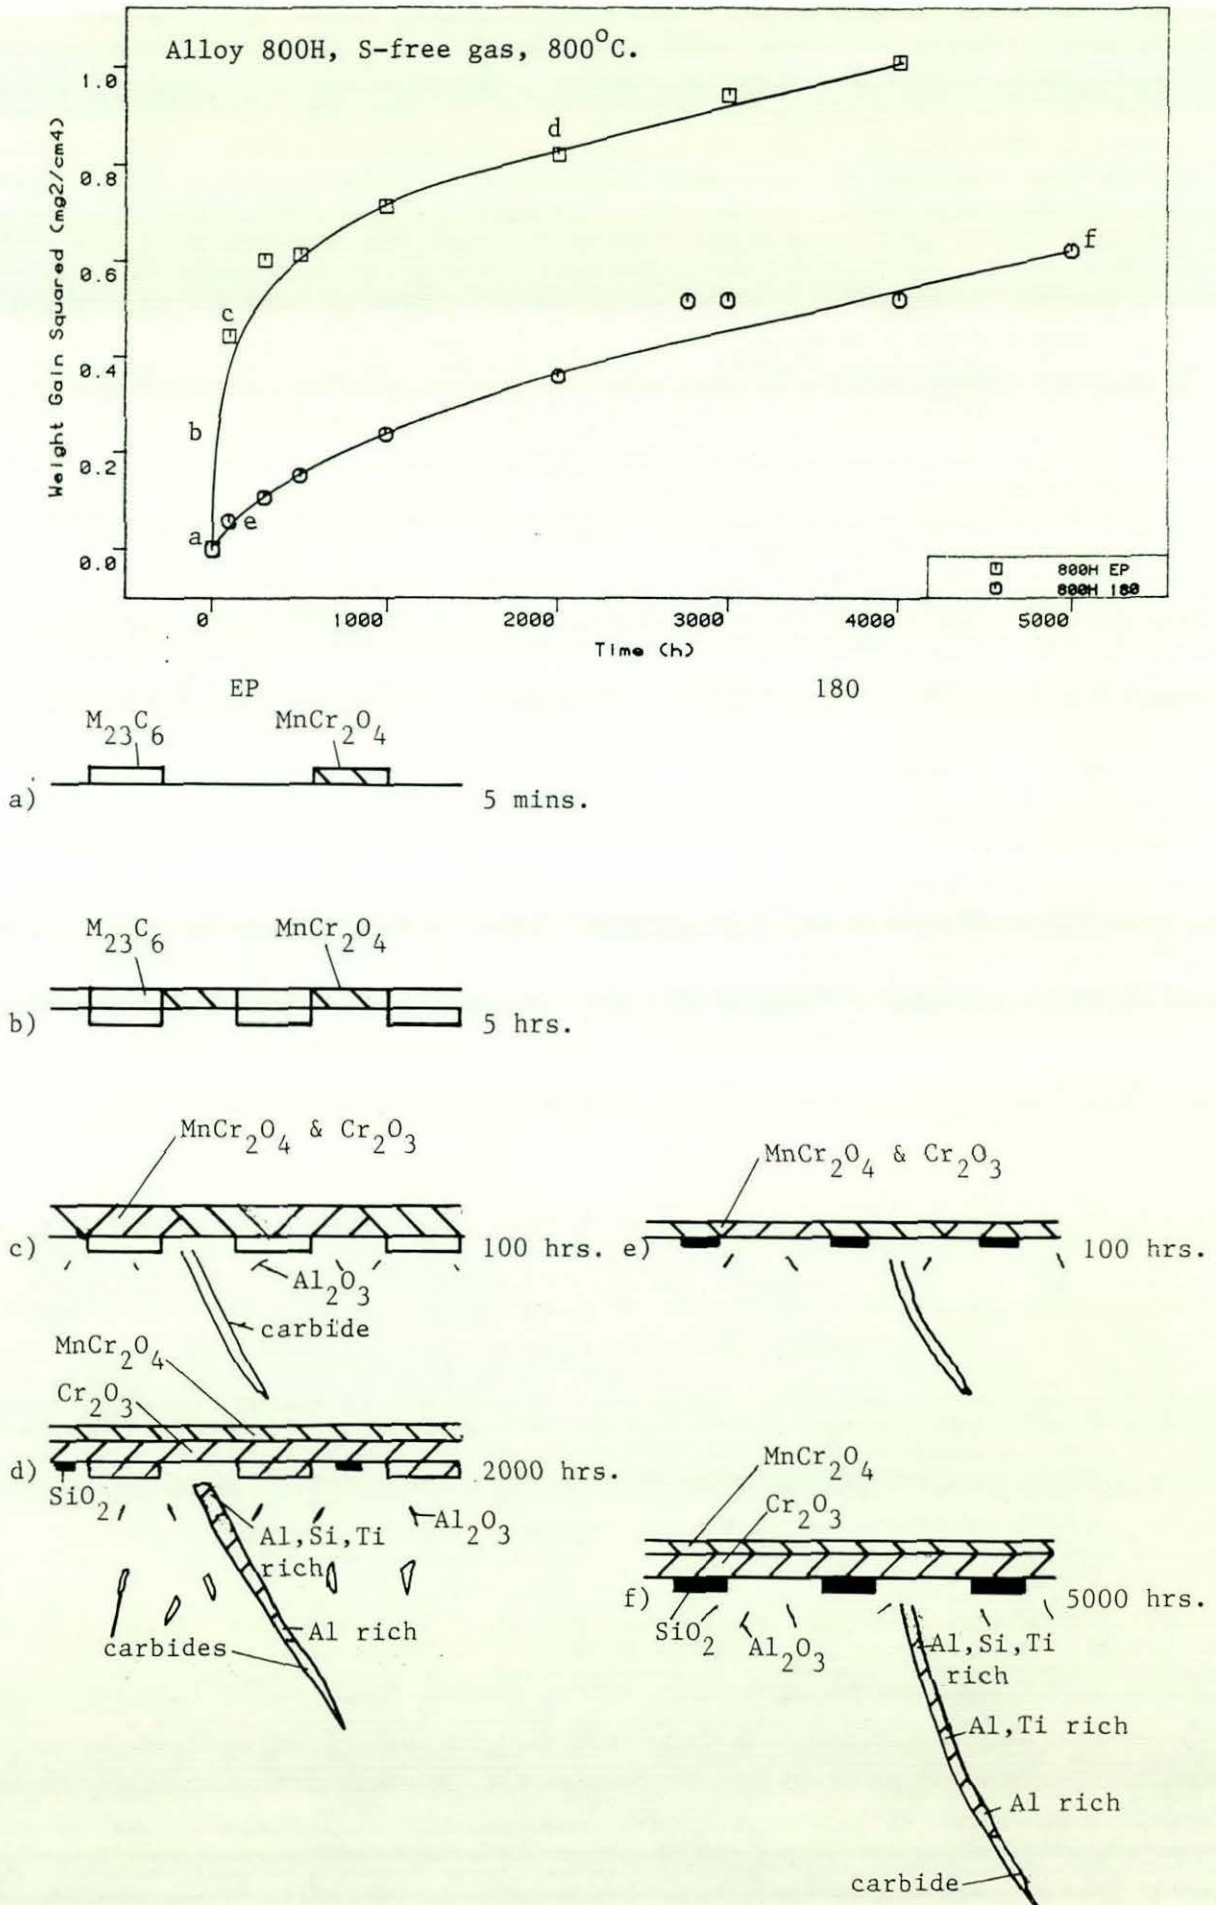
Figure 4.120

Summary figure for the corrosion behaviour of Alloy 800H in the sulphur-free gas at 800°C.

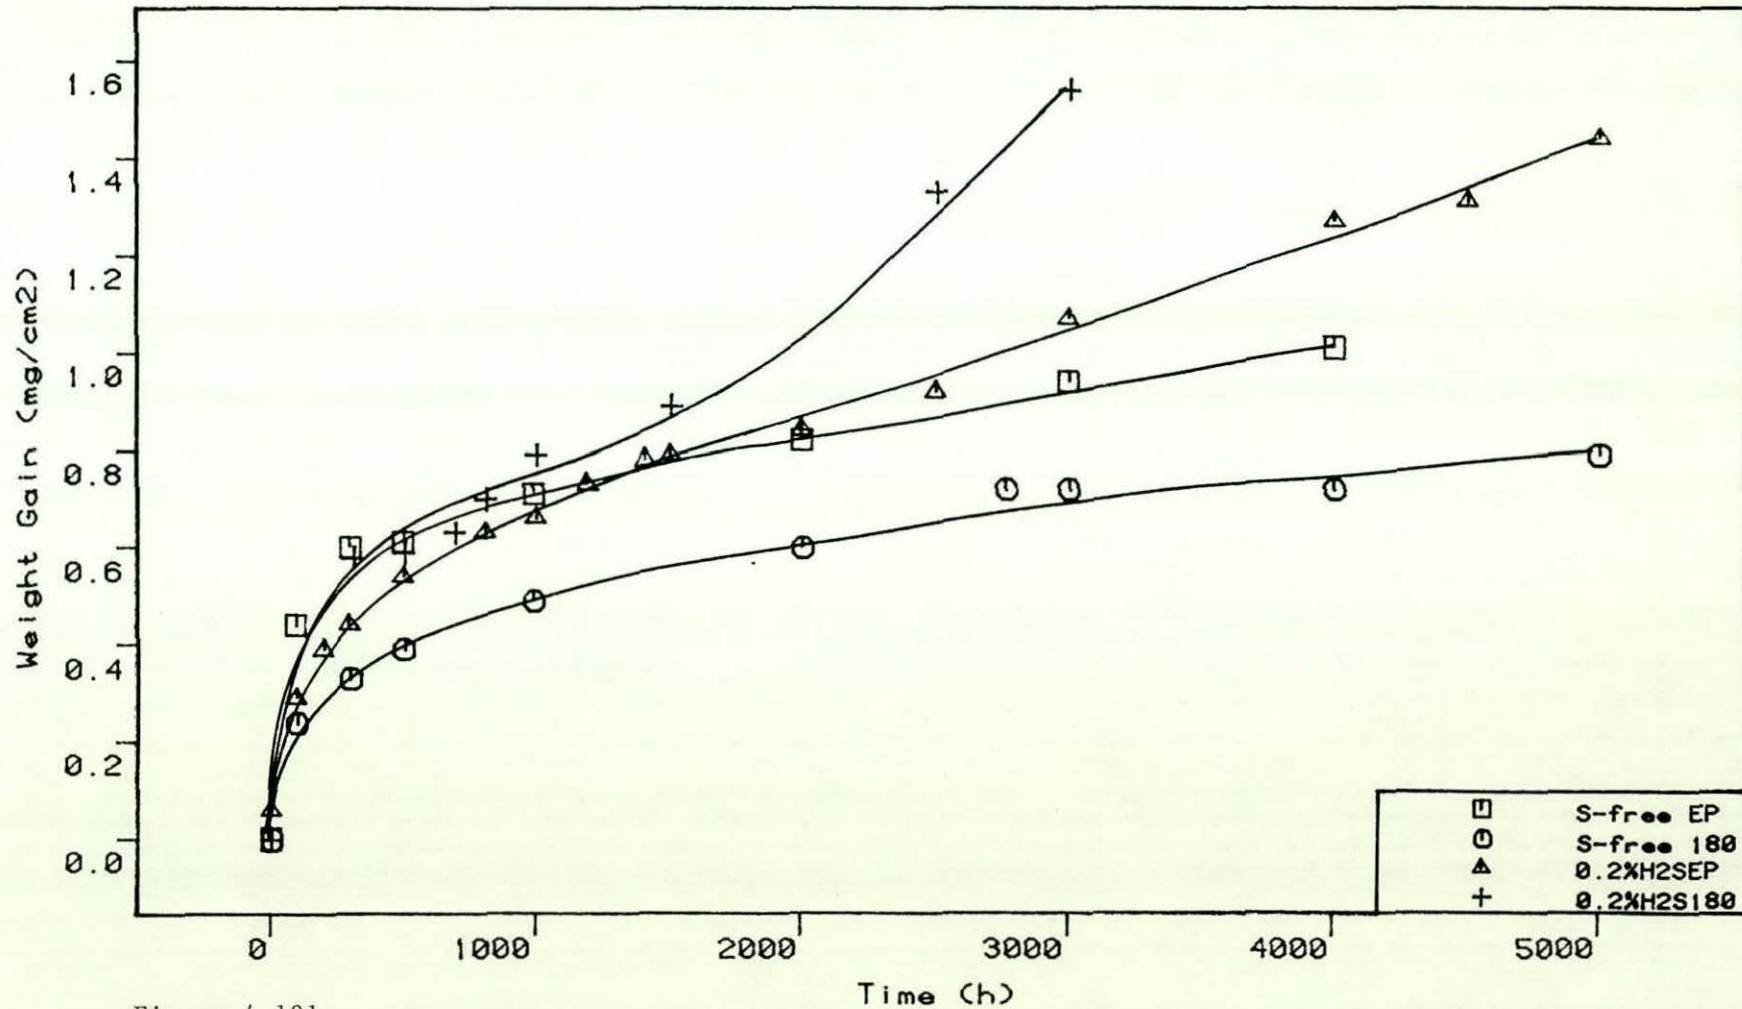
Figure 4.121

Kinetic data for Alloy 800H exposed to the sulphur-free and 0.2% H₂S gases at 800°C.

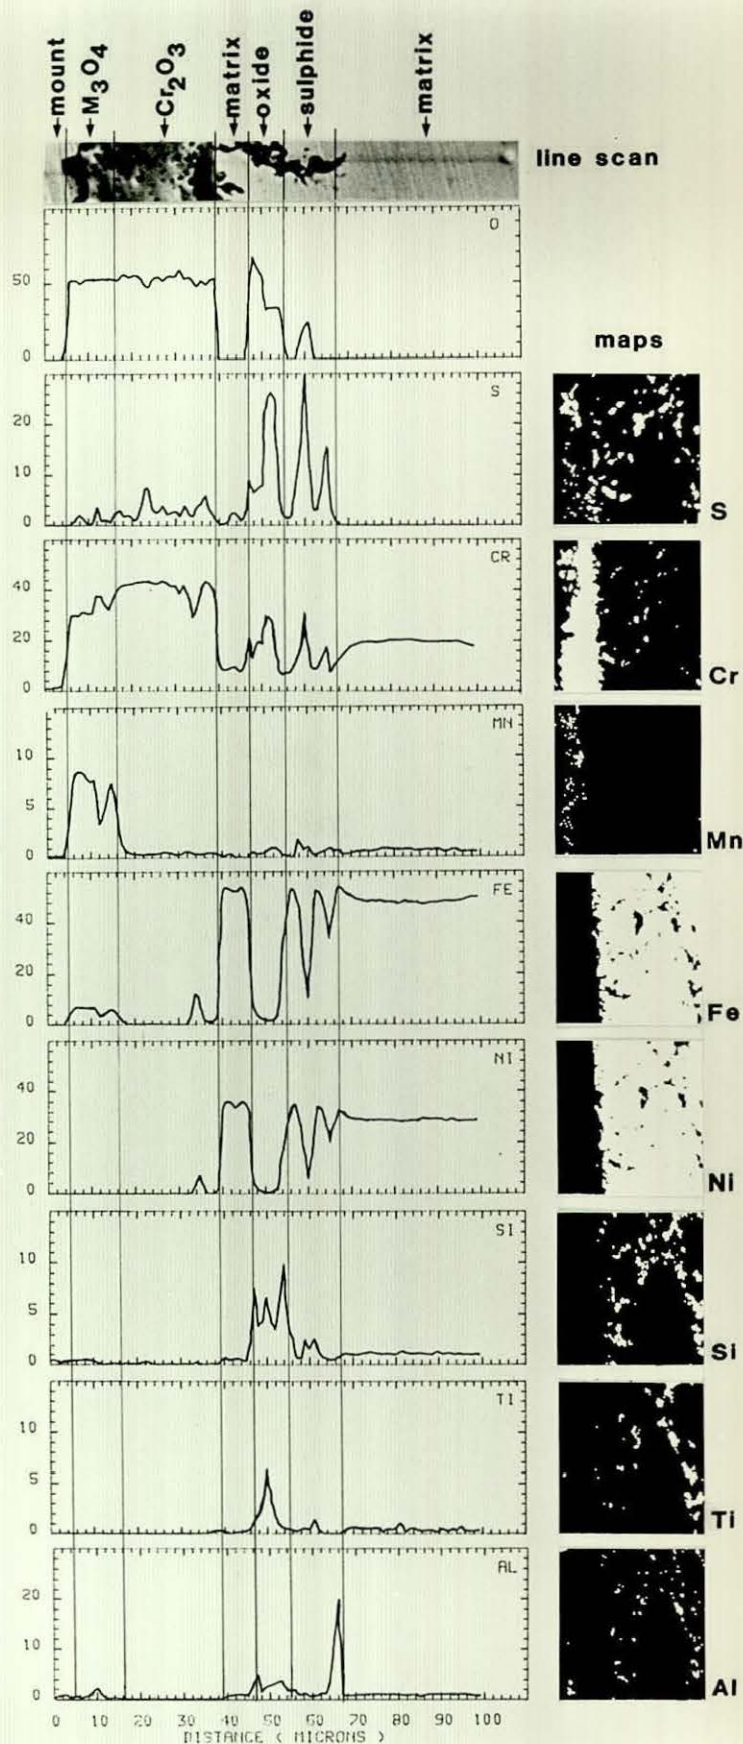
Figure 4.124

EPMA line scan on Alloy 800H exposed to the 0.2 % H₂S gas at 800°C for 5000 hours, electropolished (EP) condition.

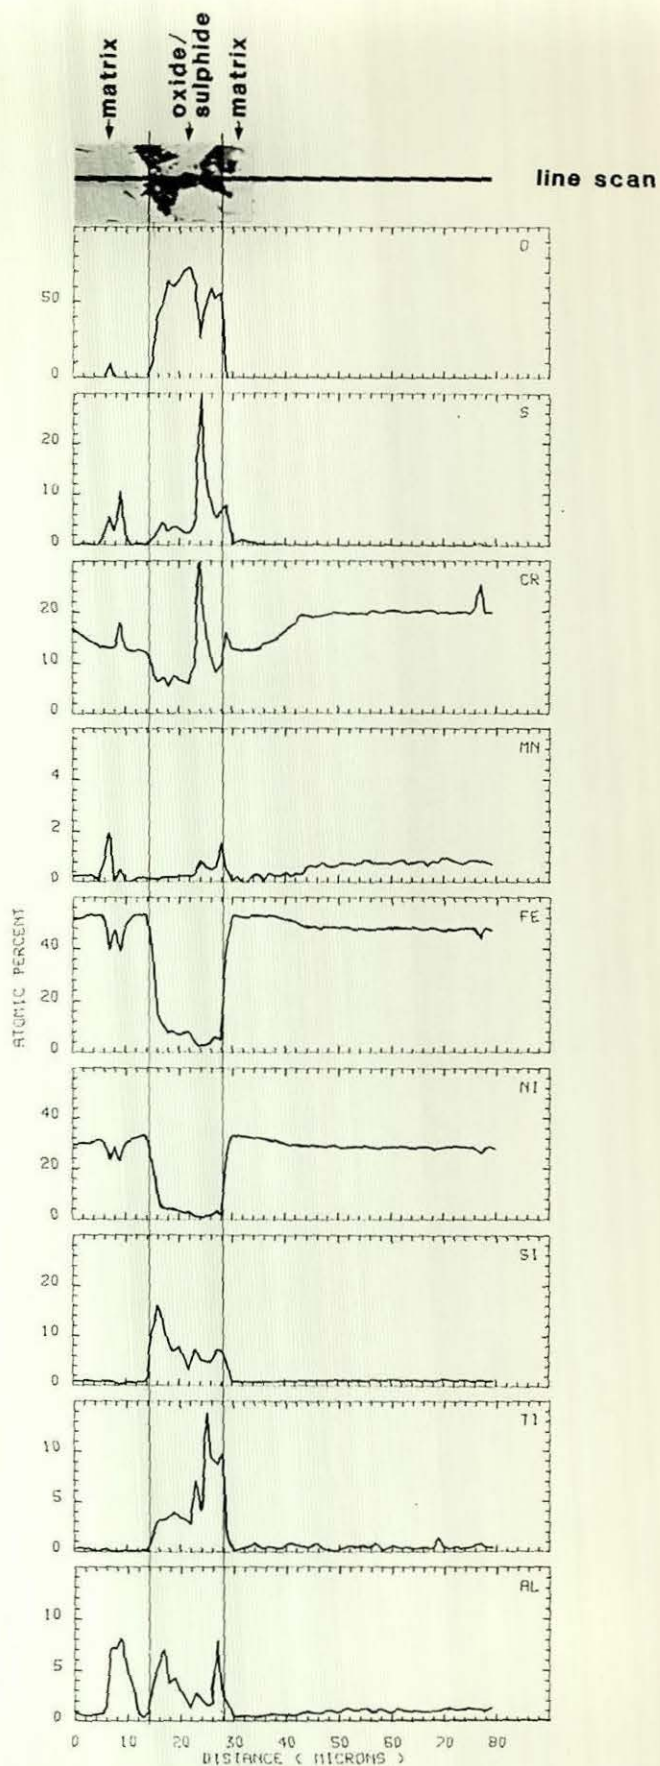
Figure 4.125

EPMA line scan on an area of localized attack in Alloy 800H exposed to the 0.2 % H_2S gas at 800°C for 5000 hours, electropolished (EP) condition.

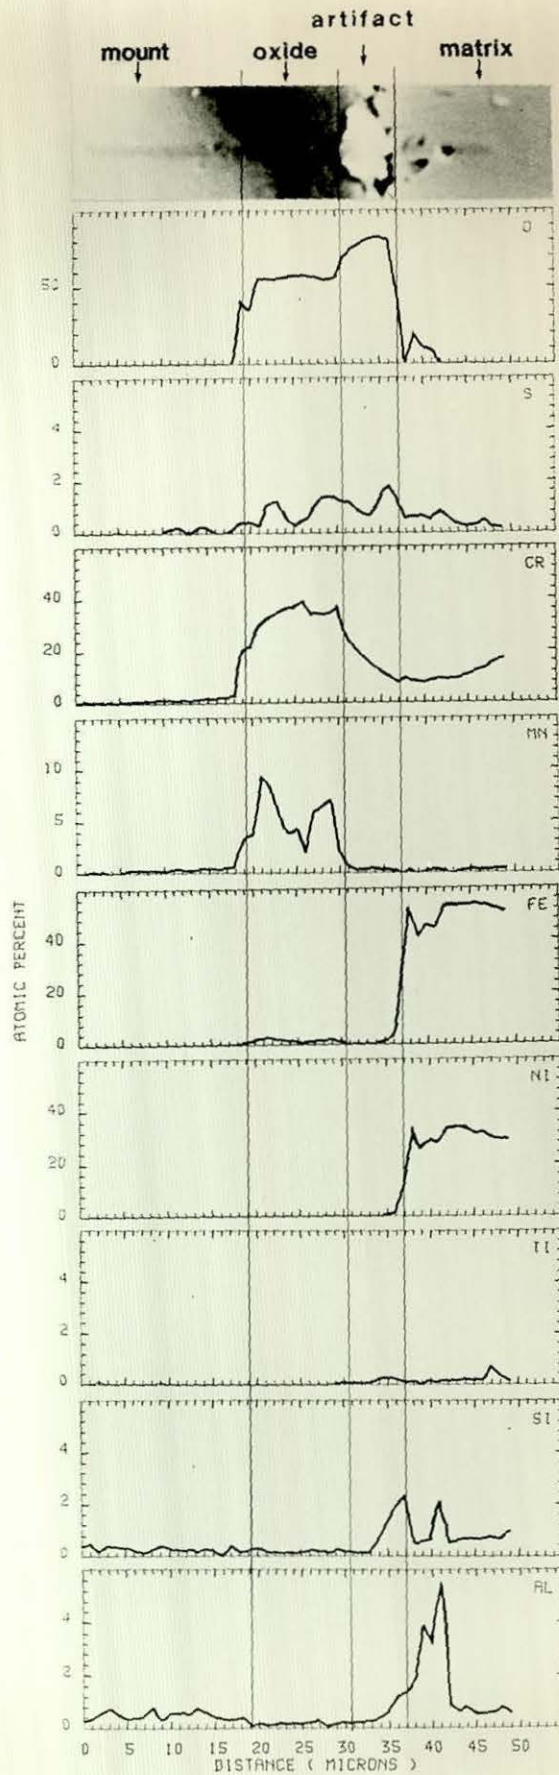
Figure 4.129

EPMA line scan on Alloy 800H exposed to the 0.2 % H_2S gas at 800°C for 2000 hours, 180 grit condition.

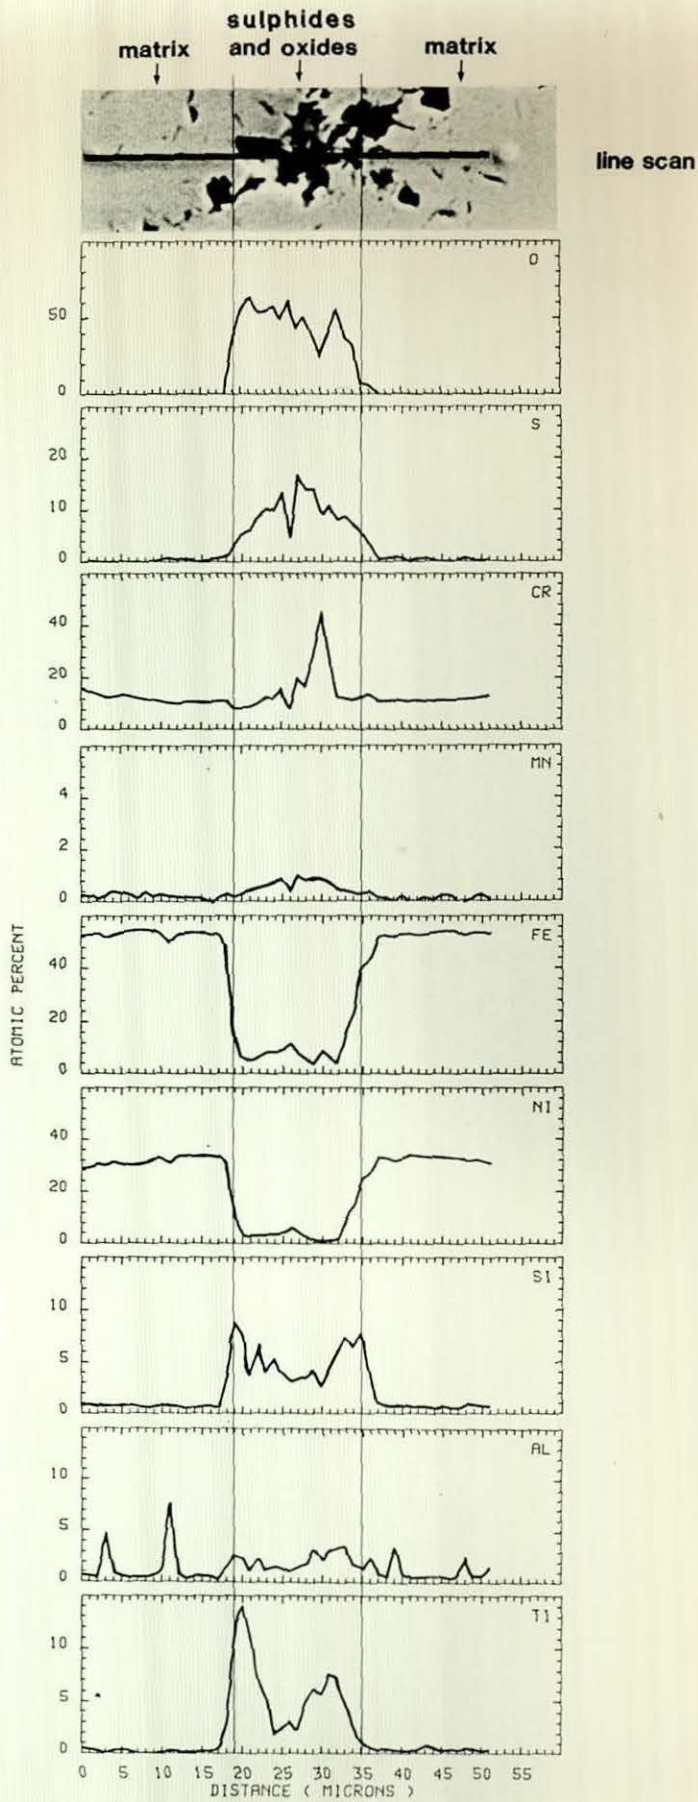
Figure 4.130

EPMA line scan on an area of localized attack in Alloy 800H exposed to the 0.2 % H_2S gas at 800°C for 2000 hours, 180 grit condition.

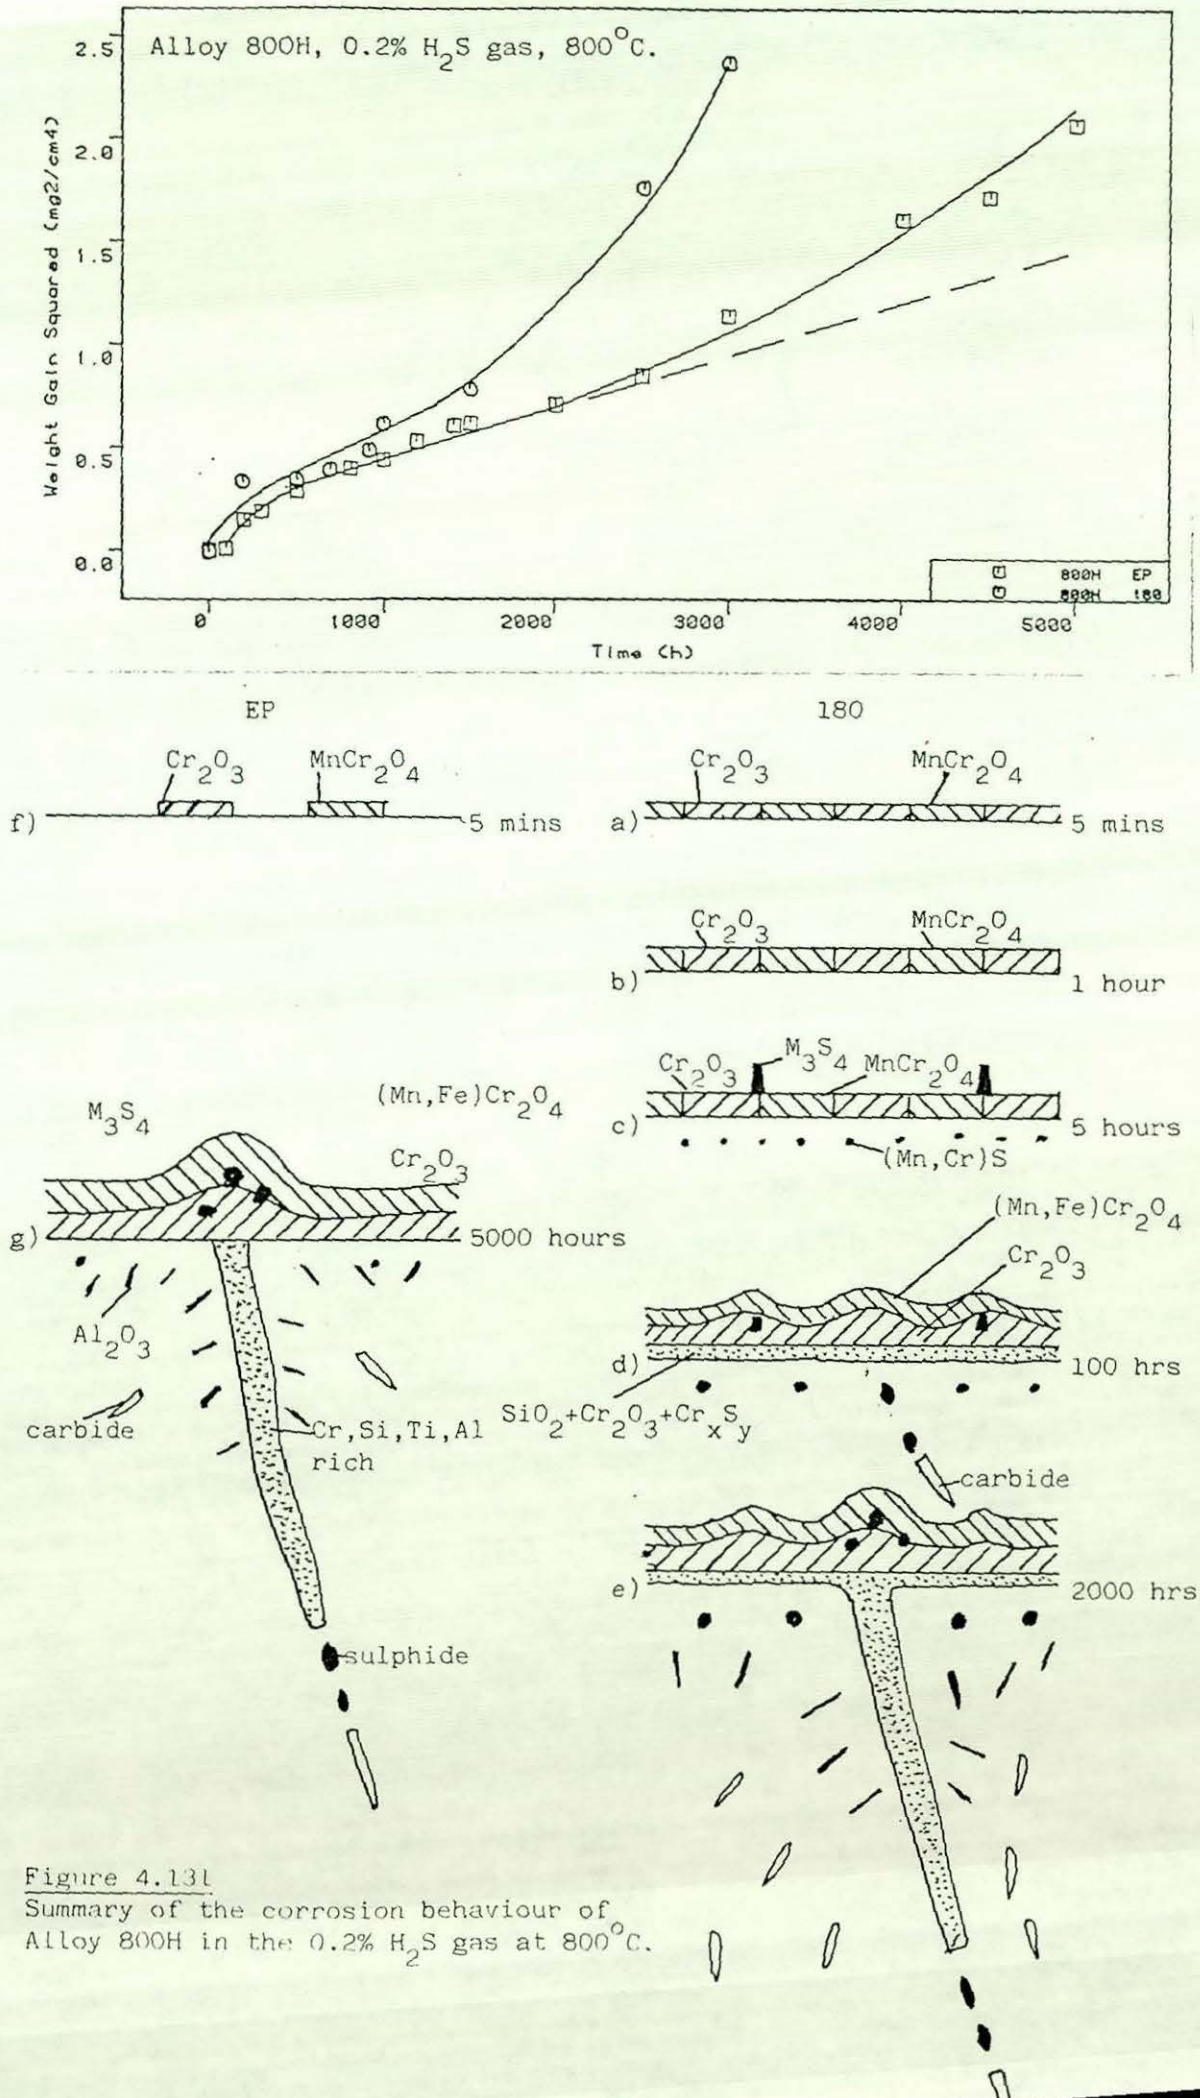
Figure 4.131
Summary of the corrosion behaviour of
Alloy 800H in the 0.2% H₂S gas at 800°C.

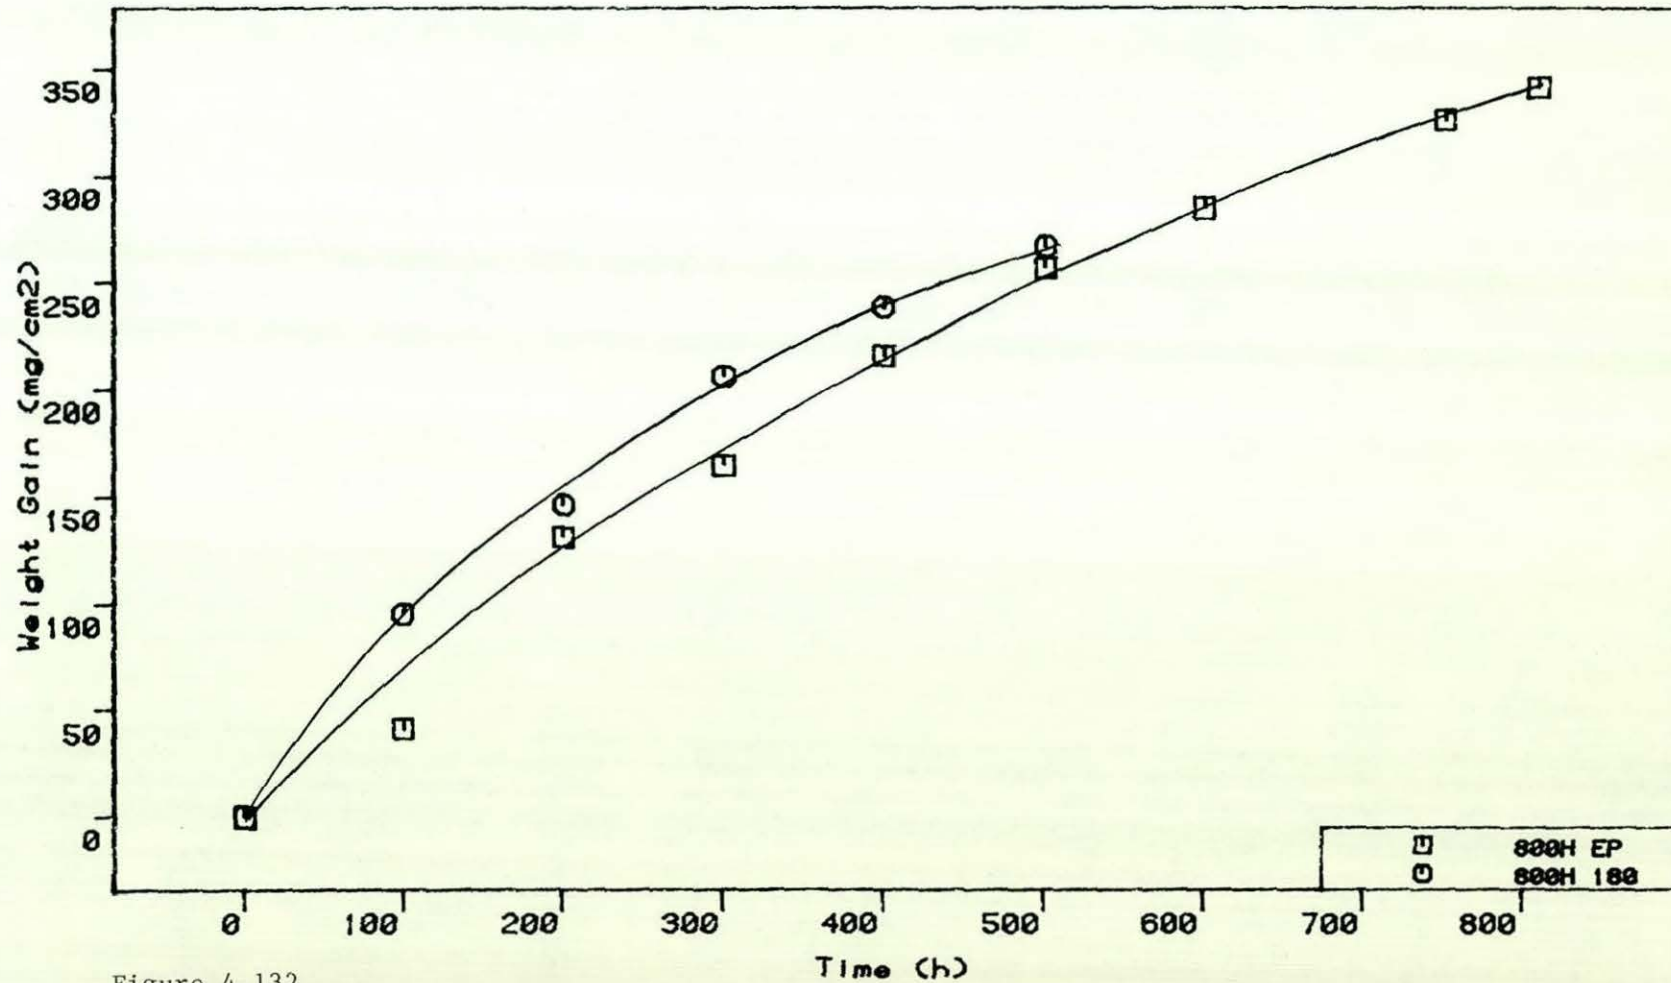
Figure 4.132
Corrosion kinetics for Alloy 800H in the 0.6% H₂S gas at 800°C.

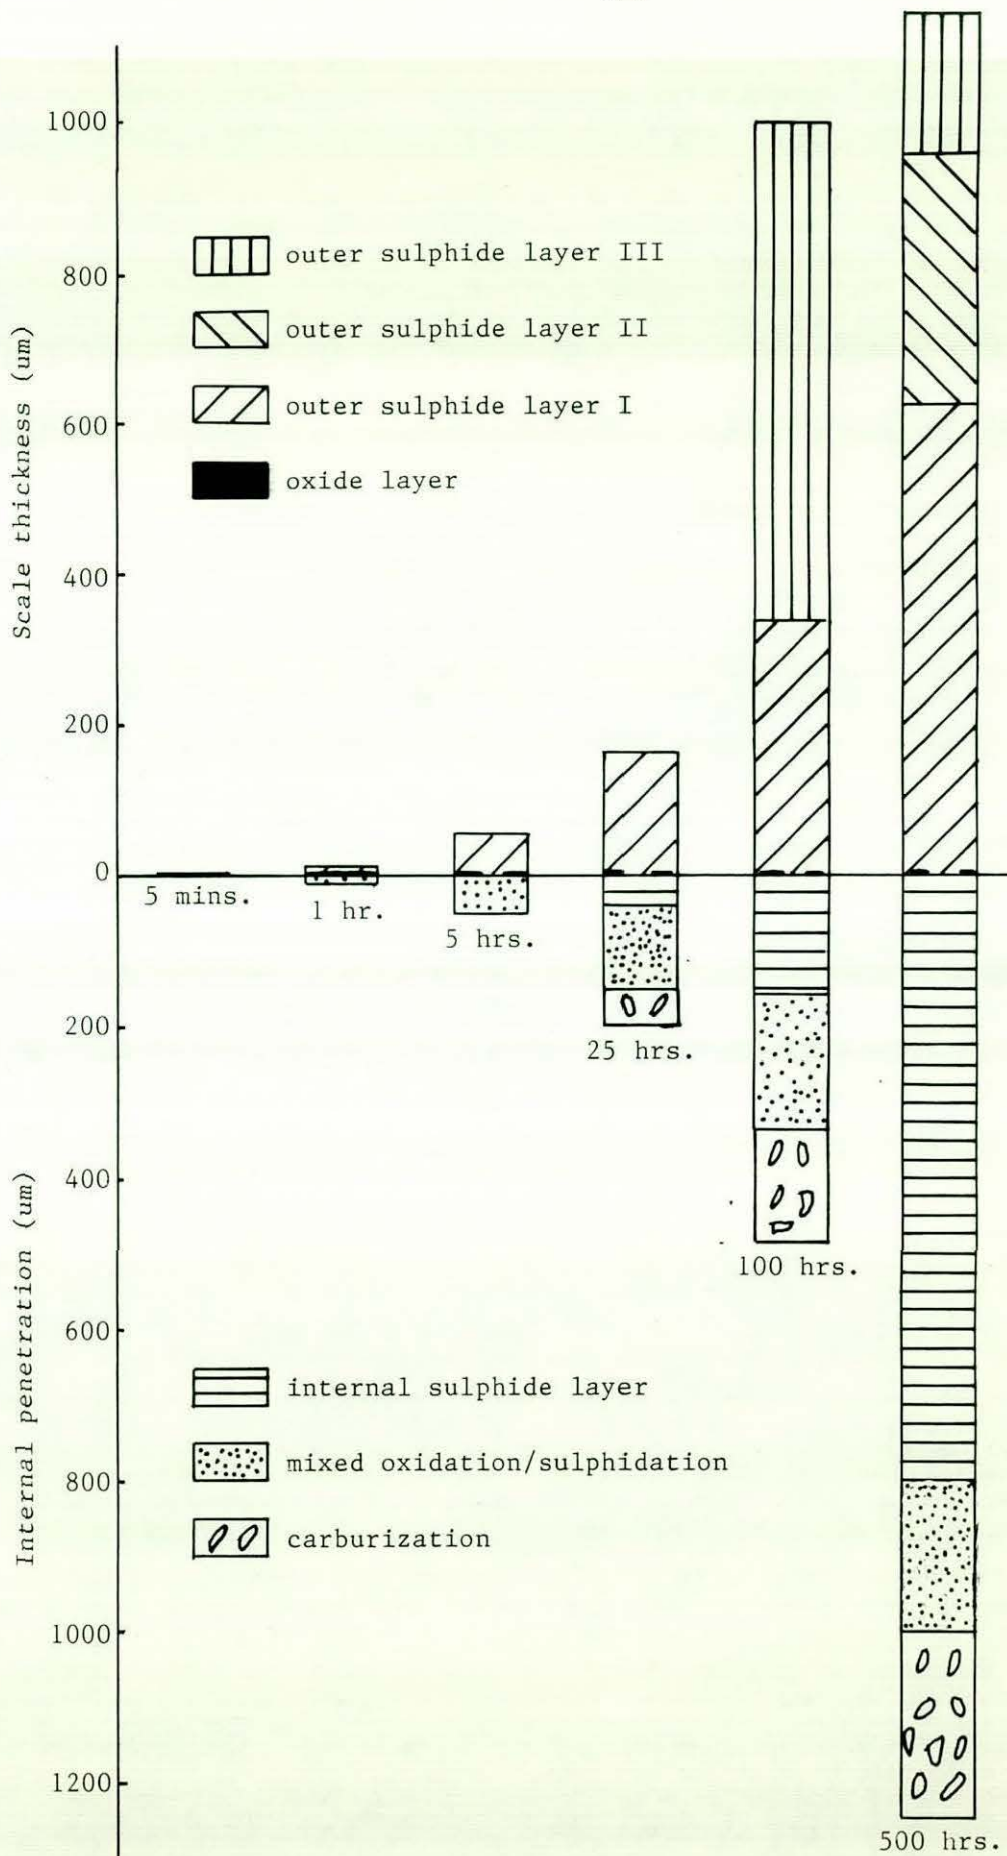
Figure 4.133

Diagram depicting the thickness of the various corrosion layers formed on Alloy 800H during exposure to the 0.6 % H_2S gas at $800^{\circ}C$.

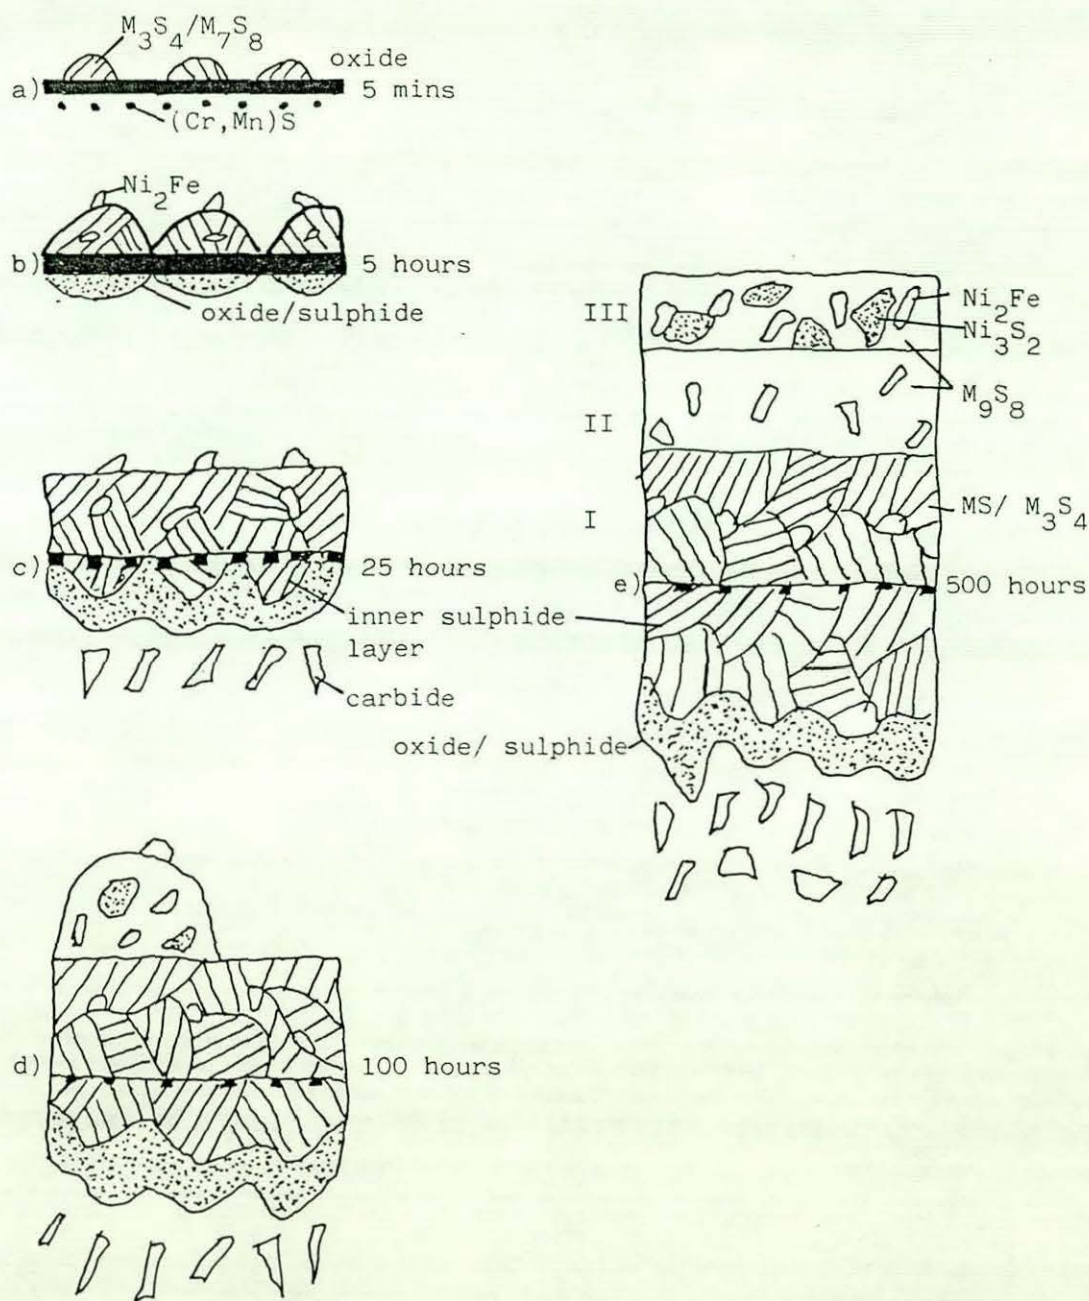
Figure 4.134

Summary figure showing the corrosion morphology of Alloy 800H in the 0.6% H_2S gas at $800^\circ C$.

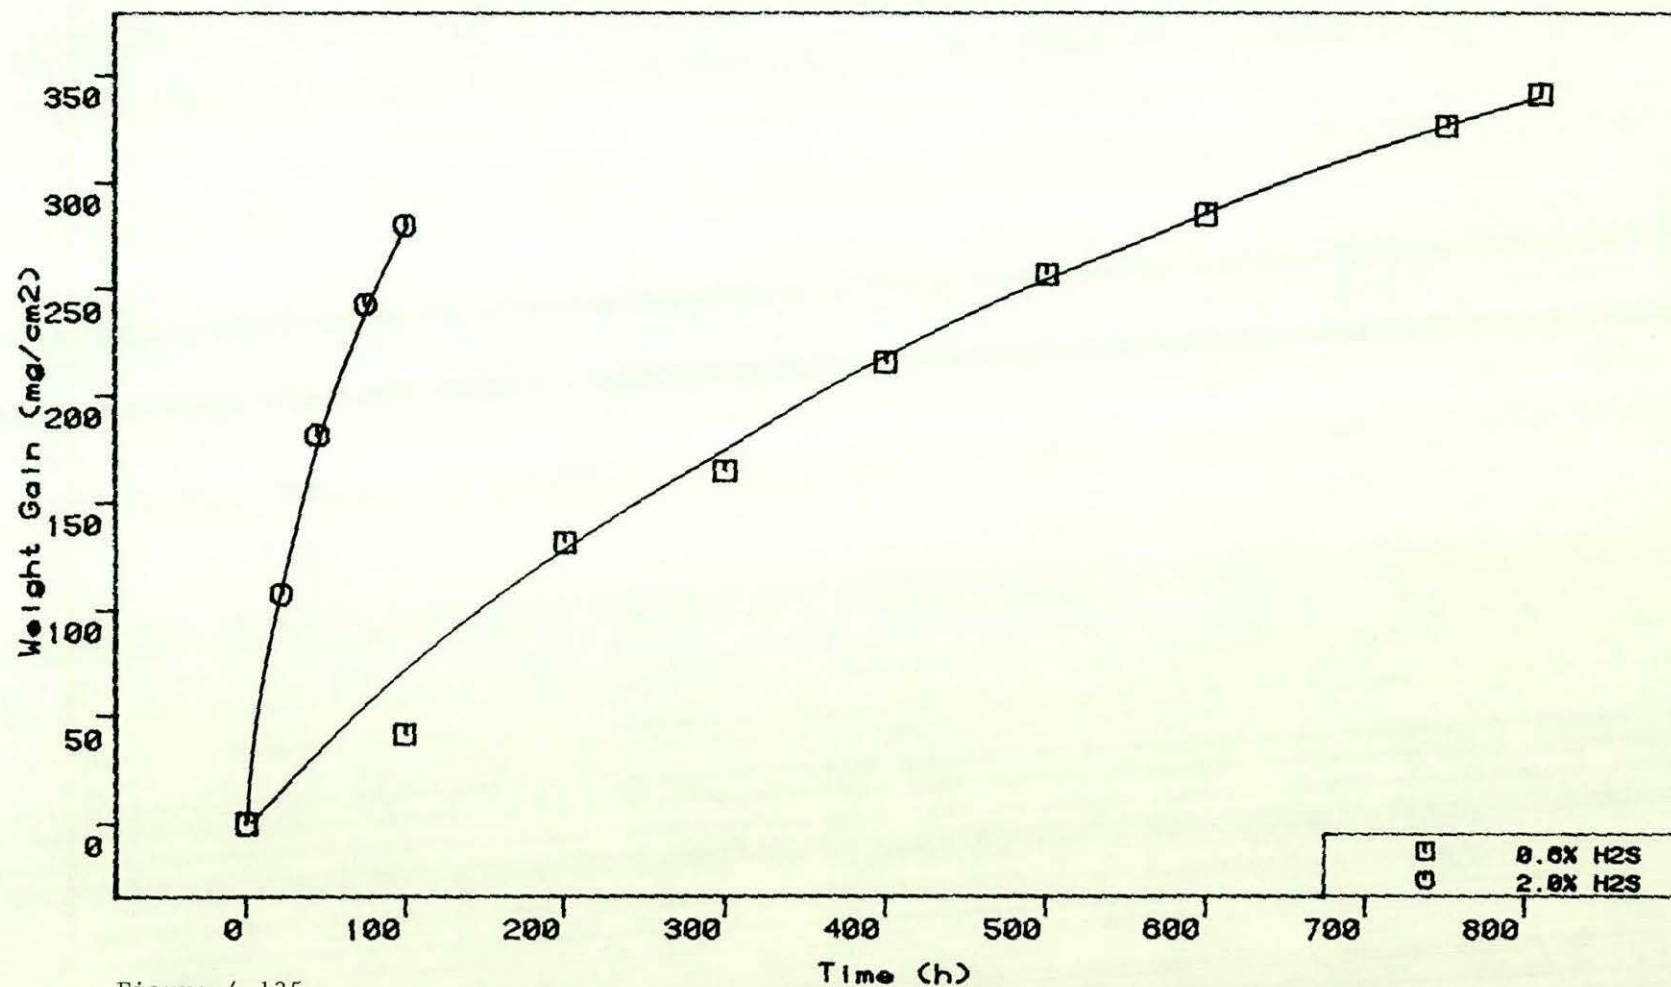
Figure 4.135

Corrosion kinetics for Alloy 800H in the 0.6% and 2.0% H_2S gases at 800°C.

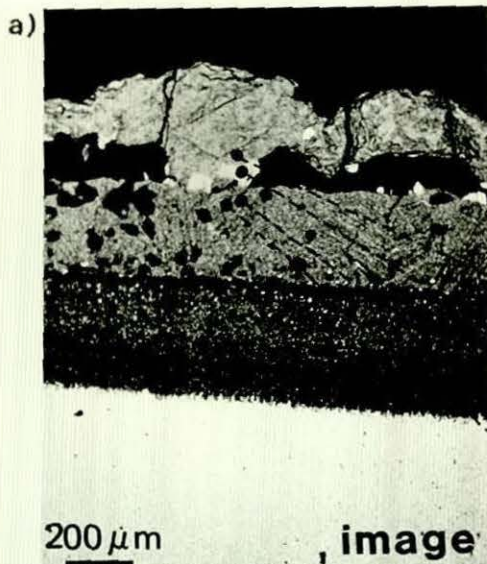
E.P.M.A. of Alloy 800H specimen
exposed for 22.5 h in 2.0% H_2S
- containing atmosphere at 800°C

Cr	Fe	Ni	S at%
0.4	30.5	30.0	39.2
-	29.8	70.2	-
32.2	18.8	-	49.0
10.0	32.5	17.4	40.1

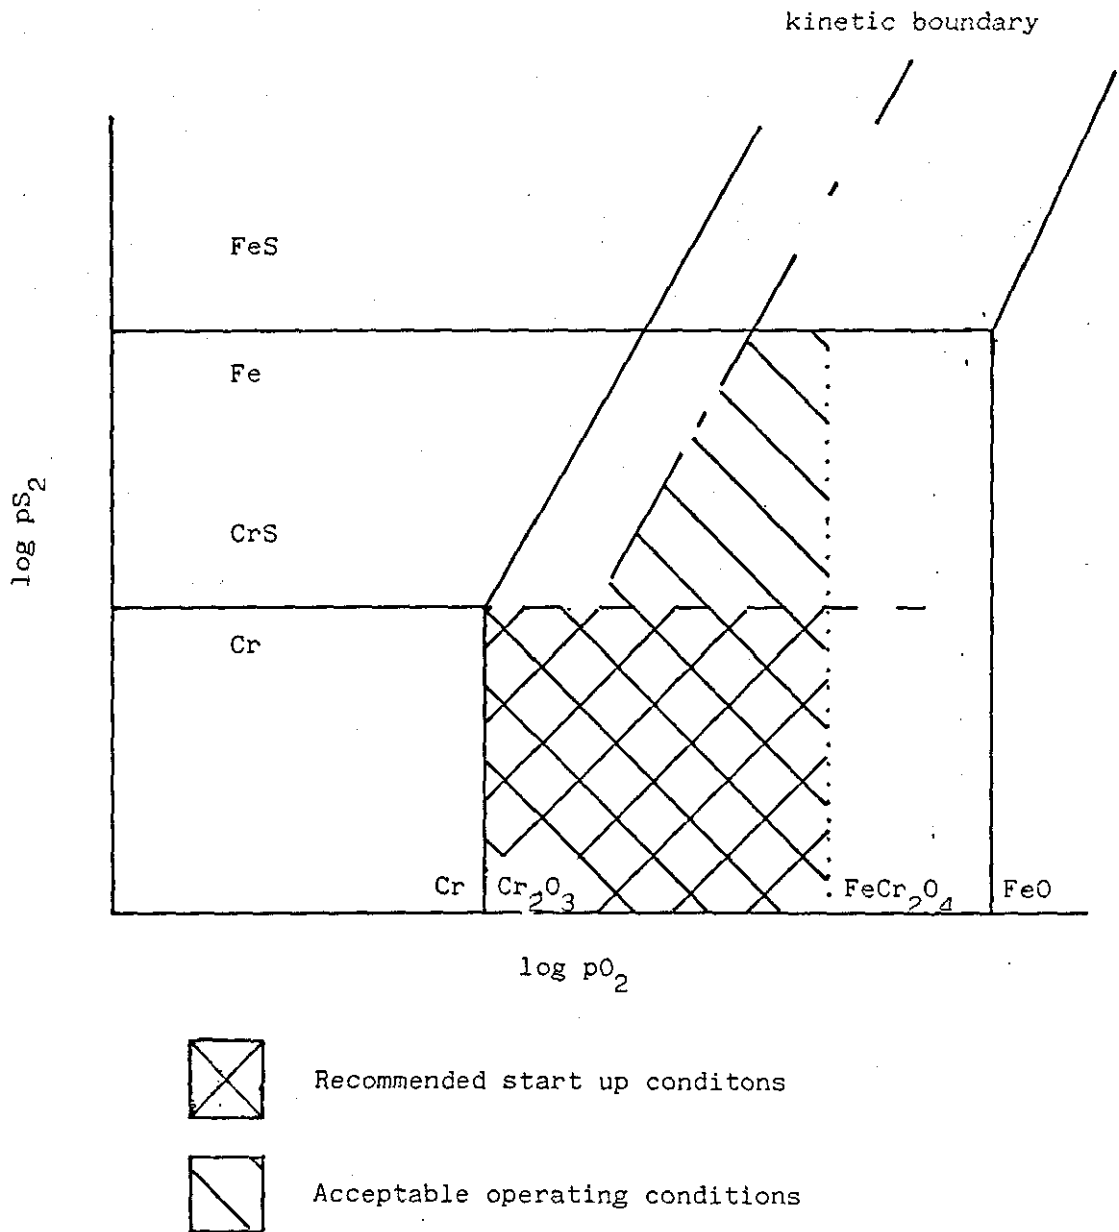
Figure 5.3

Schematic metal stability diagram indicating acceptable start up and operating conditions for technological processes.
