The Influence of the Parent Metal Condition on the Cross-weld Creep Performance in Grade 91 Steel

John A. Siefert

Department of Materials
Loughborough University

A doctoral thesis submitted in partial fulfillment of the
requirements for the award of Doctor of Philosophy

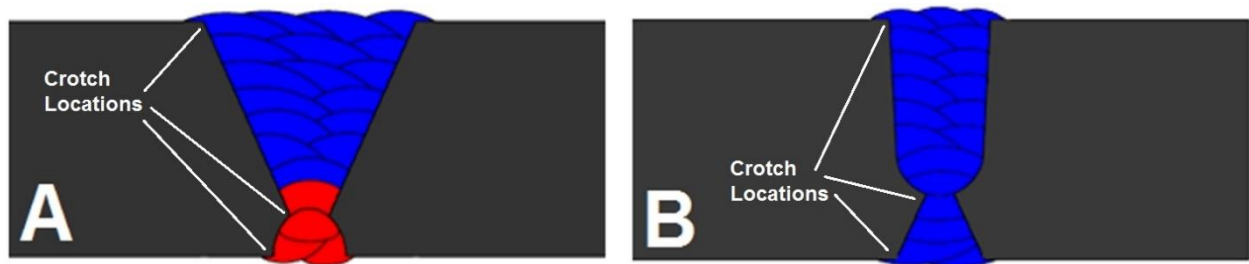
Figure 2-25. Difference in performance of seam welded Grade 91 type components have been recorded during service. Damage and cracking were found in elbows which had been made using a high bevel angle (A) rather than in straight pipe sections where the weld profile was significantly different (B) (Komai 2016)

(Viswanathan and Foulds 1995). The aforementioned crotch locations (and as identified in two conventional seam-weld geometries in Figure 2-25) are a direct result of the selected weldment geometry (e.g. X-groove or a compound bevel such as in a girth weld), over-welding at the outside diameter (OD) location and/or due to back-gouging and re-welding at the inside diameter (ID) location as is commonly practiced in seam-welded construction. The influence of the welding thermal cycle, metallurgical evolution and other relevant issues will be discussed in more detail later in Chapter 2.

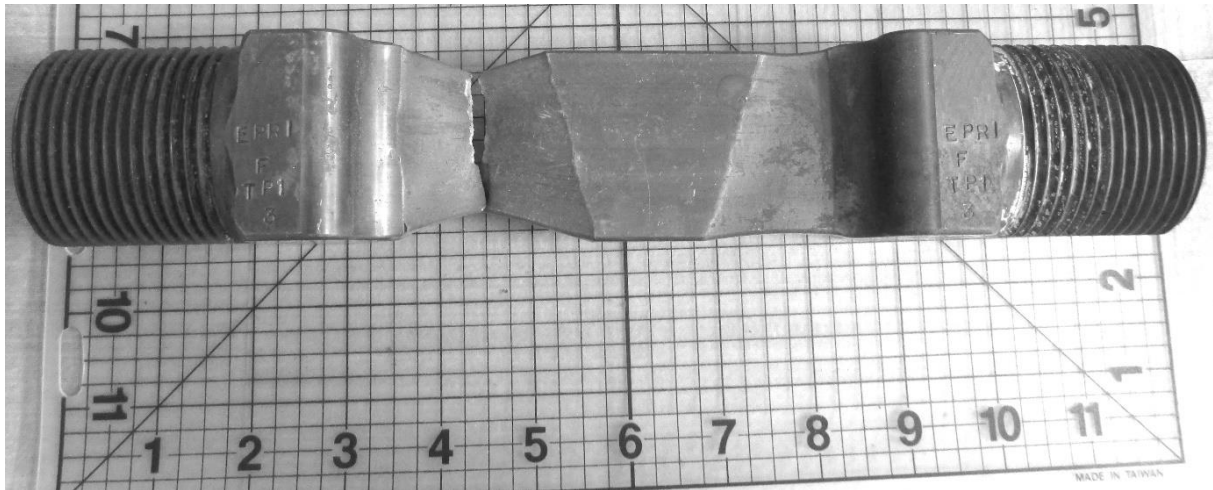
Figure 6-11. Example of parent metal dominated failure (sample F-TP1-3)

The determination of failure location in Table 6-4 is based on a simple, macroscopic failure criterion and examples of the different failure-types are given in Figure 6-11 to Figure 6-13. Figure 6-11 provides an example of a parent metal dominated failure; the necking in the gauge sample is clearly away from the weld metal and HAZ. Figure 6-12 provides an example of necking and damage which is macroscopically weld metal dominated and Figure 6-13 provides an example of a HAZ dominated failure.

The accommodation of strain in the F-TP1 tests is more global in nature, as evidenced by the general necking (Figure 6-11). For the 80 and 60 MPa tests, the general concentration of strain in the parent metal resulting a local neck is accelerated for the tests at 80 MPa (relative to the 60 MPa test) such that the test lives do not achieve the mean-20% of the scatter-band for cross-weld behavior. This result is linked to the relative ratios between the yield stress and the applied stress. The yield strength at 625°C for F-TP1 material is given in Table 6-5 and compared below:
