TITANIUM NITRIDE COATED HIGH SPEED  
STEEL CUTTING TOOL INSERTS

Neville Charles Whittle

A Doctoral Thesis submitted in partial fulfilment of the requirements for the award of Doctor of Philosophy of the Loughborough University of Technology. September 1987.

A detailed study has been made of commercially produced, powder metallurgy, BT42 grade high speed steel (H.S.S.) indexable cutting tool inserts coated with a thin layer of titanium nitride (TiN) by chemical vapour deposition (C.V.D.).

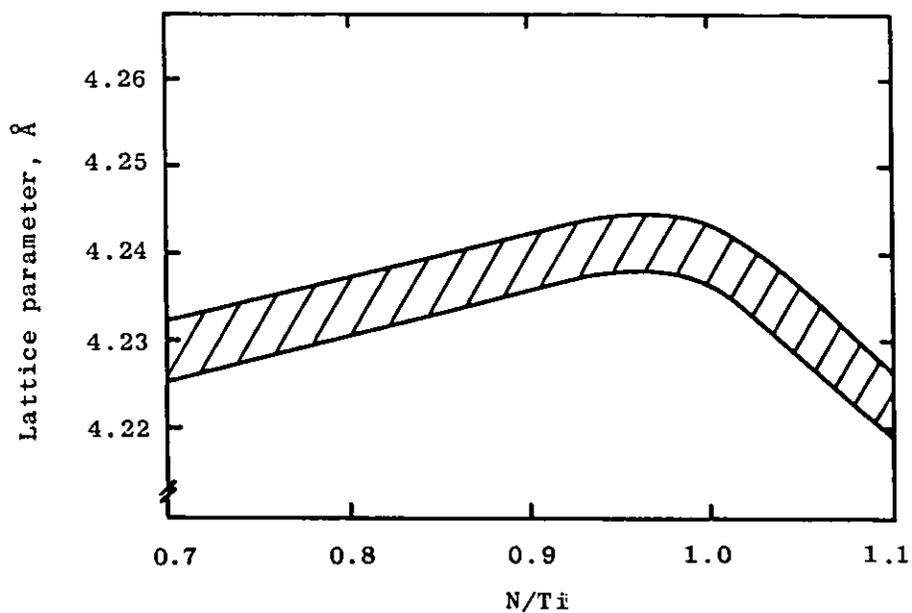
Figure 2.1 Lattice parameter of TiN as a function of nitrogen content (58).

Kieffer<sup>(65)</sup>, and those obtained by other workers<sup>(43,62)</sup>. Schwarzkopf and Kieffer also presented graphical data showing the lattice parameter of TiN as a function of nitrogen content, and that of Ti(C,N) as a function of mole % TiN and TiC concentration. These two sets of data have also been presented by Sundgren et al<sup>(58)</sup> and, in the case of the latter, corroborated by the results of other investigations<sup>(48,62)</sup>. The versions presented by Sundgren et al are shown in Figures 2.1 and 2.2.

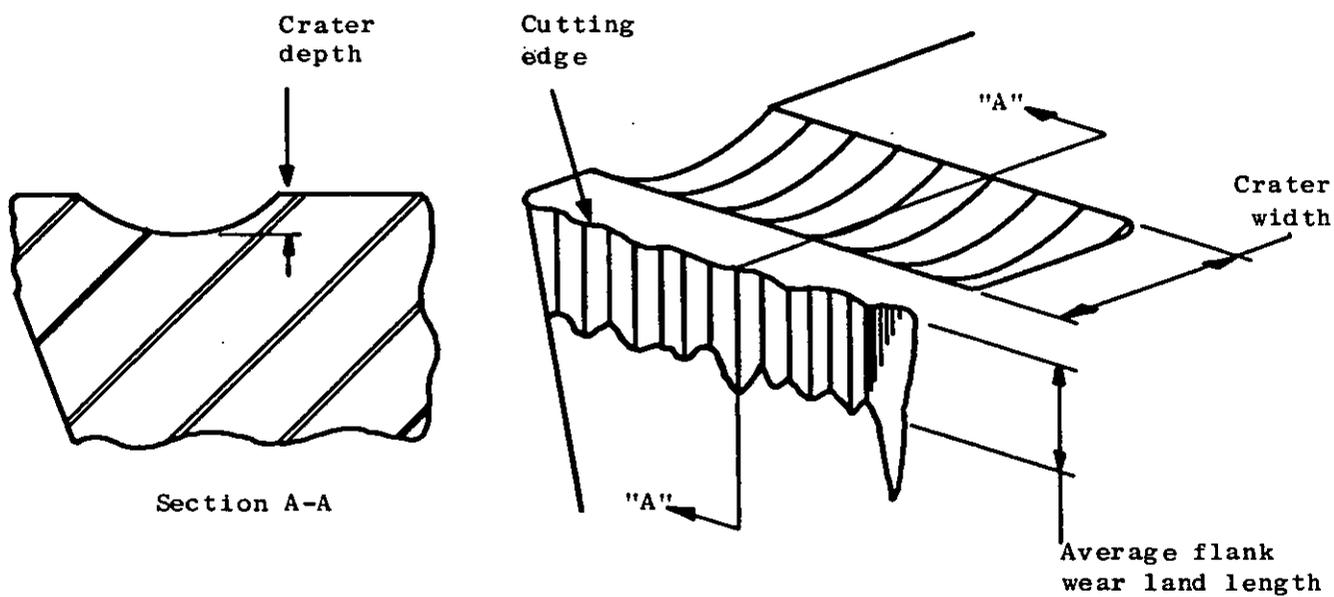
Figure 3.6 Wear regions on a turning tool.

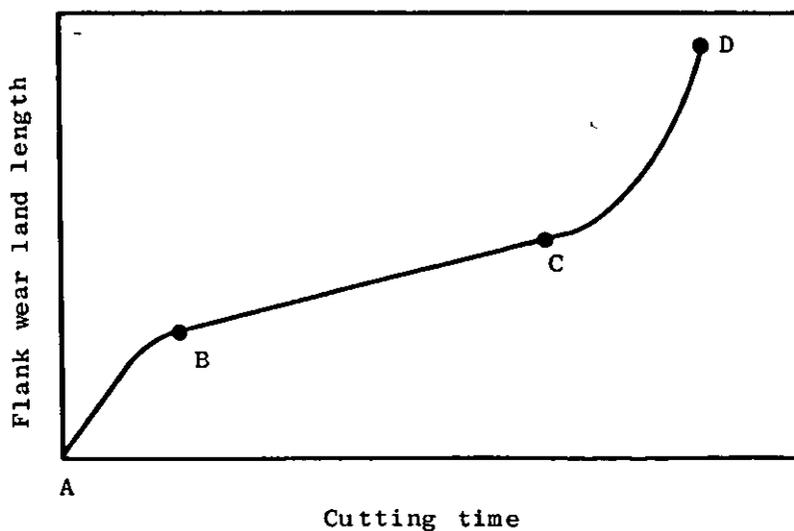
Figure 3.7 Flank wear land length versus cutting time (147).

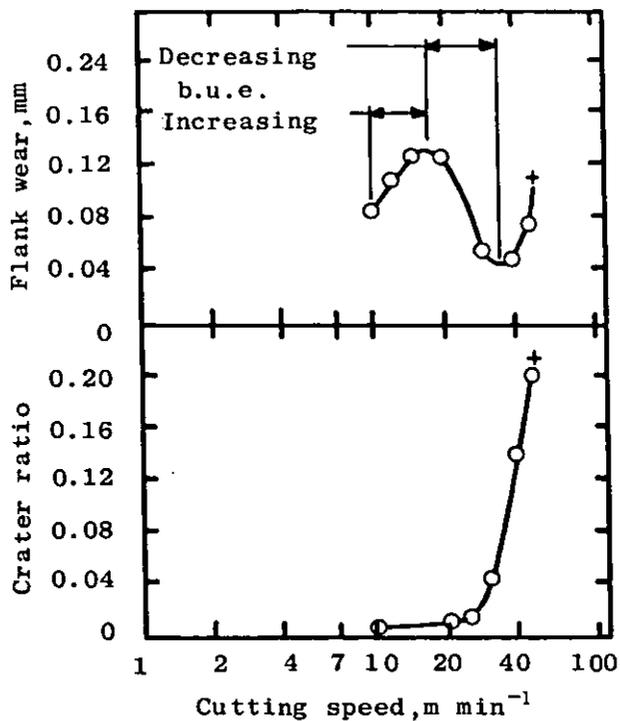
**Figure 3.8** Effect of cutting speed on flank and crater wear of H.S.S. tools <sup>(141)</sup>.

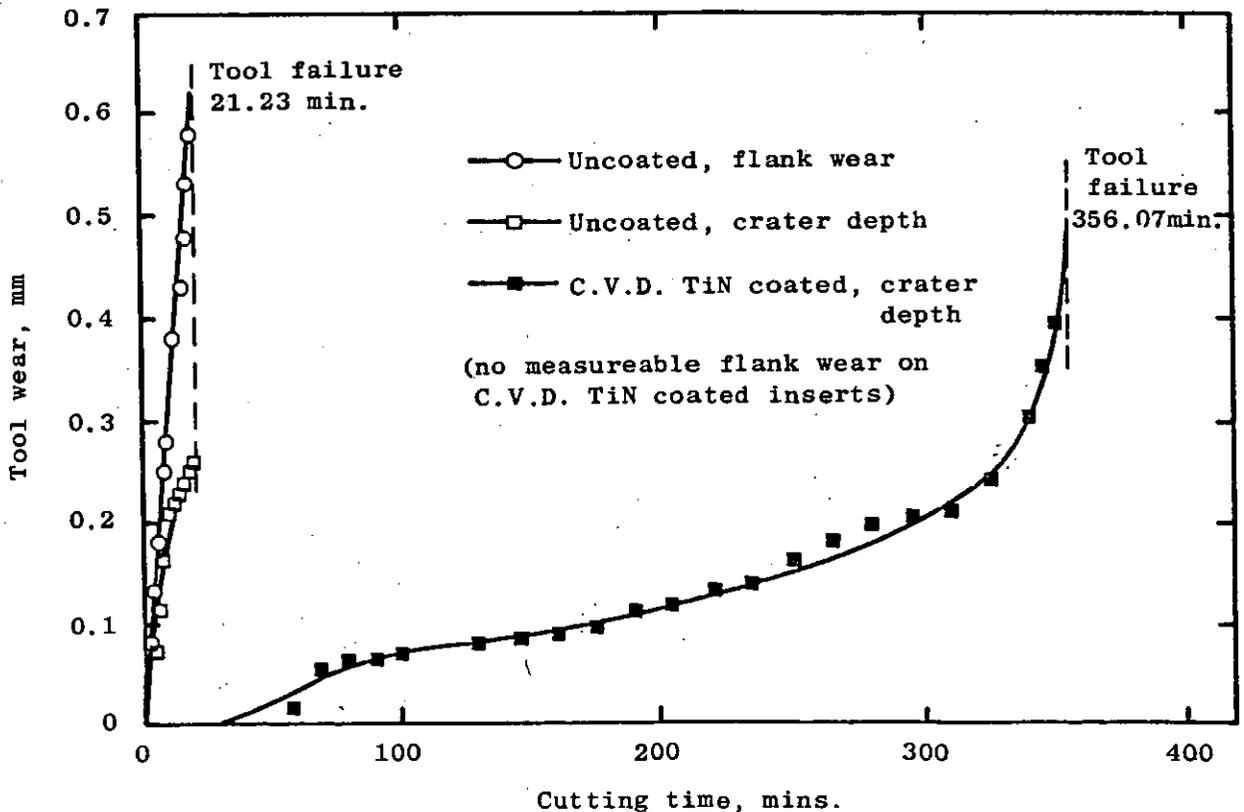
**Figure 3.15** Increase in average flank wear land length and maximum crater depth with cutting time for uncoated and C.V.D. TiN coated BT6 grade H.S.S. inserts at cutting speed of  $45\text{m min}^{-1}$  (22, 24, 25).

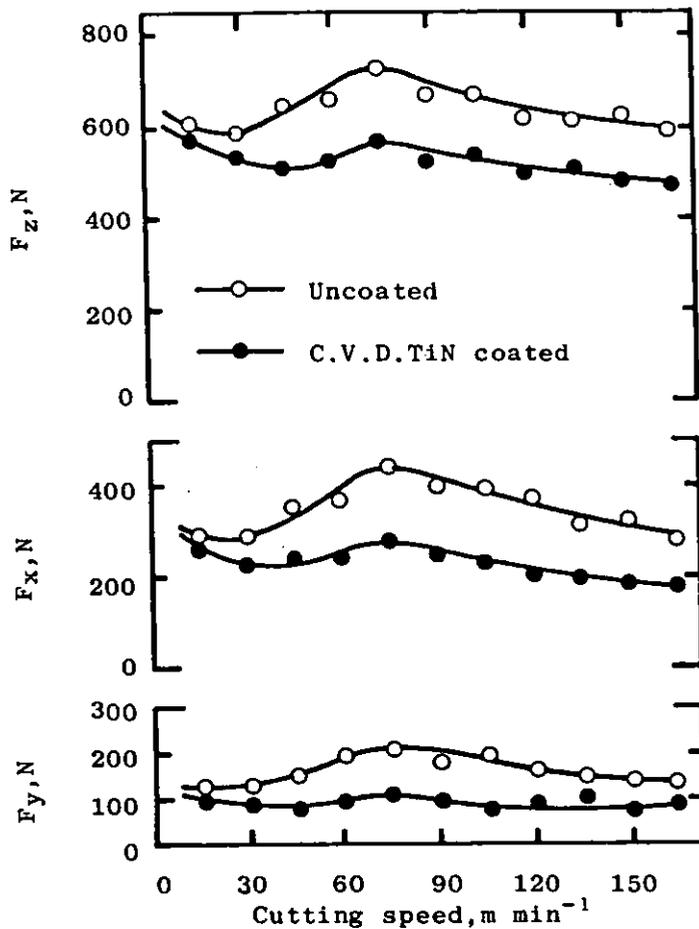
**Figure 3.16** Variation of tool forces with cutting speed for uncoated and C.V.D. TiN coated BT42 grade H.S.S. inserts. (151).

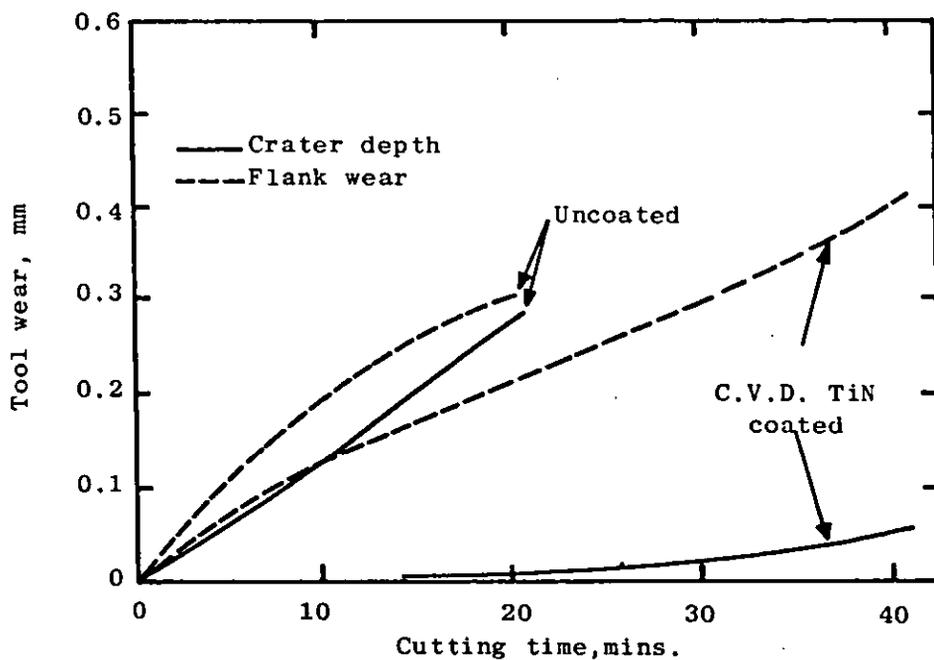
**Figure 3.23** Increase in flank wear land length and crater depth with cutting time for uncoated and C.V.D. TiN coated cemented carbide tools at cutting speed of  $123 \text{ m min}^{-1}$  (199).

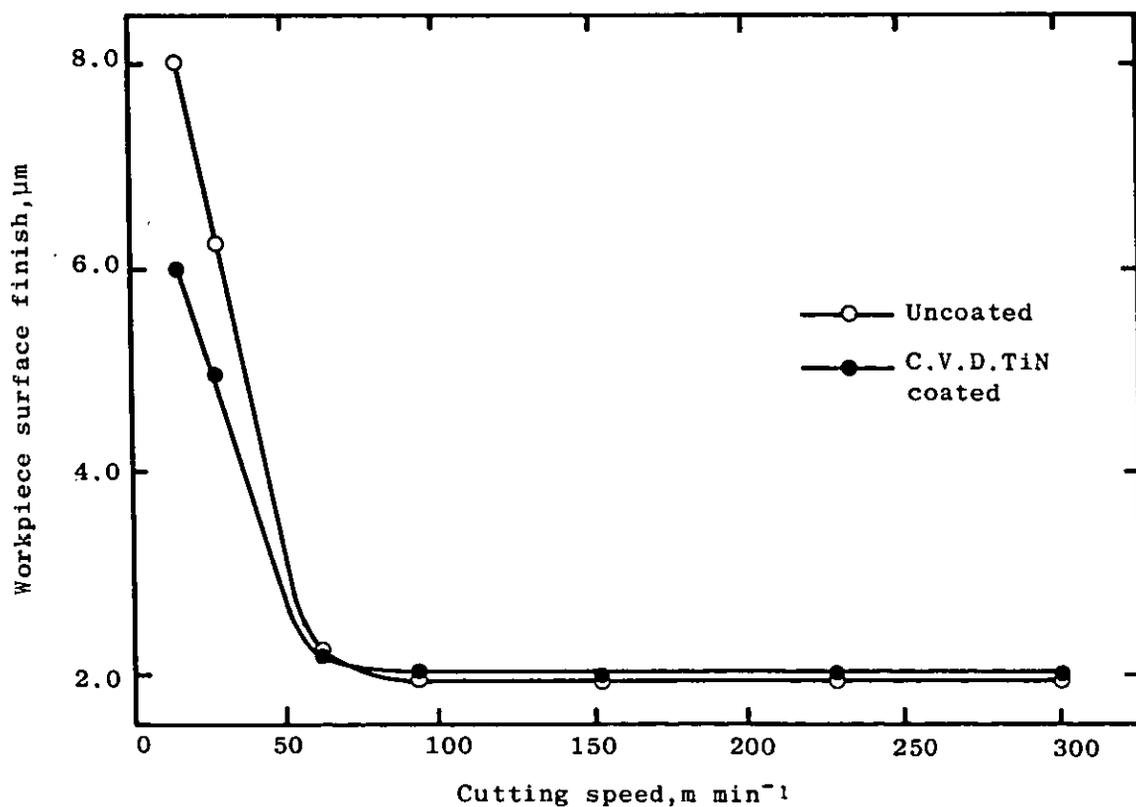
**Figure 3.24** Variation of workpiece surface finish with cutting speed for uncoated and C.V.D. TiN coated cemented carbide tools (172).

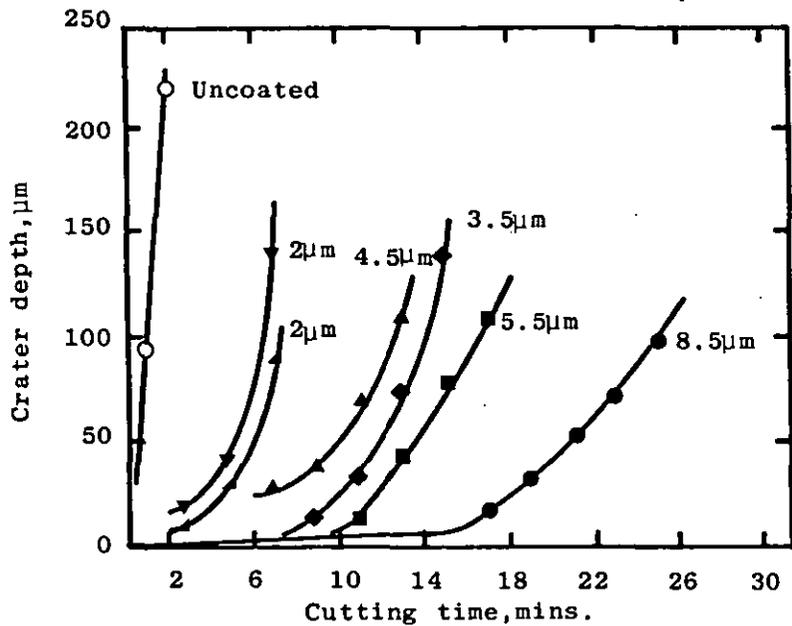
**Figure 3.28** Effect of coating thickness on increase in crater depth of C.V.D.  $\text{Al}_2\text{O}_3$  coated cemented carbide tools with cutting time at cutting speed of  $280 \text{ m min}^{-1}$  (204,205).

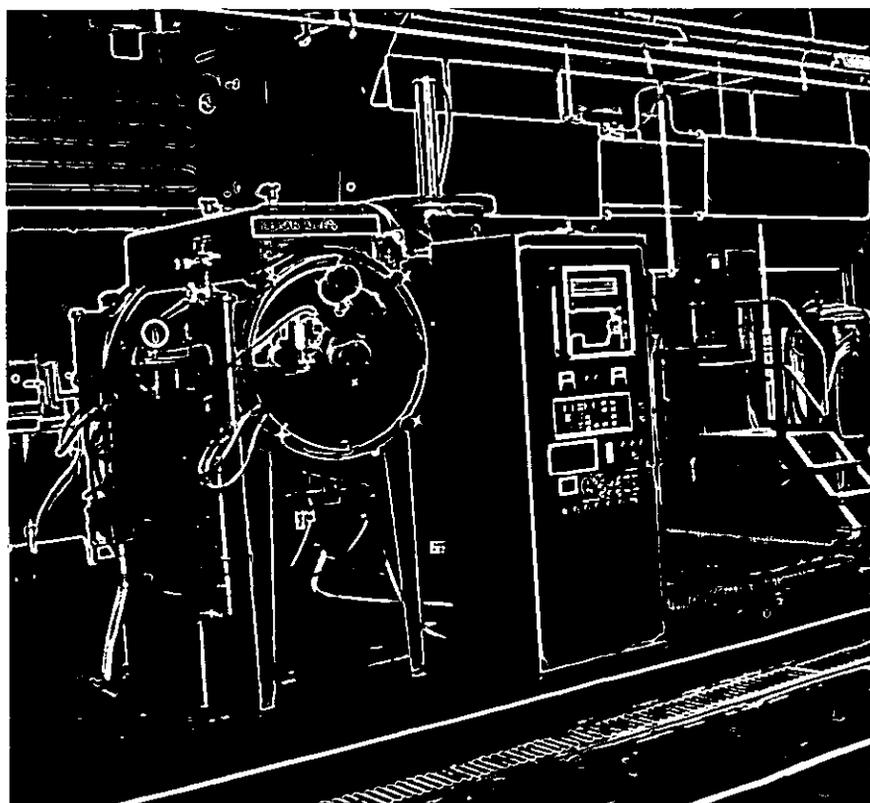
Figure 4.2 Vacuum sintering furnace at Edgar Allen Tools.

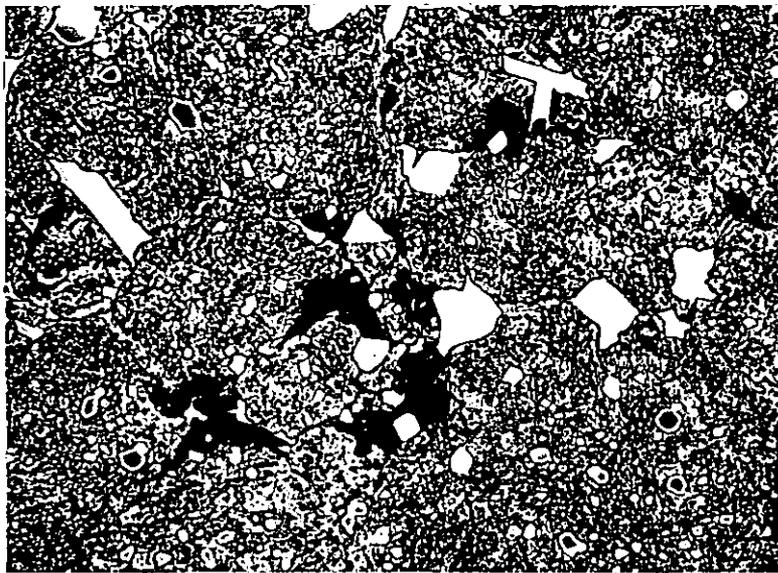
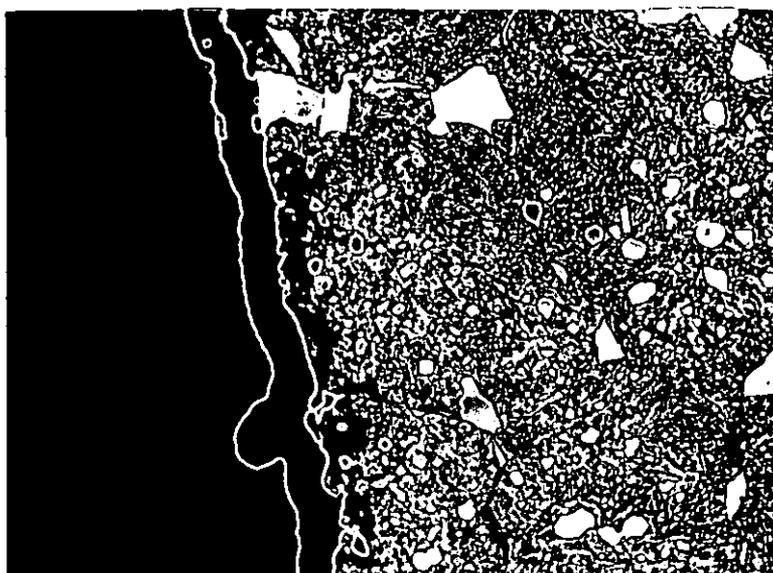
**Figure 4.14** Section through as-coated inserts. Etchant 2% nital, x 1000.  
(a) Bulk substrate microstructure, (b) Rake surface, (c) Flank surface.

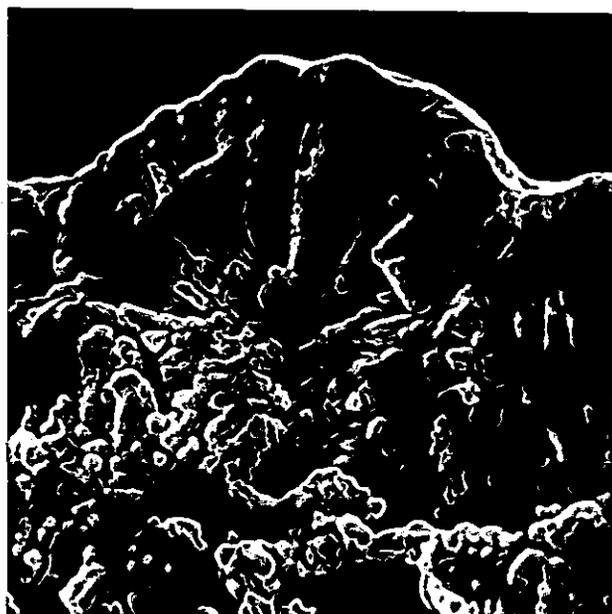
Figure 4.18 Fracture surface of C.V.D. TiN coating on an as-coated insert showing coating structure associated with surface protrusion. S.E.M. x 7000.

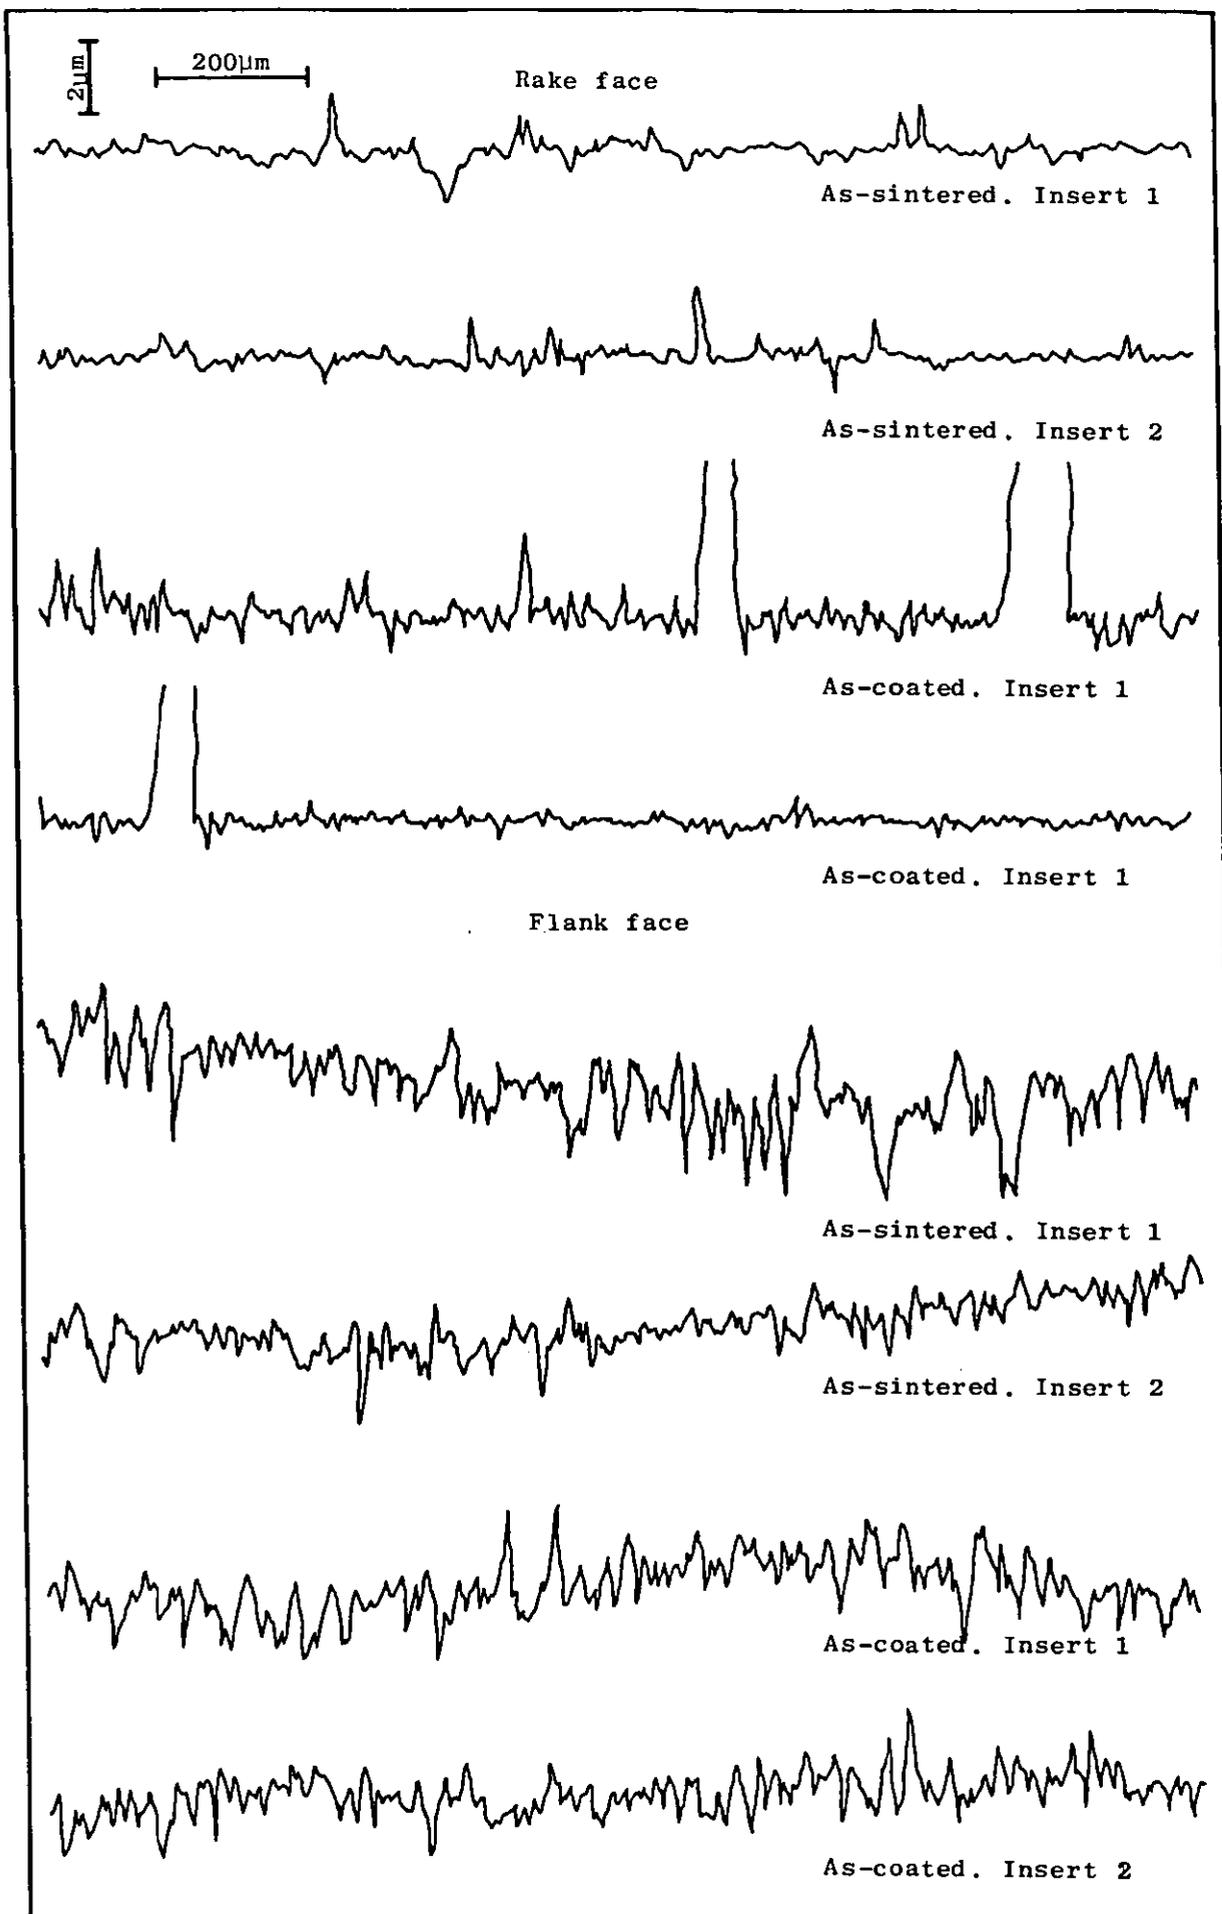
**Figure 4.19** Typical rake and flank face Talysurf traces for two as-sintered and two as-coated inserts.

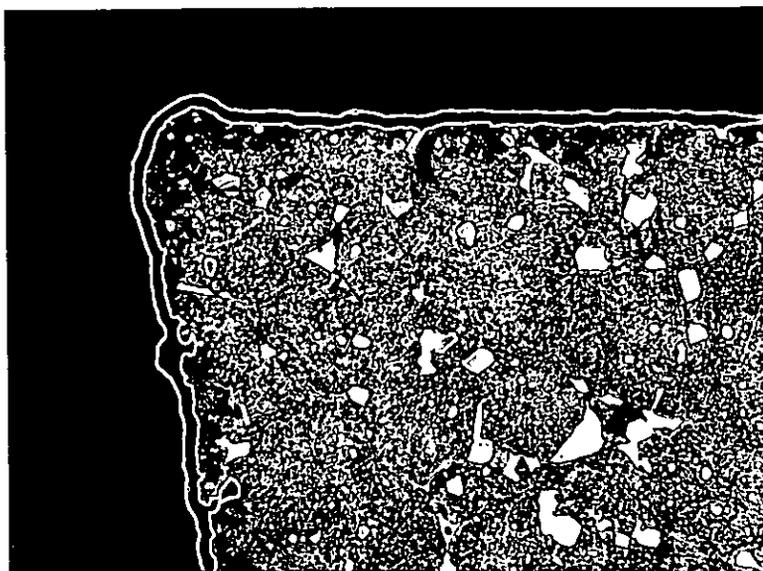
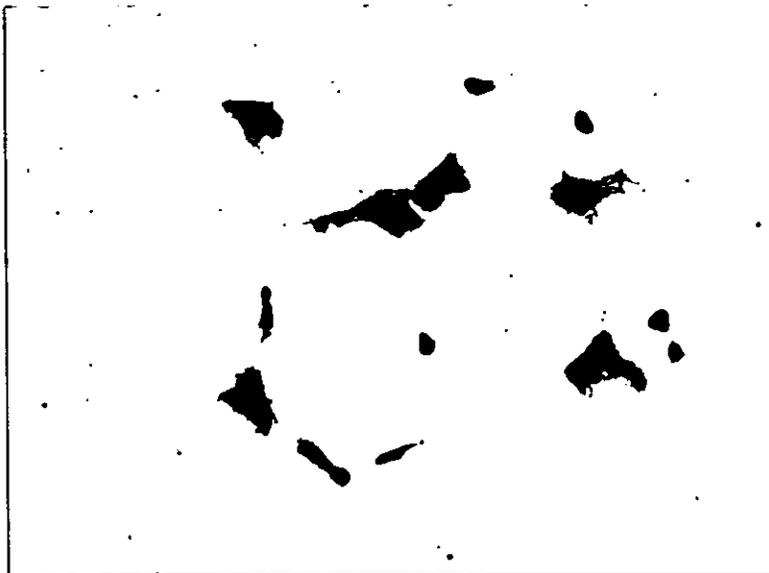
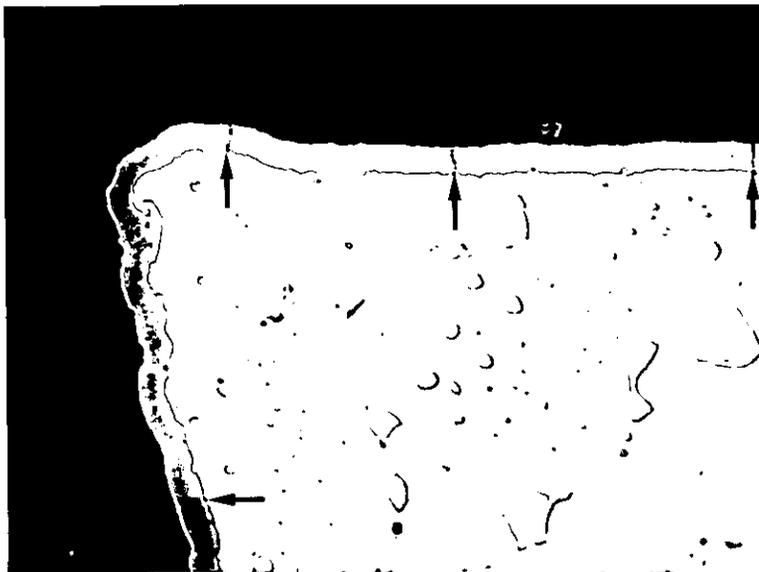
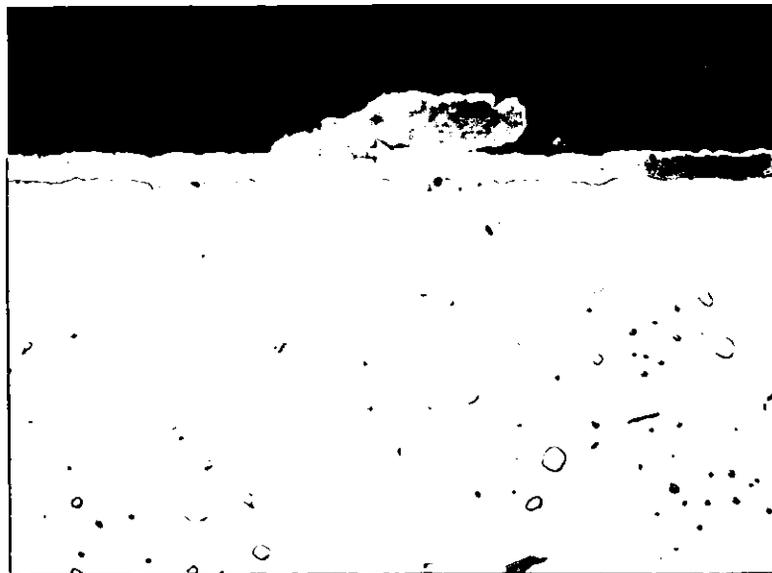
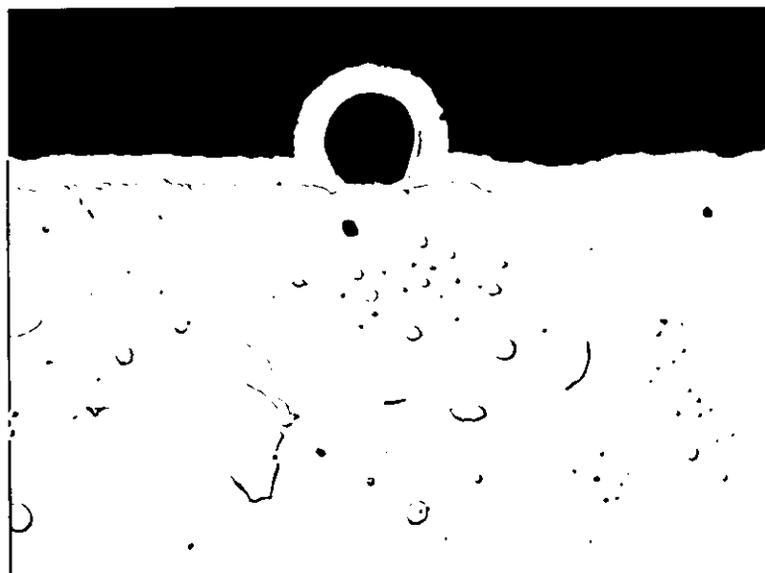
**Figure 4.26** Section through (a)As-sintered, (b)As-coated and (c)-(g) Heat treated, coated inserts showing substrate and coating defects. (a)and(b)Etchant 2% nital,x 400.(c)-(g) Unetched,x 750. (a) and (b) Raised cutting edge.

**Figure 4.26** Section through (a)As-sintered, (b)As-coated and (c)-(g) Heat treated, coated inserts showing substrate and coating defects. (a) and (b) Etchant 2% nital, x 400. (c)-(g) Unetched, x 750. (c) Porosity in P.M. H.S.S. substrate, (d) Cracks in coating.

**Figure 4.26** Section through (a)As-sintered, (b)As-coated and (c)-(g) Heat treated, coated inserts showing substrate and coating defects. (a)and(b) Etchant 2% nital, x 400. (c)-(g) Unetched, x 750. (e)Coating surface aggregation, (f)Coating surface protrusion, (g) Coated particle on substrate surface.

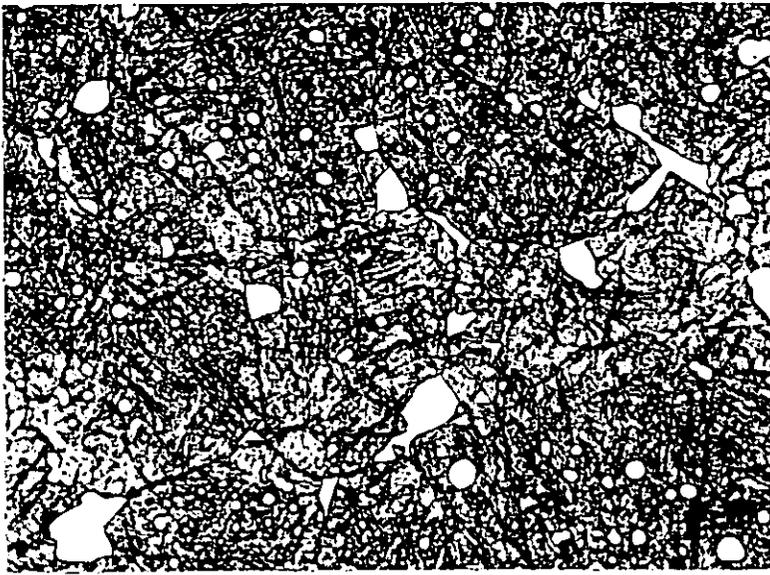
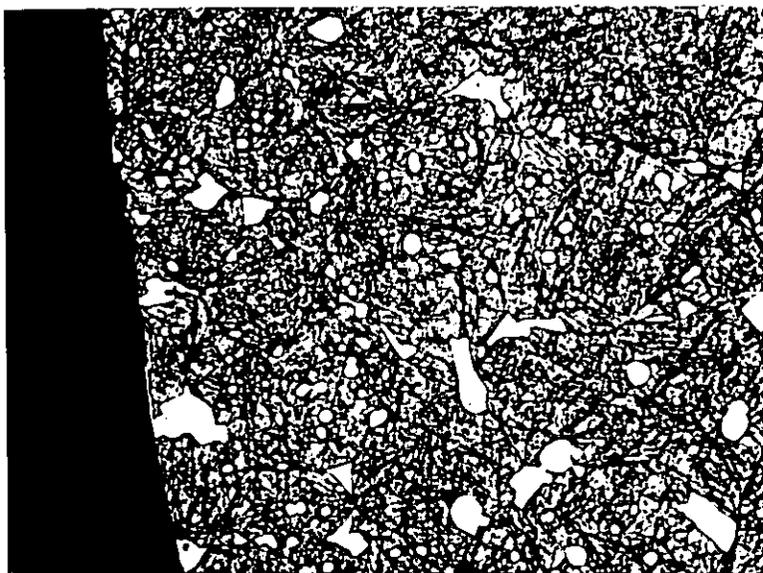
**Figure 4.27** Section through heat treated, uncoated insert. Etchant 5% nital, x 1000. (a) Bulk substrate microstructure, (b) Rake surface, (c) Flank surface.

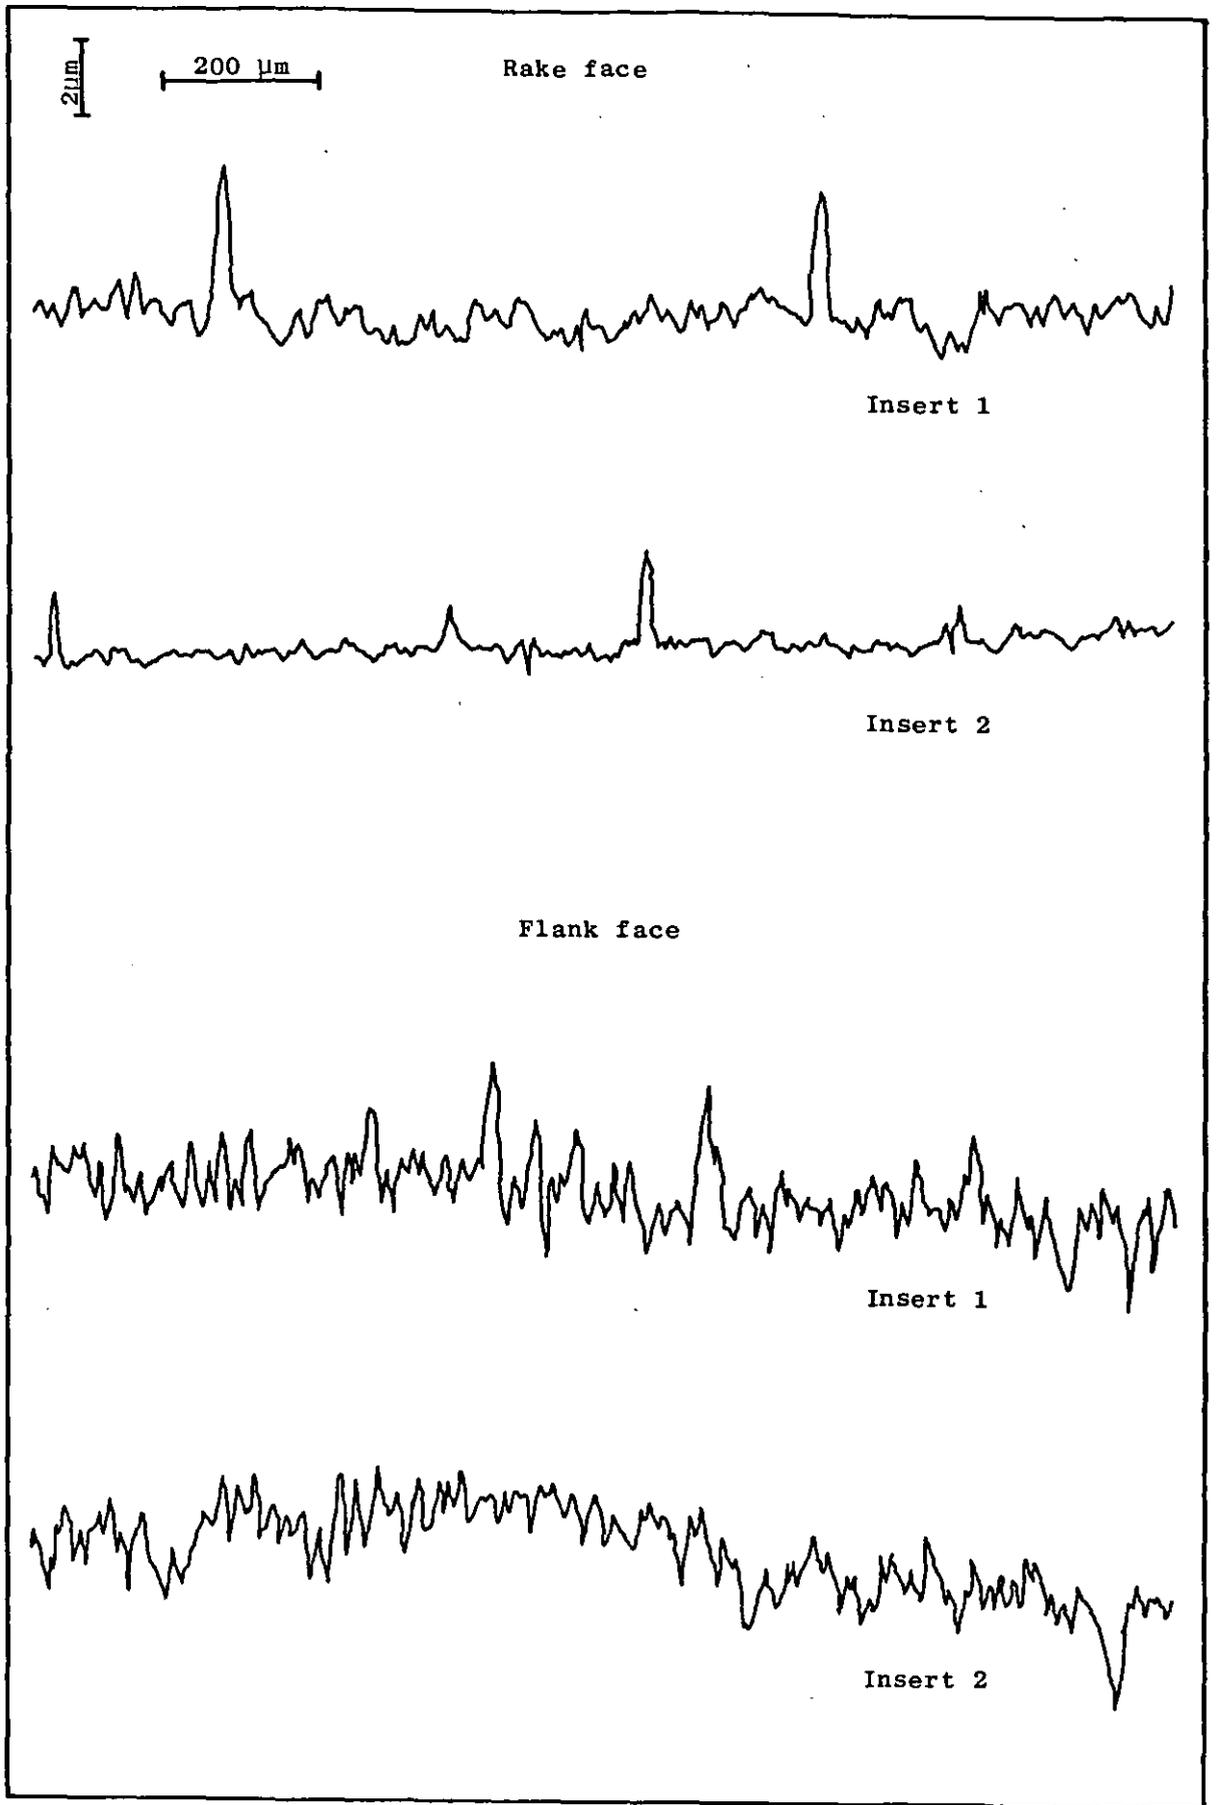
Figure 4.31 Typical rake and flank face Talysurf traces for two heat treated, coated inserts.

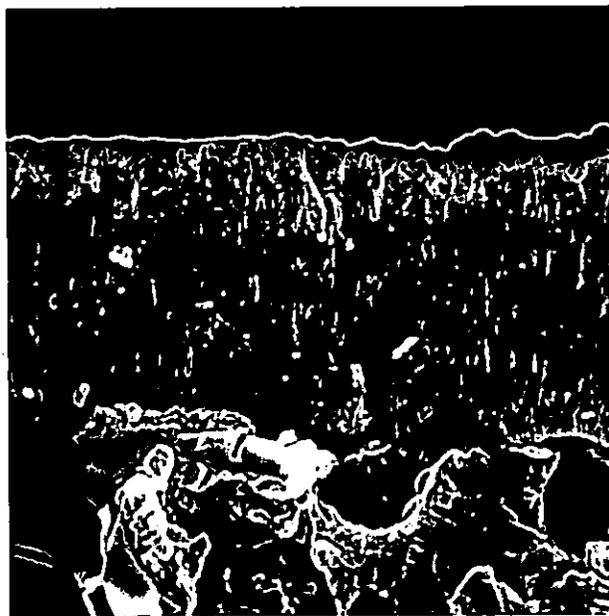
**Figure 4.51** Fracture surface of TiN coating on a sputter ion plated insert showing typical coating structure. S.E.M., (a) x 2600, (b) x 7000.

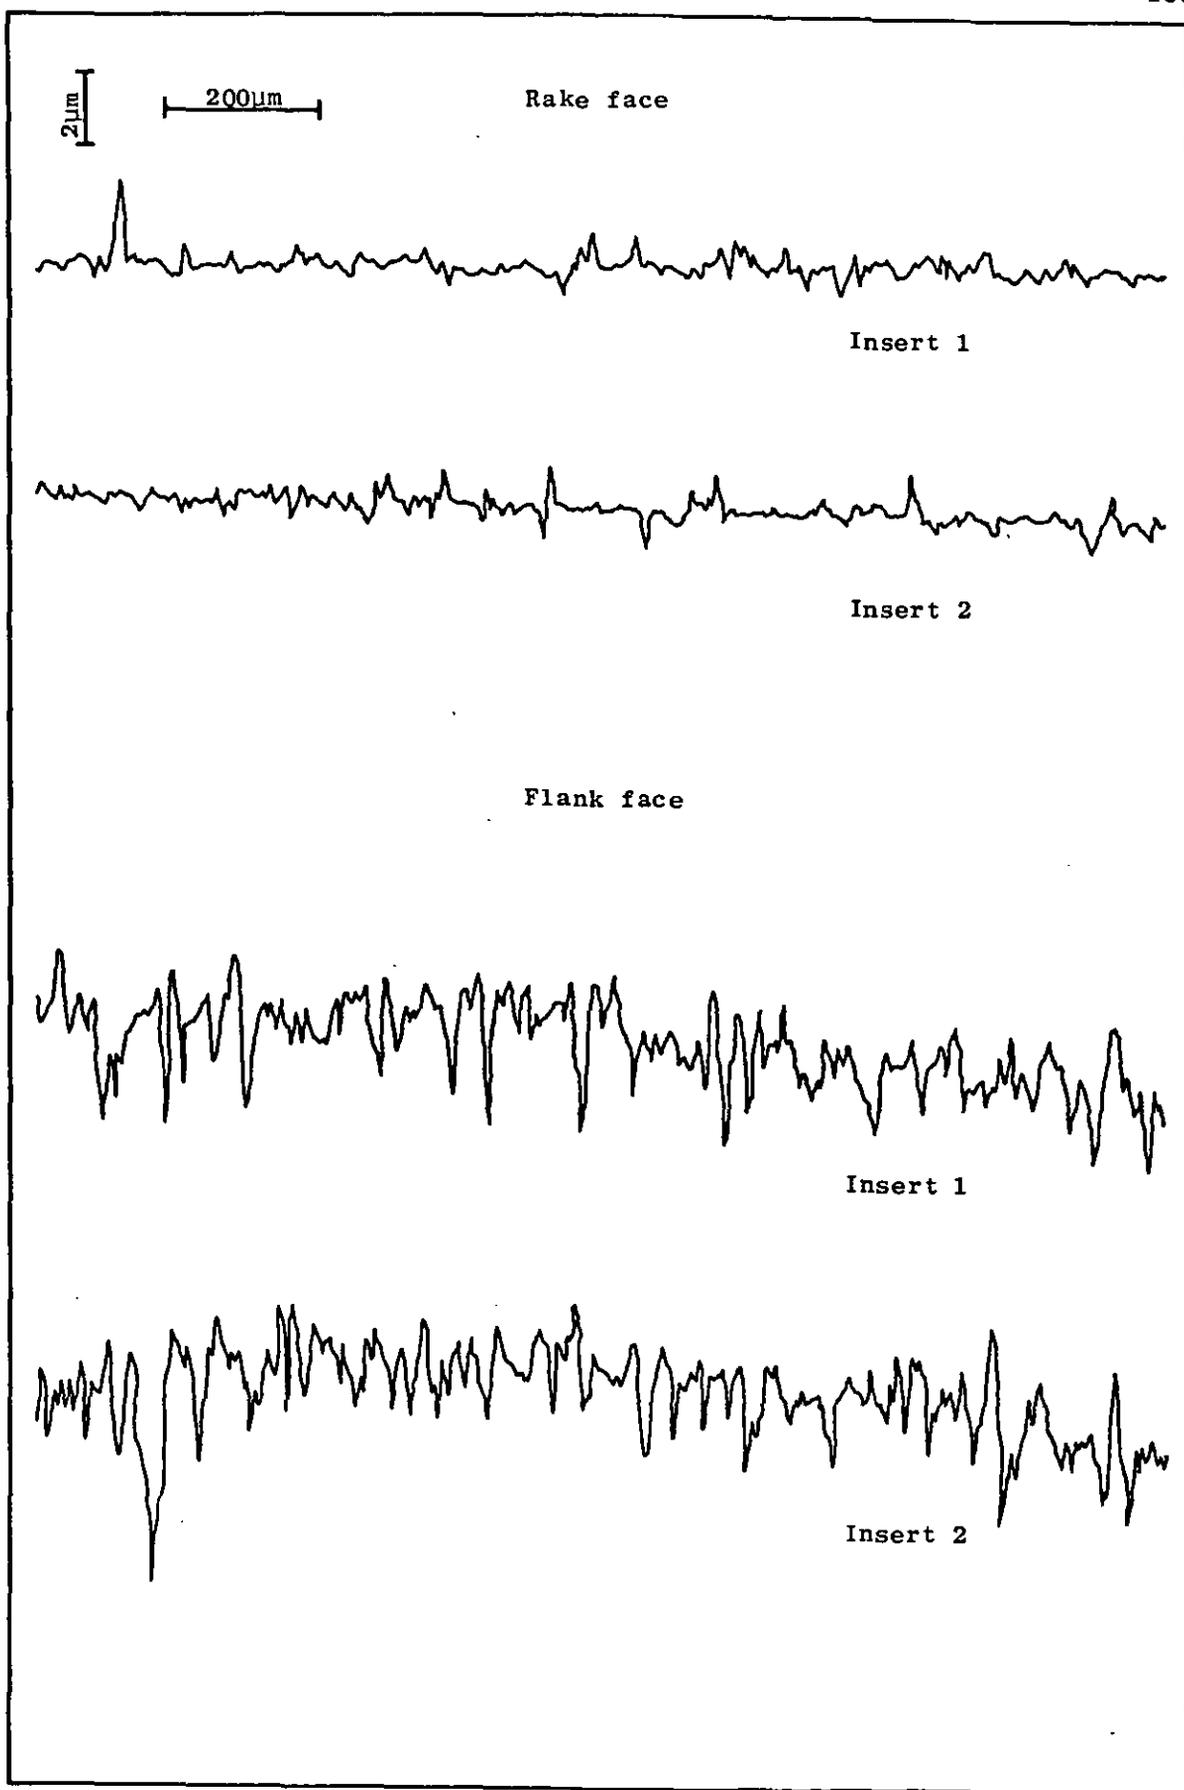
Figure 4.52 Typical rake and flank face Talysurf traces for two sputter ion plated inserts.

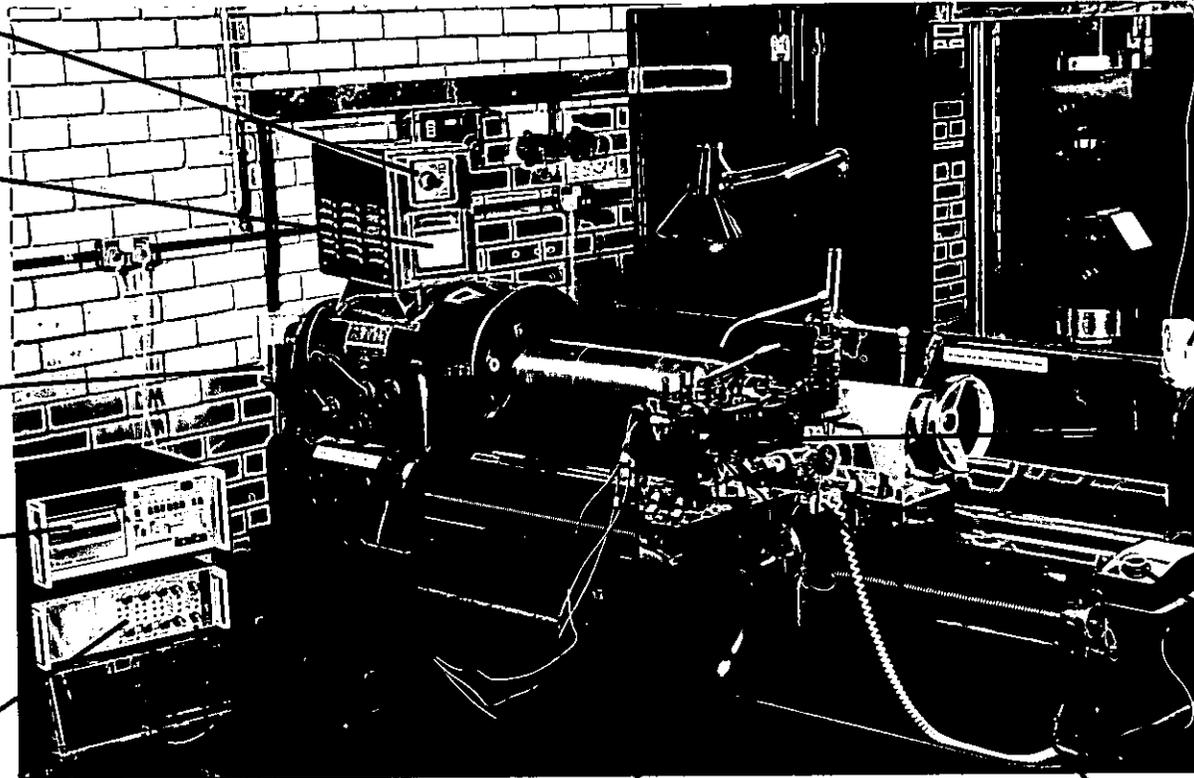
Figure 5.3 Lathe and associated equipment for use in cutting tests.

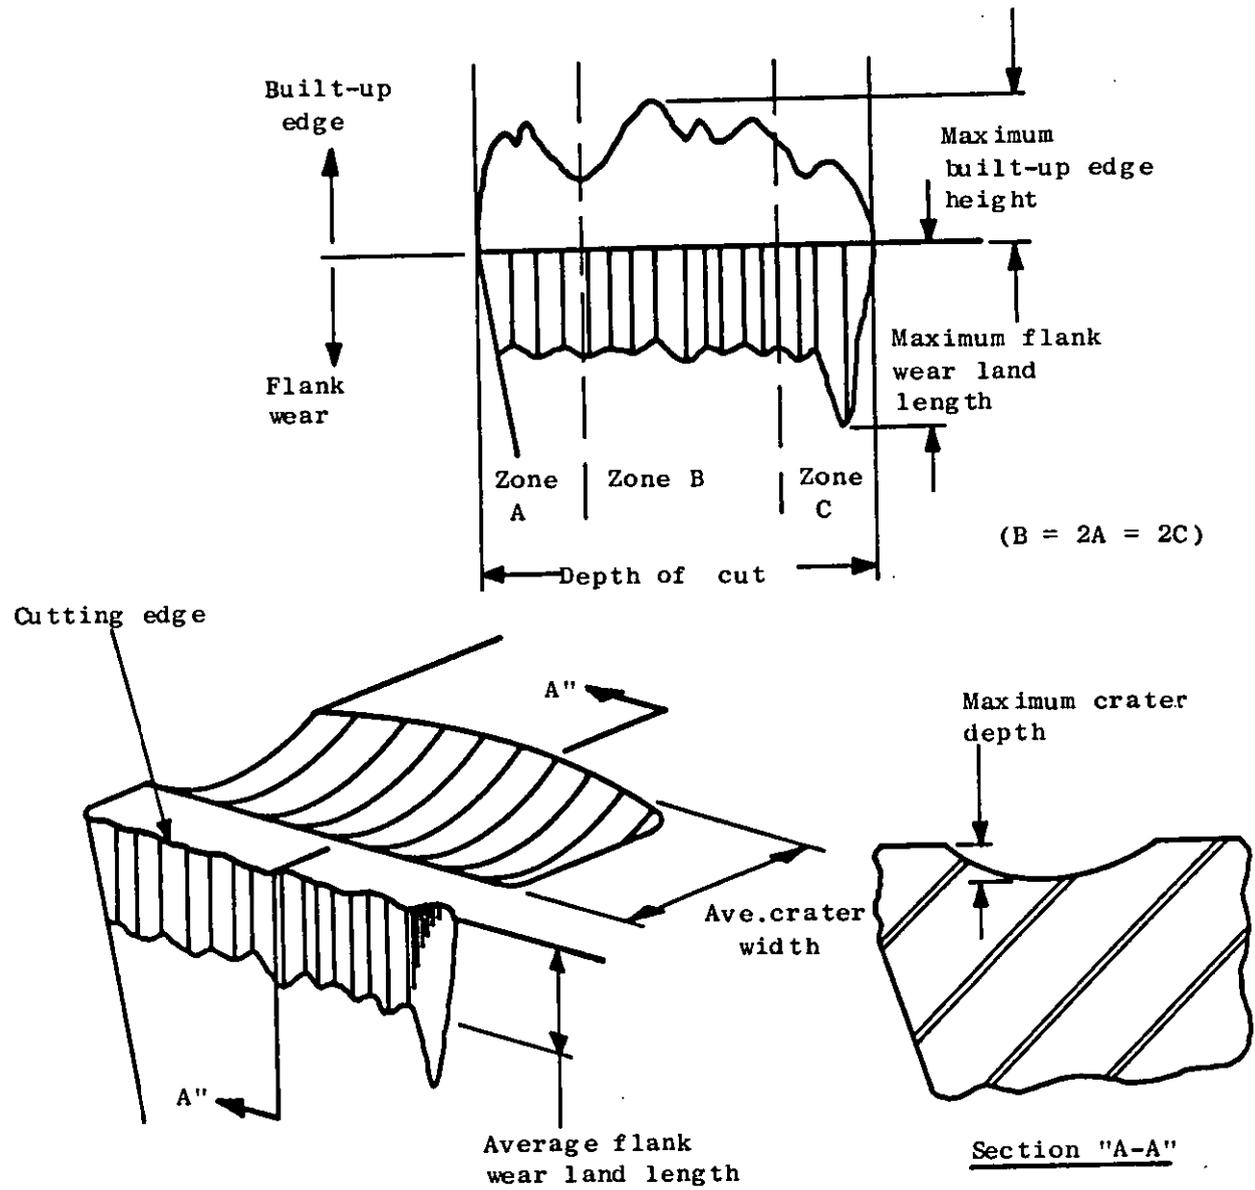
Figure 5.12 Definition of tool wear and  
 b.u.e. measurements.
