TITANIUM NITRIDE COATED HIGH SPEED  
STEEL CUTTING TOOL INSERTS

Neville Charles Whittle

A Doctoral Thesis submitted in partial fulfilment of the requirements for the award of Doctor of Philosophy of the Loughborough University of Technology. September 1987.

A detailed study has been made of commercially produced, powder metallurgy, BT42 grade high speed steel (H.S.S.) indexable cutting tool inserts coated with a thin layer of titanium nitride (TiN) by chemical vapour deposition (C.V.D.).

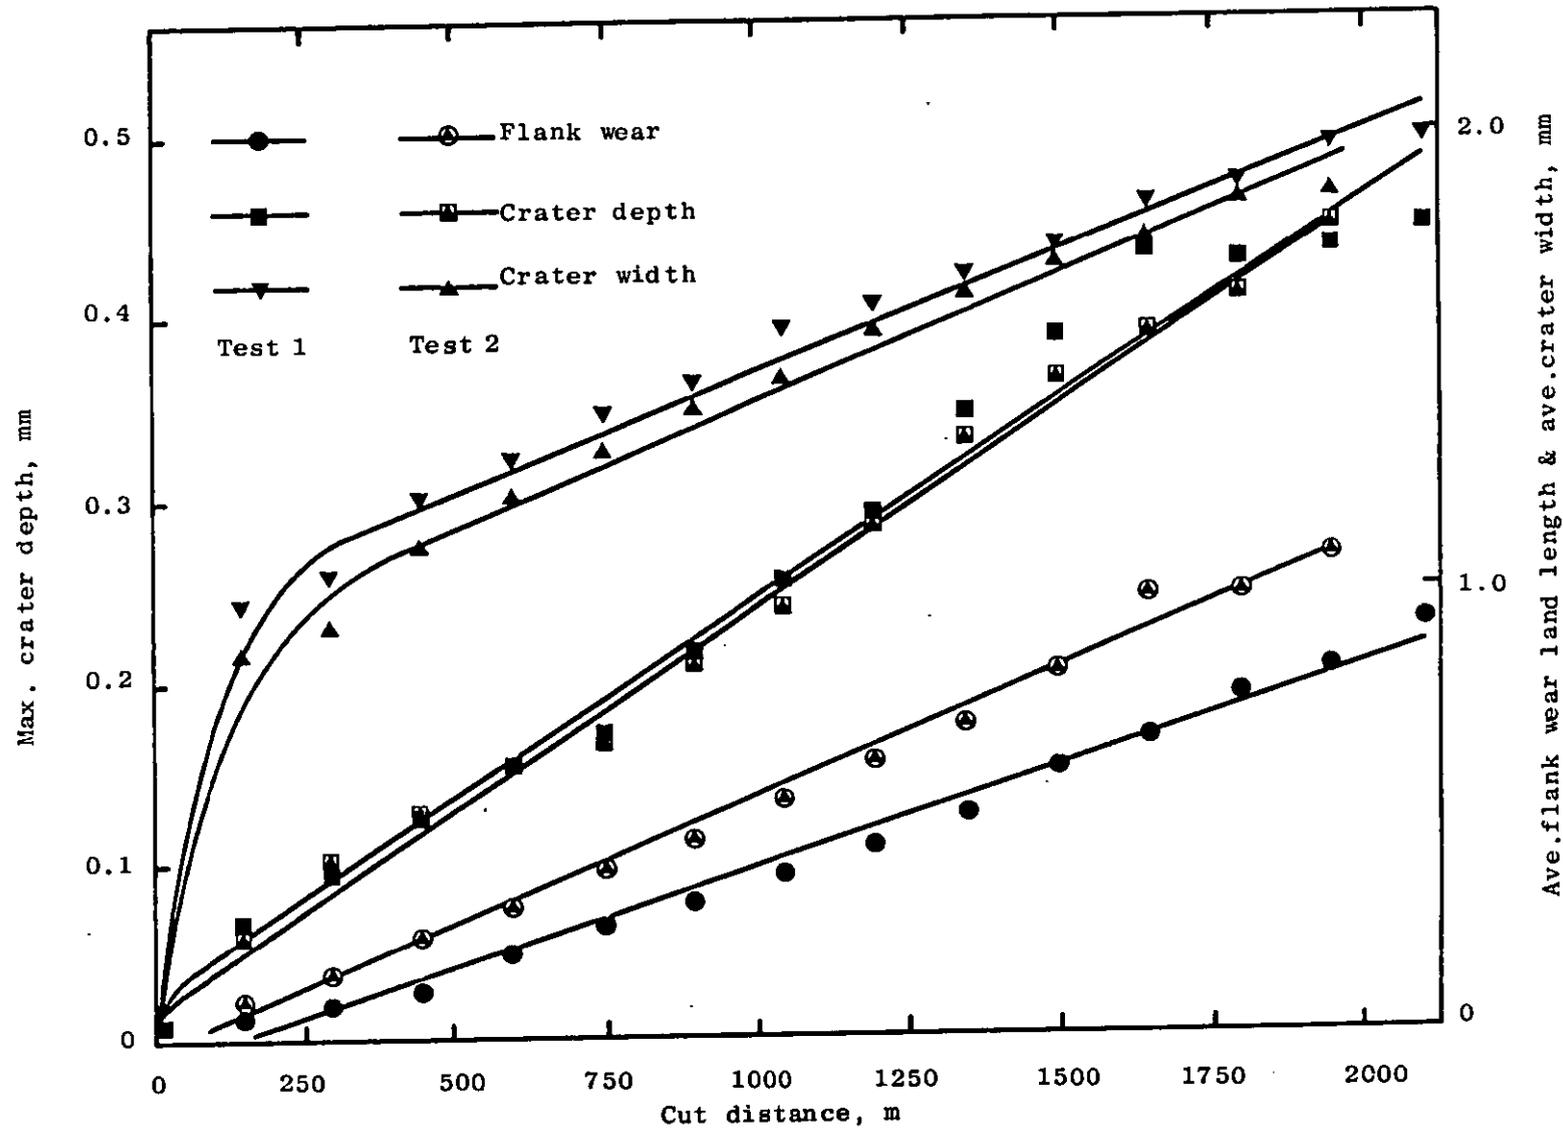
**Figure 5.13** Increase in average flank wear land length, maximum crater depth and average crater width of uncoated inserts with cut distance. Cutting speed  $30 \text{ m min}^{-1}$ .

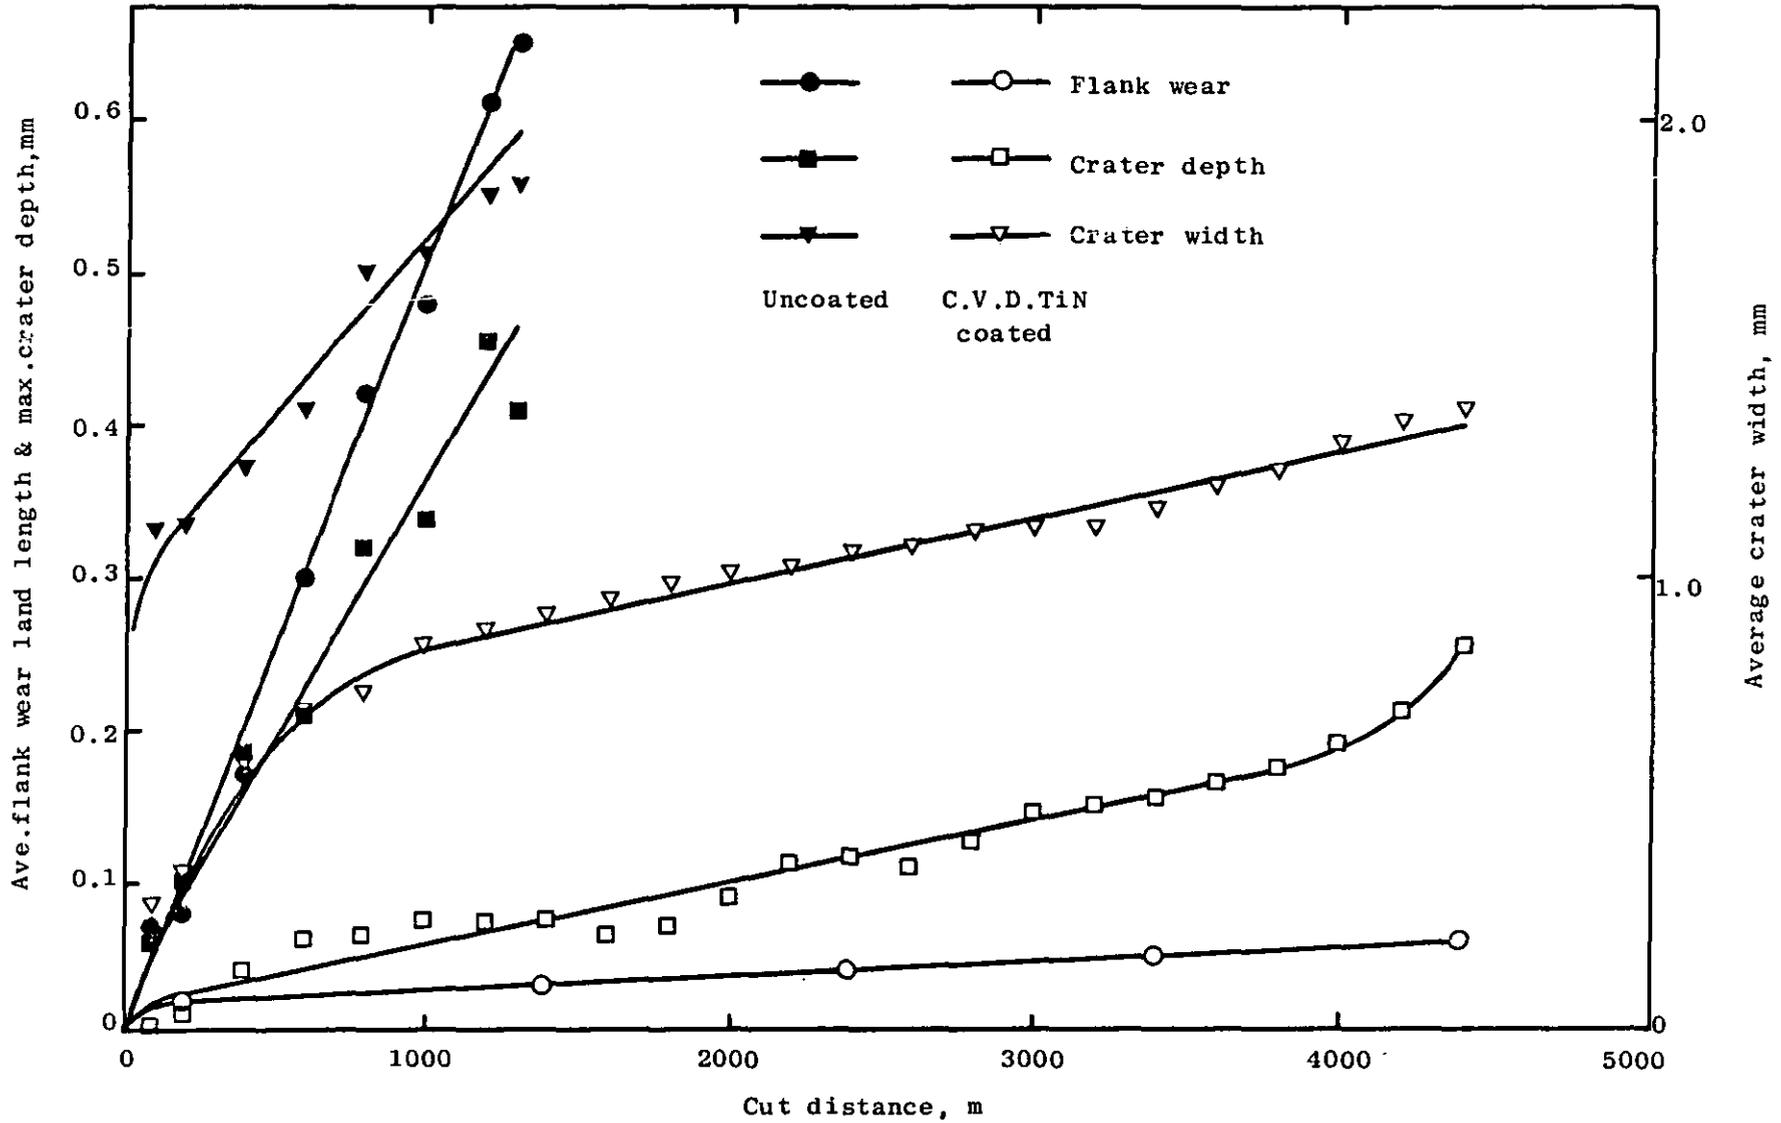
**Figure 5.14** Increase in average flank wear land length, maximum crater depth and average crater width of uncoated and C.V.D. TiN coated inserts with cut distance. Cutting speed  $37.5 \text{ m min}^{-1}$ . Test 1.

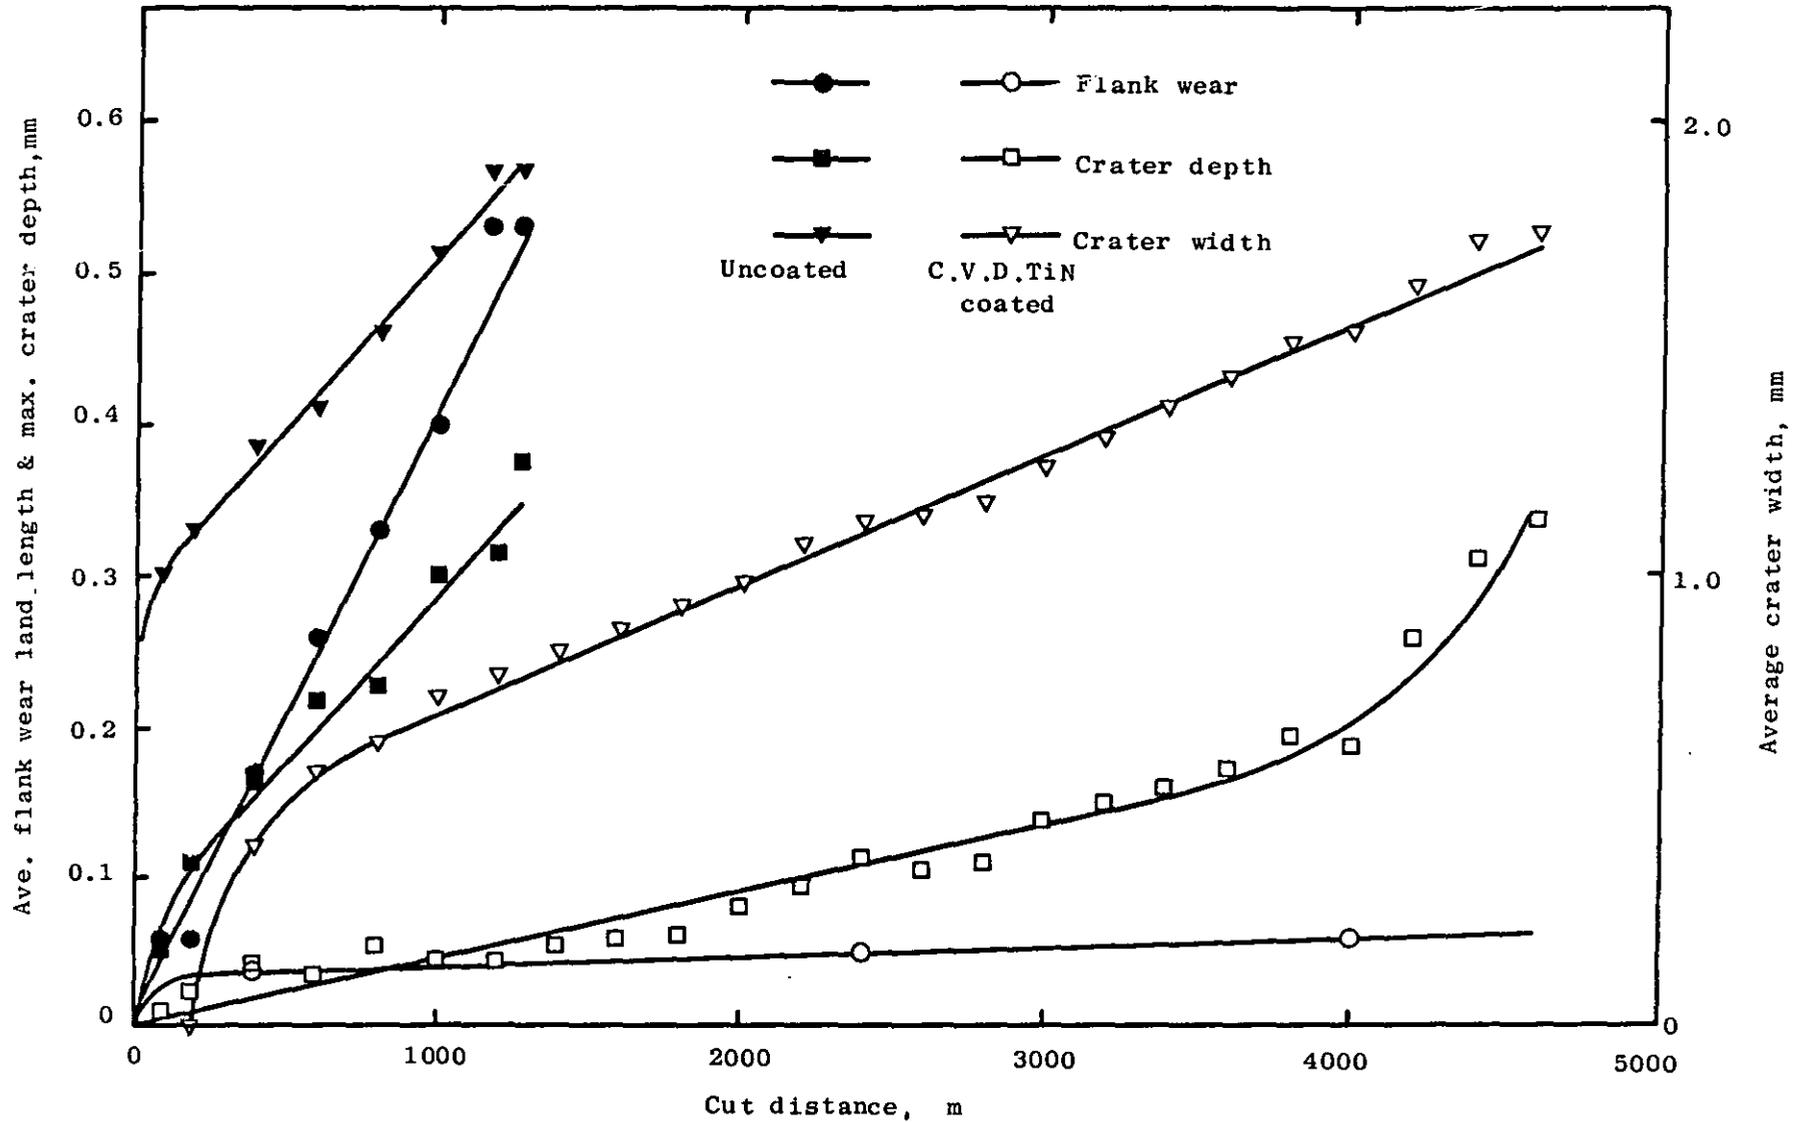
Figure 5.15 Increase in average flank wear land length, maximum crater depth and average crater width of uncoated and C.V.D.TiN coated inserts with cut distance. Cutting speed  $37.5 \text{ m min}^{-1}$ . Test 2.

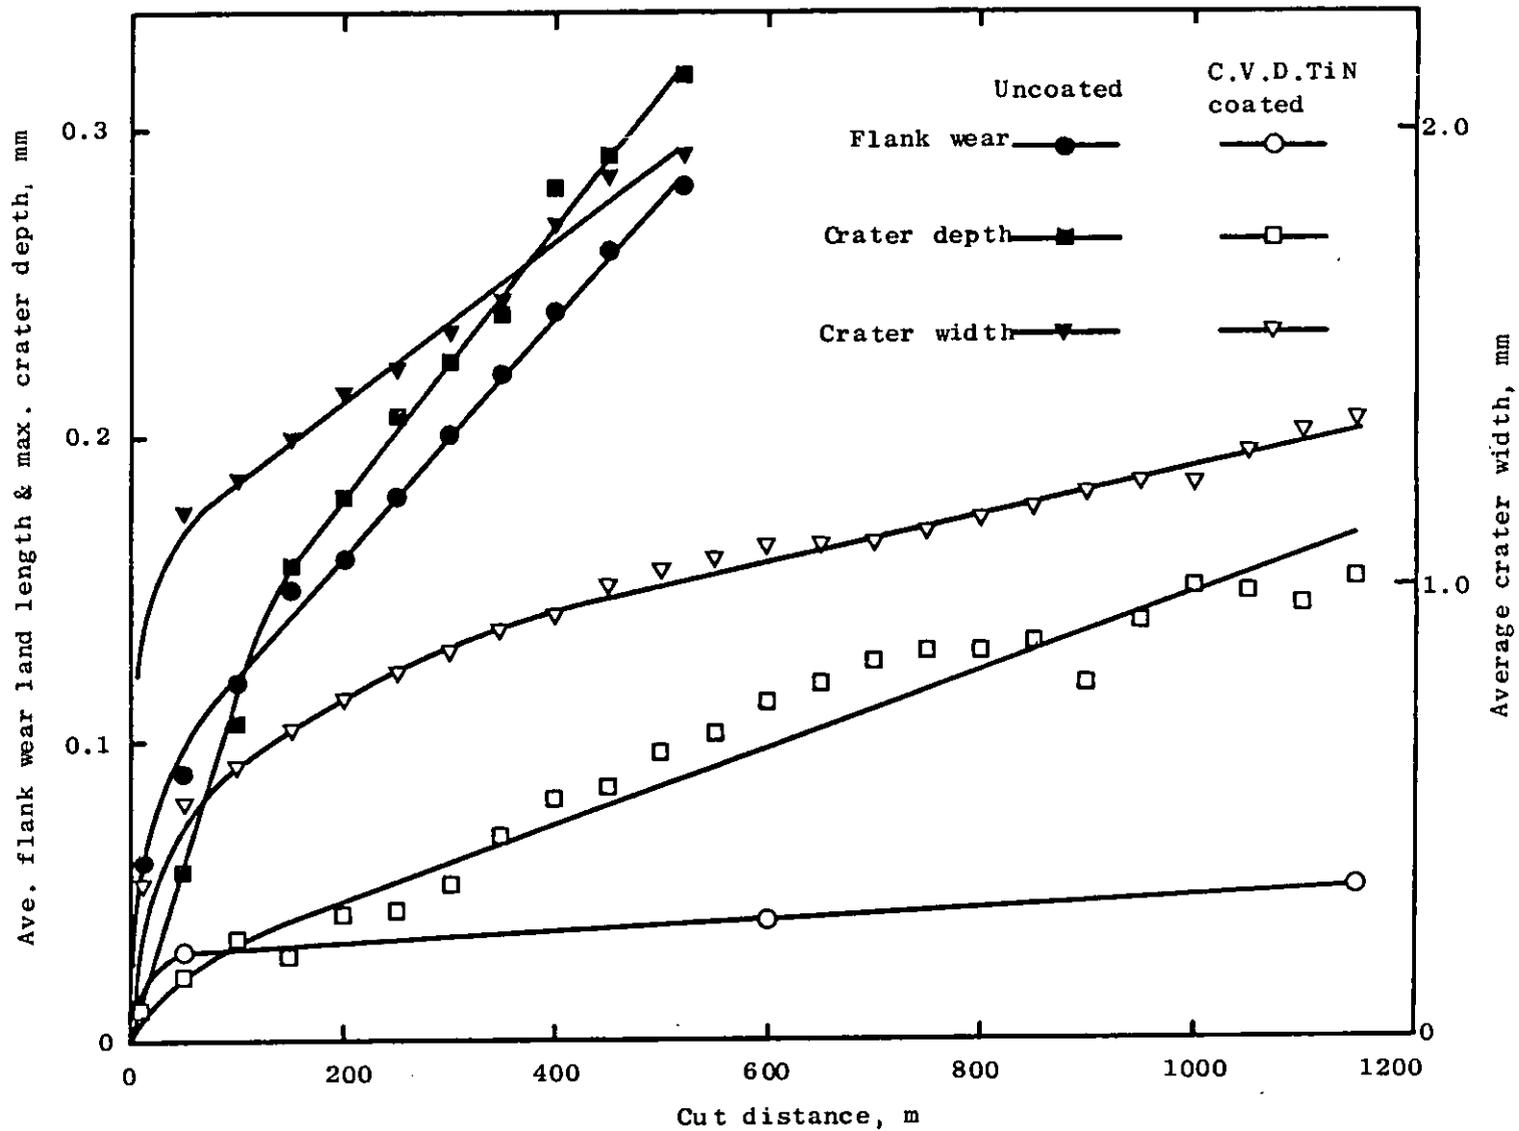
**Figure 5.16** Increase in average flank wear land length, maximum crater depth and average crater width of uncoated and C.V.D. TiN coated inserts with cut distance. Cutting speed  $45 \text{ m min}^{-1}$ . Test 1.

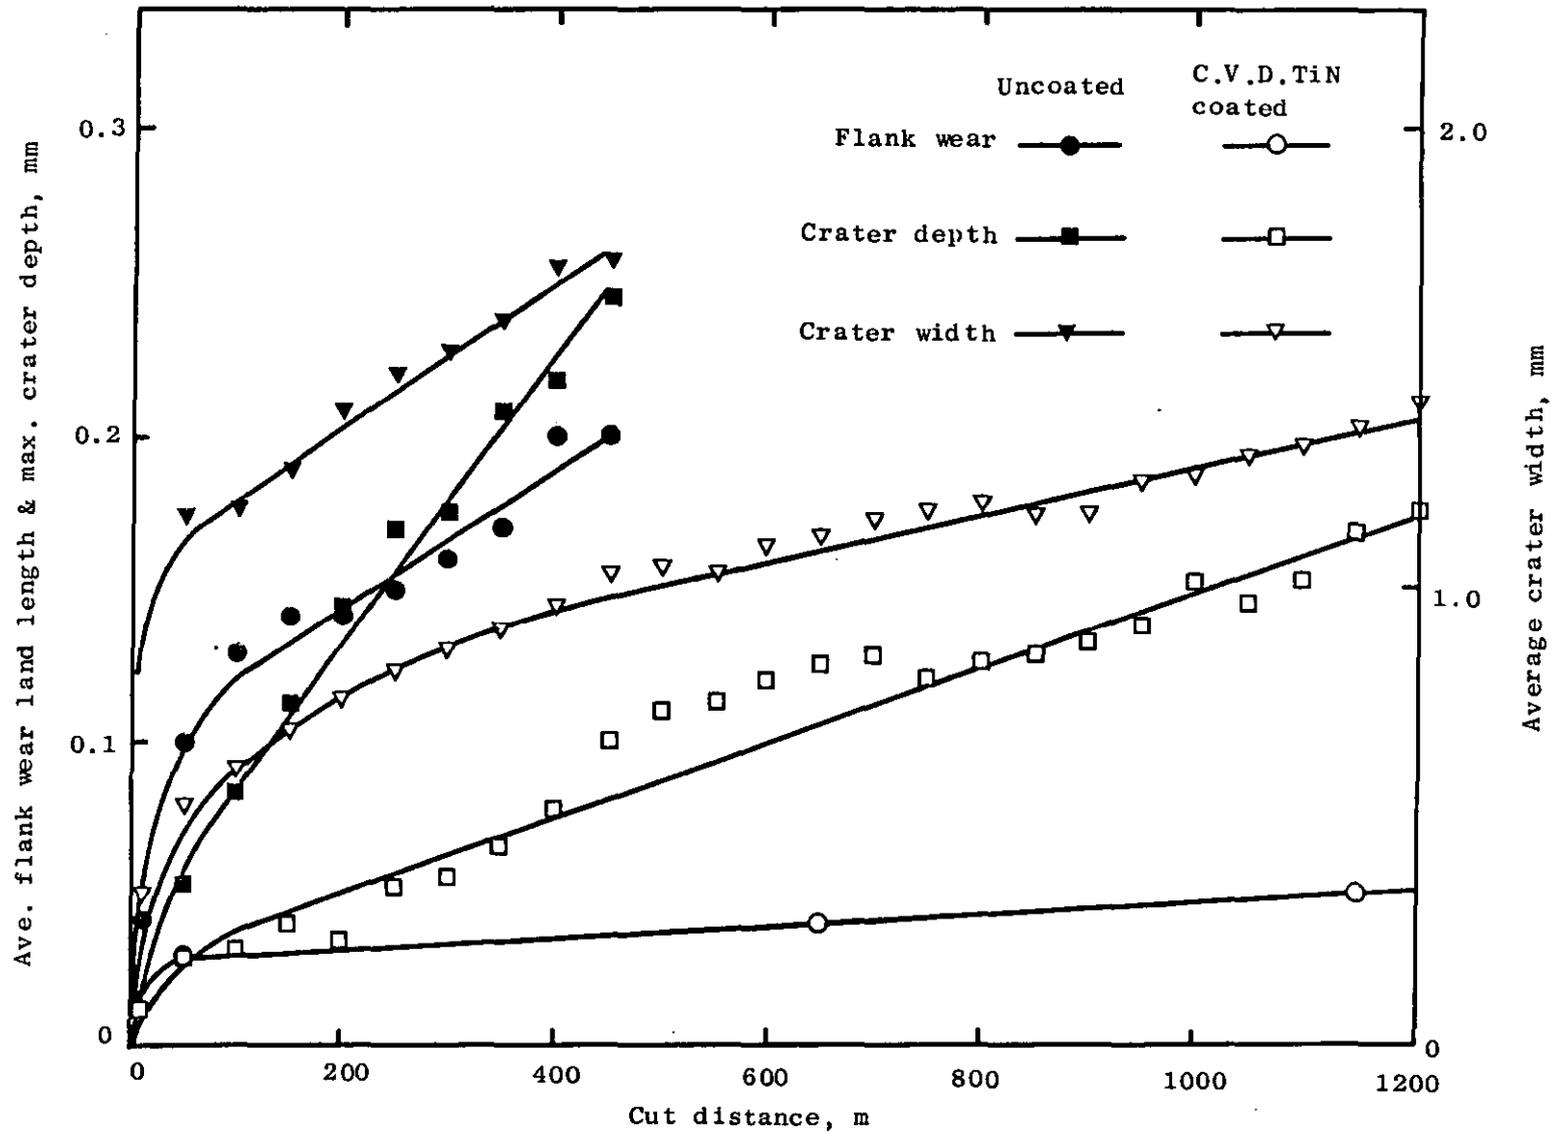
**Figure 5.17** Increase in average flank wear land length, maximum crater depth and average crater width of uncoated and C.V.D. TiN coated inserts with cut distance. Cutting speed  $45 \text{ m min}^{-1}$ . Test 2.

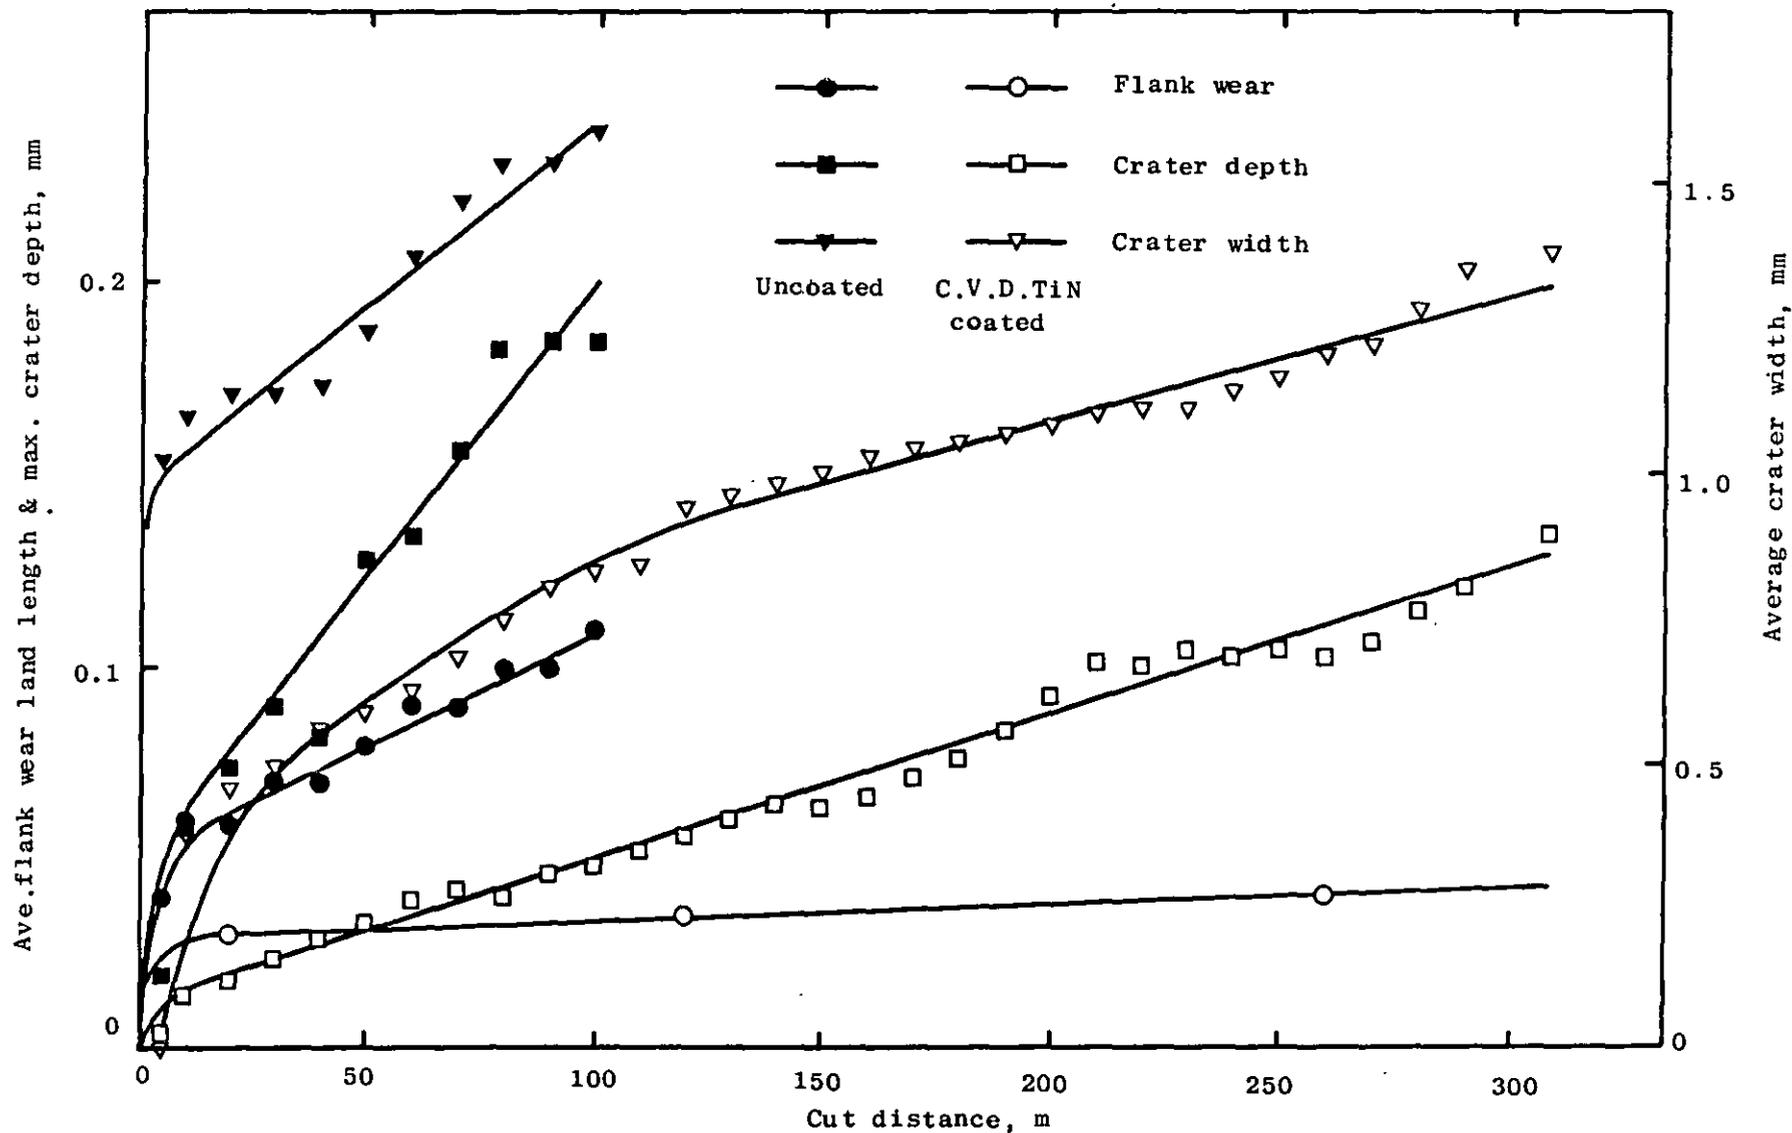
Figure 5.18 Increase in average flank wear land length, maximum crater depth and average crater width of uncoated and C.V.D. TiN coated inserts with cut distance. Cutting speed  $52.5 \text{ m min}^{-1}$ . Test 1.

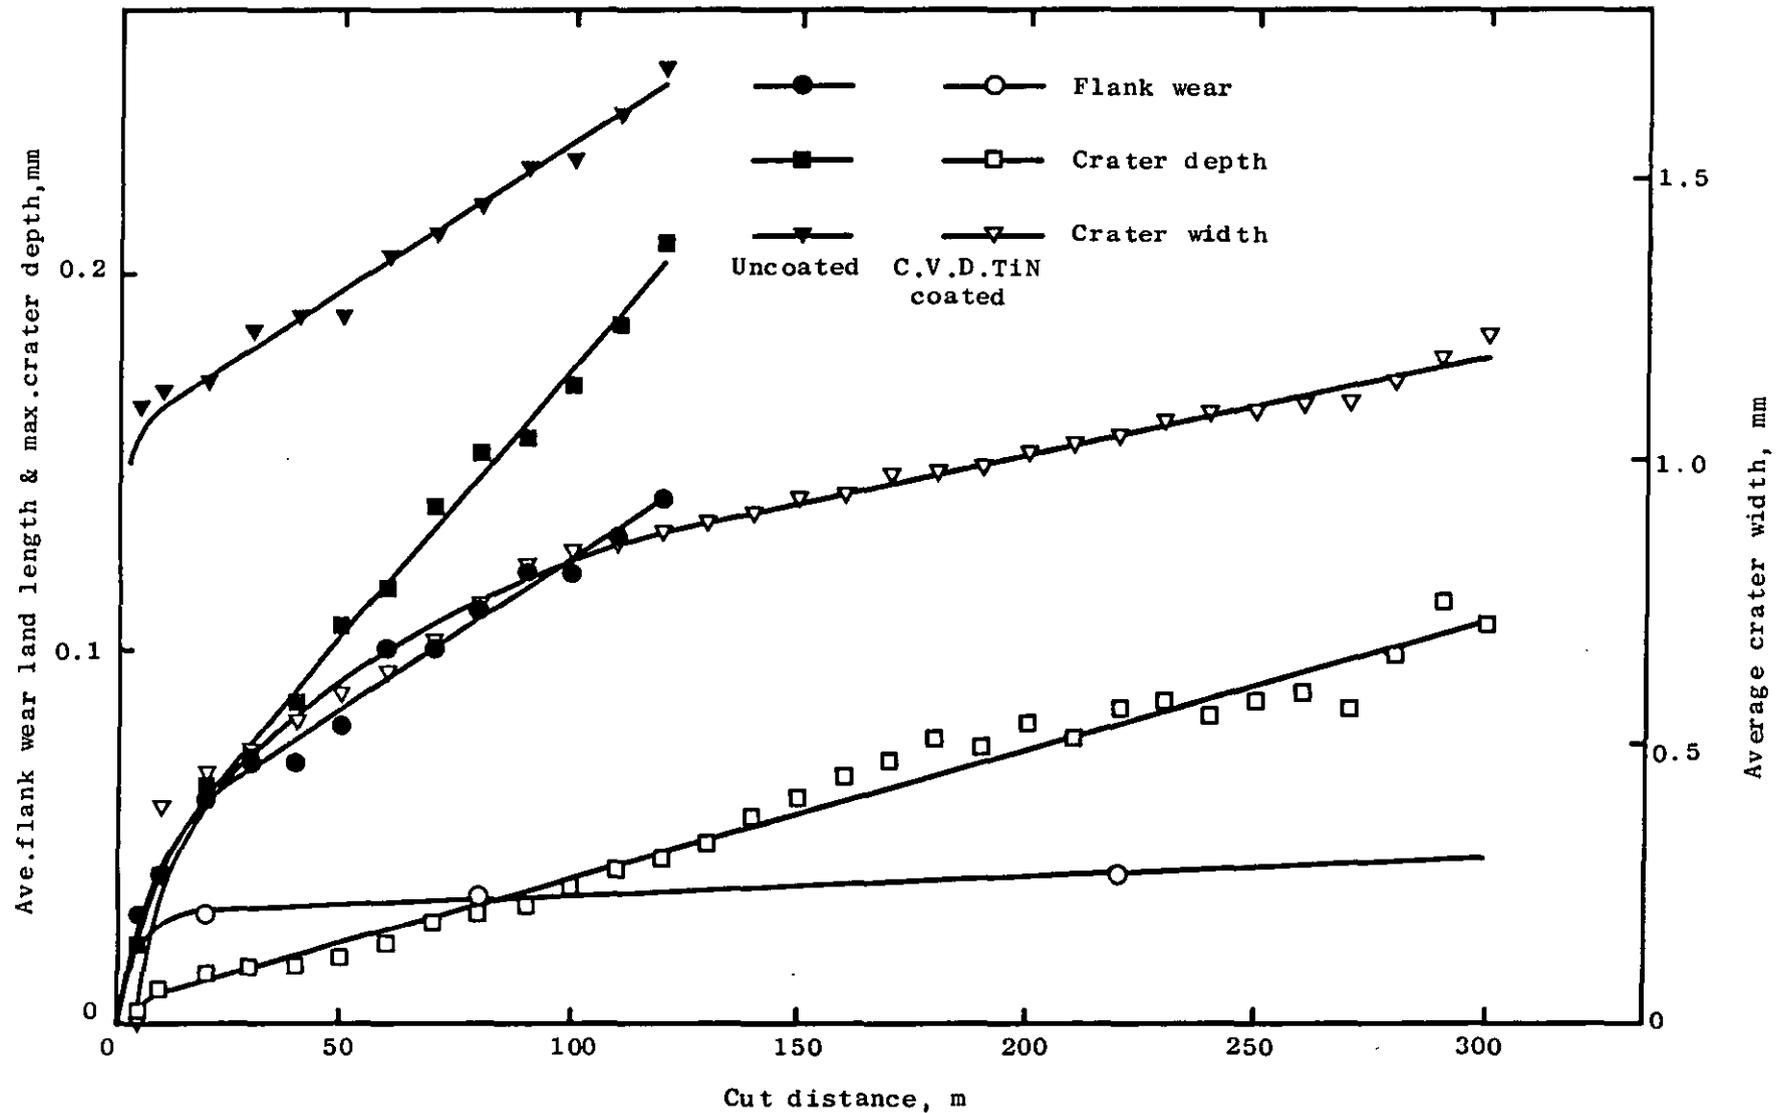
**Figure 5.19** Increase in average flank wear land length, maximum crater depth and average crater width of uncoated and C.V.D. TiN coated inserts with cut distance. Cutting speed  $52.5 \text{ m min}^{-1}$ . Test 2.

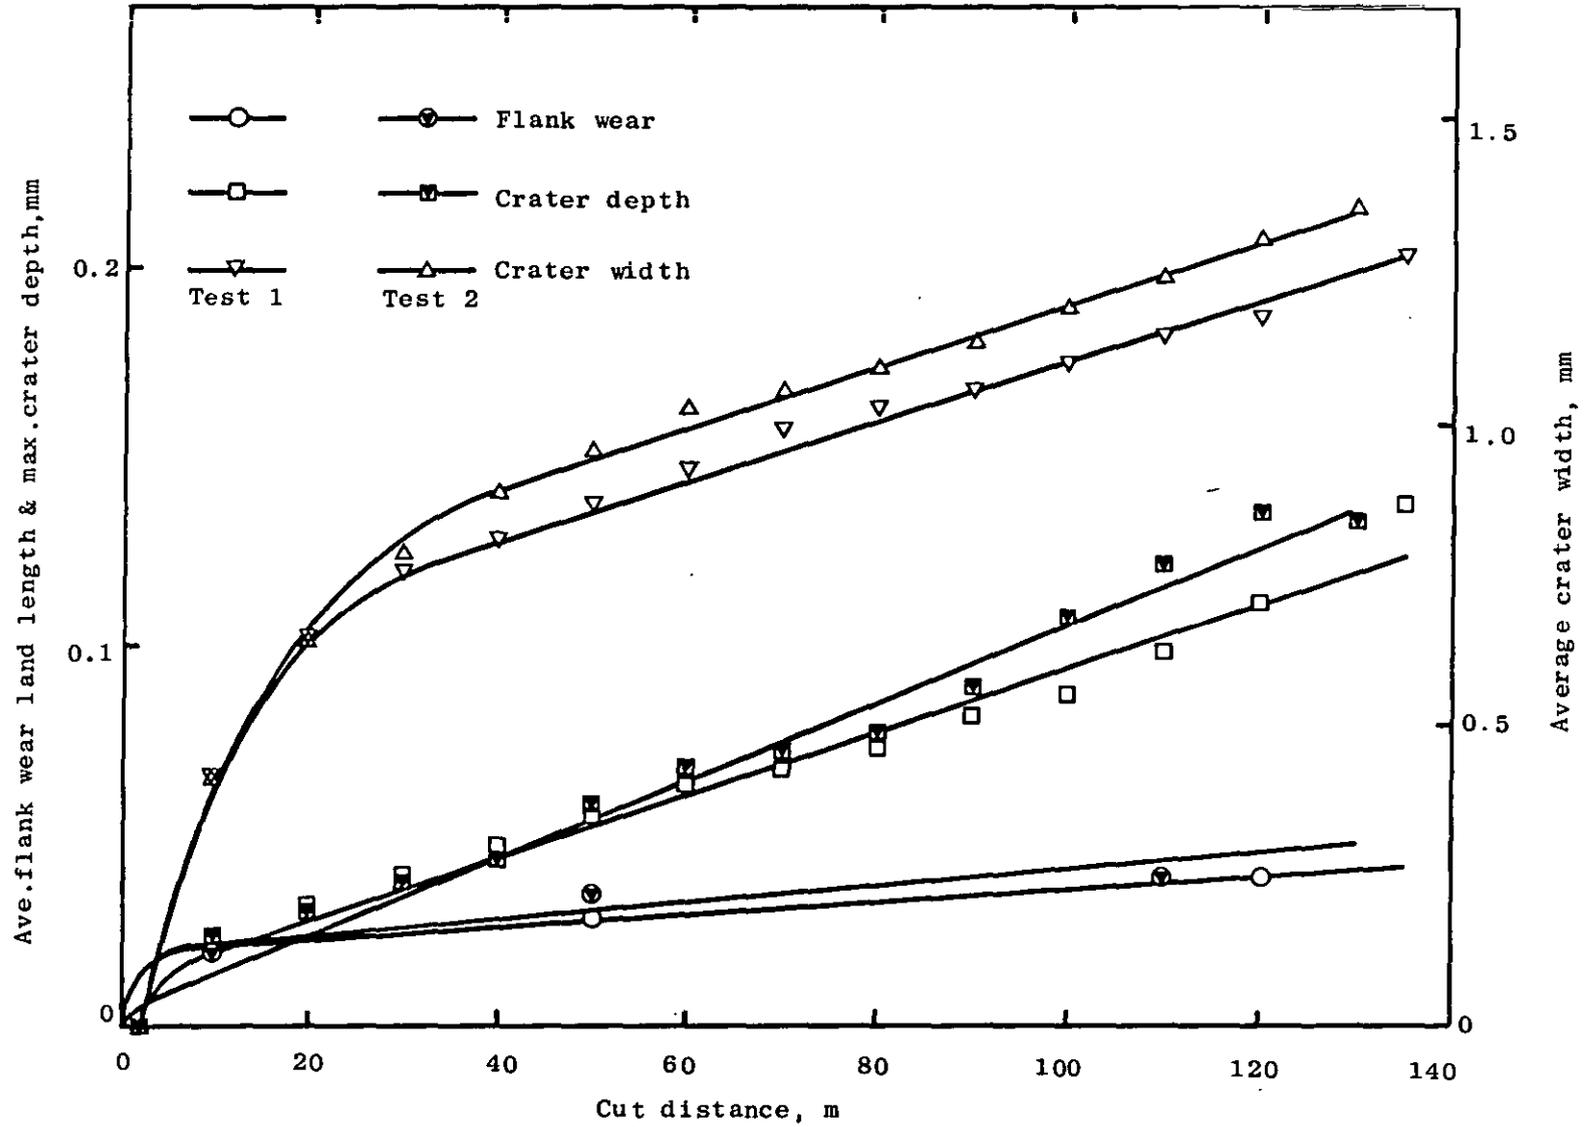
**Figure 5.20** Increase in average flank wear land length, maximum crater depth and average crater width of C.V.D. TiN coated inserts with cut distance. Cutting speed  $60 \text{ m min}^{-1}$ .

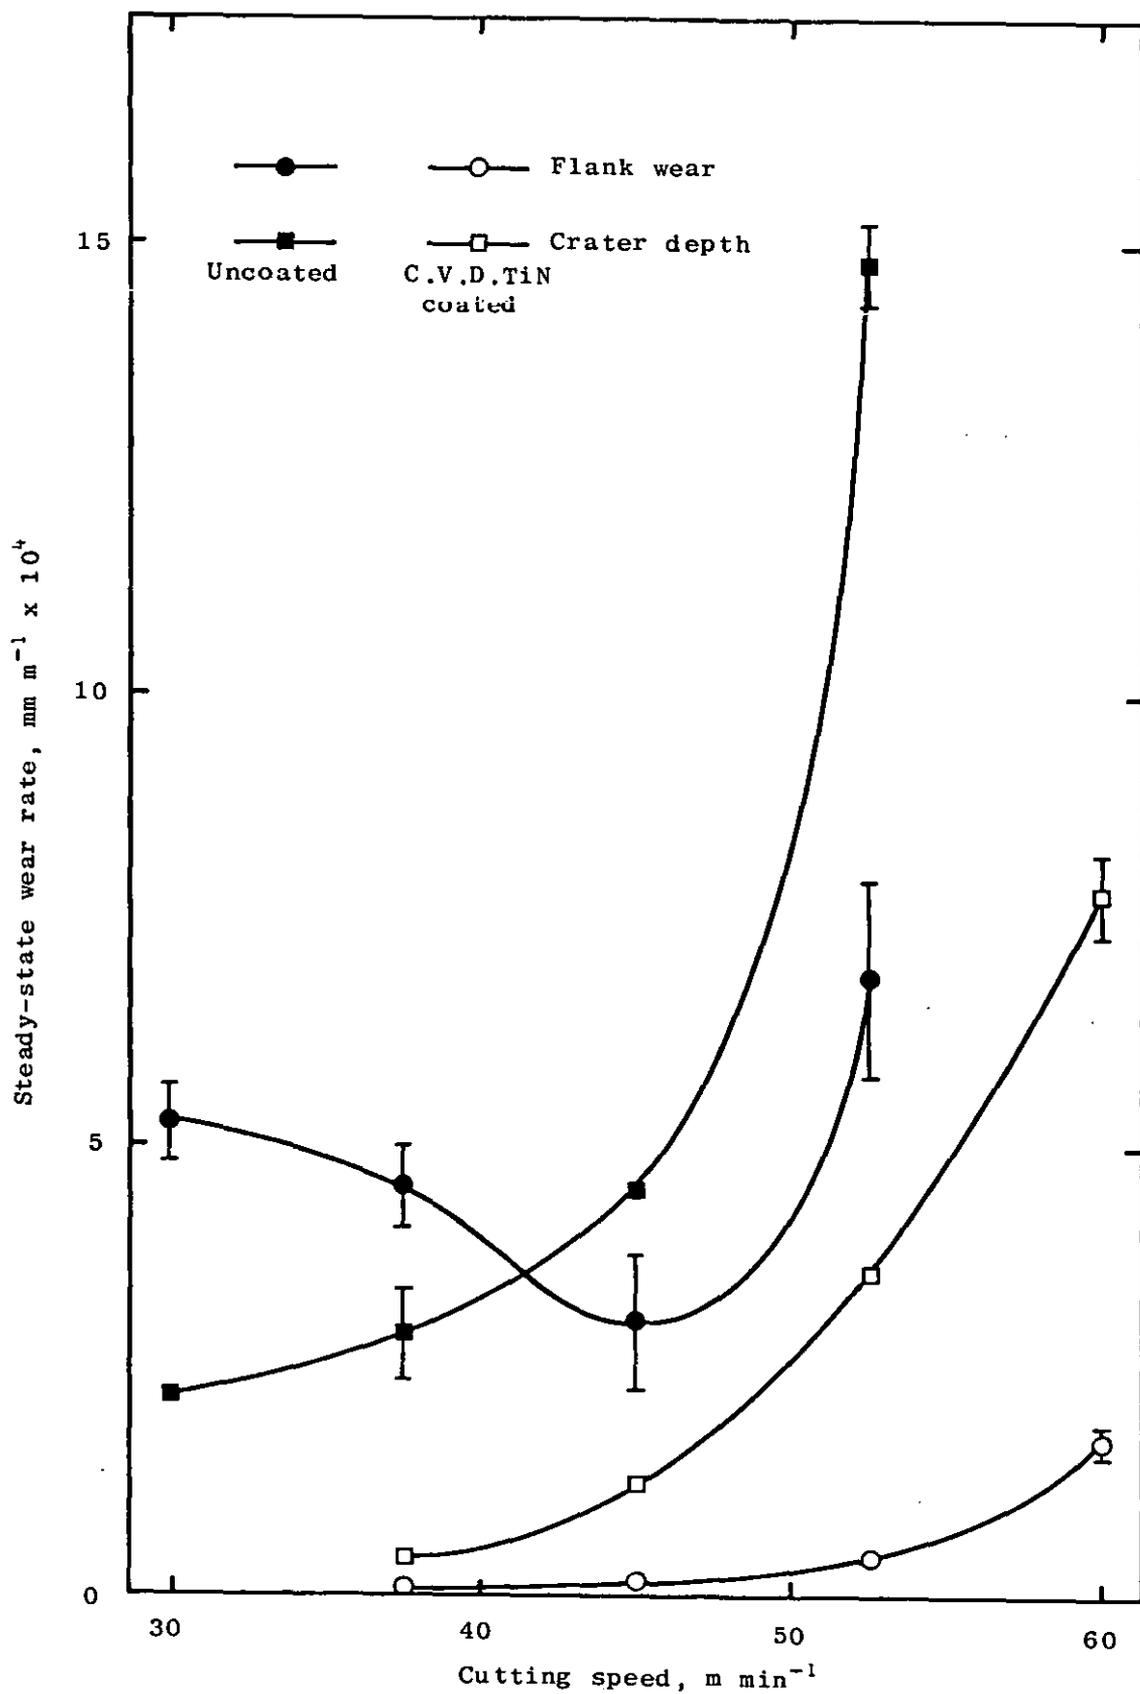
**Figure 5.21** Steady-state flank and crater depth wear rates of uncoated and C.V.D. TiN coated inserts versus cutting speed.

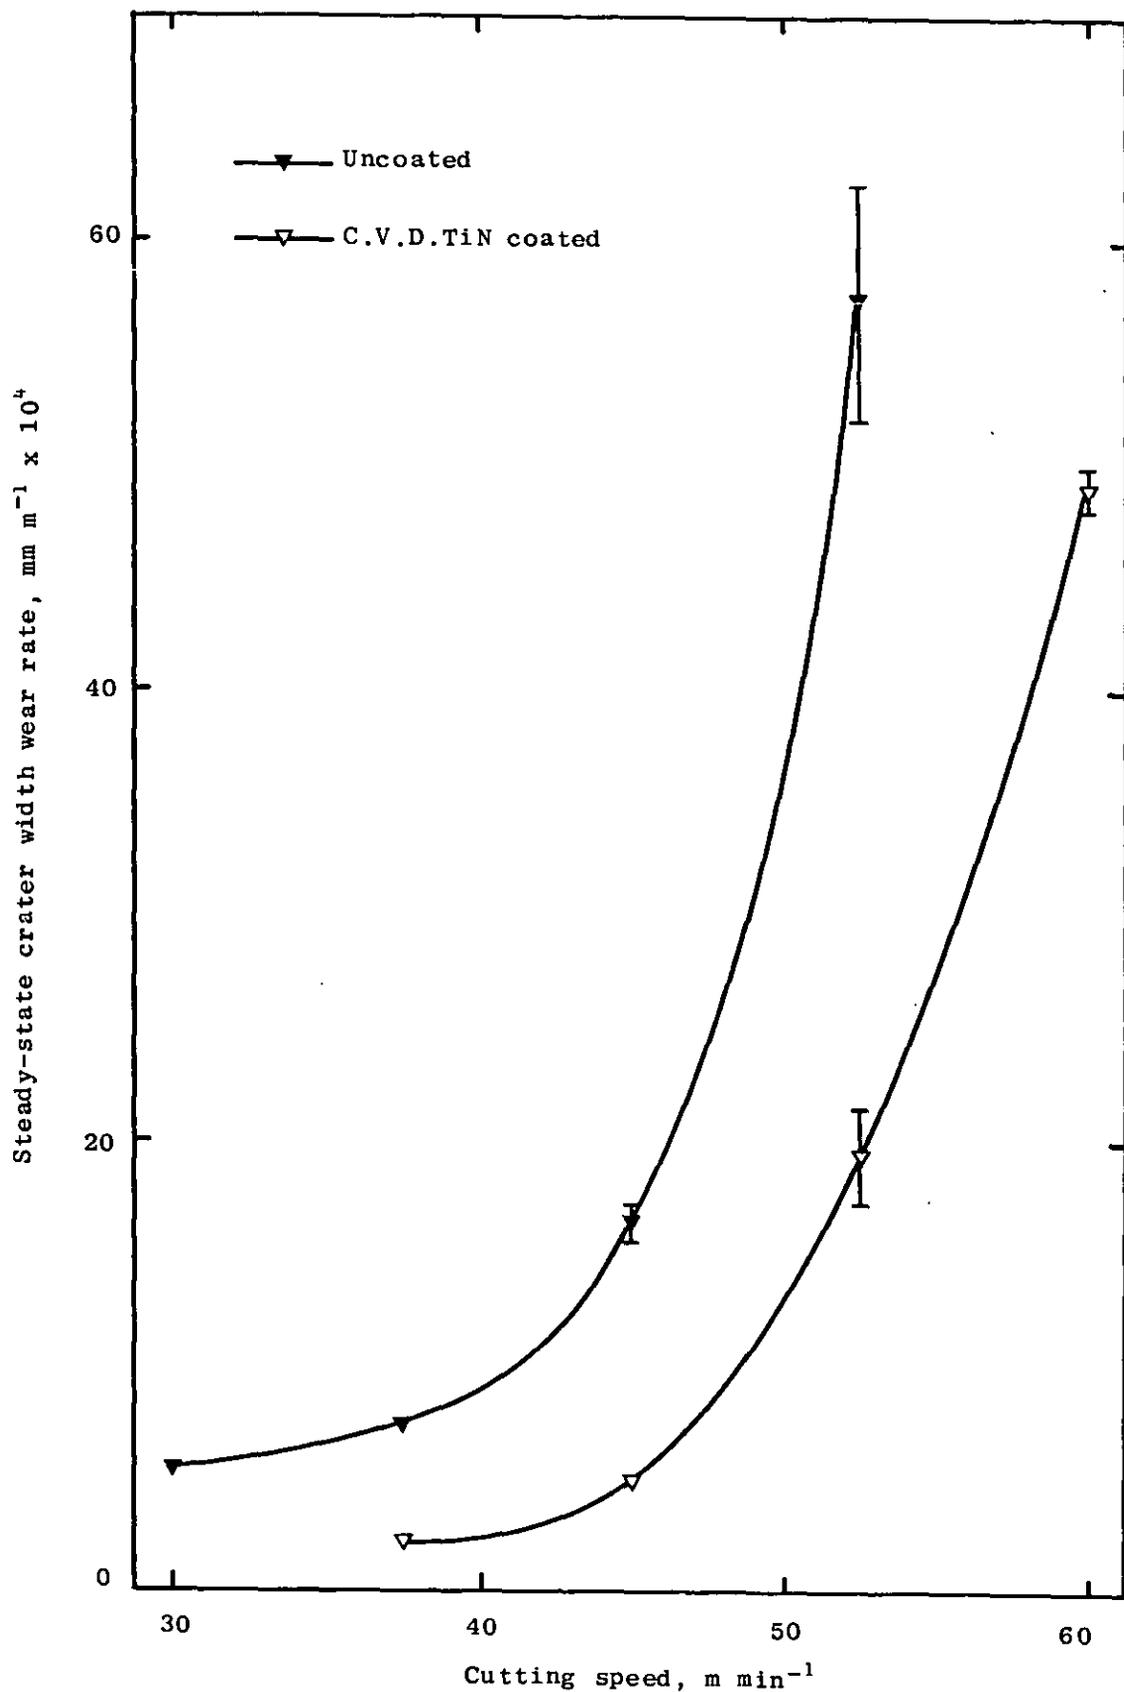
**Figure 5.22** Steady-state crater width wear rate of uncoated and C.V.D. TiN coated inserts versus cutting speed.

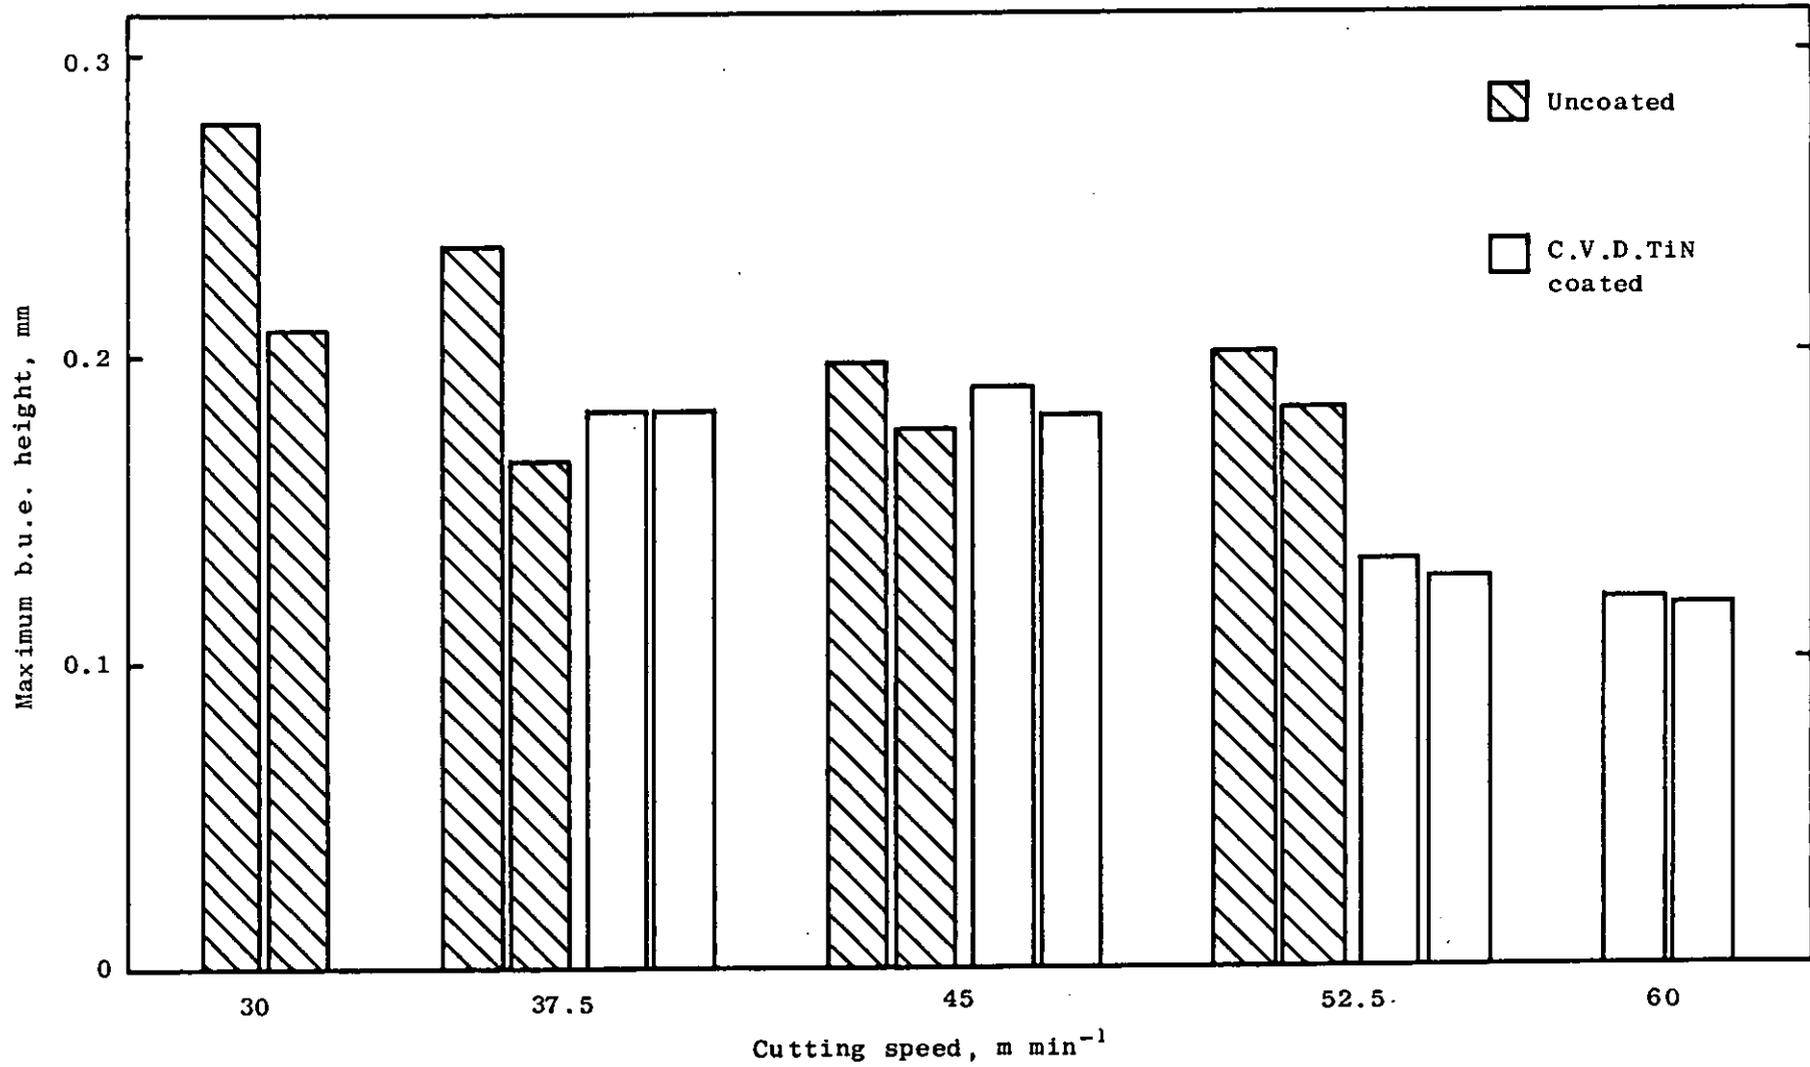
Figure 5.23 Maximum height of b.u.e. on uncoated and C.V.D. TiN coated inserts.
