TITANIUM NITRIDE COATED HIGH SPEED  
STEEL CUTTING TOOL INSERTS

Neville Charles Whittle

A Doctoral Thesis submitted in partial fulfilment of the requirements for the award of Doctor of Philosophy of the Loughborough University of Technology. September 1987.

A detailed study has been made of commercially produced, powder metallurgy, BT42 grade high speed steel (H.S.S.) indexable cutting tool inserts coated with a thin layer of titanium nitride (TiN) by chemical vapour deposition (C.V.D.).

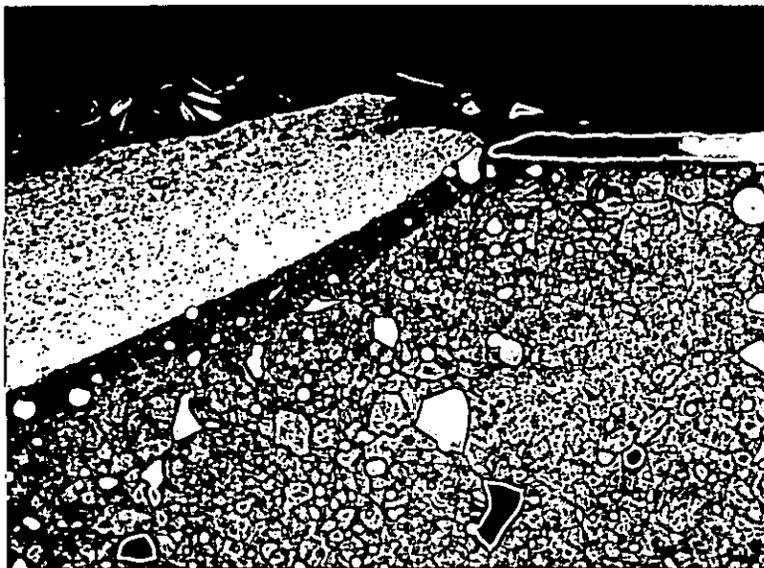
**Figure 5.38** Typical rake face sections. C.V.D. TiN coated inserts. Etchant 5% picral,  $\times 1000$ . (a) Near cutting edge, cutting speed  $45 \text{ m min}^{-1}$ , (b) Within the crater, cutting speed  $45 \text{ m min}^{-1}$ , (c) Rear of crater, cutting speed  $52.5 \text{ m min}^{-1}$ .

All the polished and etched sections through the worn flank and crater surfaces of the uncoated and C.V.D. TiN coated inserts thus obtained were then subjected to a detailed optical examination at a magnification of 1000x. For both types of insert, it was found that the nature of the worn flank surface did not change with cutting speed, a typical worn flank section for the uncoated and for the C.V.D. TiN coated inserts being shown in Figure 5.35. Also for both types of insert, an interfacial layer was found to be present between the b.u.e. and the rake face close to the cutting edge at all cutting speeds. This is illustrated in Figures 5.36(a) and 5.38(a) for the uncoated and C.V.D. TiN coated inserts respectively. With regard to the worn crater surfaces; essentially the same features were observed for the uncoated inserts tested at the cutting speeds of 30, 37.5 and  $45\text{m min}^{-1}$ , a typical worn crater section illustrating these features being presented in Figure 5.36(b). The worn crater surface of the uncoated insert tested at the cutting speed of  $52.5\text{m min}^{-1}$  was, however, observed to be different, exhibiting evidence of wear by superficial plastic deformation as illustrated in Figure 5.37. Finally, it was found that the nature of the worn crater surface of the C.V.D. TiN coated inserts did not change with cutting speed, typical worn crater sections being shown in Figures 5.38(b) and (c).

As described previously in Section 5.3.2, essentially the same features were observed in the worn crater sections of the C.V.D. TiN coated inserts at all the cutting speeds investigated in the present work, Figure 5.38(b) illustrating these features for an insert tested at  $45 \text{ m min}^{-1}$ . The features shown in this figure are quite similar to those for the uncoated inserts tested at the cutting speeds of 30, 37.5 and  $45 \text{ m min}^{-1}$ , typified by Figure 5.36(b). As with the uncoated inserts, the worn crater surface can be seen to be in intimate contact with material which is believed to be the b.u.e. fragments mentioned in Section 5.3.1 that hampered the crater depth measurements, particularly with the C.V.D. TiN coated inserts. The latter is hardly surprising given that if, as shown in the previous section, the presence of the TiN coating decreases the stability of the b.u.e. so that more b.u.e. fragments pass down the flank face of the inserts, then there should be a corresponding increase in the number of b.u.e. fragments carried across the rake face by the chip. Despite the increase in the number of b.u.e. fragments carried across the rake face, it is apparent from the correlation coefficients mentioned earlier in this section that they did not significantly affect the accuracy of the crater depth wear rates determined. As a consequence of this and the similarity between the worn crater surfaces of the typical uncoated and C.V.D. TiN coated inserts, it is reasonable to assume

Near the cutting edge of the C.V.D. TiN coated inserts it is evident, as shown in Figure 5.38(a) for an insert tested at the cutting speed of  $52.5 \text{ m min}^{-1}$ , that the coating does not extend to the entrance to the crater, but is partially worn and fractured before the crater entrance, and unworn near the cutting edge. In the latter region, a thin interfacial layer can be seen between the b.u.e. and the coating indicating that some diffusion has occurred between them. In the present work the composition of this layer is not known, but Jonsson<sup>(202)</sup> (see Section 3.3.2.1) found similar evidence of diffusion with TiC coated cemented carbide tools and identified it as an Fe-C alloy. Jonsson<sup>(202)</sup> also found that thinner interfacial layers formed when a TiC coating was present on the tools than in the uncoated case and thus concluded that the TiC coating hindered diffusion and thus bonding between the b.u.e. and the tool. Such a direct comparison between the thickness of the interfacial layers on the uncoated and C.V.D. TiN coated inserts in the present work is, unfortunately, not possible as the latter inserts, for the reason given previously in Section 5.3.2, were used for a longer time.

Since diffusion is a time and temperature dependent process, the b.u.e. near the cutting edge of the C.V.D. TiN coated inserts is probably relatively "stationary", except in areas further away from the interfacial layer. Indeed, from the character of the flow pattern in the b.u.e.'s etched structure in Figure 5.38(a) it appears that there is an inner "stationary" layer over which b.u.e. sliding occurs on a path to the entrance to the crater. It is therefore suggested that occasional detachment of the b.u.e. removes fragments of the coating near the crater through the bond created by the b.u.e./coating interdiffusion; coating detachment perhaps being aided by the cracks produced in the coating from the obligatory H.S.S. substrate heat treatment (see Section 4.4). Furthermore, between the formation and detachment of the inner "stationary" b.u.e. and interfacial layer, some b.u.e. sliding occurs over the coating near the entrance to the crater to cause some coating wear by adhesion.

In contrast to the condition at the entrance to the crater, the TiN coating can be seen from the typical section shown in Figure 5.38(c), to be worn approximately in-line with the H.S.S. substrate at the rear of the crater and must, therefore, have some influence on the wear of the substrate. Since the above observations clearly discount plastic deformation of the substrate (i.e. a crater with the coating intact within) as explaining the effect of the coating on crater wear after the crater depth exceeds the coating thickness (i.e. coating breakthrough), and it is unlikely that the conditions on/near the cutting edge are such that the coating softens, requiring a temperature of the order of 1200°C (227), or forms an oxide with the chip so that a wear resistant layer is created in the crater, it is suggested that the presence of the coating at the rear of the crater acts as a chip breaker and reduces crater wear through its high hardness (e.g. see Table 4.15) and superior frictional characteristics<sup>(26)</sup> (c.f. H.S.S.). Further, although the "bridging support theory" is also clearly discounted as the chip is not directly supported by the coating at the front of the crater, it is suggested that crater wear is also reduced because the chip is supported by the coating at the periphery, but not the front, of the worn crater.

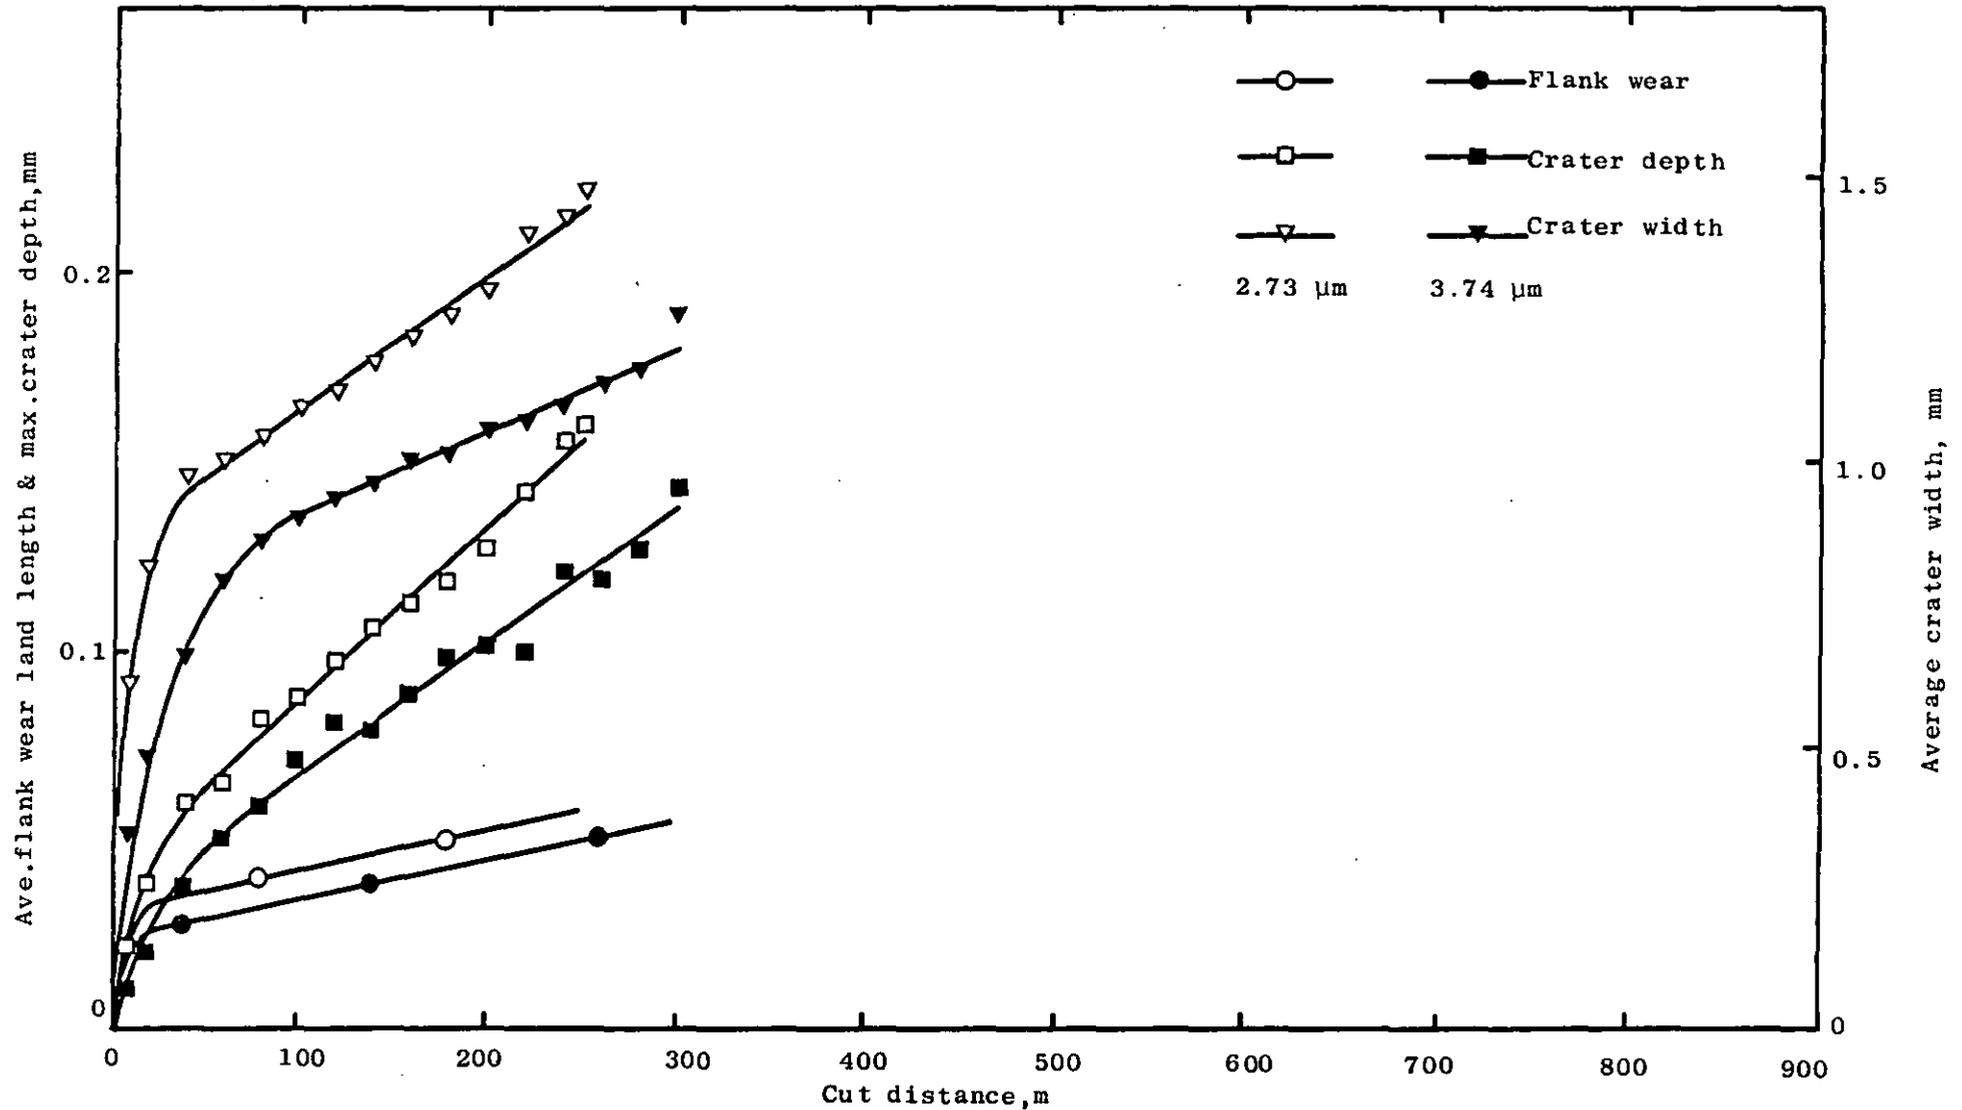
**Figure 5.43** Effect of coating thickness on increase in average flank wear land length, maximum crater depth and average crater width of C.V.D. TiN coated inserts with cut distance. Cutting speed  $52.5 \text{ m min}^{-1}$ .

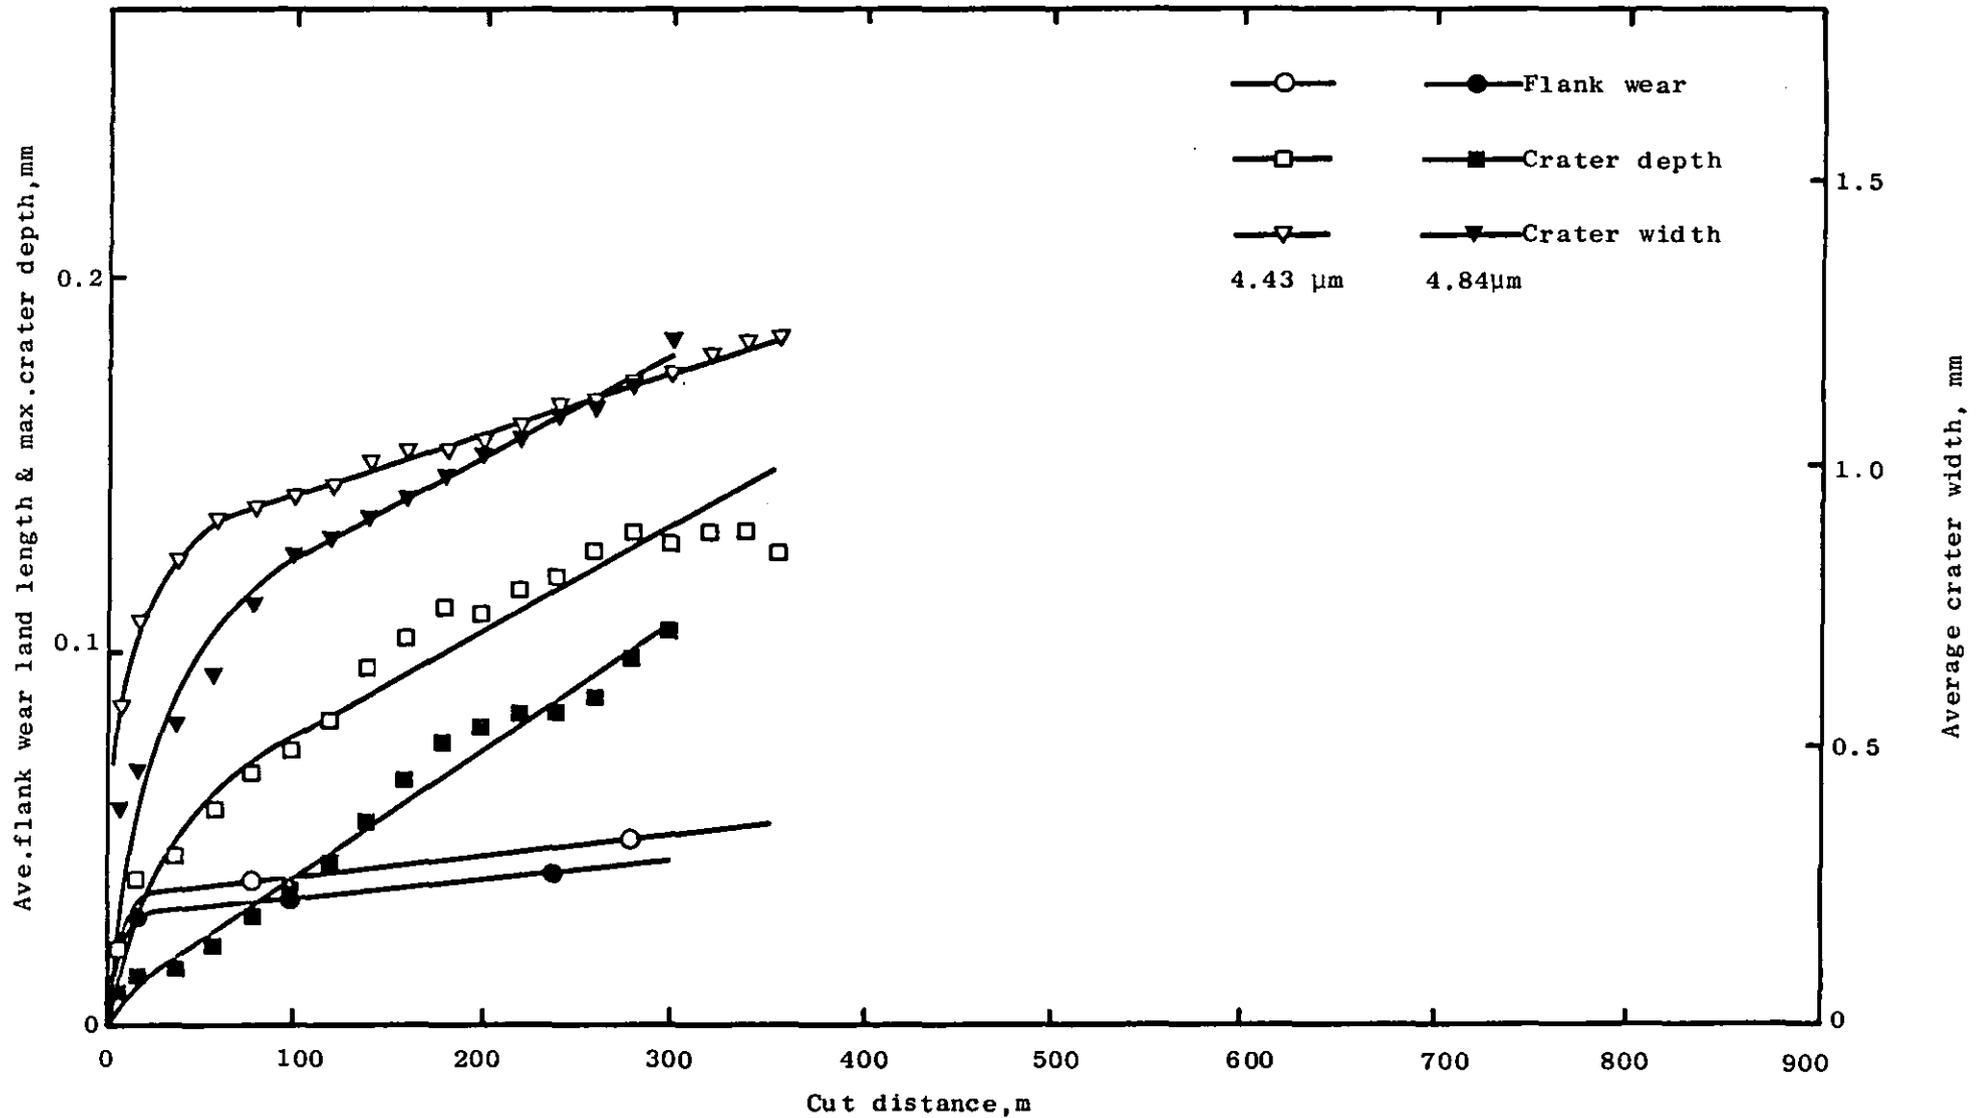
**Figure 5.44** Effect of coating thickness on increase in average flank wear land length, maximum crater depth and average crater width of C.V.D.TiN coated inserts with cut distance. Cutting speed  $52.5 \text{ m min}^{-1}$ .

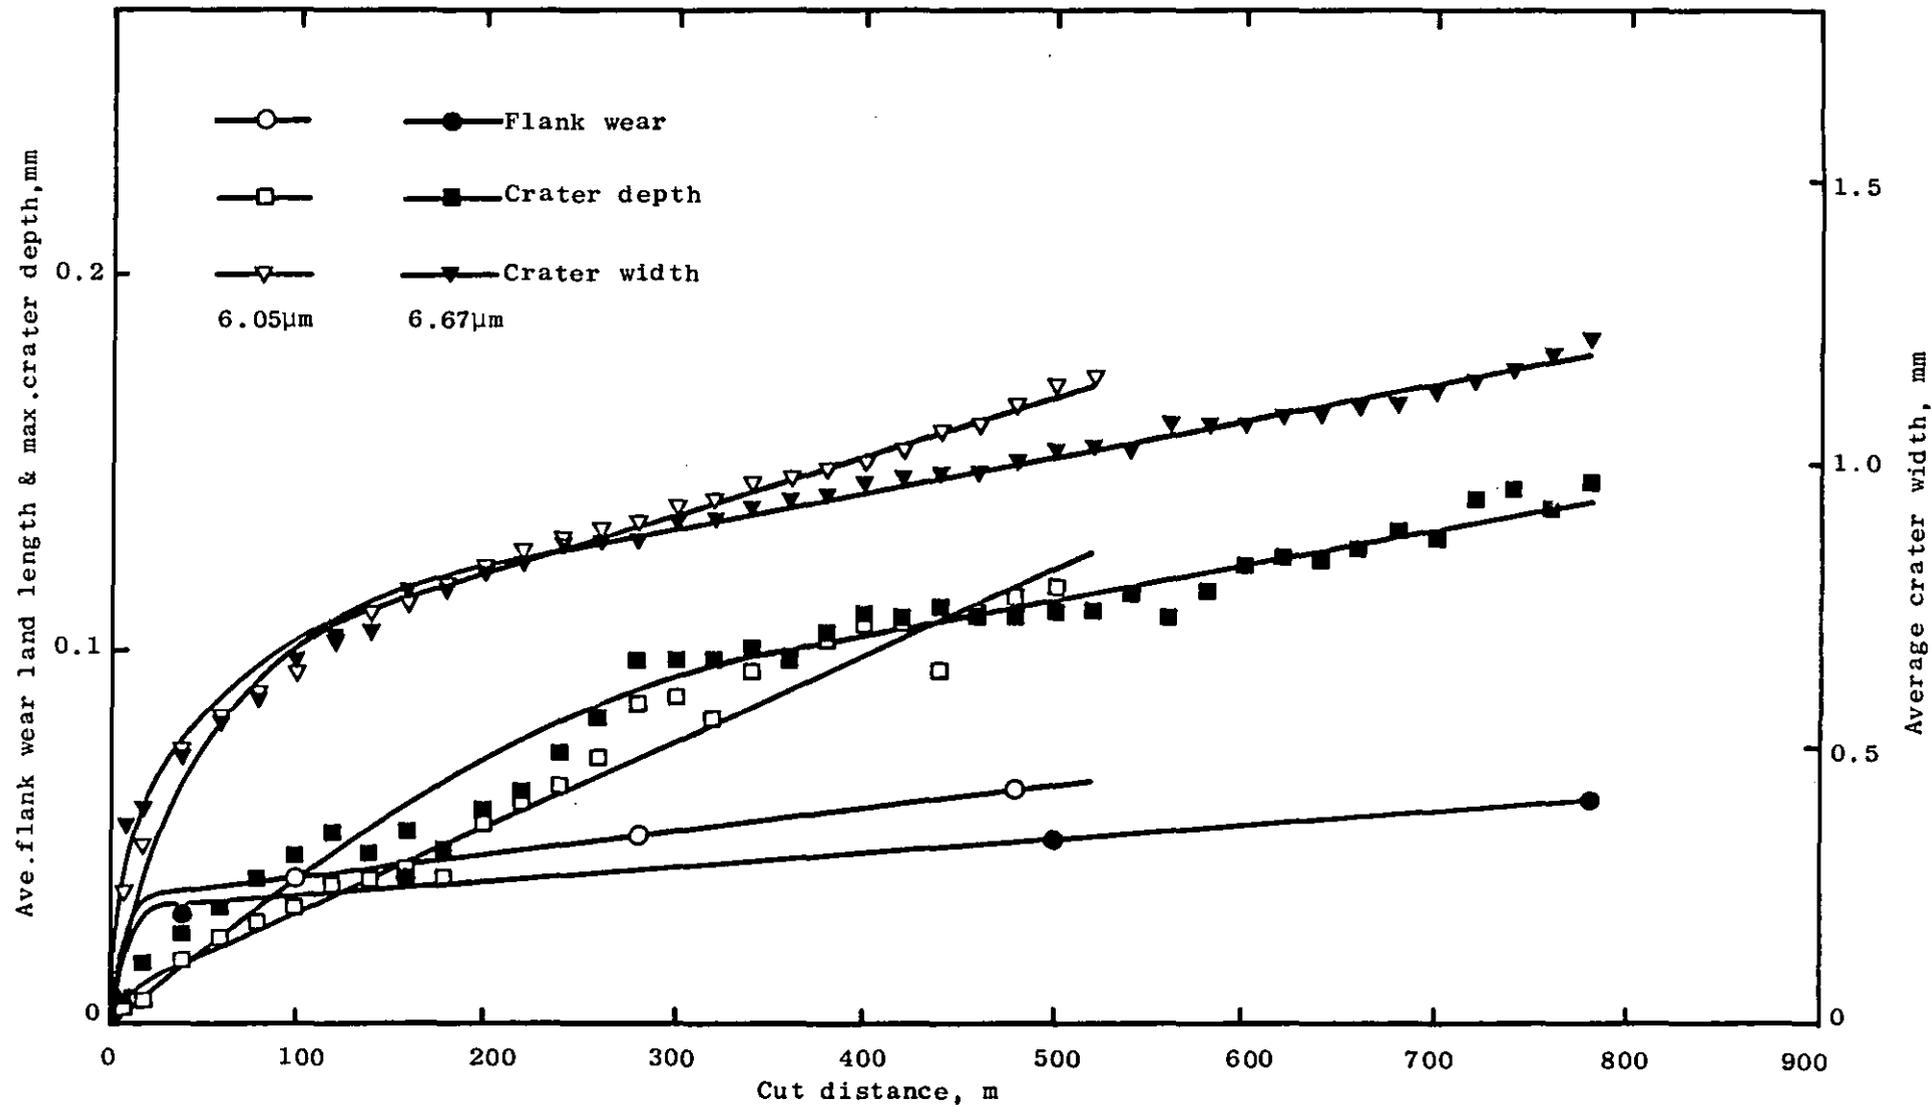
**Figure 5.45** Effect of coating thickness on increase in average flank wear land length, maximum crater depth and average crater width of C.V.D. TiN coated inserts with cut distance. Cutting speed  $52.5 \text{ m min}^{-1}$ .

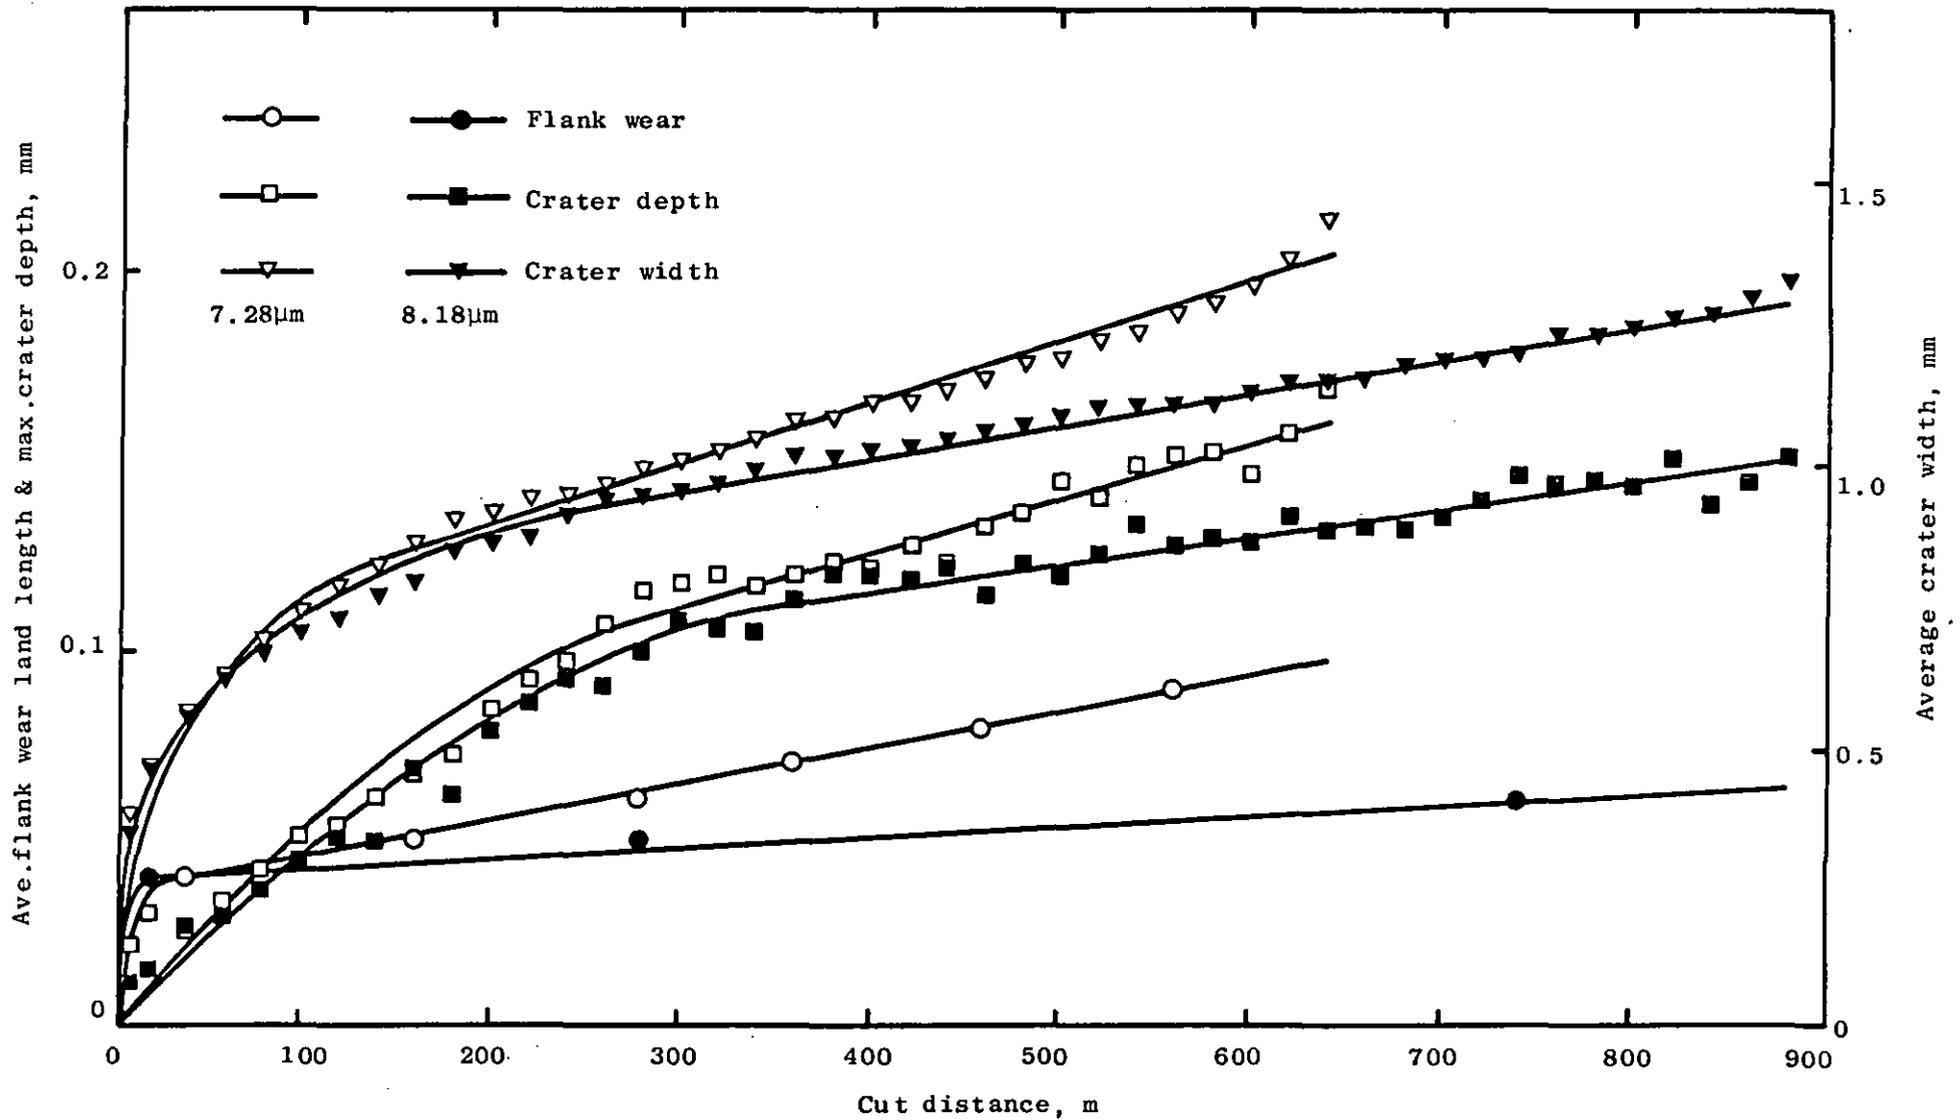
**Figure 5.46** Effect of coating thickness on increase in average flank wear land length, maximum crater depth and average crater width of C.V.D. TiN coated inserts with cut distance. Cutting speed  $52.5 \text{ m min}^{-1}$ .

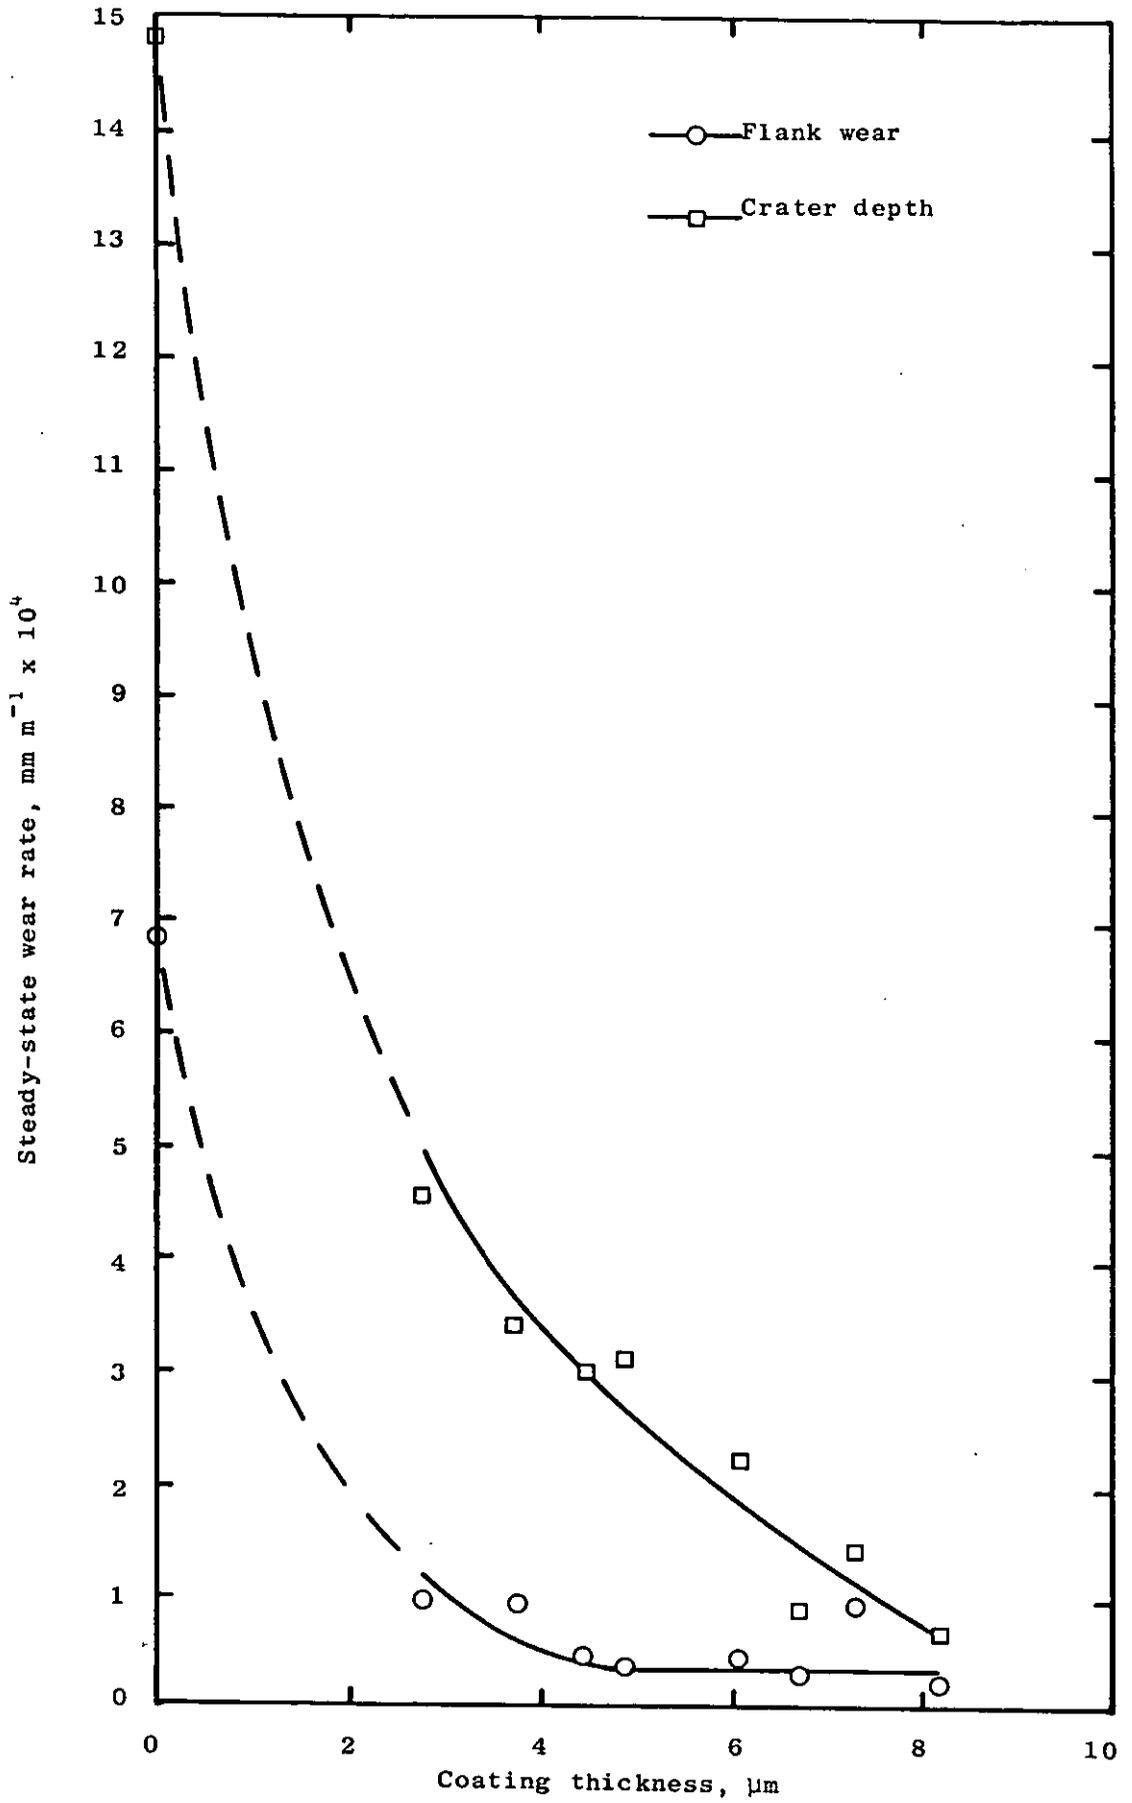
**Figure 5.47** Effect of coating thickness on steady-state flank and crater depth wear rate of C.V.D. TiN coated inserts. Cutting speed 52.5 m min<sup>-1</sup>.

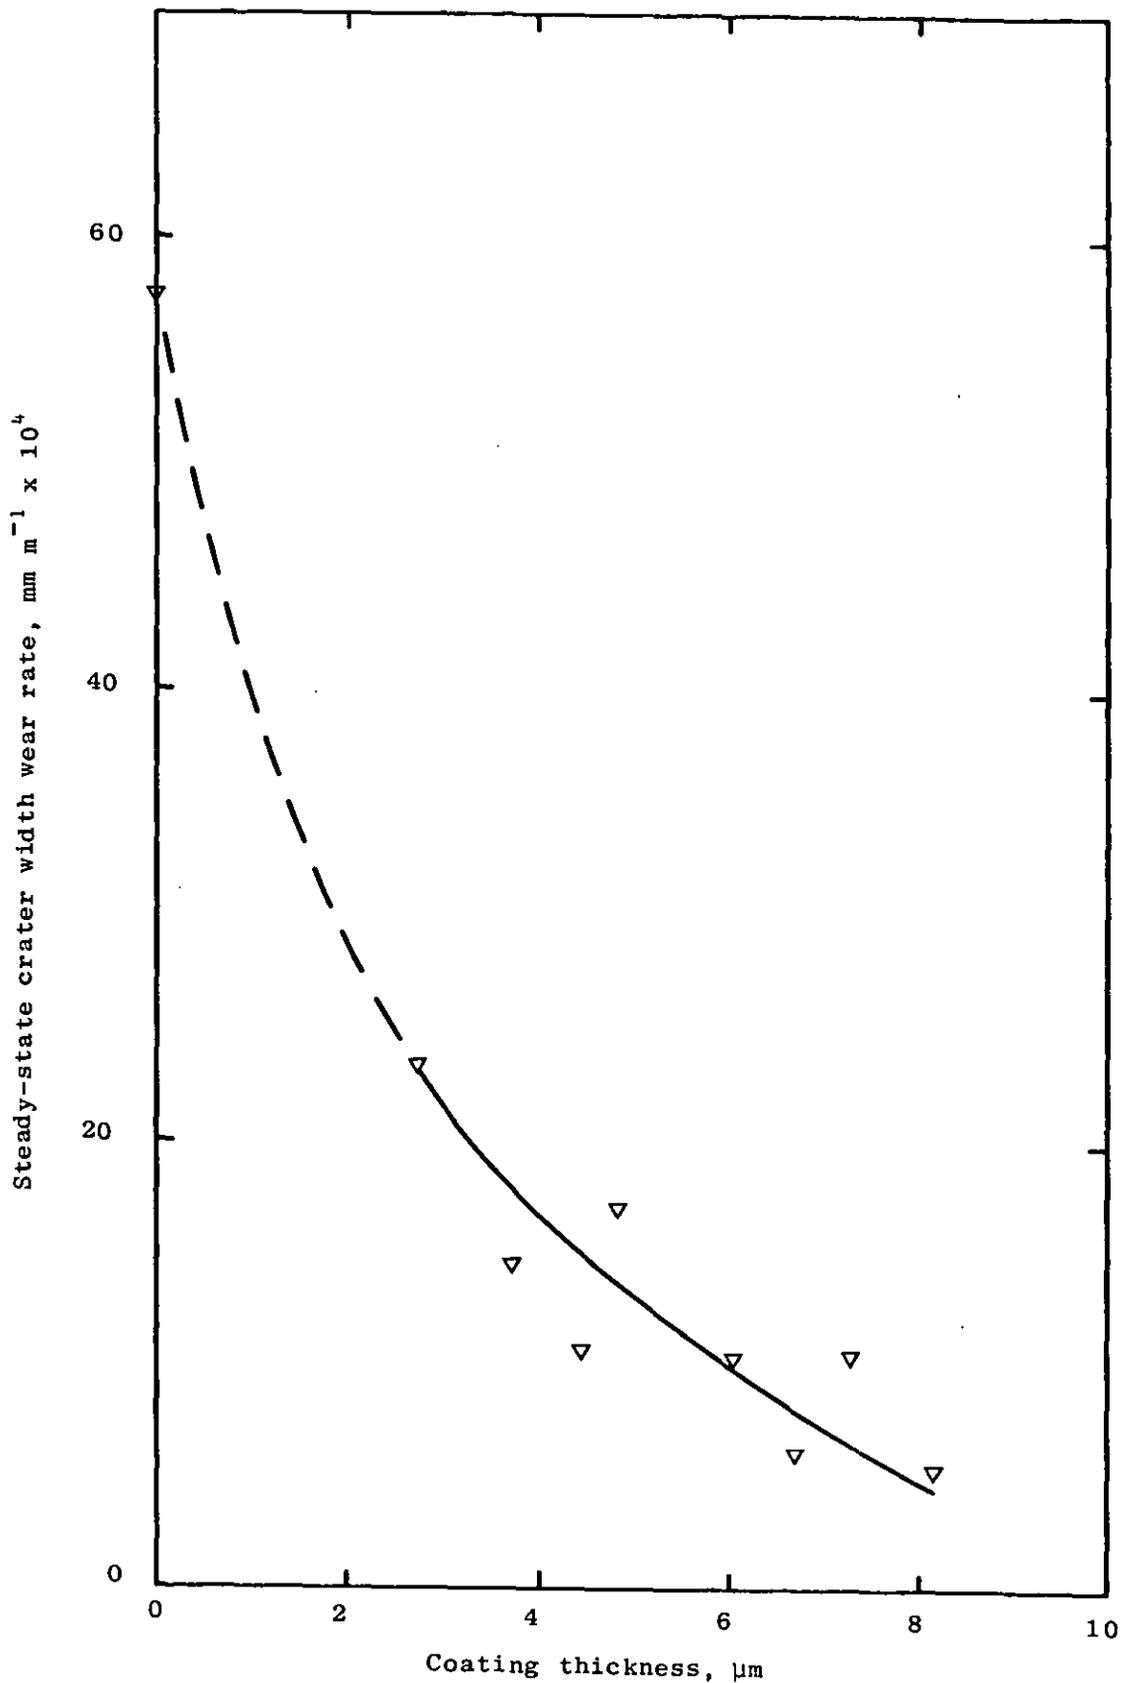
**Figure 5.48** Effect of coating thickness on steady-state crater width wear rate of C.V.D. TiN coated inserts. Cutting speed  $52.5 \text{ m min}^{-1}$ .

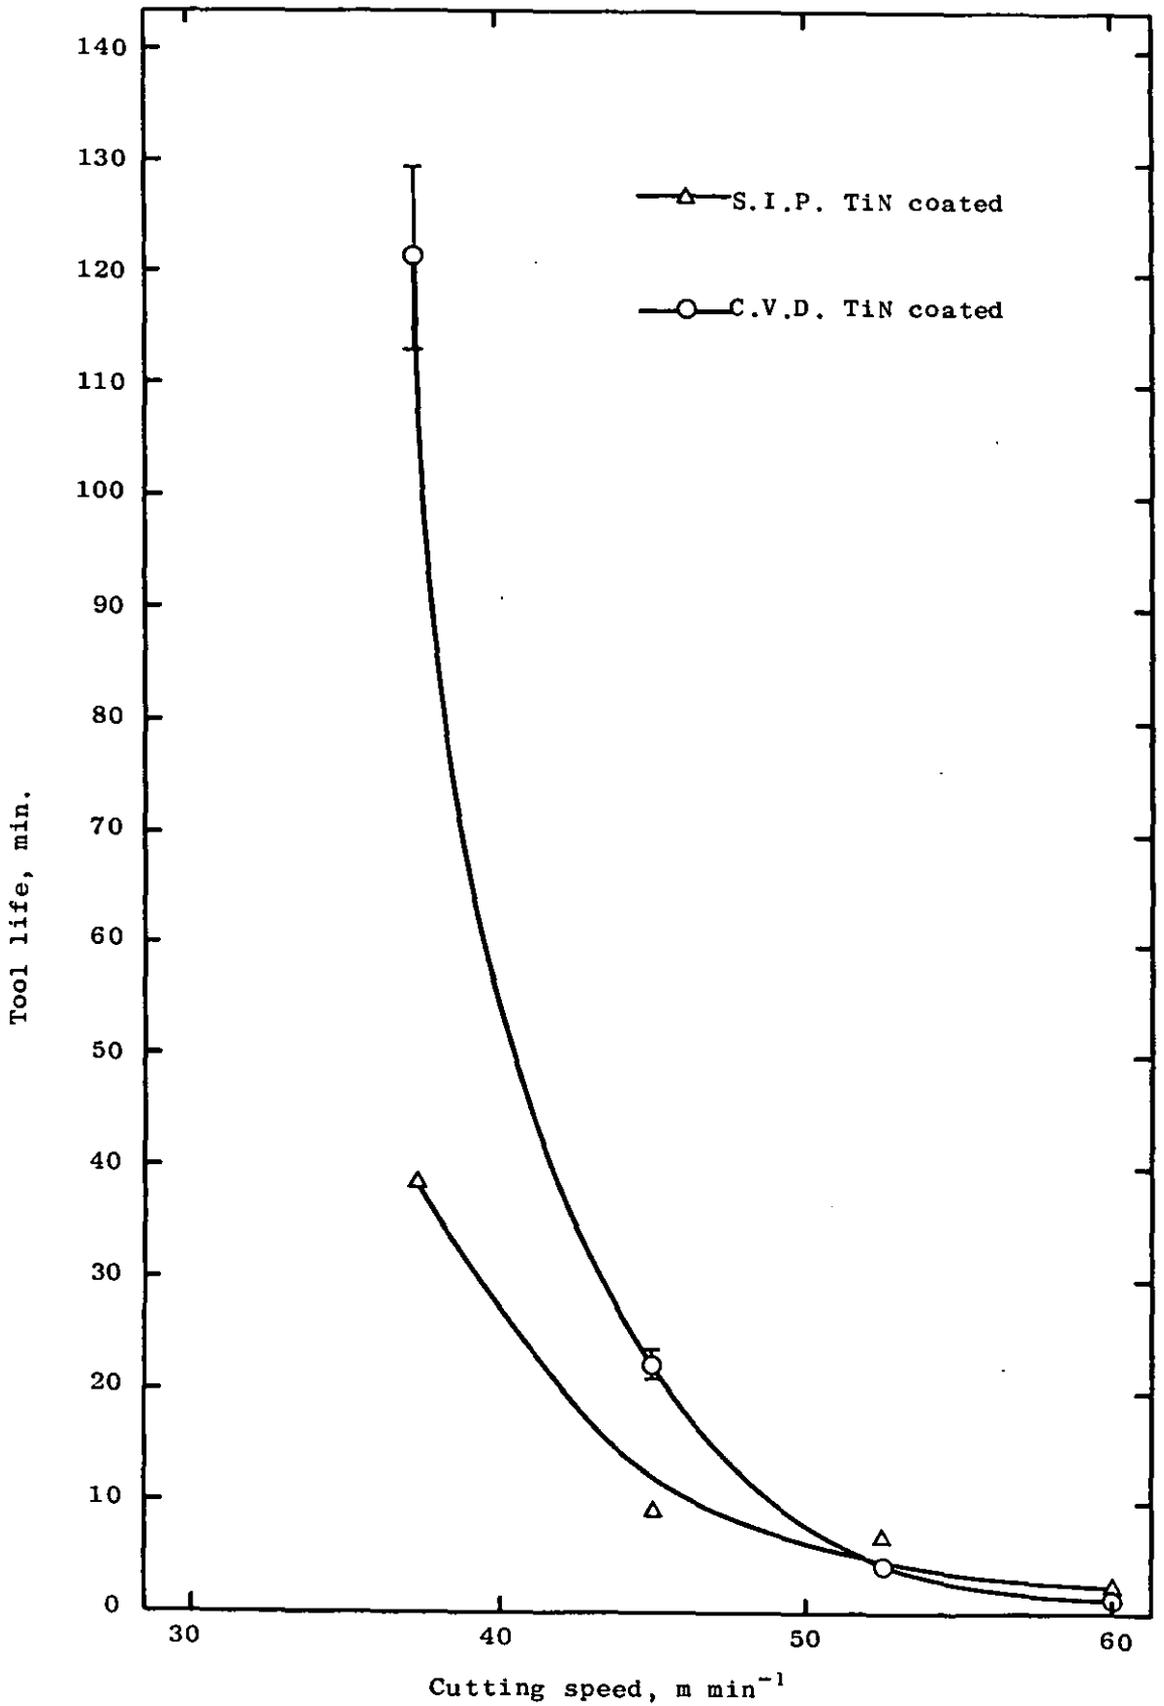
**Figure 5.49** Variation of tool life of S.I.P. and C.V.D. TiN coated inserts with cutting speed.

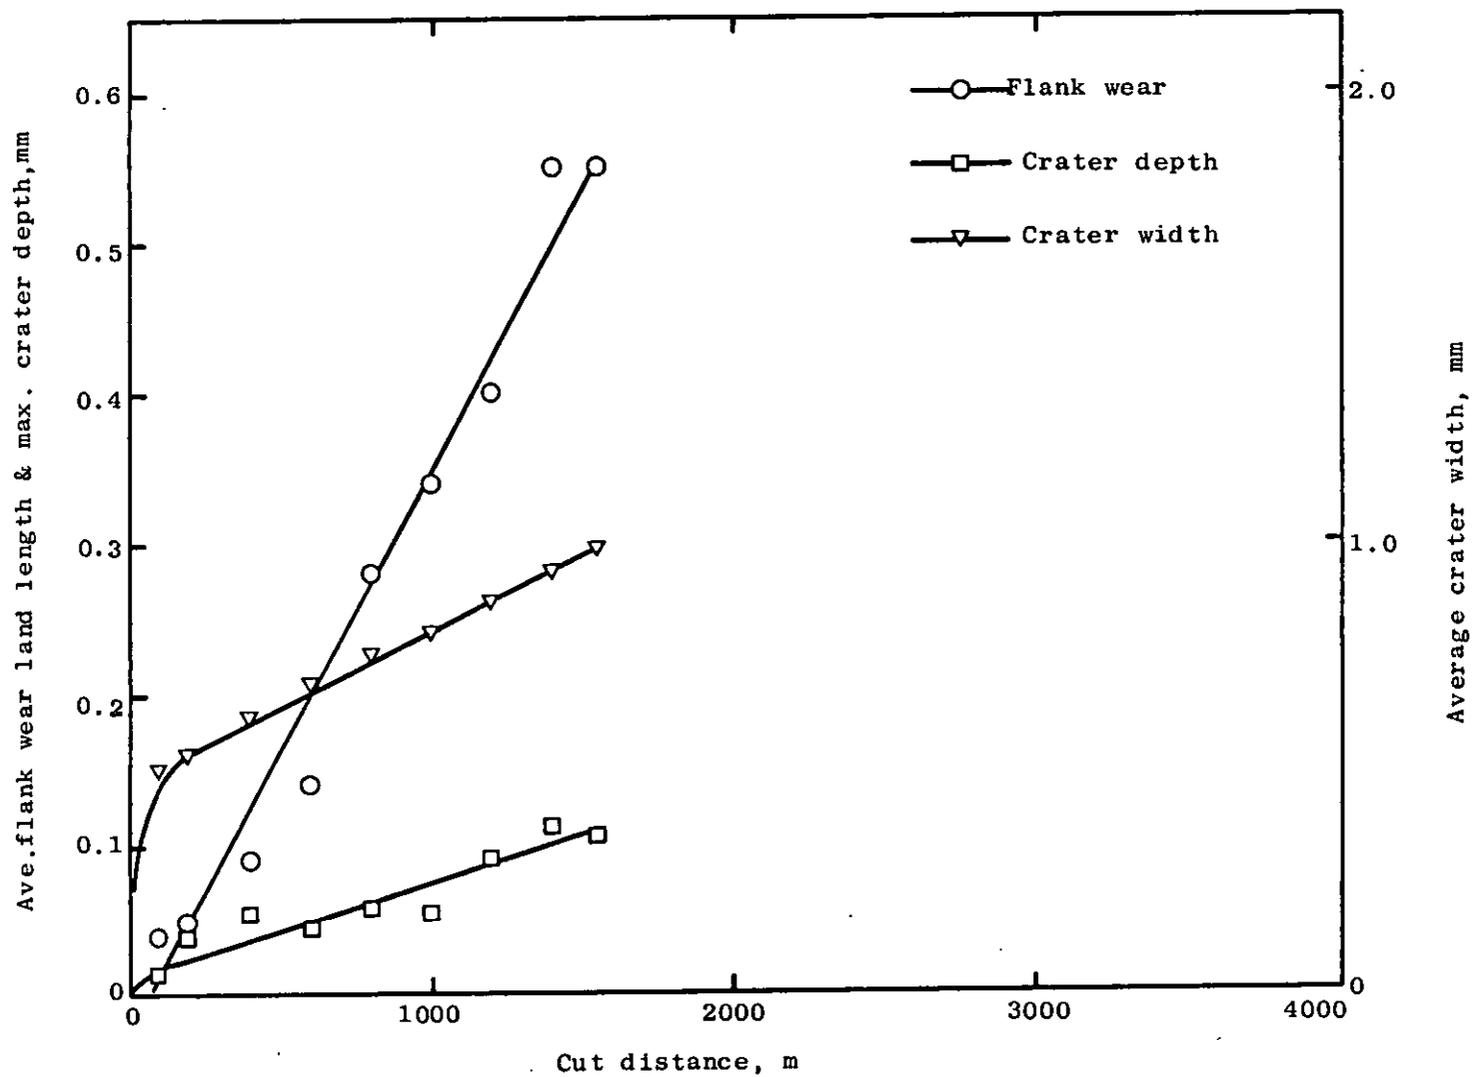
**Figure 5.50** Increase in average flank wear land length, maximum crater depth and average crater width of S.I.P.TiN coated inserts with cut distance. Cutting speed  $37.5 \text{ m min}^{-1}$ .

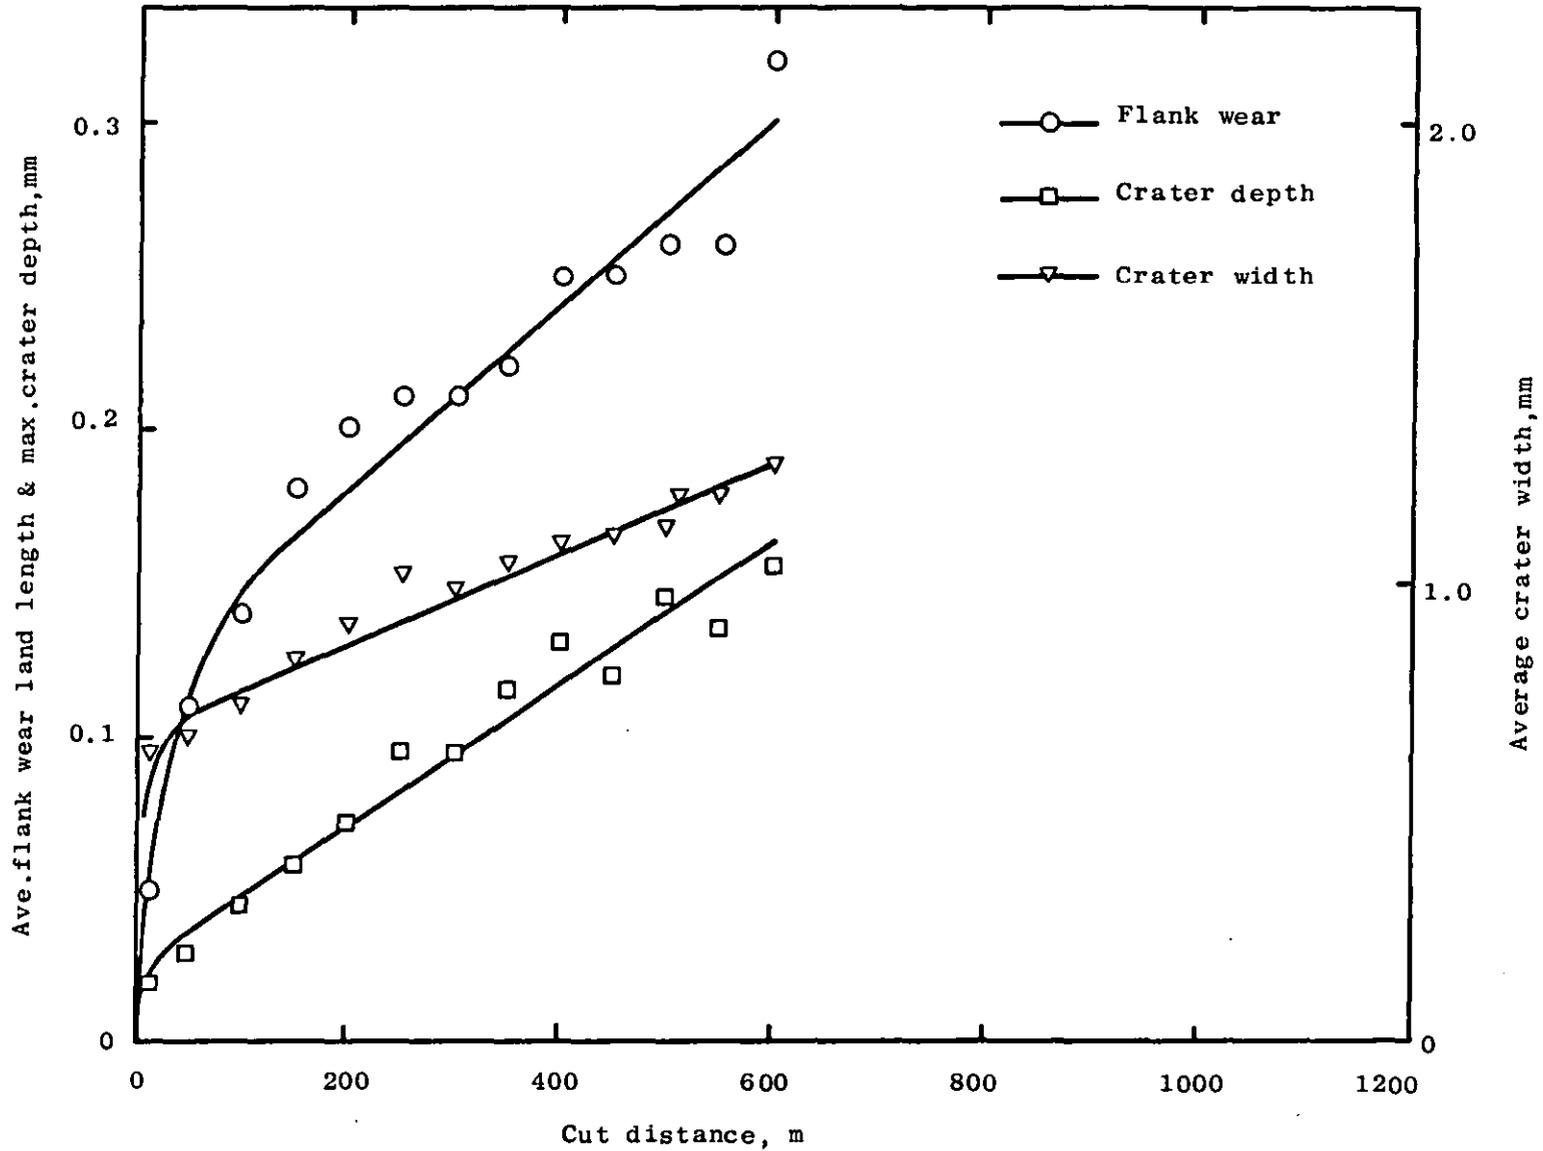
**Figure 5.51** Increase in average flank wear land length, maximum crater depth and average crater width of S.I.P.TiN coated inserts with cut distance. Cutting speed 45 m min<sup>-1</sup>.
