TITANIUM NITRIDE COATED HIGH SPEED  
STEEL CUTTING TOOL INSERTS

Neville Charles Whittle

A Doctoral Thesis submitted in partial fulfilment of the requirements for the award of Doctor of Philosophy of the Loughborough University of Technology. September 1987.

A detailed study has been made of commercially produced, powder metallurgy, BT42 grade high speed steel (H.S.S.) indexable cutting tool inserts coated with a thin layer of titanium nitride (TiN) by chemical vapour deposition (C.V.D.).

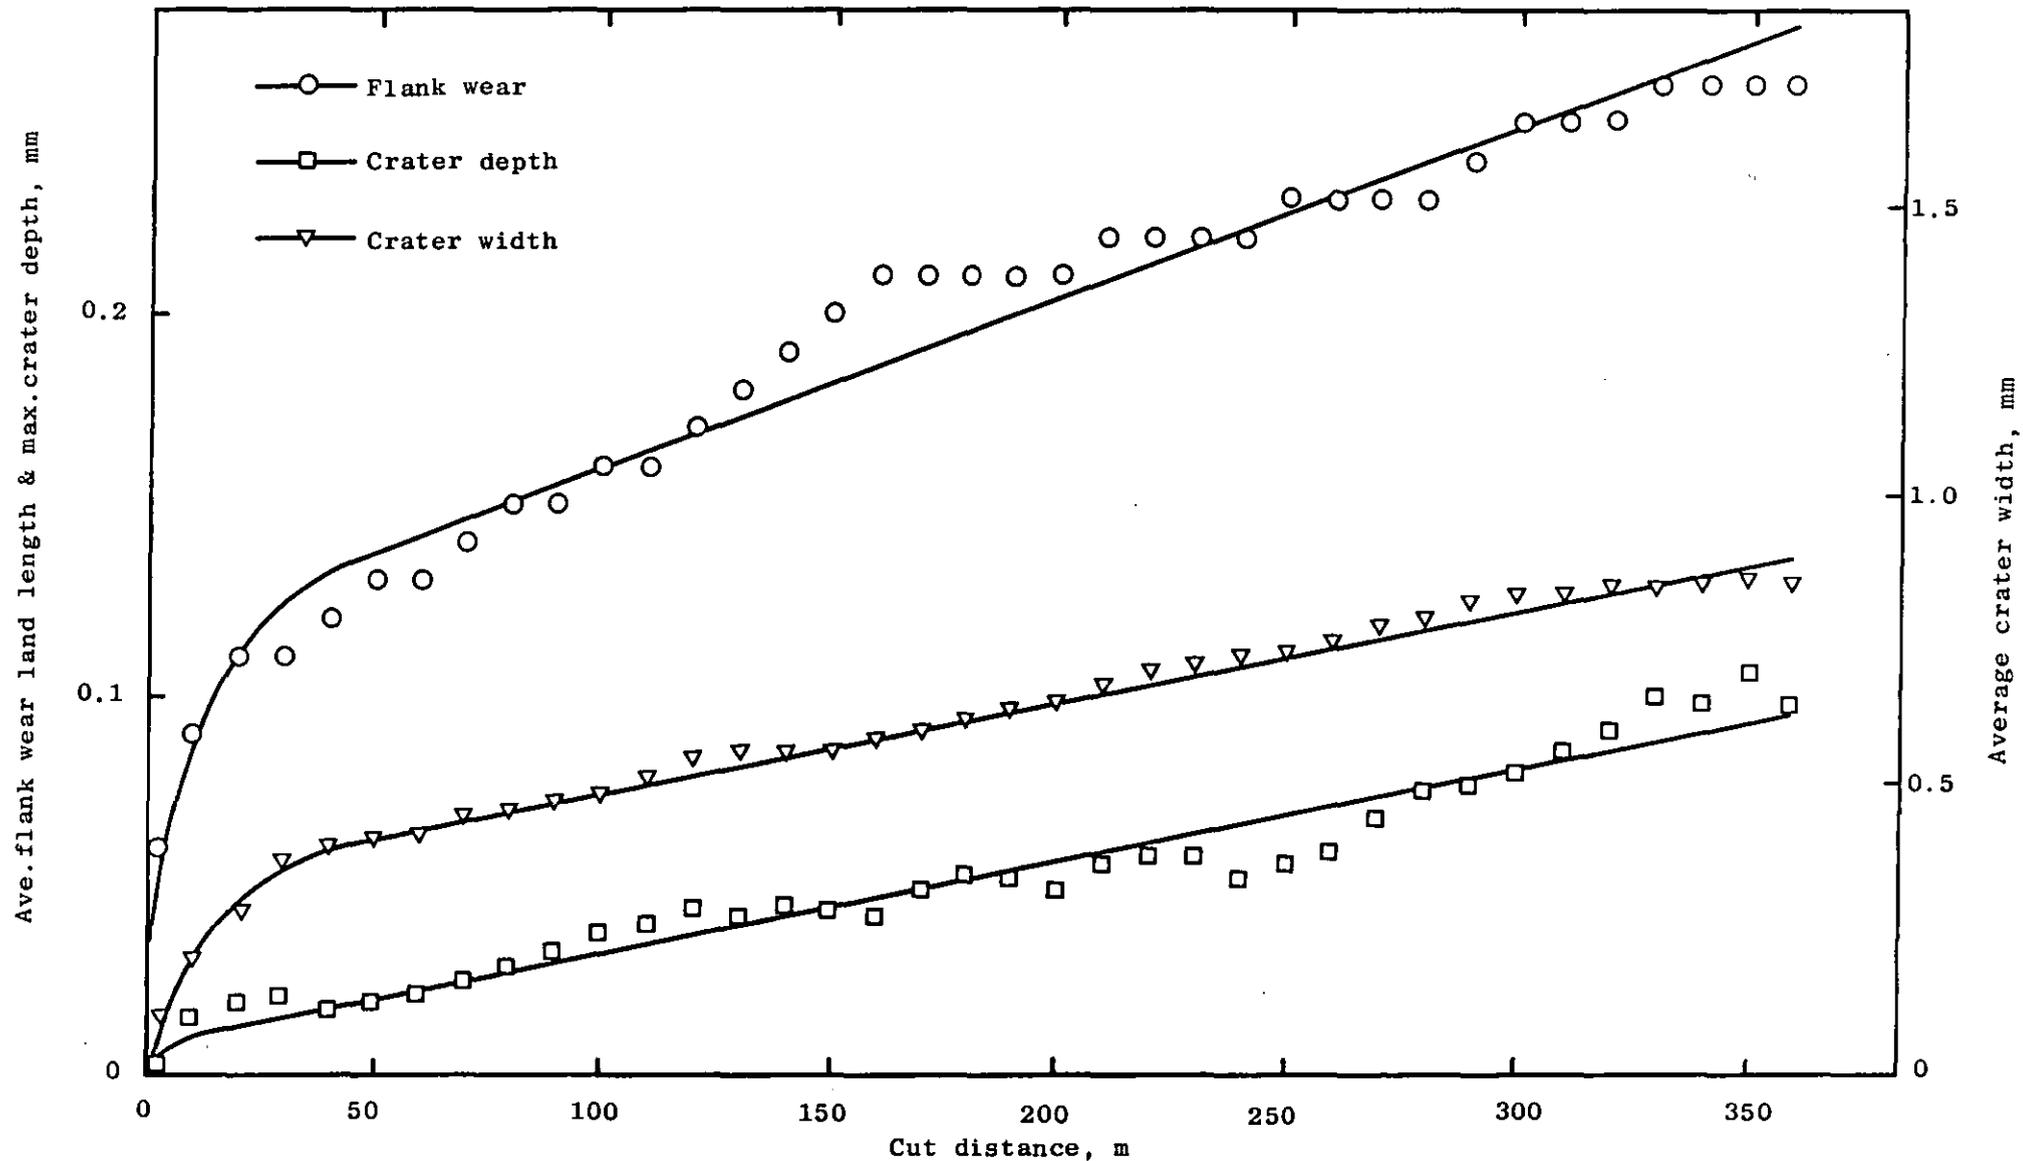
**Figure 5.52** Increase in average flank wear land length, maximum crater depth and average crater width of S.I.P. TiN coated inserts with cut distance. Cutting speed  $52.5 \text{ m min}^{-1}$

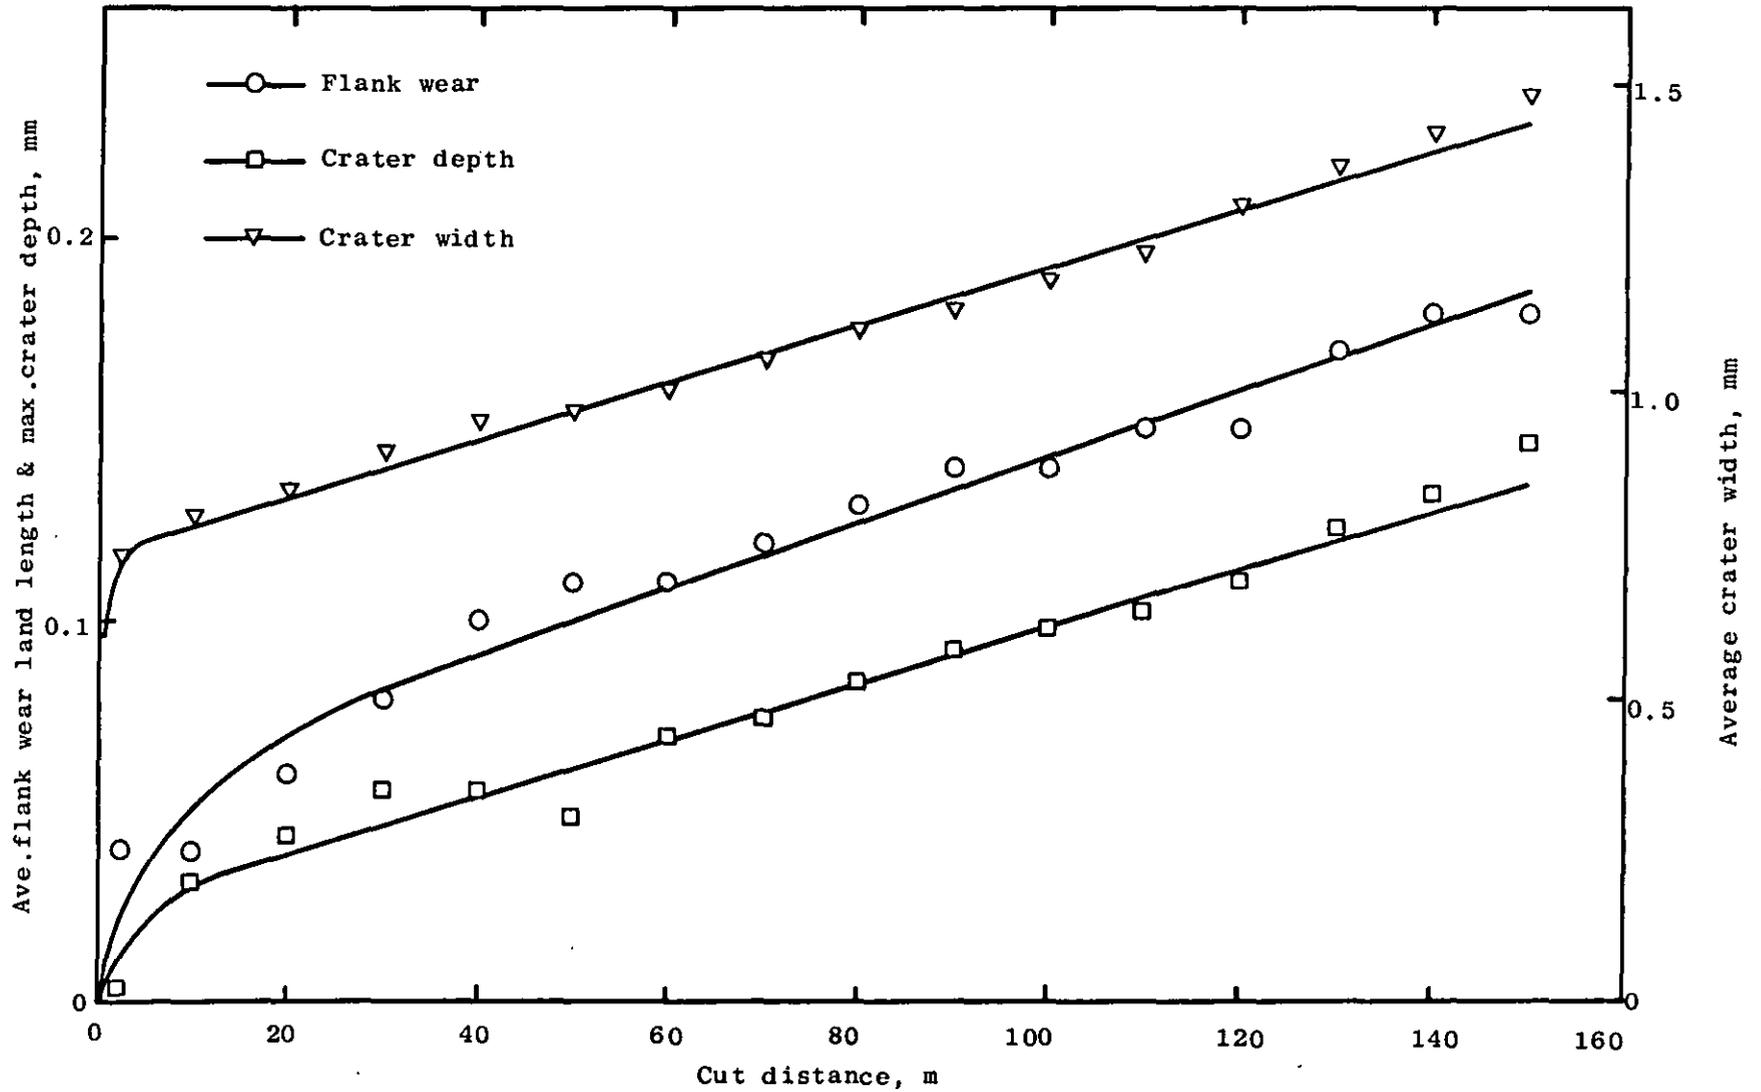
**Figure 5.53** Increase in average flank wear land length, maximum crater depth and average crater width of S.I.P. TiN coated inserts with cut distance. Cutting speed  $60 \text{ m min}^{-1}$ .

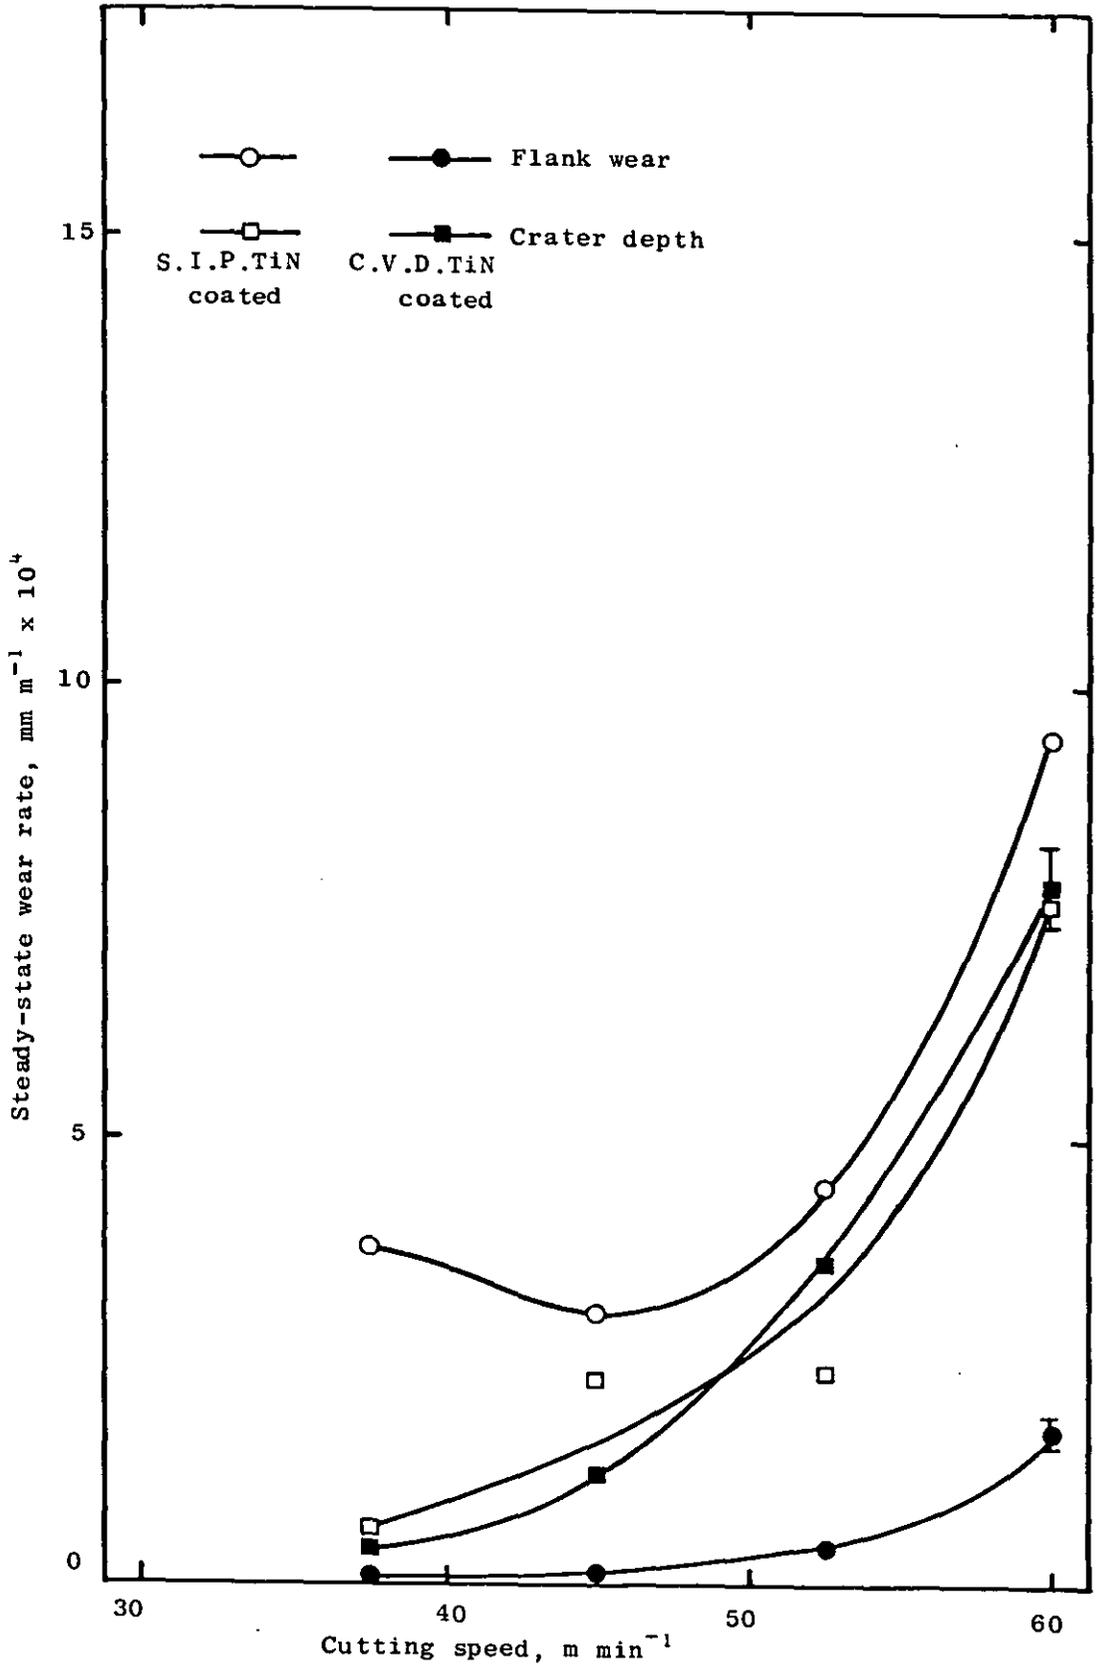
**Figure 5.54** Steady-state flank and crater depth wear rates of S.I.P. and C.V.D. TiN coated inserts versus cutting speed.

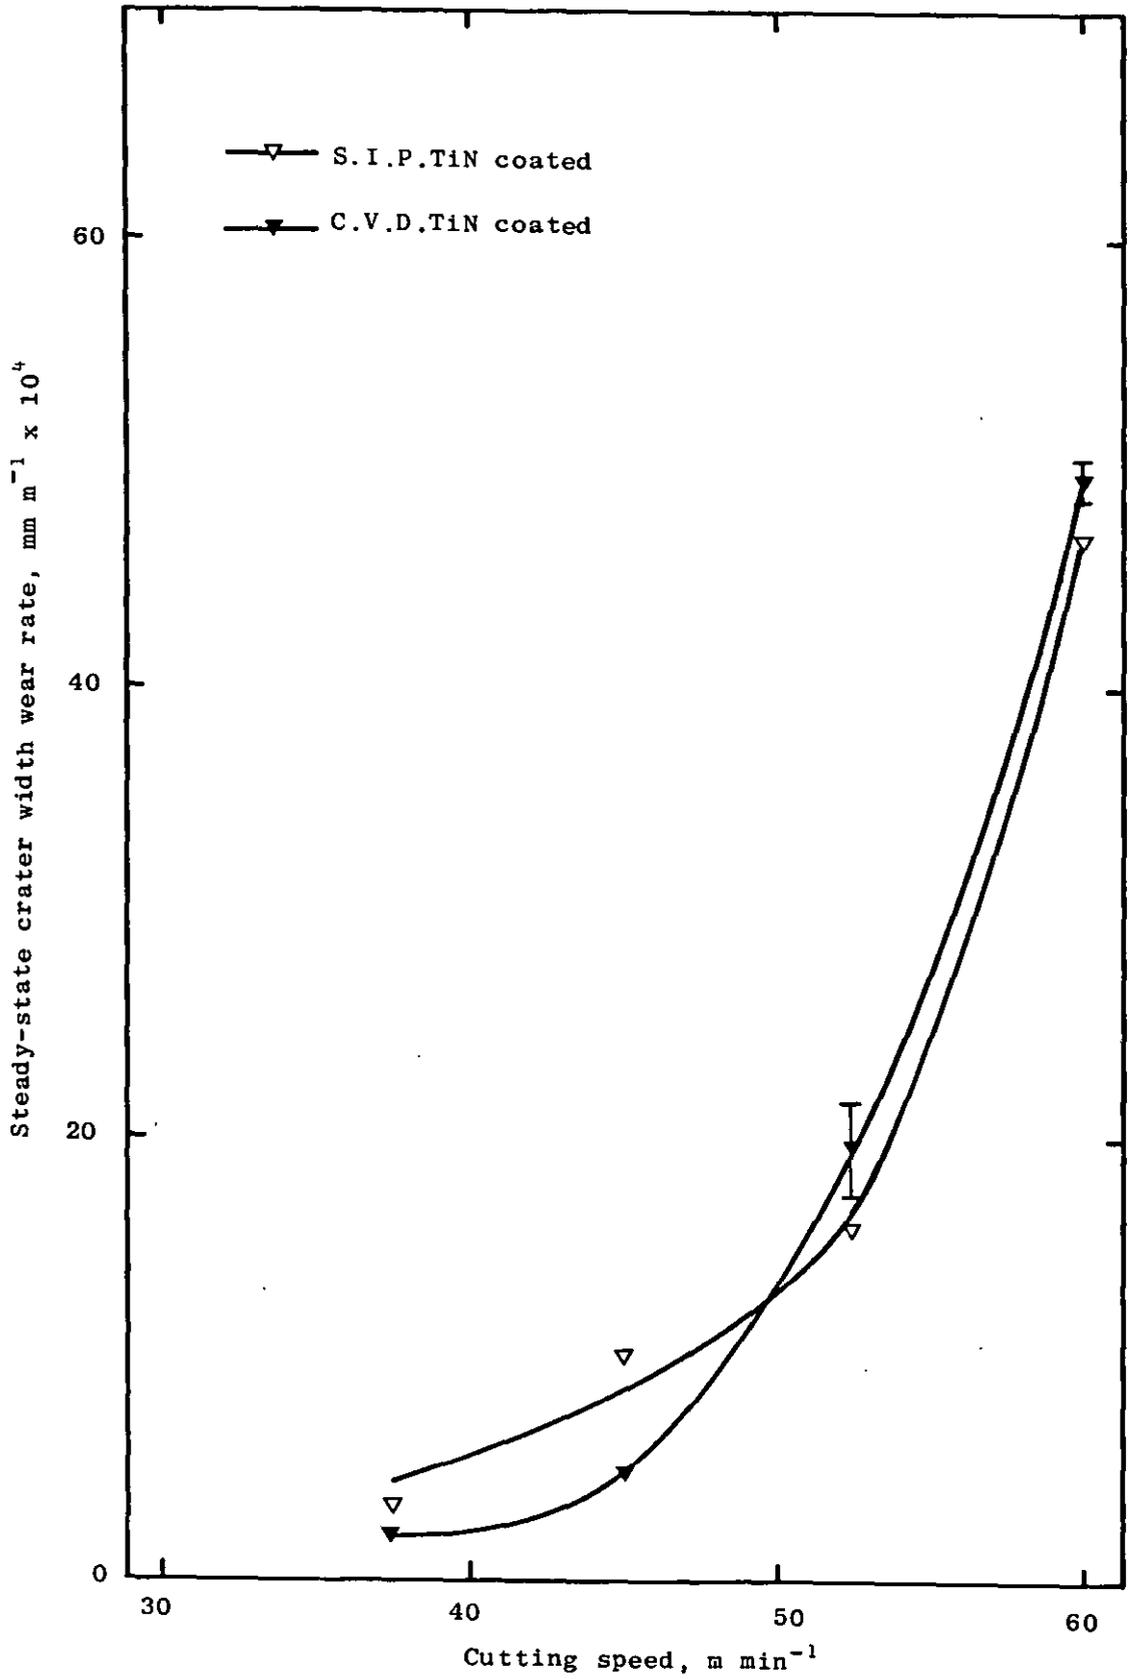
**Figure 5.55** Steady-state crater width wear rate of S.I.P. and C.V.D. TiN coated inserts versus cutting speed.

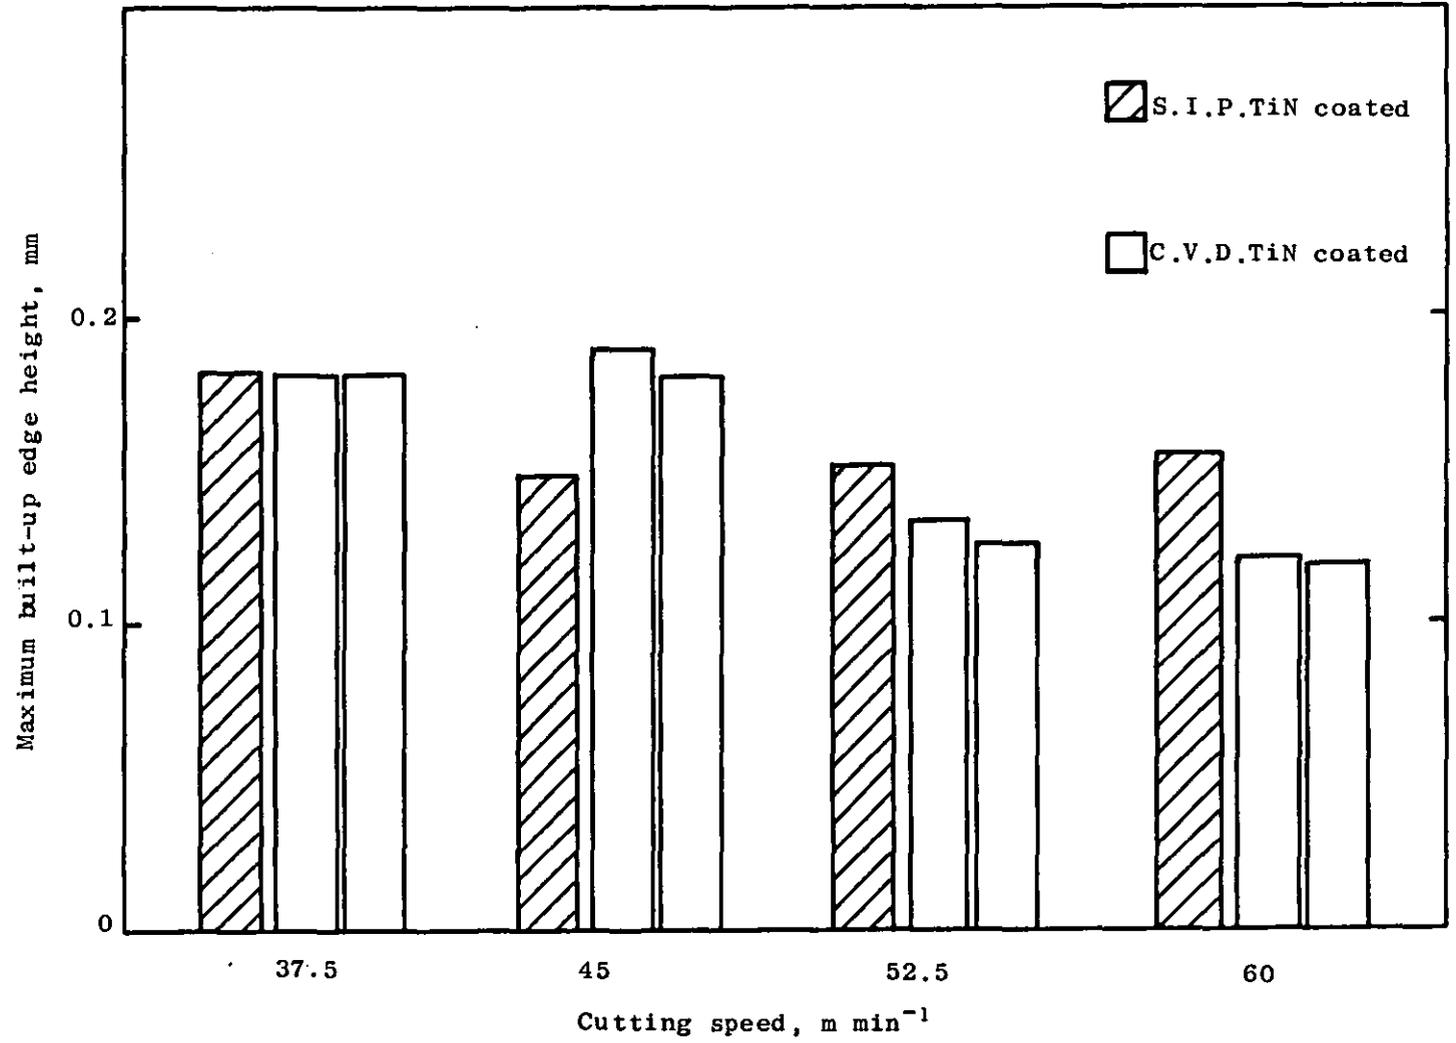
Figure 5.56 Maximum height of b.u.e. on S.I.P. and C.V.D. TiN coated inserts.

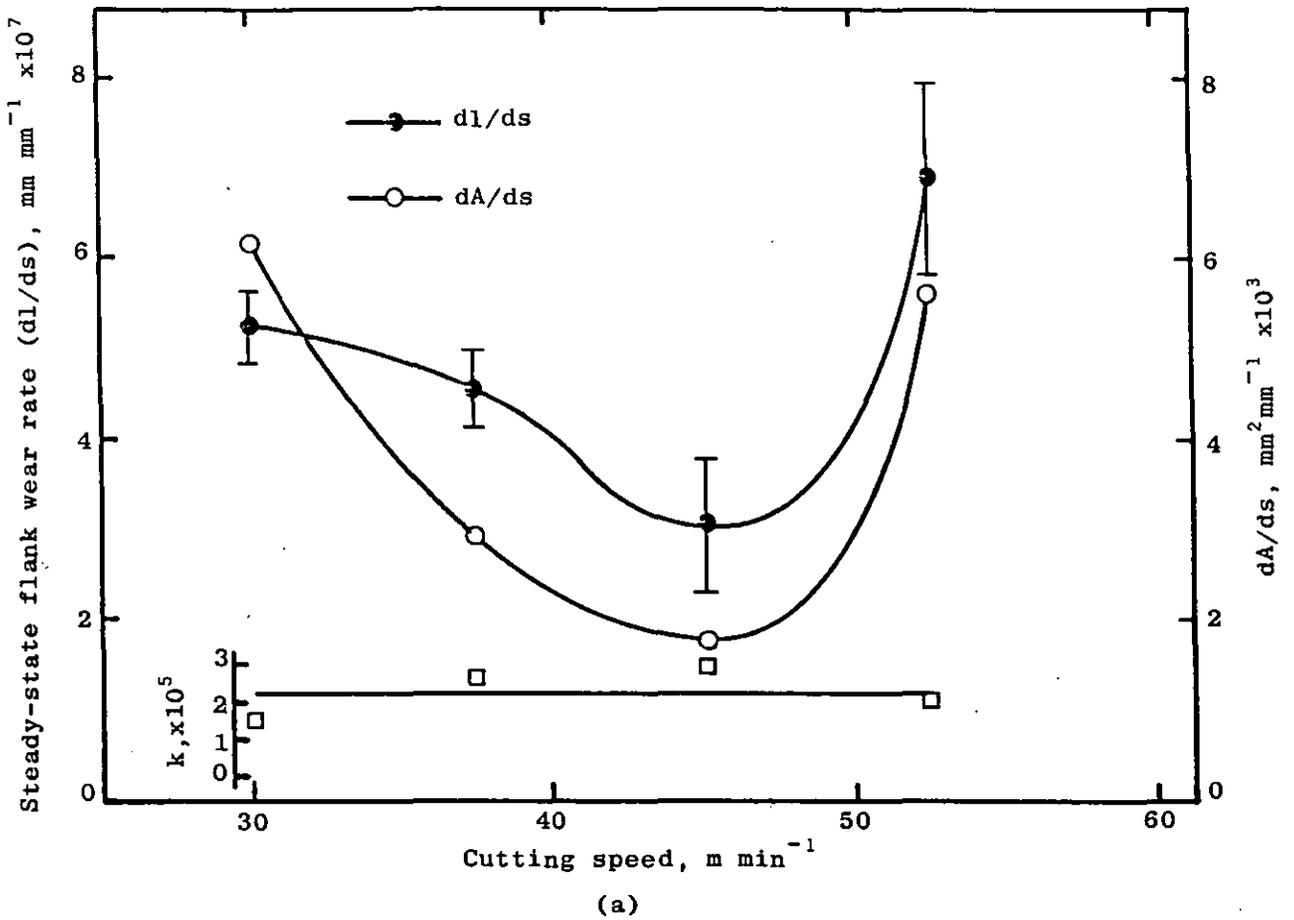
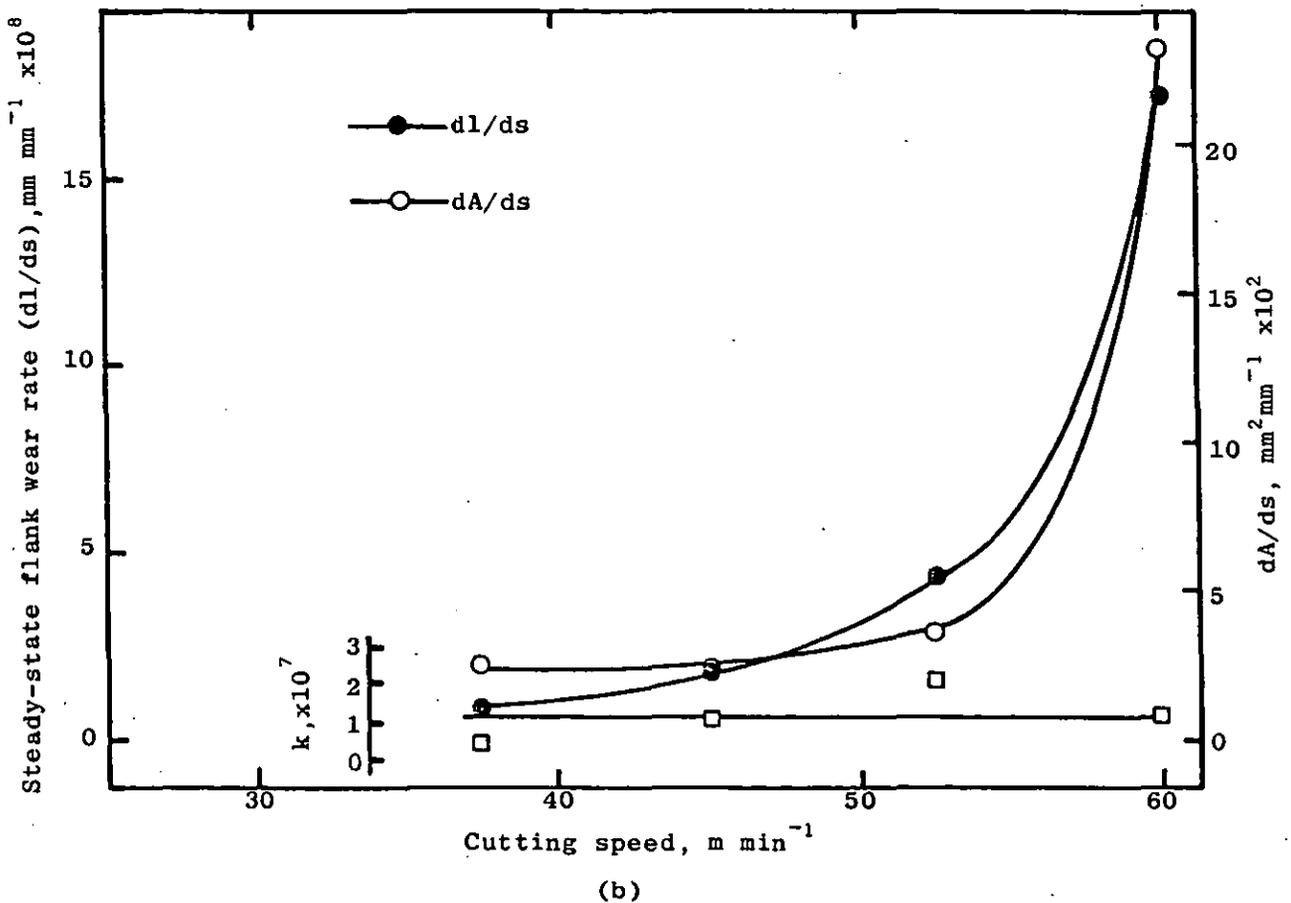
**Figure 6.1** Effect of cutting speed on steady-stage flank wear rate ( $dl/ds$ ), total area of b.u.e. fragment plateaux per unit sliding i.e. cut distance ( $dA/ds$ ) and wear coefficient  $k$ . (a) uncoated inserts, (b) C.V.D. TiN coated inserts.

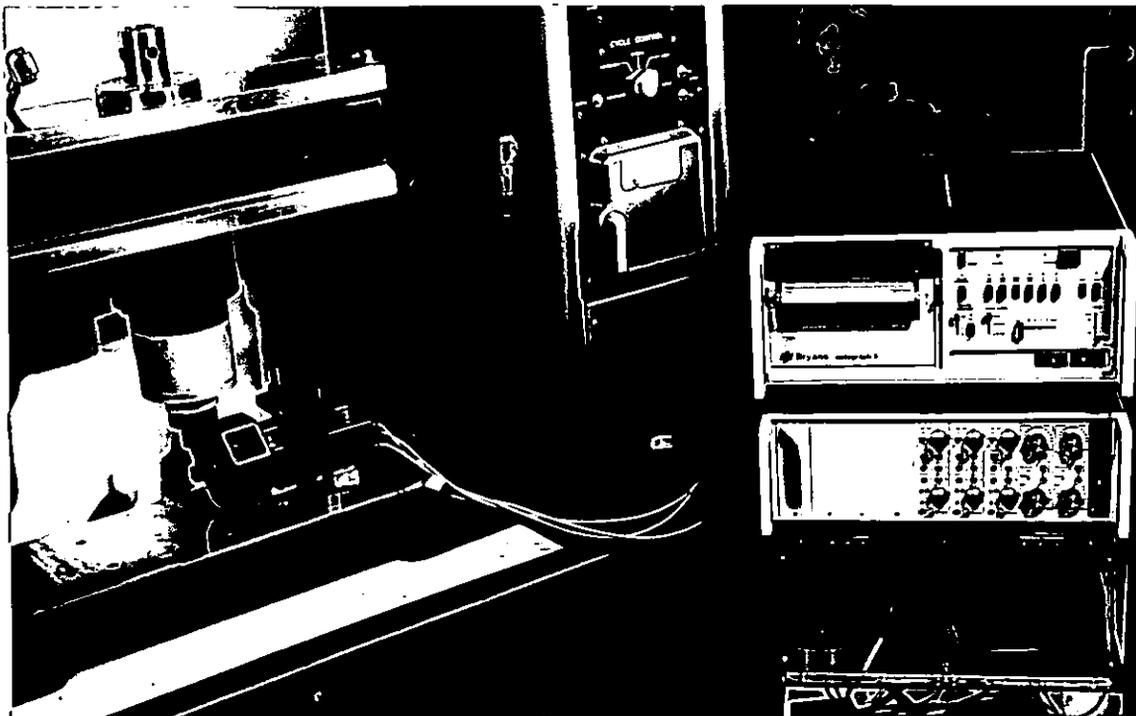
Figure A1.3 General set-up used for calibration of three-component strain gauge dynamometer.

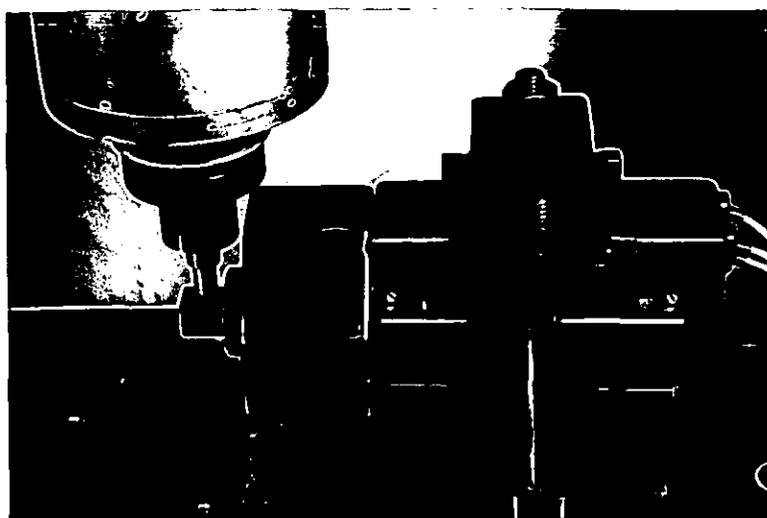
**Figure A1.5** Strain gauge dynamometer located for calibration in (a) Vertical, (b) Axial and (c) Radial direction.
