# Investigation of Zinc Whisker Growth from Electrodeposits Produced Using an Alkaline Non-Cyanide Electroplating Bath

By Liang Wu

Department of Materials, Loughborough University, UK

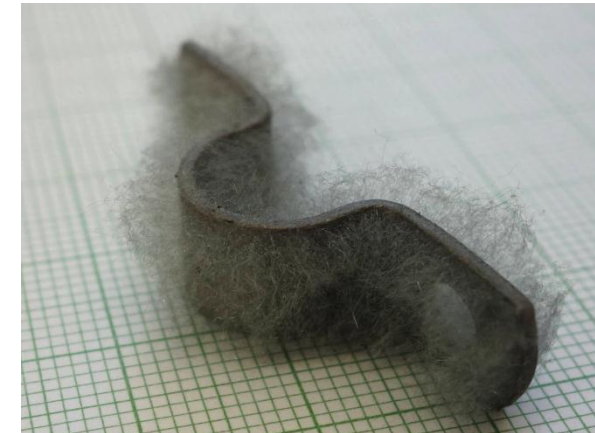
Many long zinc whiskers on zinc coated steel [1]

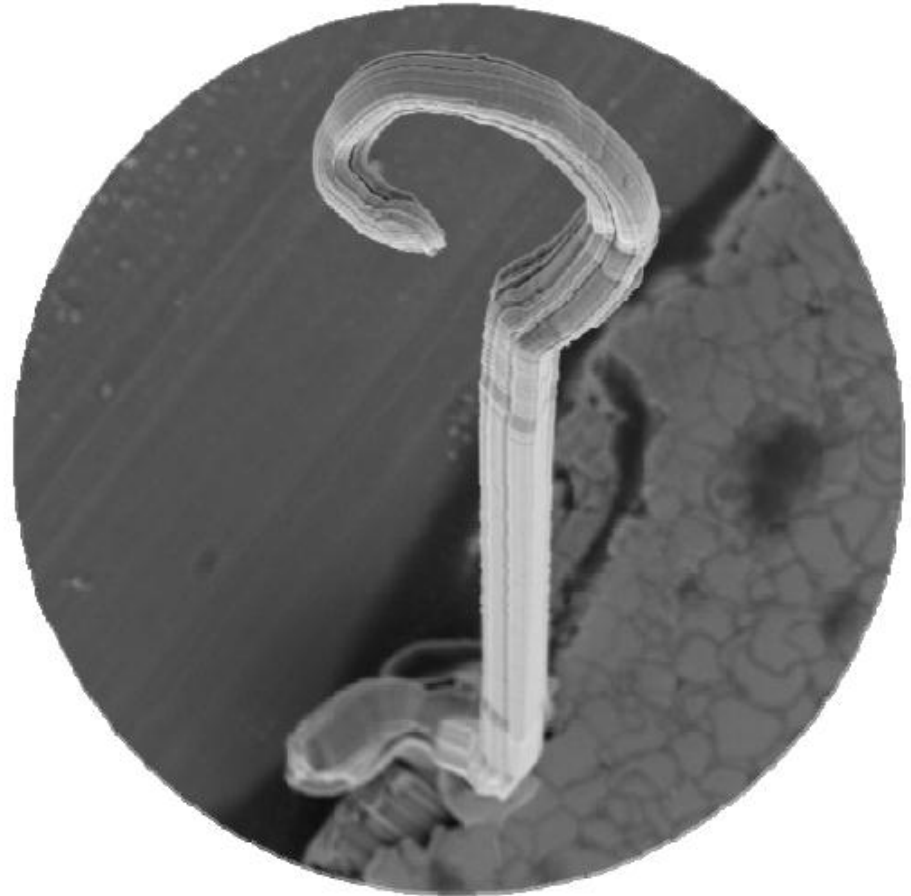
'Question mark' tin whisker from Dr Mark Ashworth
