## **AIS 3+ head injury mechanisms and crash characteristics - a review of airbag deployed crashes**

# **AIS 3+ HEAD INJURY MECHANISMS AND CRASH CHARACTERISTICS - A REVIEW OF AIRBAG DEPLOYED CRASHES**

**Ruth Welsh, Steven Reed, Andrew Morris  
VSRC, Loughborough University, UK**

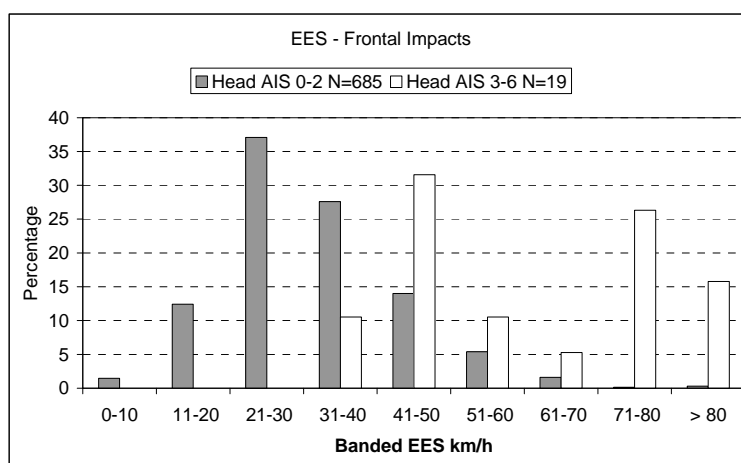
**Figure 1 Crash Severity (EES) - Frontal Impacts**

Figure 1 shows the impact speed (approximated by Equivalent Energy Speed - EES) for those occupants with AIS 3+ head injury compared to those with AIS 0-2 head injury outcome. There is a clear shift towards higher severity crashes for the AIS 3+ cases.

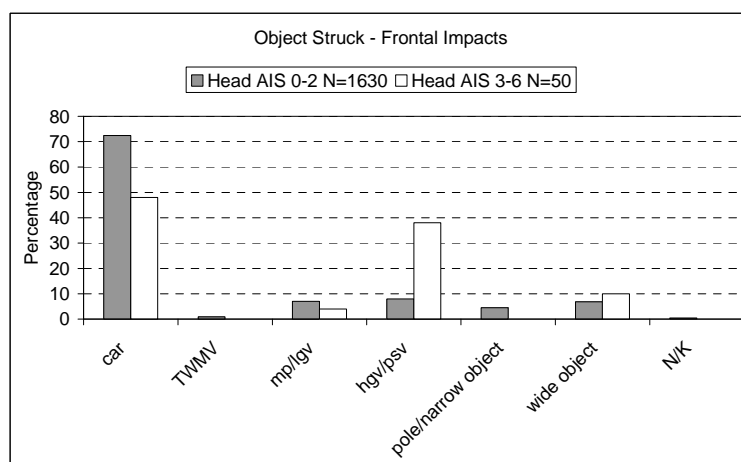
**Figure 2 Impact Object - Frontal Impacts**

Considering the impact object, figure 2 shows that there is a considerably higher proportion of impacts with large vehicles (HGV - Heavy Goods Vehicle / PSV - Public Service Vehicle) for cases with AIS 3+ head injury outcome compared to those with AIS 0-2 outcome.

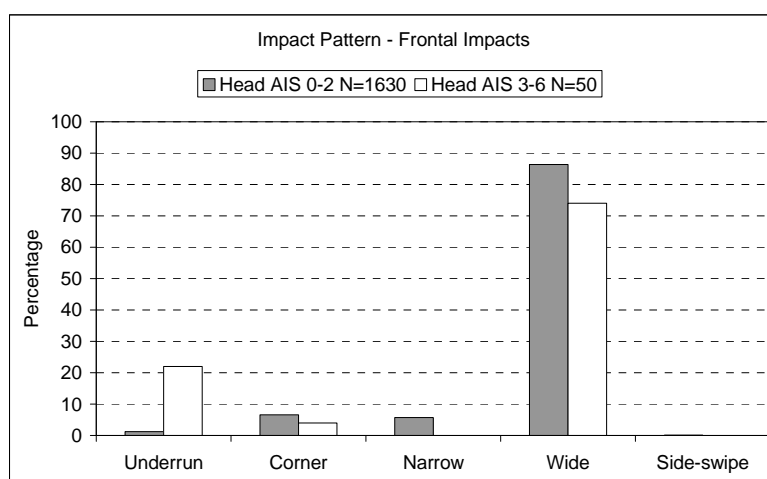
**Figure 3 CDC Impact Pattern - Frontal Impacts**

The 'type' of impact according to the CDC classification is shown in figure 3. In accordance with the higher rate of impacts to large vehicles, cases with AIS 3+ head injury outcome show a higher prevalence of underrun type impacts compared to those with AIS 0-2 head injury outcome.

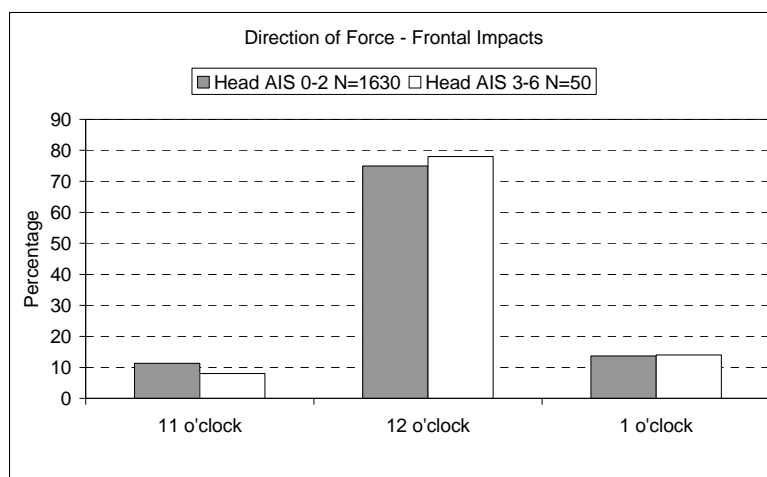
**Figure 4 CDC Direction Of Force Of Impact - Frontal Impacts**

Comparing the direction of force of the impact, figure 4 shows there to be little variation between those cases with AIS 3+ head injury outcome and those with AIS 0-2 head injury outcome.

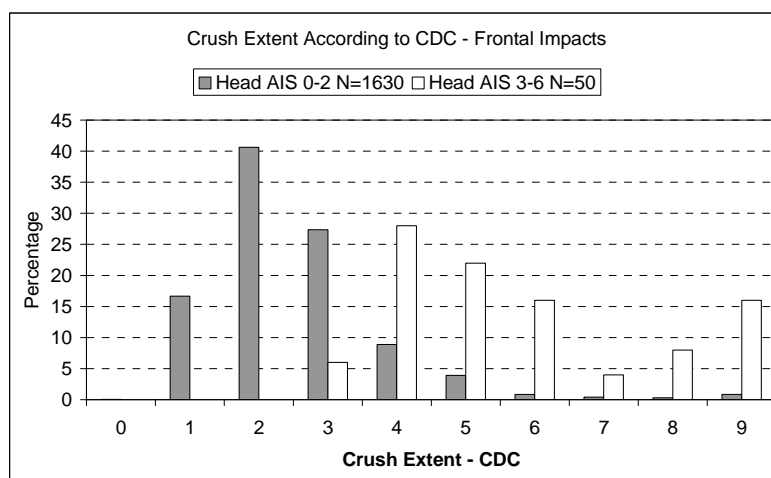
**Figure 5 CDC Crush Extent - Frontal Impacts**

Considering the CDC crush extent, figure 5 shows clearly that the AIS 3+ cases have a higher crush distribution than the AIS 0-2 cases.

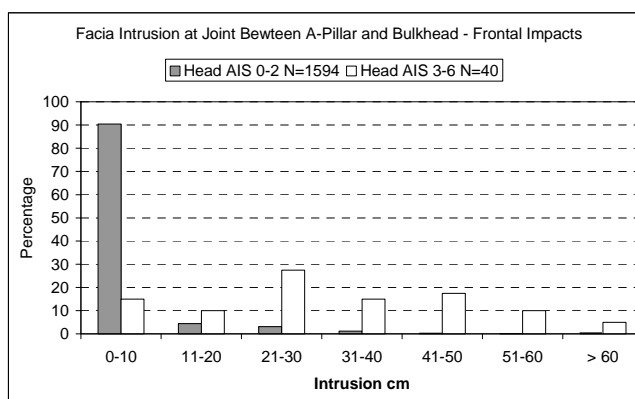
**Figure 6 Intrusion - Frontal Impacts**

Figure 6 (and associated diagram) shows the frontal intrusion into the passenger cell measured inwards from the joint between the A pillar and the bulkhead. It is apparent that greater intrusion is associated with the more serious head injury outcome group.

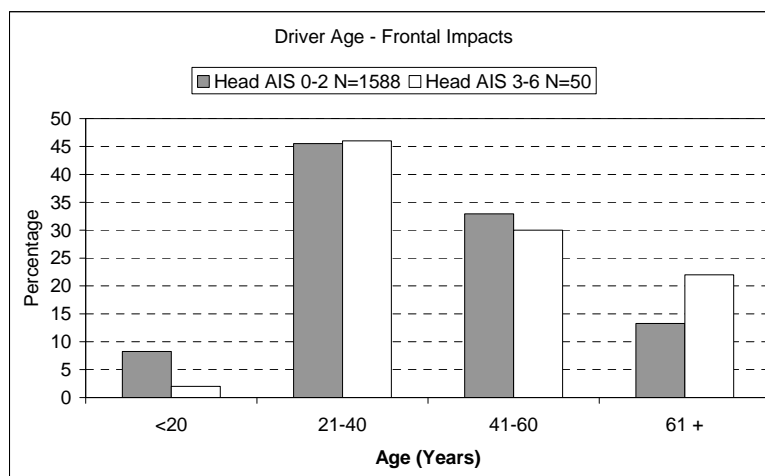
**Figure 7 Occupant Age - Frontal Impacts**

Figure 7 shows the age distribution for the AIS 3+ head injury cases and the AIS 0-2 head injury cases. Four age bands have been considered, <20, 21-40, 41-60 and 61+. There appears to be an over-representation of AIS 3-6 head injuries in the older age group.

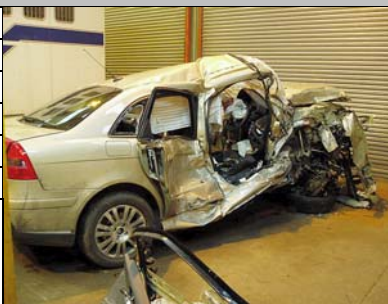
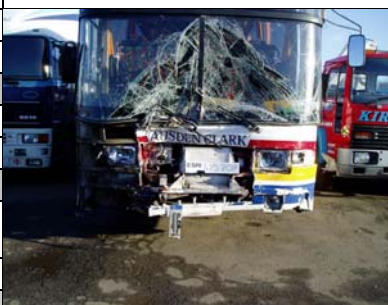
Case 1 - Fatal

CDC	03RYAW4	
Impact Object	Coach	
EES	43 km/h	
Maximum Crush	460 mm	
Relevant lateral intrusion	300mm from base of window down to sill	
Belt Use	Belted	
Airbags	Hub - Activated Knee bolster - Activated Seat back thorax - Activated Curtain - Activated	
Occupant Age	57 years	
Occupant Gender	Male	
Head Injuries and sources

# Skull AIS 3 - External object		
Subdural bleed AIS 4 - External object		
Other injuries		
Multiple fractured ribs with hemothorax AIS 5		
Liver lacerations AIS 2		
Cause of Death		
Multiple injuries		
Comments		
The head injuries are attributed to contact with an external object, there is evidence of hair and skin tissue at the base of window of the coach. Due to the nature of the impact the resultant deformation may give the impression of a higher energy impact than that calculated. The calculated value is believed to be representative. The side curtain has deployed. The side curtain would have been expected to have provided head protection to mitigate this kind of injury.

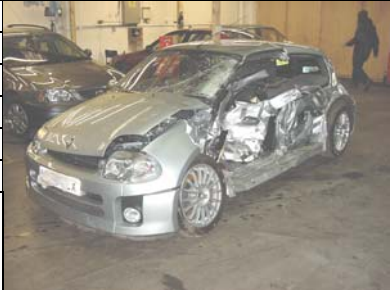
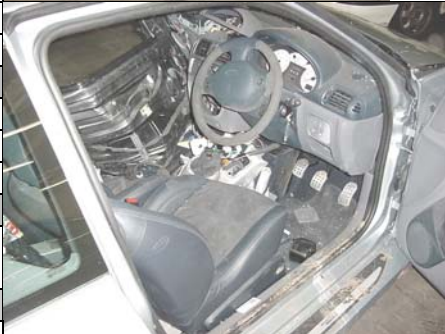
Case 2 - Fatal

CDC	09LPEW4	
Impact Object	Citroen Van	
EES	32 km/h	
Maximum Crush	590 mm	
Relevant lateral intrusion	550 mm base window/mid door	
Belt Use	Belted	
Airbags	Facia - Not Activated Seat back head and thorax- Activated	
Occupant Age	20 years	
Occupant Gender	Male	
Head Injuries and sources

# Skull AIS 2 - External object		
Subarachnoid Hematoma AIS 3 - External object		
Cerebral Oedema AIS 3 - External object		
Other injuries		
# Ribs with Hemothorax AIS 4 , Diaphragm tear AIS3, Spleen injury AIS 2, # Pelvis AIS 2		
Cause of Death		
Multiple injuries		
Comments		
The head injuries are attributed to contact with an external object, the striking vehicle. It is possible that the calculated EES value is a slight underestimate. The seat back head/thorax bag has deployed. The side bag would have been expected to have provided head protection to mitigate this kind of injury.

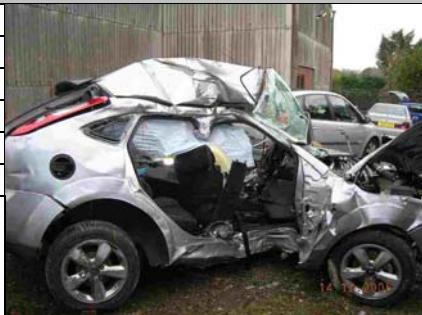
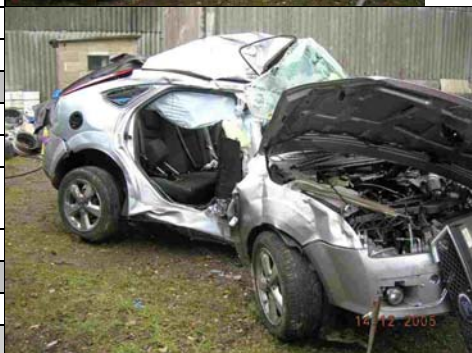
Case 3 - Fatal		
CDC	03RPAW5

Impact Object	Tree	
EES	n/k	
Maximum Crush	910 mm	
Relevant lateral intrusion	550 mm at cant rail	
Belt Use	Belted	
Airbags	Hub - Not activated Seat back thorax - Not activated Curtain - Activated

Occupant Age	47 years	
Occupant Gender	Male	
Head Injuries and sources		
Extensive regions of disruption to brain stem AIS 5 - B Pillar		
Extensive regions of disruption to the cerebellum AIS 3 - B Pillar		
Extensive regions of disruption to both cerebral hemispheres AIS 3 - B Pillar		
Complicated fracture base and vault of skull AIS 4 - B Pillar		
Other injuries

# Pelvis AIS 2, Liver Lacerations AIS 4, # Arm AIS 2		
Cause of Death		
Head Injuries		
Comments		
Given the crush extent the crash severity is likely to be high but no reliable calculation could be made due to the nature of the damage. Though the head injuries have been attributed to the B pillar in this case, it is also likely that some external contact was made with the tree given the location of the impact and the perpendicular direction of force. The curtain might have been expected to offer better head protection.

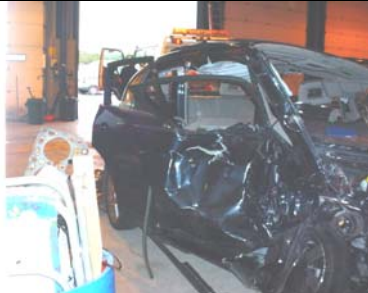
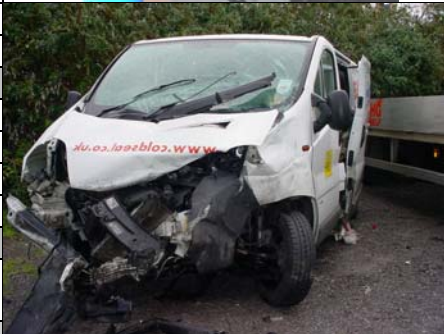
Case 4 - Fatal

CDC	01RYAW3	
Impact Object	Vauxhall Van	
EES	44 km/h	
Maximum Crush	560 mm	
Relevant lateral intrusion	340 mm at base of door	
Belt Use	Belted	
Airbags	Hub - Activated Seat back thorax - Activated Curtain - Activated	
Occupant Age	73 years

Occupant Gender	Male	
Head Injuries and sources		
Subdural haemorrhage AIS 4 - Own side nfs		
Subarachnoid haemorrhage AIS 3 - Own side nfs		
Brain swelling AIS 3 - Own side nfs		
Contusions in cortex AIS 3 - Own side nfs		
Other injuries

# leg, # thoracic spine, # ribs with hemothorax, lung contusions, ruptured atrium, liver and kidney lacerations		
Cause of Death		
Multiple injuries		
Comments		
Due to the nature of the impact, the resultant deformation may give the impression of a higher energy impact than that calculated. The calculated value is however believed to be representative. This elderly occupant has received a fatal injury to the heart. Given the extent of the vehicle damage and the deployed side airbags, the head injuries are surprising.

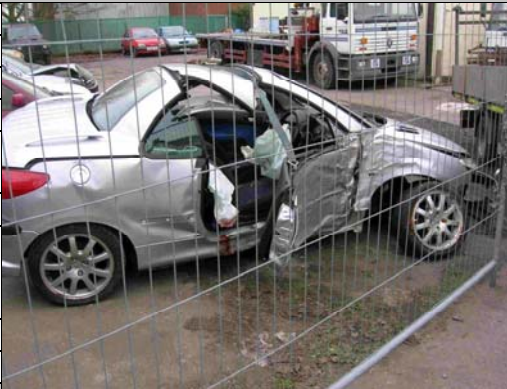
Case 5 - Fatal		
CDC	02RPAW3

Impact Object	Tree	
EES	33 km/h	
Maximum Crush	320 mm	
Relevant lateral intrusion	180 mm from cant rail down to mid door level	
Belt Use	Belted	
Airbags	Hub - Activated Seat back head and thorax - Activated	
Occupant Age	63 years	
Occupant Gender	Female	
Head Injuries and sources

# Base of skull AIS 3 - external contact with tree		
Subarachnoid haemorrhage AIS 3 - tree		
Intraventricular haemorrhage AIS 4 - tree		
Other injuries		
Pleural haemorrhage AIS 3		
Cause of Death		
Multiple injuries		
Comments		
The calculated EES is believed to be representative of the impact. This is a convertible. The side head airbag is relatively small. The non perpendicular impact could have resulted in occupant kinematics such that the head missed both the hub and the side airbag during the impact phase. If a larger airbag had been present then the contact with the tree may have been avoided.

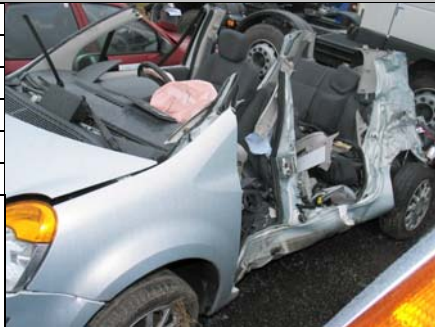
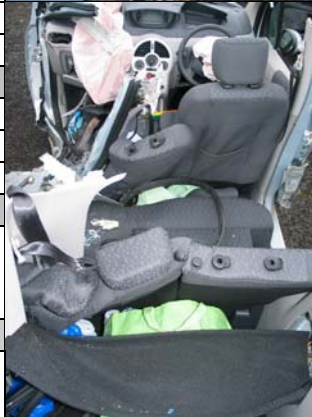
Case 6 - Fatal			
CDC	10LZAW5

Impact Object	Truck		
EES	Not Known		
Maximum Crush	380 mm		
Relevant lateral intrusion	710 mm at base of window		
Belt Use	Belted		
Airbags	Facia - Activated Seat back thorax - Activated Curtain - Activated		
Occupant Age	52 years		
Occupant Gender	Female		
Head Injuries and sources

Basal # Skull AIS 3 - External object			
Blood present in meninges AIS 3 – External object			
Bone shards present in brain stem AIS 6 – External object			
Other injuries			
Multiple rib # with bilateral haemopneumothorax AIS 5, Atlanto-axial subluxation with severed spinal cord AIS 6,# spine AIS 2, Bilateral acetabulum # & multiple pelvic #s AIS 2			
Cause of Death			
Multiple injuries			
Comments			
The head injuries are attributable to an external object (Truck) and the extensive intrusion into the vehicles nearside would support this. Considering the level of intrusion the curtain bag could have provided a level of protection although overloading may be a possibility

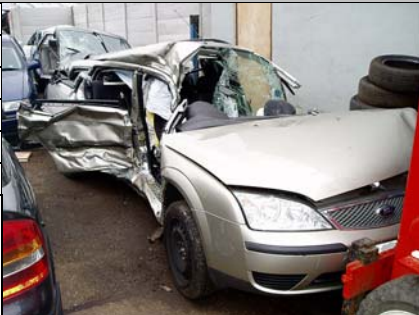
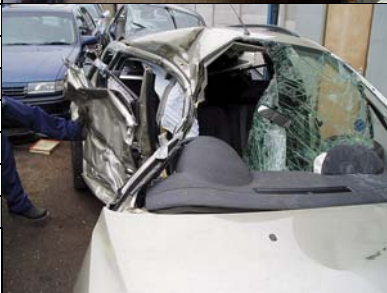
Case 7 - Serious		
CDC	01RYAW4

Impact Object	Truck	
EES	45 km/h	
Maximum Crush	400 mm	
Relevant lateral intrusion	350 mm base of window / mid door	
Belt Use	Belted	
Airbags	Hub - Activated Seat back - Activated Curtain - Activated	
Occupant Age	28 years	
Occupant Gender	Male	
Head Injuries and sources

# Base of skull, CSF leak AIS 3 - External object

Cerebral contusions AIS 3 - External object		
Subdural hematoma AIS 4 - External object		
Other injuries		
Internal chest injuries AIS 3		
Comments		
Due to the nature of the impact the resultant deformation may give the impression of a higher energy impact than that calculated. The calculated value is believed to be representative. The head injuries are attributed to contact with an external object though no inspection was made of the truck. The side curtain has deployed. The side curtain would have been expected to have provided head protection to mitigate this kind of injury.

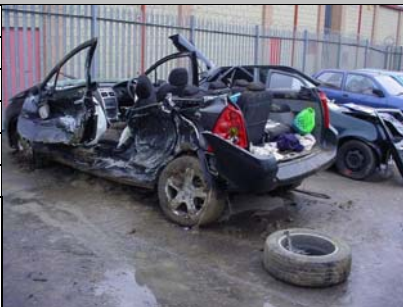
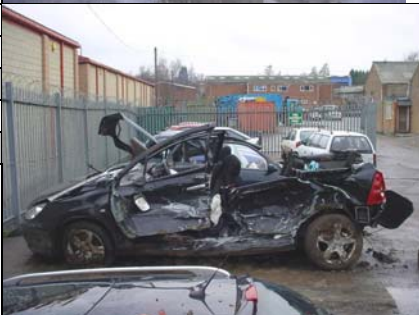
Case 8 - Serious		
CDC	09LPEW3

Impact Object	Car	
EES	35 km/h	
Maximum Crush	400 mm	
Relevant lateral intrusion	200 mm at cant rail and mid door level

Belt Use	No evidence of belt use	
Airbags	Facia - Activated Seat back thorax - Activated Curtain - Activated	
Occupant Age	16 years	
Occupant Gender	Male	
Head Injuries and sources		
Small brain hematoma AIS 3 - Own side/B pillar		
Other injuries		
None		
Comments		
This vehicle has been substantially damaged by the emergency services giving the impression of a higher severity impact. The calculated EES is believed to be representative. The only injury to this occupant is the brain hematoma. The curtain would have been expected to mitigate this type of injury. There was no evidence of belt use. This was a perpendicular impact and therefore evidence of belt use is not necessarily expected.

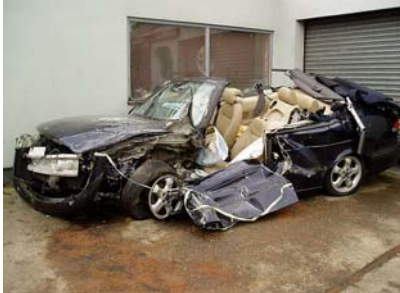
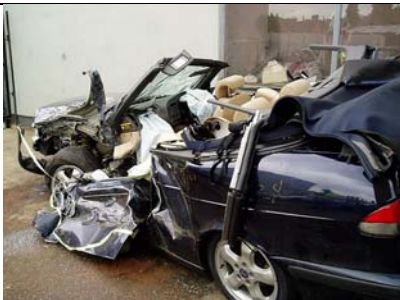
Case 9 - Serious		
CDC	11LYAW4

Impact Object	Transit Van	
EES	31 km/h	
Maximum Crush	400 mm	
Relevant lateral intrusion	390 mm at base of door	
Belt Use	Belted

Airbags	Facia - Activated Seat back head and thorax - Activated	
Occupant Age	66 years	
Occupant Gender	Female	
Head Injuries and sources		
Inter cerebral contusion AIS 3 - External object		
Subarachnoid haemorrhage AIS 3 - External object		
Other injuries		
AIS 2/3 injuries to the upper extremity, pelvis and lower extremity		
Comments		
The nature of the collision was such that there was substantial soft structure damage (e.g. the wings) which gives the impression of a higher EES. The calculated EES is believed to be representative. This is a convertible. The side head airbag is relatively small. The non perpendicular impact could have resulted in occupant kinematics such that the head missed the side airbag during the impact phase.

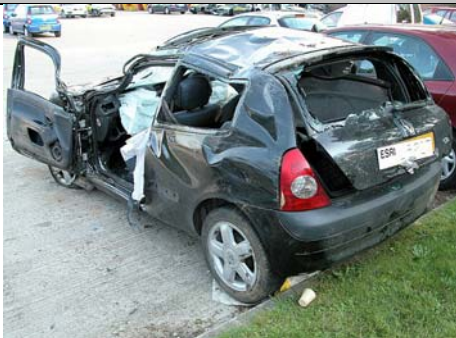
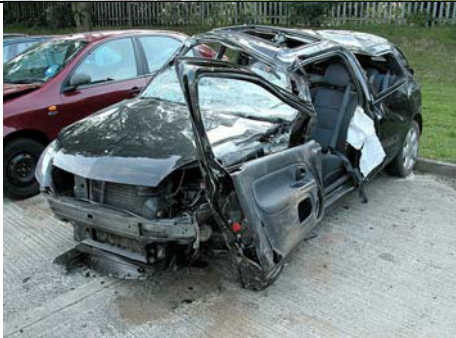
Case 10 - Serious		
CDC	00LDAW3

Impact Object	Ditch Side	
EES	U/K	
Maximum Crush	7mm	
Belt Use	Belted	
Relevant lateral intrusion	Nil

Airbags	Facia - Activated Seat back head and thorax - Activated	
Occupant Age	22 years	
Occupant Gender	Male	
Head Injuries and sources		
# Skull AIS 2 - Roof		
Mild R subarachnoid haemorrhage AIS 3 – Roof		
Loss of consciousness AIS 2 - Roof		
Other injuries		
Abrasion with swelling L forehead AIS 1		
Comments		
The head injuries are attributable to a roof (internal cant rail area) contact due to the non horizontal impact with the ditch side. The seat back head and thorax bag has deployed and would be expected to mitigate these injuries.
