Landslide hazard evaluation by means of several monitoring techniques, including an acoustic emission sensor

N. Dixon & M.P. Spriggs

ABSTRACT: At Passo della Morte in the Italian Eastern Alps a geomorphological survey has identified potential instability of the valley side slope that could result in a debris/rock avalanche, which would threaten the Tagliamento River. A nationally important road passes through a tunnel 130 m long behind the potentially unstable slope. The stratum comprises a sequence of Limestone layers, dipping in the slope direction towards the river. Although currently there is no clear evidence of movement, the geological setting indicates a pre-disposition to instability that could involve a large landslide and extremely fast deformations can be foreseen. To appraise the physical characteristics of the rock mass and to provide an early warning of instability, monitoring instrumentation has been installed and monitored since late 2010. Extensometers, MEMS, TDR cables, a vertical inclinometer, a seismic station to monitor Limestone rock mass deformation generated micro-tremors and an acoustic emission (AE) monitoring system have been installed. The instruments

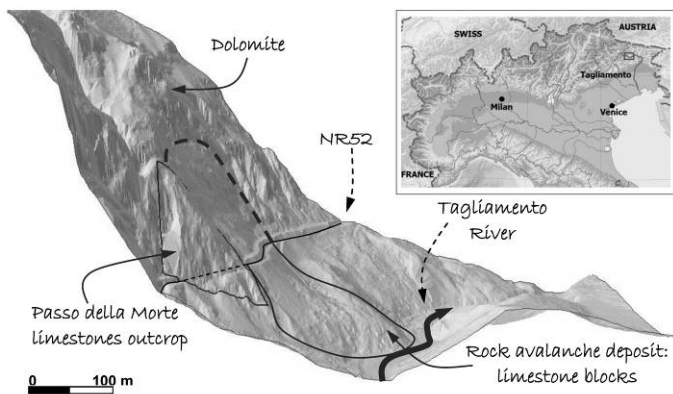
Figure 1. Area of investigation at Passo della Morte and 3D representation of the slope with the landslides highlighted.

The paper deals with two related phenomena (Figure 1); one developed in the past as a rock avalanche which caused a temporary 20 meters deep damming of the Tagliamento River Valley, the other represents a potential landslide due to the structural setting of the slope that shows signs of instability with different mechanism of slope evolution possi-

The left flank of the Tagliamento River Valley, east of Forni di Sotto along the National Road 52 (Figure 1), is affected by several hill-slope processes, characterized by a range of typologies and different state of activity (Marcato 2007). These phenomena were mainly caused by debuttressing due to a melting glacier, which occupied the valley until approximately 10,000 years ago. The landslide blocks at this site influence operation of two road tunnels and they have the potential to impact on the Tagliamento River through valley damming. The potentially unstable slope is formed from Limestone (Calcarei scuri stratificati - lower Carnian), with Dolomite (Dolomia dello Schlern - upper Ladinian) forming the underlying bedrock (Figure 1).

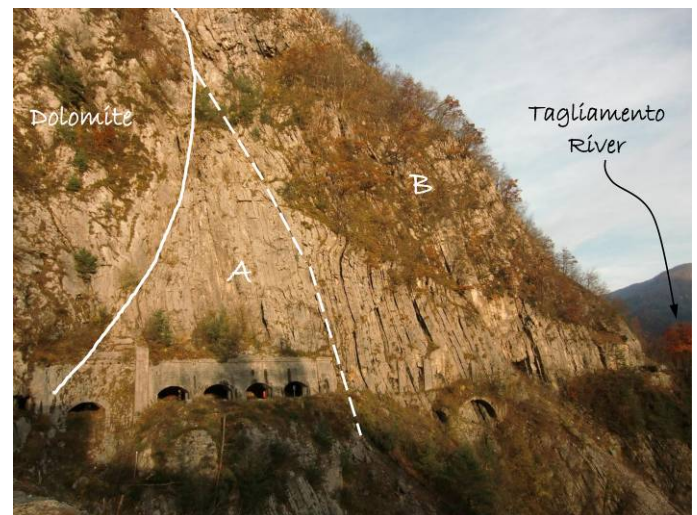
Figure 2. Limestone rock mass, Zone A is described as a compact rock mass while Zone B is characterized by open bedding discontinuities. The dashed line marks the boundary between Zones A and B and coincides with a poor Rock Quality Design (RQD <25%) band, two metres wide.

From the structural point of view it is possible to identify in the Limestone rock mass two distinct zones. These are shown in Figure 2 where they are divided by the dashed line.

- Zone A has planar and slightly irregular layers, the bedding planes are substantially closed or rarely open a few millimeters and fill material is absent.
- Zone B is characterized by open bedding planes, or partially open, that are planar to undulating and have marl in-filling. In the upper part of the zone, associated with small folds, the Limestone layers have a shallower slope angle.

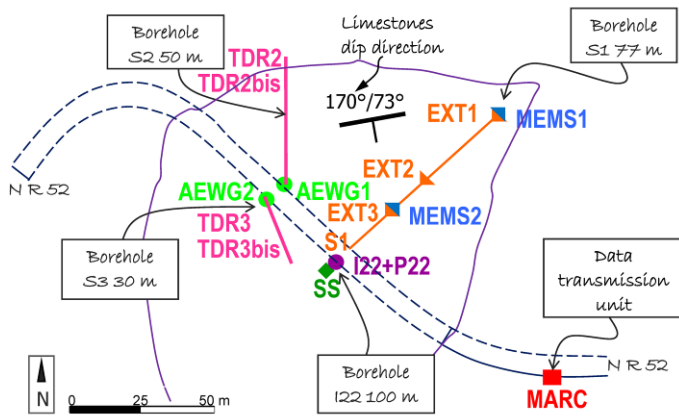
Figure 3. Plan view of the monitoring system layout.

Four boreholes were drilled in the rock mass, three of them sub-horizontal (S1, S2 and S3) and one vertical (I22) at locations shown in Figure 3. They have been designed to investigate and then monitor the extent of the Limestone rock mass, taking into account the geological features and in particular the dip direction of the strata. The most important features monitored are:

The monitoring devices installed in the slope are listed in Table 1 and their locations are shown in Figures 3 and 4.

Boreholes S1, S2 and S3 were drilled from within the NR52 road tunnel (Figure 3). S2 and S3 were each instrumented with two TDR cables, with different diameters, and 50 mm diameter steel waveguides for acoustic emission monitoring (see Section 4). Borehole S2 penetrates the contact between the Limestone and Dolomite bedrock and S3 traverses the layers of Limestone located between the tunnel and outer face of the slope. The extensometers, TRD cables and waveguides were grouted in the boreholes using a cement and fine sand grout mix. Boreholes S1, S2 and I22 and associated instruments were formed/installed in November/December 2010 and S3 in September 2011. A seismic station (SS) was also installed in December 2010 and is located adjacent to the inclinometer borehole (Figure 3). This sensor (Mark L-4C 1.0 Hz seismometer) was set with a sampling frequency of 200 Hz and was designed, installed and operated by University of Trieste to measure micro-tremors generated by rock falls and deformations within the Limestone rock mass. It forms part of the regional seismic monitoring network. A weather station records temperature and precipitation for the site.

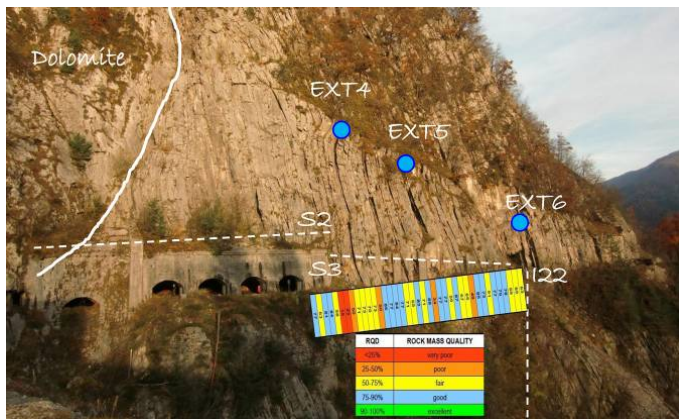
Figure 4. Projected RQD analysis from the S1 core on the west rock mass face, location of external extensometers and indicative location of inclinometer casing, wave-guides and TDR cables.

RDQ analysis was performed on the core retrieved from borehole S1 and this information was used to locate the anchor point for extensometer EXT1 within competent intact rock and to ensure monitoring takes place of the “poor” rock mass band within the Limestone. Three extensometers were installed in borehole S1 in order to understand which zones of the rock mass are involved in the landslide mechanism and hence to locate the primary shear plane that controls stability. Two MEMS type accelerometers were also installed in borehole 1 to provide additional information to the extensometer data trend. Core analysis also provided an opportunity to observe the type of fracturing affecting the rock mass, joint surface morphology and their condition. For example, interlayer marls when stresses reveal evidence of movement through the formation of graphite. Projection of the borehole S1 core analysis in the west rock mass face (Figure 4) supported the geomechanical survey and selection of the optimum type and location of sensors. High precision (± 0.01 mm) wire extensometers (EXT4, EXT5 and EXT6)

were installed across open bedding planes in areas of poor rock quality (Figure 4).

During the monitoring period to date only EXT4 has measured deformations. This extensometer is located on the slope surface across a bedding plane

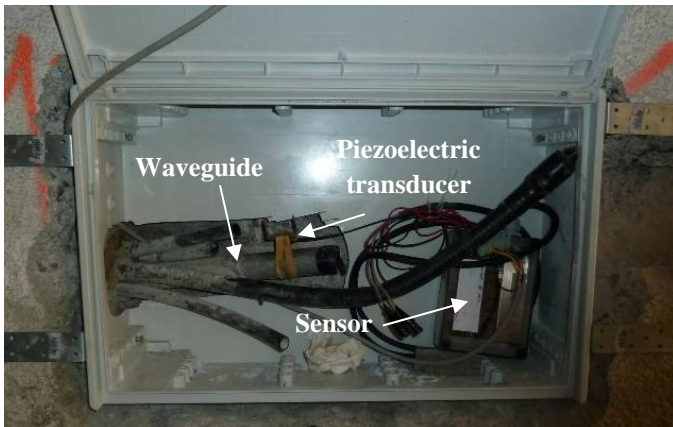
Figure 5. Piezoelectric transducer and AE sensor located on waveguide AEWG2, borehole S3.

The piezoelectric transducer is placed on the waveguide (Figure 5), and the sensor and waveguide are enclosed in a cover to eliminate the possibility of

anything coming into contact with the waveguide. The battery is charged by a solar panel.

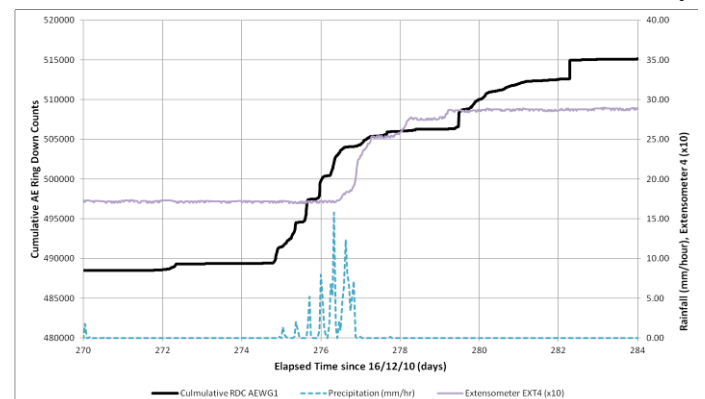
Figure 6. Example rainfall, cumulative AE (AEWG1) and cumulative displacement (EXT4).

crack (Figure 4). Total deformations of 3 mm, comprised from several events, have been measured over the period July to September 2011. Each episode of movement is associated with a rainfall event, although typically deformations occur a few hours after peak rainfall occurs. Figure 6 shows time series for rainfall, cumulative AE and cumulative EXT4 deformations. None of the deformation events generated detectable AE in borehole S2. This is not unexpected due to the large distance between waveguide AEWG1 and the slope surface, and the fact that no deformations were recorded in borehole S1 extensometers concurrently with EXT4, thus indicating that general deformation of the Limestone mass did not occur. Borehole S3 and instruments TDR3, TDR3bis and waveguide AEWG2 have been located specifically to monitor the outer layers of Limestone involved in the deformation behaviour measured by

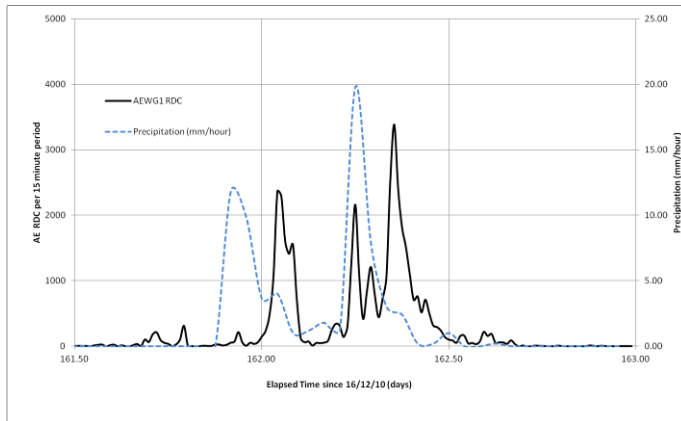
Figure 7. Example relationship between rainfall and AE rates.

There is a strong correlation between rainfall and AE measured using AEWG1. Figure 7 compares rainfall and AE rates for a 1 1/2 day period in May 2011. This is a typical response, with peak AE rates lagging one to two hours behind the peak rainfall rate. This lag is thought to be due to the time required for rainfall to flow into the rock mass through discontinuities. It is currently not clear whether measured AE is generated directly by this ground-water flow or by stress increases, and hence strains, resulting from build-up of pore water pressures within the rock mass. Although the borehole extensometers have not indicated deformations during these rainfall events it is still possible that AE monitoring to detected very low strains as it is a more sensitive technique. Further monitoring is required to establish the mechanism generating the AE as concurrent measurement of rock mass deformation is required to establish the signature of deformation generated AE events. There are a small number of clear AE events that cannot be attributed to rainfall but the mechanism causing these is currently unknown.
