## **CLADDING INTERFACE MANAGEMENT: UOB PLAZA, SINGAPORE**

Alistair G.F. Gibb

### **SUMMARY**

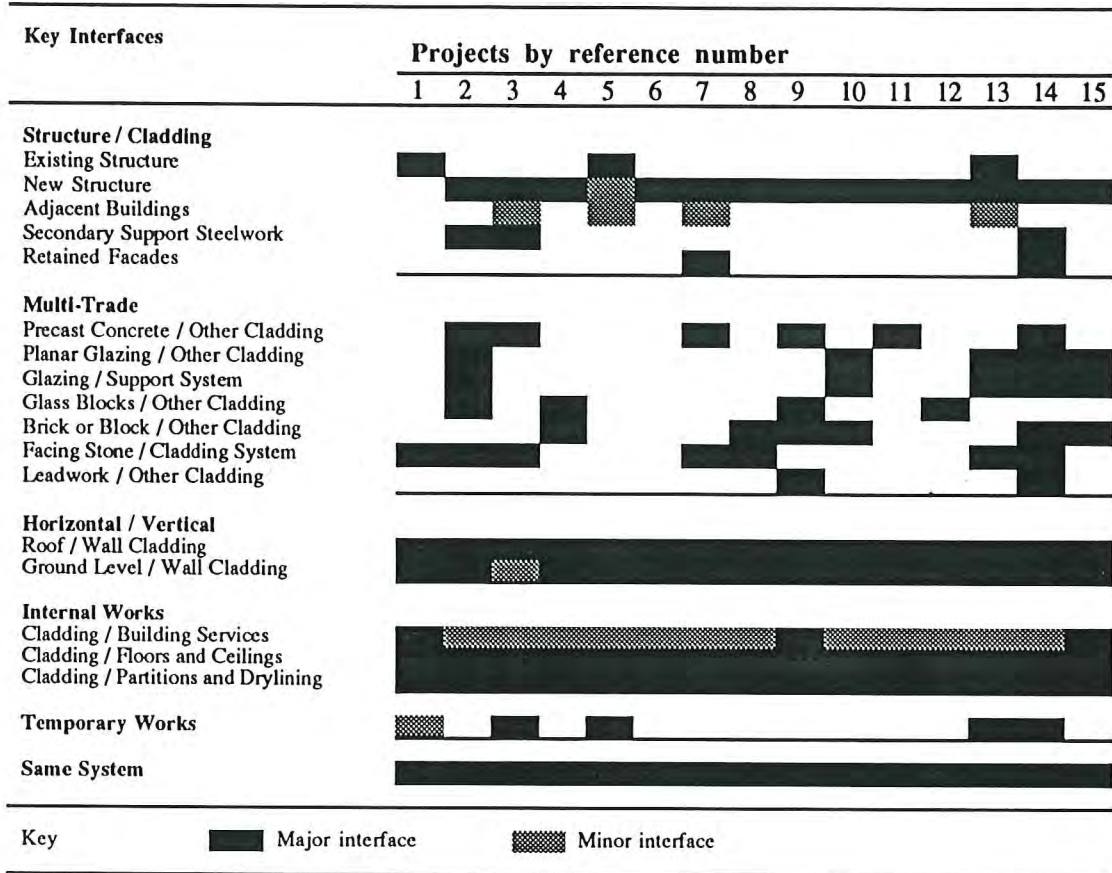
Figure 2 Key interfaces on case study projects

The research identified the key interfaces that occurred on the case study projects. These are shown in Figure 2. The interfaces are defined as major and minor interfaces. For example, on all projects there was some interface between the cladding and the building services, which was often relatively straight forward. The relative importance of these interfaces is outside the scope of this paper and has been discussed elsewhere by the author. [1,5]

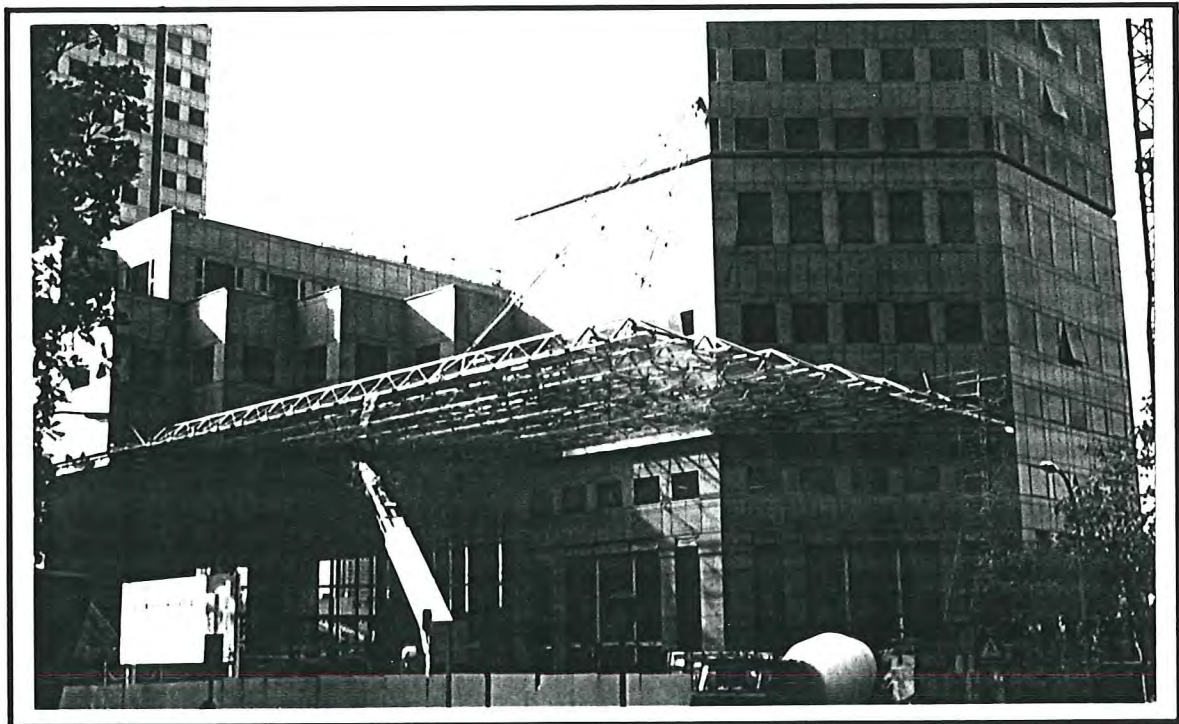
Plaza 2 includes a 26.3 x 36.3m glazed entrance canopy cantilevering out from the main building (Figure 3). The value of the canopy glazing package was S\$ 3.5 million (~£ 1.6 million) The canopy design was developed in Austria by Grill and Grossmann (GIG). The canopy structure is a series of fully welded, tubular stainless steel trusses. The trusses were fabricated in Austria, but the longer sections could not be shipped, so were welded on site.

Figure 3 Inverted glazed canopy to plaza 2 - main structural hanger shown at the top centre

The glazing used was the Tempoint system from Ashai Glass, Japan. This is a similar system to Pilkington's Planar. The Planar system has been used in the UK in an inverted roofing condition (i.e. where the support is above the glazing) on projects such as Vintners Place and East Croydon Railway Station. However, this is the first time that the Tempoint system has been used horizontally. The system supports the glass panels at a number of node points. The node fixings are a highly engineered, bespoke design. There is a chamfered hole in the glass through which a stainless steel bolt with a chamfered washer connects the glass to the node fixing.
