Hybrid corrosion protection of a prestressed concrete bridge

EUROCORR 2013

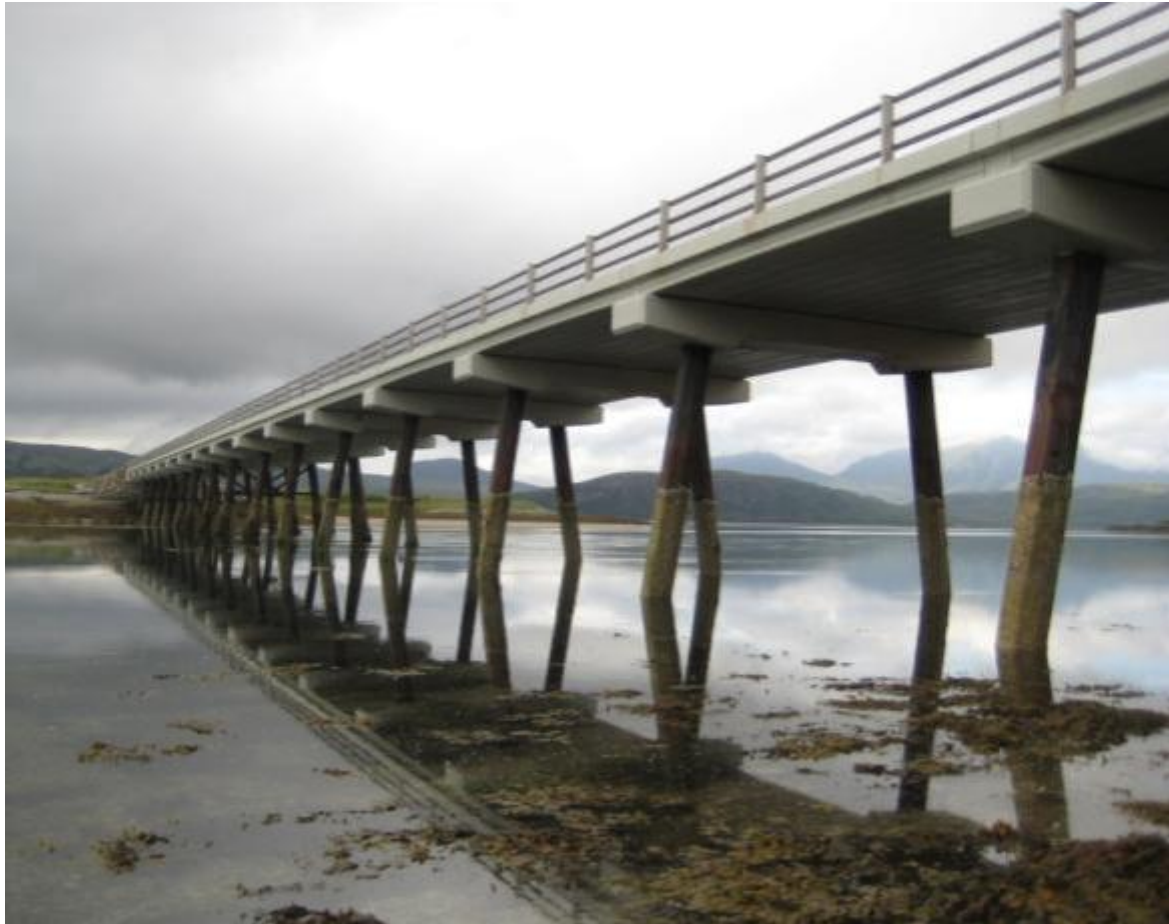
The Kyle of Tongue Bridge in Sutherland, Northern Scotland carries the A838 road across the estuary of Tongue (Figure 1). It opened in 1970 and has an overall span of 184m and consists of 18 approximately equal simply supported spans. The bridge width is 8.5m consisting of a single 5.5m wide carriageway with two lanes and 1.2m and 1.8m wide footpaths.

Figure 1: General view of the Kyle of Tongue bridge

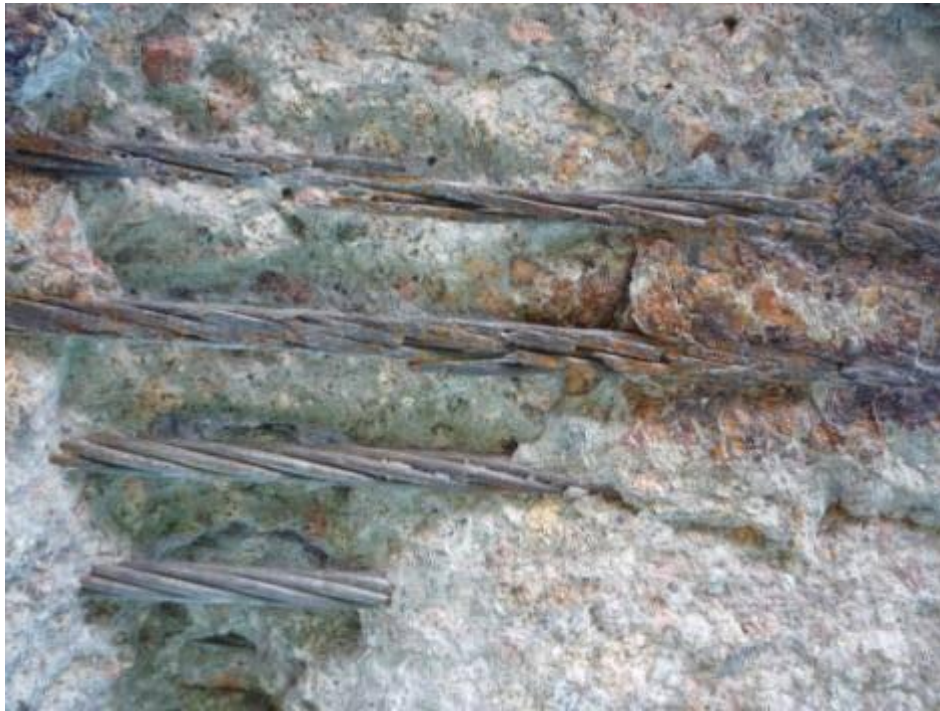
- widespread chloride contamination
- chloride induced deterioration of the prestressed concrete beams (Figure 3)
- chloride induced deterioration of the reinforced concrete crossbeams (Figure 4)

Figure 3: Typical chloride induced deterioration of the prestressed concrete beams

Chloride sampling throughout the structure indicated chloride concentrations exceeding 1% by weight of cement at the depth of reinforcement which indicates a high risk of corrosion (Design Manual Roads Bridges 1990). In some cases, chloride concentrations exceeded 2% by weight of cement. With regards to carbonation, depths were generally low and there were no instances where they reached the depth of the steel.

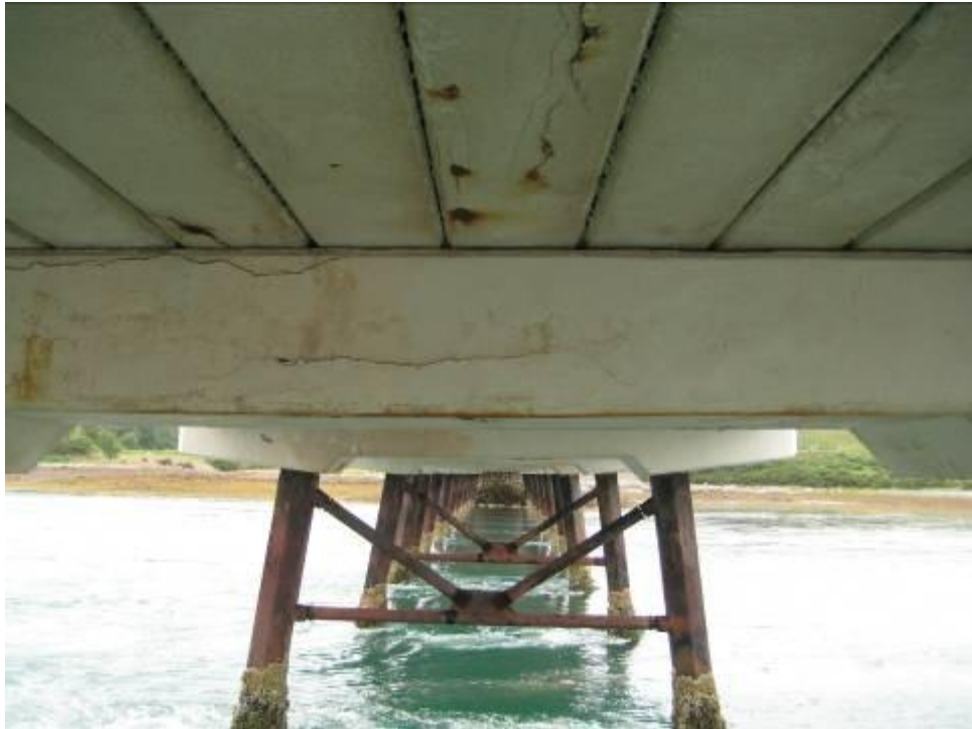
Figure 4: Typical chloride induced deterioration of the bridge

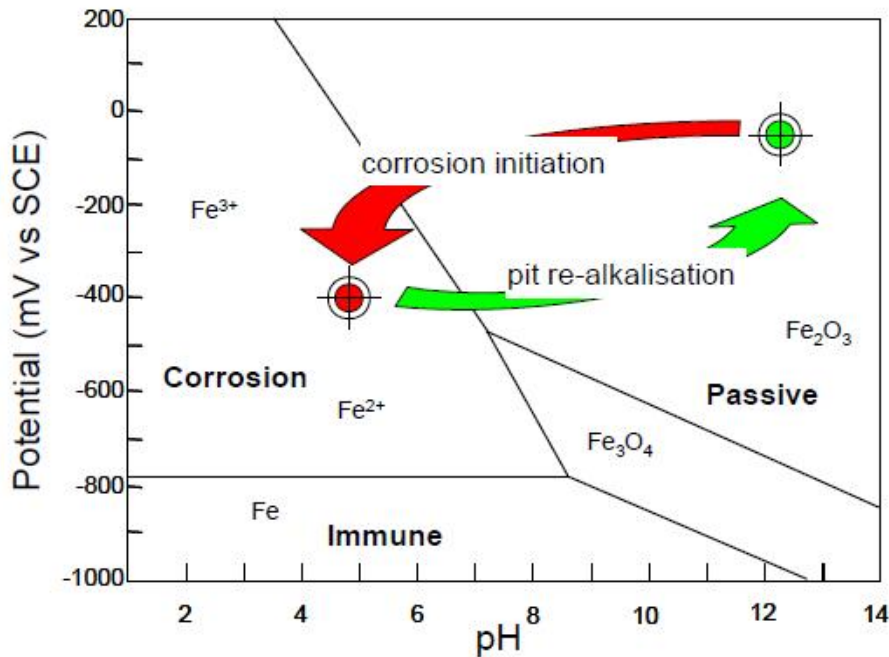
Concrete is normally highly alkaline and steel in this environment is protected by a passive film. Figure 5 shows a section of the potential-pH diagram for iron and its oxides in water (Pourbaix 1990). Passive films are not perfect and some reaction of iron and water does occur. This is usually negligible. However, in the presence of chloride ions, hydrochloric acid is produced and localised pitting corrosion results (Glass et al. 2007). The production of acid is considered to be an essential feature leading to significant corrosion damage on passive steel (Glass et al. 2008). This process is illustrated in Figure 5. The local environment at the steel is moved from a region where insoluble oxides are the most stable product to a region where iron is soluble in the process of corrosion initiation.

Figure 5: Model of corrosion initiation and arrest showing the stability of iron and its corrosion products (Pourbaix 1990).

One of the effects of an electrochemical treatment is also to produce hydroxyl ions on the steel raising the pH. The local environment at the steel is then moved from a region where iron is soluble to a region where insoluble oxides are the most stable product. This has been proven to provide sustained protective effects to the steel reinforcement even when the protective current has been interrupted and chloride contamination remains (Christodoulou et al. 2010, Christodoulou et al. 2012). This re-alkalisation process is also illustrated in Figure 5 and would lead to a restoration in steel passivity. It is termed pit re-alkalisation when localised pitting corrosion is arrested (Glass et al. 2008).

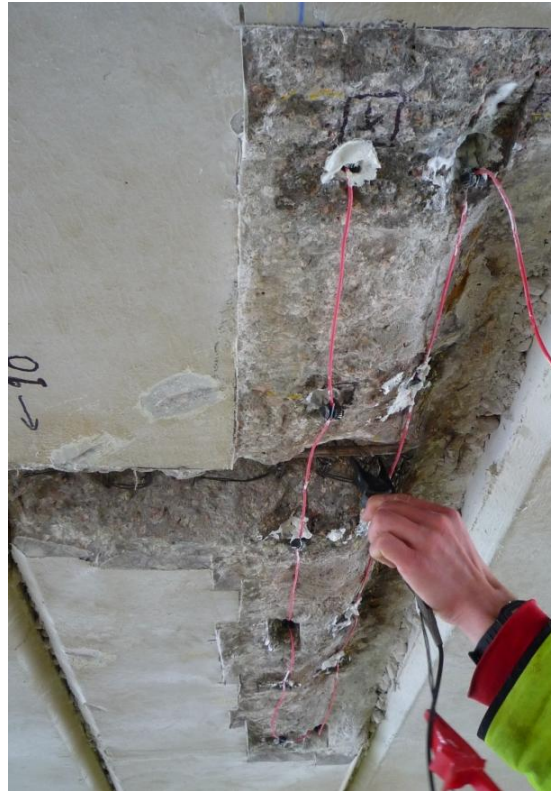
Only physically deteriorated concrete was removed from the prestressed concrete beams. Hybrid anodes 18mm in diameter and 37mm long were installed in drilled cavities between the prestressing tendons of the beams. The pre-drilled cavities were filled with proprietary low strength mortar to fully cover the anodes and provide separation from the repair concrete (Figure 6).

Figure 6: Hybrid anode installation on a prestressed concrete beam

The hybrid anodes included an integral titanium wire to facilitate the delivery of an impressed current and were connected in a series for each repair. Each series of anodes for the individual repairs was terminated in a junction box which also facilitated a connection to the steel reinforcement. This provided a convenient location to connect them to the temporary power supply for delivering the initial current treatment and later connecting them together in a galvanic cell.

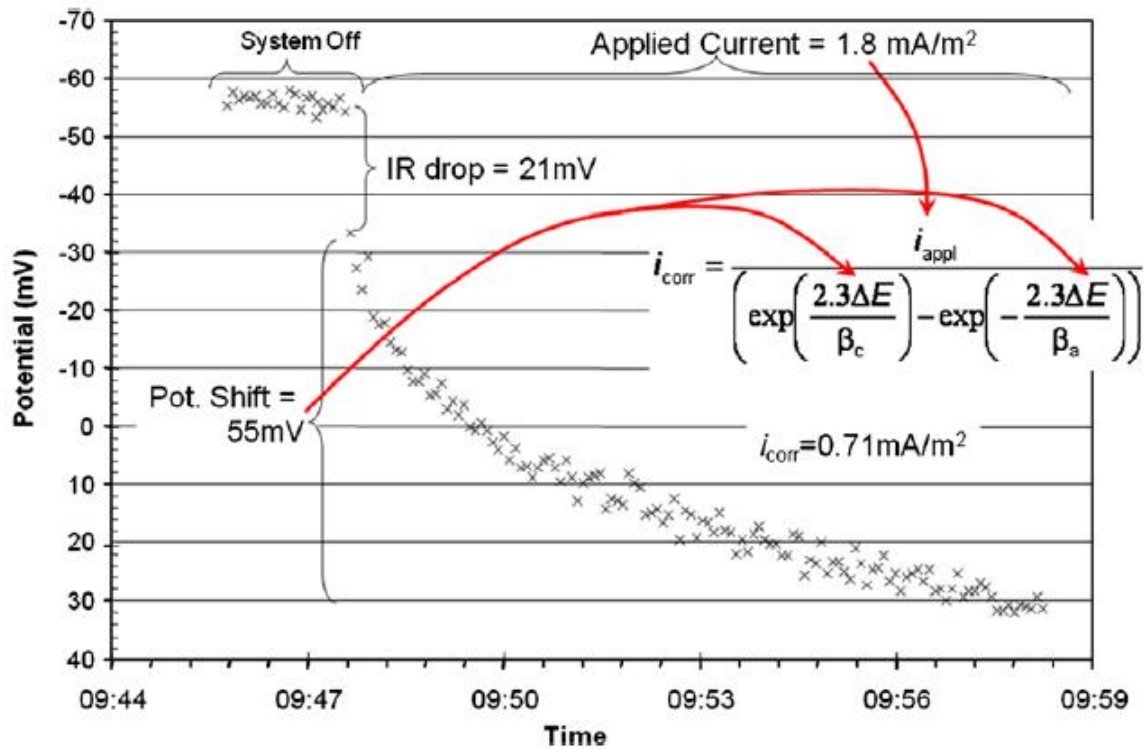
Corrosion current densities are calculated based on the applied current and the achieved potential shift. A small current density applied to the steel produces a steel potential shift and a voltage drop (IR drop) through the concrete (Christodoulou et al. 2010). The potential shift and applied current density are inserted into the Butler–Volmer equation, which provides the basis for polarisation resistance theory, to calculate the corrosion current density (Figure 7). It has previously been shown the acceptance criteria based on low steel corrosion rates are strongly related to acceptance criteria based on a minimum potential shift (Glass et al. 1997).

Figure 7: Example corrosion current density calculation (Christodoulou et al. 2010)

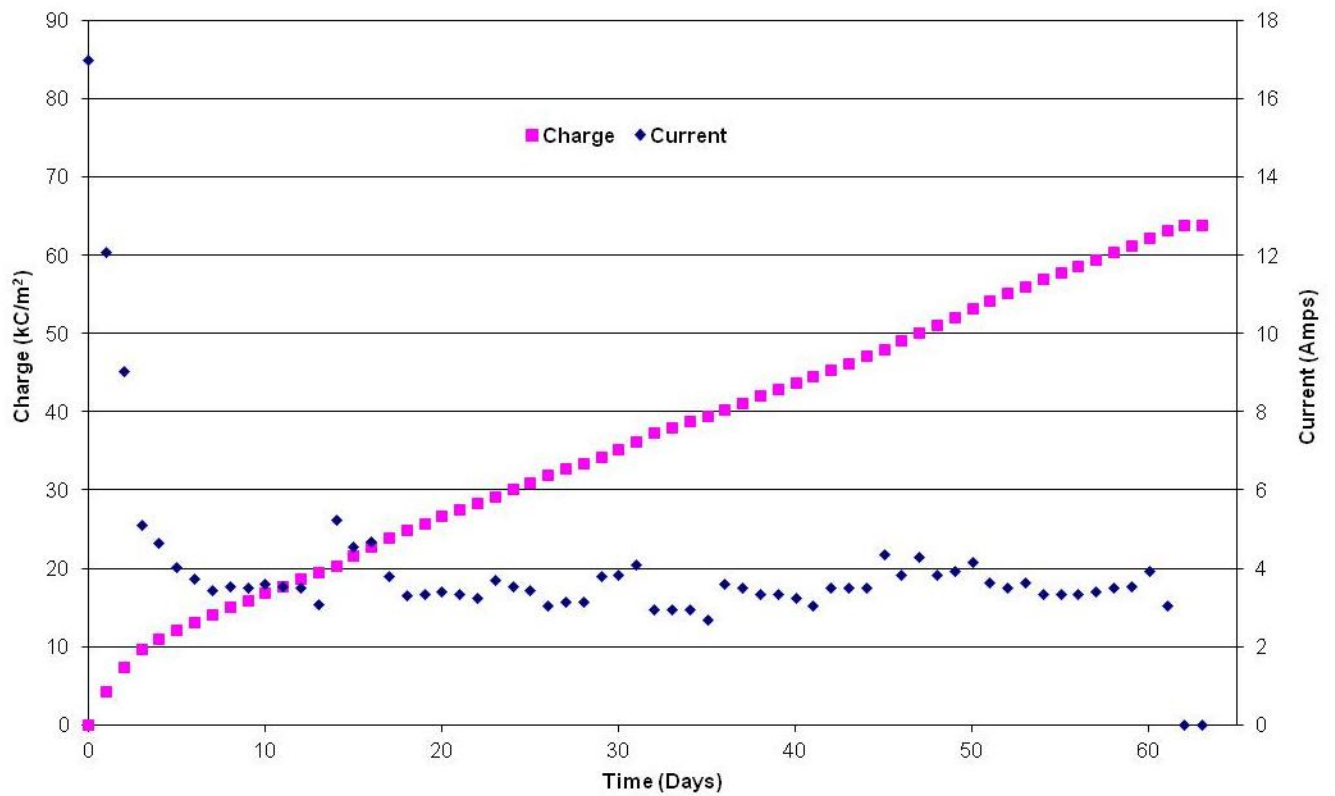
Figure 8 illustrates typical monitoring data for the charge density delivered by the hybrid anodes on a repair of a prestressed concrete beams. The minimum charge density was set at 50 kC/m² delivered over a period of 8 weeks or approximately 60 days. The results presented here are typical and similar data were obtained for all the repairs monitored.

Figure 8: Typical charge density and current applied to a repair area on a prestressed concrete beam.
