# Permanent capping of temporary waste slopes: The challenge of declining waste streams

G. J. Fowmes

K. Zamara

**ABSTRACT:** With diminishing waste streams many sites now face closure before filling to intended profiles. As a result, slopes which were intended as temporary waste slopes now require permanent capping solutions to be installed. These slopes are often steep and challenging to cap. Various stability and integrity issues arise with solutions including the use of reinforcement within the capping layers. However, on long slopes the total forces are often large and anchorage on benches can be problematic. Tapering the cover soils can achieve a stable solution; however, large soil volumes may be required to achieve a satisfactory resistance to failure.

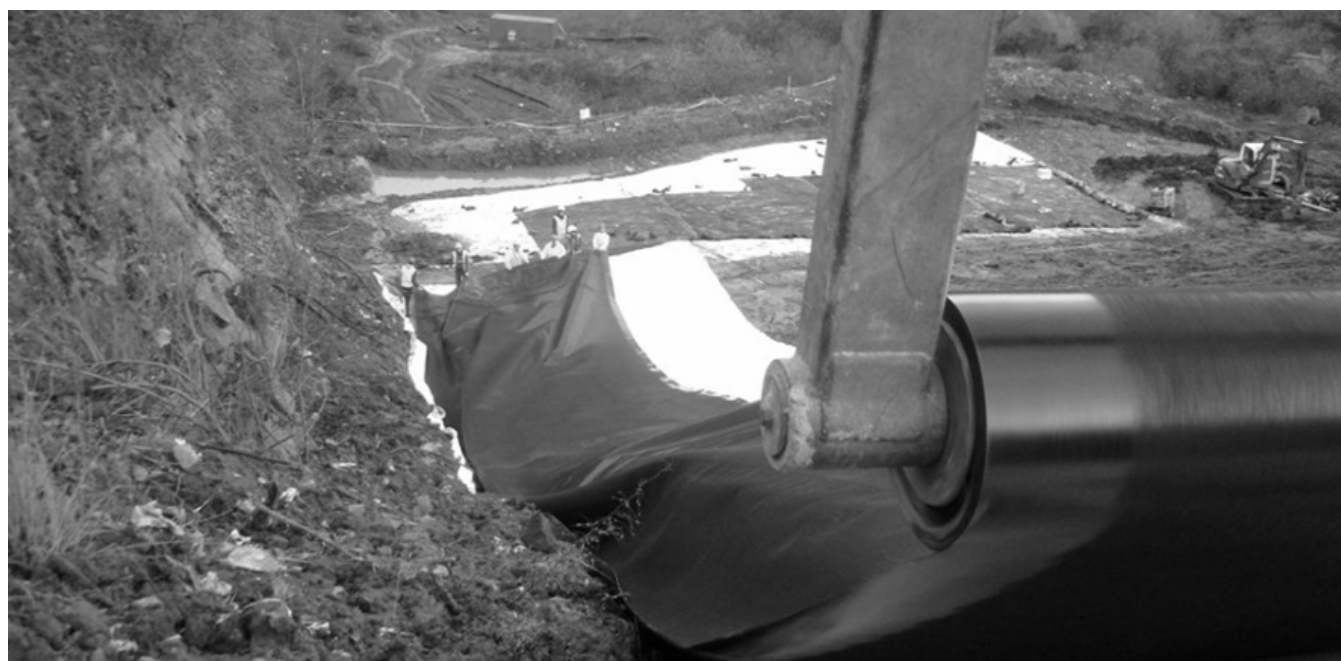
Figure 2 shows deployment of the geosynthetics from the first bench. Use of small scale excavators and hand digging was required to find the tie-ins to side containment and roped access was used to allow welding personnel to work safely on the steeper areas of the slope.

Figure 2. Deployment of geosynthetics on steep slopes

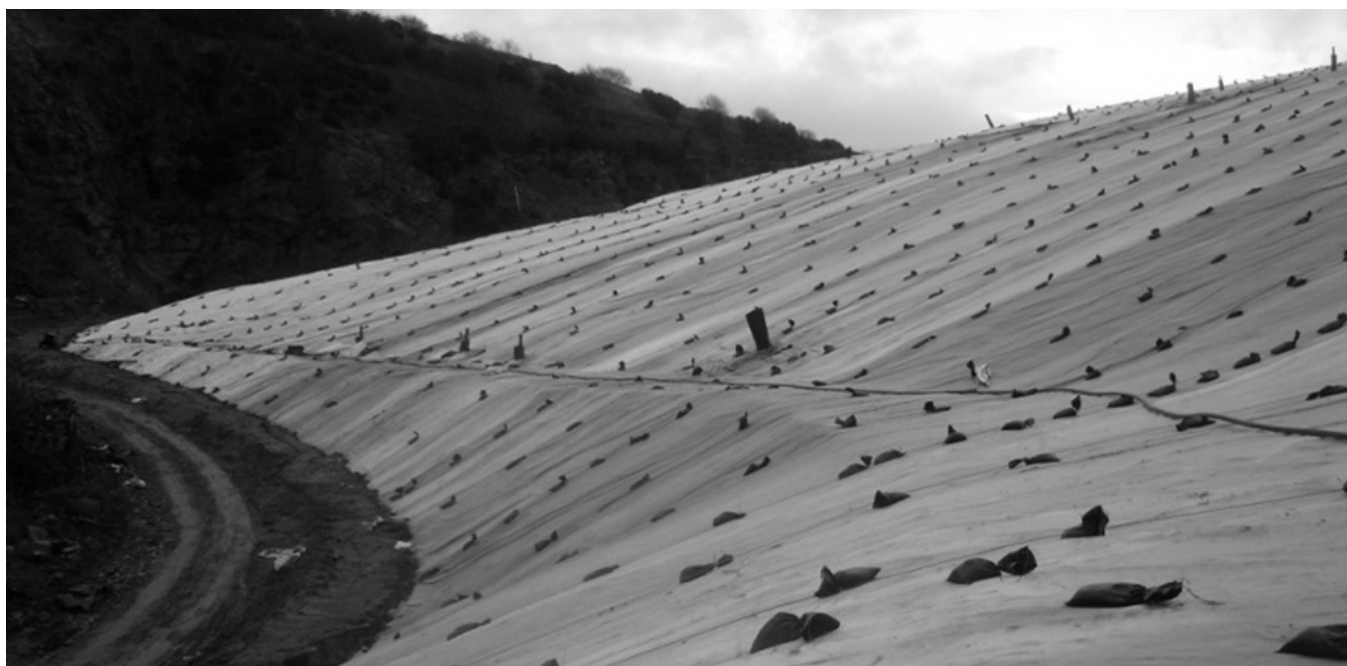
Given the phased nature of the construction, gas infrastructure reinstatement was required prior to the cover soil placement. Figure 3 shows the slope following geosynthetic installation. The smooth geosynthetic surface and steep slopes posed significant challenges for temporary reinstatement of gas infrastructure particularly as plant could not be deployed in order to protect the geosynthetics.

Figure 3. Planarity of case study slopes

One of the challenges on modelling any veneer slopes in a stability risk assessment is selection of a representative geometry to include in the model. Whereas with a cell construction the slopes tend to be engineered to specified gradients, capping slopes are a function of an often irregular profile, further exacerbated by heterogeneous settlement. Figure 3 highlights issues with the planarity of the case study site.

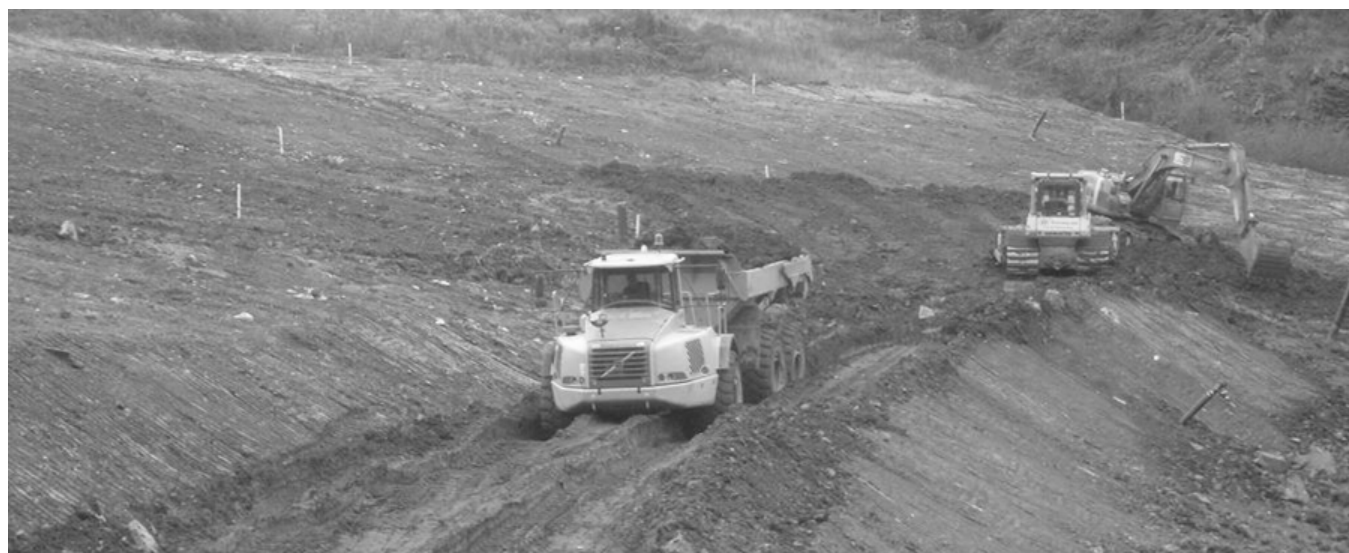
The restoration soils were placed wetter than anticipated, and due to the north facing internal slope, within a quarry, the slope received very little sunlight, therefore, when the restoration soils got wet, there was limited chance of drying prior to deployment of the geosynthetics. Figure 4 shows the field deployment of the regulating layer. In order to quantify this, twenty moisture-density core samples were taken in twenty locations in order to statistically profile the slope and select a representative worst case for shear box testing. The tests for the regulating layer geotextile interface were then conditioned to this moisture content as part of the shear box tests for the lower interface. Additionally six CD Triaxial strength tests were specified to facilitate an assessment of the long term behaviour of the regulating layer behavior.

Figure 4. Regulating layer deployment on the steep capping slope

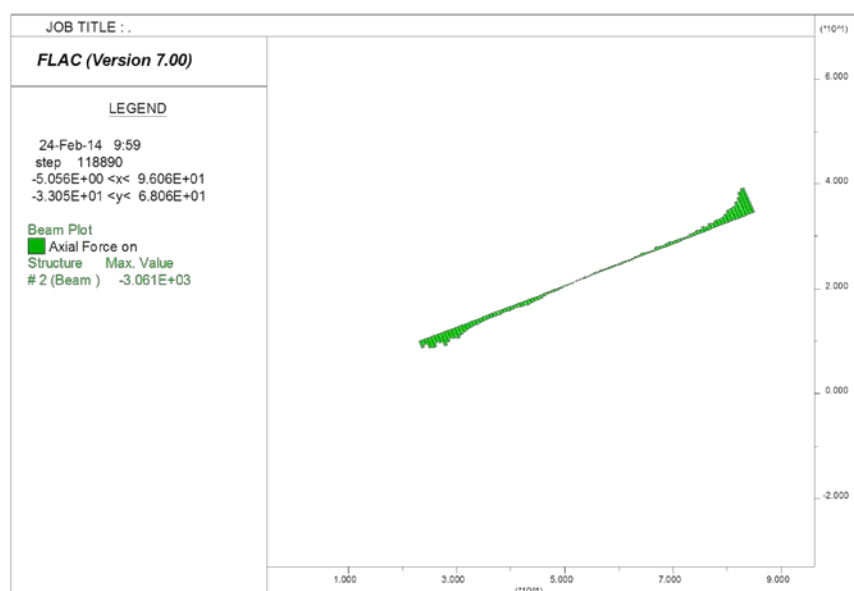
Figure 6. FLAC generated prediction of geomembrane axial strains (maximum tension at crest of slope, 3.06 kN/m )

Due to the challenges listed above, the process of construction has been delayed in order to acquire more information on interface properties. A number of direct shear box tests have been carried out, to add confidence in the design, as stability risk assessment based on Zhang et al.(2012) with initial tests results were indicating a rupture failure on the top geosynthetic. As a result of these tests it was decided by the designer in consultation with the regulatory body to conduct more detailed stability and integrity assessment of the capping system. Further assessment was carried out using the explicit finite difference modelling code, FLAC (Itasca 2013) to investigate possible scenarios of geosynthetic materials and interface interactions, however, due to the commercial timescales for the analysis, strain dependent interface behaviour was not fully defined and whilst post peak displacements were predicted, the magnitude of interface movements and presence of geosynthetic tension could not be accurately predicted. The modelling mesh used in the analyses is shown in Figure 5 and the outputs in terms of strains in the geomembrane are presented in Figure 6.

To progress the project in a timely fashion it has been agreed that instrumentation will be placed on the slope to measure the *in situ* performance of the slopes. The proposed instrumentation will include Demec strain gauges and extensometers as deployed by Zamara *et al.* (2012). The FLAC modelling indicates maximum tensile strains near the crest of the slope, and this is in line with finding of Fowmes *et al.* (2005 and 2008). Therefore, the Demec gauges will be placed 1m below the crest of the slope and the extensometer system shall target the top 5 m of the slope to assess strains within the capping system.
