Quantification of reactivated landslide behaviour using acoustic emission monitoring

Dixon N, Spriggs MP, Smith A, Meldrum P, Haslam E (2014) Quantification of reactivated landslide behaviour using acoustic emission monitoring. *Landslides*, pp 12.
DOI: 10.1007/s10346-014-0491-z

N. Dixon^[1], M.P Spriggs^[1], A. Smith^{[1]*}, P. Meldrum^[2] & E. Haslam^[2]

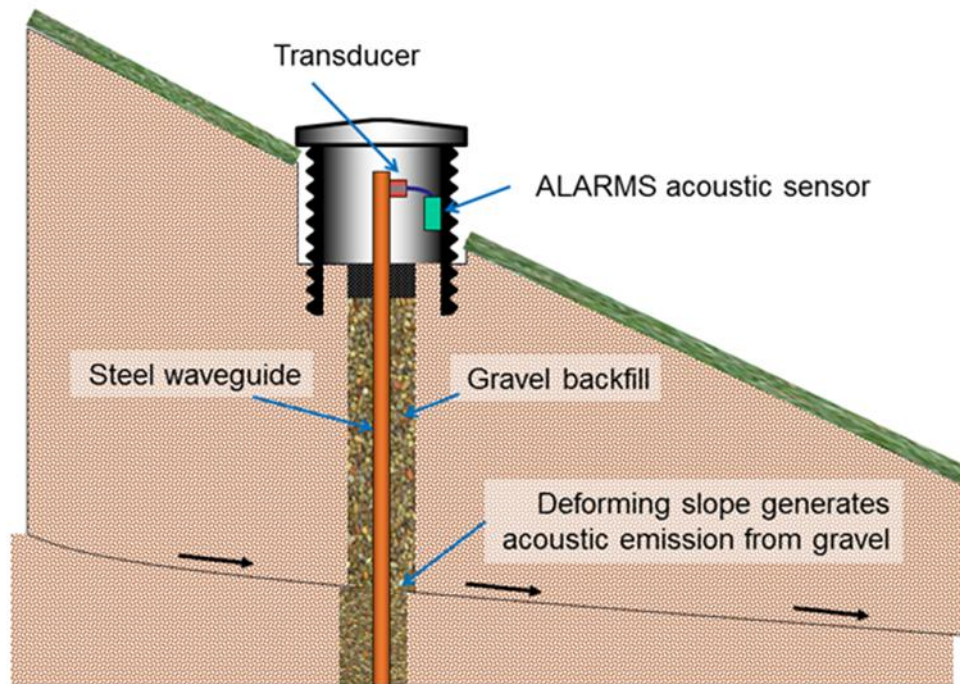
Fig. 1 Schematic of an active waveguide installed through a slope deforming on a shear plane, with AE monitoring sensor attached to the top of the waveguide and protected by a cover (after Dixon et al. 2012)

The AE sensor is located on the active waveguide, which comprises a steel tube installed in a gravel filled borehole constructed into a potentially unstable soil slope (Figure 1). The waveguide length can be many tens of metres long, with the length dictated by the need to intersect potential shear surfaces that may form beneath the slope. Acoustic emissions are generated as the straining soil slope deforms the gravel backfill in the borehole and are transmitted to the ground surface by the steel waveguide. In real-time, generated AE are recorded at pre-defined time intervals. Measured AE rates are the number of times in each time period (i.e. 15, 30 or 60 minutes) that the detected signal exceeds a pre-determined threshold (i.e. a RDC). RDC are used to derive displacement rates accurate to an order of magnitude, which is in line with current practice for classifying slope movements (Transportation Research Board 1978).

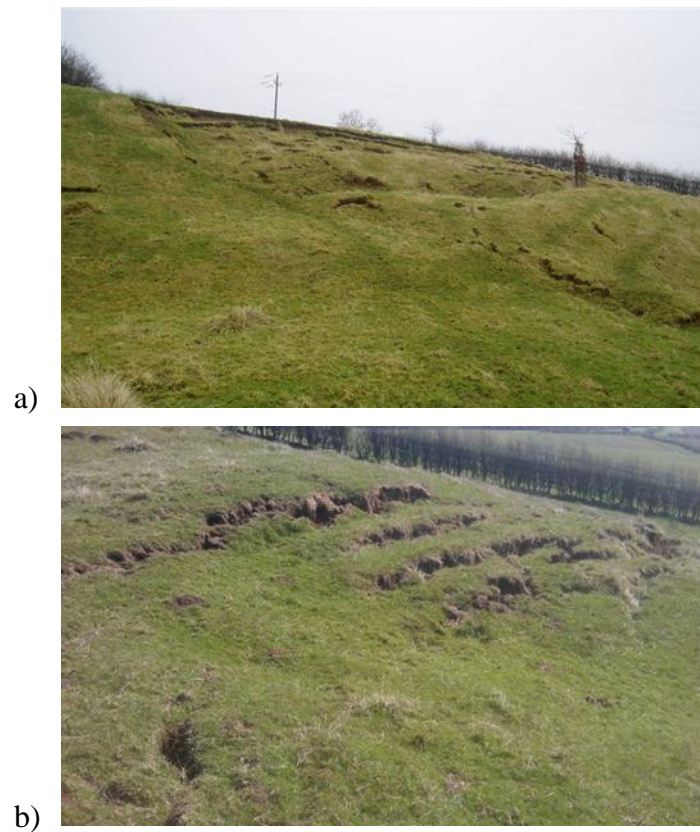
Fig. 2 a) Rotational sliding in the upper part of the slope, and b) materials degrading and forming lobes sliding down the lower part of the slope

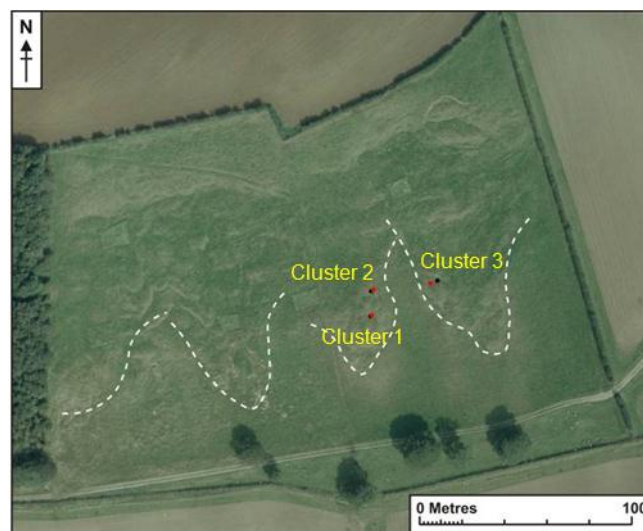
Fig. 3 Outline of active lobes in the lower part of the slope and the location of the three clusters of instruments, each comprising a pair of AE waveguides and inclinometer castings. Clusters 1 and 2 on the western lobe and cluster 3 on the eastern lobe (© UKP/Getmapping Licence No. UKP2008/01)

Three clusters of active waveguides and inclinometer casings have been installed through two of the lobes (Figures 3 and 4). The waveguides were installed in 130 mm diameter holes to depths of 5.7 m below ground level. The waveguides comprise two 3.0 m lengths of 50 mm diameter 3 mm thick steel tubing connected with screw threaded couplings. The annulus around the steel tubing, which is located in the centre of the borehole, is backfilled with angular 5 mm to 10 mm gravel compacted in nominally 0.25 m high lifts. The top 0.3 m of the borehole is backfilled with a bentonite grout plug to seal against the ingress of surface water. The steel tube extends 0.3 m above ground level and is encased in a secure protective chamber. Inclinometer casings were installed approximately 1.0 m from the waveguides with keyways orientated along the slope dip and strike directions. The inclinometer casings penetrate to depths of 6 m to 7 m below ground level and the annulus around the casing is grouted using medium stiffness cement bentonite grout.

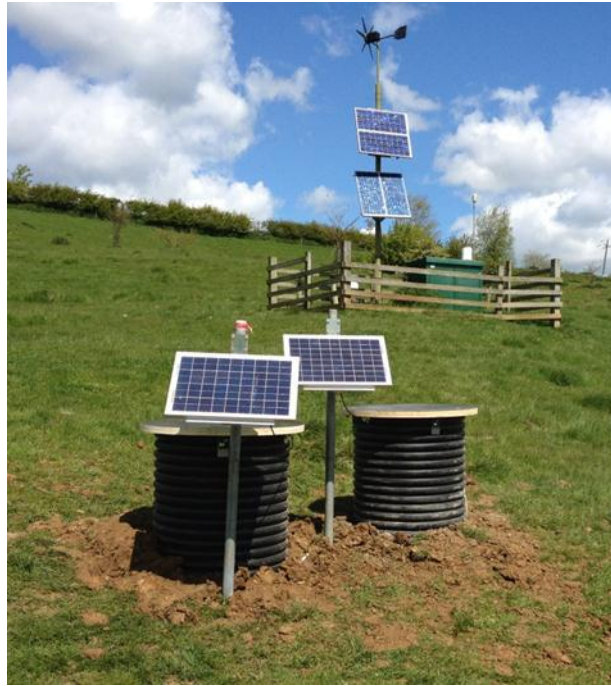
Fig. 4 Two waveguide assemblies with covers and solar panels installed on the western lobe (Cluster 2). The BGS ERT instrument compound can be seen up slope of the waveguides

A unitary AE sensor is located inside the protective cover (Figures 5a and 5b). A piezoelectric transducer is attached to the waveguide and linked to the sensor via a cable. The AE sensor is powered by a battery, which is recharged by a solar panel (Figure 4). Monitoring is continuous.

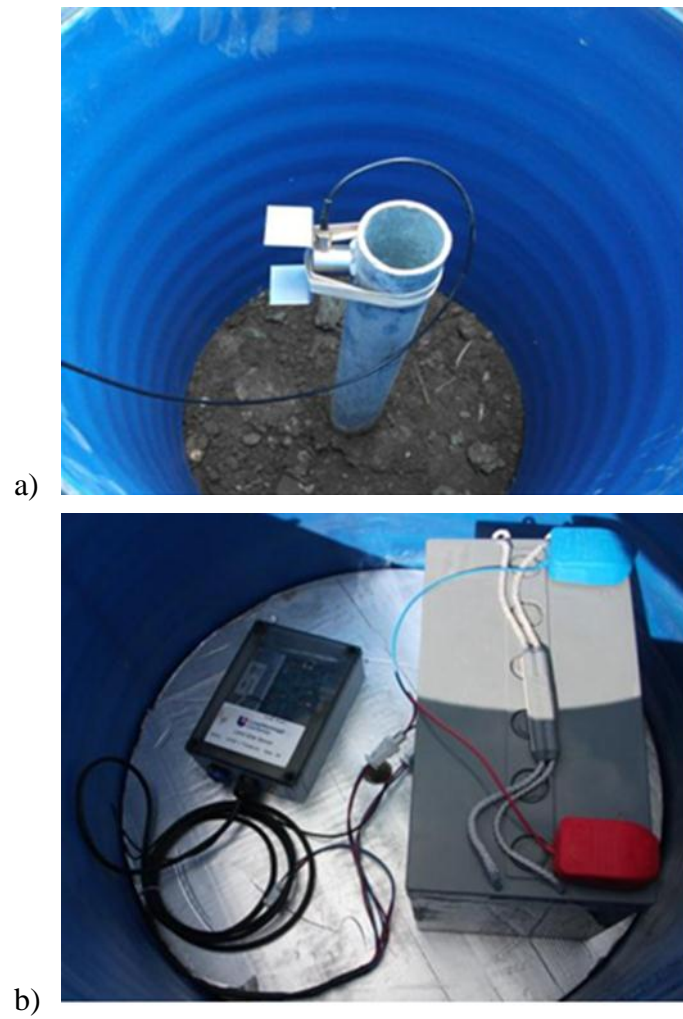
Fig. 5 a) Waveguide with piezoelectric transducer attached, and b) AE sensor and battery inside cover

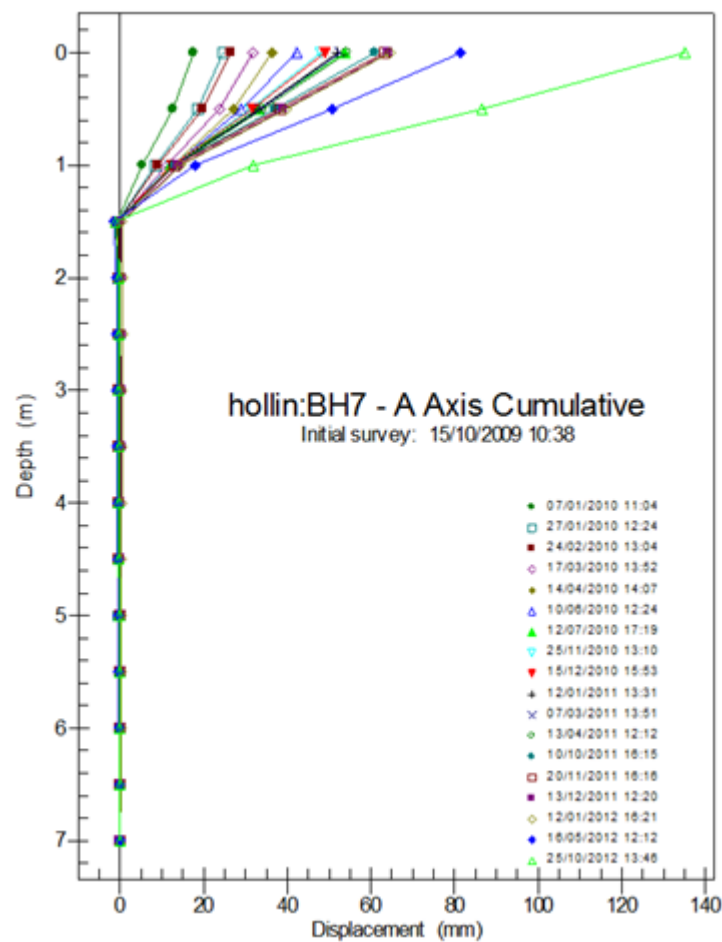
Fig. 6 Selected surveys of the inclinometer casing at Cluster 1 western flow lobe between January 2010 and October 2012 showing a shear plane at a depth of 1.0 m to 1.5 metres below ground level and sporadic periods of deformations that are in response to periods of rainfall

The inclinometer surveys show that the shear plane at Clusters 1 and 2 is relatively shallow at 1.0 m to 1.5 m below ground level on the western lobe (Figure 6). Inclinometer data from the eastern lobe (Cluster 3) shows active shear surface deformation at two depths; 1.5 m and 4.0 m below ground level. A number of deformation events were identified in February 2010 at the end of the winter period when the slope was at its wettest. Following 18 months of unusually dry weather in 2010 and 2011 when the slope was stable, deformations were next recorded in 2012 in response to a period of high precipitation during the summer months. Continued precipitation caused further slope movements with the inclinometer casings recording substantial slope deformations in November 2012. These deformations induced excessive curvature of the casings and the probe could no-longer pass and hence the casings became unusable and inclinometer measurements ceased. A decreased frequency of

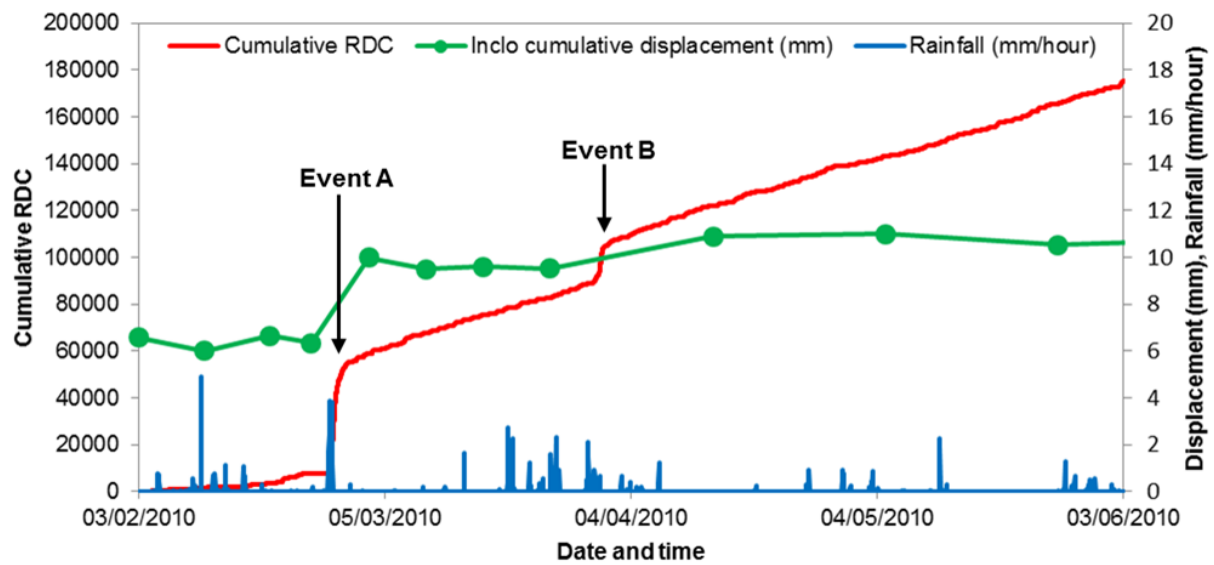
Fig. 7 ‘S’ shaped cumulative RDC curves defining periods of slope deformation at Cluster 2 and validated by inclinometer measurements. Events 1 and 2 are highlighted

Figure 7 shows cumulative RDC for Cluster 2, rainfall per hour and the cumulative inclinometer displacements at a depth of 1 m during the first few months of 2010. Of note are the steep increases in the cumulative RDC record, labelled Events A and B, which follow intensive periods of rainfall. The combination of antecedent moisture being accumulated over long periods (i.e. typically during the winter) and a relatively shallow shear surface (1.0 m to 1.5m) mean that short periods of intense rainfall cause a build-up of pore water pressures in the region of the slip surface, inducing short periods (see Section 3.7) of reactivated slope movements on the existing shear surface. Such renewals of movement on pre-existing shears are expected to be of modest speed and travel as the strength is already at, or close to, the residual value and therefore little further loss of strength can occur, and the stress-strain behaviour is non-brittle in nature (Hutchinson 1988; Leroueil 2001). The 'S' shaped increases in cumulative RDC (Figure 7) are interpreted as defining periods of slope deformation and this is validated by the inclinometer measurements. Other similar events recorded at the three clusters are interpreted in the same way and it is hypothesised that AE time relationships can be used as a measure of the timing and rate of slope displacements. As continuous measurements of deformation were not available, it is an assumption at this time that the steps in cumulative RDC give the timing of the slope movements. This hypothesis has been tested and validated at other sites where continuous slope deformations have been measured using in-place inclinometers. The existence and timing of the events at Hollin Hill, along with confirmation of movements from inclinometer measurements, is consistent with, and hence supports, the AE/slope displacement behaviour observed at other sites. For example, following periods of rainfall measurements at Clusters 1 and 2 AE events occur at exactly the same time, which is expected as they are located on the same lobe of the landslide. Events have also been identified to occur on Cluster 3 (eastern lobe) at similar times to Clusters 1 and 2 (western lobe). Merritt et al. (2013) also identified simultaneous activations of slope

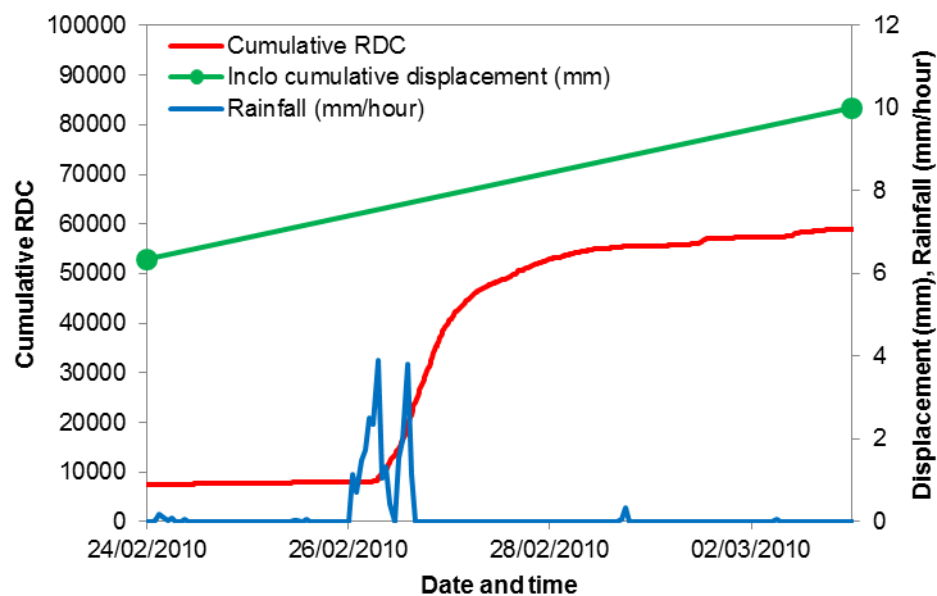
Fig. 8 Cumulative RDC, triggering rainfall event and measured displacements for Event A at Cluster 2

Figure 8 shows Event A at a larger scale. It can be seen that the AE generation is triggered by a preceding rainfall event. The AE rate (RDC/hour) rapidly increases, denoted by the slope of the cumulative RDC vs. time relationship, and then slowly decreases, giving a characteristic 'S' shaped curve. This shape is produced by the large majority of the AE events that are generated by reactivated slope deformations at Hollin Hill. Displacement-time relationships for slope movement patterns are reported to exhibit similar 'S' shaped curves (e.g. Allison & Brunsden 1990, Petley et al. 2005 and Massey et al. 2013). Such reactivated slope kinematics are explained by an initial acceleration of the slide mass due to increasing pore water pressures on the shear plane, and hence reducing shear strength and stability, and a peak velocity is approached. This is followed by a deceleration of movements as pore water pressures dissipate and due to mobilisation of shear resistance internally in the slide mass and through remoulding at the landslide toe.

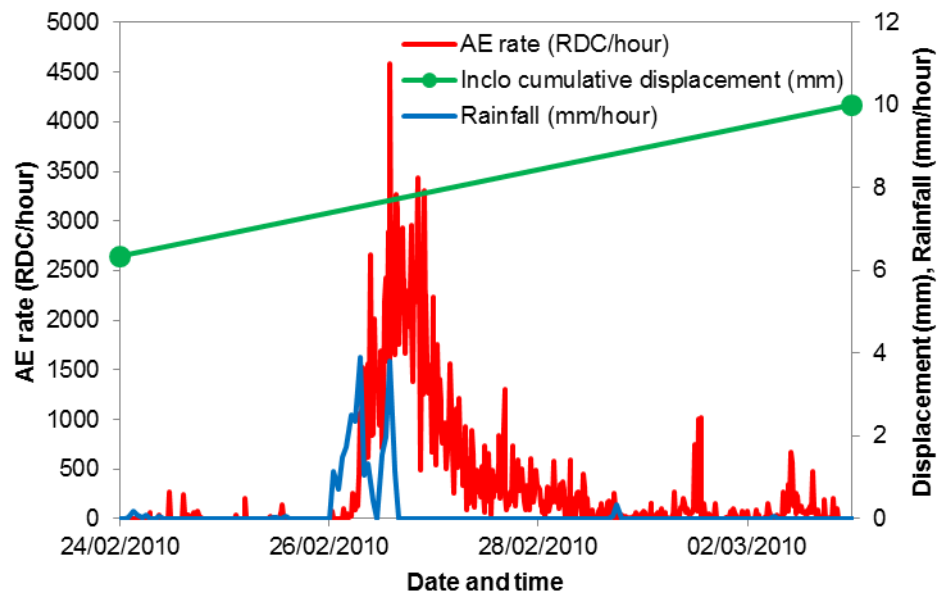
Fig. 9 AE rate (RDC/hour), triggering rainfall event and measured displacements for Event A on Cluster 2

The AE ring down count rate per hour for Event A is shown in Figure 9. The log normal bell shaped relationship is produced by the 'S' shaped cumulative RDC measurements and is typical of the events monitored. The shape of the AE rate-time curve for the deformation event is indicative of acceleration followed by deceleration of slope movements and hence it is analogous to a velocity profile. A gradual reduction in AE rate occurs as slope movement and therefore waveguide backfill deformation ceases. Leroueil (2001) presented a conceptual velocity-time profile for the 'reactivation stage' of slope movements that possessed the shape of a normal distribution, and hence velocity is expected to increase exponentially with time during reactivated slope movements until a peak velocity is reached and the velocity subsequently decays exponentially until movement ceases. AE rate (RDC/hour)-time relationships for deformation events at Hollin Hill are analogous to such behaviour; however the AE measurements demonstrate that the velocity profiles for reactivated slope movements at the Hollin Hill site are predominantly log normal in shape. This indicates that 'slip' during the onset of movement accelerates the sliding mass to a peak velocity at a faster rate when compared to the rate at which the sliding mass can mobilise resistance and decelerate to

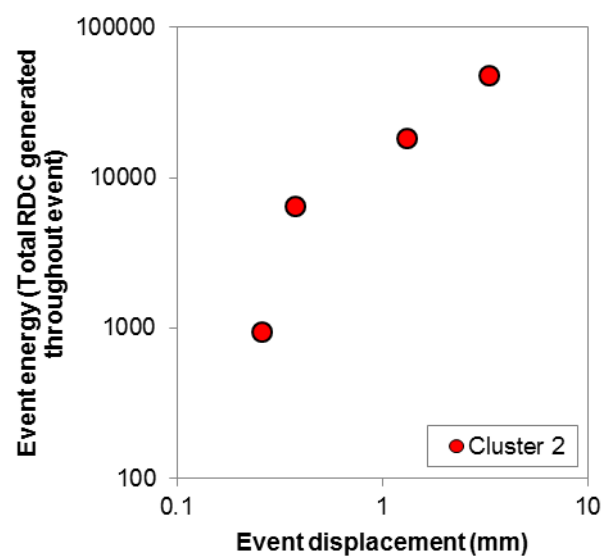
Fig. 10 Relationship between deformation event AE energy (total RDC generated throughout event) and event cumulative slope displacement magnitude for Cluster 2 plotted on log-log scales

Figure 10 shows the energy-displacement relationship, plotted log-log, for four events that occurred at Cluster 2 during 2010. Deformation events of greater magnitude produced proportionally greater AE energy.

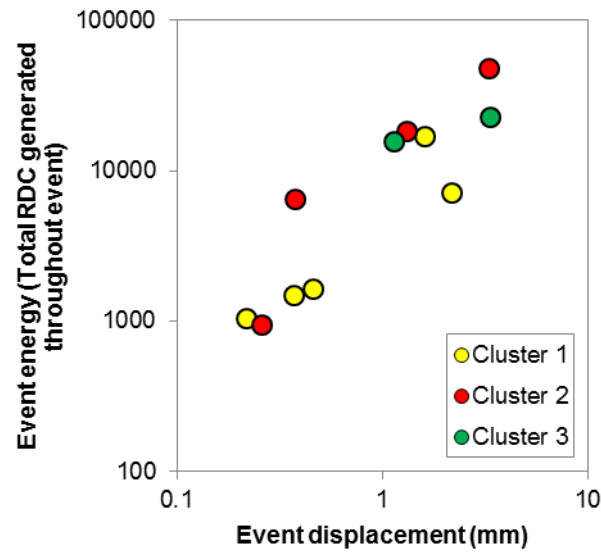
Fig. 11 Relationship between deformation event AE energy (total RDC generated throughout event) and event cumulative slope displacement magnitude for Clusters 1, 2 and 3 plotted on log-log scales

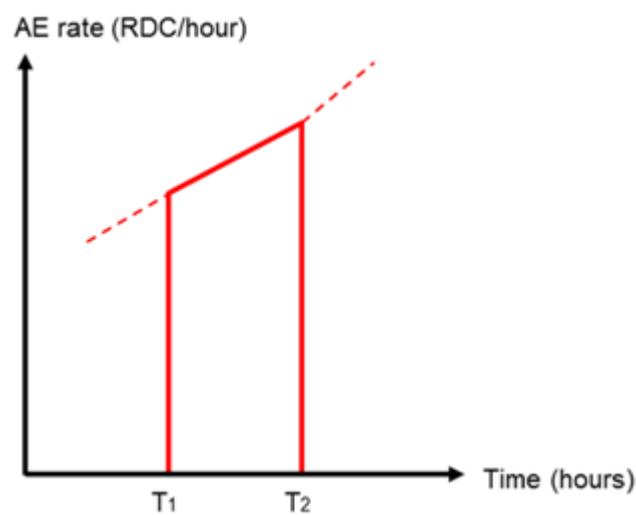
Fig. 12 Trapezoidal interrogation of AE rate data to obtain incremental event velocity from the displacement/time relationship

This allowed the velocity over each trapezoid under the curve to be determined from the displacement/time relation (Figure 12, Equation 2 and Equation 3).

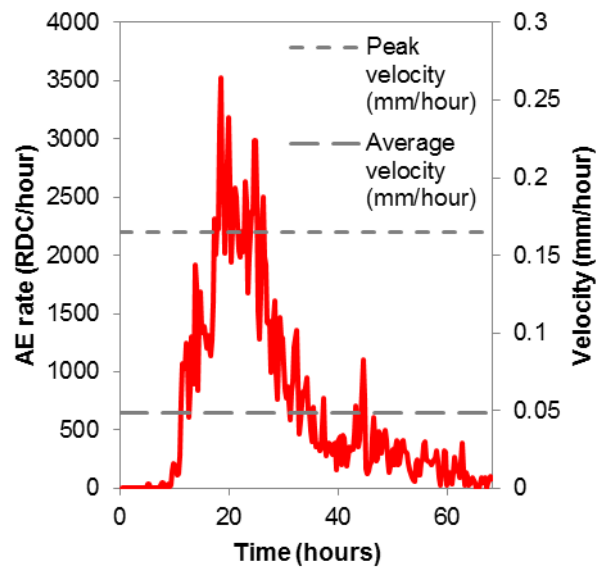
Fig. 13 AE rate and derived velocity for Event A at Cluster 2

Each point in time throughout the event shown in Figure 13 has both a corresponding AE rate and a velocity. Hence a calibration AE rate -velocity relationship (Figure 14) can be produced for that specific monitoring system, and this can be used to derive slope displacement velocities from the measured AE rate that occur in response to subsequent deformation events. There is the potential to do calculations in real-time if the calibration relationship is included in an algorithm within the sensor architecture. Such a calibration could be produced in the laboratory prior to installation in the field. A generic calibration technique that quantifies the influence of all variables that yield changes in AE rate outputs could also be produced.

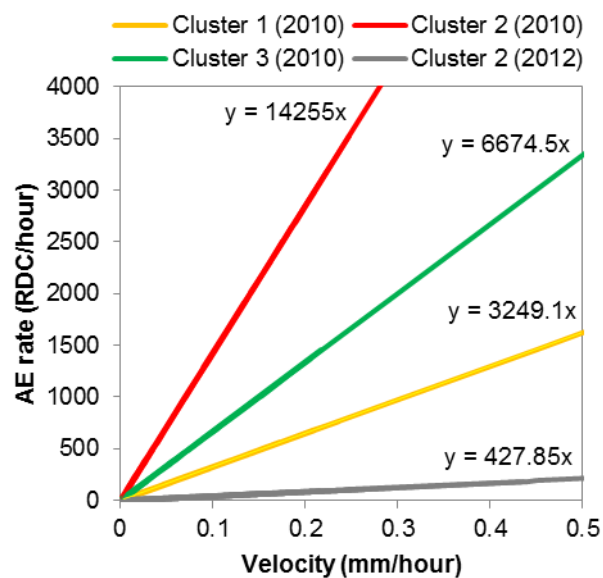
Fig. 14 AE rate-velocity calibration relationships for events on different systems over the course of monitoring at the Hollin Hill site

Of interest is the coefficient of proportionality, or gradient, ‘m’ in Figure 14. This is dependent on the characteristics of the measurement system used, which dictates the magnitude of AE rate produced in response to an applied velocity (i.e. the systems sensitivity). The coefficient of proportionality is influenced by many different variables as discussed in Section 3.7 (i.e. voltage threshold on sensor, depth to the shear surface and attenuation characteristics of the active waveguide etc). In the study at Hollin Hill the coefficient was different for each monitoring system that was used. The calibration relationships for the three clusters and their sensor settings are shown in Figure 14. It can be seen that Cluster 2 (2010) has the greatest ‘sensitivity’, as a greater magnitude of AE rates were produced in response to a given applied slope velocity. Cluster 2 (2012) had the lowest ‘sensitivity’ by contrast.

The respective relationships shown in Figure 14 were used to obtain slope movement velocities from subsequent events that occurred while the systems operated with the same settings and configuration. As continuous deformation data was not available, only average velocities could be compared. The average AE rate over each deformation event was converted to an average velocity using the calibrations in Figure 14 (i.e. ‘calculated’). The ‘actual’ average velocity was determined from inclinometer data and event duration using the displacement/time relationship. The ‘calculated’ and ‘actual’ values were compared to provide validation and an indication of accuracy of velocity interpretations through the use of the AE rate -velocity calibration approach. Eight events were selected for this part of the analysis, and are numbered in Figure 15 in no particular order. The results are shown in

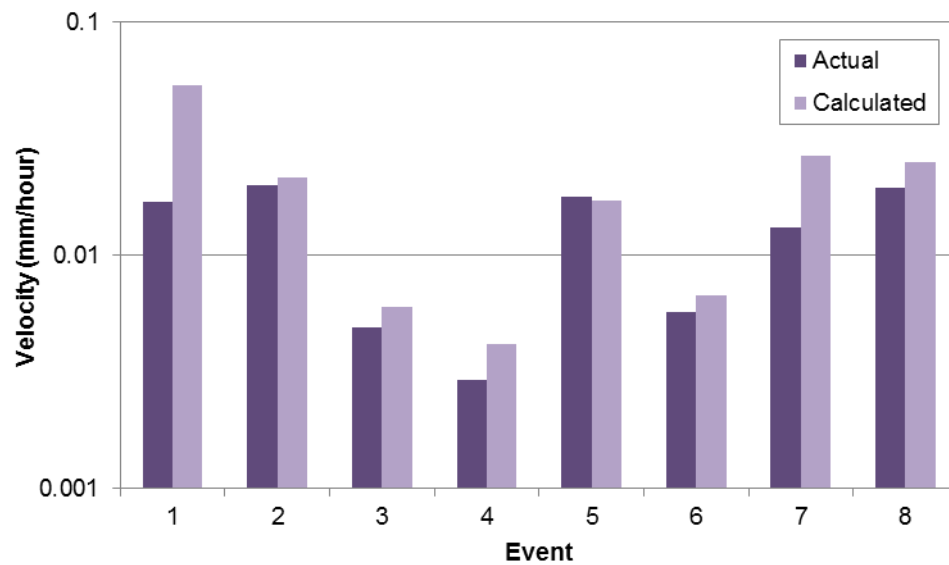
Fig. 15 Comparison of measured slope deformation event velocities and those calculated from the AE rates

Figure 15 on a logarithmic scale, which demonstrates that the procedure produced errors of less than an order of magnitude (i.e. the difference between ‘actual’ and ‘calculated’ velocity). Standard assessment for landslide classification uses order of magnitude accuracy and hence the results presented in Figure 15 demonstrate the potential of an AE system to provide this level of information. An example of how the calibration equation was used for interpretation of displacement rates from AE rate is shown in Equation 4.

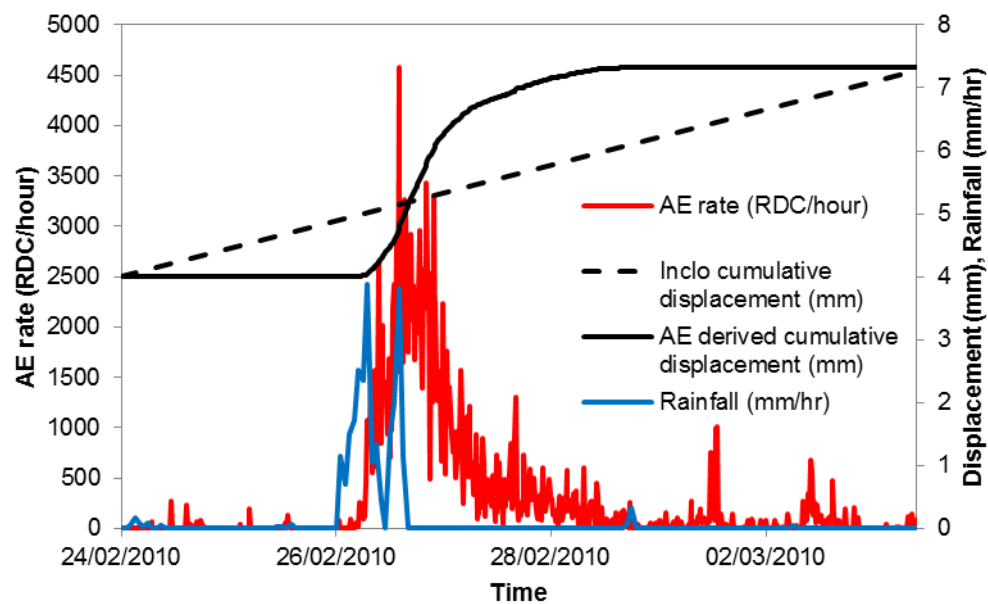
Fig. 16 Derivation of cumulative displacements from AE measurements for Event A on Cluster 2

Figure 16 illustrates how the AE data can be used to produce continuous cumulative deformation data for Event A on the western landslide lobe based on the calibration at Cluster 2. The velocity-time profile produced from the AE data was used to determine the cumulative displacement throughout the deformation event. This approach provides temporal resolution for the cumulative inclinometer data and demonstrates the potential of continuous AE monitoring using technology such as Slope ALARMS sensors to deliver real-time deformation rate information, as an alternative to traditional in-place inclinometers or SAA. Figure 17 shows the AE rates measured at each of the three clusters in response to a period of rainfall. The AE monitoring shows that all three locations became unstable and experienced similar cumulative displacement magnitudes and rates.

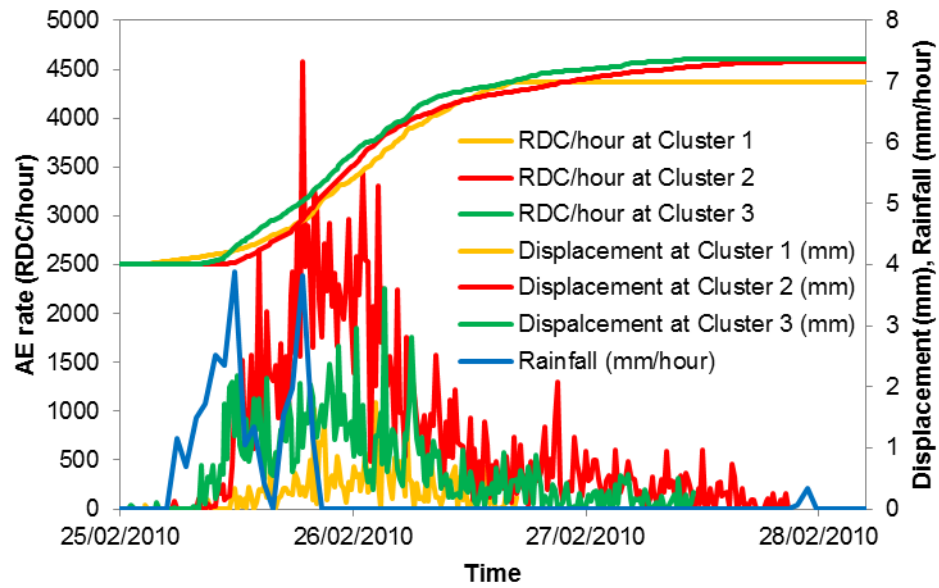
Fig. 17 AE responses of all three clusters to a rainfall event and the derived slope cumulative displacements at each location
