Accelerated Creep(ing): A 'buy & forget' mentality for Chinese homes

Robert Schmidt III.¹, Andrew Baldwin² and Chaoqun Zhuang²

The estate

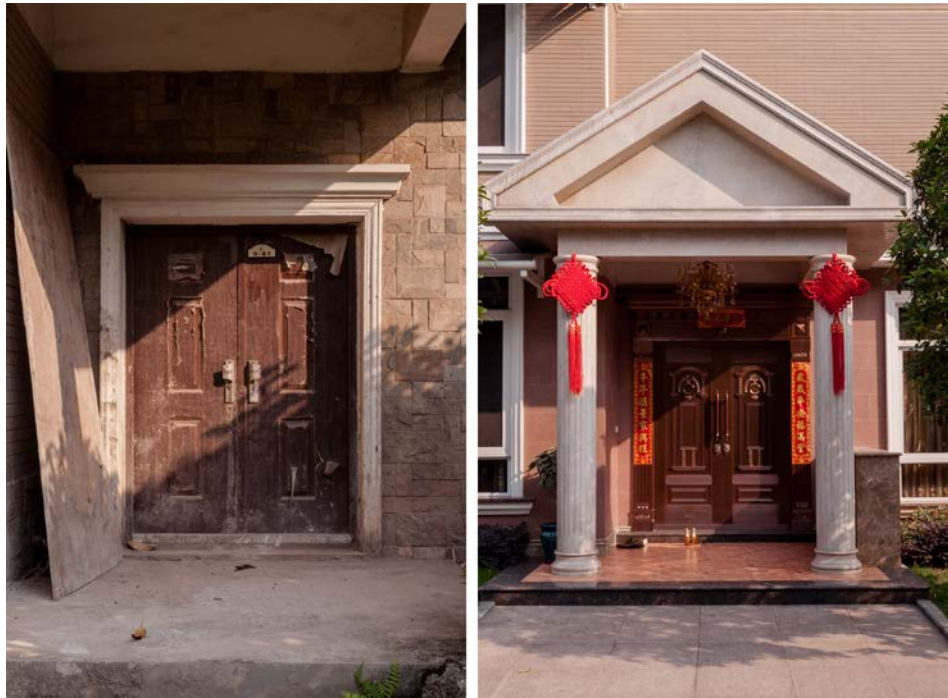
Figure 1 'Entrances': many doors of unoccupied homes have the plastic shipping wrap still partially intact (left) while others have been replaced with more ornate doors and adorned with Chinese good fortune messages and in this case gold chandeliers and shoes (right)

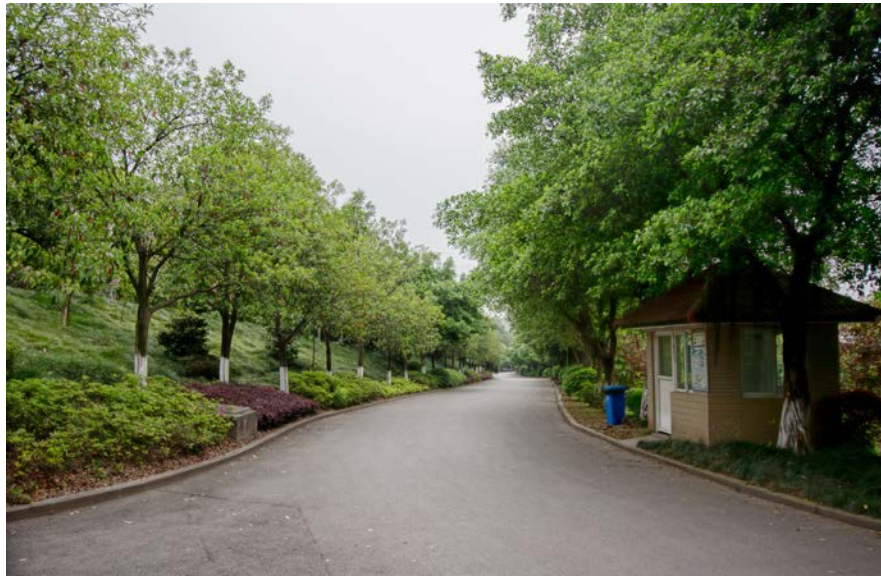
Figure 4 Green lined road

The 'upmarket' residential development of *Ever Green Lake* is a gated community that is situated within the Nan'an district in Central Chongqing. A Singapore-based developer purchased the land in the 1980s at the start of the post-reform era (1979 -). The estate was designed by a prominent Chinese architecture practice from the South-east of China and built just over 10 years ago between 2003 and 2006. Thus, the homes were constructed within the timeframe of the Chinese Golden Age of construction – these types of 'suburban' estates were a response to a growing demand for a contrasting luxury lifestyle of 'detached' homes set in a quiet, low-density, green environment (Bosker, 2013). The estate has a total of 405 houses with three types of homes – detached villas⁵, terraced houses and semi-detached houses. Homes vary in size between 200m² – 700m² with the largest homes surrounding the lake. The exterior of the homes are of a Western style in the realm of colonial revival; however, like much of Chinese Western influenced architecture it is a result of a selective combination of desired elements. The homes are less a response to actual residents' needs and more a response to a progressive, modern and luxurious lifestyle. One can notice quickly that the occupied homes are clearly 'home' to the rich with the number and types of cars and the types of exterior upgrades applied to the homes (doors, gates, garden, etc.). In addition, every home has a garden ranging from 80m² - 200m². According to the management company, the estate is just under 20% building density with almost 55% greenery – Figure 4.

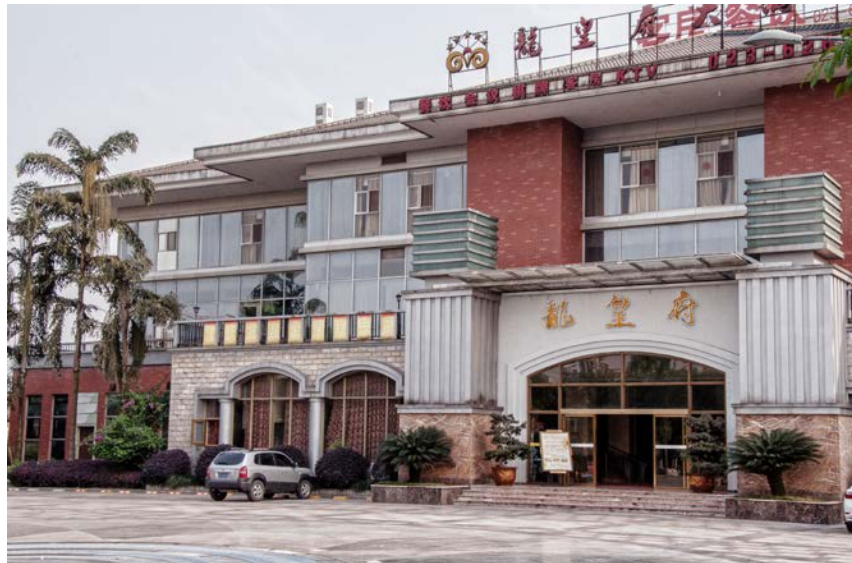
Figure 5 Community building at entrance

While purchasing a home came with the optimism of continued growth surrounding the community, little has been built with regards to amenities and supporting commercial infrastructure. An estate brochure advertises a five-star club, exclusive hospitals, elite kindergartens, supermarkets, public transportation systems and more. Within the estate at the entrance there is a large restaurant and community centre, office building but this appeared to be all but abandoned during our trips to the estate - Figure 5. The estate remains relatively isolated as a commuter community. The closest food market is 45 minutes away by foot; as well as, the closest metro train stop. There are a lack of quality schools in the vicinity which is of top importance to Chinese and according to residents traffic congestion has actually gotten worse which is a problem as most workplaces are not located nearby.

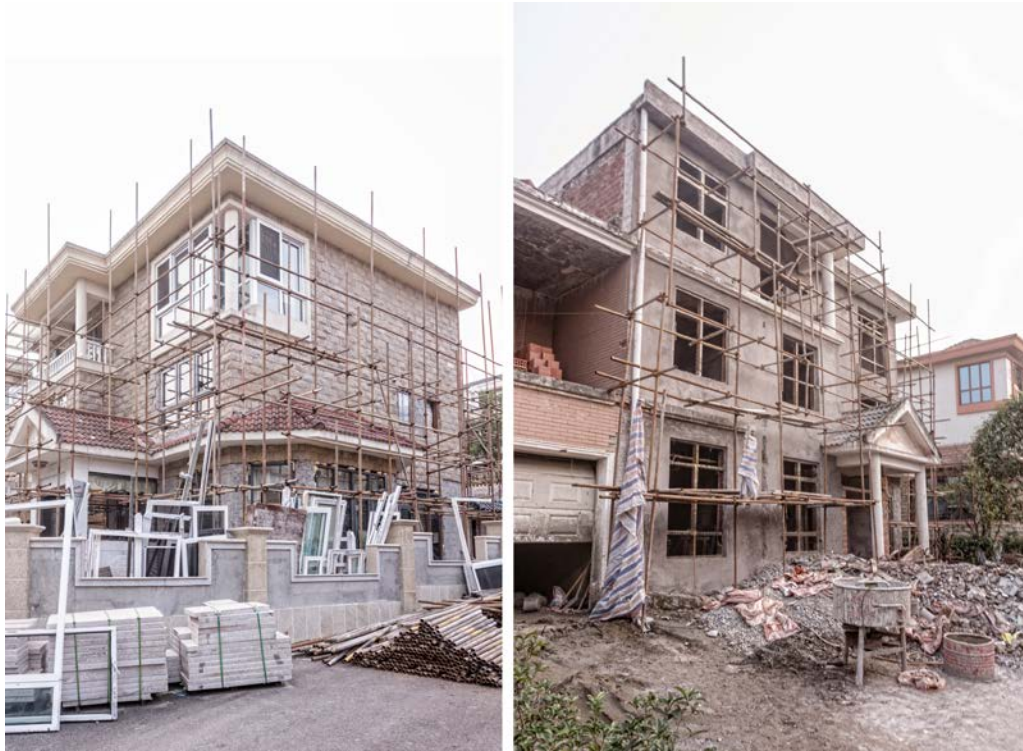
Figure 6 (Re)construction: replacement of windows and lower panels (left)⁶; stripped back to the concrete structure (right).

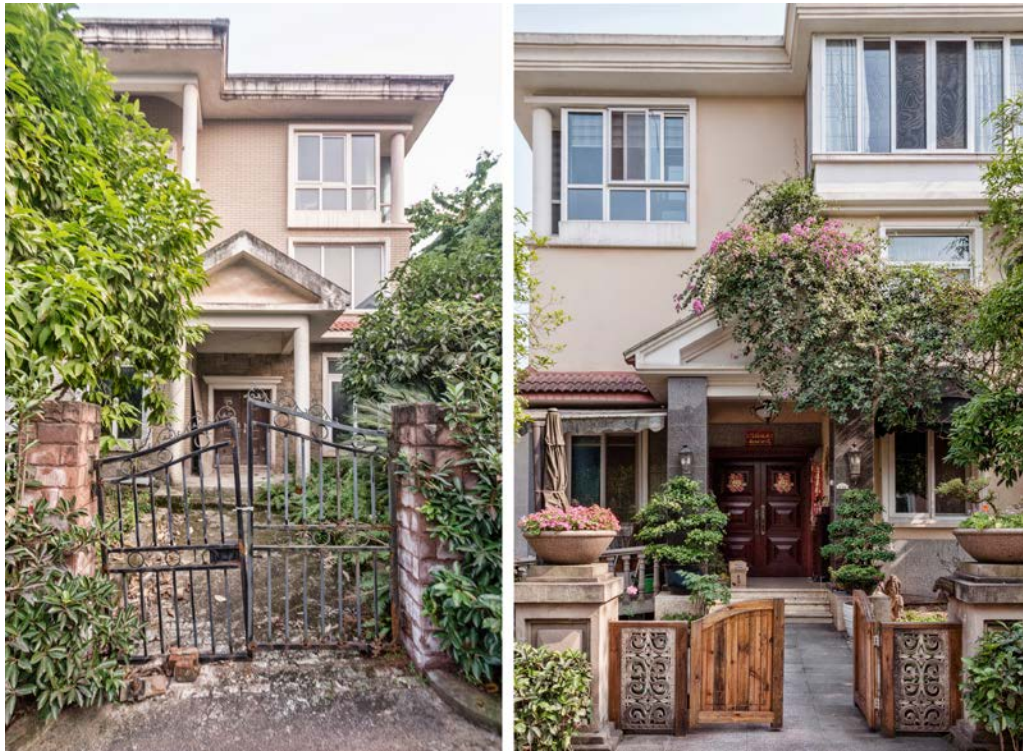
Upon visiting the community, the result is a remarkable juxtaposition of luxuriously kept homes directly adjacent to weathered, dilapidated and unoccupied homes - Figure 7. *How could these homes be only 10 years old? How had the material deterioration advanced so quickly?* Was the root cause physical (construction flaw) and/or social (type of home didn't fit how they wanted to live)? For the homes in poor condition, much of the exterior decorative work, balustrades, mouldings, veneer panels, etc. were not only stained but broken, with concrete/plaster spalling off the units. The overriding impression was poor construction and poor maintenance of the housing units, but the high quality landscaping still made the development an attractive place.

Figure 7 'Neighbours': well-kept homes (right) are directly adjacent to homes that have never been occupied (left).

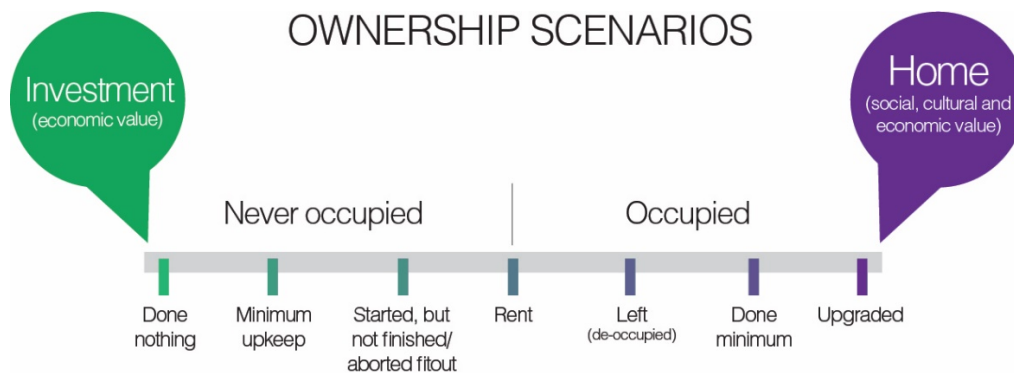
Figure 8 Ownership scenarios

It was easy to forget that residences in this type of housing development can be simply a commodity with a value on the real estate market. A range of scenarios were hypothesized and are presented on a continuum between two sets of values – a pure investment (left) and a home for living (right) – Figure 8. The spectrum helps contextualize the existing condition where all scenarios are present, but what makes the estate situation so interesting is that the outer two are the most prevalent and in direct physical relation to each other. And in discussing with residents, there were no concerns with the value of their home with regards to the adjacent unoccupied and deteriorating properties. Discussion with an owner who had not moved in to their house yet stated they bought their home because a friend had purchased one and the price was not very high. Since purchasing the home seven years ago, they've done nothing but plant two trees in the back garden. While a few of the homes were confirmed to be rented, this is typically not a viable option because while the cost of a home is typically extremely high, the rental yield is incredibly low, around 1% (Shepard, 2015). In addition, some claim that finishing a home can reduce the value of it on the second-hand market (increased amount of work to refinish). Over the 6 months investigation we could find between 20-25 homes in the estate for sale online – about half of them (9) were finished (occupied) while the other half remained unfinished (never occupied). Over the last three months two of the homes were sold. There are no 'for sale' signs or physical indication that a home is for sale on the property itself.

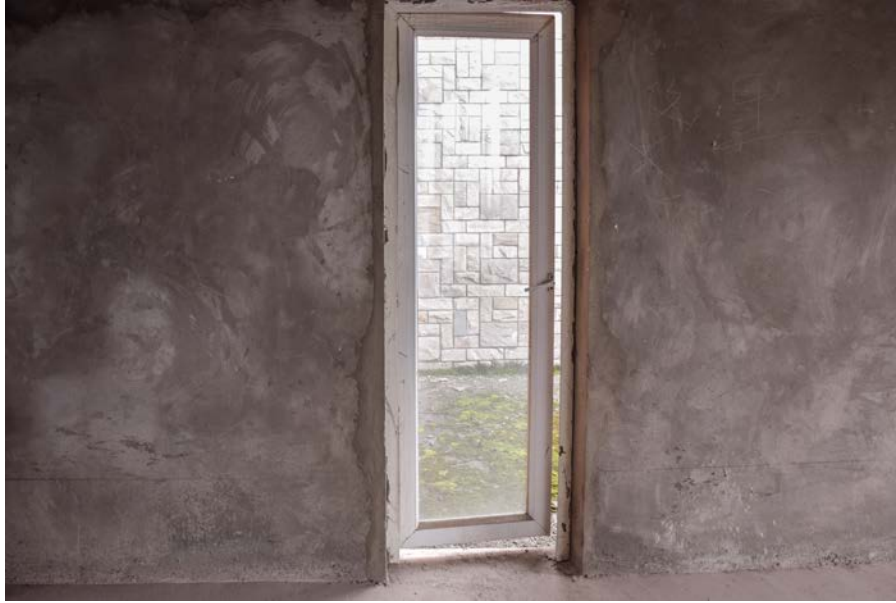
The homes are all clad with a veneer system that appeared to be done as quickly and cheaply as possible. When installing a veneer system whether it is anchored or adhered, a significant design requirement is to make sure the backup system can resist water penetration. The exterior finishes appeared to be directly adhered to the concrete structure. It appeared that the only act done prior to adhering the panels was *parging* - a thin coat of mortar to help smooth the surface and seal it against moisture. In such a case, water and water vapour that infiltrates/diffuses the exterior cladding has nowhere to go but into the house. This is especially a problem at openings (doors/windows/vents) because in this case they were poorly sealed - a lack of tight-fitting components and use of weather stripping and caulking has left openings extremely vulnerable – Figure 9.

Figure 9 Example of poorly sealed opening

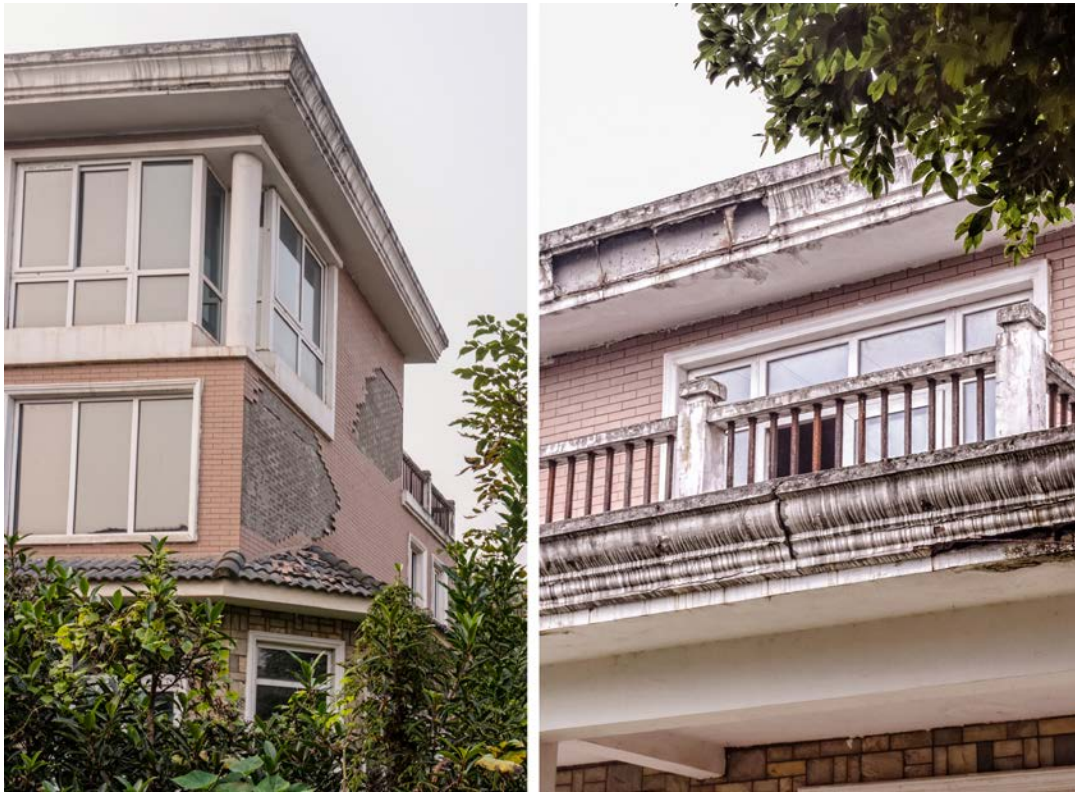
In addition, cheap and relatively non-durable panels have led to the severe and quick deterioration of the exterior with stains, cracks and large chunks falling off – all of which provide additional opportunities for water infiltration. The weathered and deteriorated condition of the exterior mouldings/trim is often the first and most obvious sign of poor construction. Mouldings are regularly stained, cracked and shattered with large chunks missing. It appears the hollow cast-in-place concrete/plaster solution has fallen victim to the infiltration of water that probably settled inside and caused havoc with the occasional freeze/thaw cycle. This condition is worsened by the inadequate rebar/metal wiring used to tie the moulding back to the structure along with a lack of movement/expansion joints compromising the integrity of the solution. Residents who have redone the cornice moulding have commented on how they've chosen to use a more solid, durable solutions such as stone or polyurethane to help remedy the condition. A lack of movement joints in the veneer panels as well fails to cater for differential movement in the structure which increases opportunities for cracking, tenting and debonding – Figure 10. The multiple opportunities for infiltration significantly increase the amount of water passage into the home. While water infiltration seemed less obvious from the ground floor slabs, one has to wonder if the site was properly graded to shed water and the slab poured on top of a water penetration layer. In addition, workers on site explained that they've often had to replace the roofing because of water infiltration (no water barrier) and that rainwater pipes were poorly installed, leaked and failed to move collected water away from the home. Rather than admitting there was an issue with the exterior finishes, the estate management team stated that some of the residents found the exterior materials were not to their liking and wanted to update them to a more fashionable choice.

Figure 10 Brick veneer falling off, stained cornice moulding and poorly sealed window openings (left); stained, hollow cornice moulding broken with insufficient metal anchorage exposed (right)

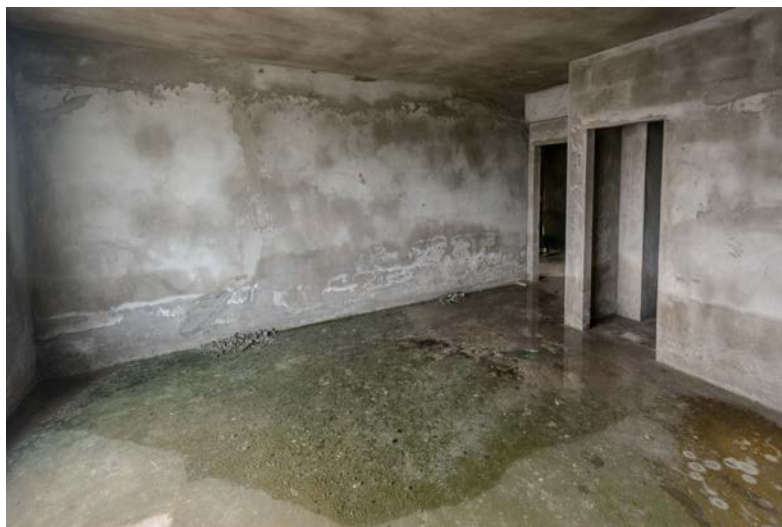
What does all this water infiltration add up to? It was obvious walking through a handful of empty homes that water infiltration through openings was a serious issue leading to the severe growth of mould – Figure 11. One could easily smell this upon entering an unoccupied home. The hot temperatures and high level of humidity provide an ideal climate for the growth of mould - high levels of air ventilation and infiltration will add to the moisture problems (poor construction can create 10 times the air exchange rate). Many residents confirmed the abundant amount of water that enters the homes through the windows and doors. Given the mould growth patterns and locations, it also appeared that some mould growth was due to severe diffusion and infiltration through the concrete structure itself.

Figure 11 Middle floor level w/ extensive water & mould

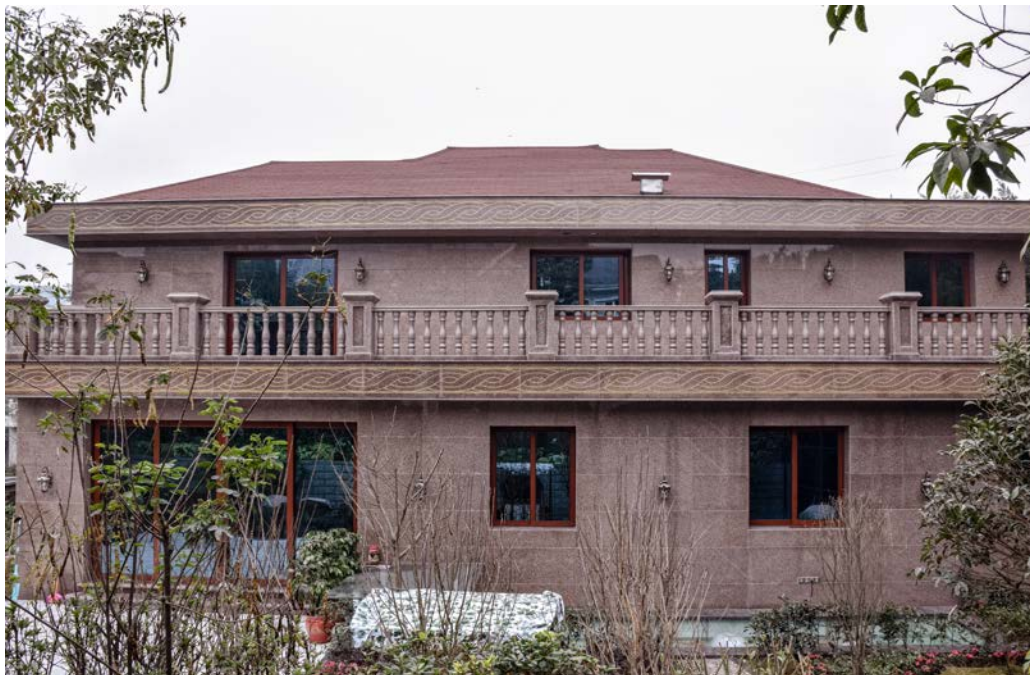
Figure 13 Exterior of the home has been completely redone with no sign of the original exterior remaining.

The reality is the 'fix' and abatement process was (and remains) far from perfect. While the exterior finishes can be replaced and stains can be removed from the concrete structure, if the issue of water infiltration and diffusion are not properly removed the condition will return. Workers stated the conventional solution is simply to (re)clad with an improved veneer adhered with a thermal mortar. While this will likely reduce water infiltration for now, a strict requirement for a refit job should be to add a proper vapour diffusion retarder (VDR) to help seal (wrap) the wall from exterior water. This would have to be done over the entire exterior envelope and work precisely with all opening details. A drainage mat (or rainscreen mat) could be added on top of the VDR to reduce moisture problems by separating the exterior veneer from the VDR and creating an airspace (cavity) that allows the wall to breathe and stay dry. The breathable net product allows for air movement and for water to drain to the exterior (e.g. flashing with weep holes). But most importantly, getting the existing concrete thoroughly dried out would prove to be especially difficult because the humid and damp year-round climate conditions keep an abundance of moisture in the air – i.e. the existing moisture in the concrete will continue to find its way out seeking equilibrium with the interior even if the exterior is sealed up properly. The visible cracking in the concrete is not believed to be structural, but forms of shrinkage or temperature cracks. In addition, residents stated that the interior mortar layer that was applied was 'too thin' as it commonly cracks and falls off. Water infiltration appeared to be present at many of the cracks since mould and staining often occurred around them. Owners appeared to have 'fixed' some of the cracks with a coat of smooth mortar applied over the top - one can visibly see the colour difference in a diagonal pattern.

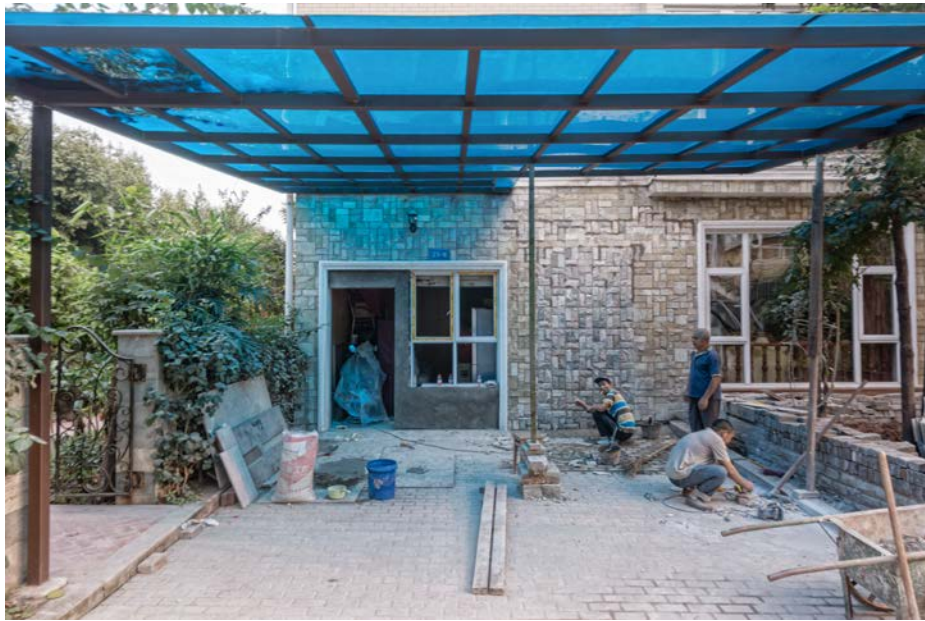
Furthermore, some residents complained about pipes leaking and needing to replace them with a higher grade. It is not clear if the pipes were simply poorly installed or an issue with material deterioration (e.g. corrosion). One worker commented that the water-supply pipes were generally too small which exacerbated the situation. Water leakage in the walls could also be another source for mould issues in the occupied homes. We were told by construction workers that the entrance location has often been switched with the neighbouring window to reduce pipe runs so as not to have pipes running above the door – Figure 14.

Figure 14 Door filled in on the right and window on the left expanded to include door; blue tinted canopy also added

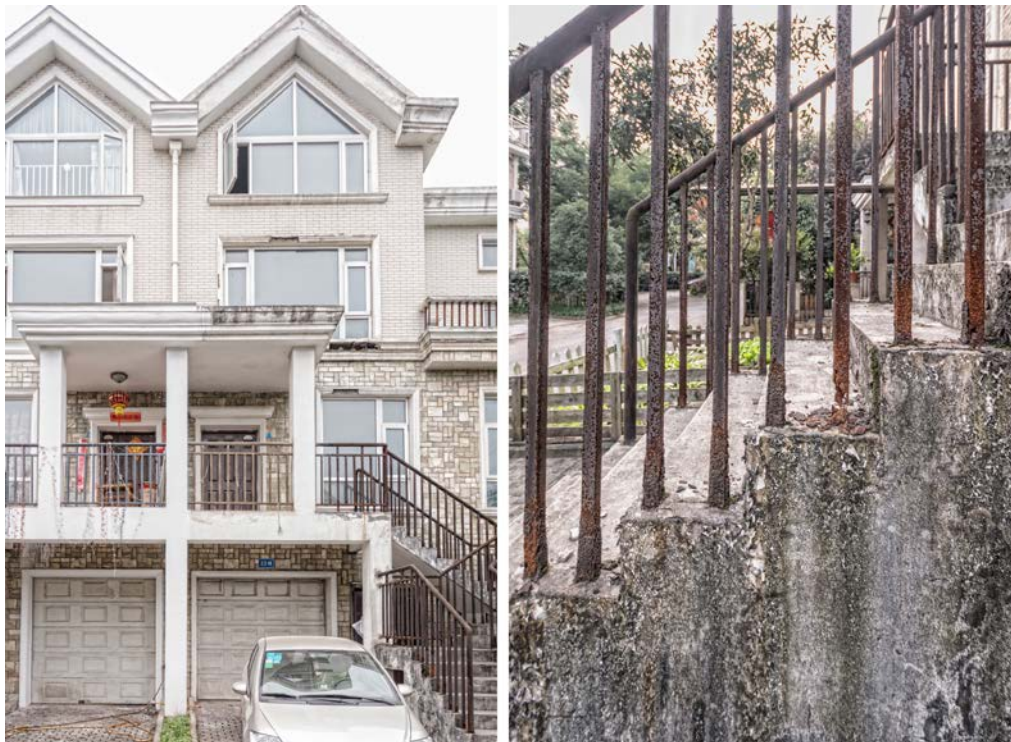
Figure 15

Corrosion is the deterioration of a metal by a chemical reaction with its environment. It is clear by the level and rate of corrosion on all of the original exterior metal that none of it was treated with any anti-corrosion efforts (e.g. reactive coating). The high temperatures and relative humidity levels of Chongqing enhance the severity of the corrosion. The metal railings for the exterior stairs and balconies are an excellent example. In the case of one of the townhouse styles the exterior staircase in the front yard leads to an additional entrance door on the second level. However, all three floors belong to the same unit and given the layout of the home it would seem unlikely for the unit to be split rendering the staircase redundant. At first the estate would not allow owners to remove the staircase, but later changed its view after many owners complained – Figure 15.

Redundant exterior stairs which have been removed by many owners (left); corrosion of exterior metal balustrades (right)

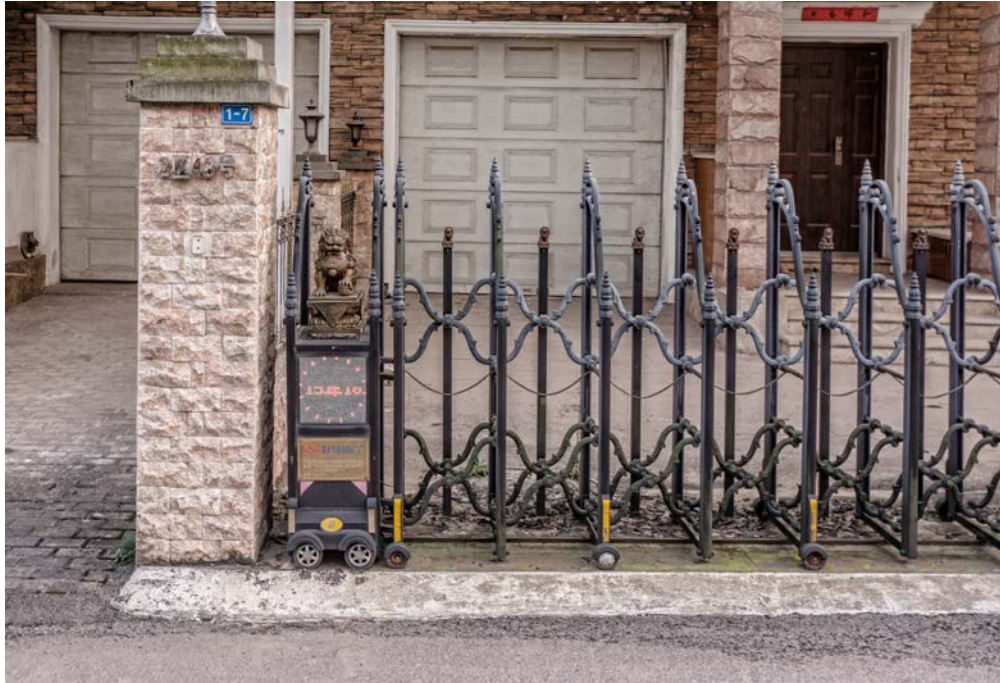
Figure 16 Orientate driveway gate with LED screen

Added segregation and delineation of space between homes exists as well - many gates and walls have been added between and across driveways and yards. Many of the driveway gates have striking ornamentation and lighting – Figure 16. The open and light white picket fences found in the original renderings and photos appear for the most part to be gone, replaced with more durable, opaque solutions.

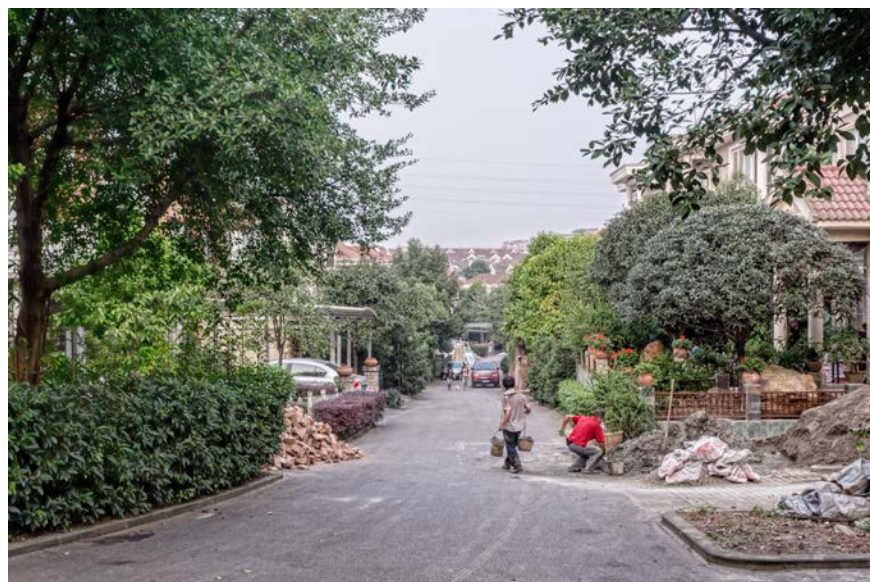
The homes benefit from a very simple load-bearing construction method of concrete and brick that allows for small teams of labours to retrofit the homes easily using manual and traditional methods. There is generally no need for heavy machinery or highly technical skills or knowledge. We watched workers mix concrete in a large barrel in the driveway and carry it to the side of the house as a small assembly line of bamboo sticks and buckets – Figure 17.

Figure 17 Workers mixing and carrying concrete to side of house

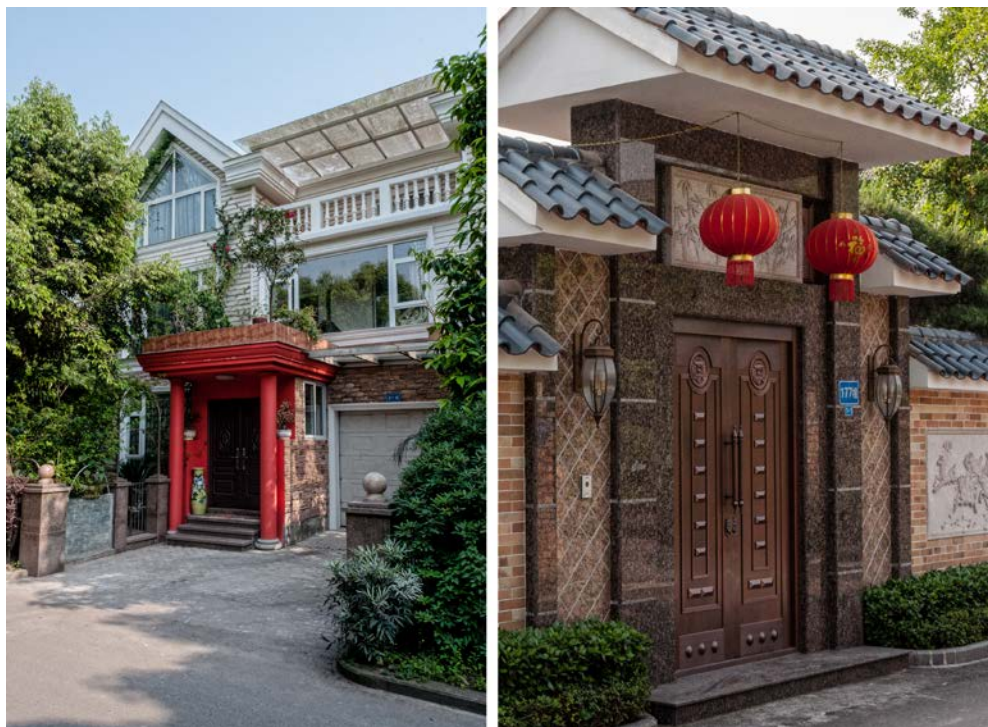
Figure 18 The redone entrance (left) and front gate (right) give the Western style homes a more Chinese appearance

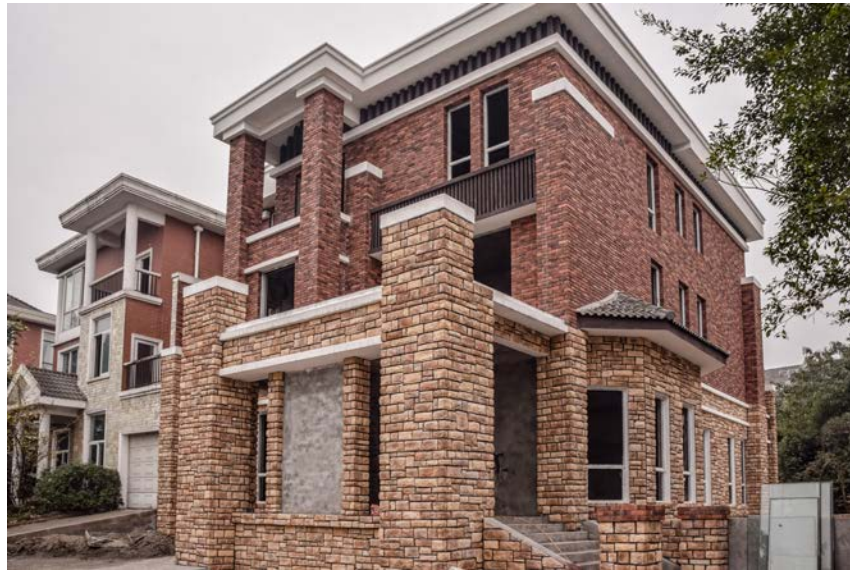
The home pictured below added a new portico entrance which protrudes out from the existing frame, re-cladded the entire exterior including the moulding and changed all the windows – Figure 19. For comparison, the adjacent home in the photo is

a mirrored version of how the home would have originally looked. In addition, the owners added an elevator shaft and built a 3 metre concrete wall to separate the back garden from the neighbour.

Figure 19 Redone home (centre) next to mirrored home (left) illustrating 'original' finish

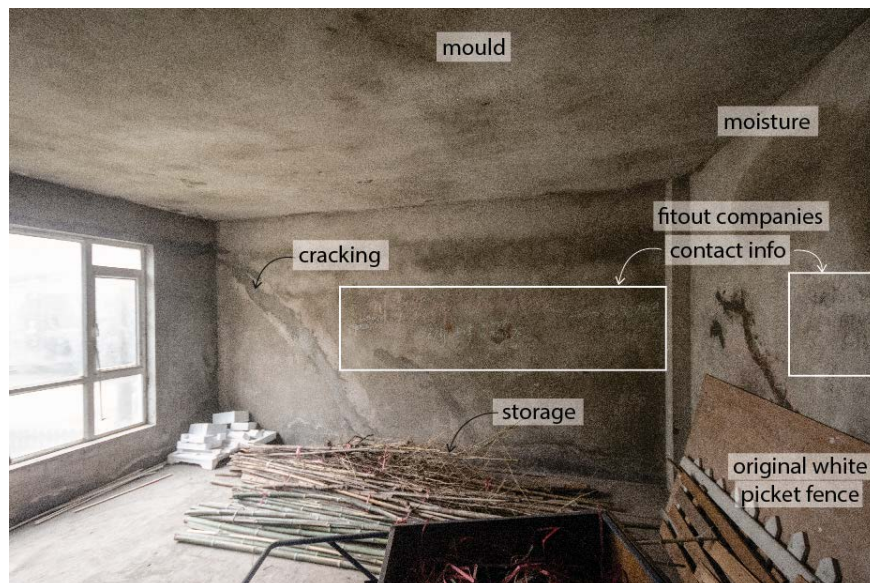
Figure 20 Ground floor with mould, cracking, storage and fit-out company's contact information

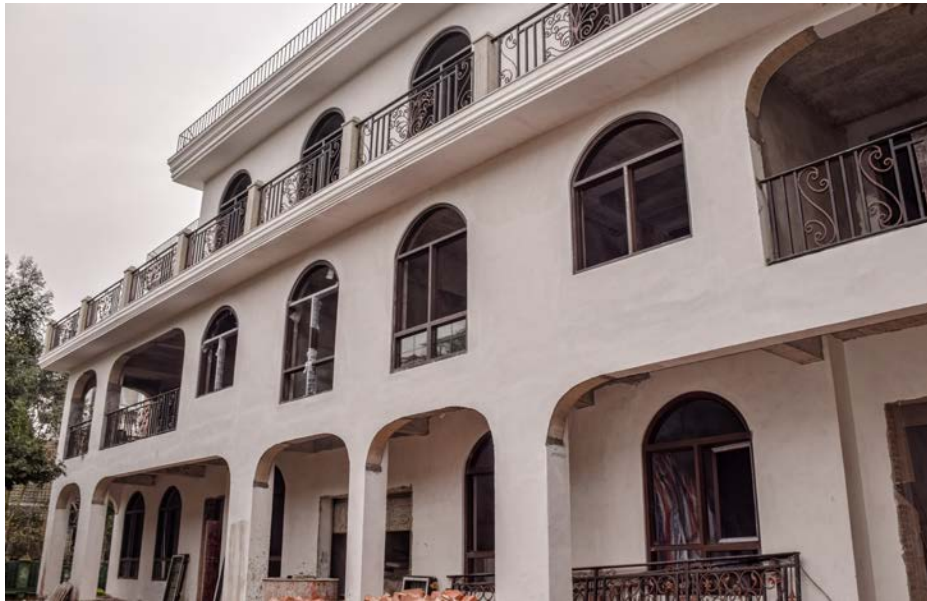
distinct appearance was brought to management's attention by neighbours and forced to stop construction - Figure 22. This would suggest on one hand that owners generally don't need to seek approval prior to constructing significant retrofits (unlike in Western countries), but on the other hand there are some rules that need to be followed.

Figure 22 Original frame of home is behind the new arcade; home was additionally extended to cover almost all of the garden space
