# Cathodic protection on the UK's Midland Links motorway viaducts

The Midland Links motorway viaducts (MLMV) are a series of reinforced concrete structures comprising 21 km of elevated motorway around the outer circumference of Birmingham. Deterioration was identified early in their serviceable life due to chloride induced corrosion of the steel reinforcement. An electrochemical treatment utilising an impressed current cathodic protection (ICCP) was successfully trialled in 1987 with the first large-scale commercial application of the treatment on the network in 1991. Since then it has been the principal corrosion management strategy for the MLMV, with 740 structures currently protected by ICCP. The aim of this paper is to offer a brief historical review of the MLMV network, discuss the deterioration mechanisms and review the historical developments of ICCP together with its overall performance as a corrosion-management method. Recent developments in cathodic protection technology and secondary beneficial effects of the ICCP previously not recognised are also discussed on how they can potentially result in significant cost savings for maintenance agencies for this and other simila

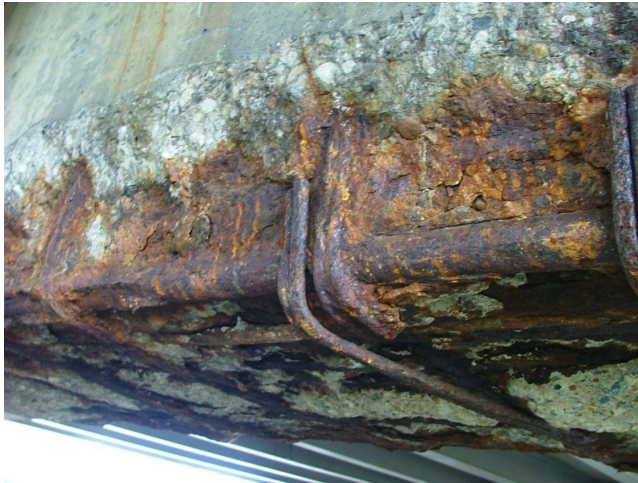
**Figure 1.** Typical chloride-induced corrosion damage to a reinforced-concrete structure

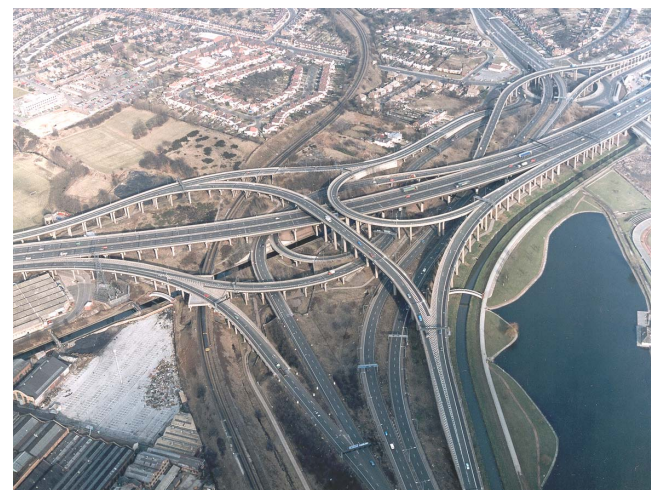
**Figure 3.** Aerial photograph of Gravelly Hill interchange on the MLMV, J6 of the M6 – known as 'Spaghetti Junction'

the Midland Links. It comprised in total 106 km of motorway of which 69 km were rural type and 37 km urban type motorway. Out of these, 21.3 km consisted of motorway viaducts or as commonly known the Midland Links motorway viaducts (MLMV). The section between Gravelly Hill and Castle Bromwich (junctions 6 to 5 of the M6) was the longest continuous viaduct in the MLMV at a total length of 5.6 km. Part of the MLMV is the Gravelly Hill interchange, junction 6 of the M6, commonly known as the 'Spaghetti Junction' owing to its complexity and was the first of its kind. It connects the M6 with the A38M motorway, A38 and the A5127 (Figure 3).

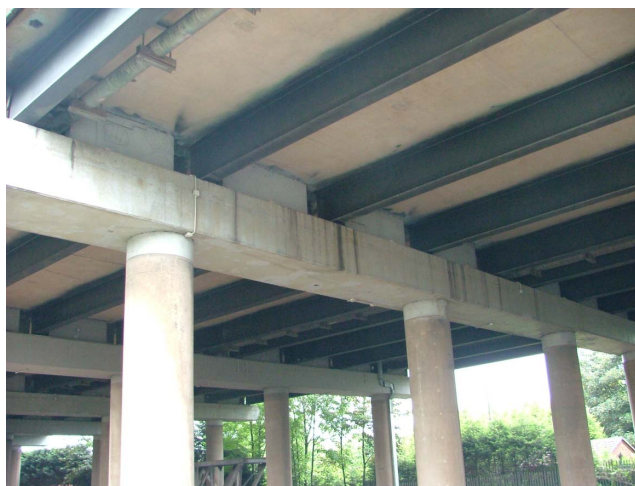
Figure 6. The first operational ICCP system on the MLMV installed in 1990 as seen on 14/03/2012

The first fully operational ICCP repair contract was installed and commissioned by July 1991; it utilised a conductive coating impressed current anode system. This particular anode system is still operational today (Figure 6). Since then it is estimated that ICCP has been installed on 740 crossbeams of the MLMV and more than  $100\,000 \text{ m}^2$  of concrete surface area have been protected.

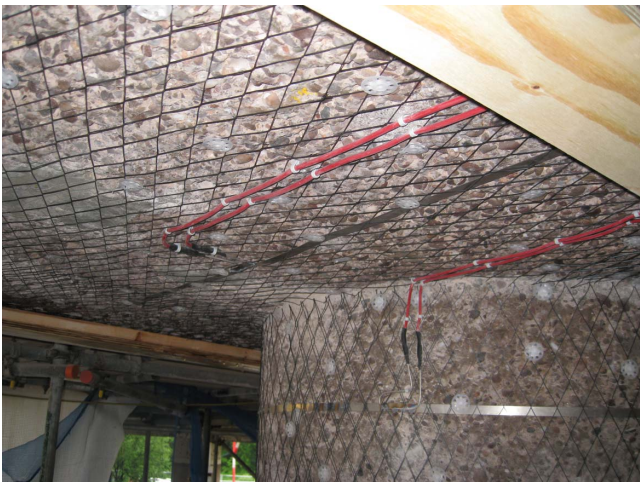
**Figure 7.** A MMO/Ti mesh fixed to a concrete beam prior to the application of the cementitious overlay

The MMO/Ti mesh system utilises a cementitious sprayed overlay mortar to embed the anode and the corresponding cabling. The cementitious overlay, typically 30 mm in thickness, serves as protection to the anode and all the associated cables. MMO/Ti mesh anode with an overlay offers increased durability against environmental conditions compared with conductive coating anodes, partly due to the increased durability of the MMO/Ti anode, and partly owing to the more rigorous surface preparation and interfacial bond. The MMO/Ti mesh serving as an anode for the ICCP system is fixed firmly to the structure and also acts as a light reinforcement to the overlay material (Figure 7). There is also a mechanical bond

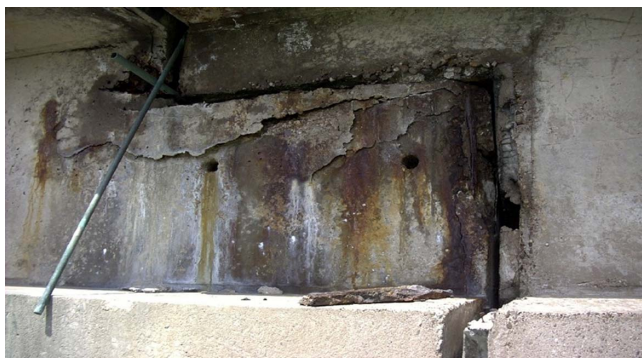
**Figure 8.** Chloride induced corrosion deterioration of a bridge half-joint

Figure 8 illustrates a bridge half-joint exhibiting chloride-induced deterioration. These areas are highly stressed and are heavily congested with steel reinforcement. Access is severely limited and thus the application of traditional concrete repairs can be undertaken only in accessible areas. Following repairs of the physically deteriorated concrete, an ICCP system utilising an MMO/Ti mesh anode was installed to arrest ongoing corrosion activity and prevent further structural deterioration.
