LOAD TRANSFER ACROSS CRACKS AND JOINTS IN CONCRETE SLABS ON GRADE

Stuart John Arnold

**A Doctoral Thesis Submitted in partial fulfilment of the requirements for the
award of
Doctor of Philosophy of Loughborough University**

20th February 2004

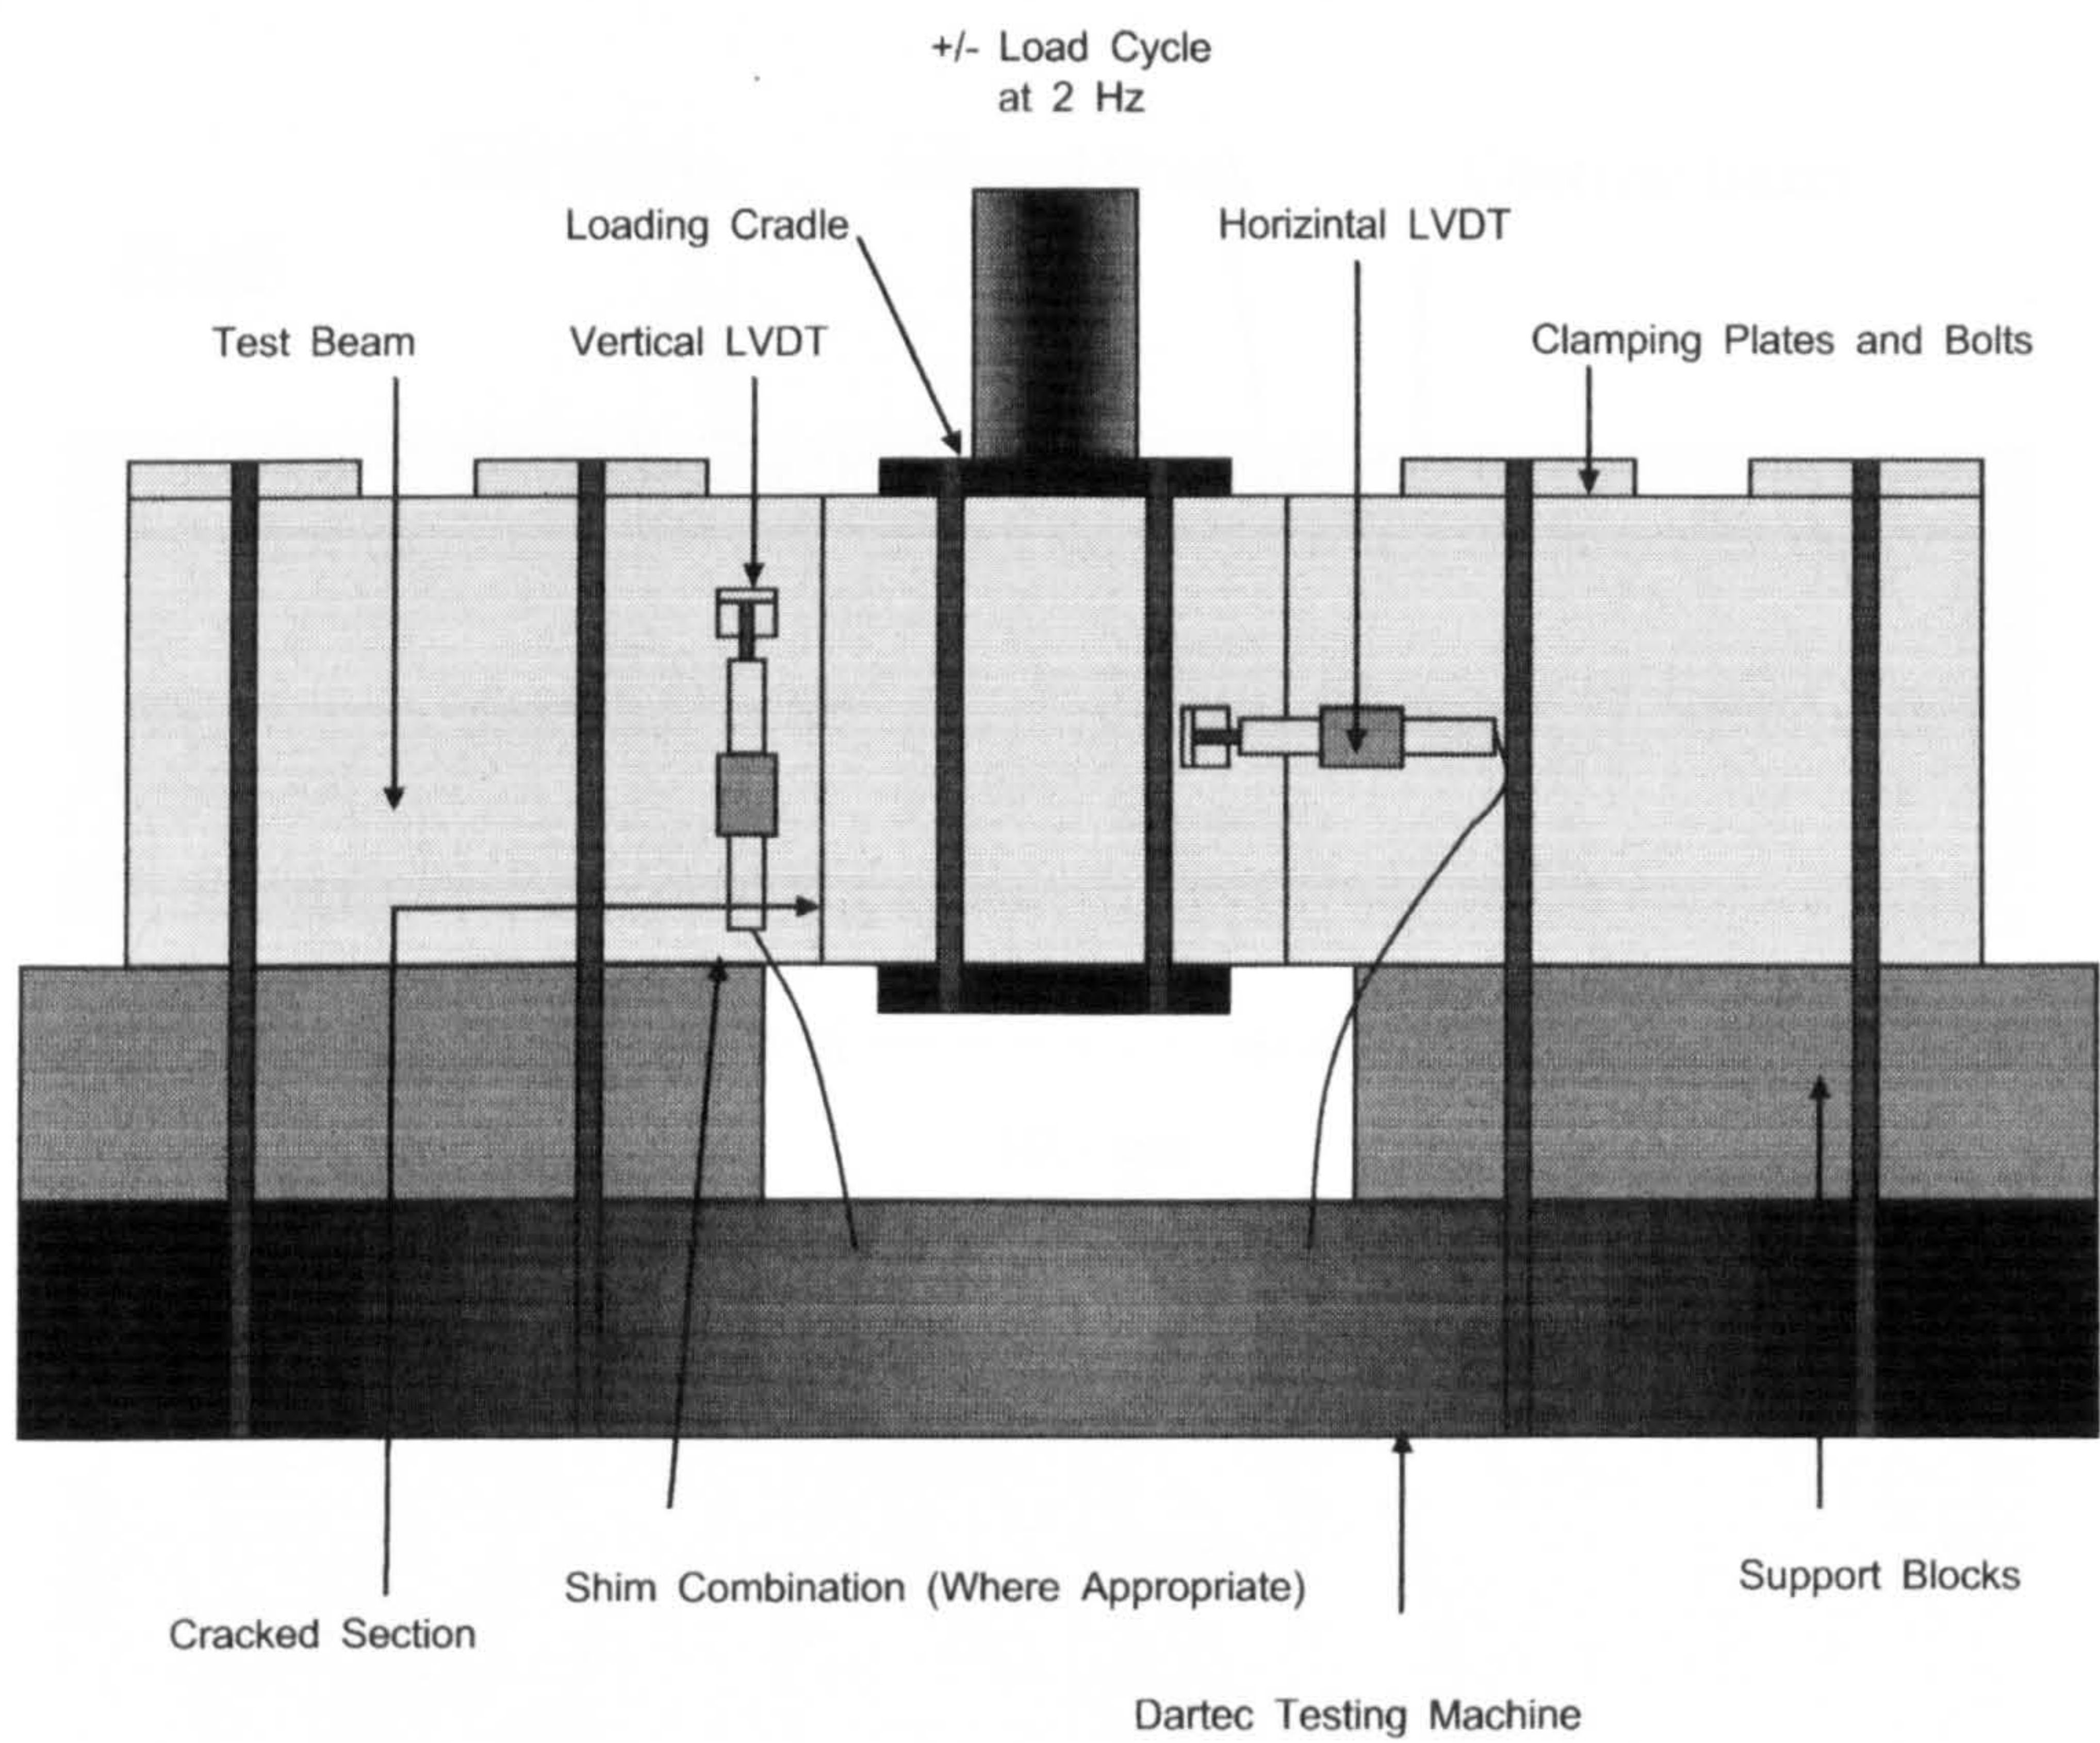
Figure 5.1 – Cyclic loading test set-up (Schematic)

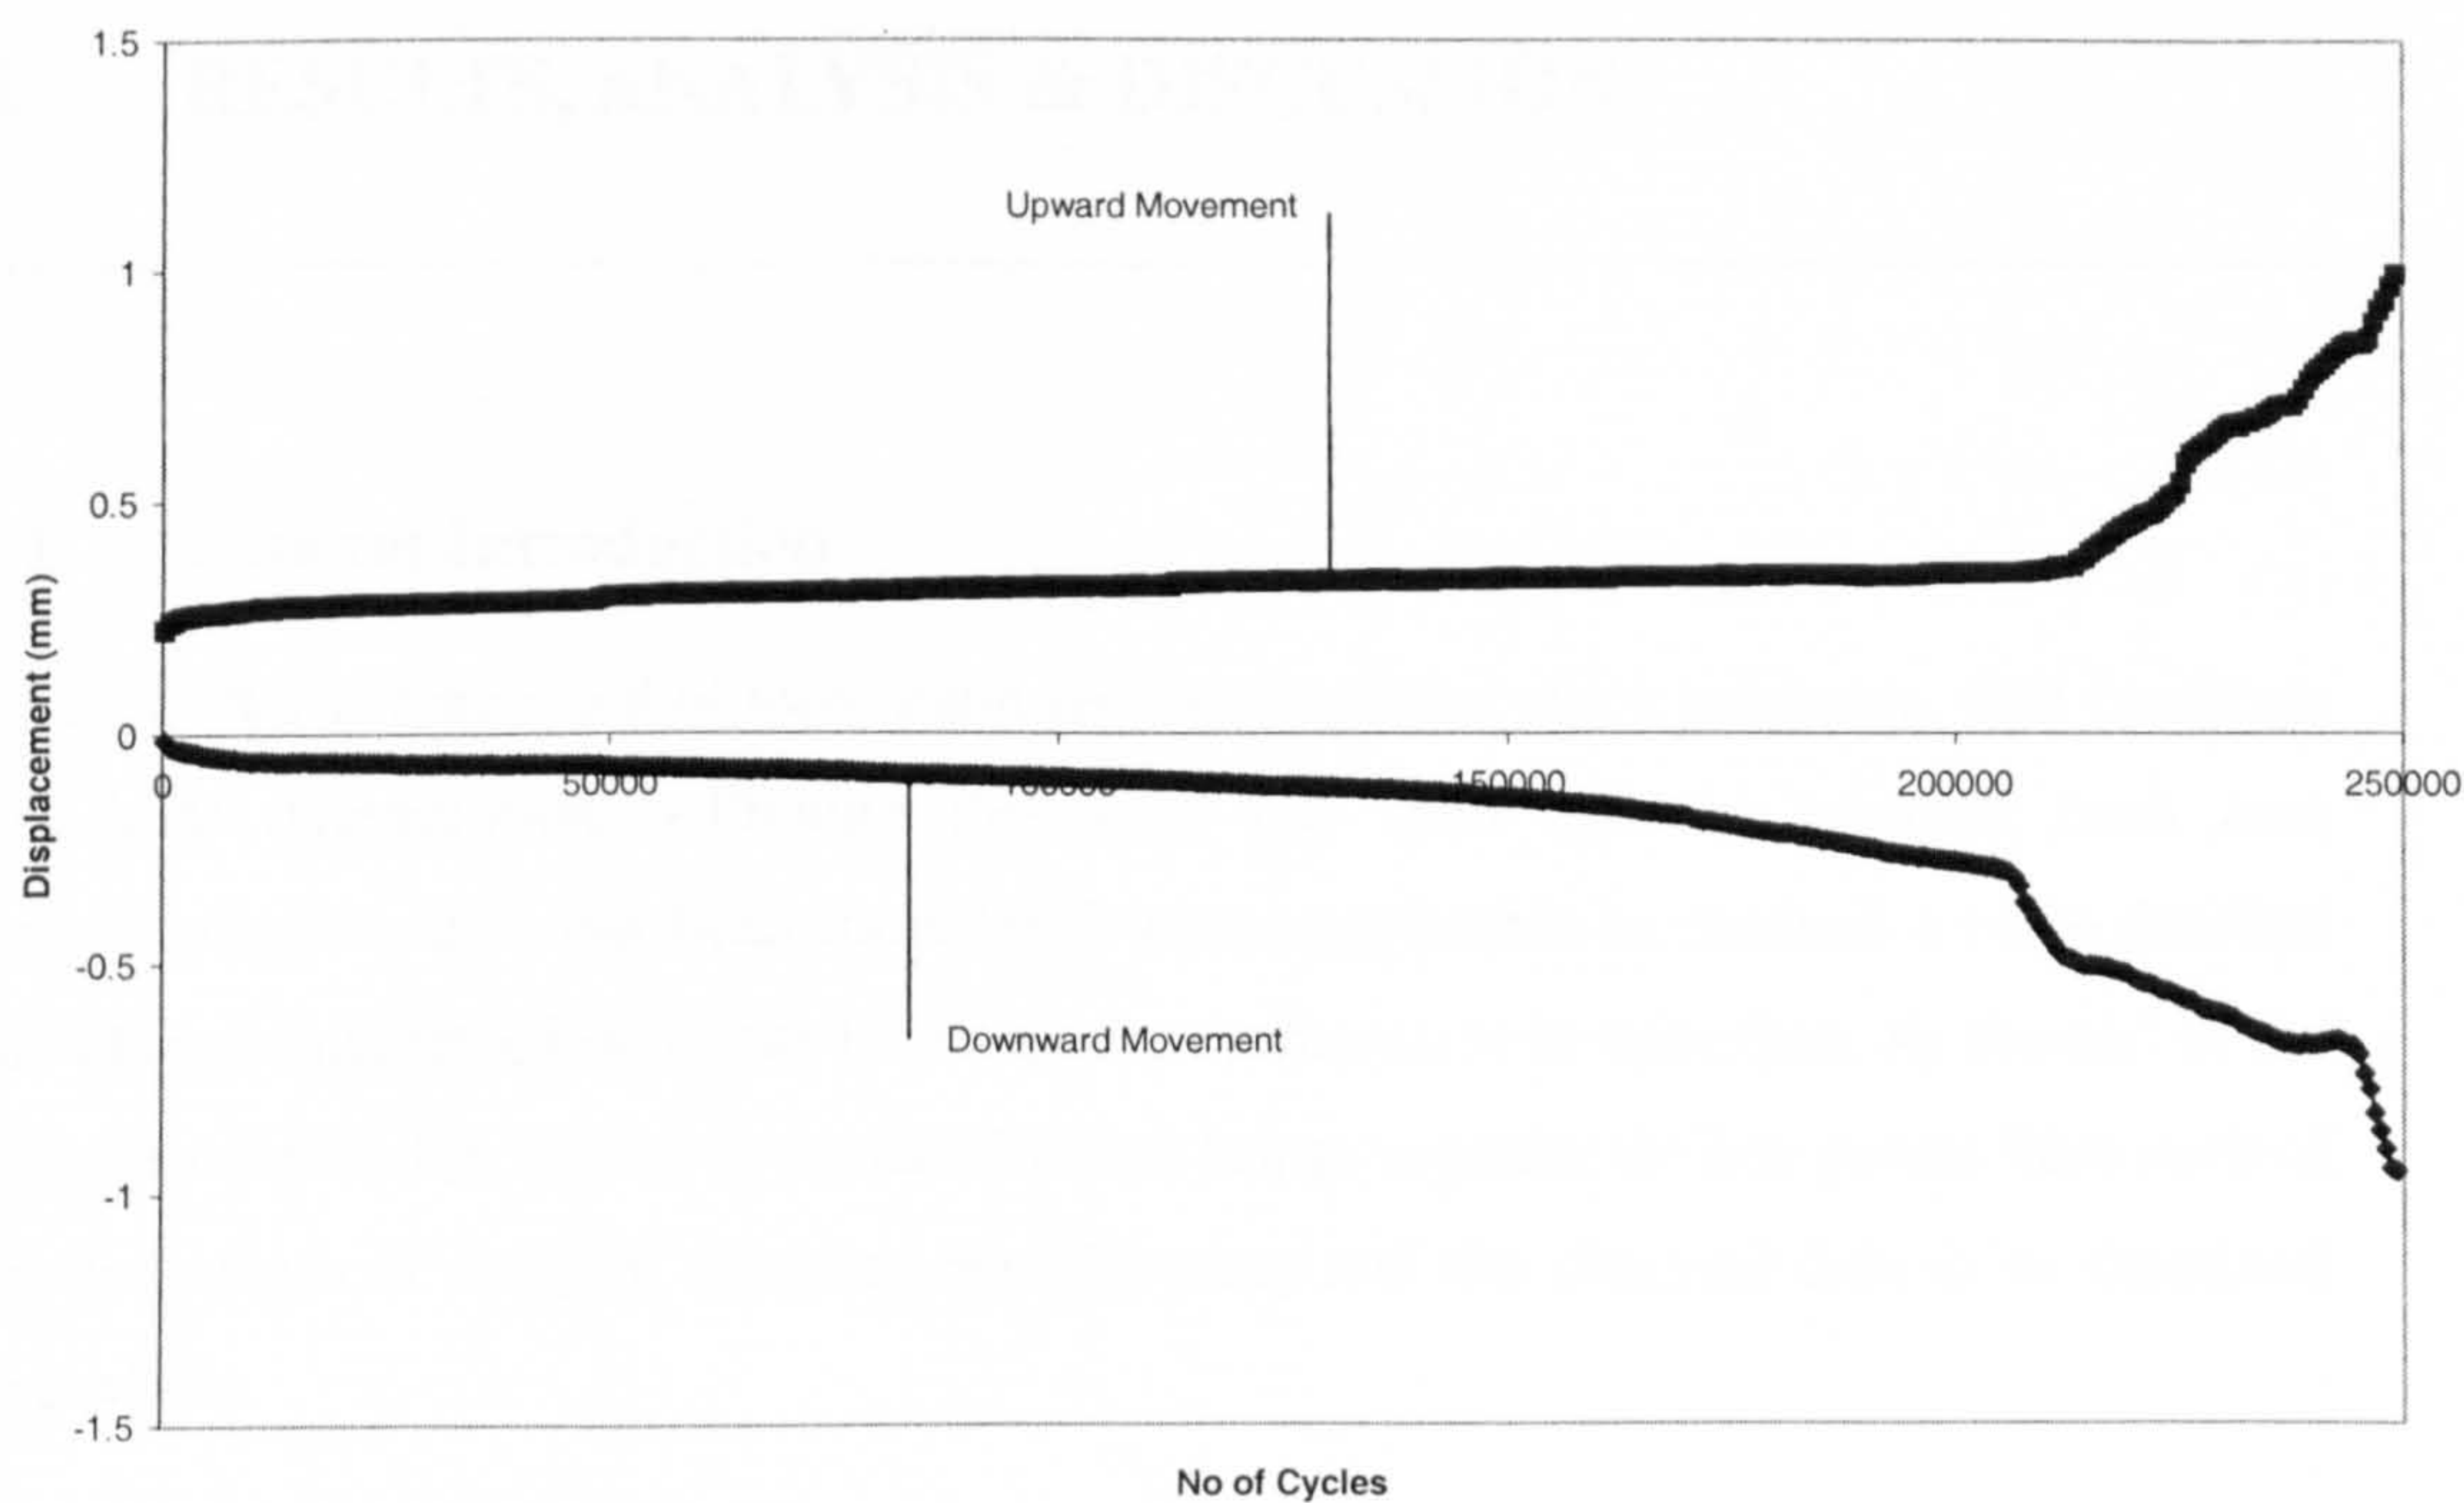
Figure 5.24 – Positive and negative displacement deterioration plot

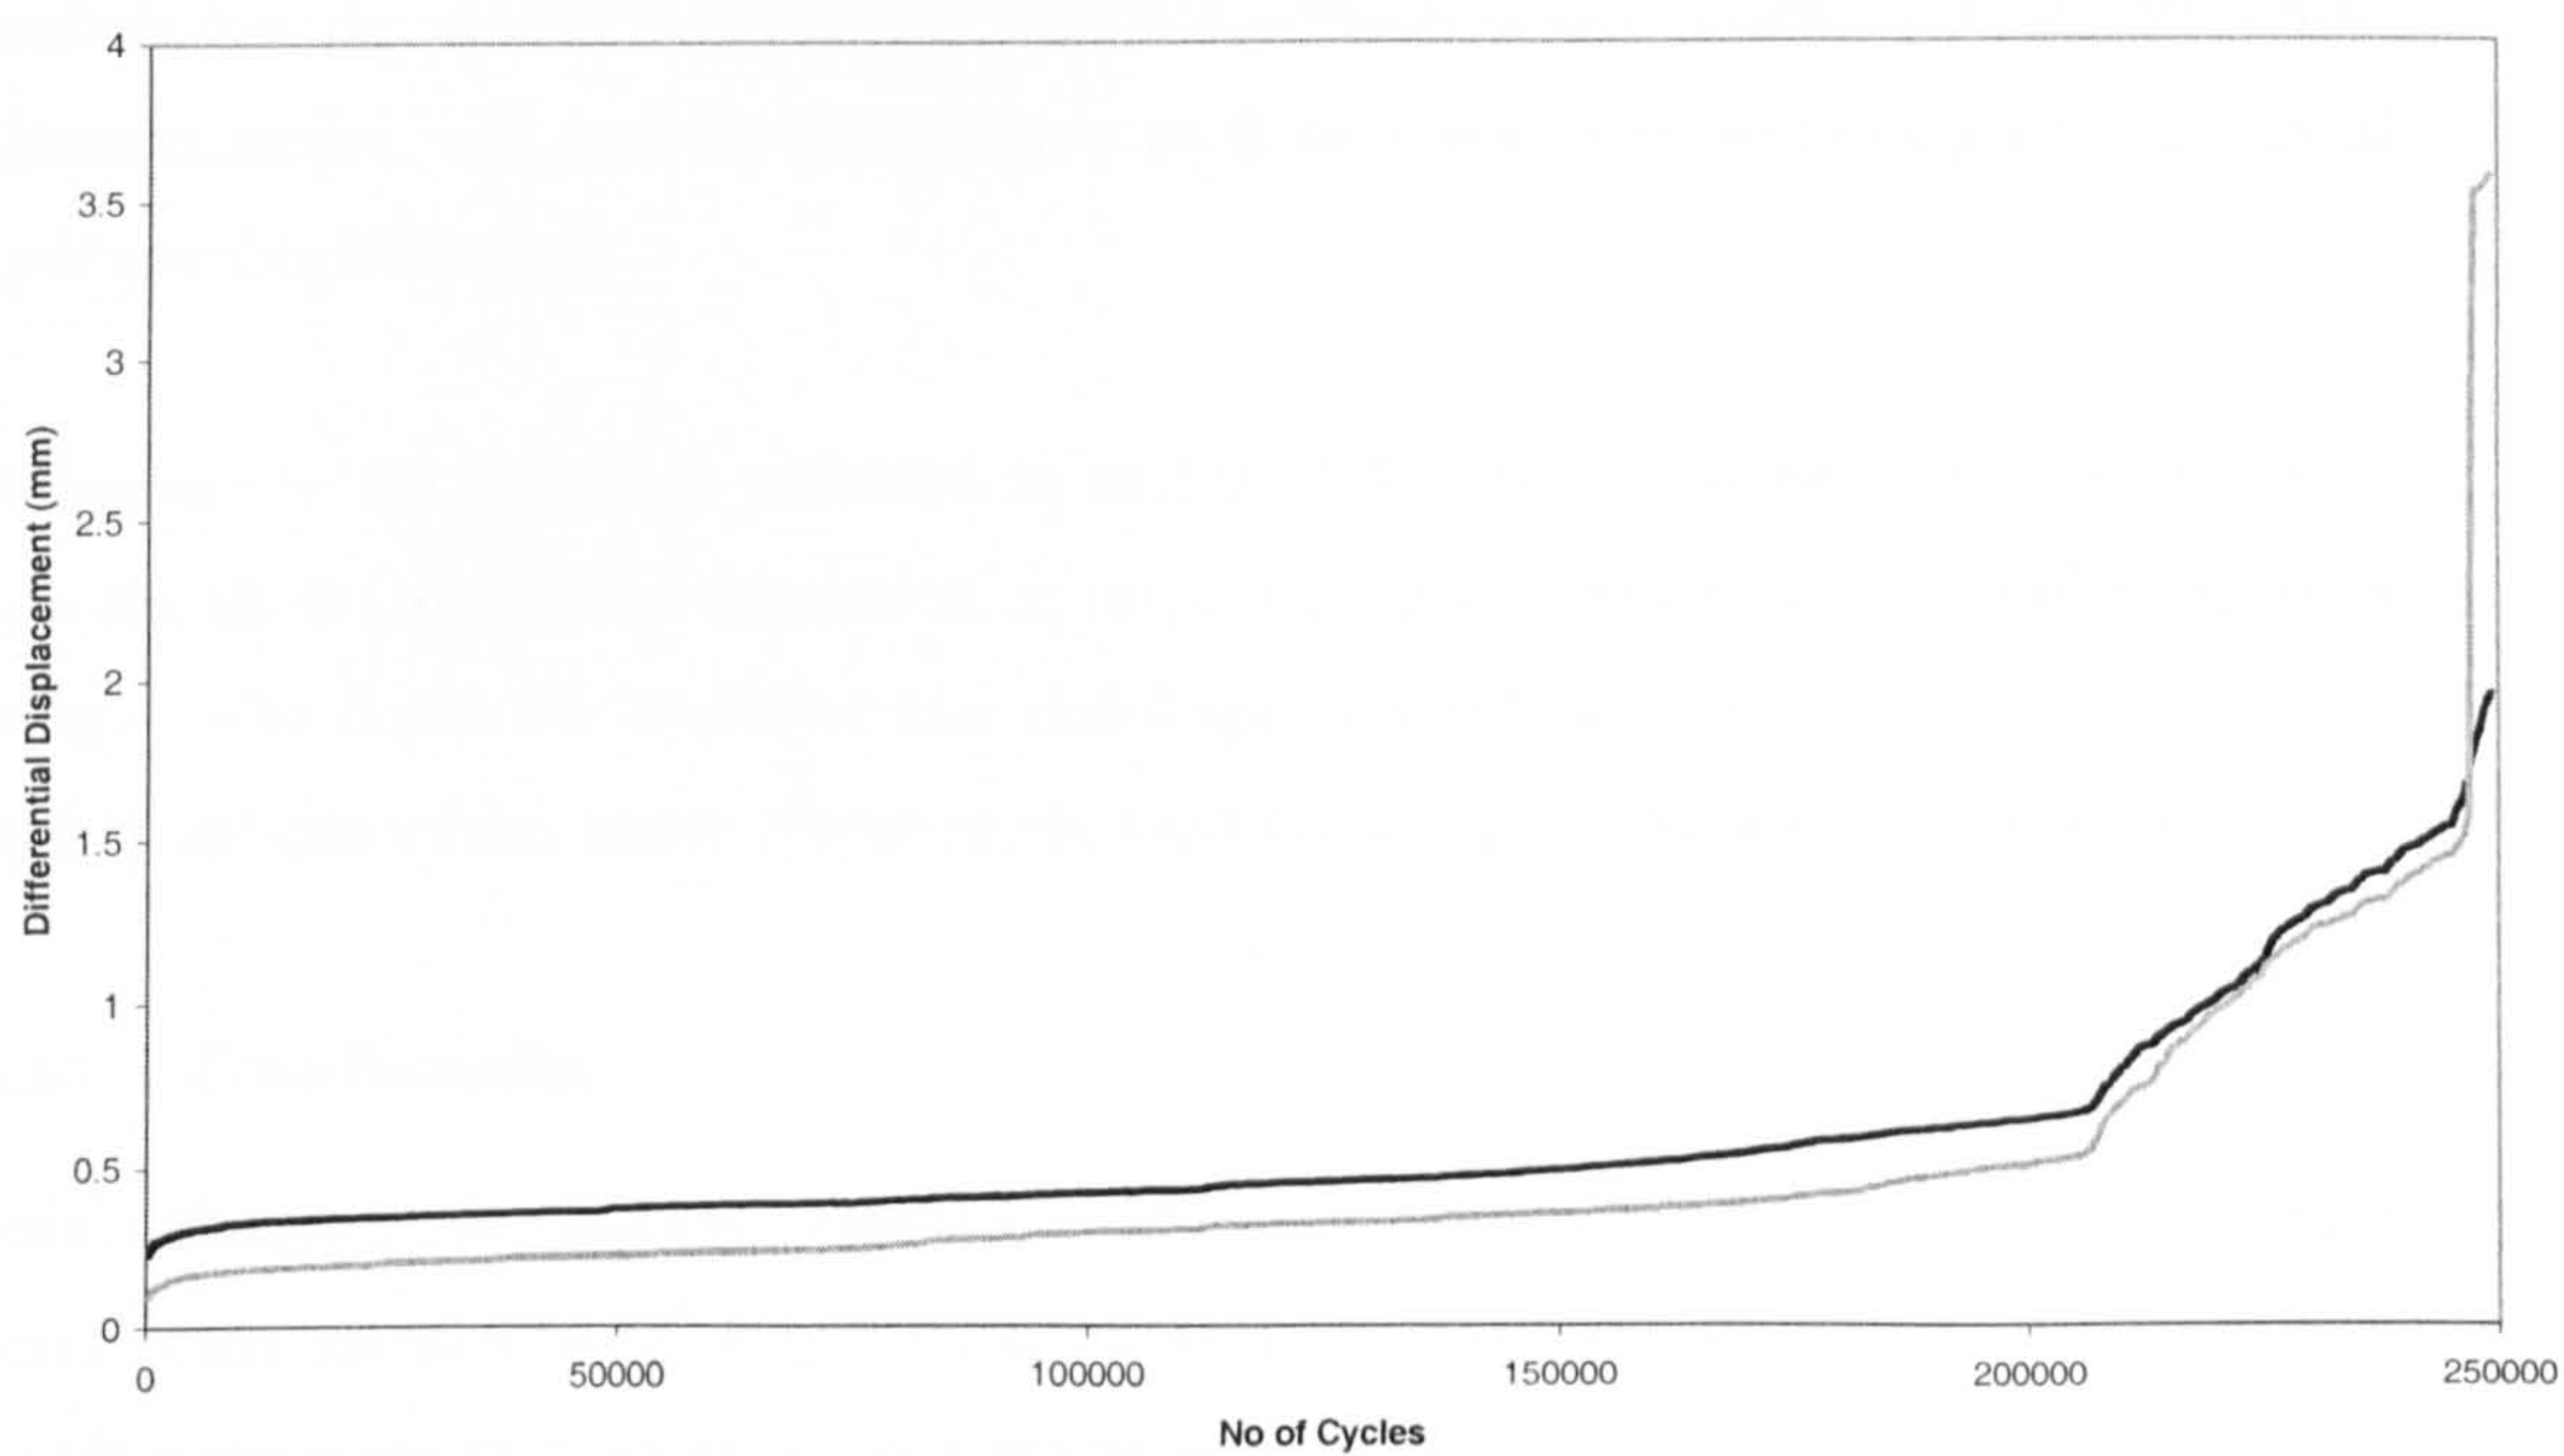
Figure 5.25 – Differential displacement deterioration plot

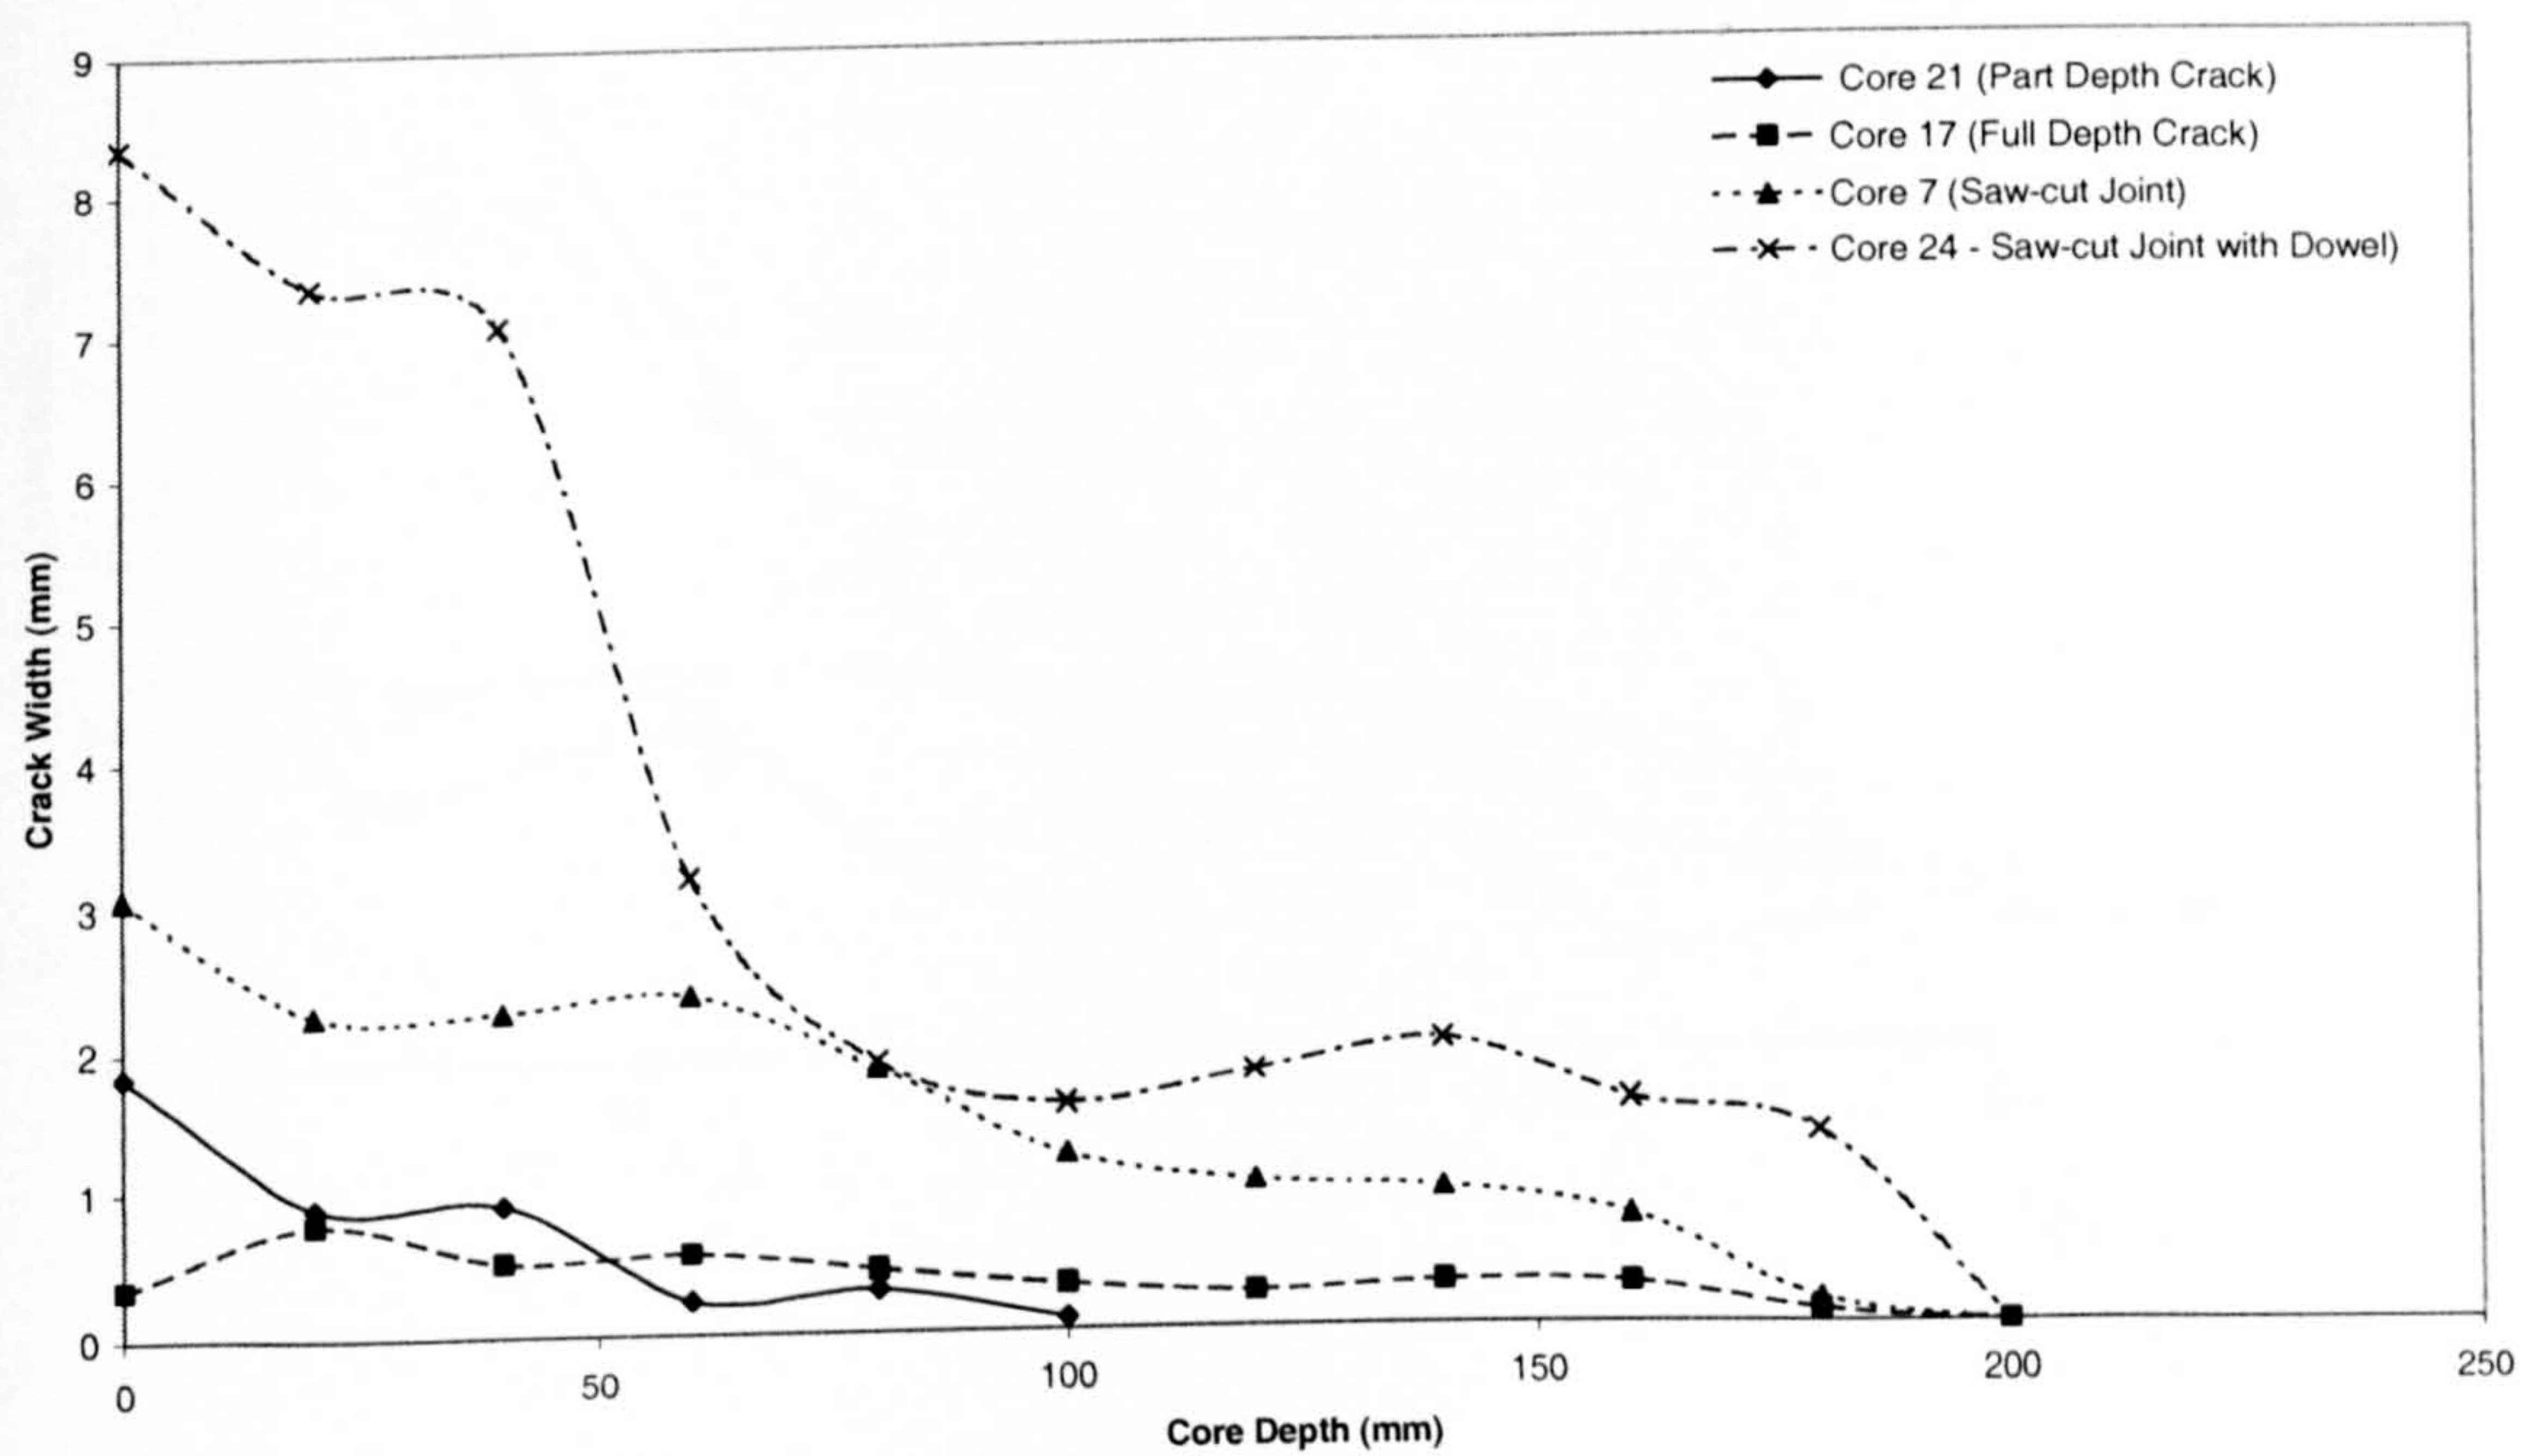
Figure 6.3 – Crack profiles from cores taken in visit 1

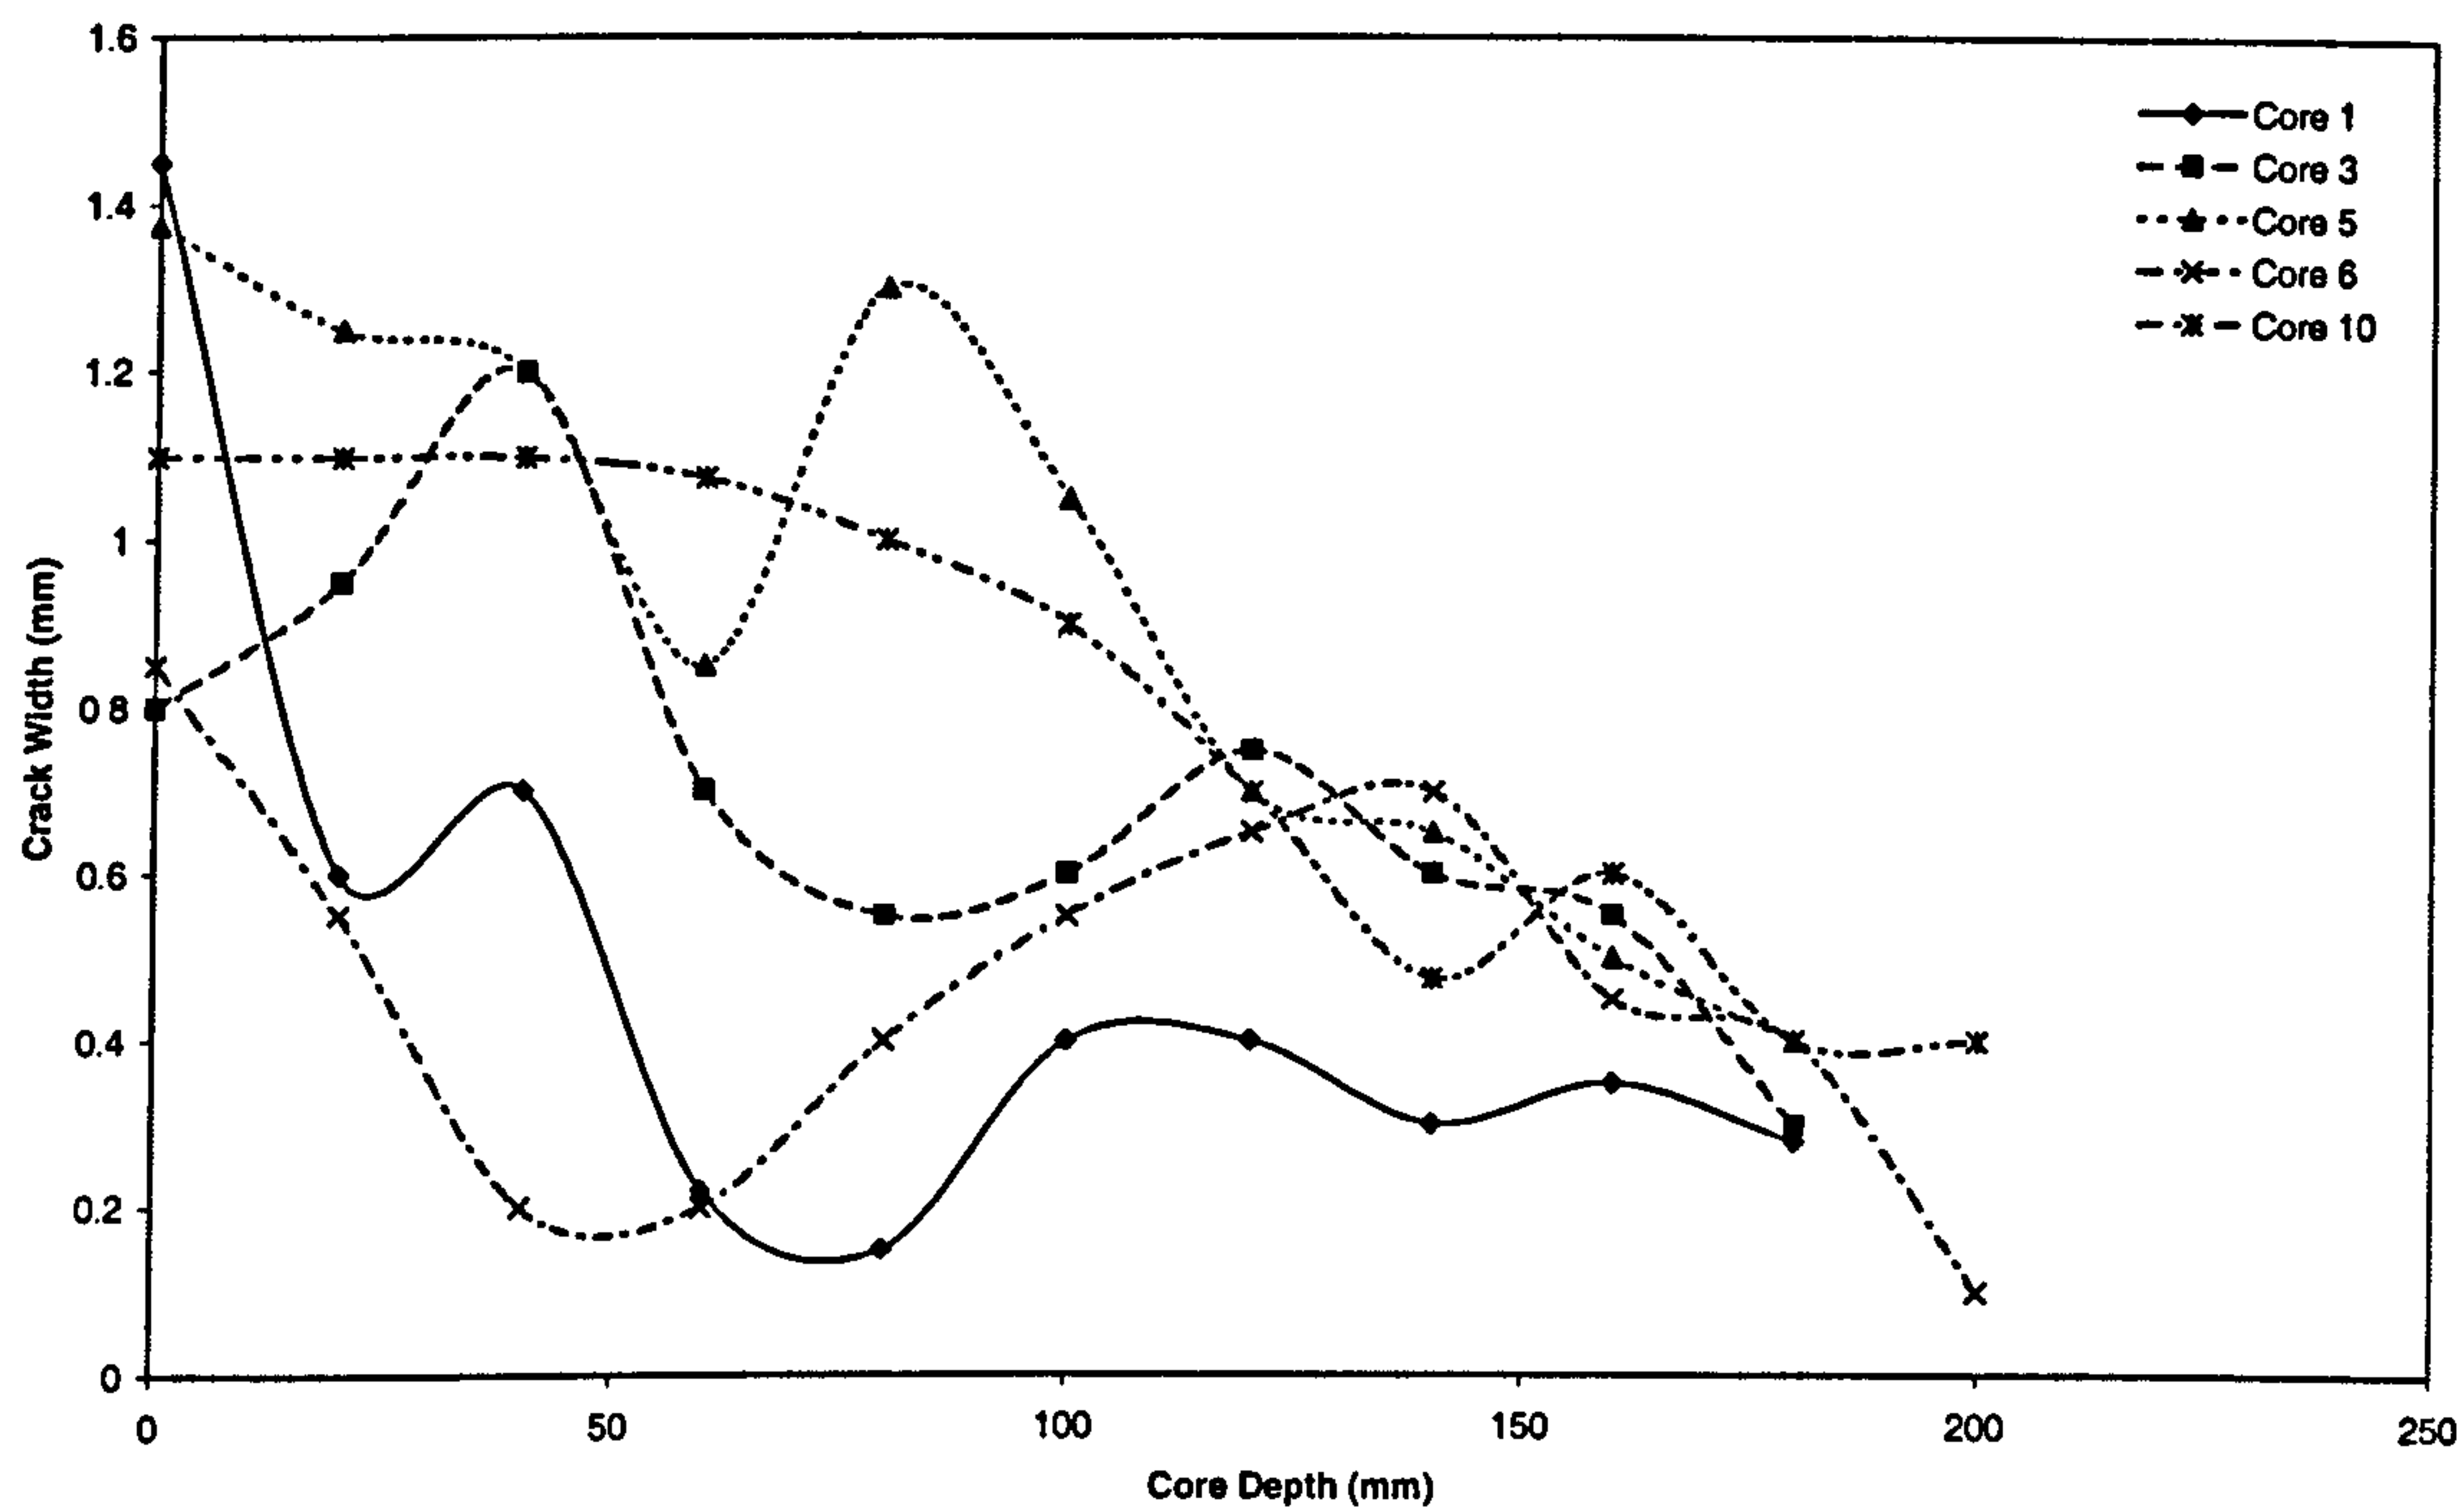
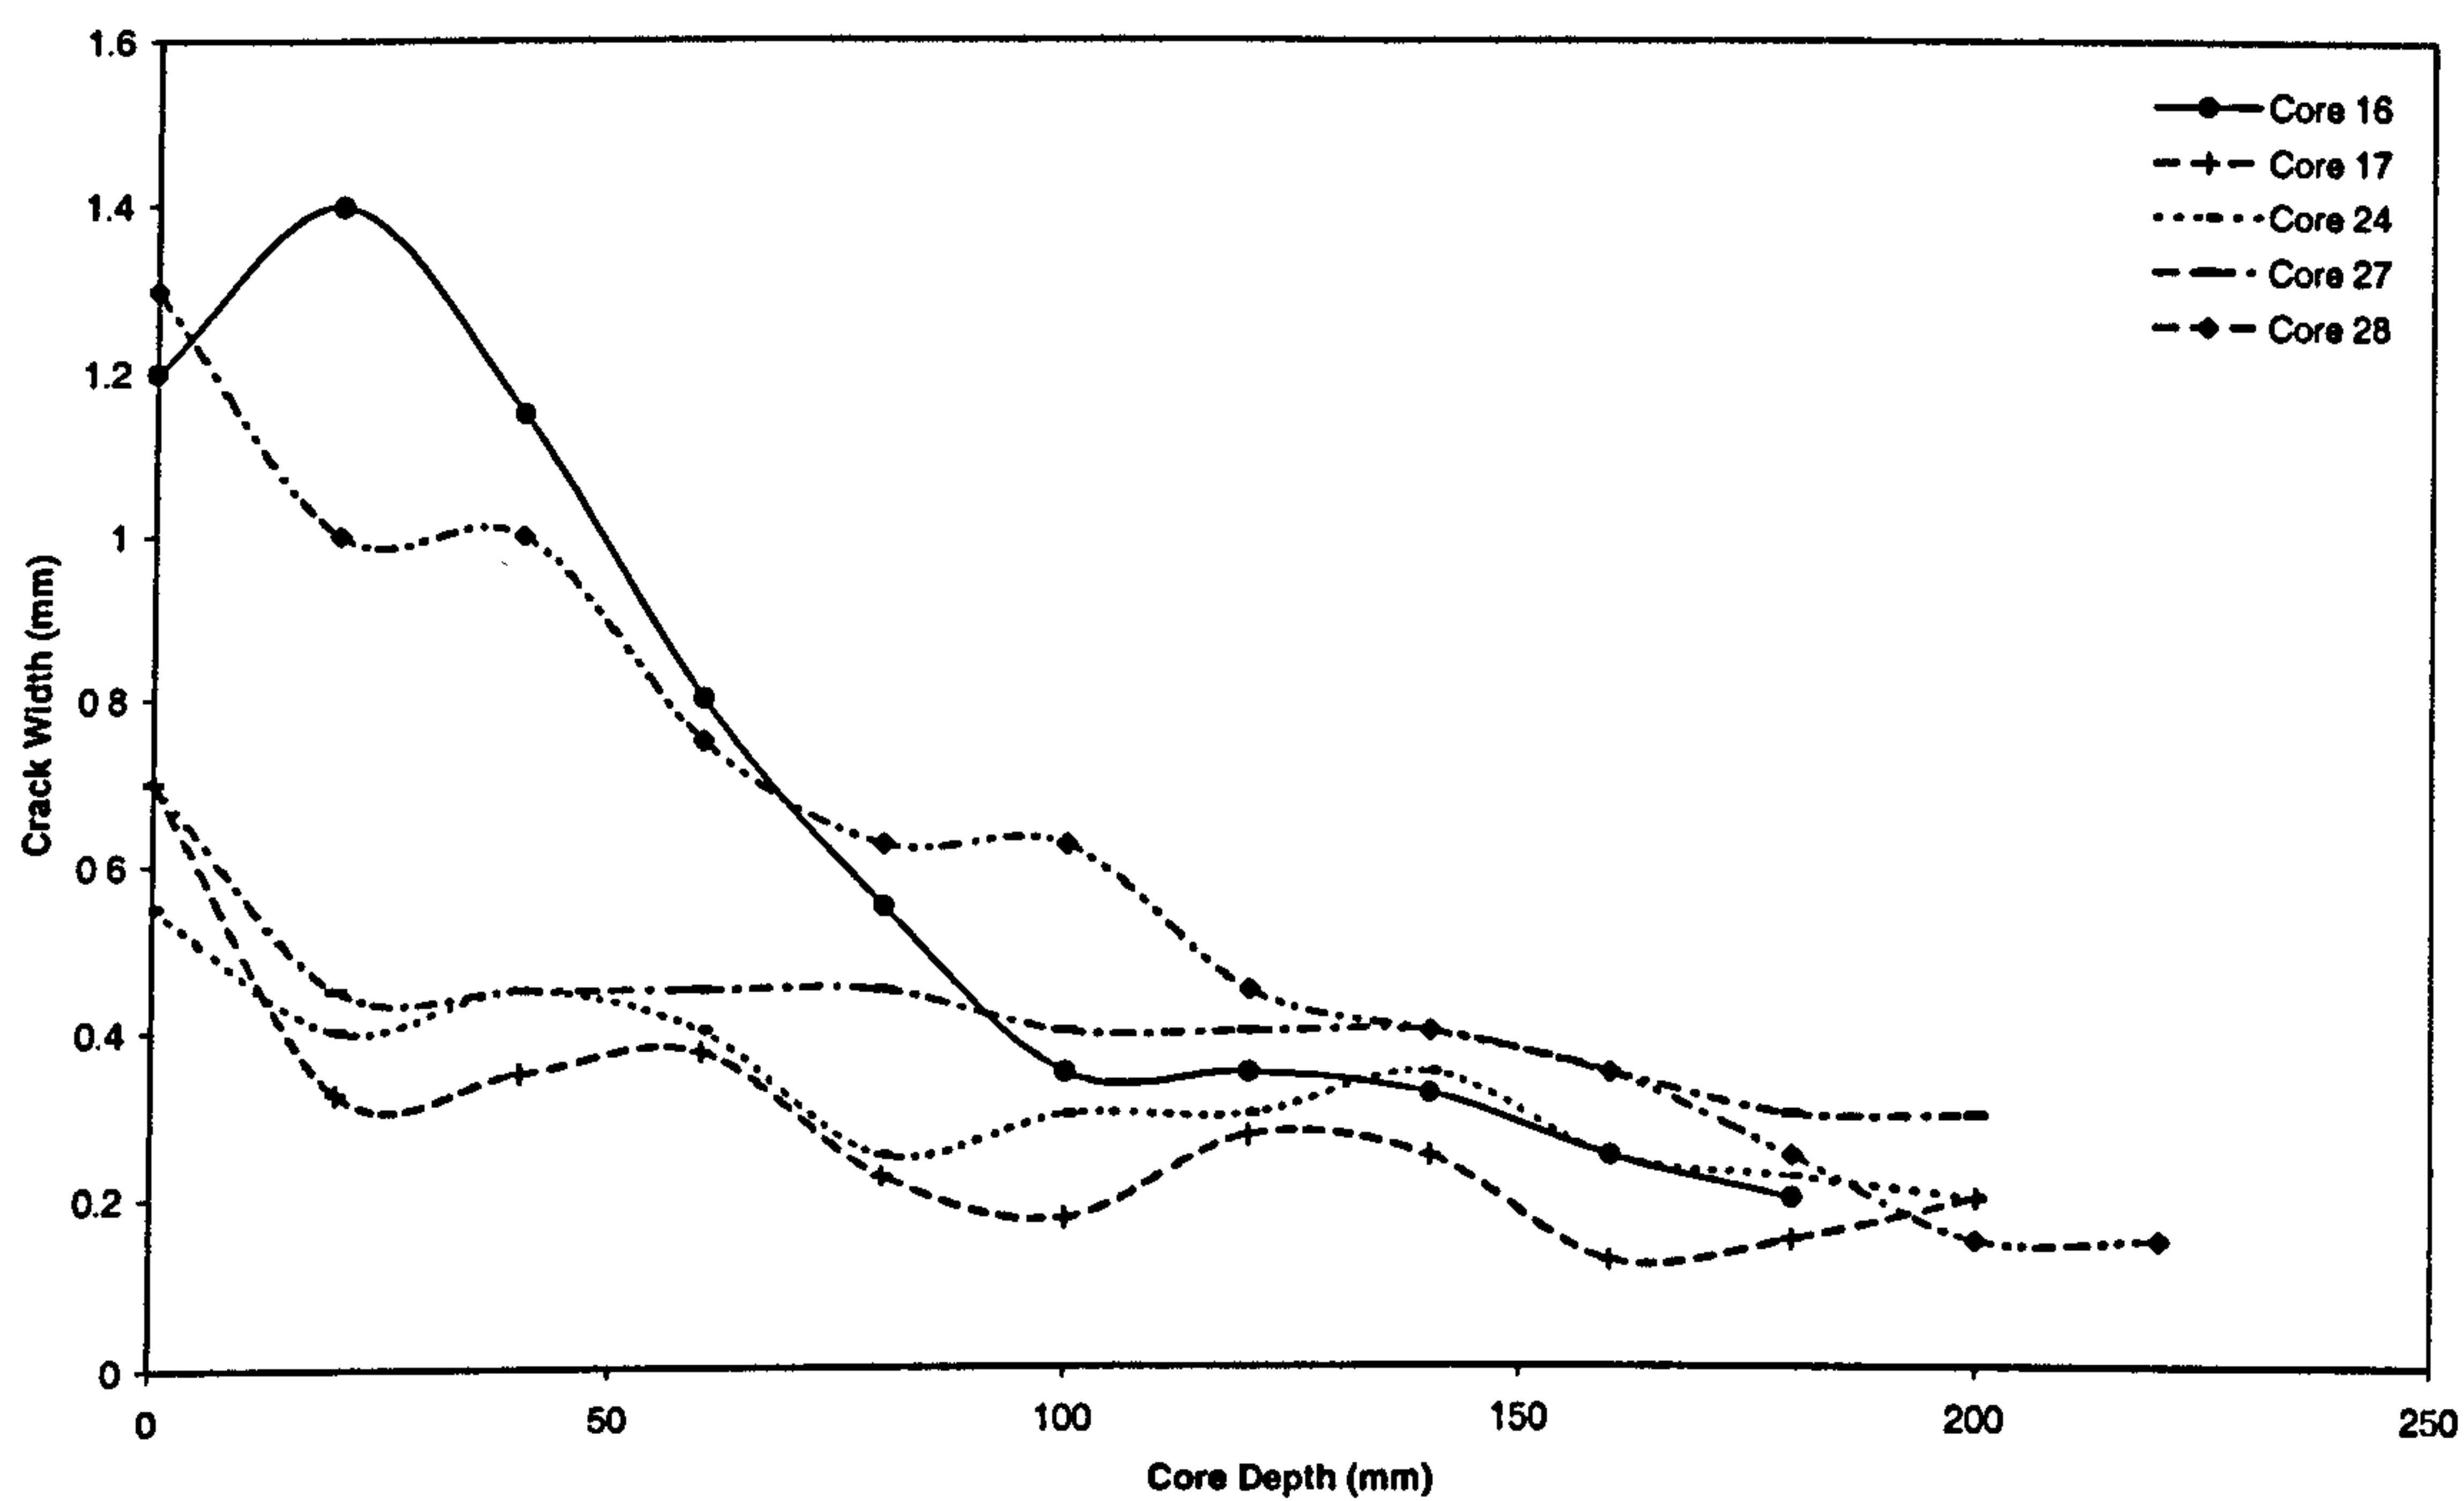
Figure 6.4 – Crack profiles from cores taken in visit 2
