LOAD TRANSFER ACROSS CRACKS AND JOINTS IN CONCRETE SLABS ON GRADE

Stuart John Arnold

**A Doctoral Thesis Submitted in partial fulfilment of the requirements for the
award of
Doctor of Philosophy of Loughborough University**

20th February 2004

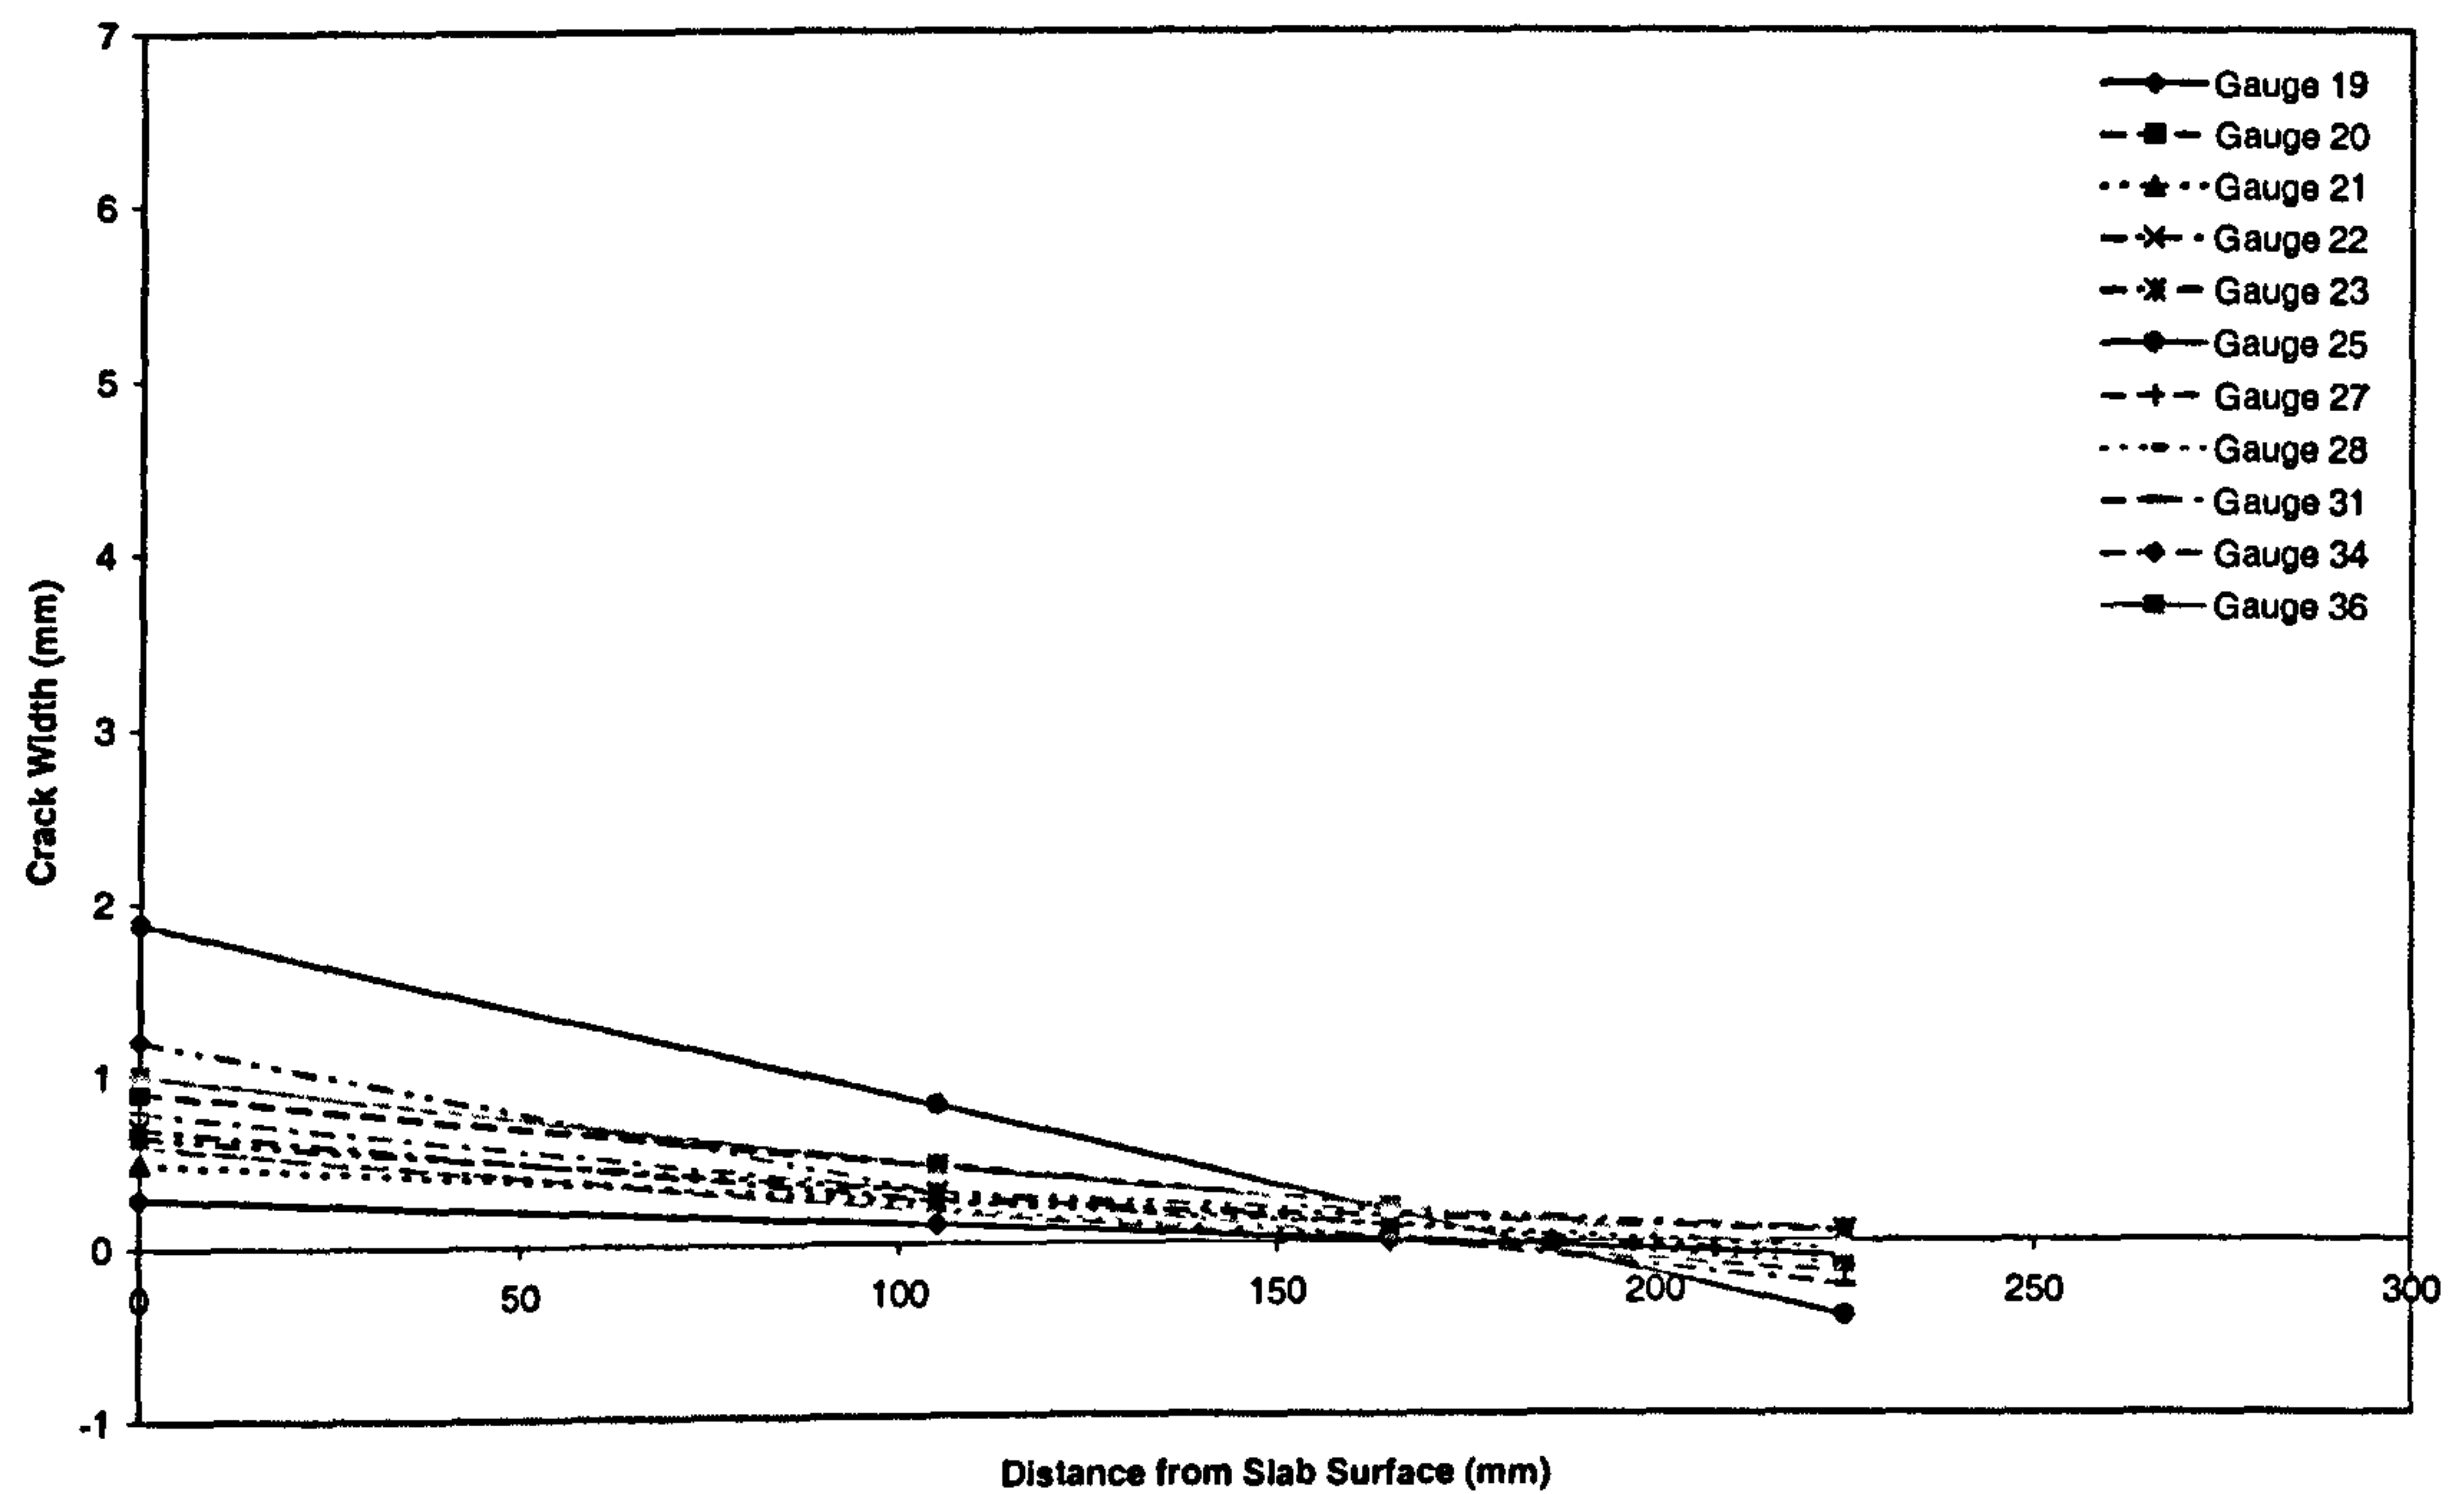
Figure 6.7a – Crack width extrapolation (Leeds)

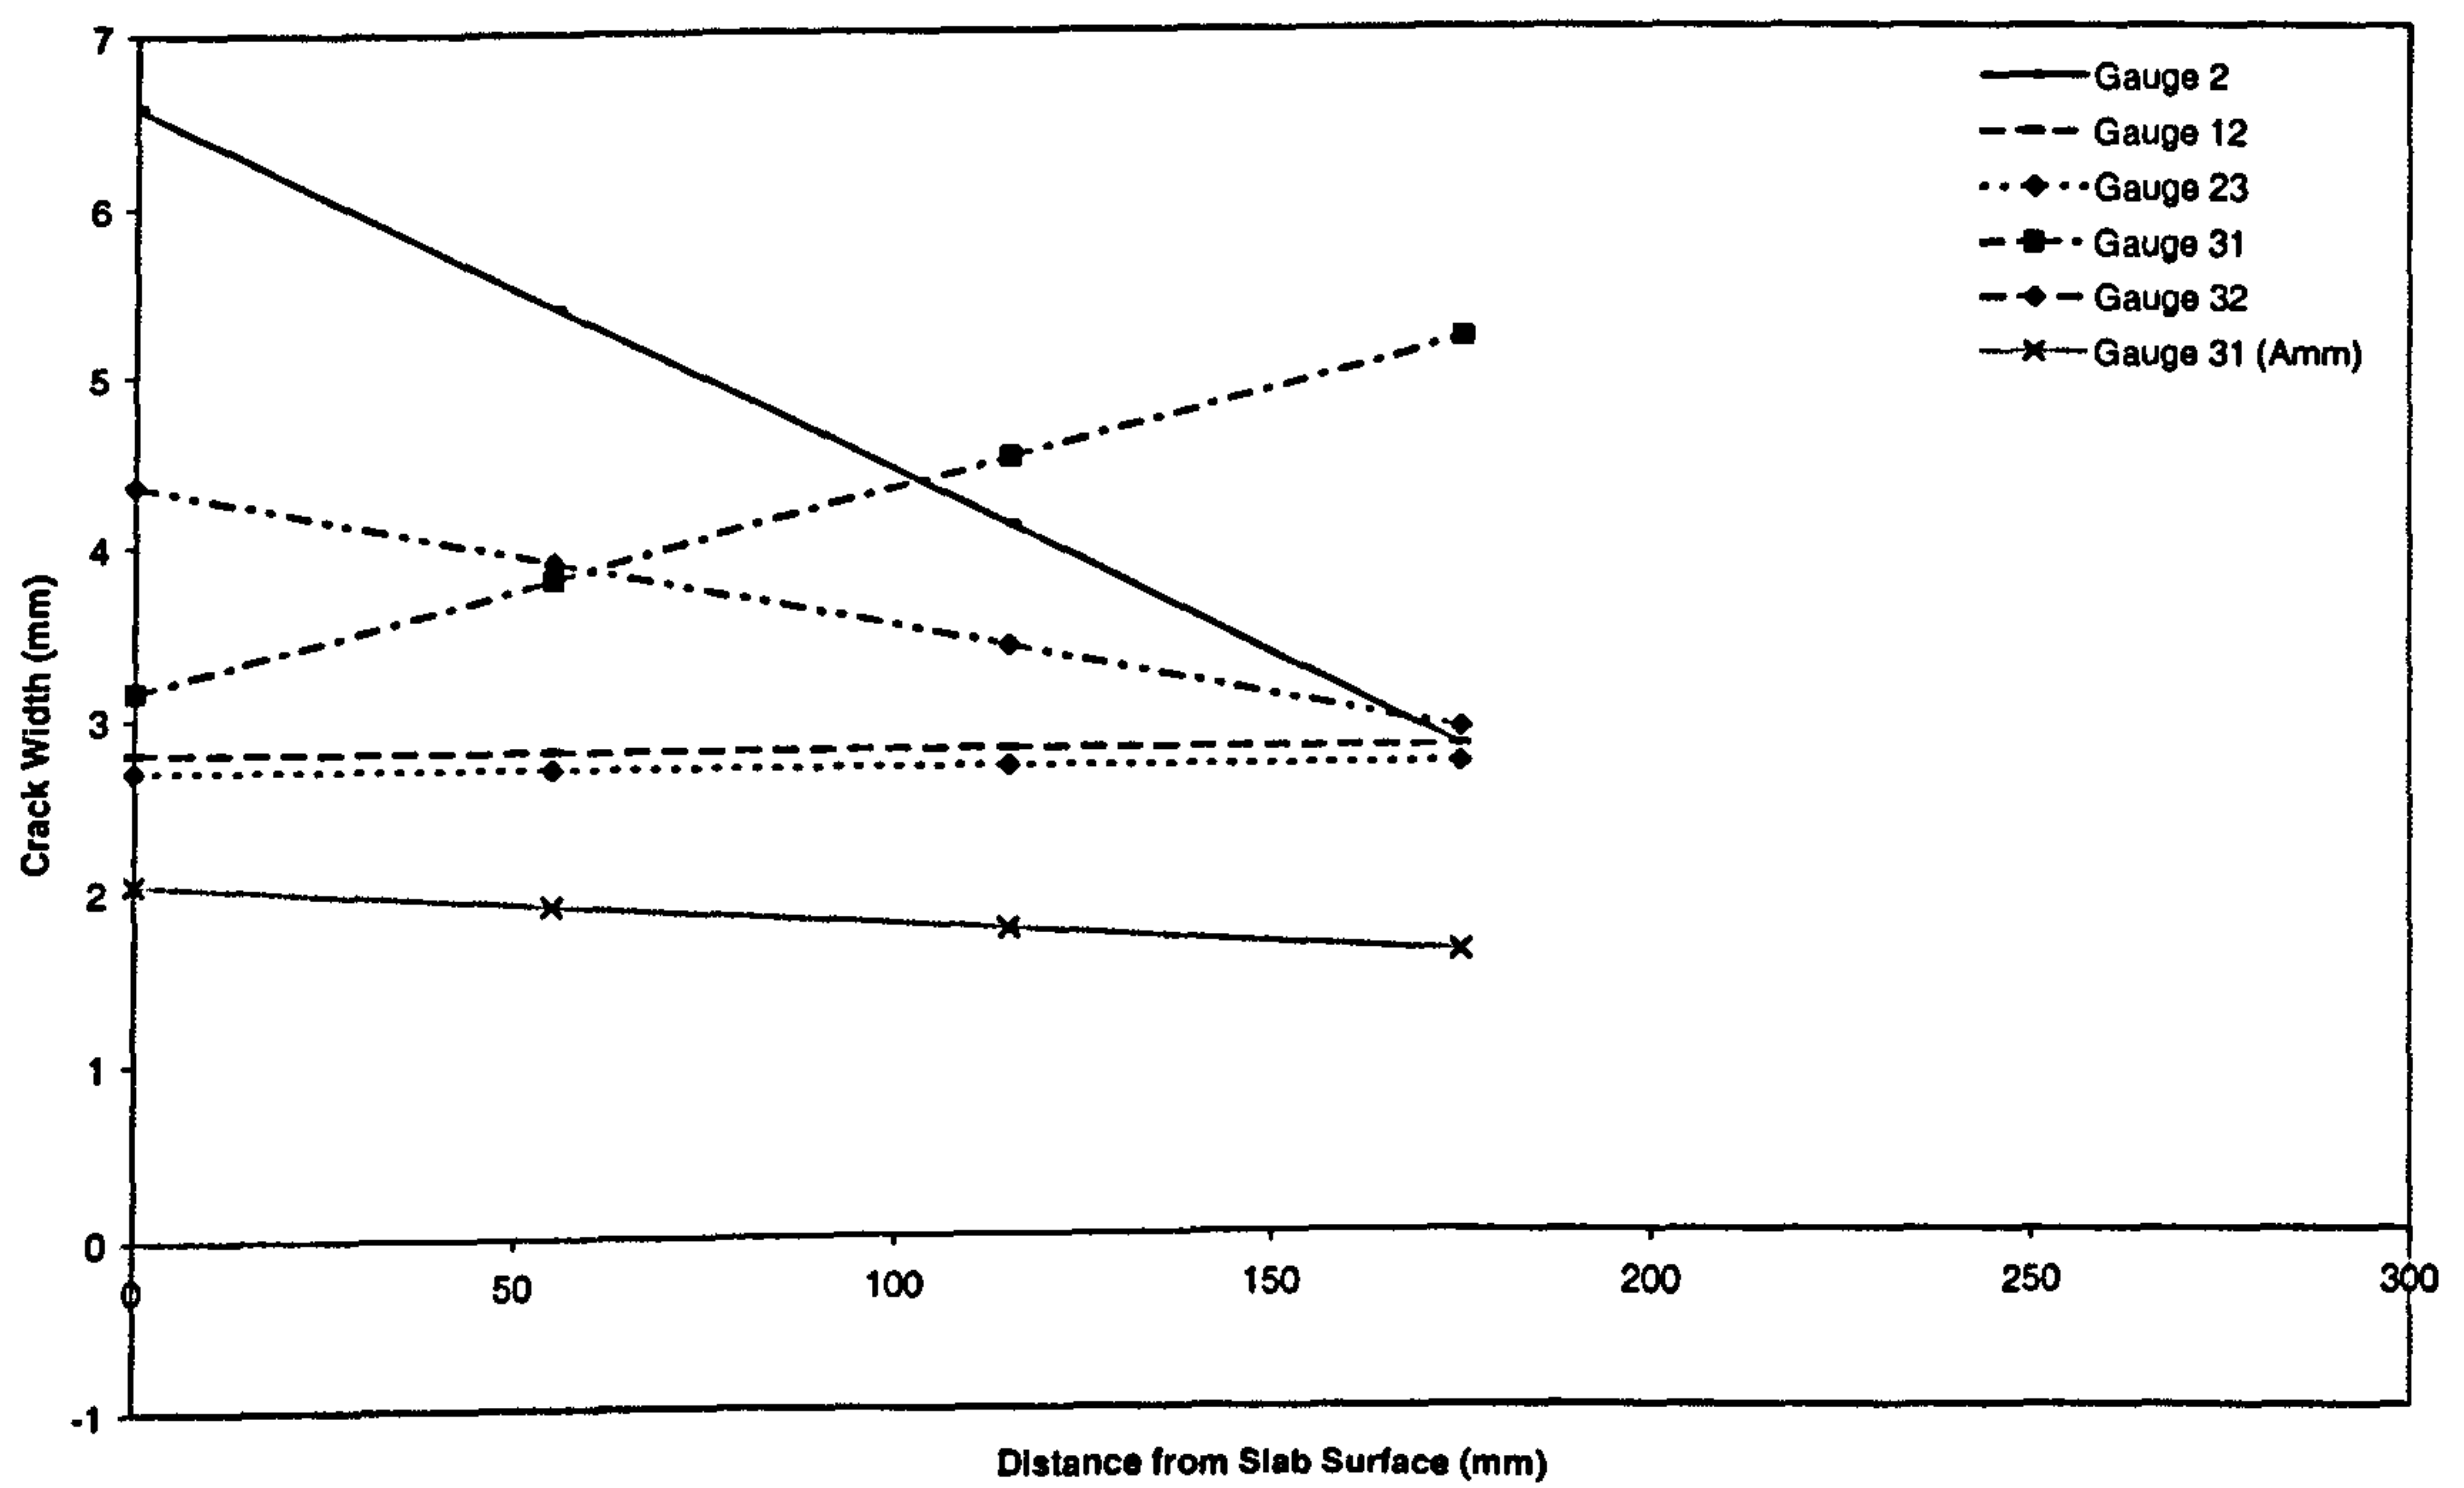
Figure 6.7b – Crack width extrapolation (Marston)

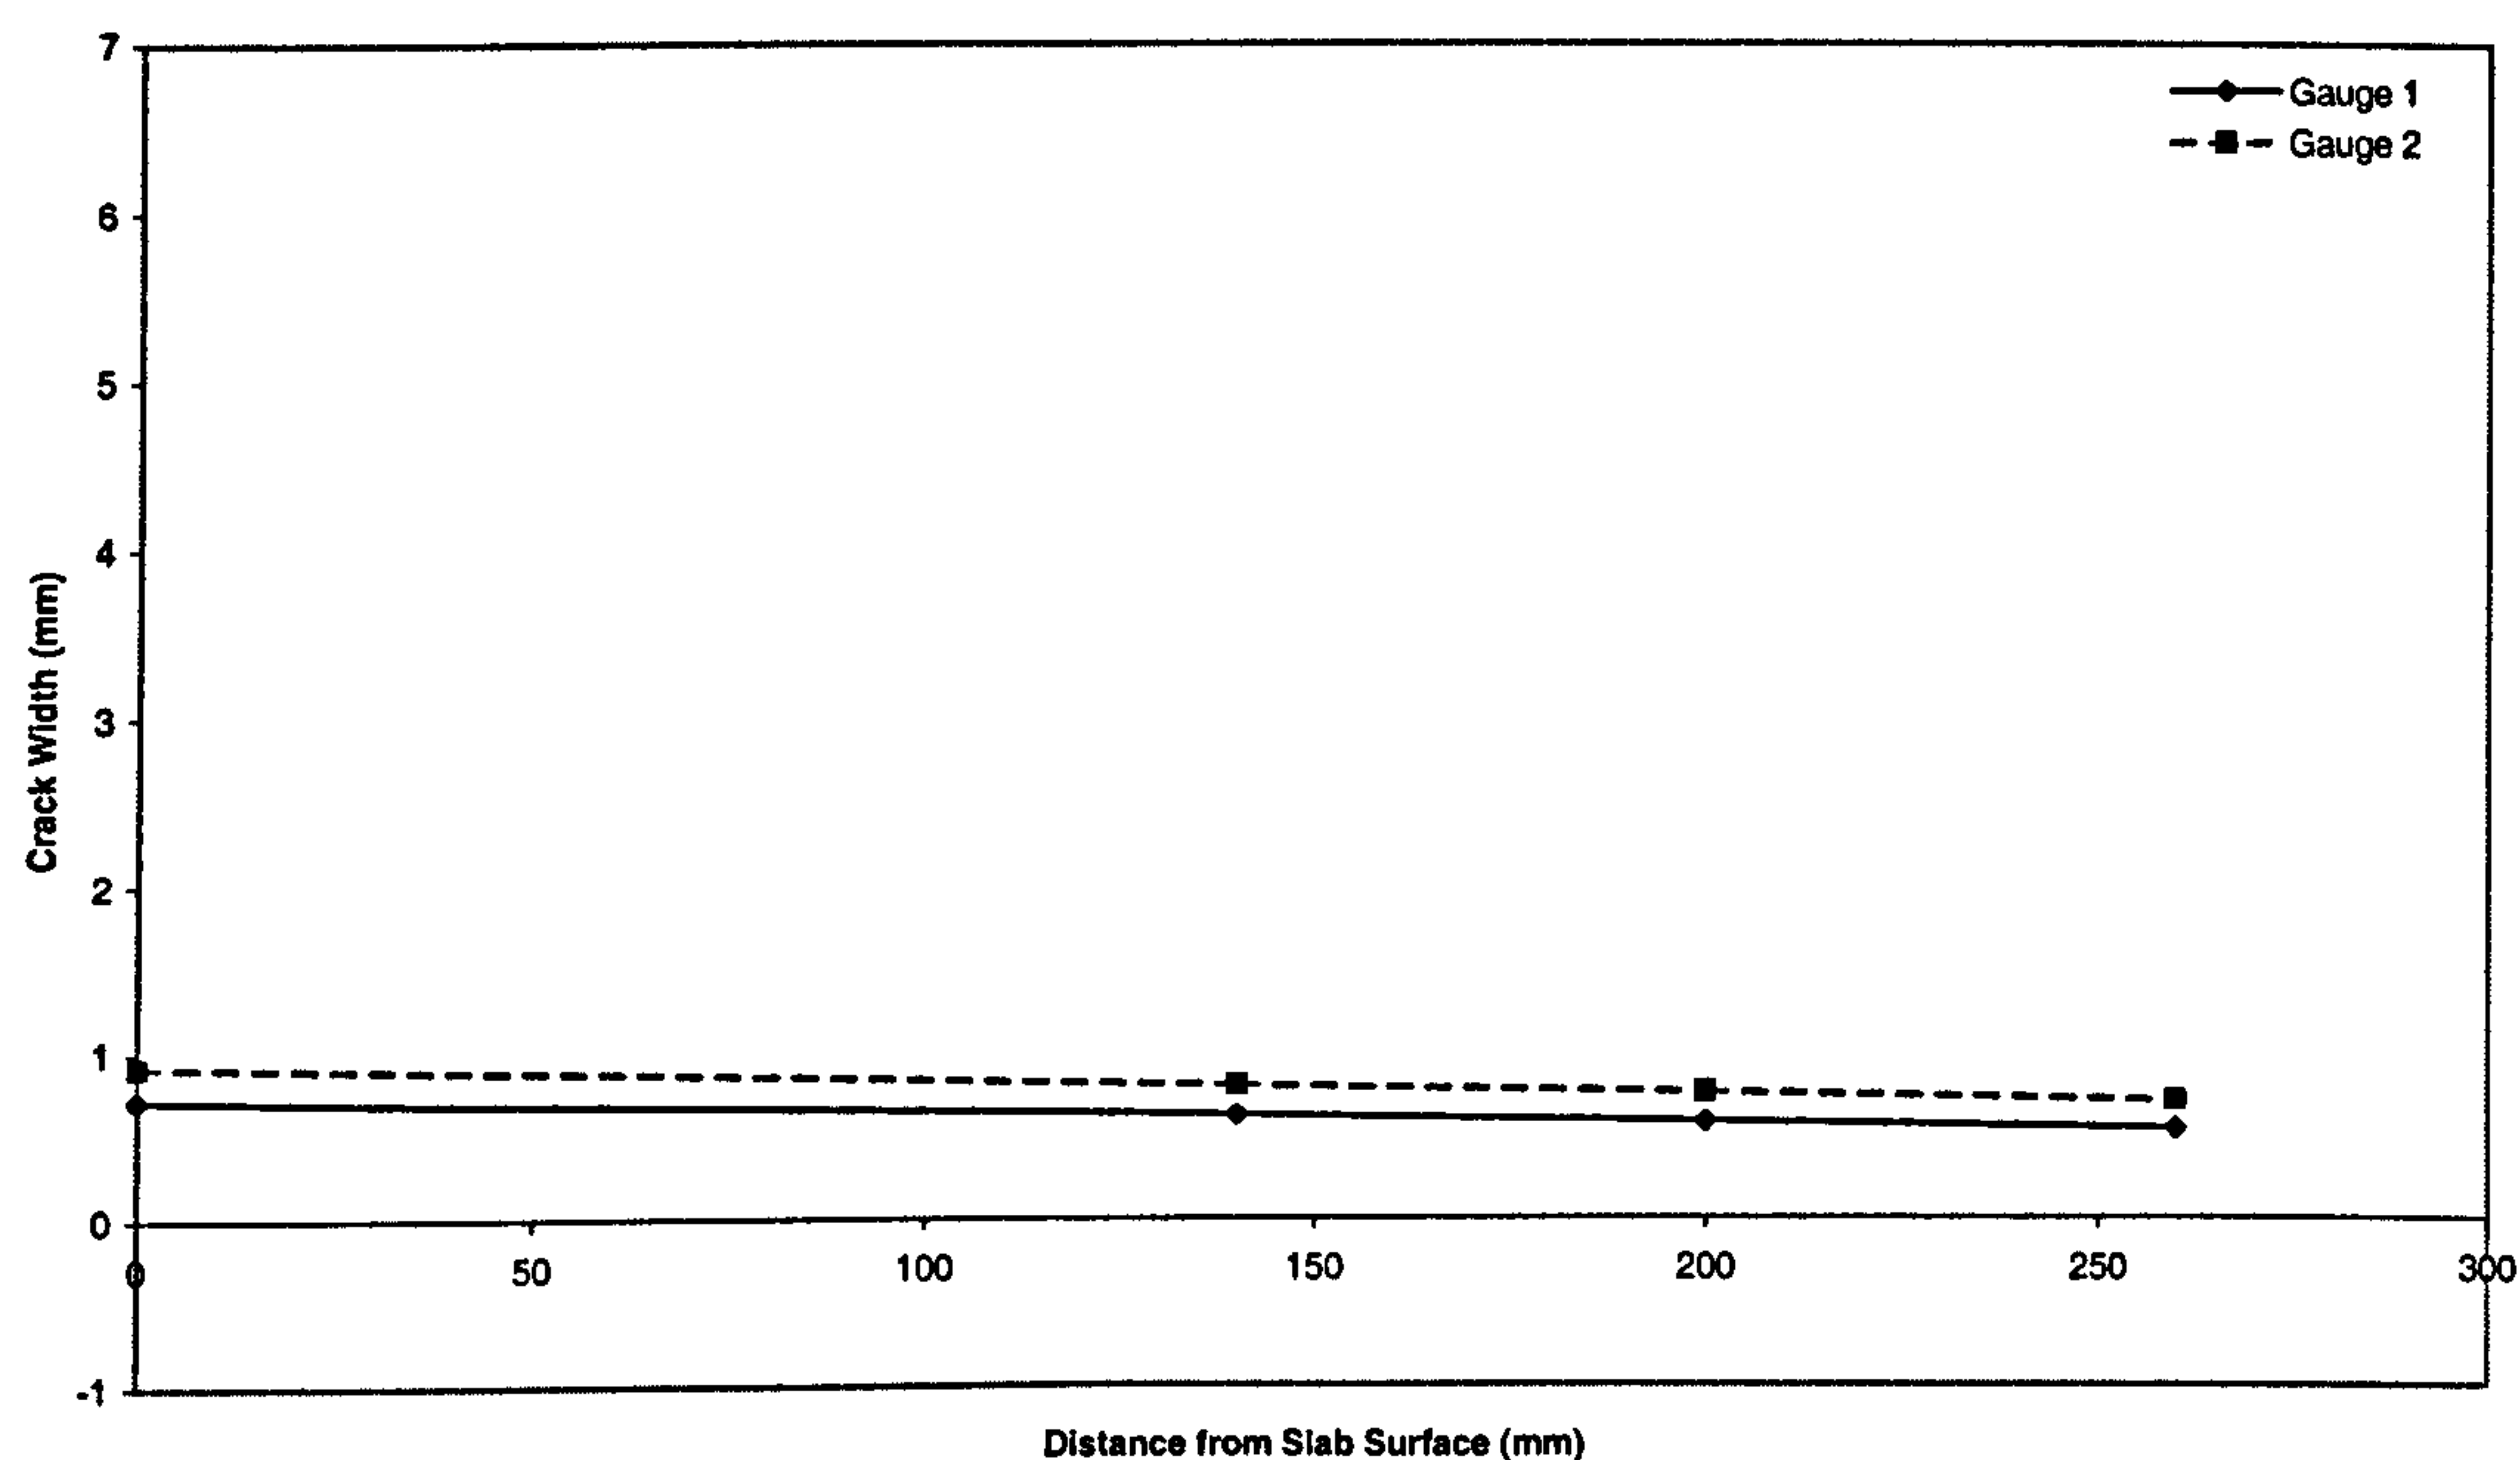
Figure 6.7c – Crack width extrapolation (Northampton)

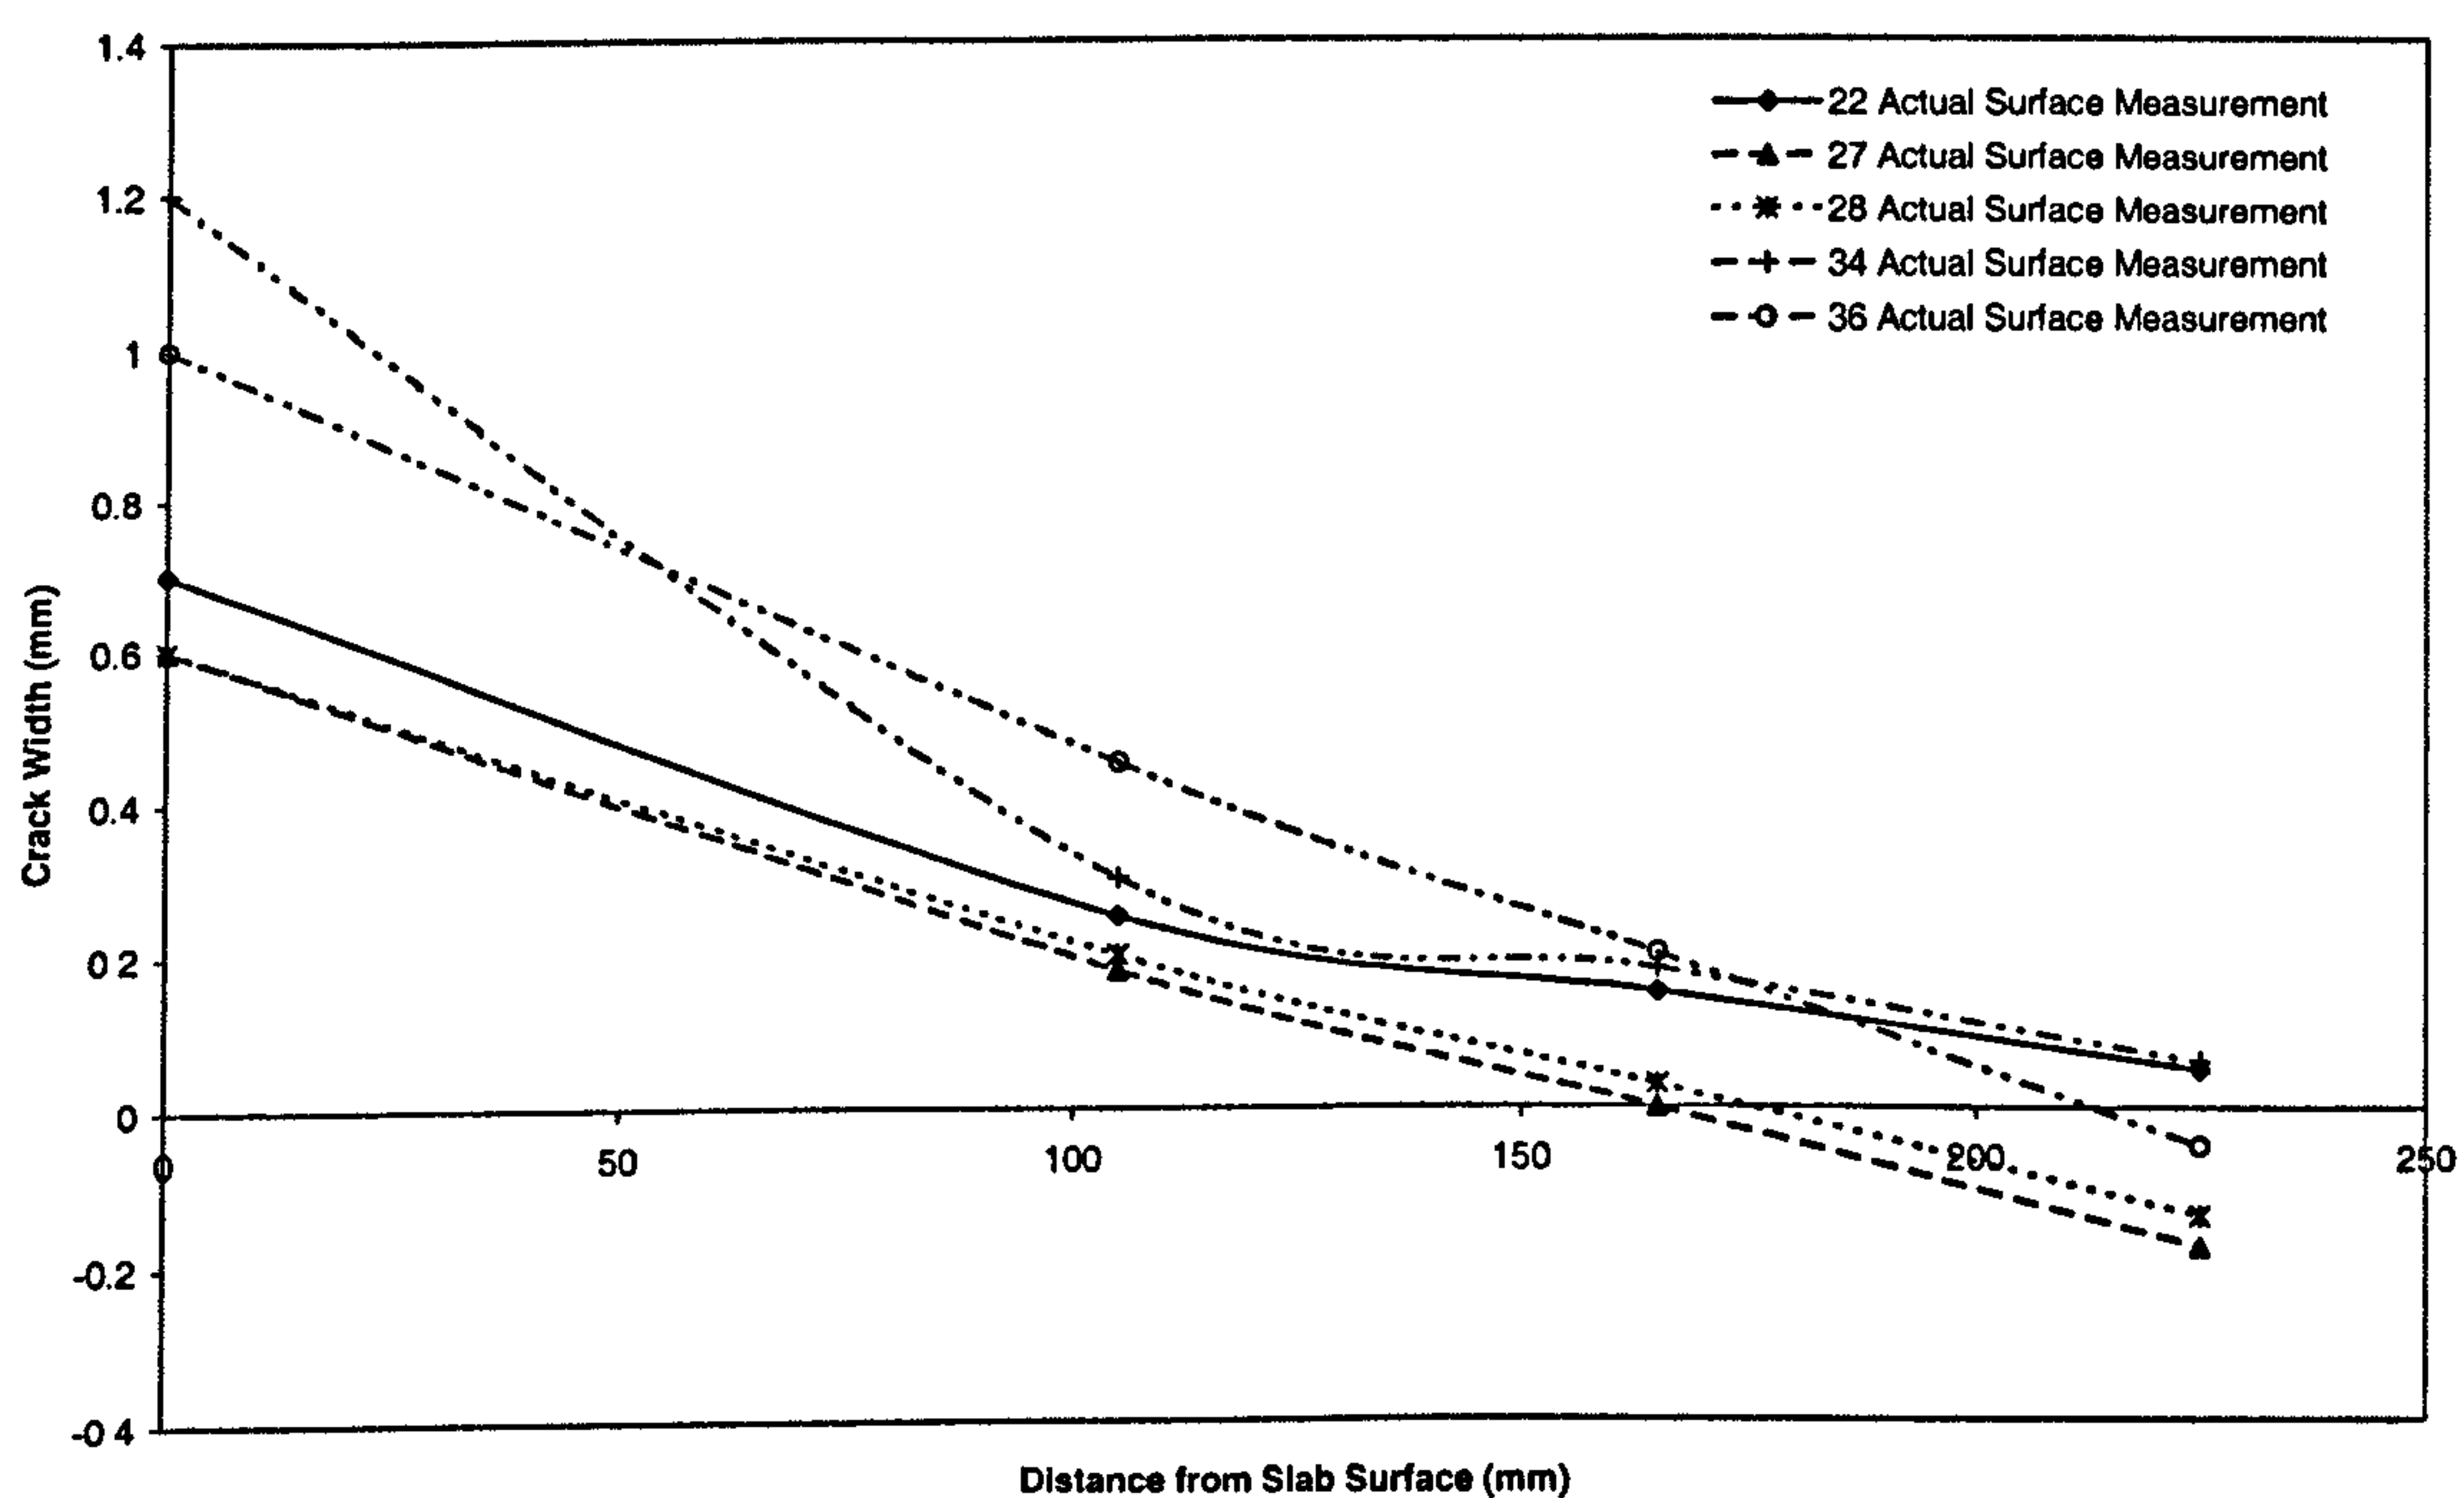
Figure 6.8 – Actual crack profile using embedded stain gauges and surface measurements (Leeds)

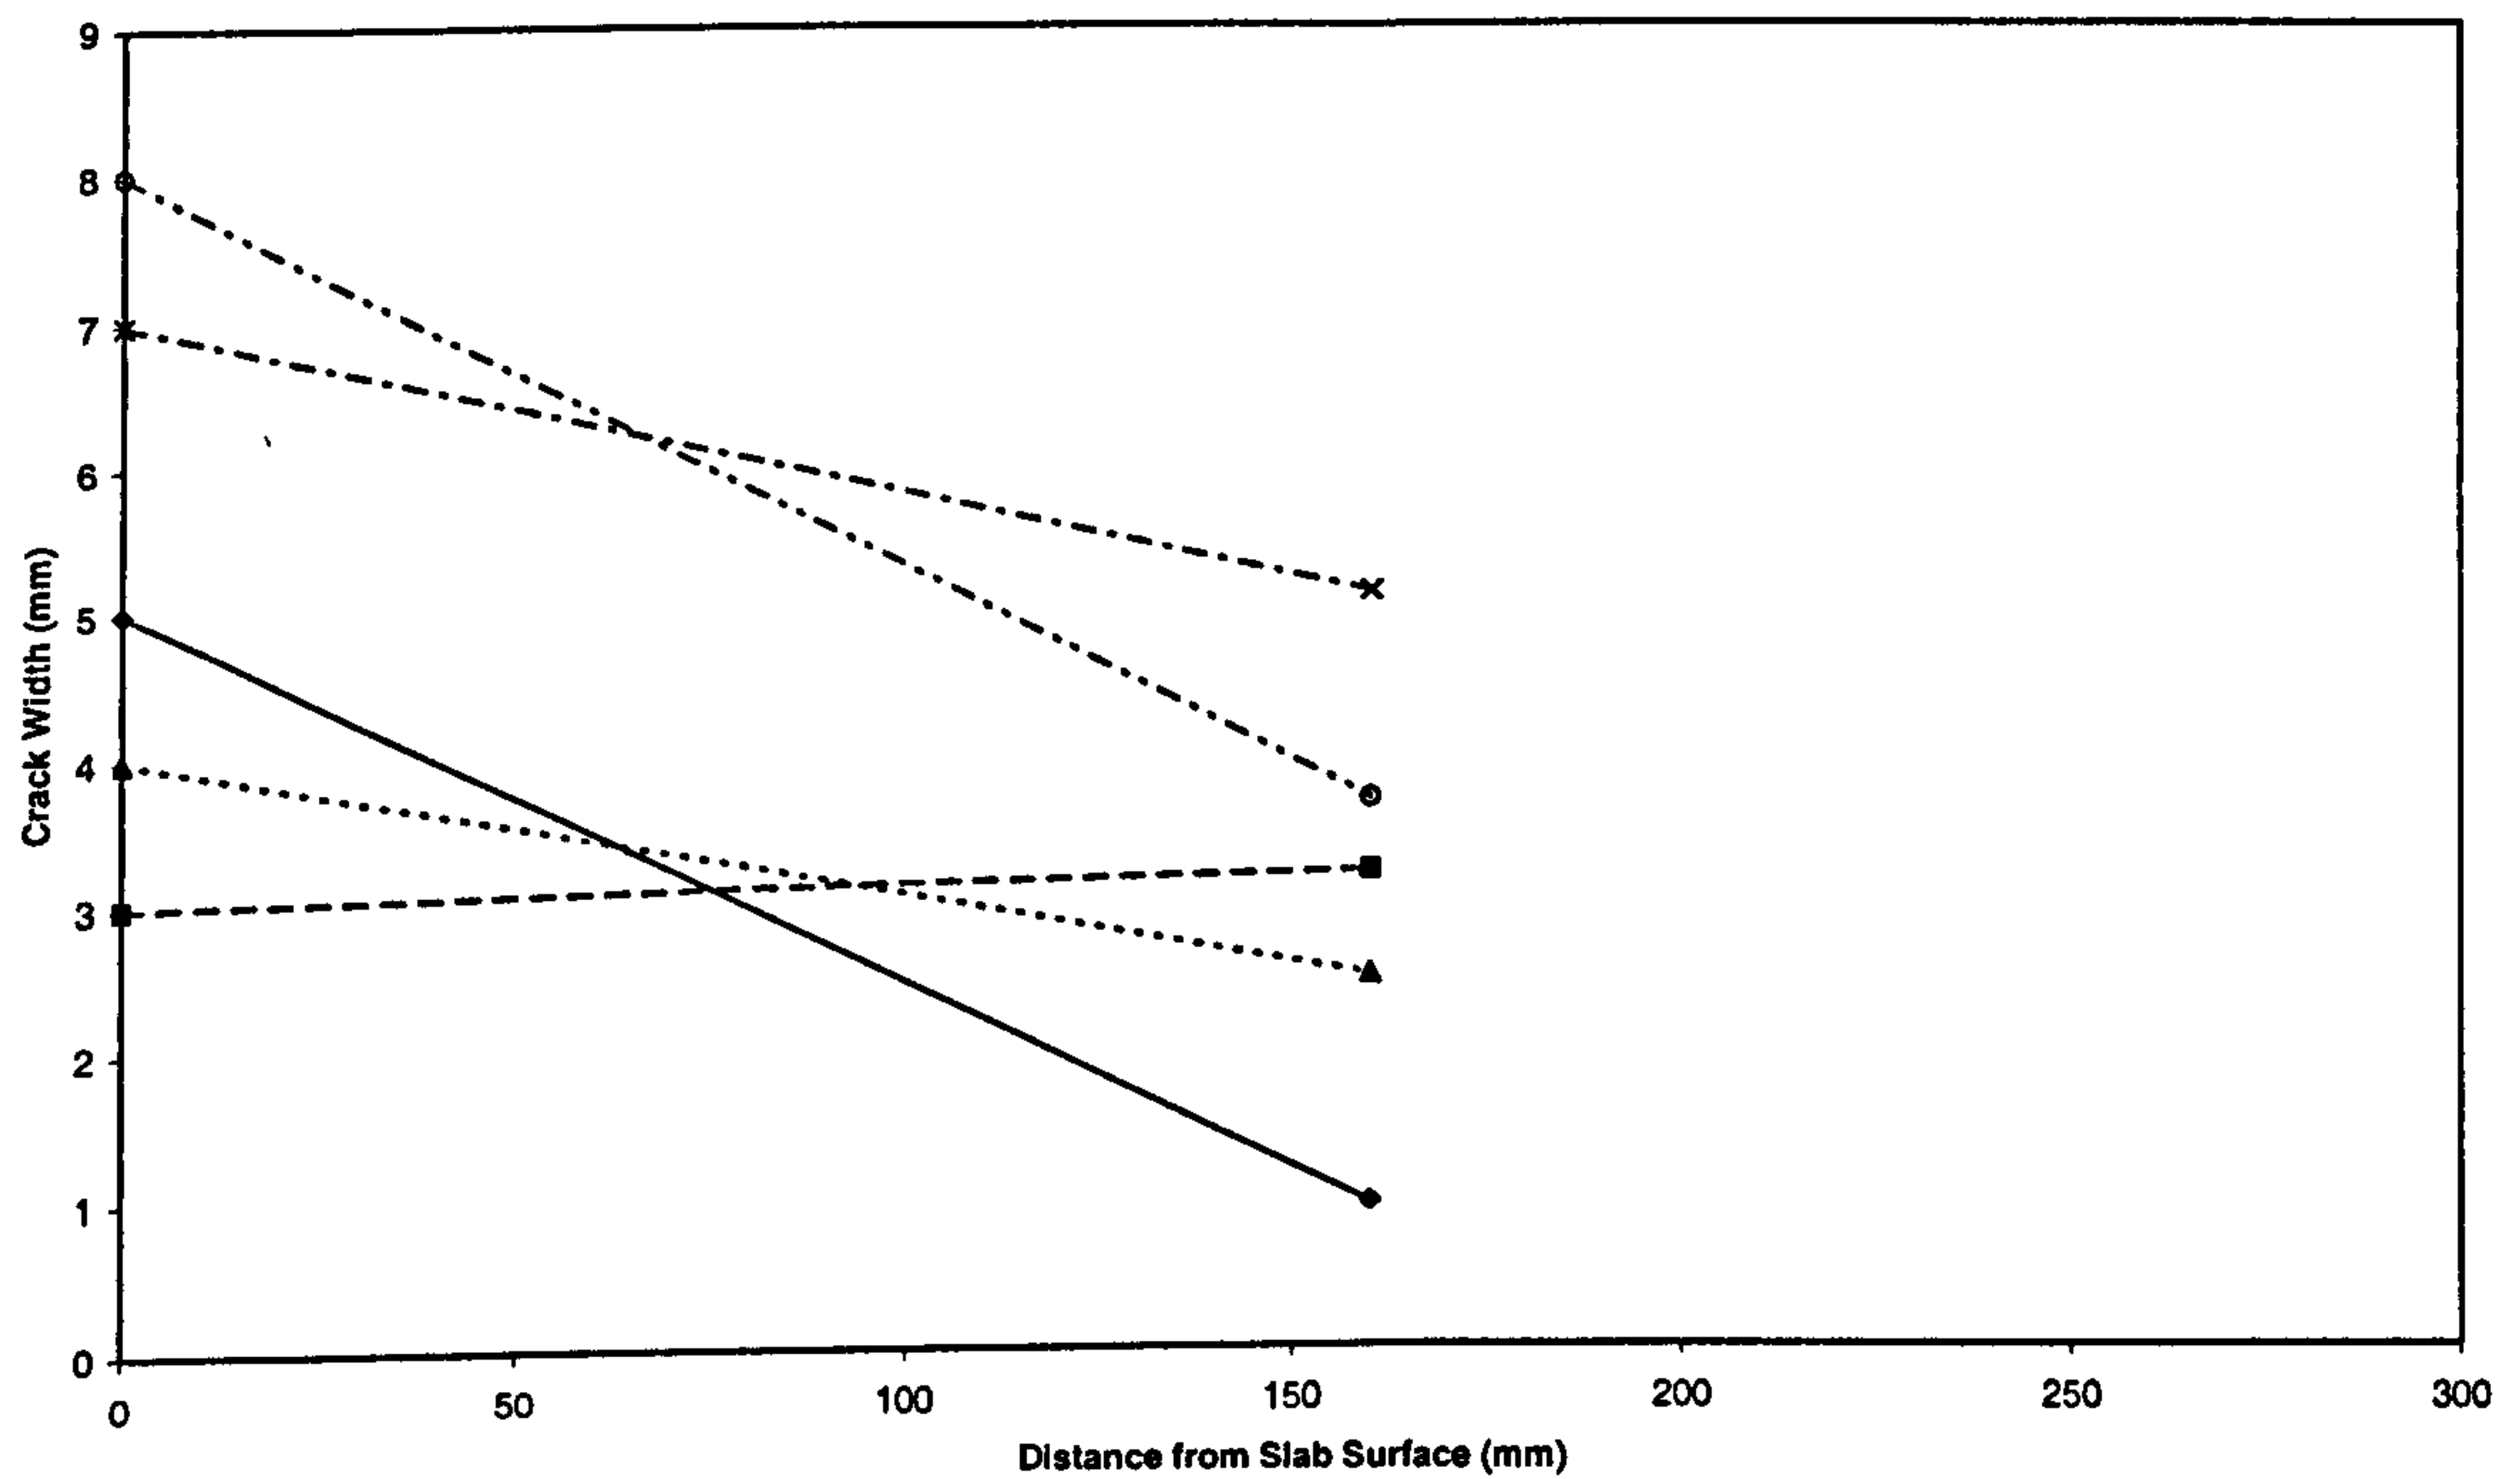
Figure 6.14 – Predicted crack profile using slab levels and surface width (Daventry)

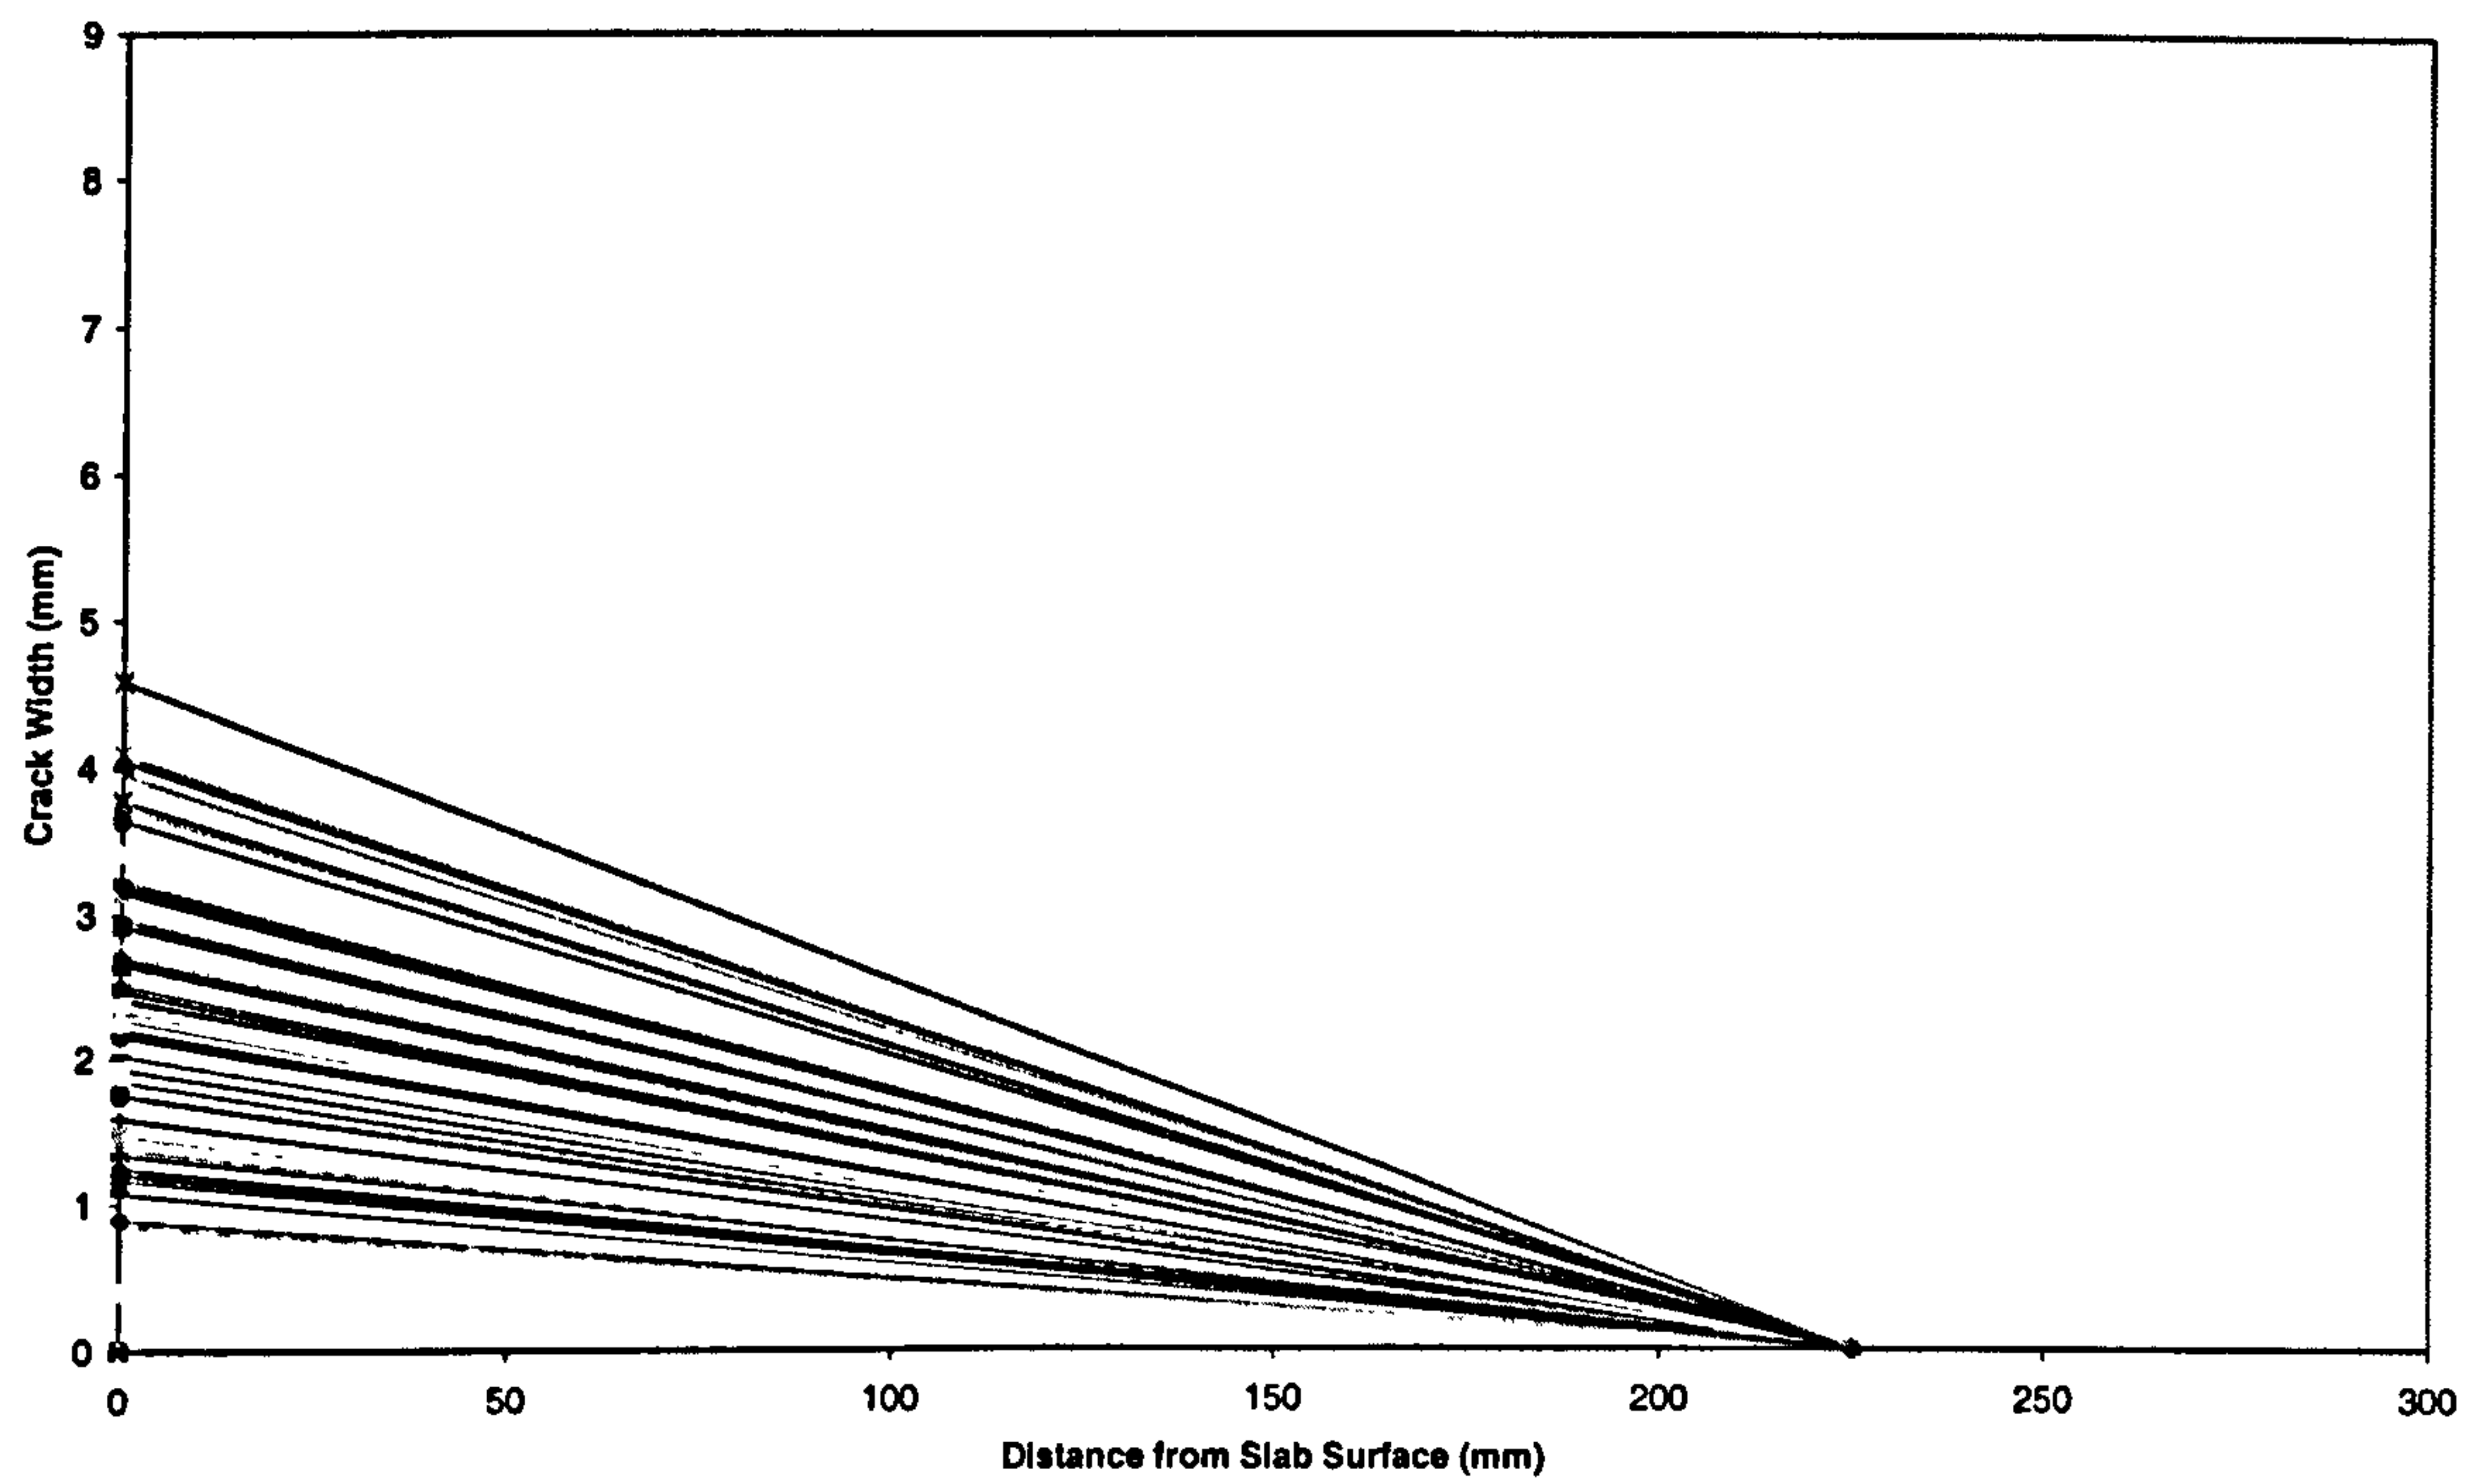
Figure 6.15 – Predicted crack profiles using edge curl (Ballymena)
