LOAD TRANSFER ACROSS CRACKS AND JOINTS IN CONCRETE SLABS ON GRADE

Stuart John Arnold

**A Doctoral Thesis Submitted in partial fulfilment of the requirements for the
award of
Doctor of Philosophy of Loughborough University**

20th February 2004

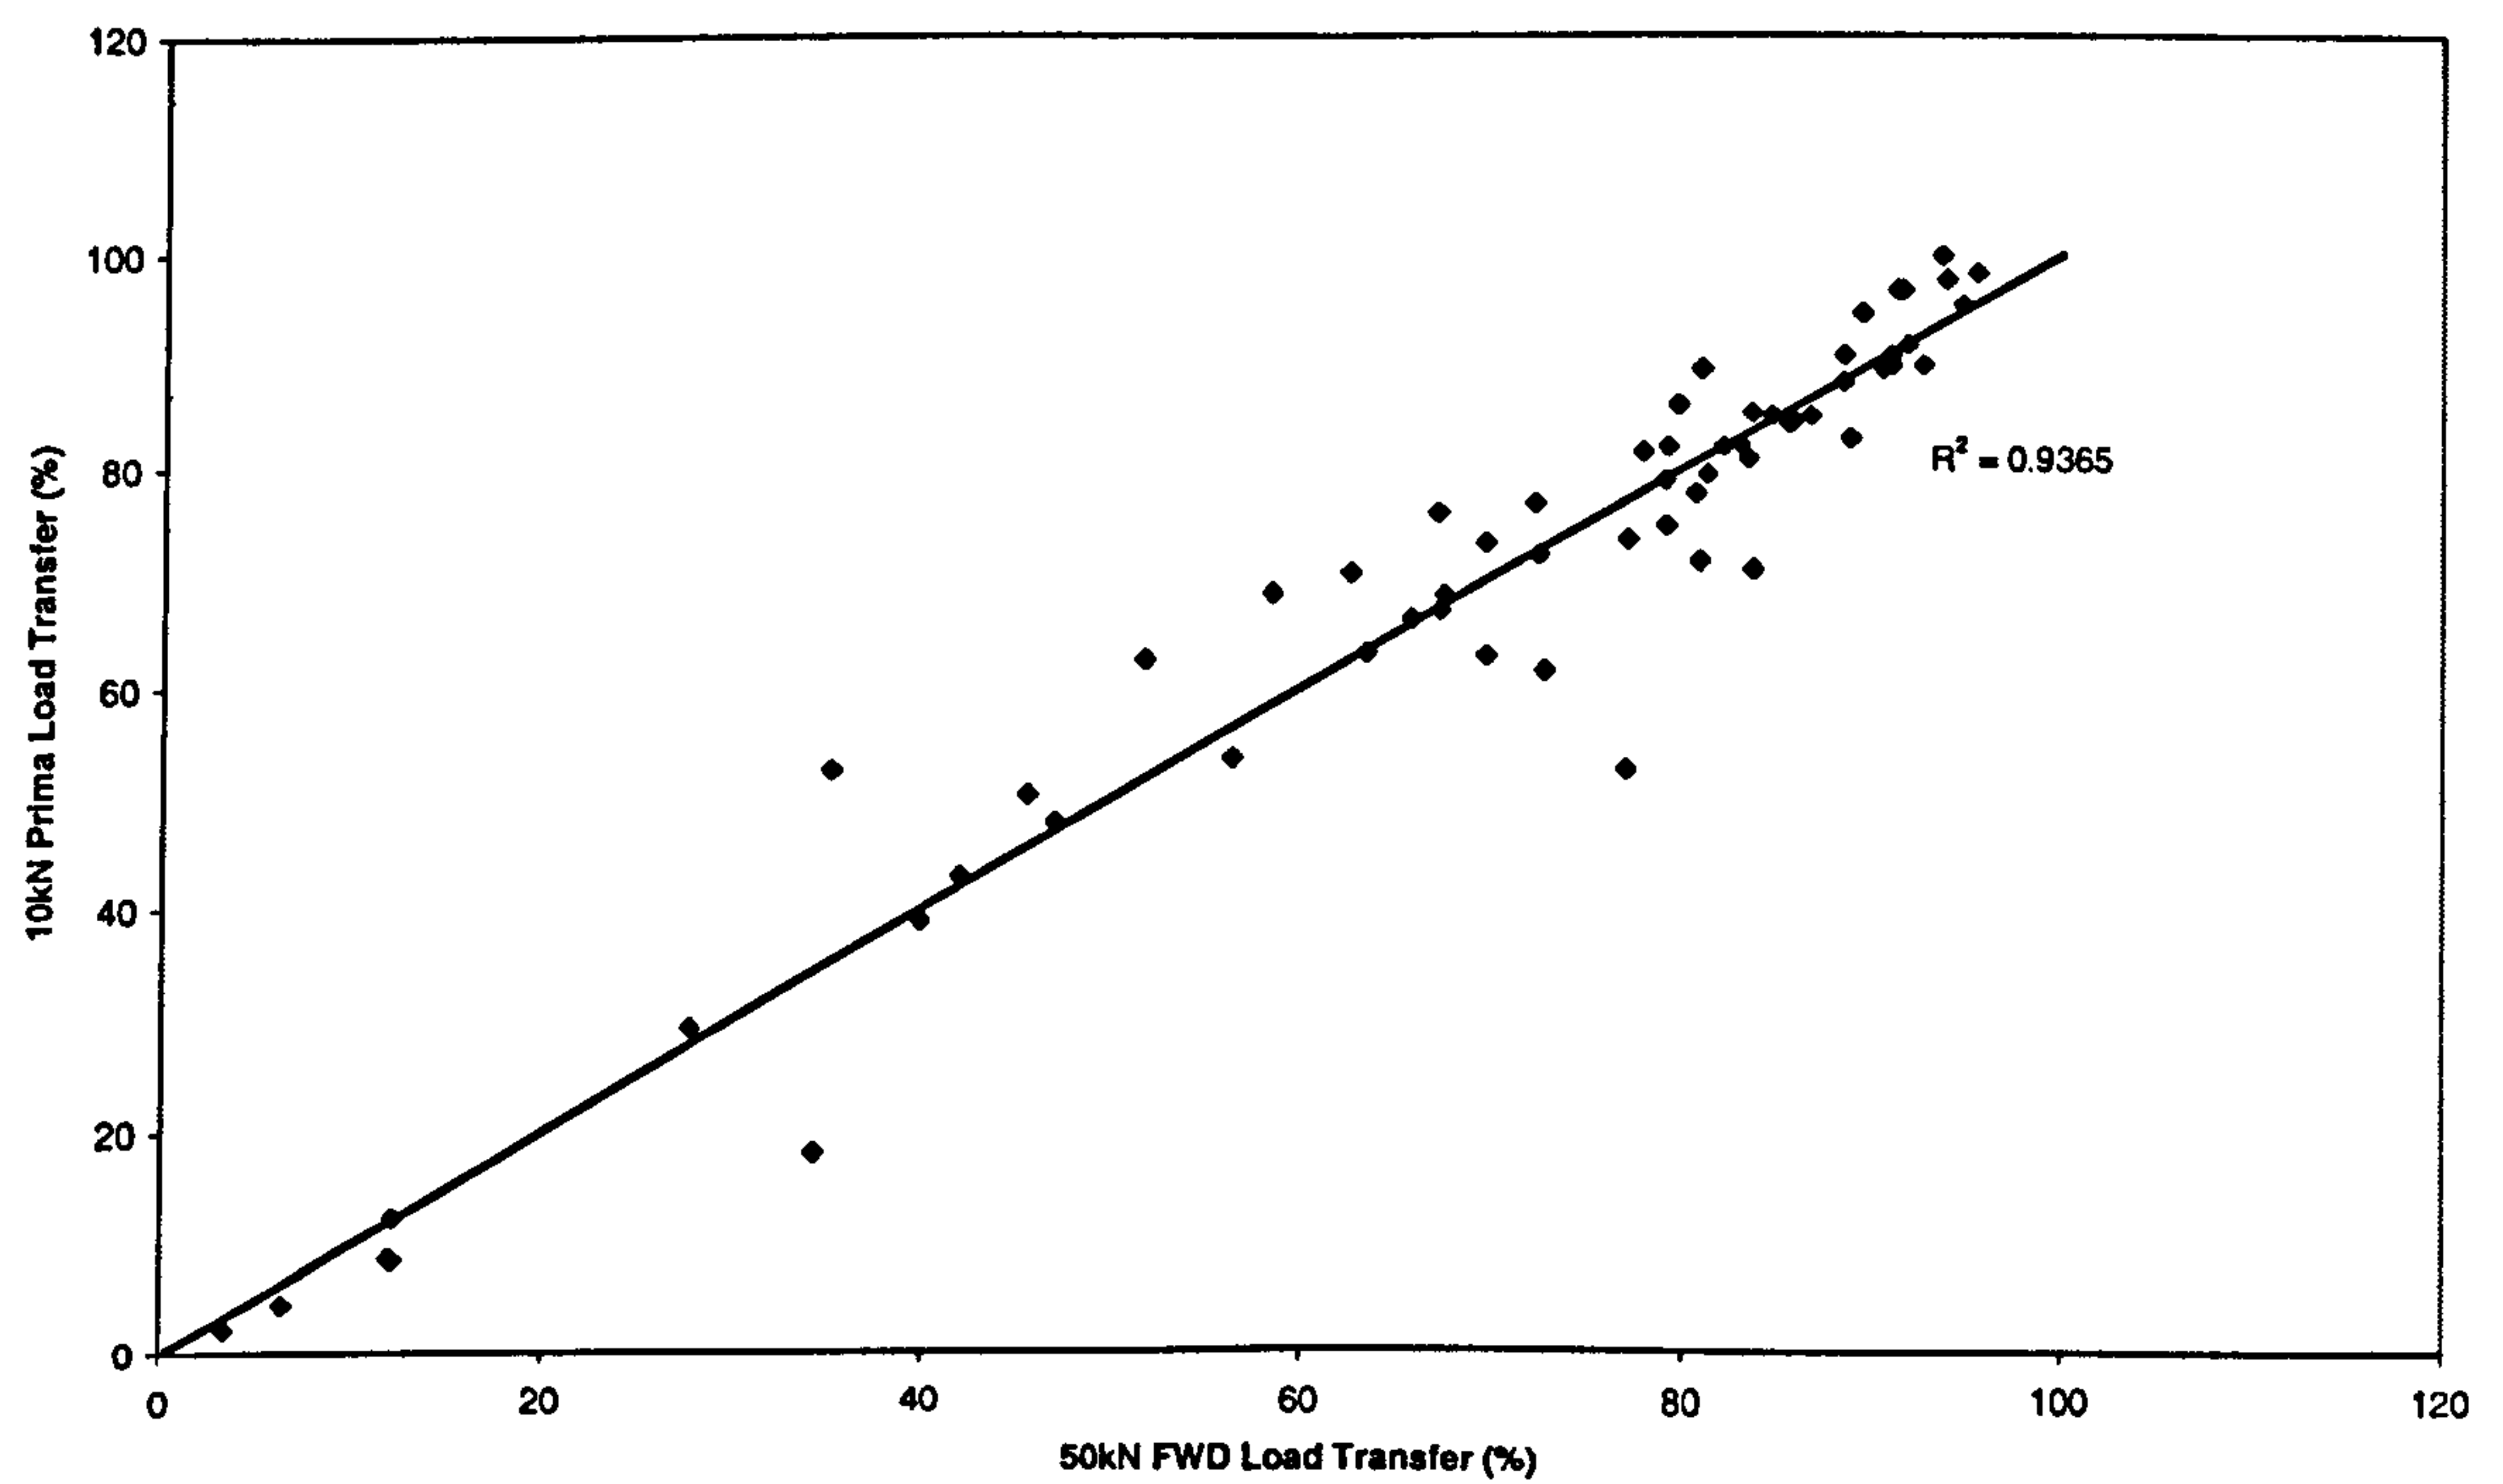
Figure 6.16 – Load transfer comparison between FWD and Prima (Daventry)

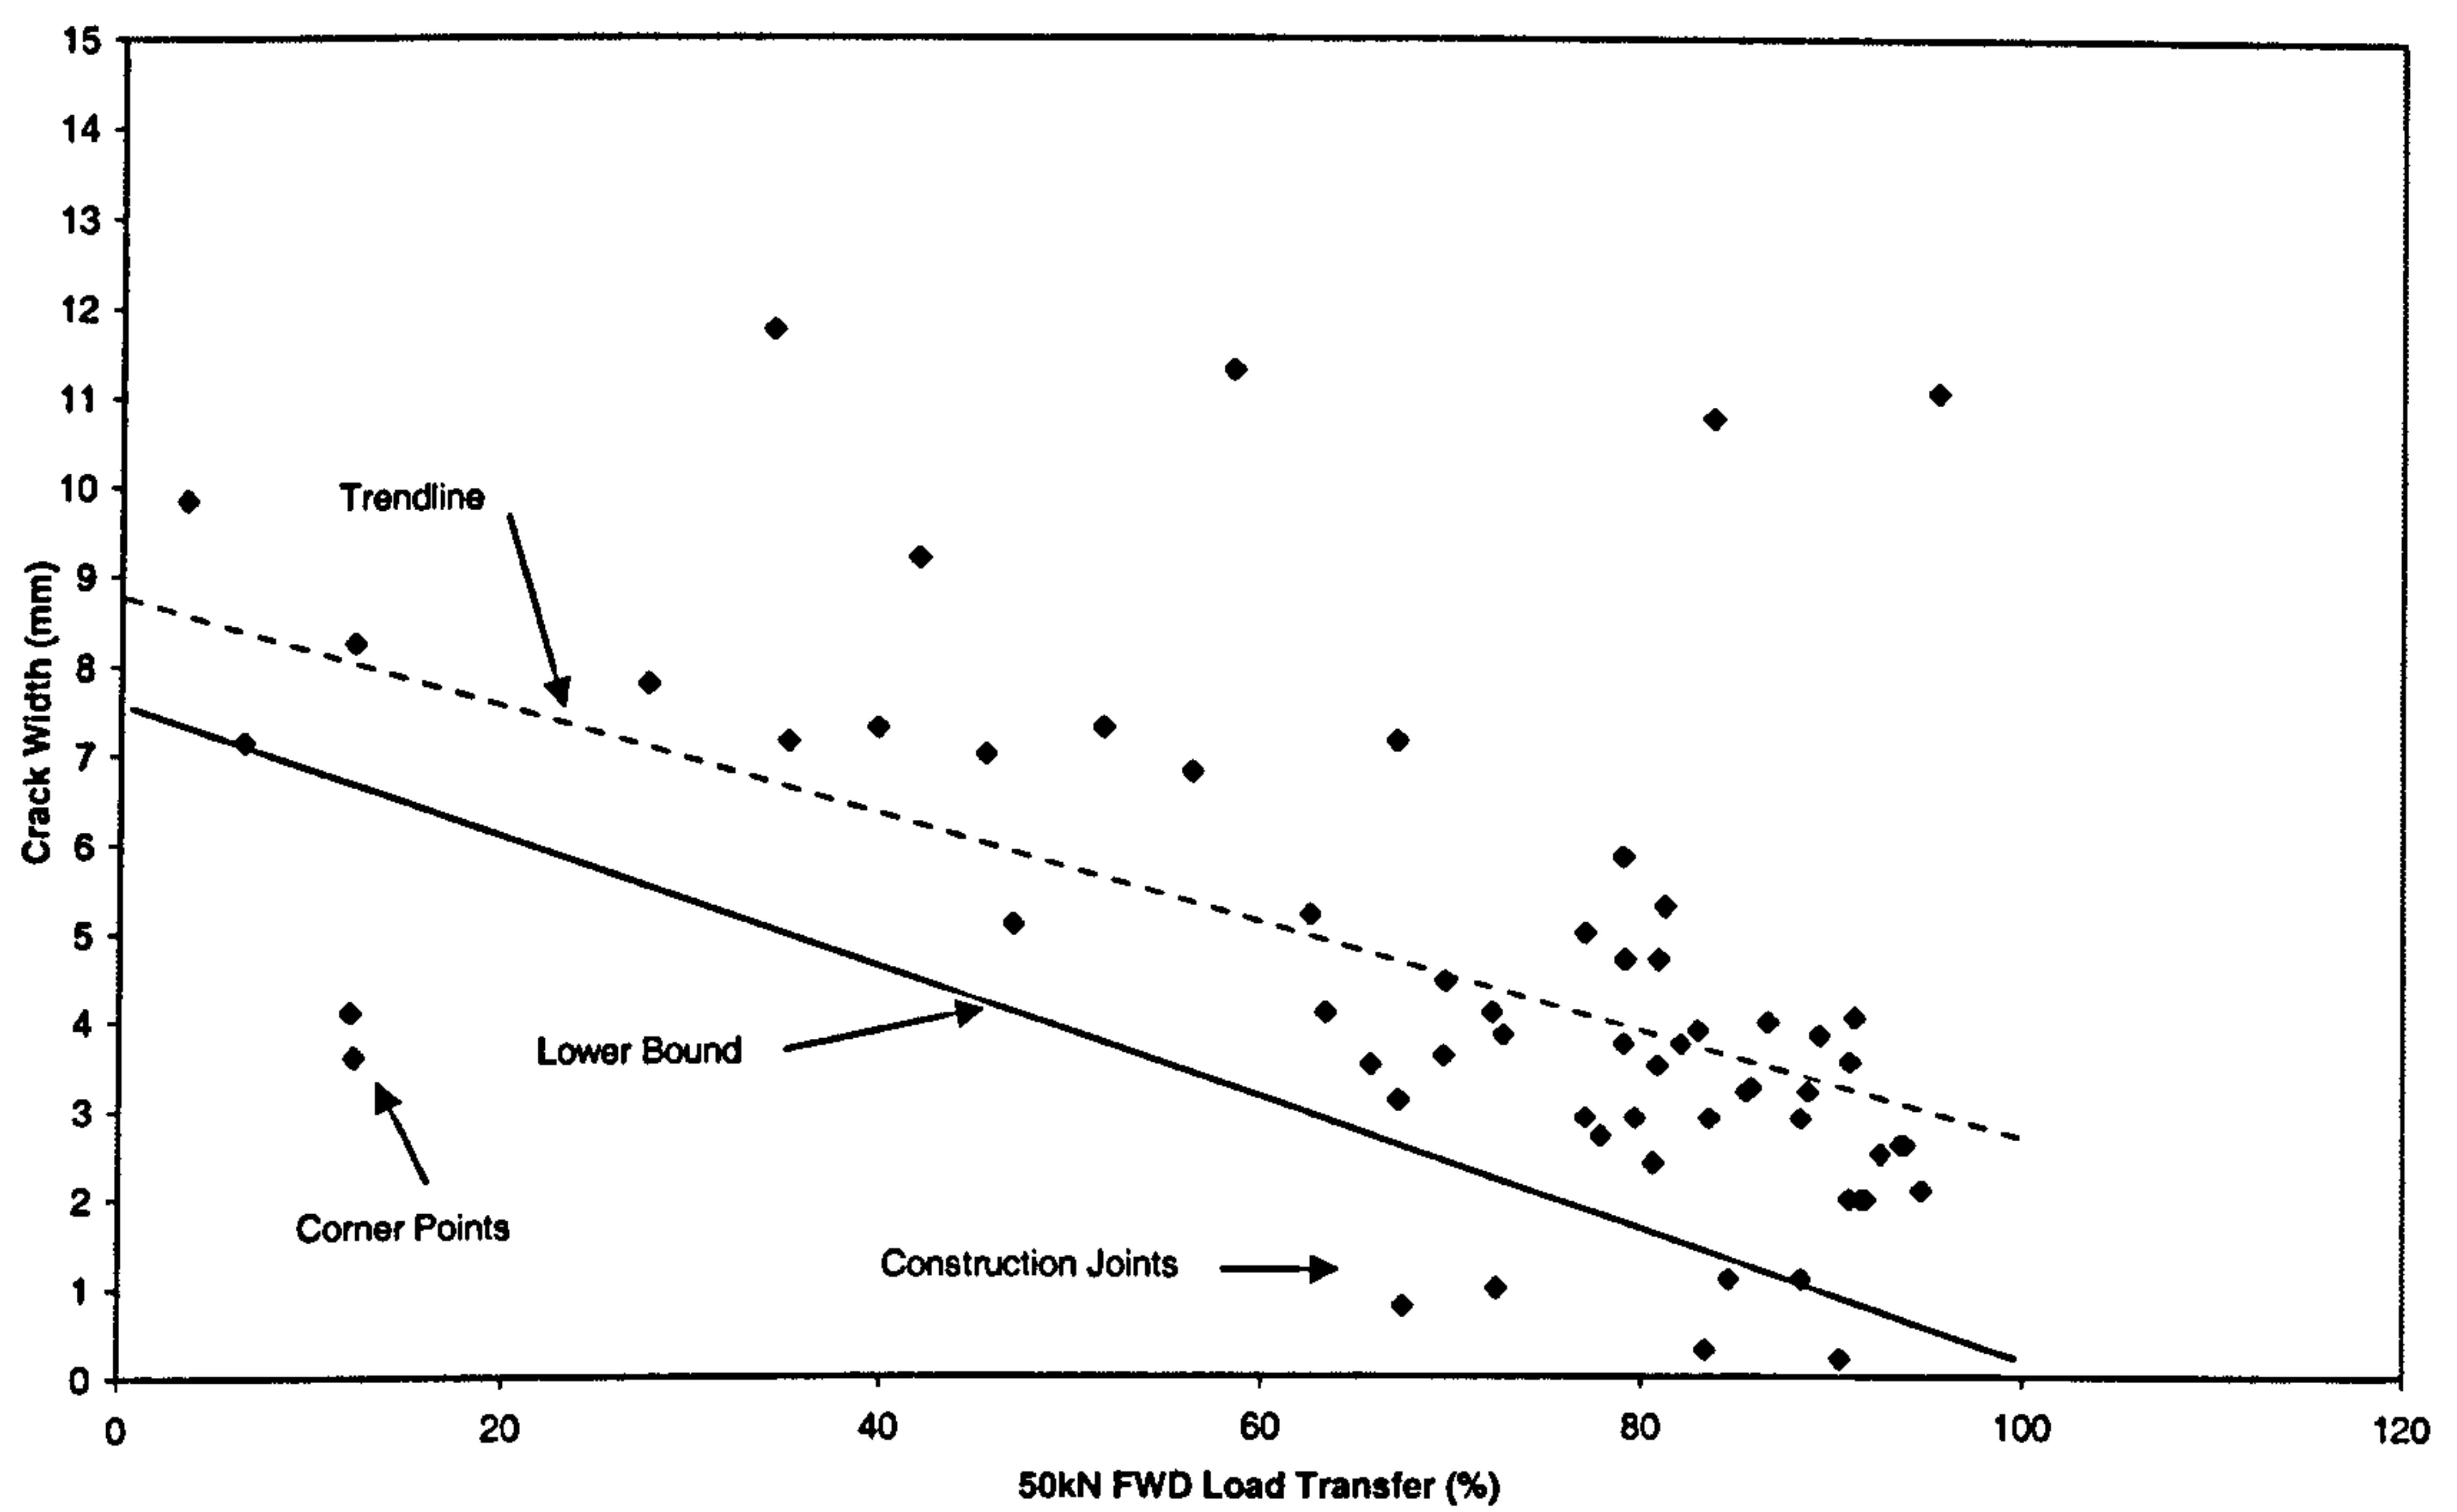
Figure 6.21a – Comparison of load transfer and crack width (Daventry)

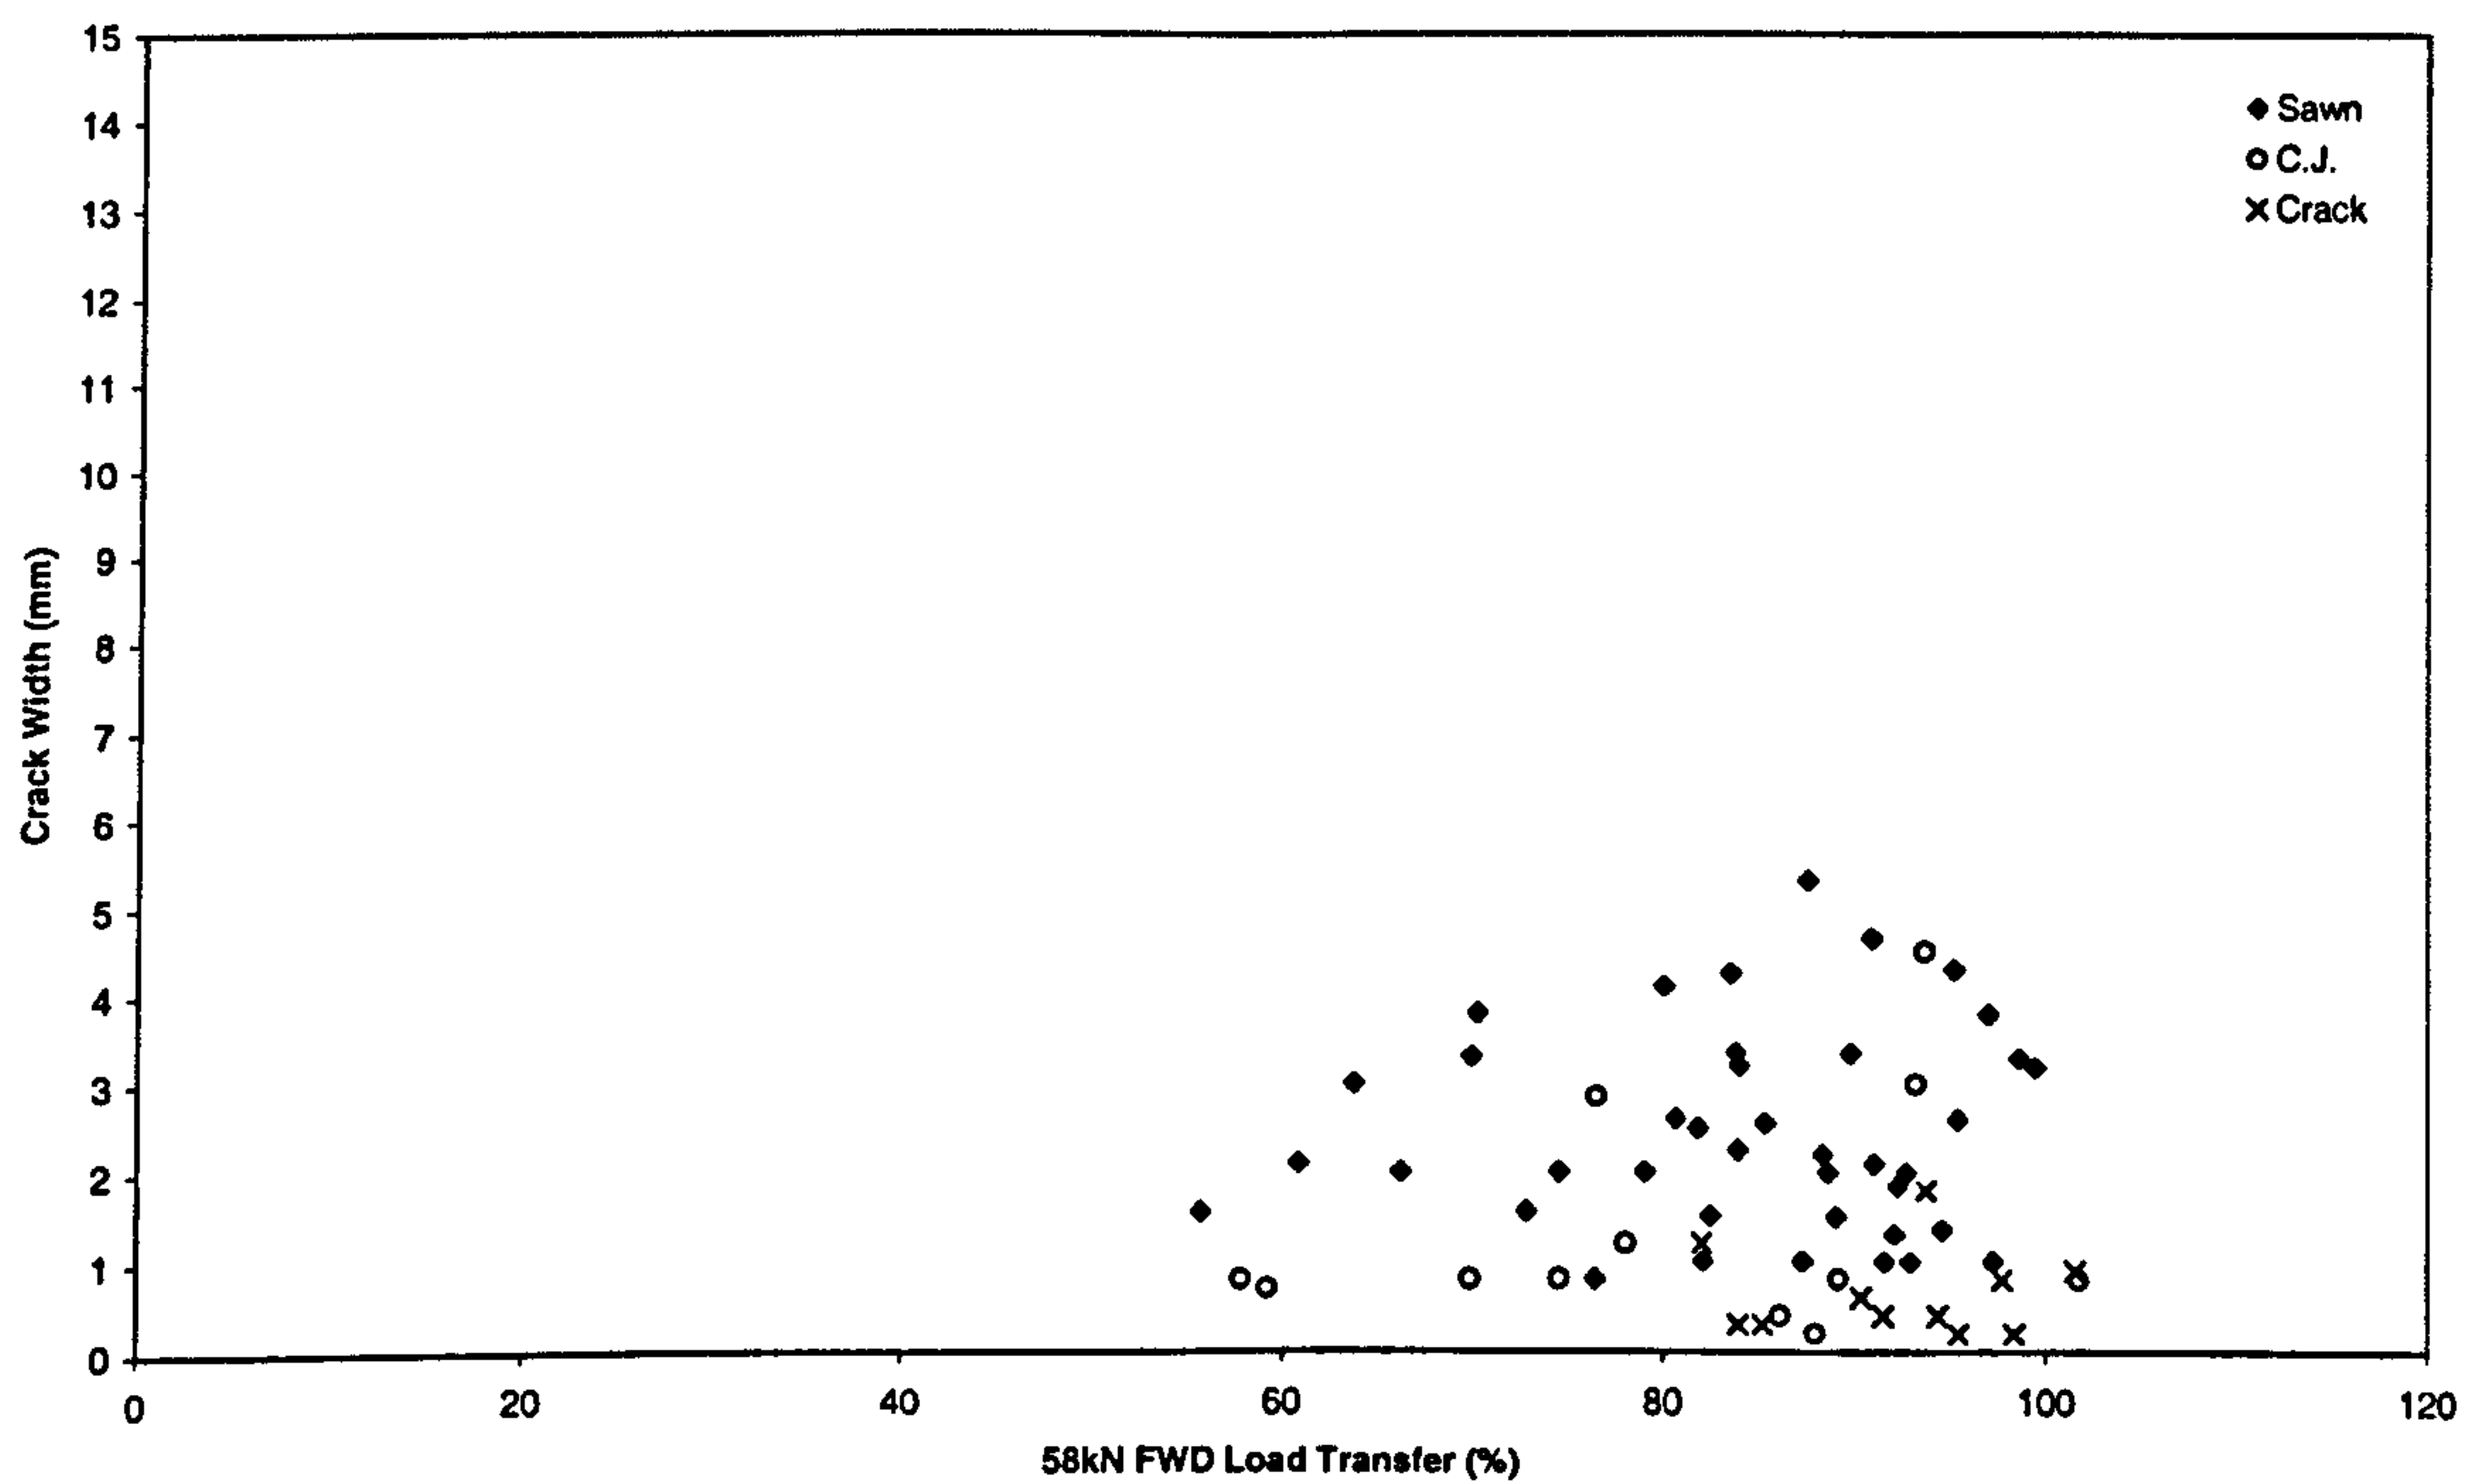
Figure 6.21b – Comparison of load transfer and crack width (Lutterworth)

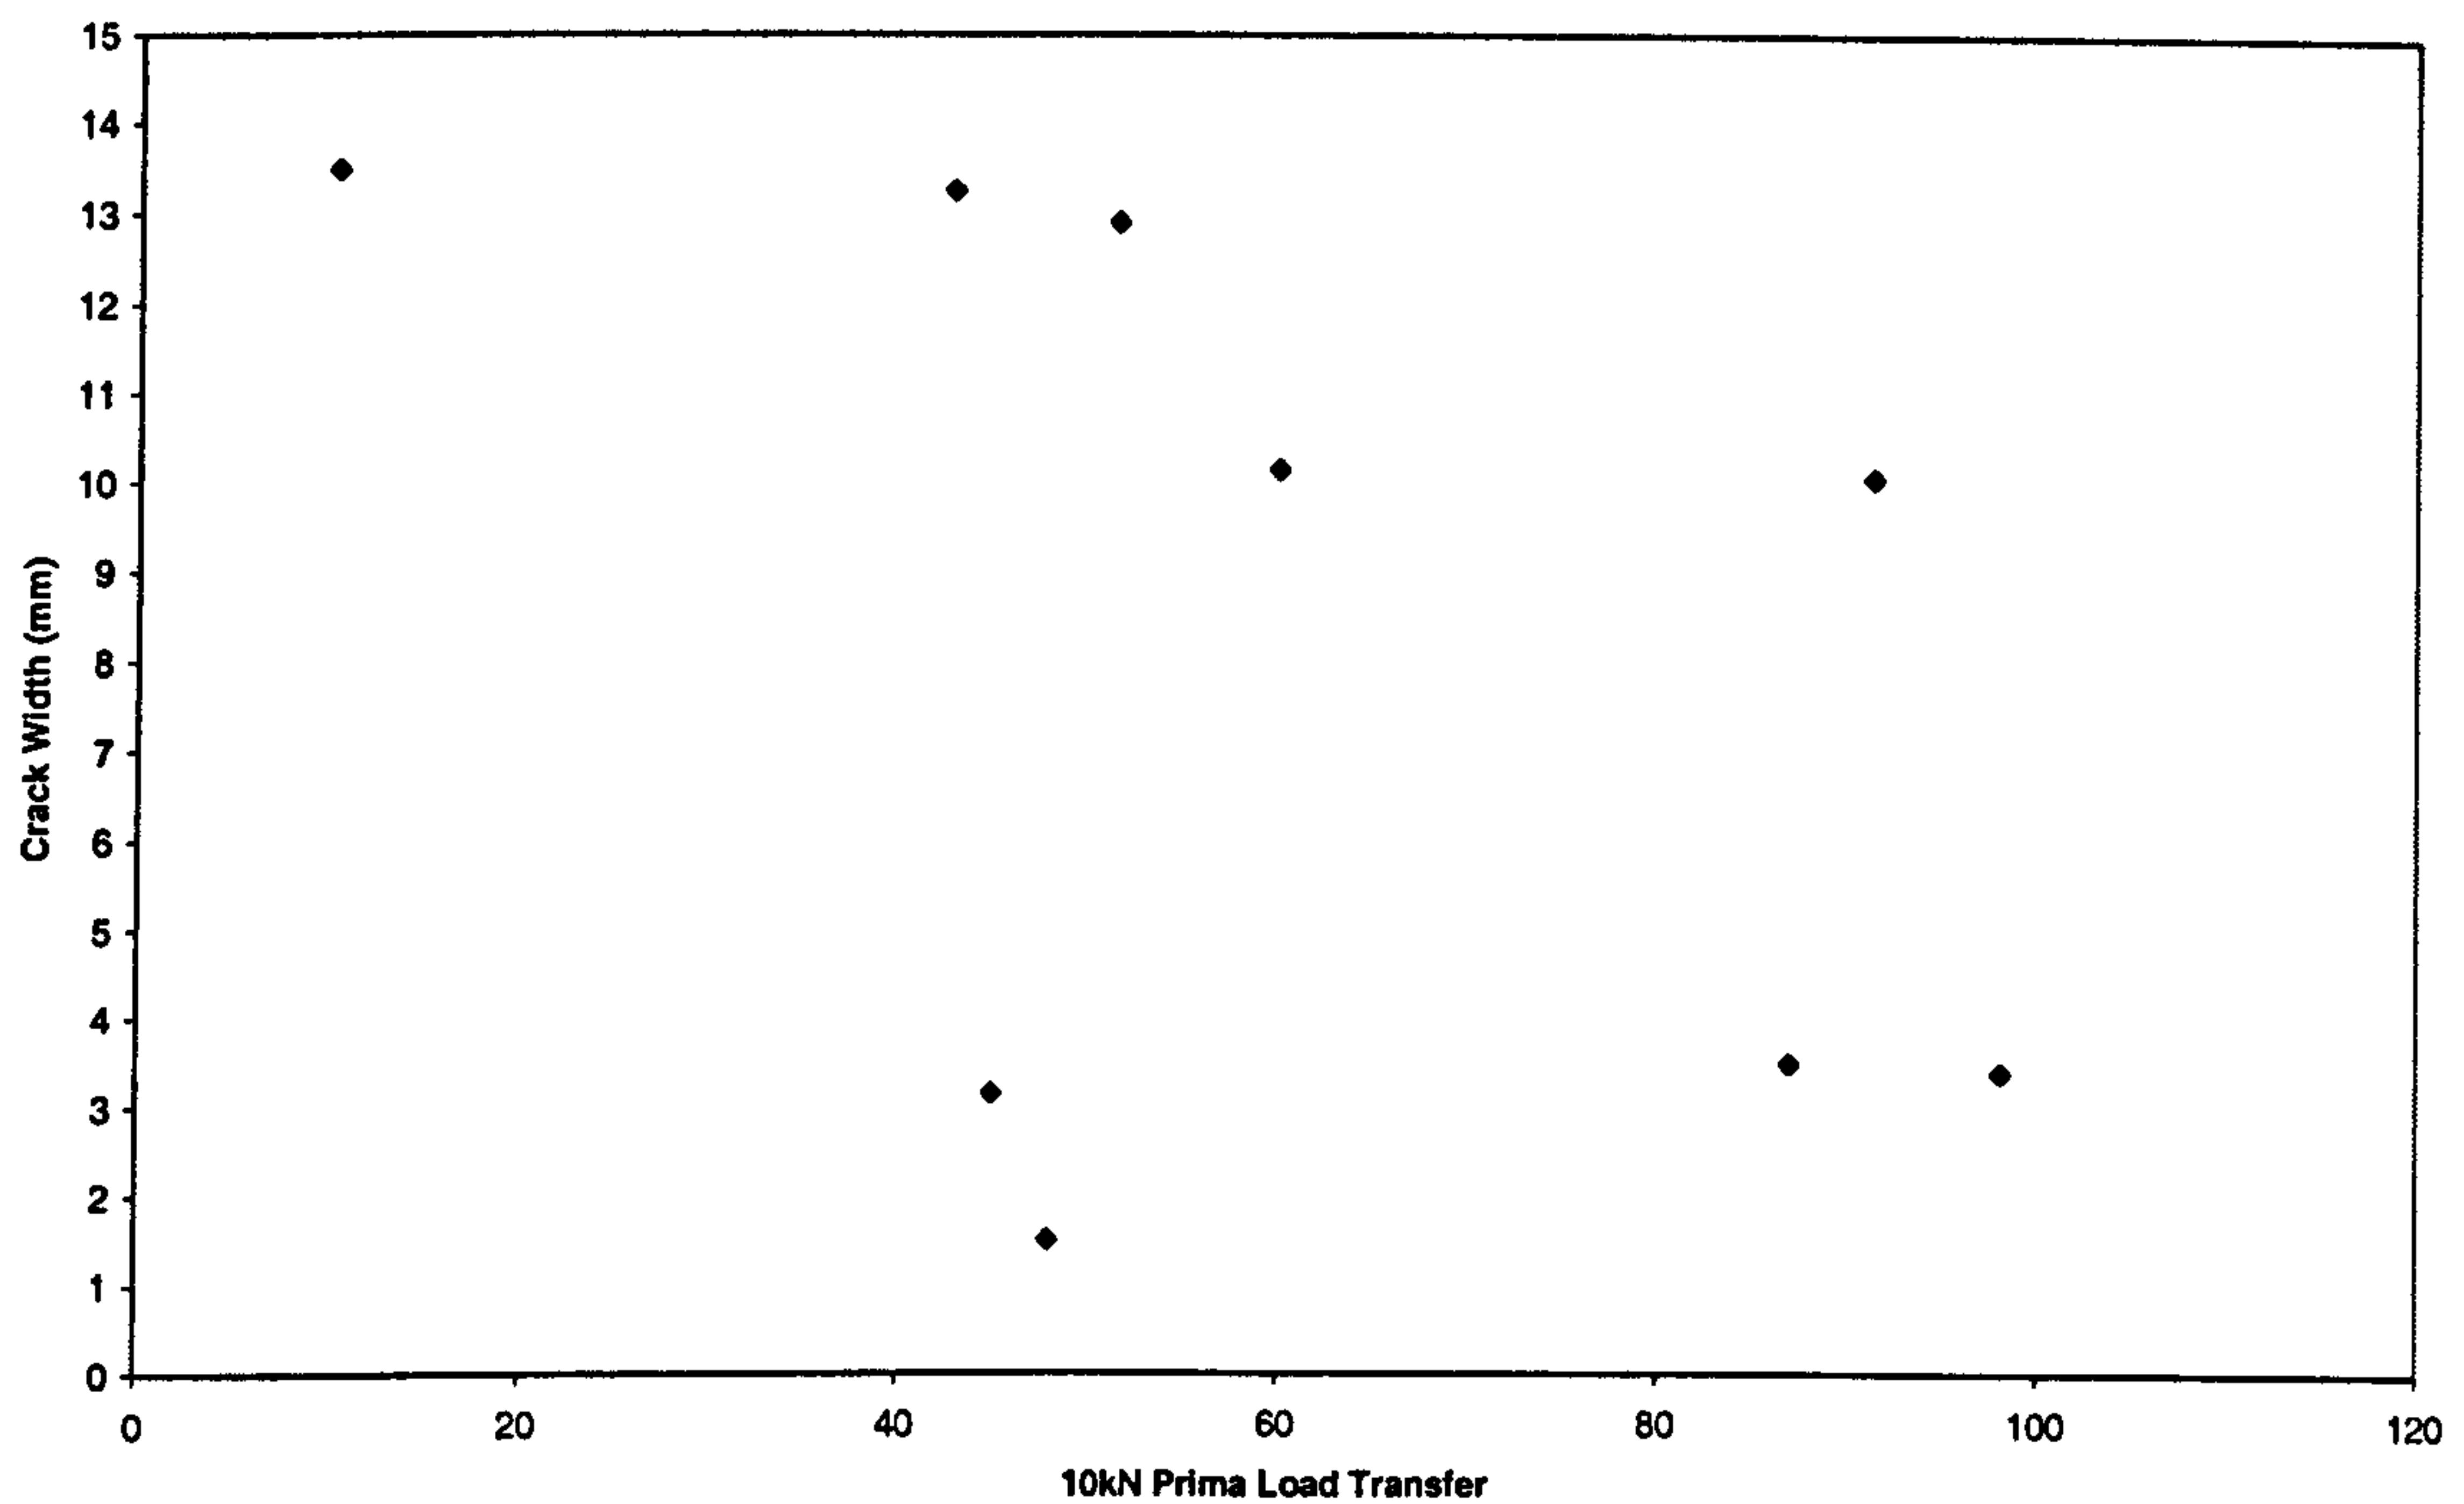
Figure 6.21c – Comparison of load transfer and crack width (Skelmersdale)

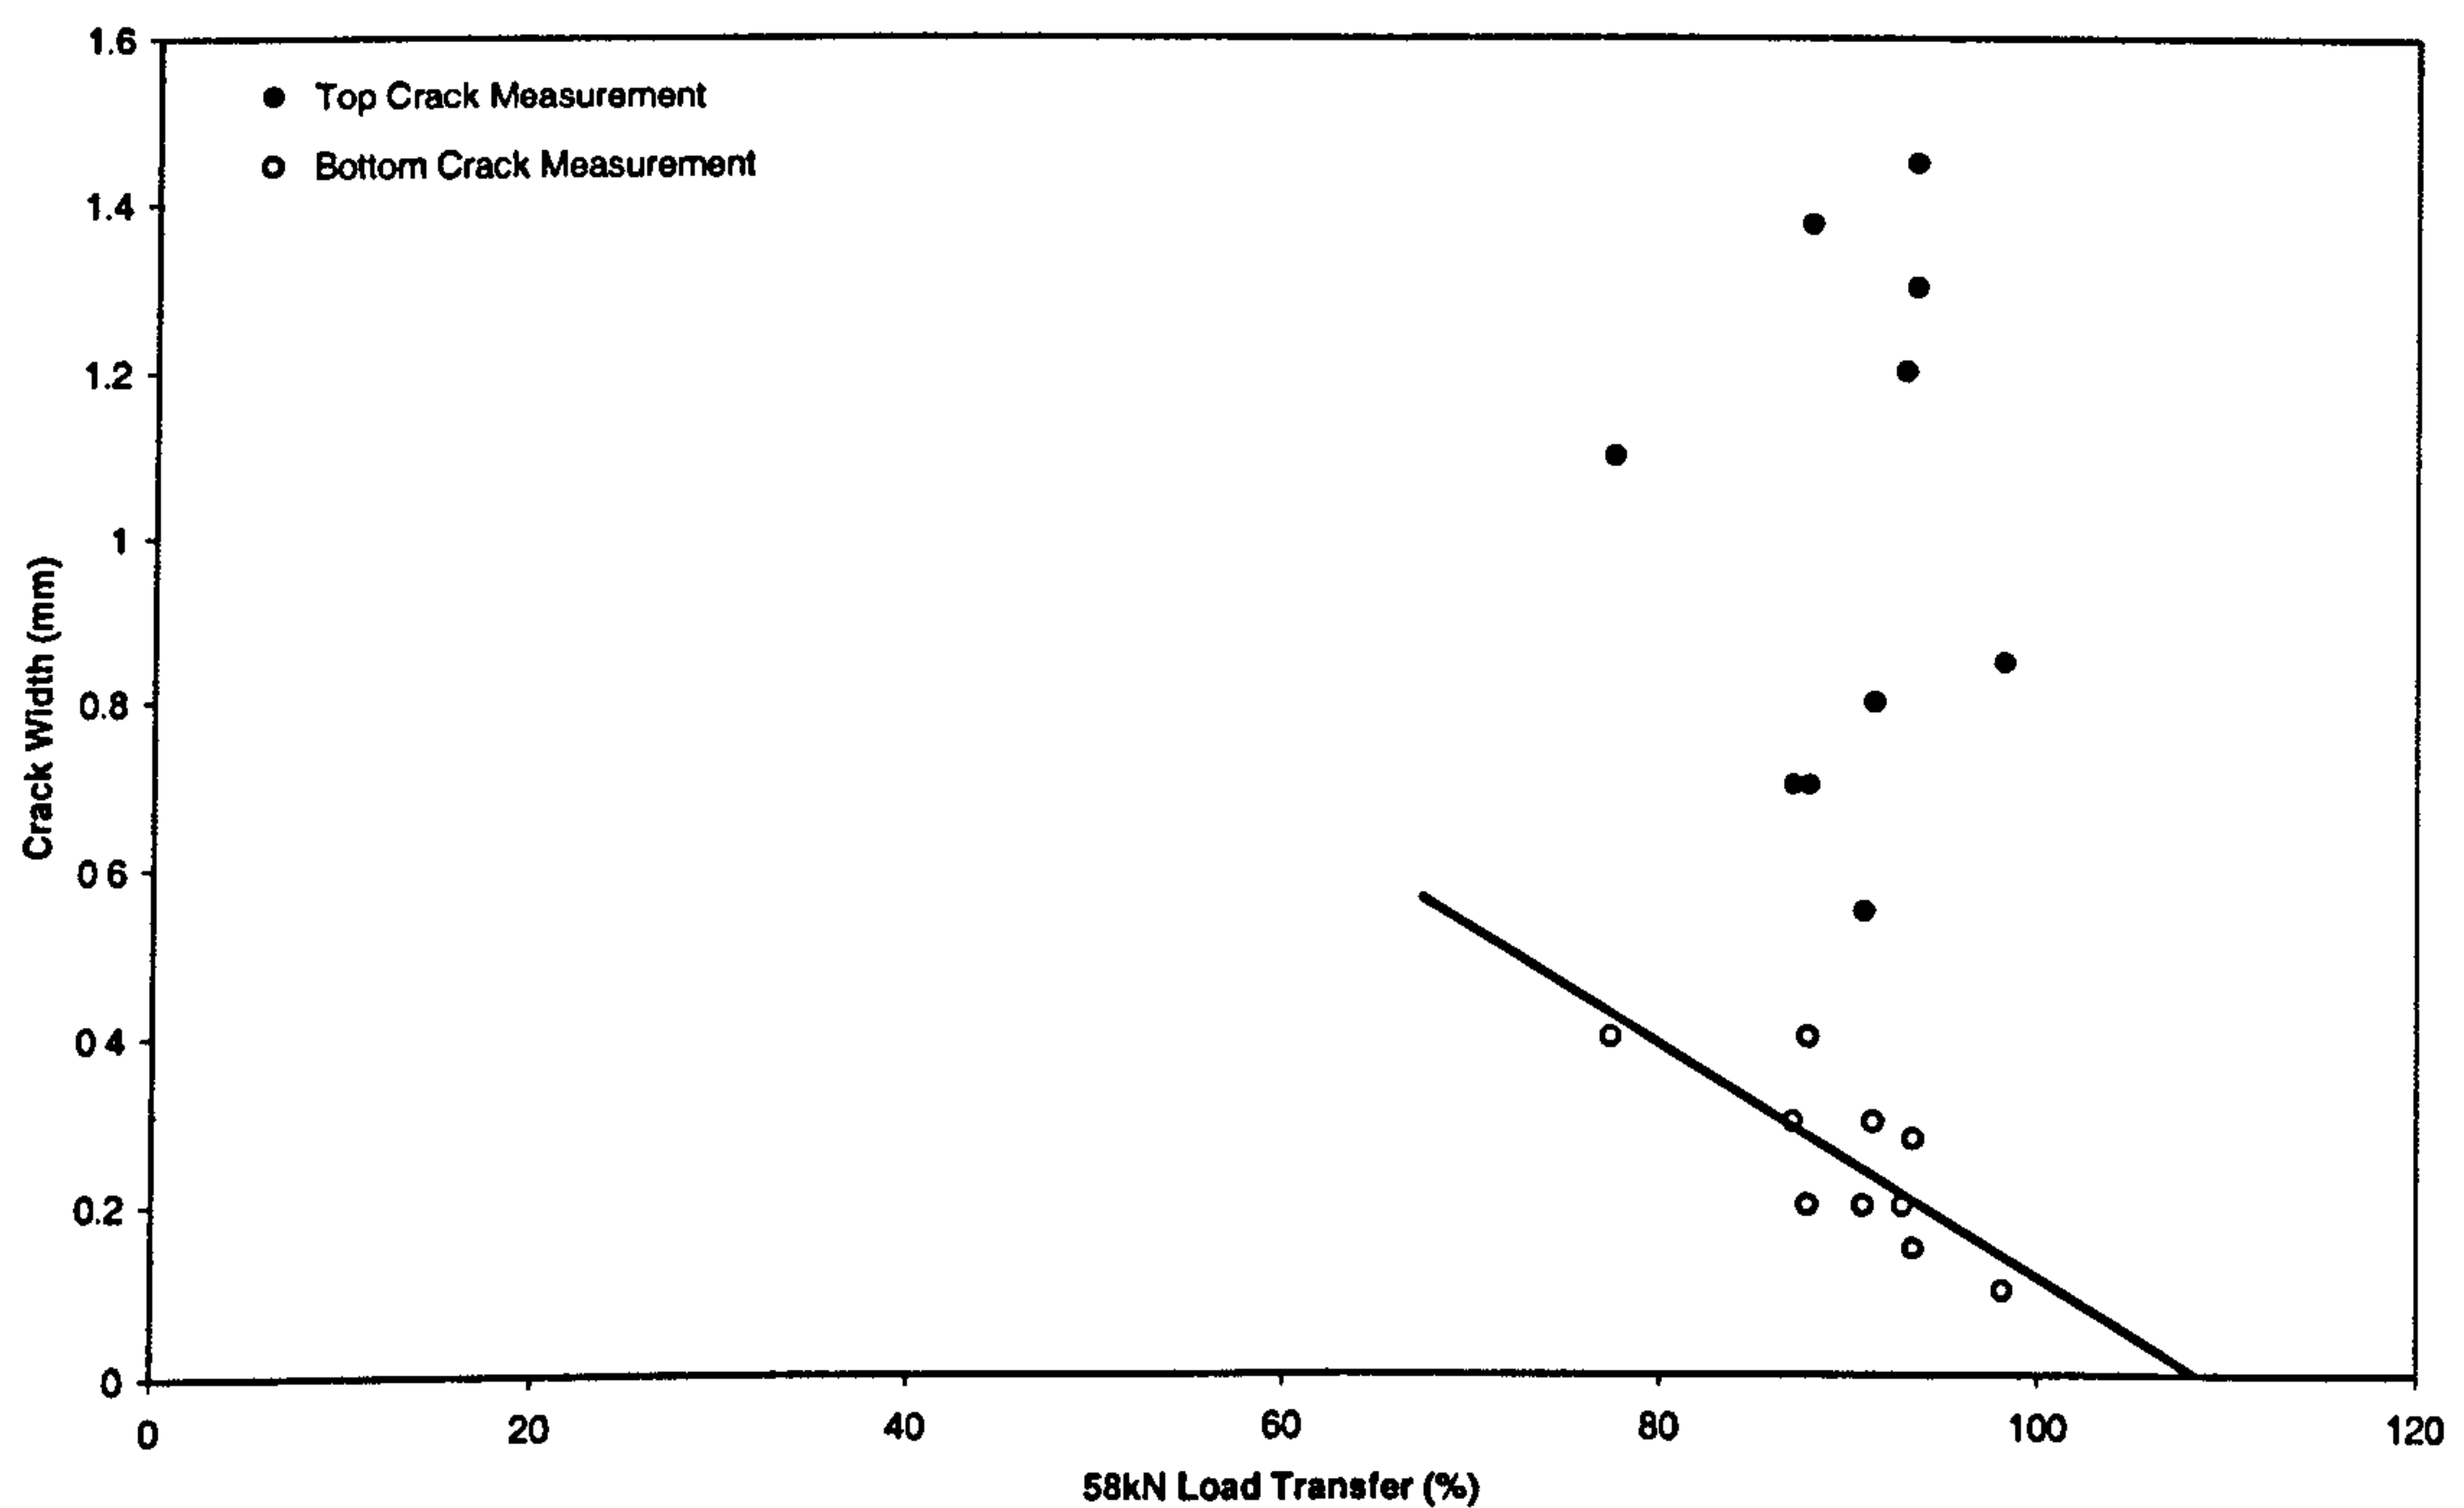
**Figure 6.22 - Comparison of load transfer with surface and base slab crack widths
(Lutterworth)**

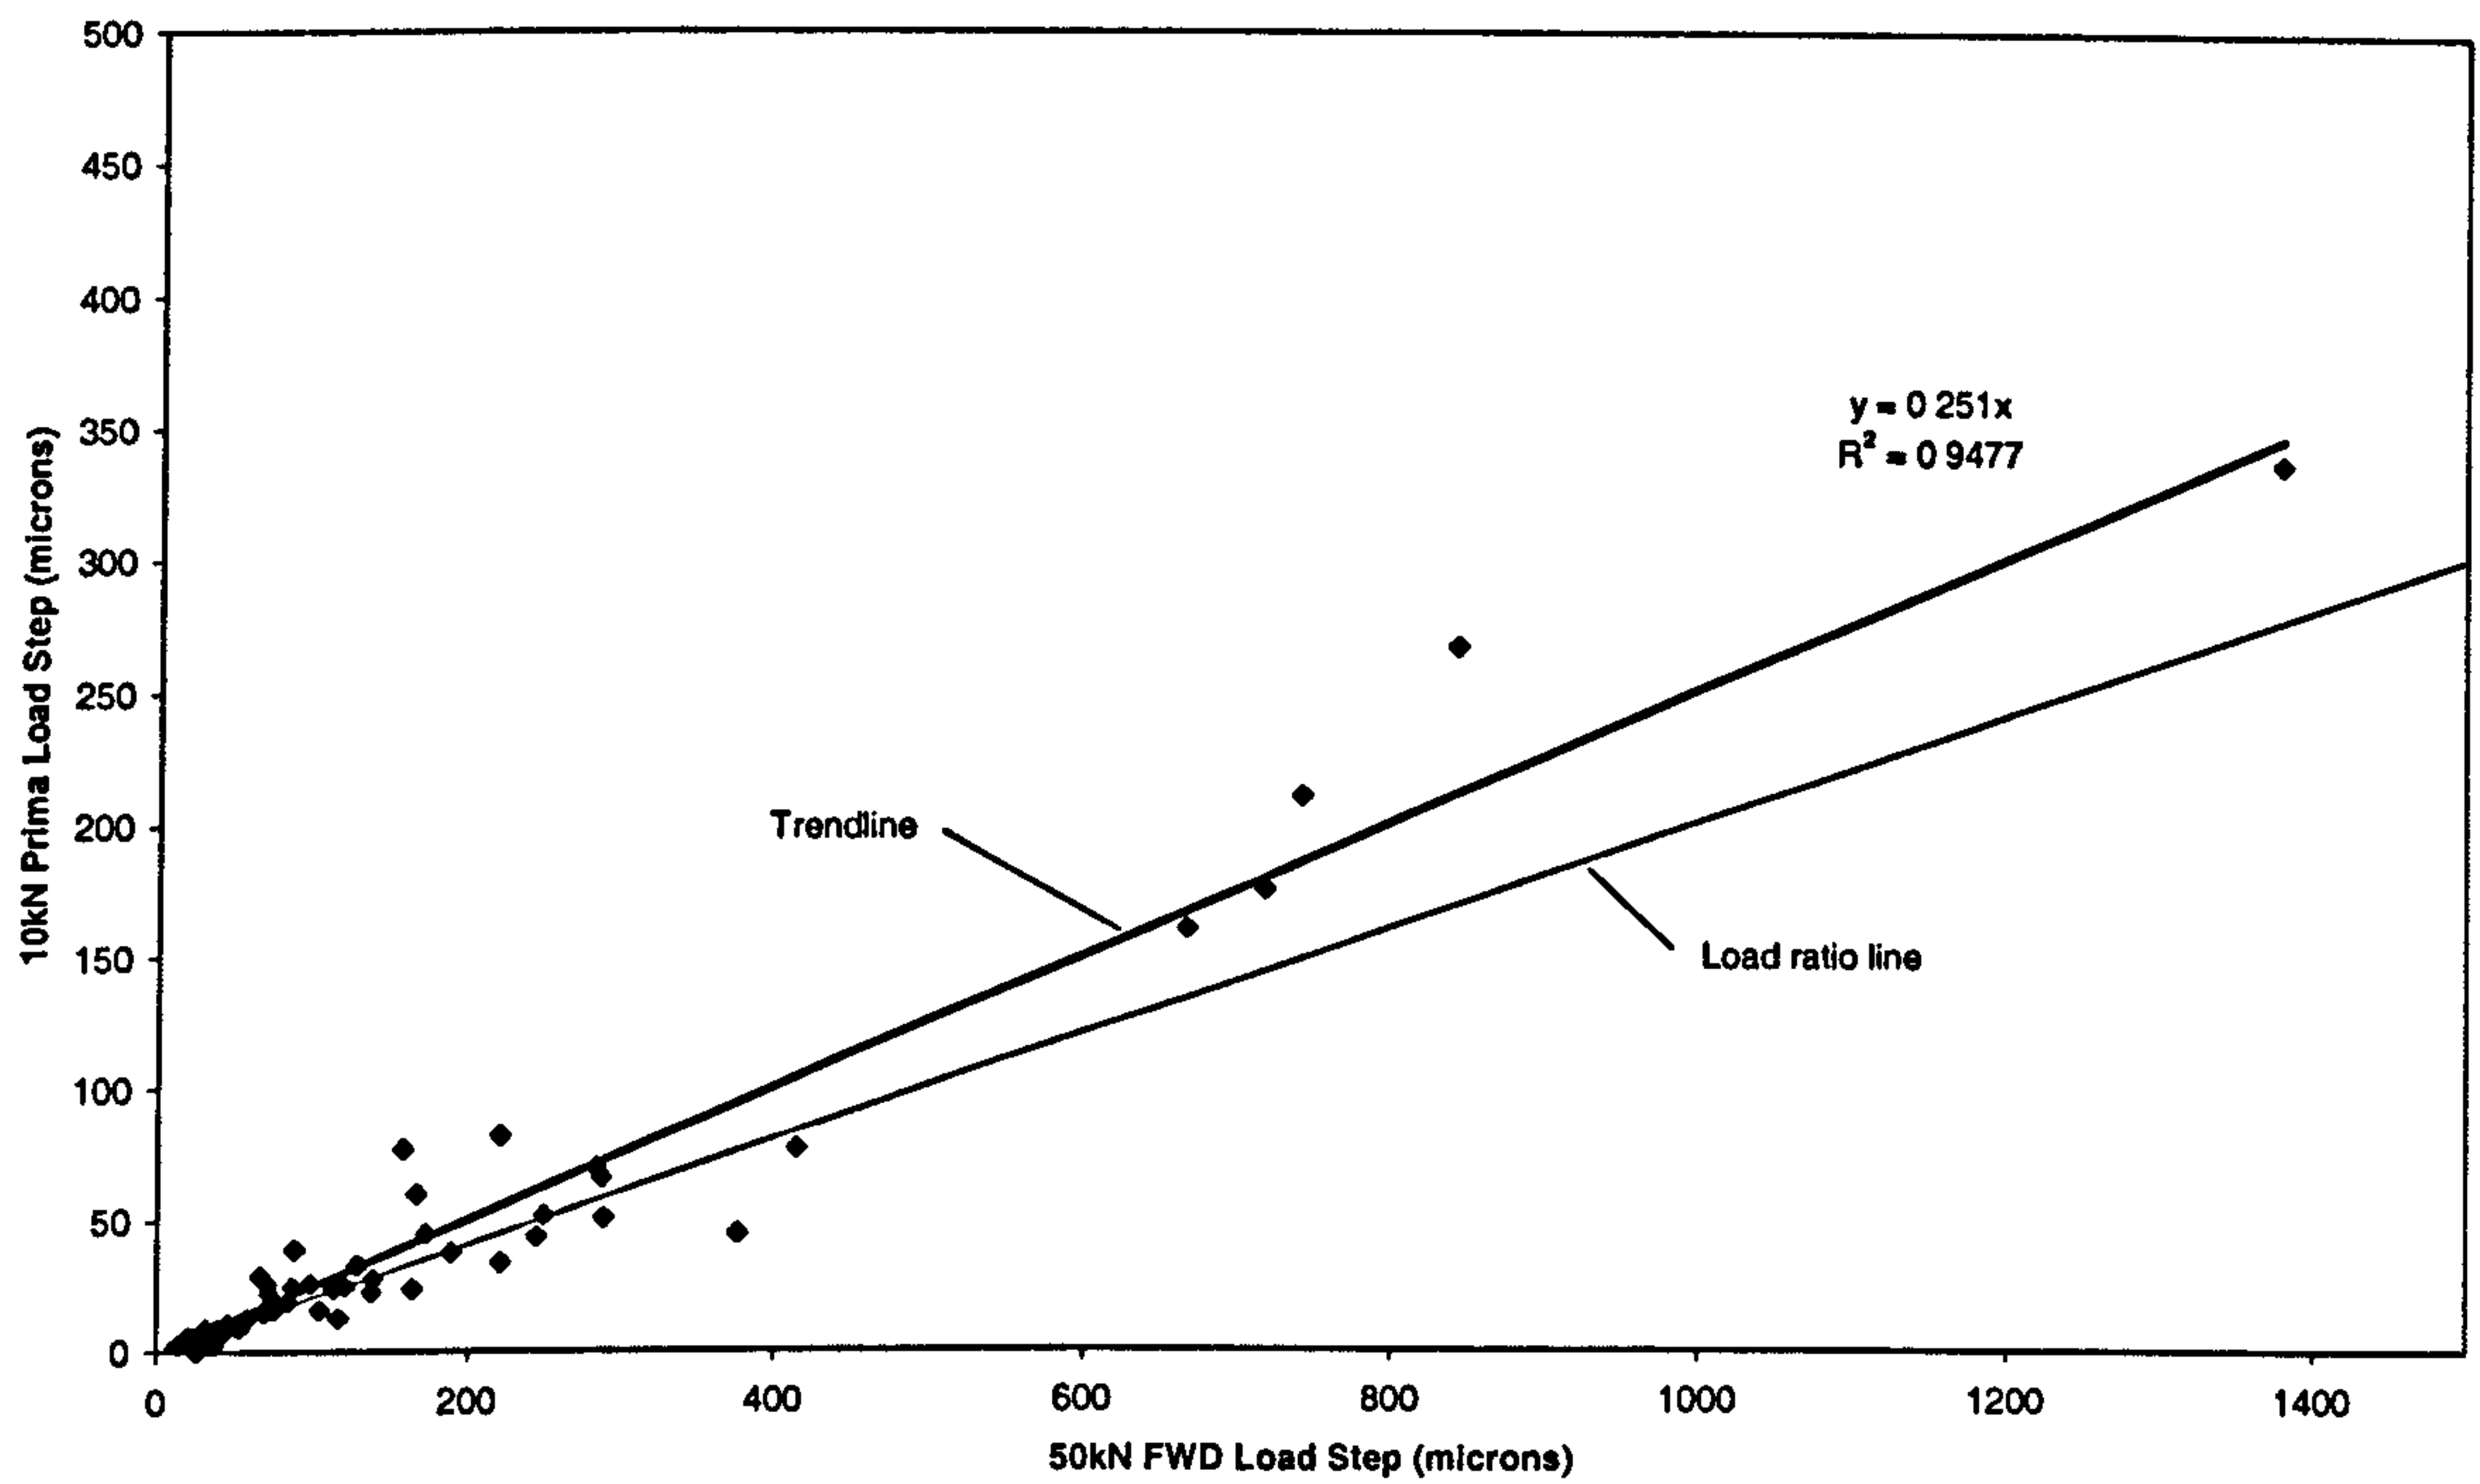
Figure 6.23 – Load step comparison between FWD and Prima (Daventry)
