LOAD TRANSFER ACROSS CRACKS AND JOINTS IN CONCRETE SLABS ON GRADE

Stuart John Arnold

**A Doctoral Thesis Submitted in partial fulfilment of the requirements for the
award of
Doctor of Philosophy of Loughborough University**

20th February 2004

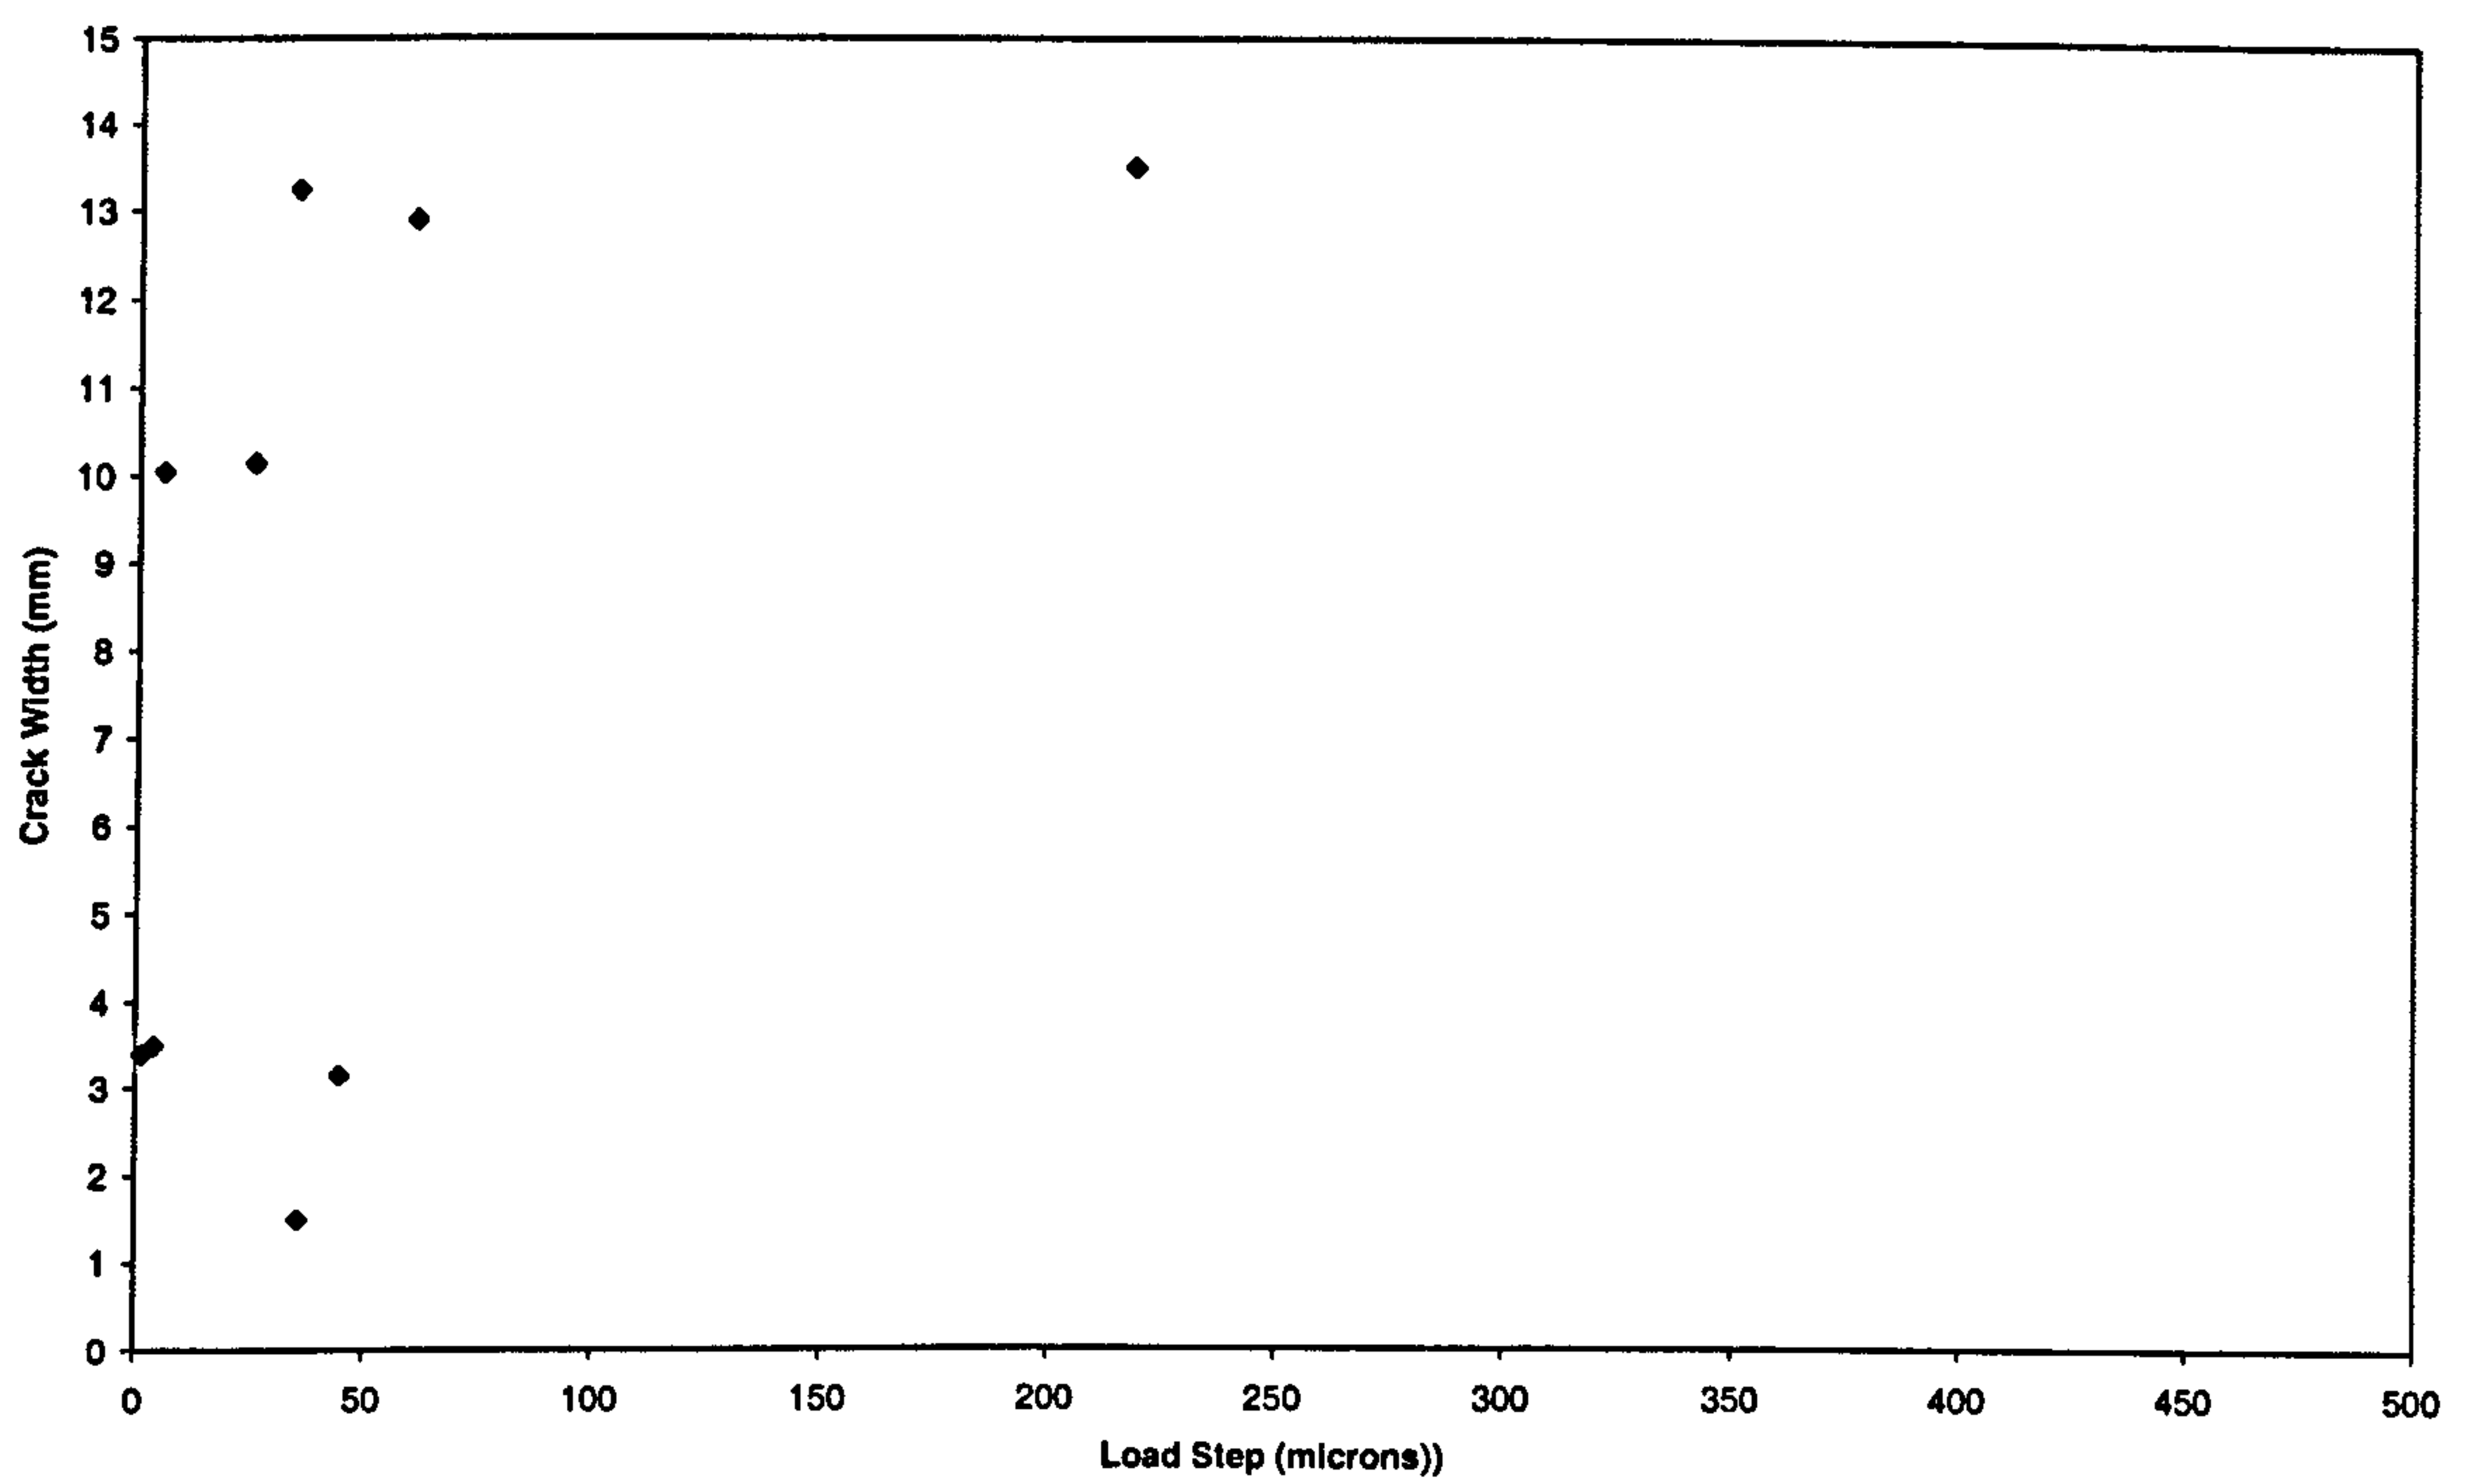
Figure 6.29c – Comparison of load step and crack width (Skelmersdale)

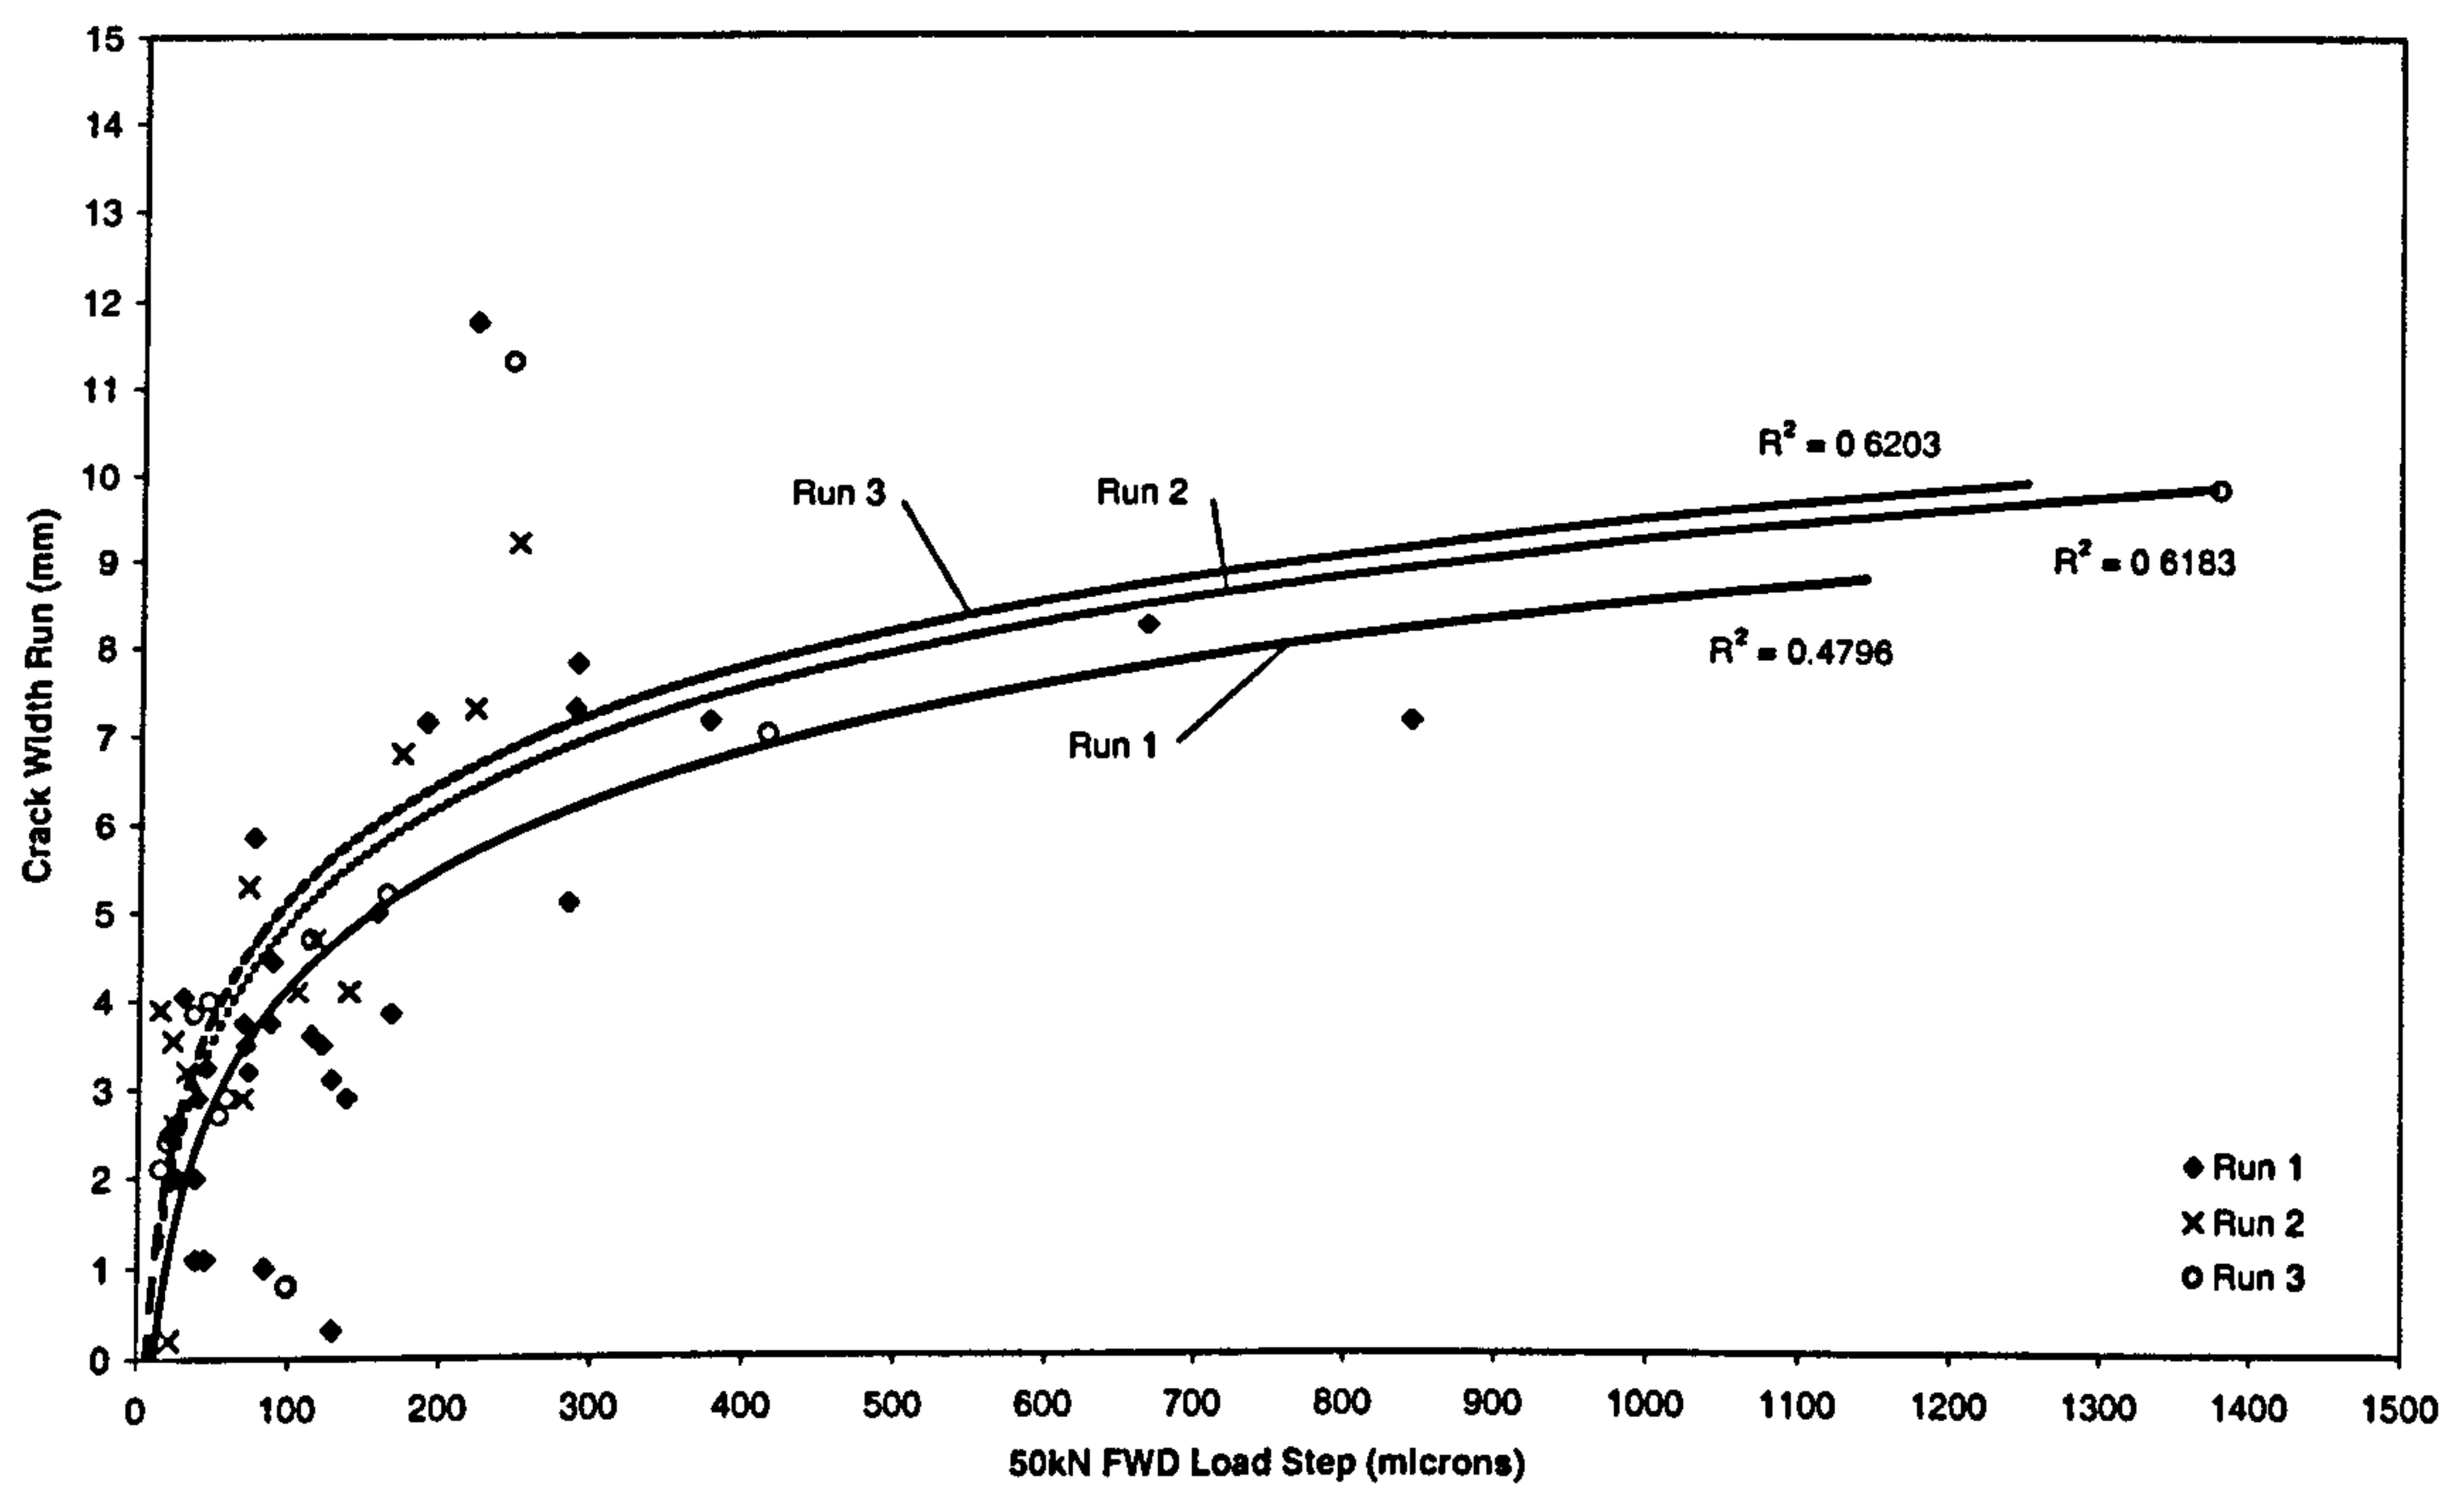
Figure 6.30 – Comparison of load step and crack width taking into account pre-load (Daventry)

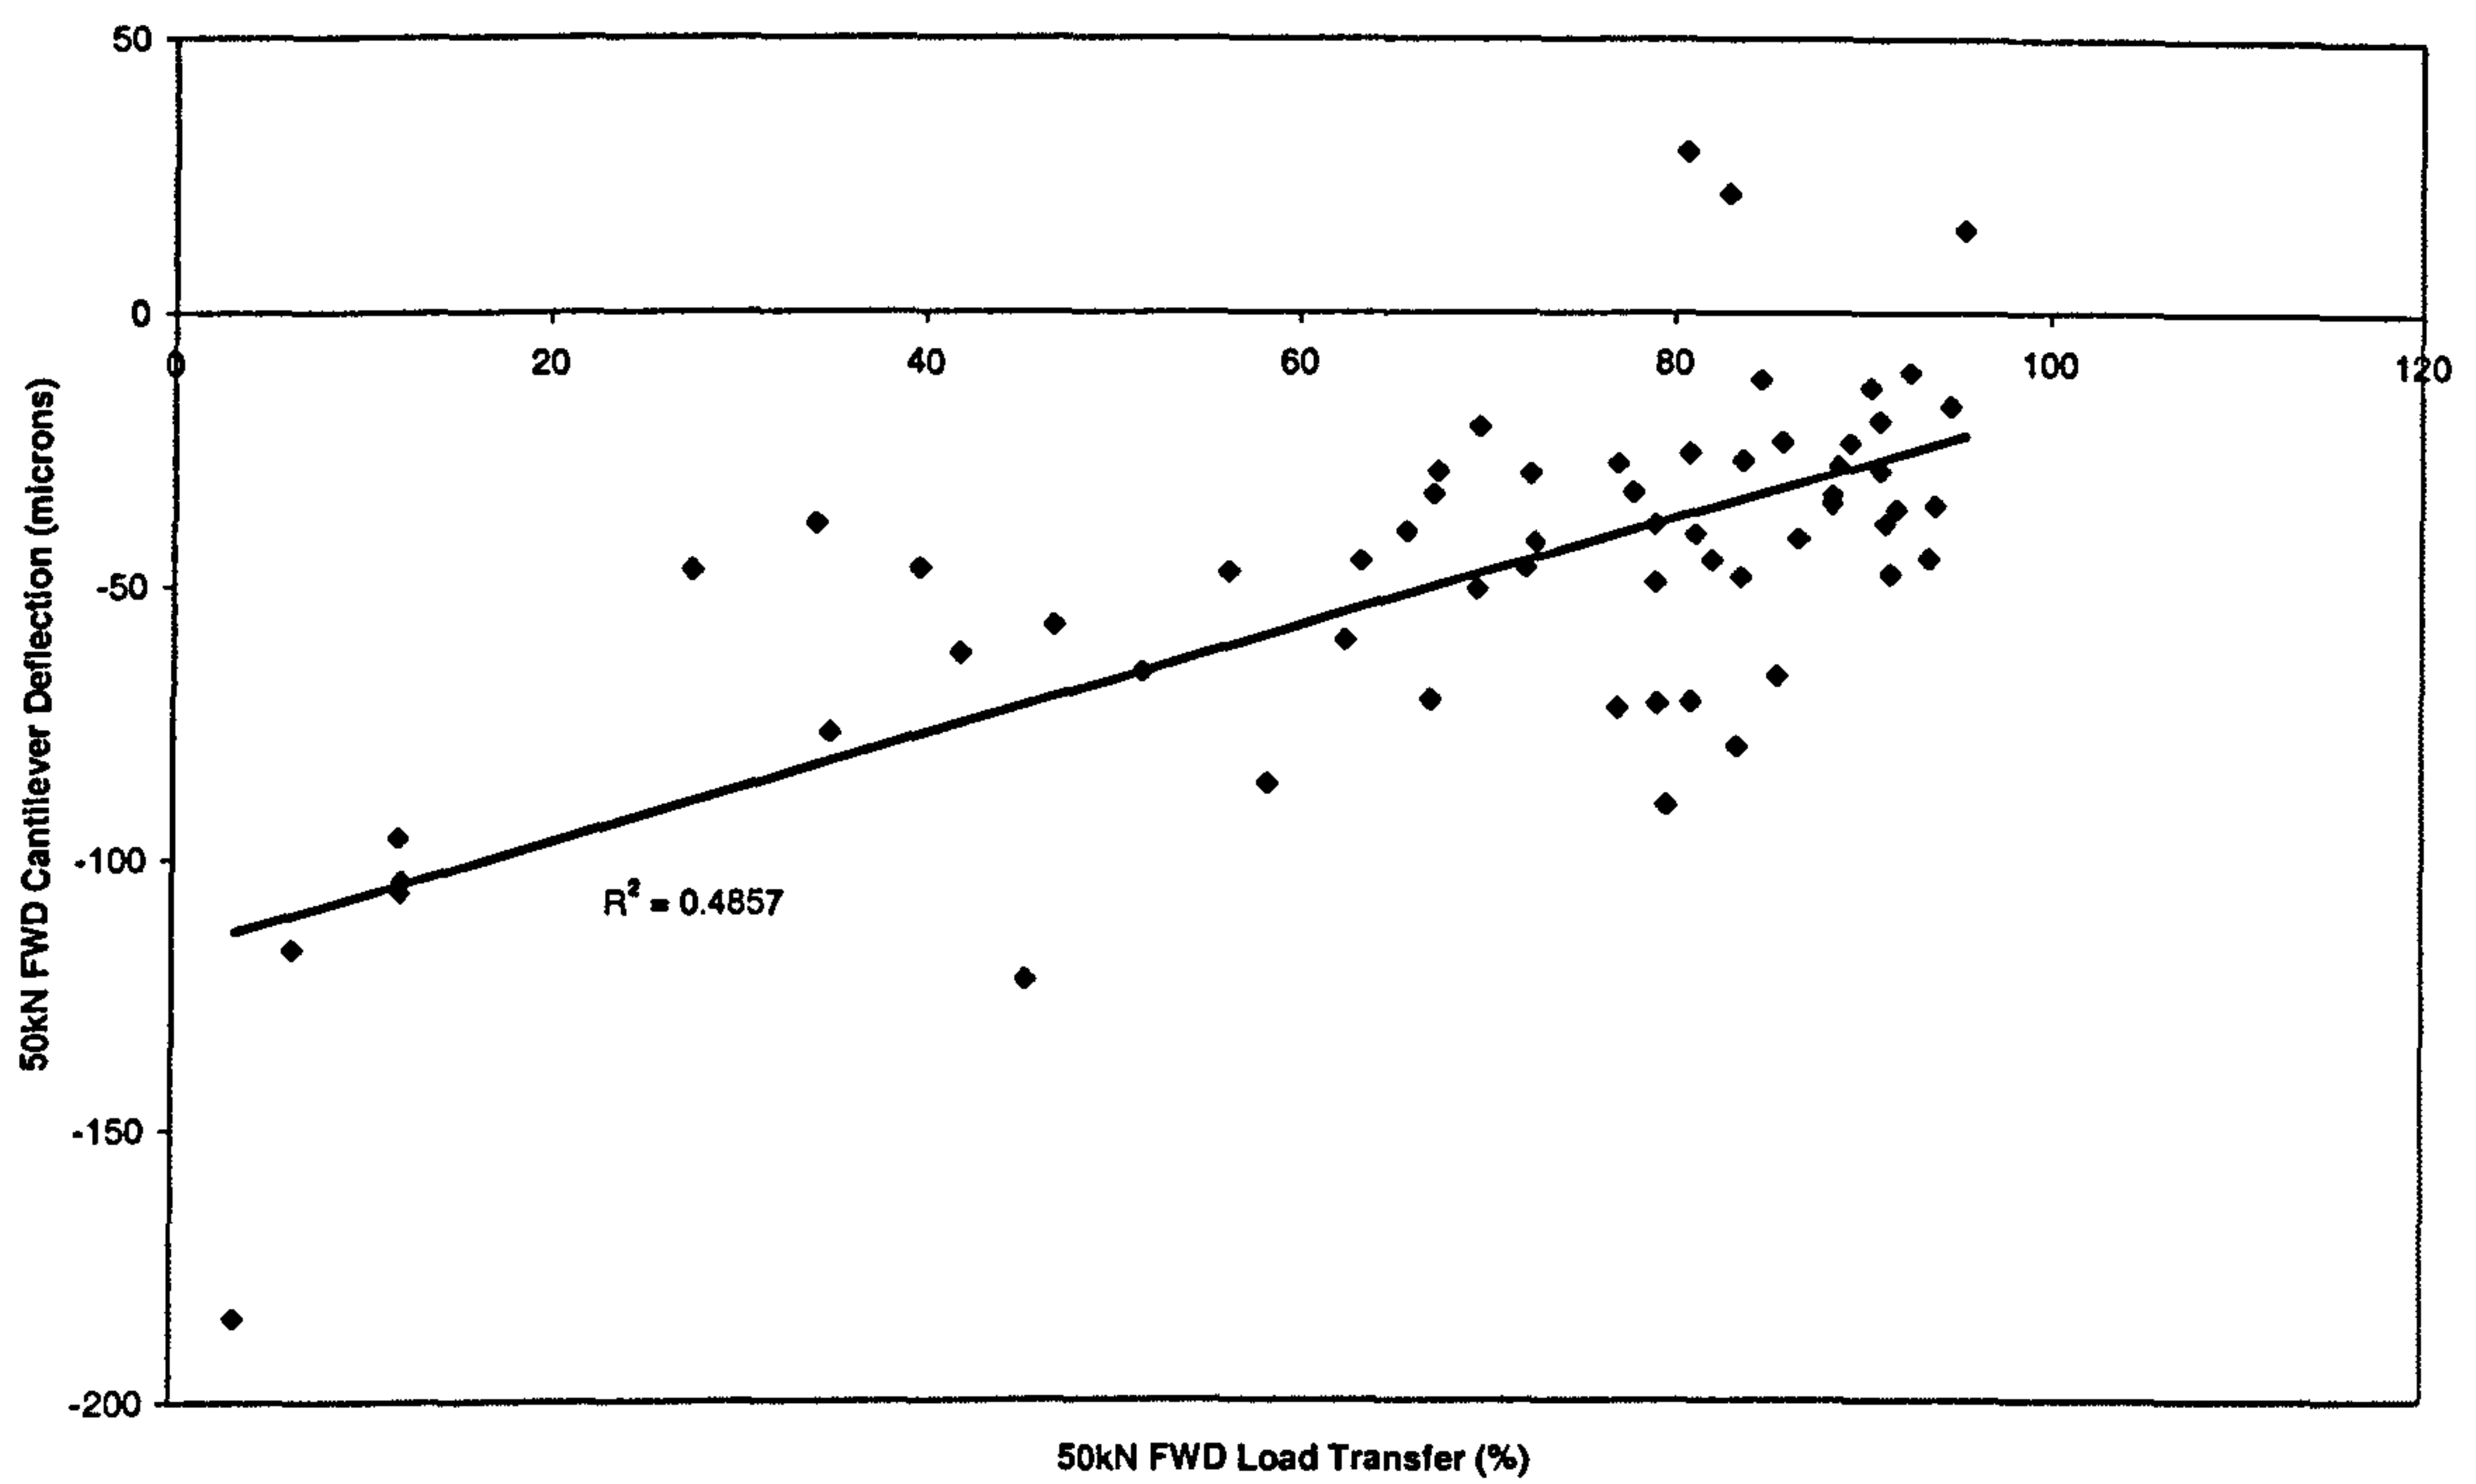
Figure 6.31a – Comparison of load transfer and edge cantilever (Daventry)

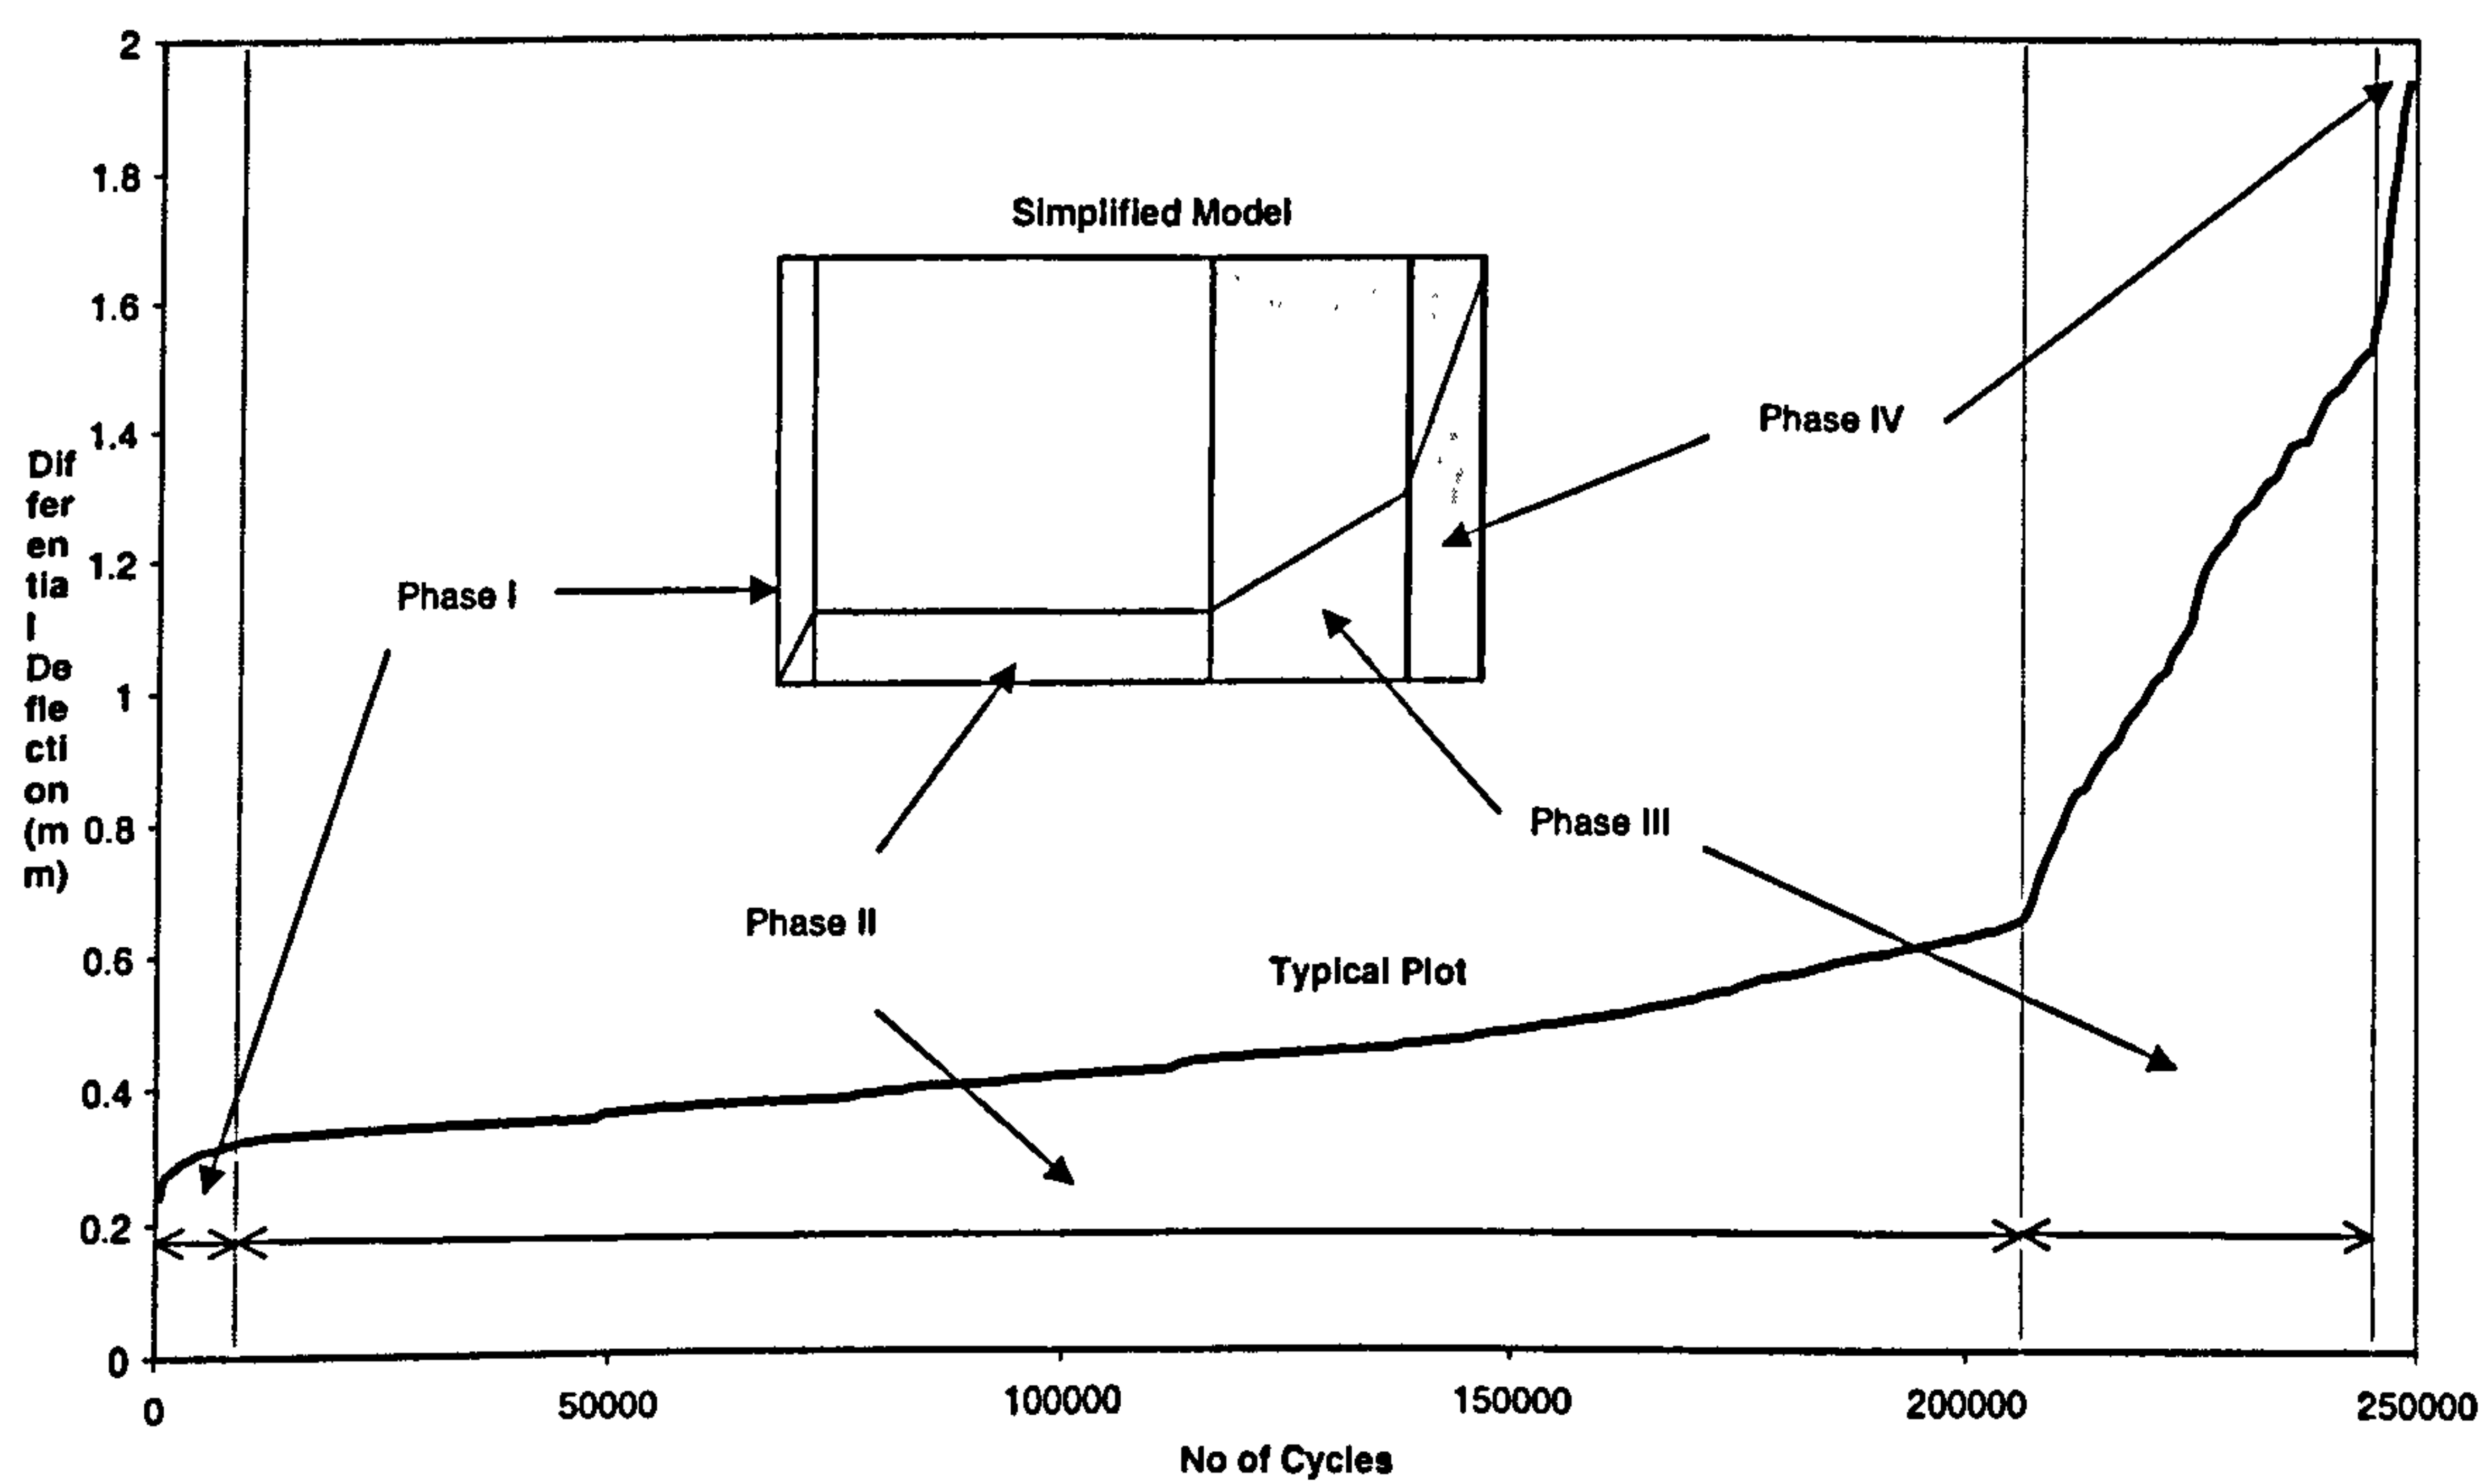
Figure 6.36 – Deterioration phases of a concrete crack

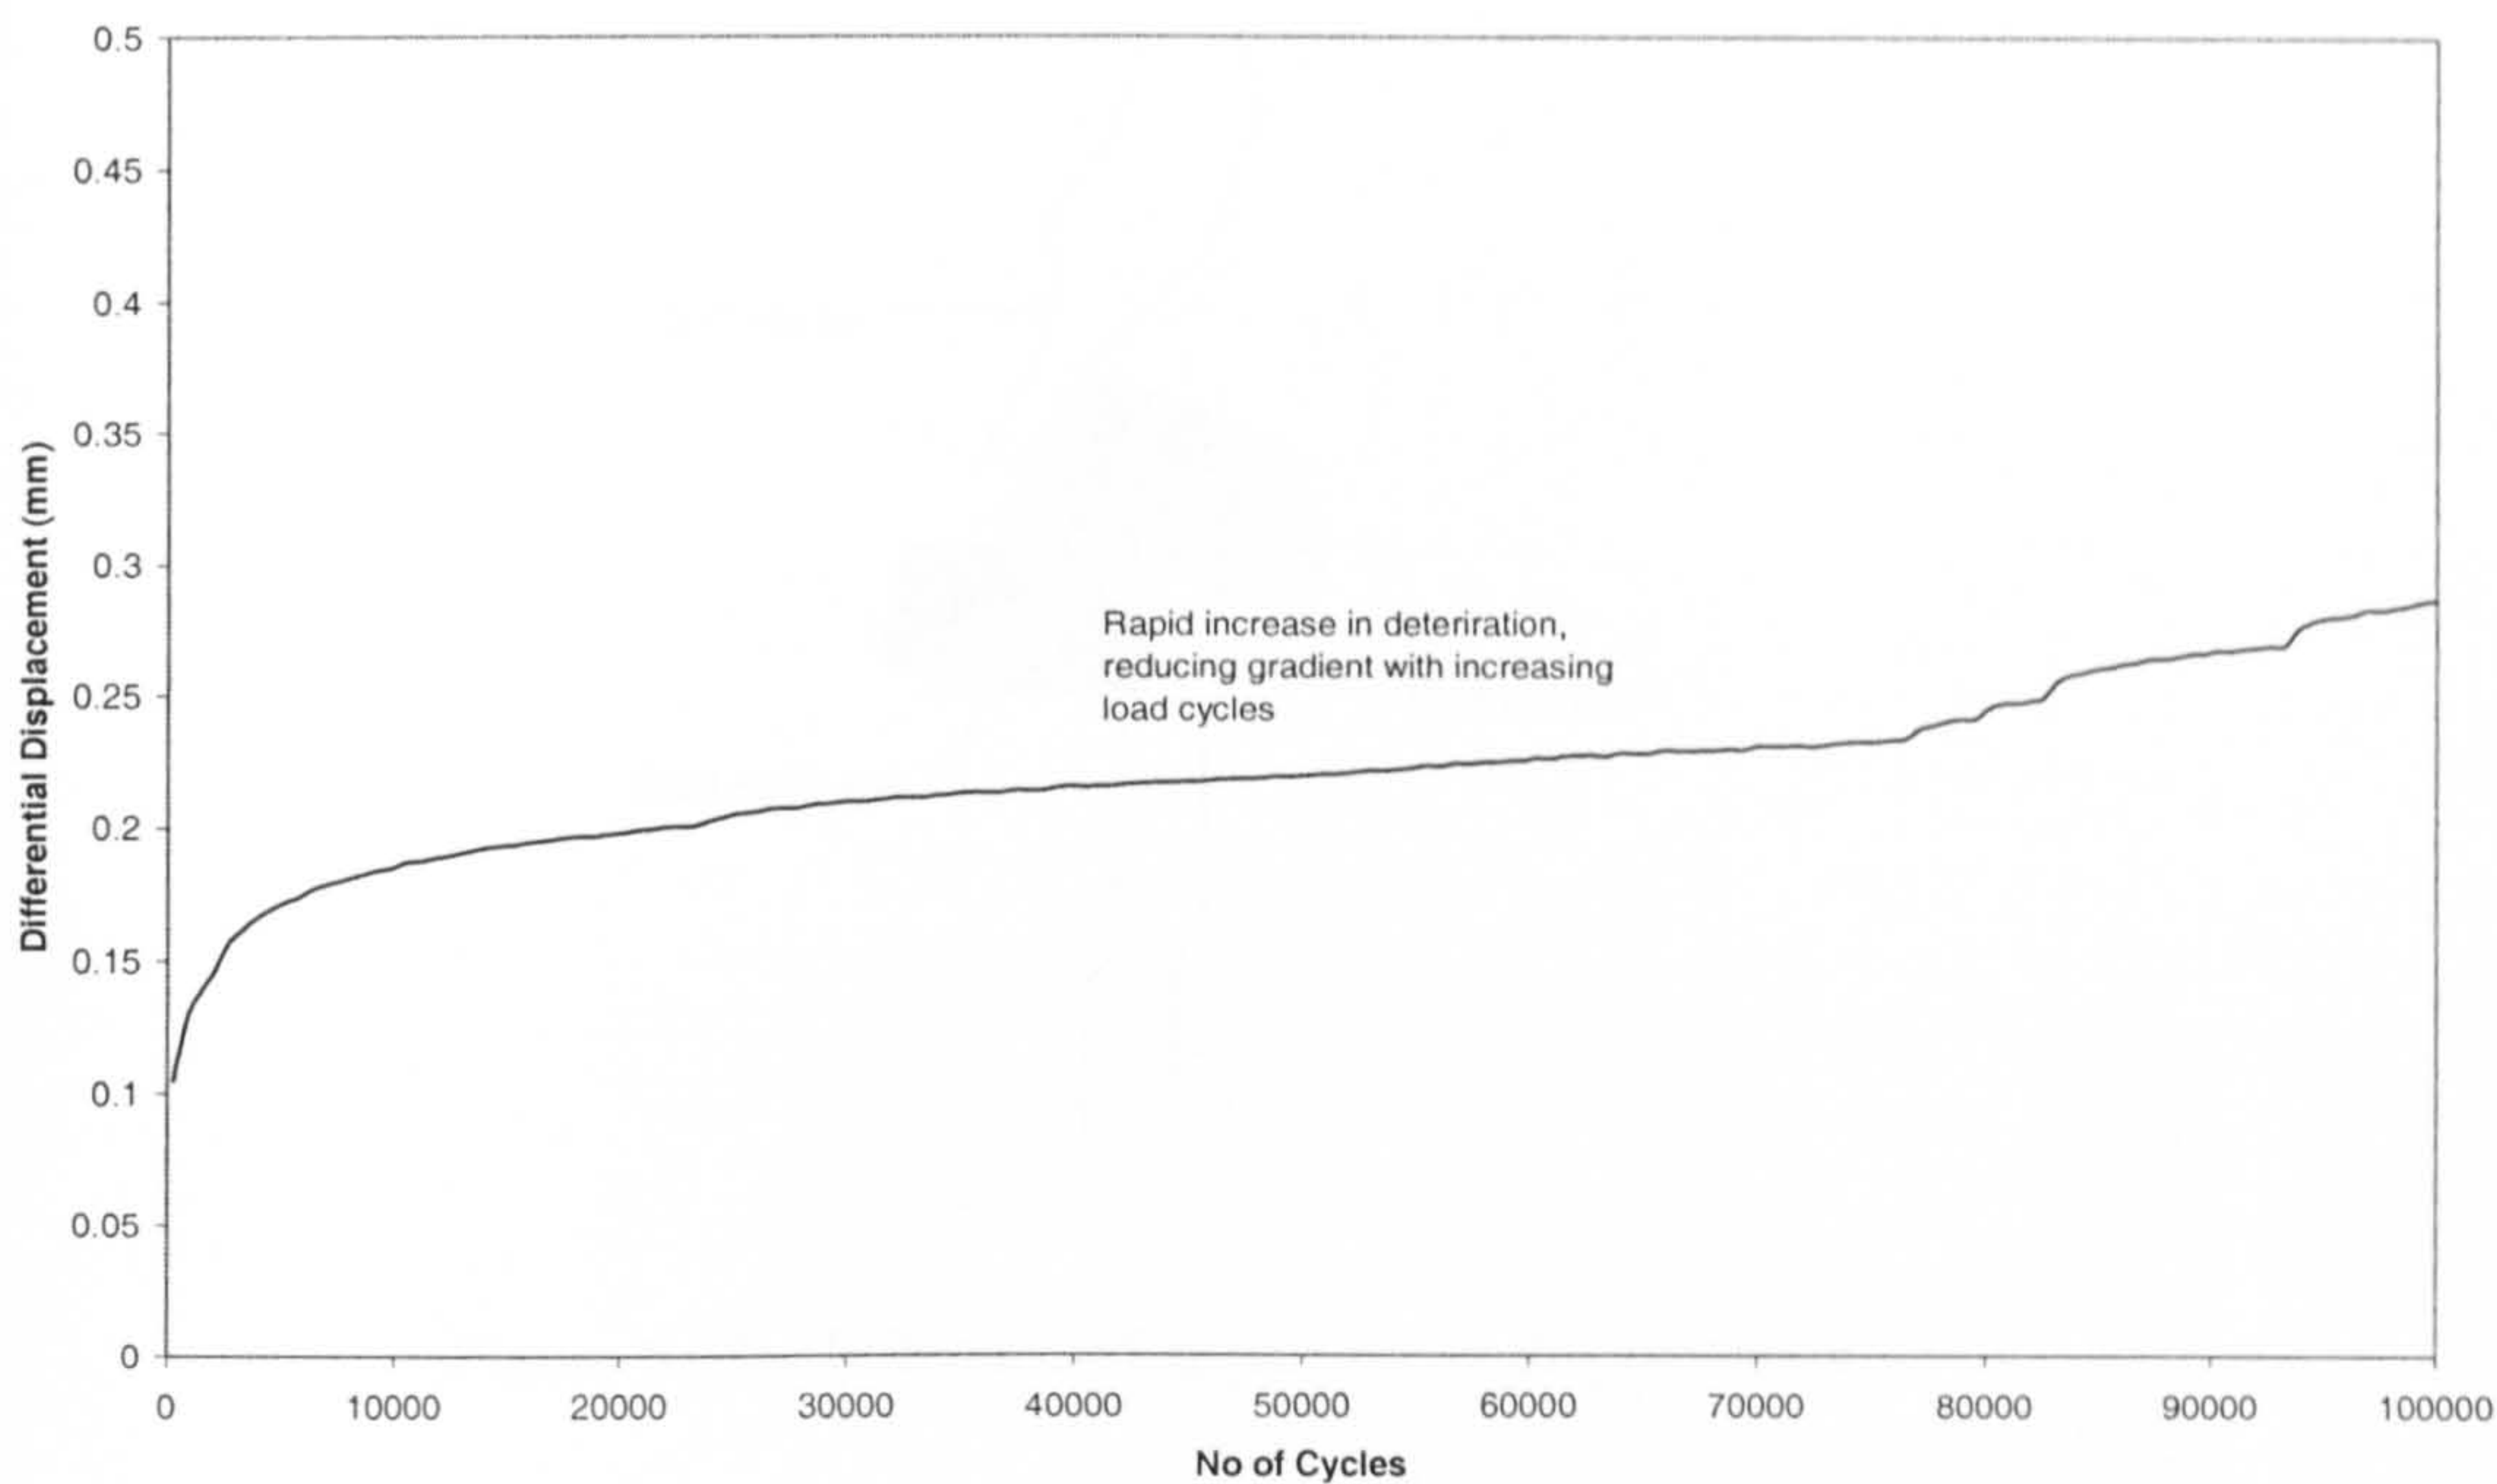
Figure 6.37 – Early deterioration in a concrete test specimen

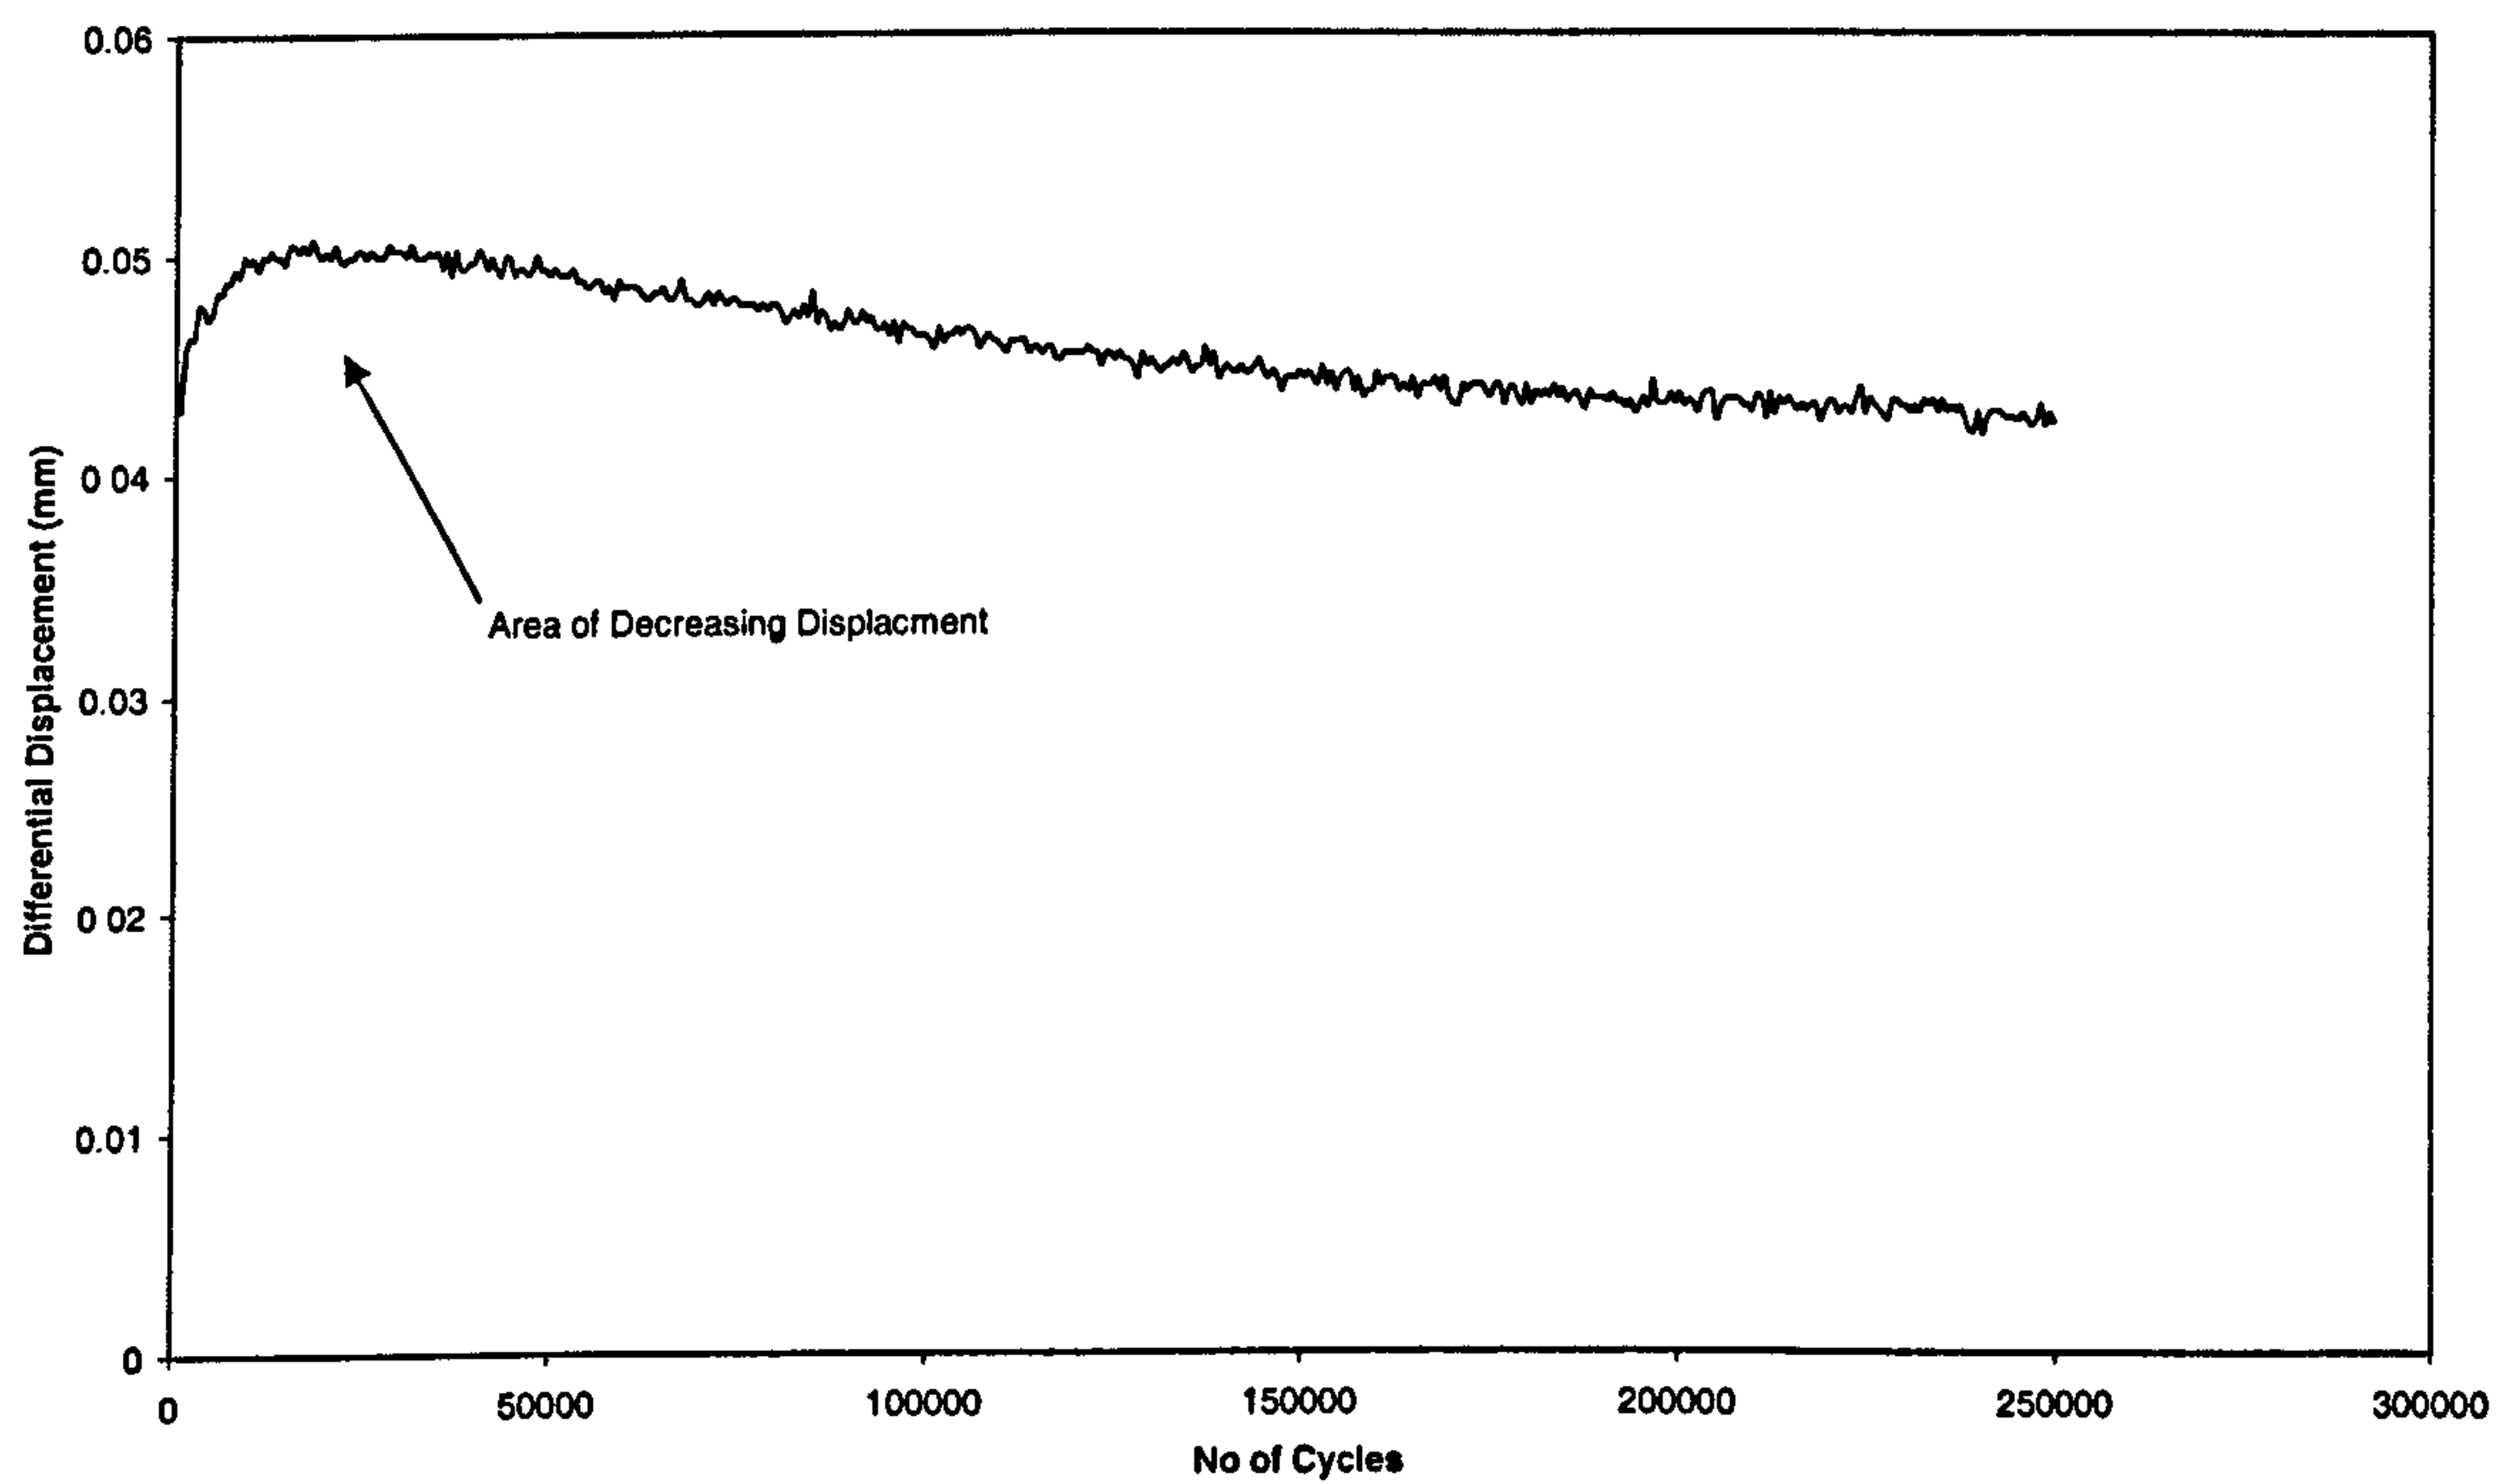
Figure 6.40 – Negative deterioration caused by small material accumulation
