LOAD TRANSFER ACROSS CRACKS AND JOINTS IN CONCRETE SLABS ON GRADE

Stuart John Arnold

**A Doctoral Thesis Submitted in partial fulfilment of the requirements for the
award of
Doctor of Philosophy of Loughborough University**

20th February 2004

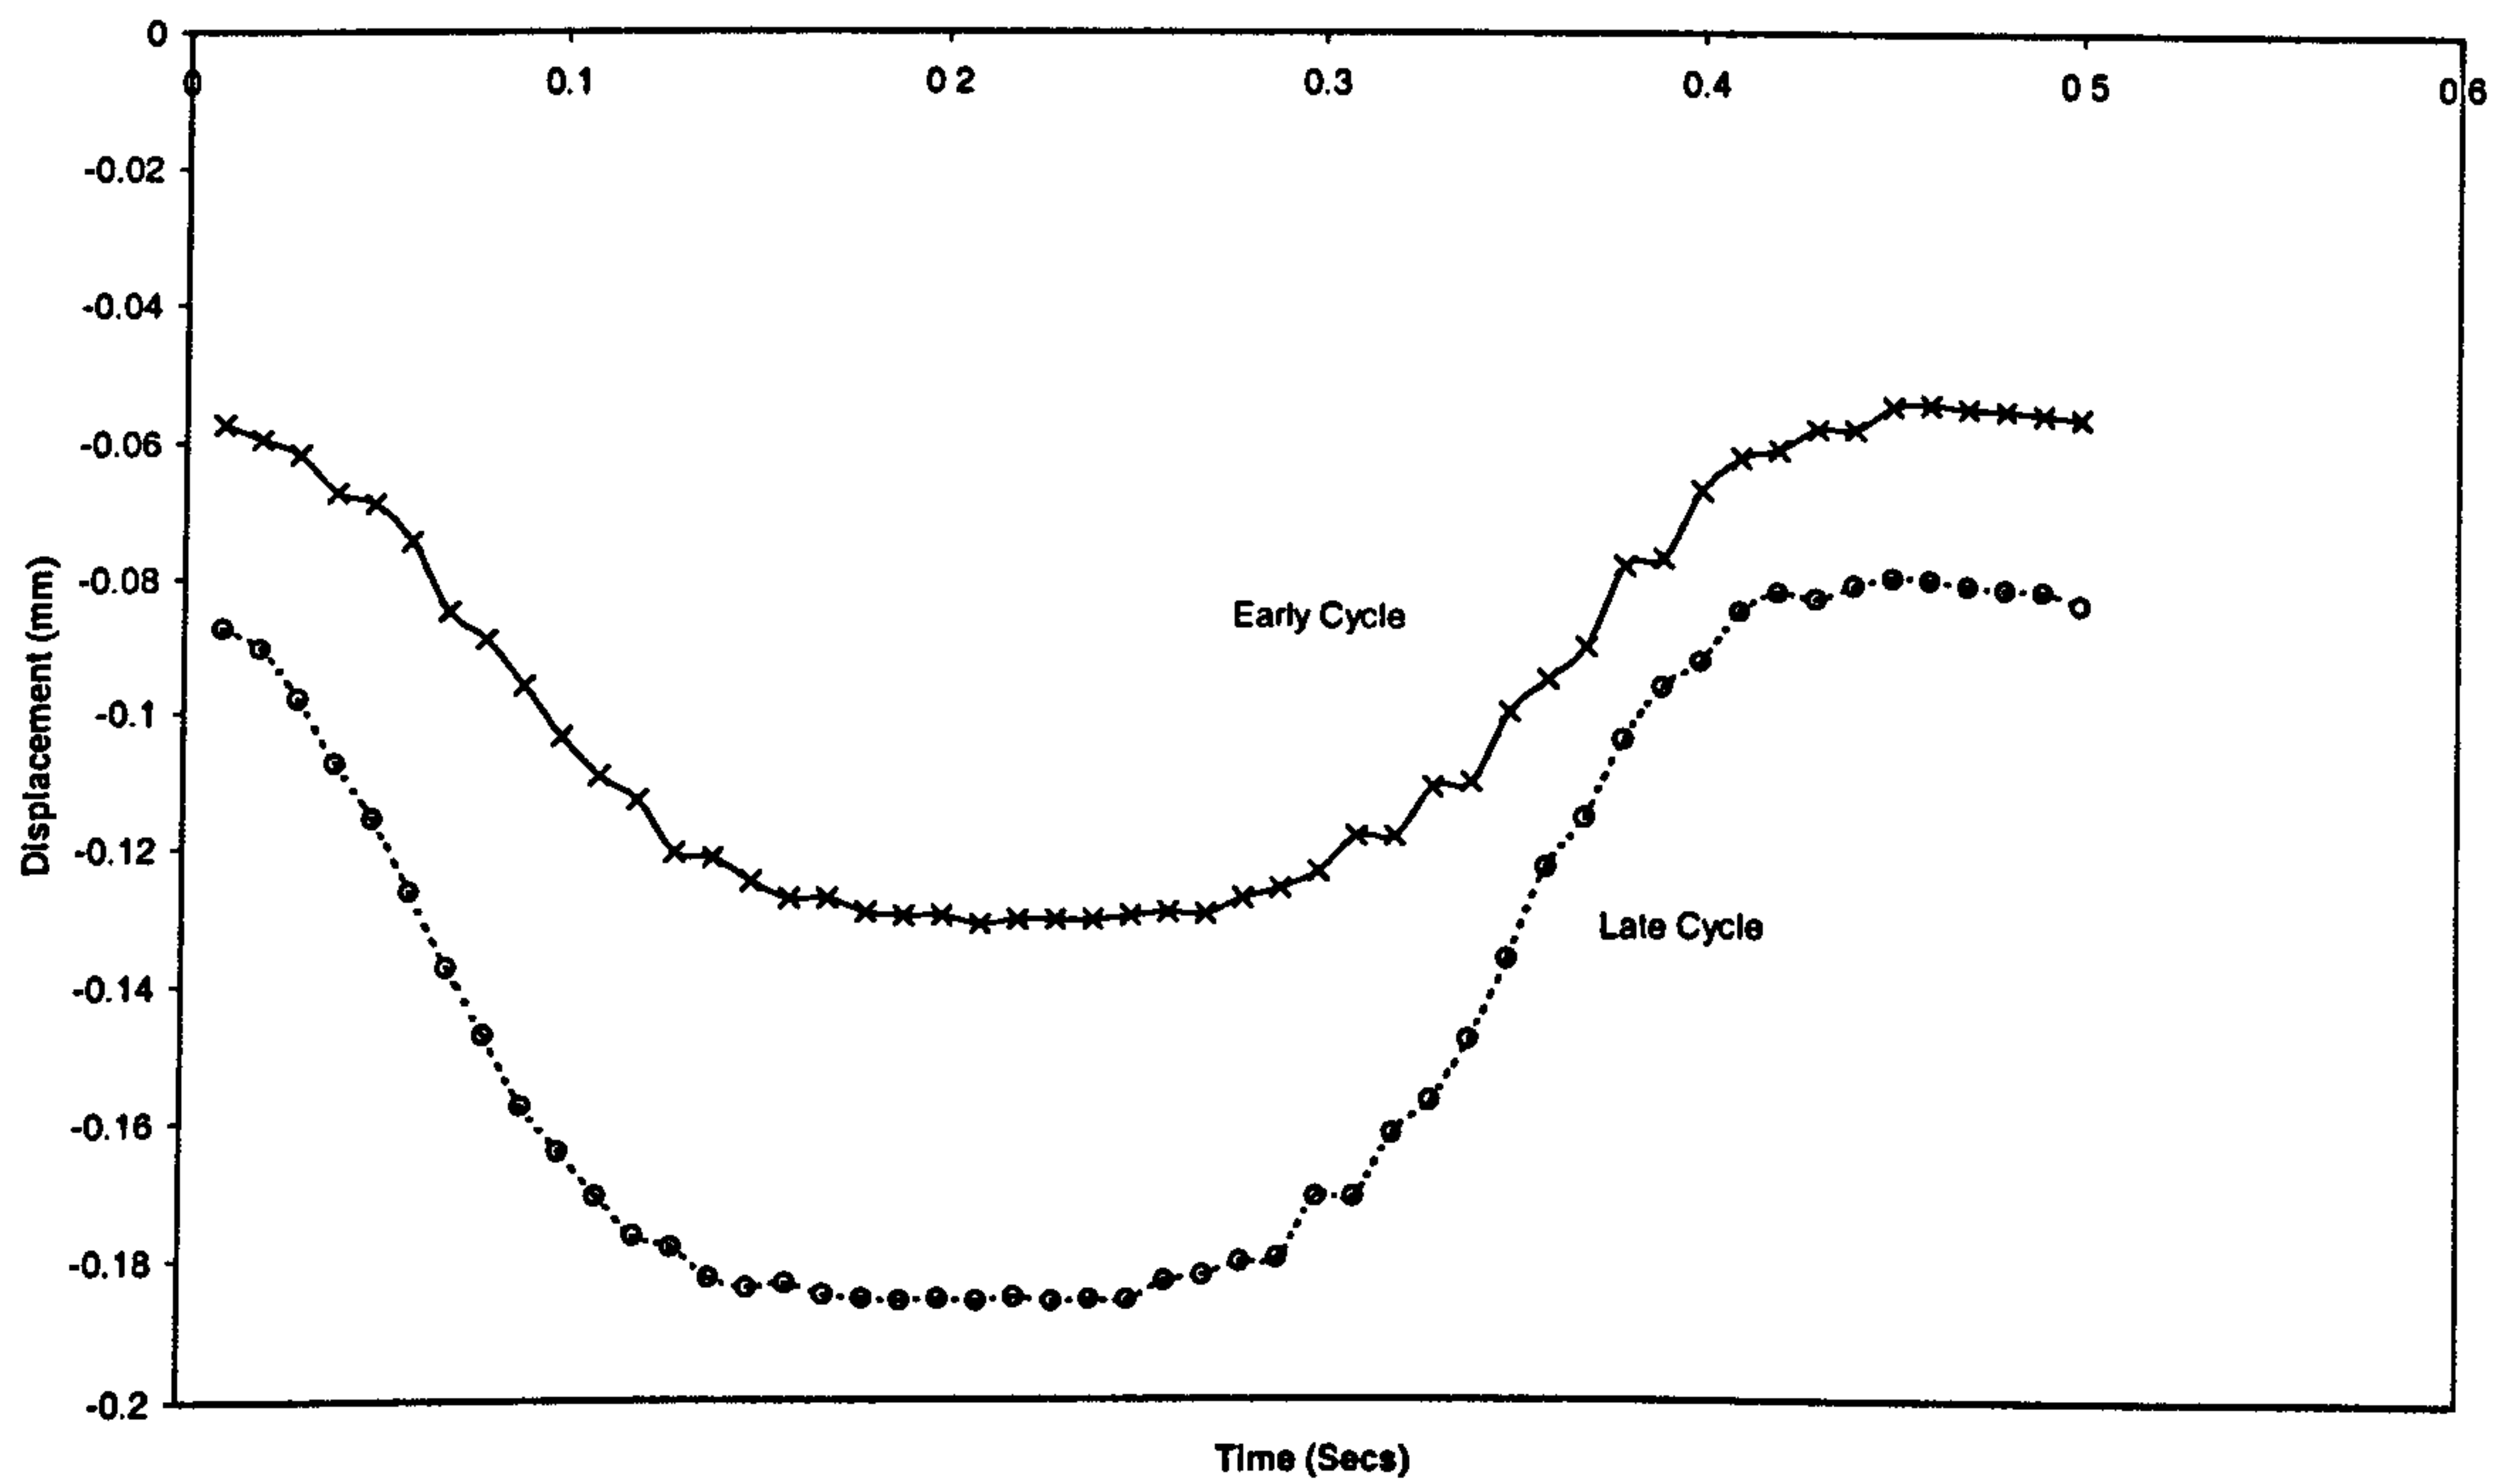
Figure 6.42a – Effect of deterioration on displacement resistance (30kg/m³ steel fibre with 1.98mm crack width)

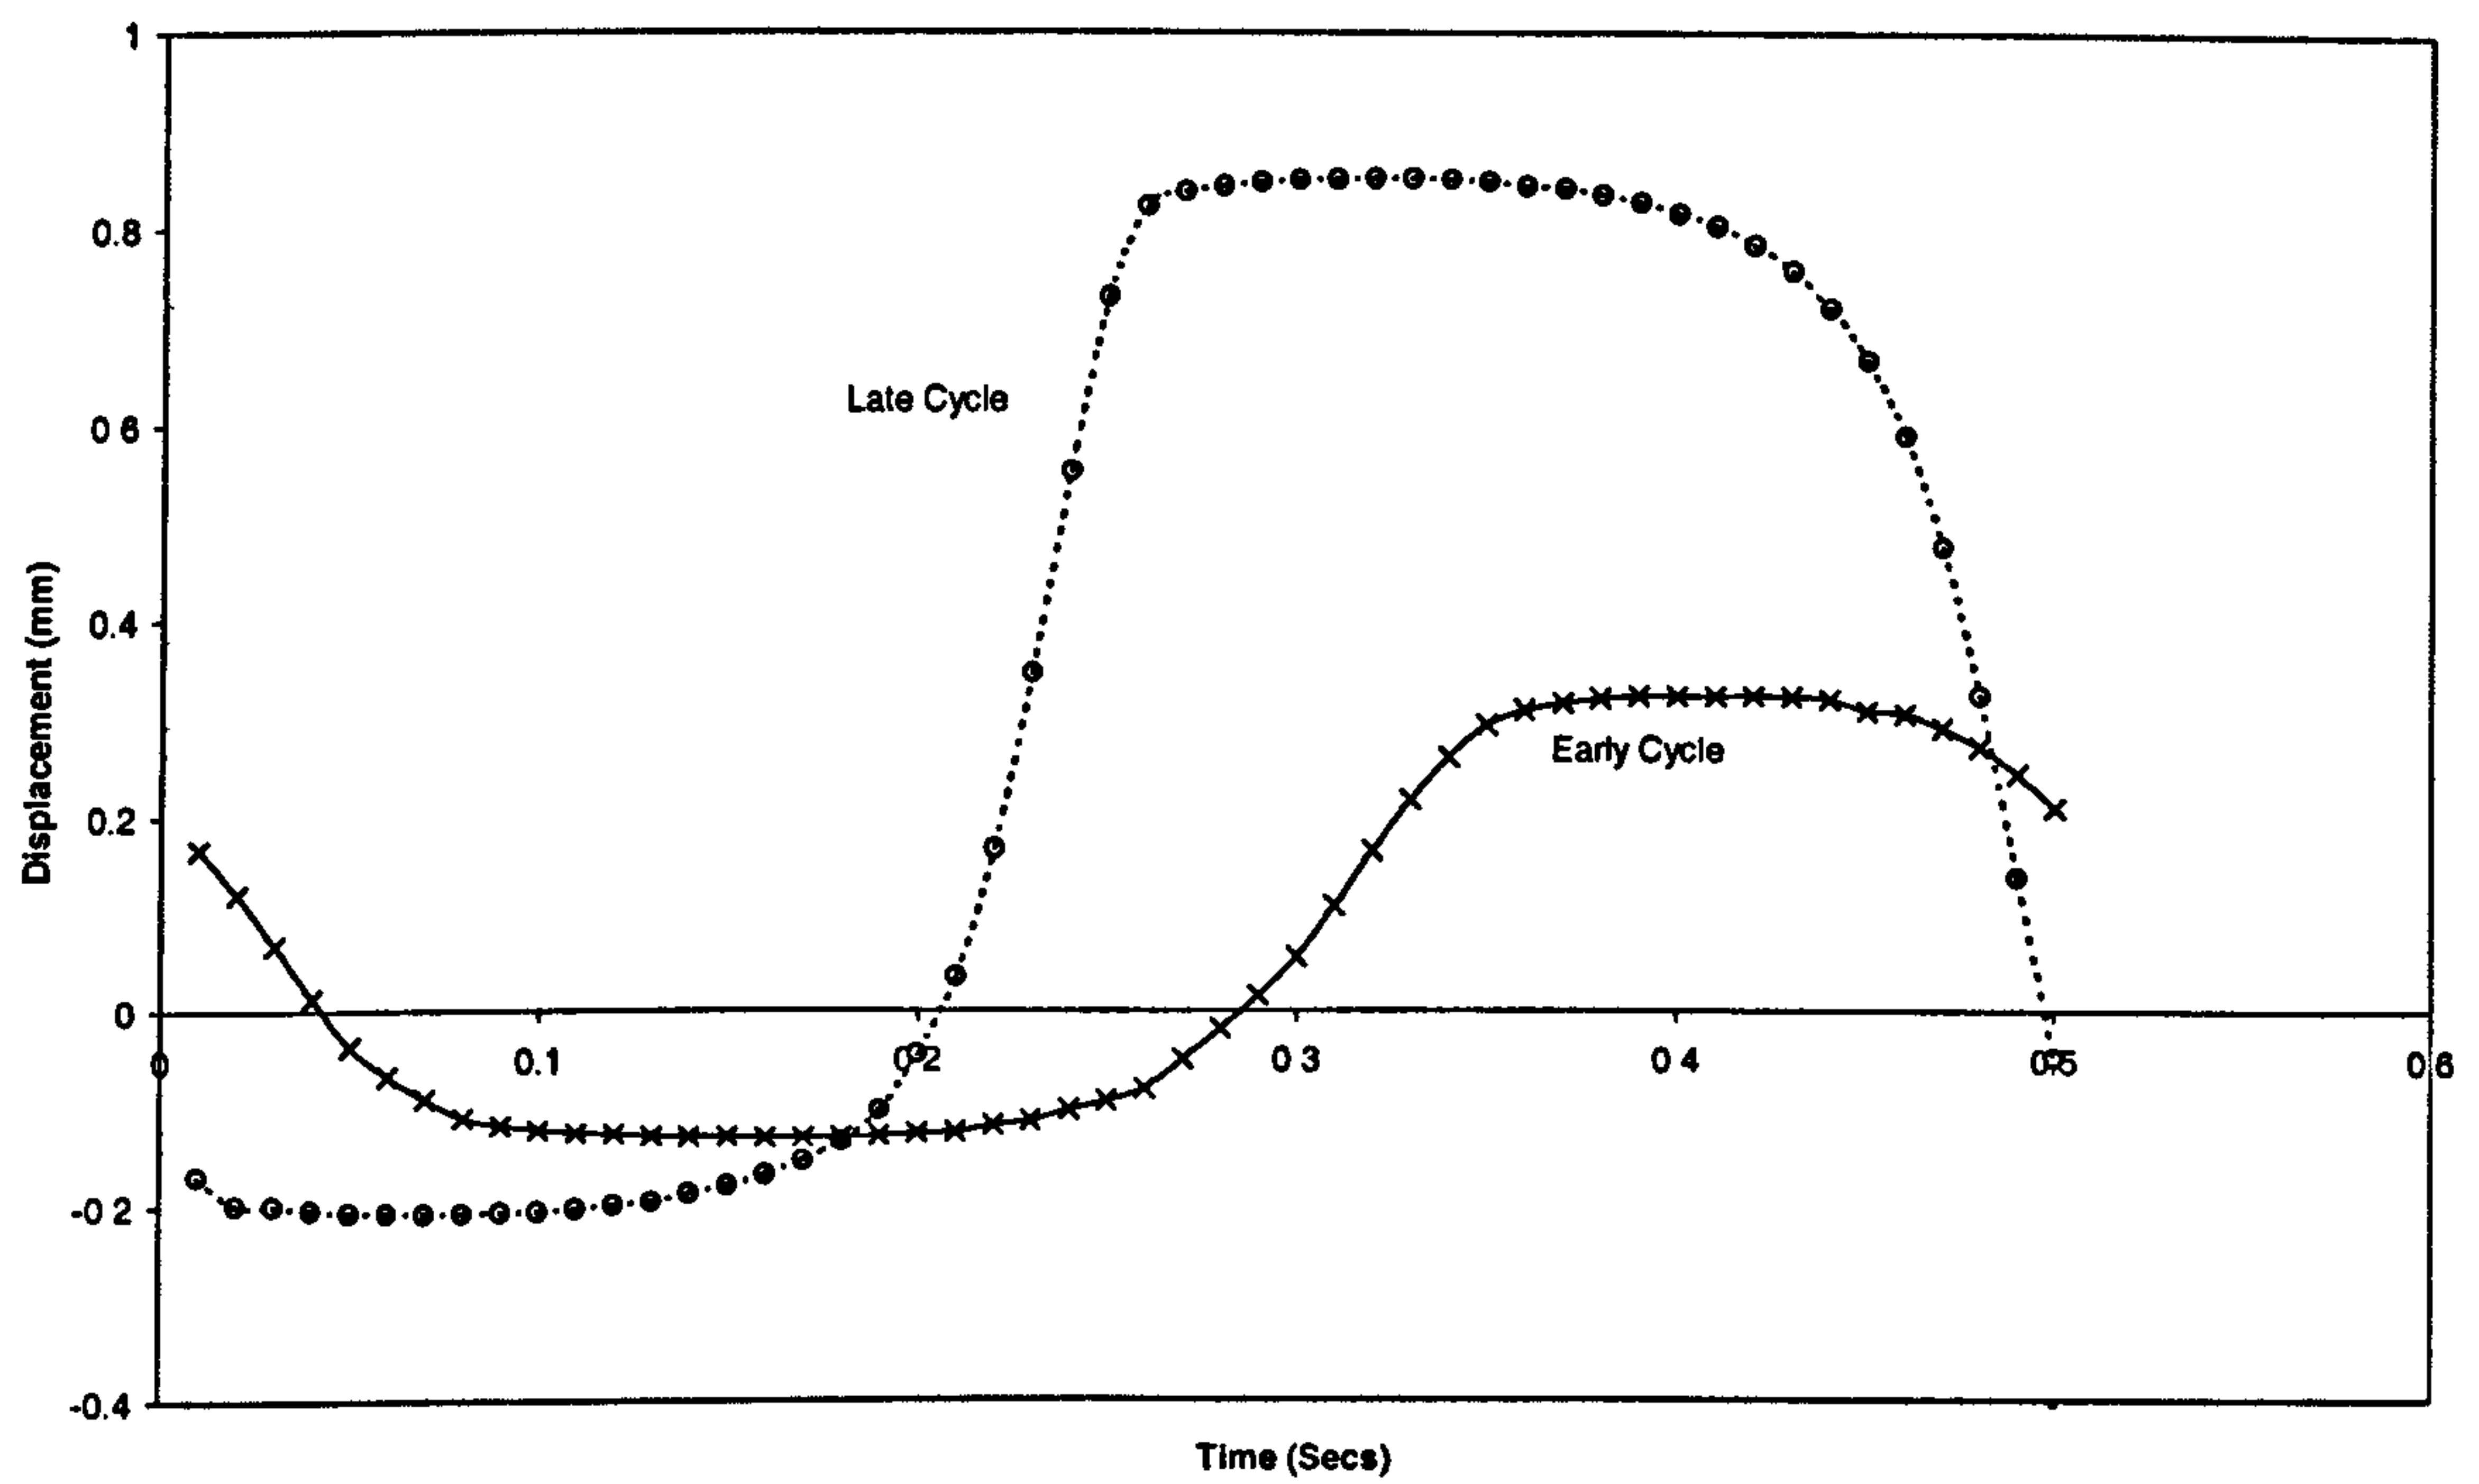
Figure 6.42b – Effect of deterioration on displacement resistance (30kg/m³ steel fibre with 5.94mm crack width)

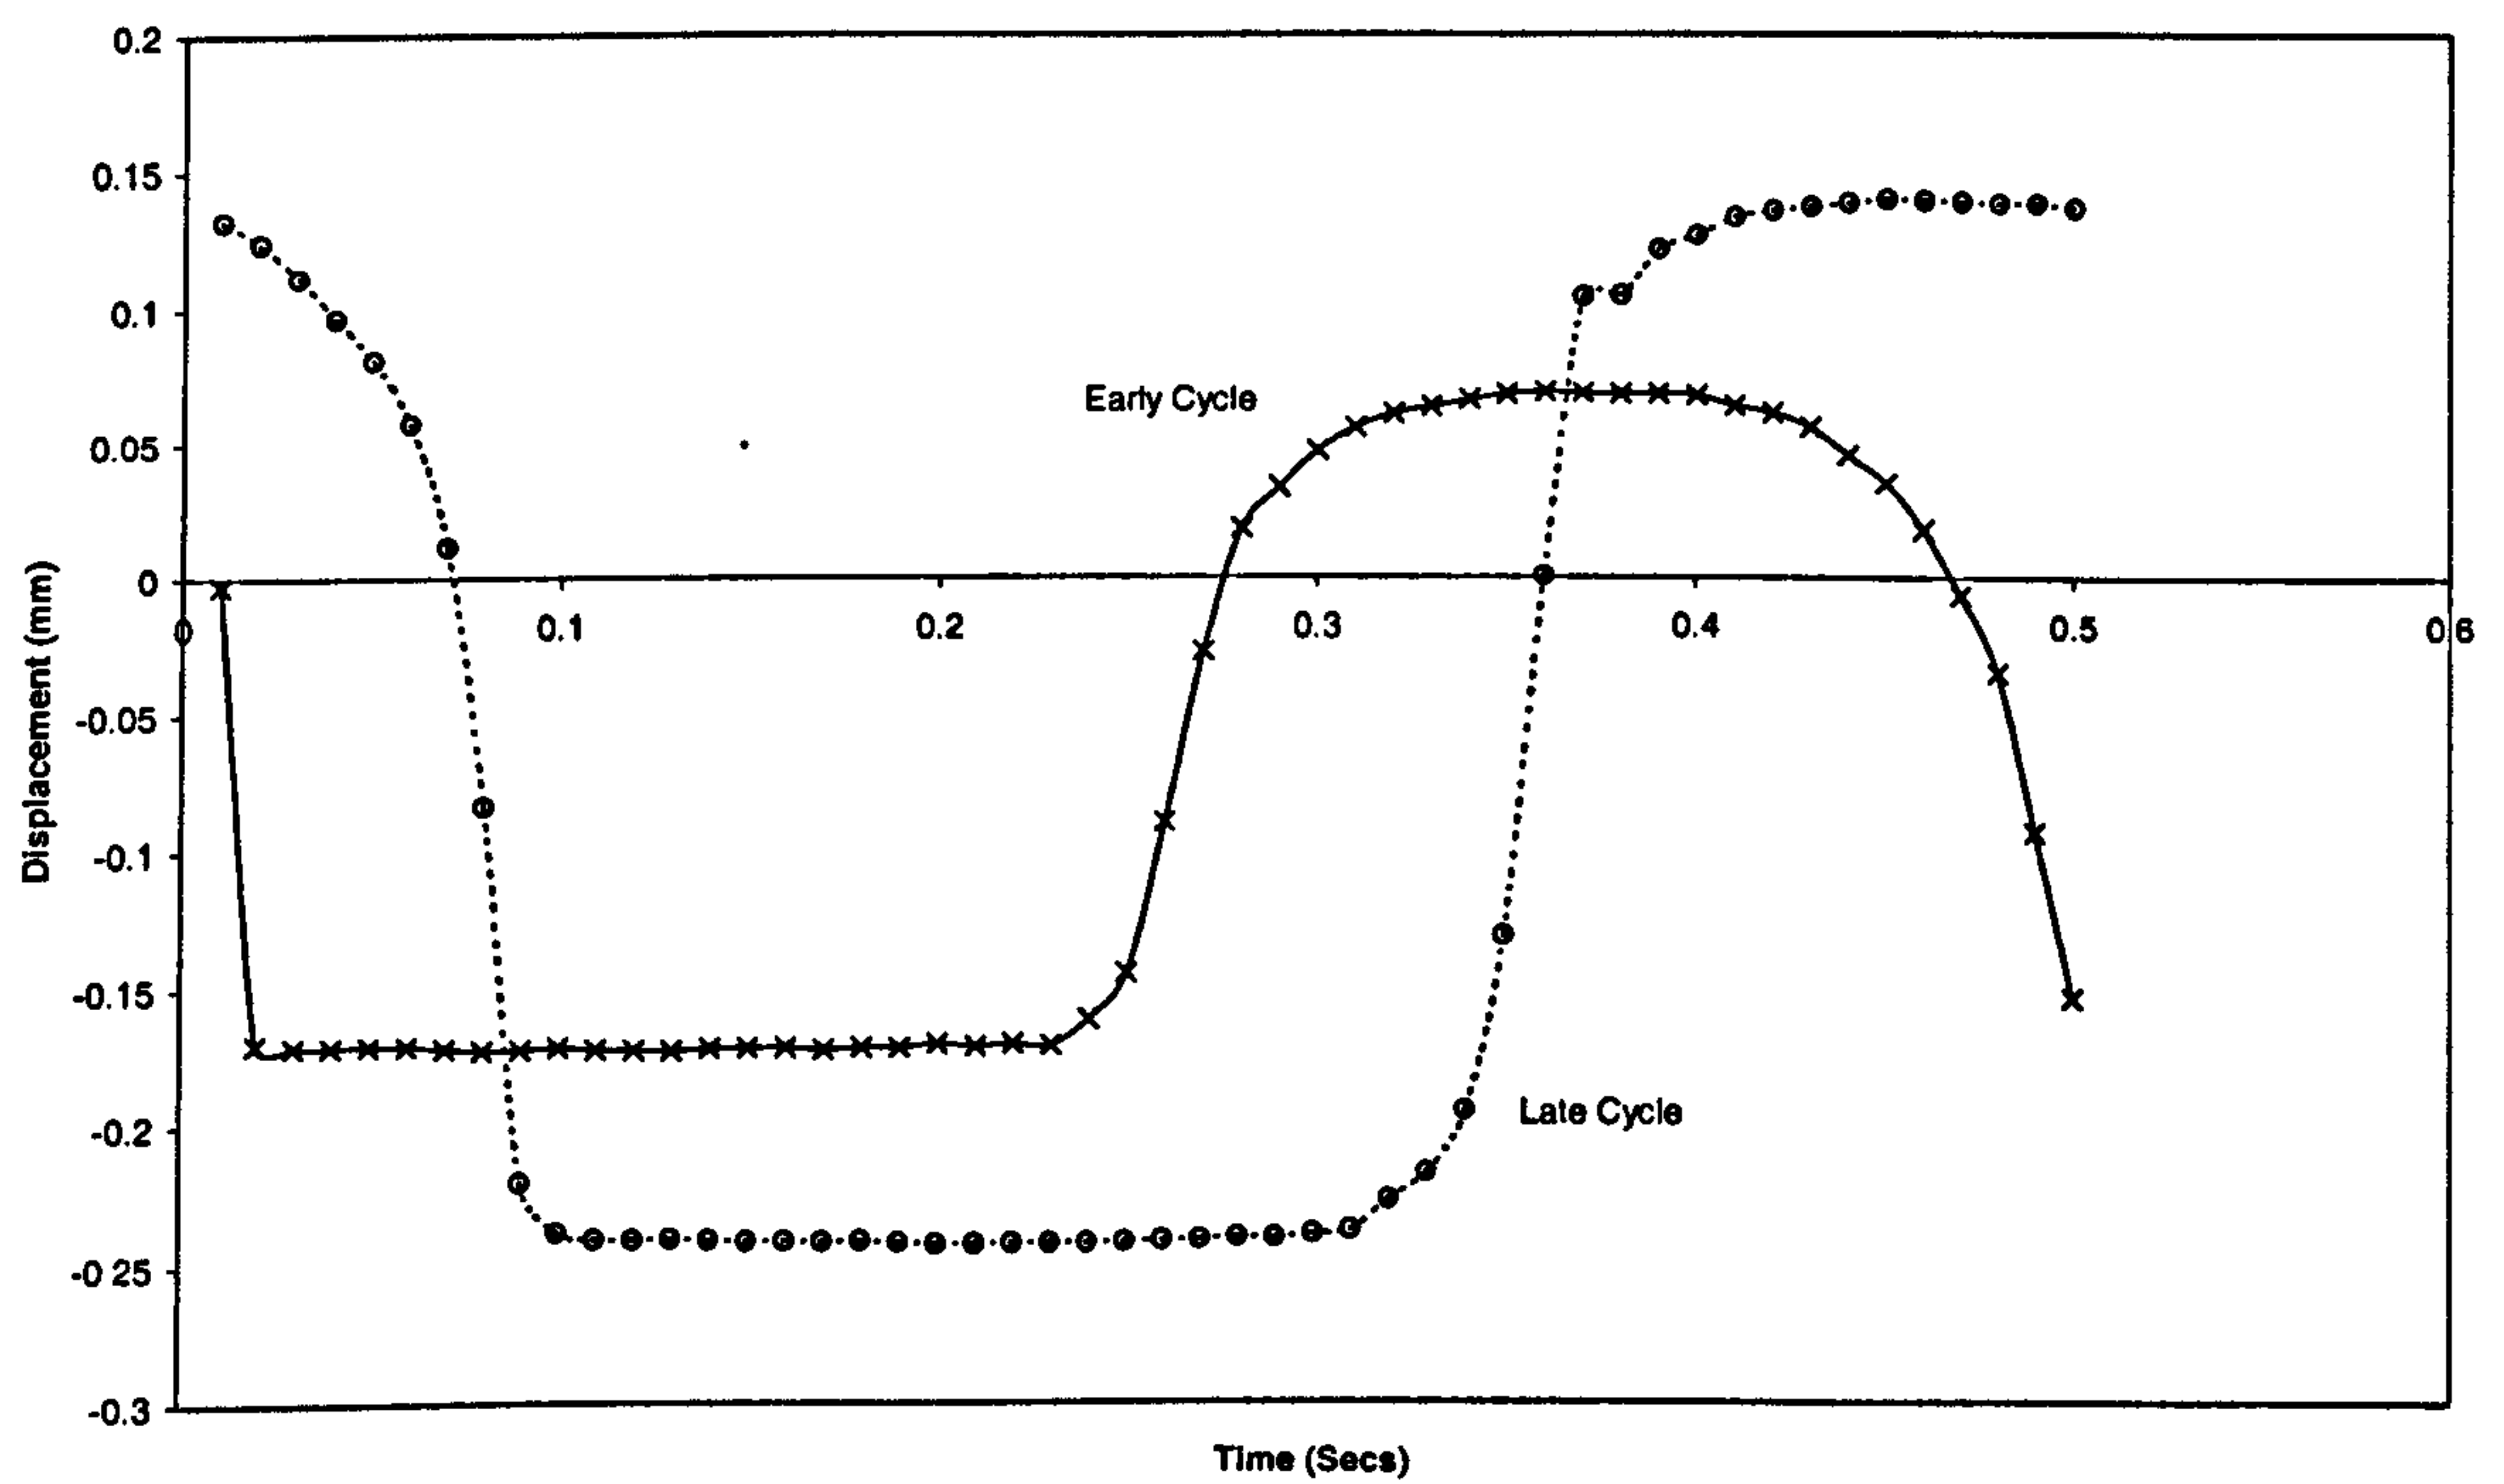
Figure 6.43a – Effect of deterioration on displacement resistance (non-reinforced with 0.66mm crack width)

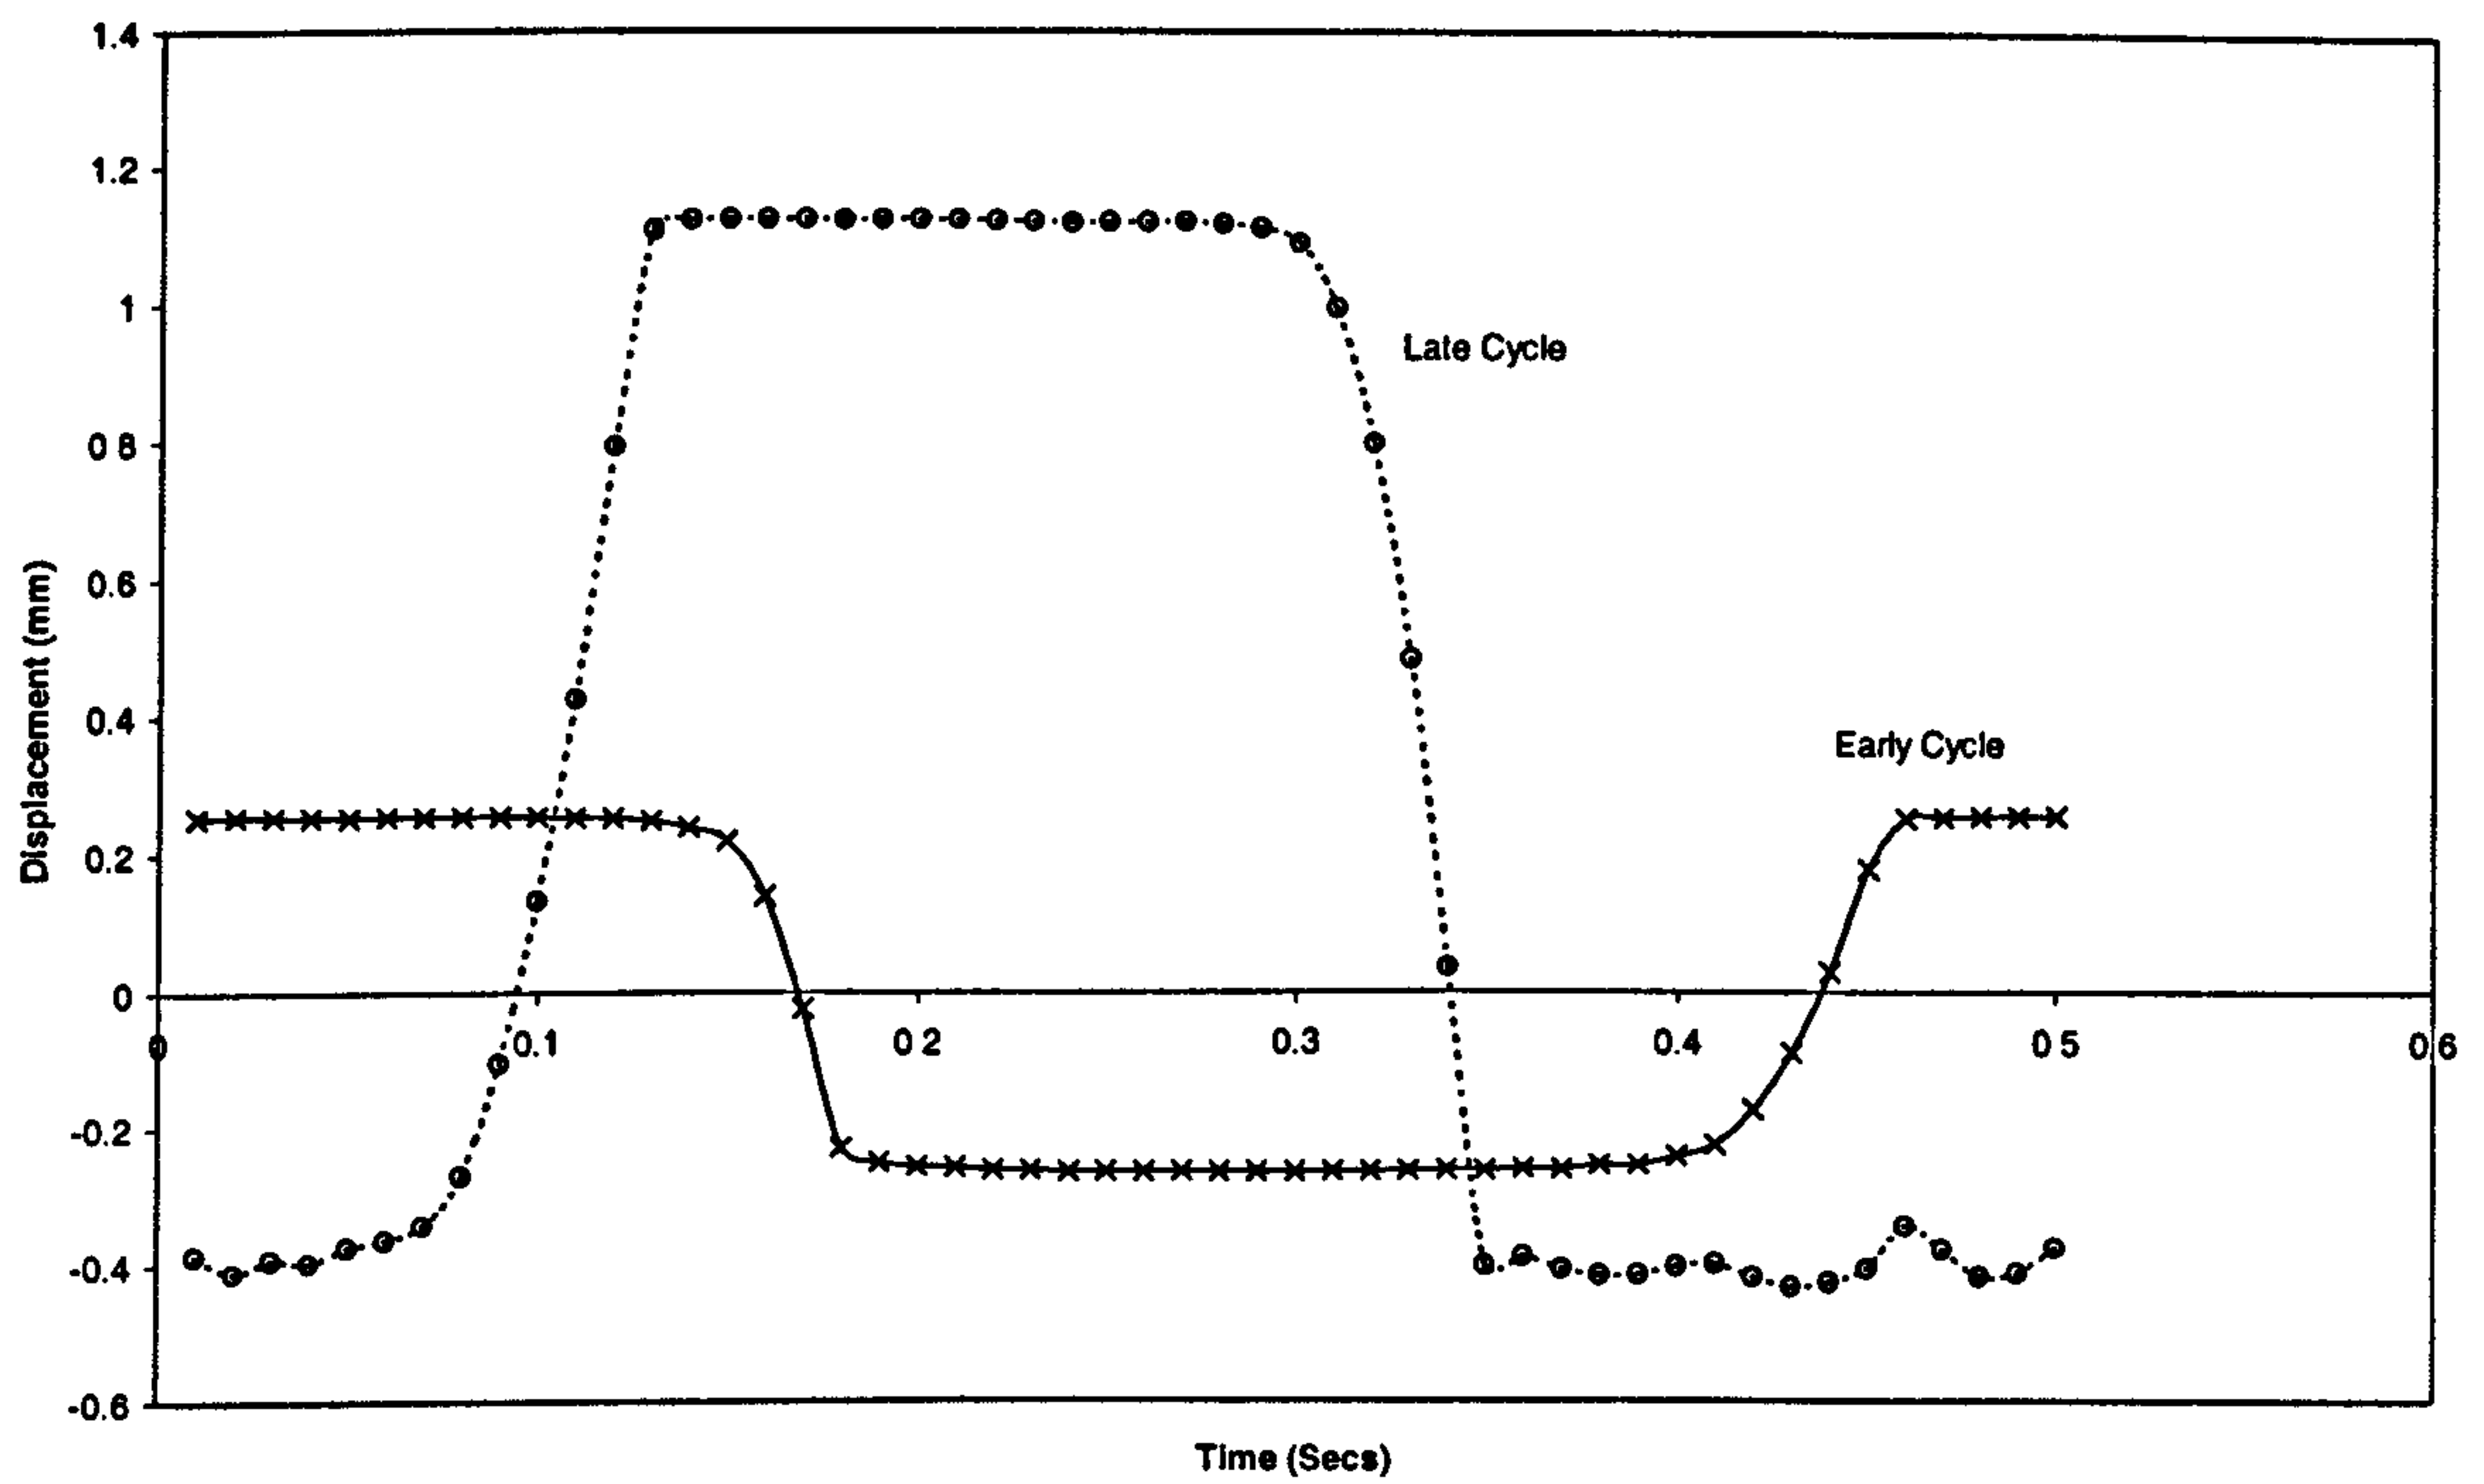
Figure 6.43b – Effect of deterioration on displacement resistance (non-reinforced with 1.98mm crack width)

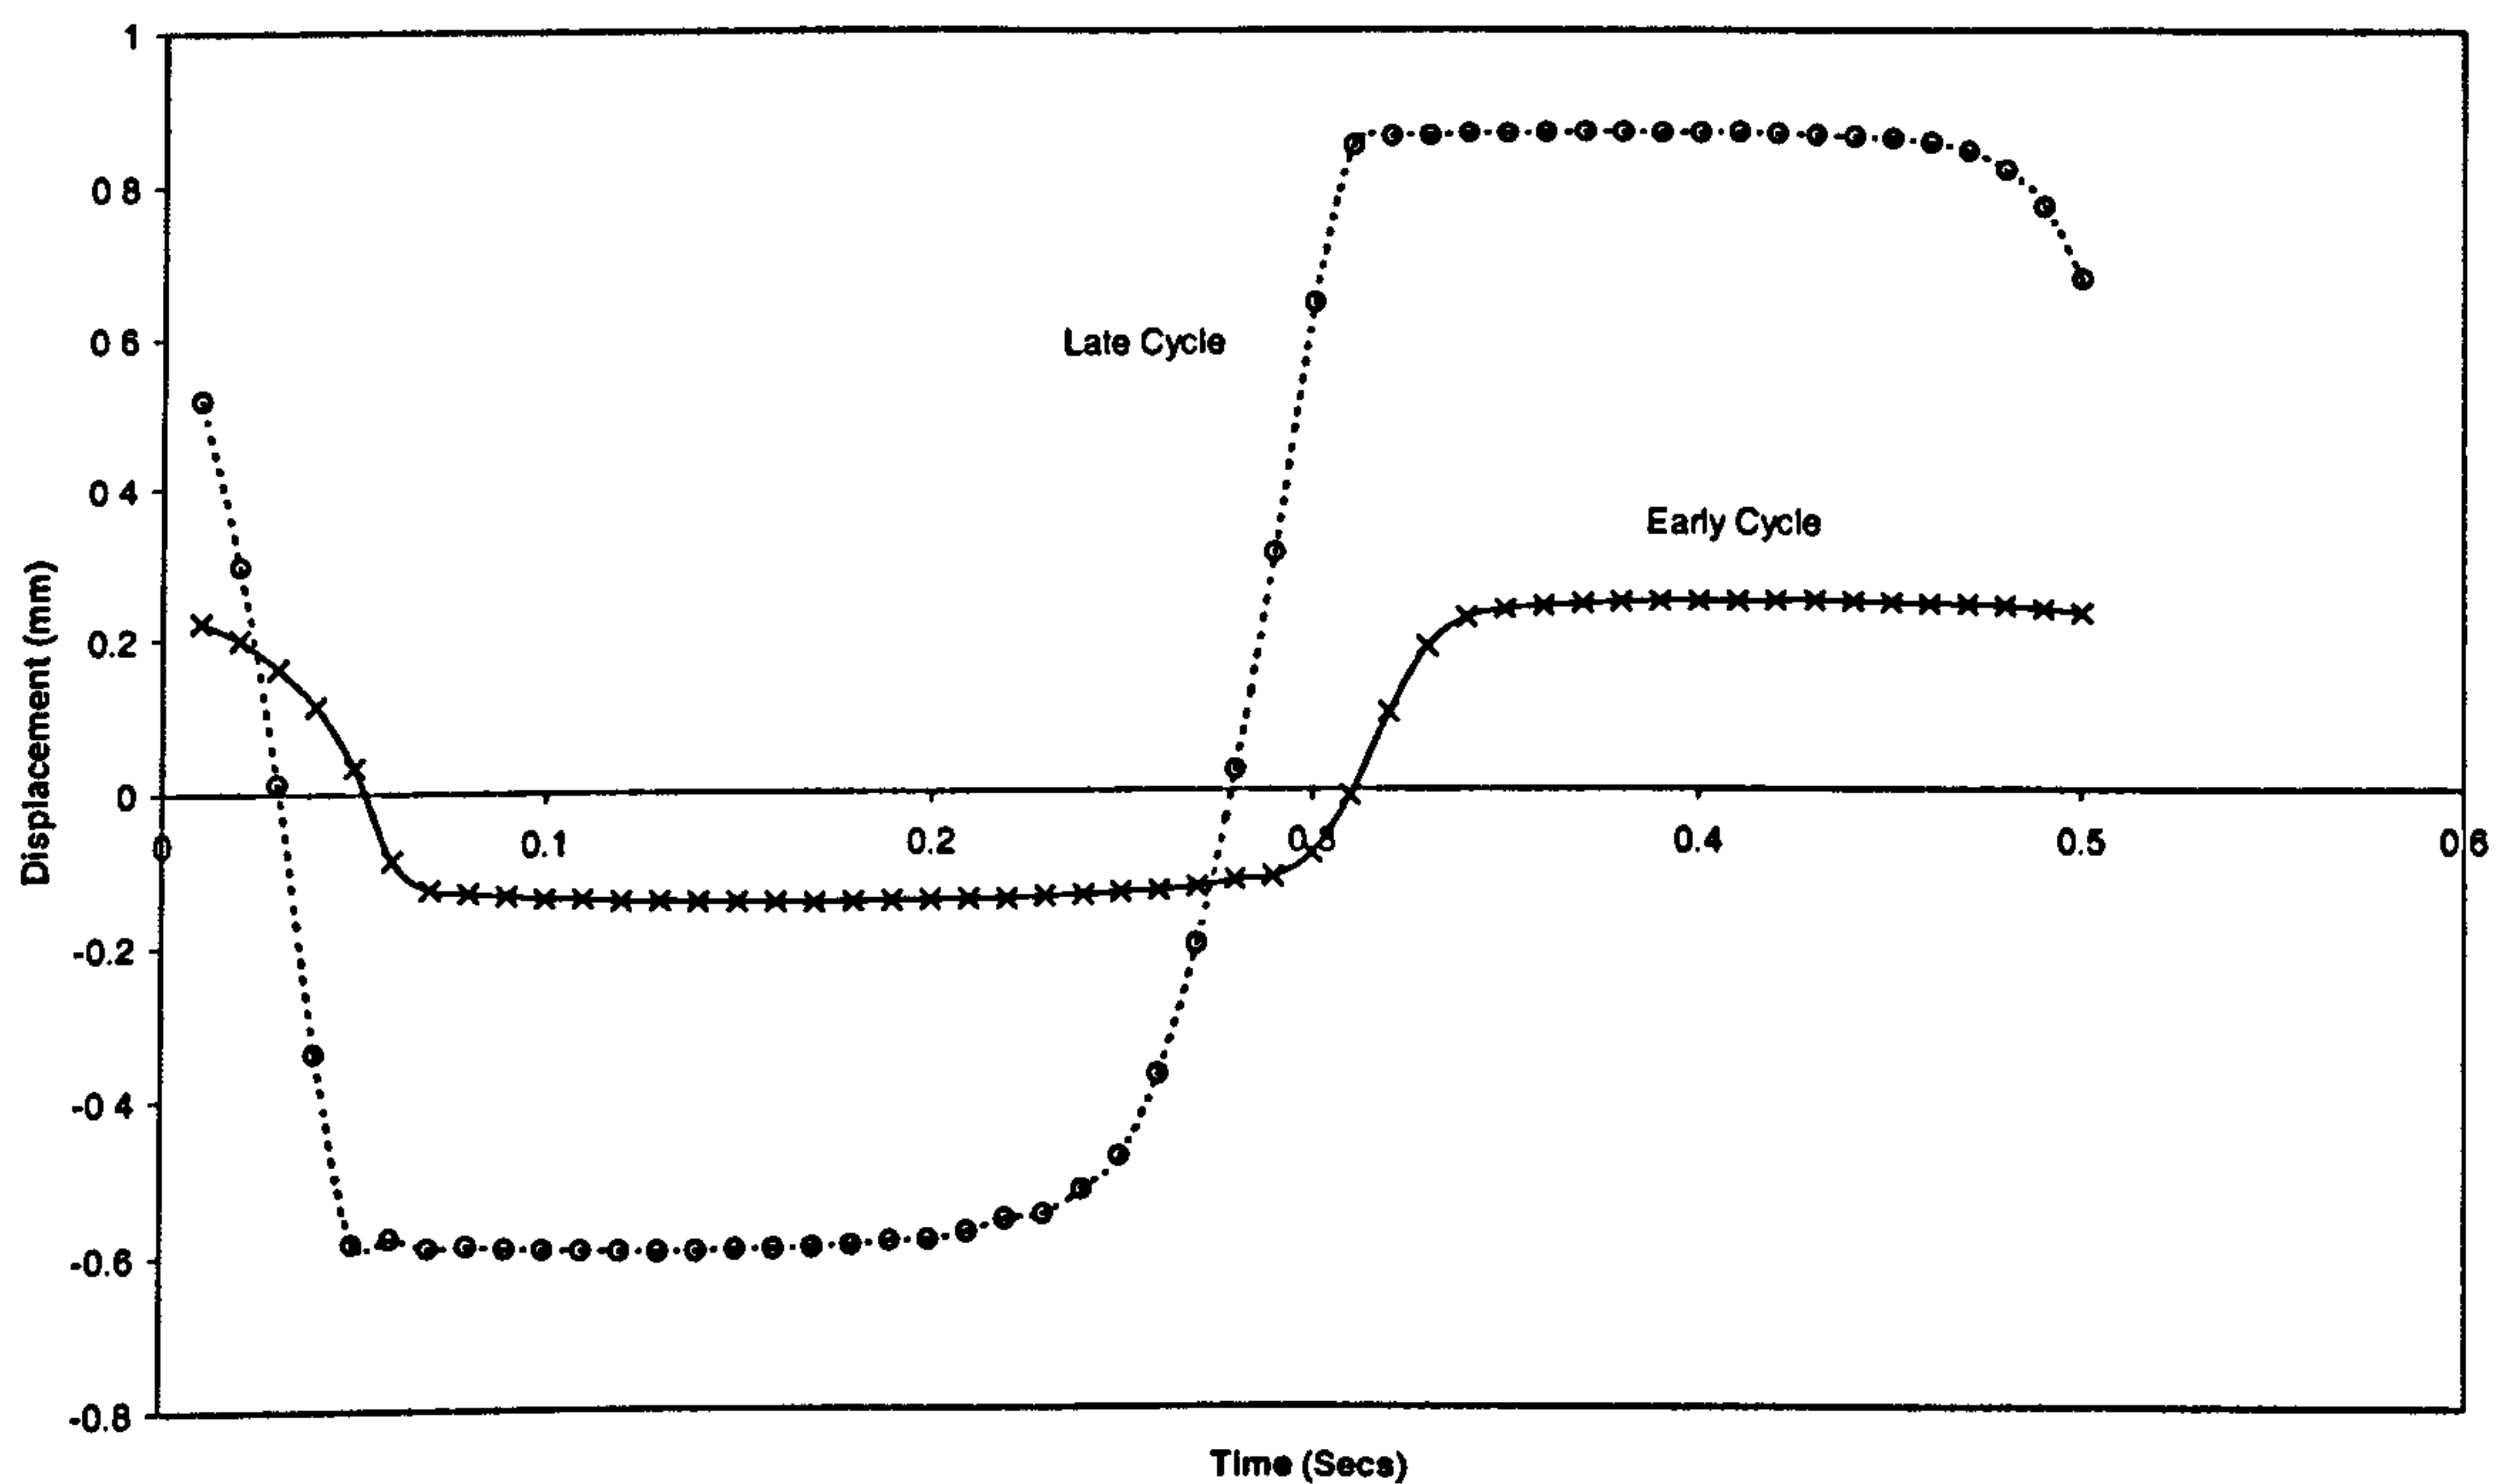
Figure 6.44 – Effect of deterioration on displacement resistance (mortar with 0.66mm crack width)

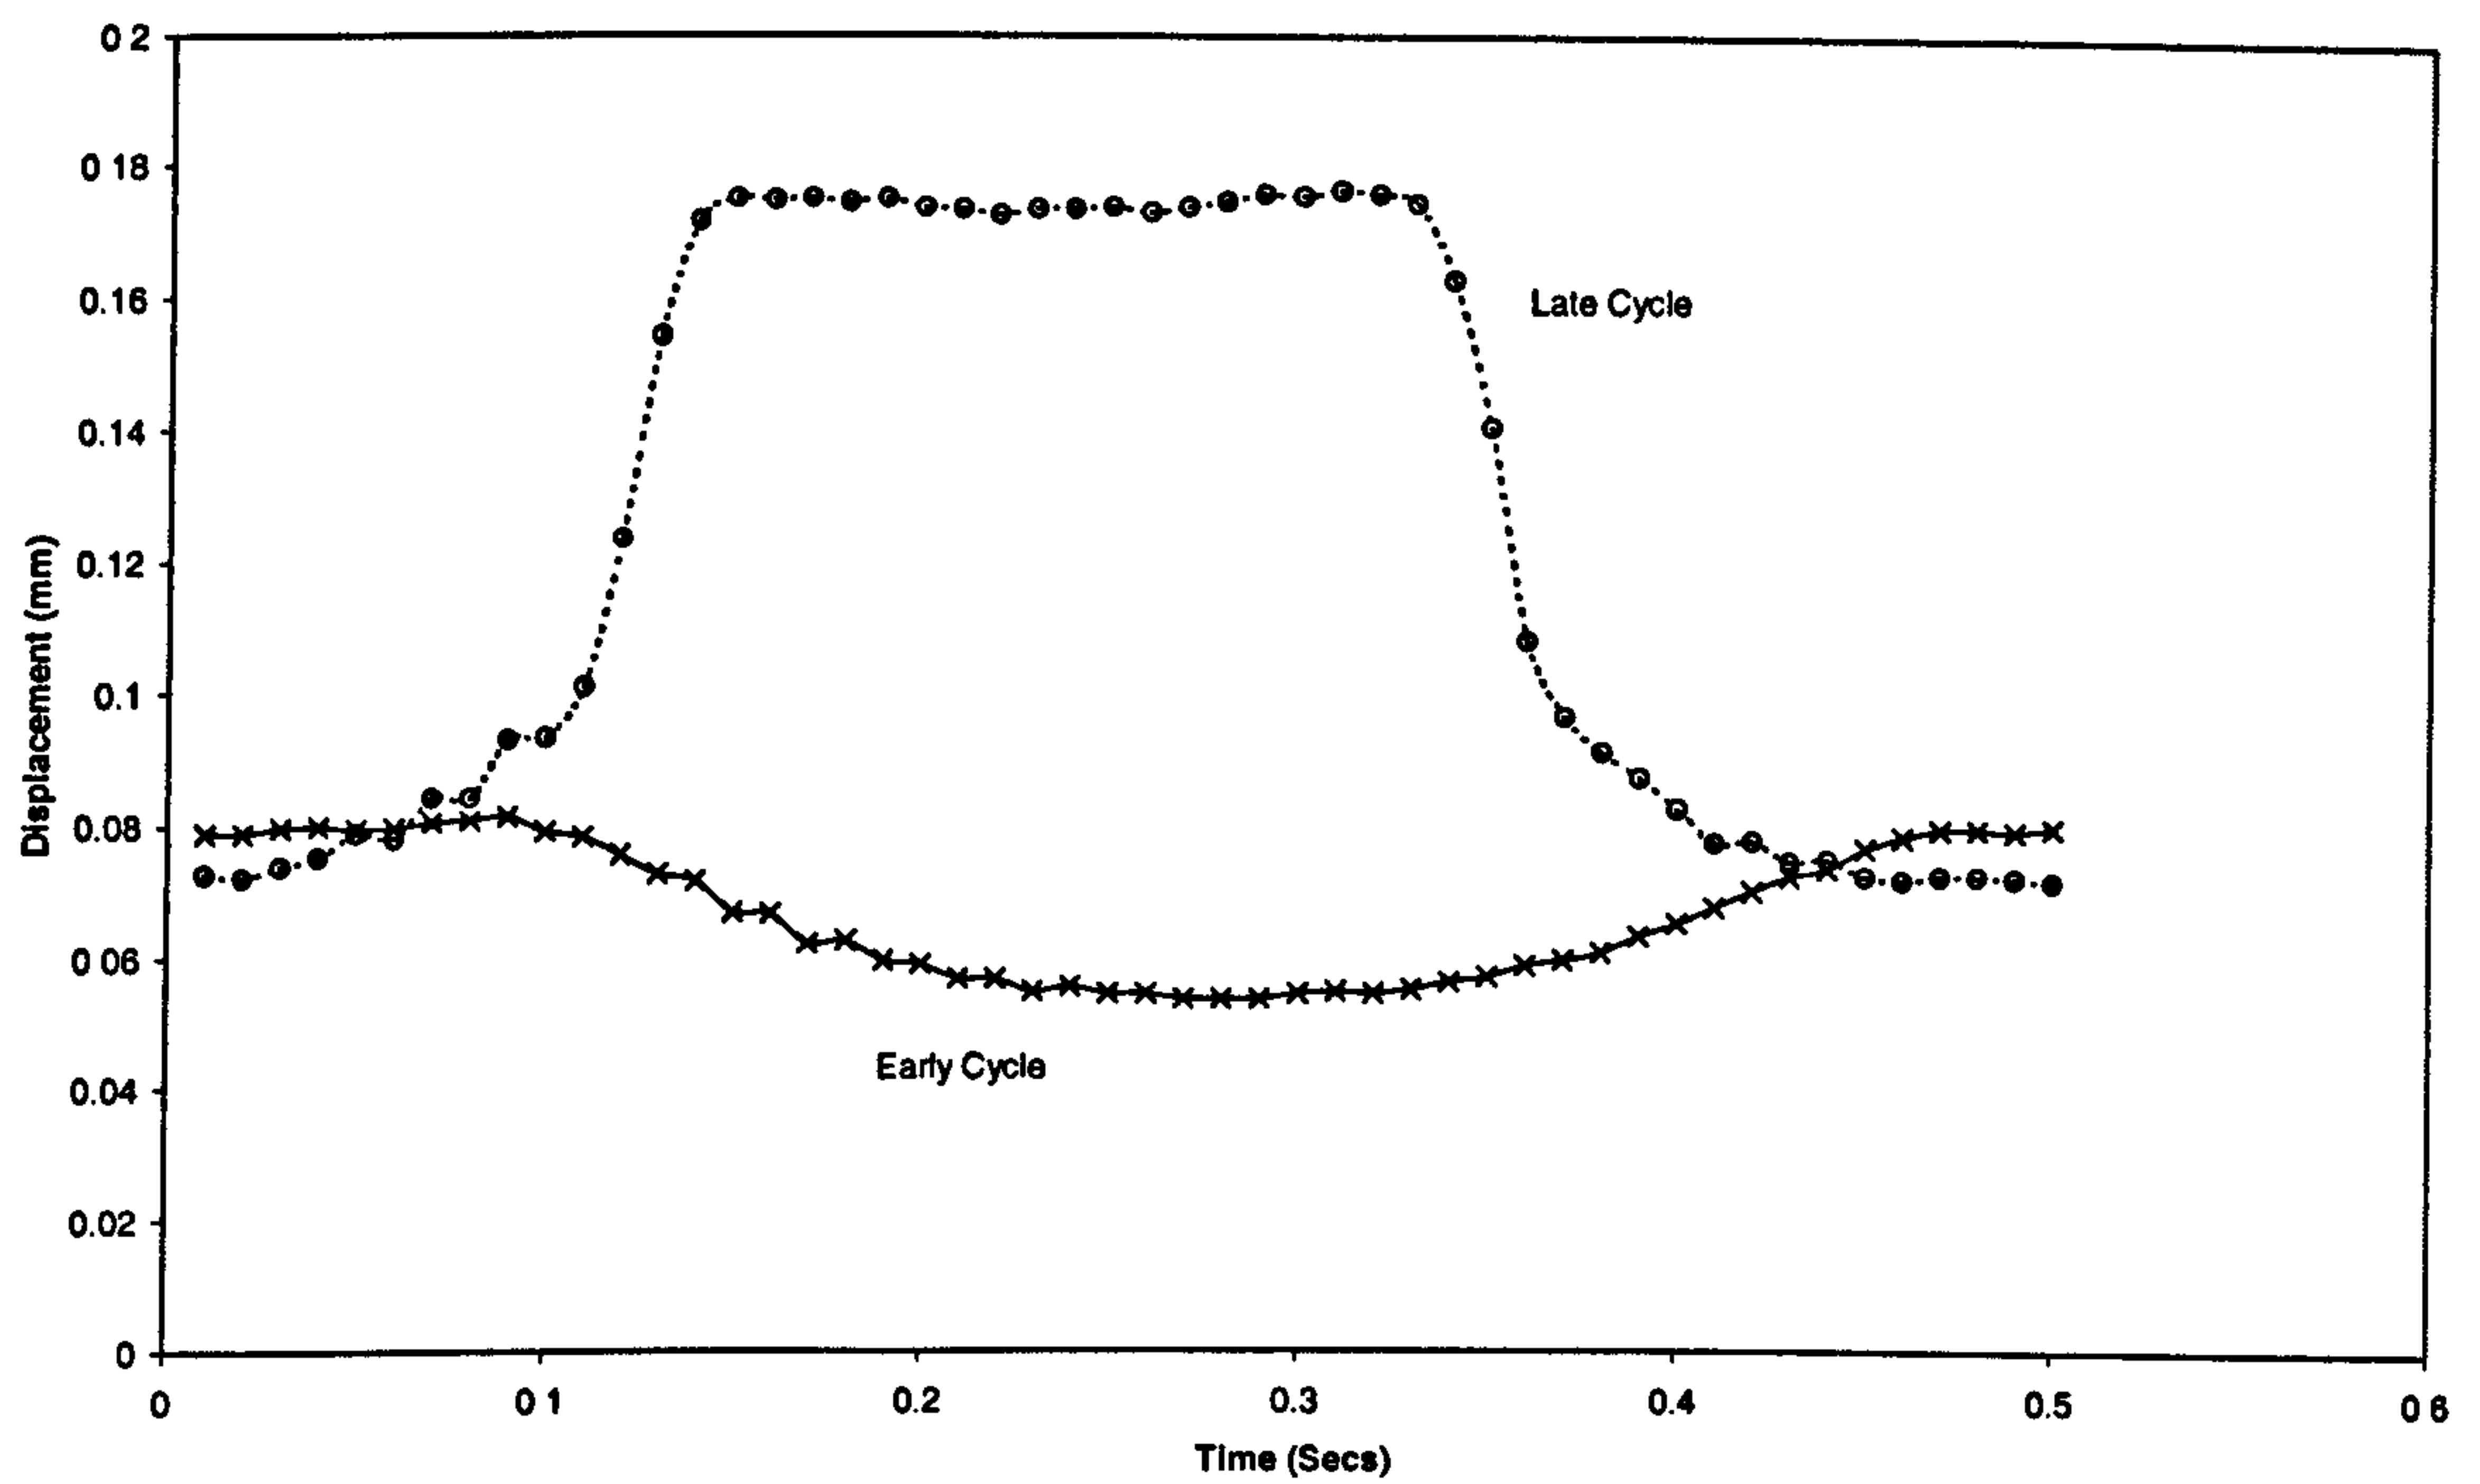
Figure 6.47a – Effect of deterioration on displacement resistance (20kg/m³ steel fibre with 0.66mm crack width)
