LOAD TRANSFER ACROSS CRACKS AND JOINTS IN CONCRETE SLABS ON GRADE

Stuart John Arnold

**A Doctoral Thesis Submitted in partial fulfilment of the requirements for the
award of
Doctor of Philosophy of Loughborough University**

20th February 2004

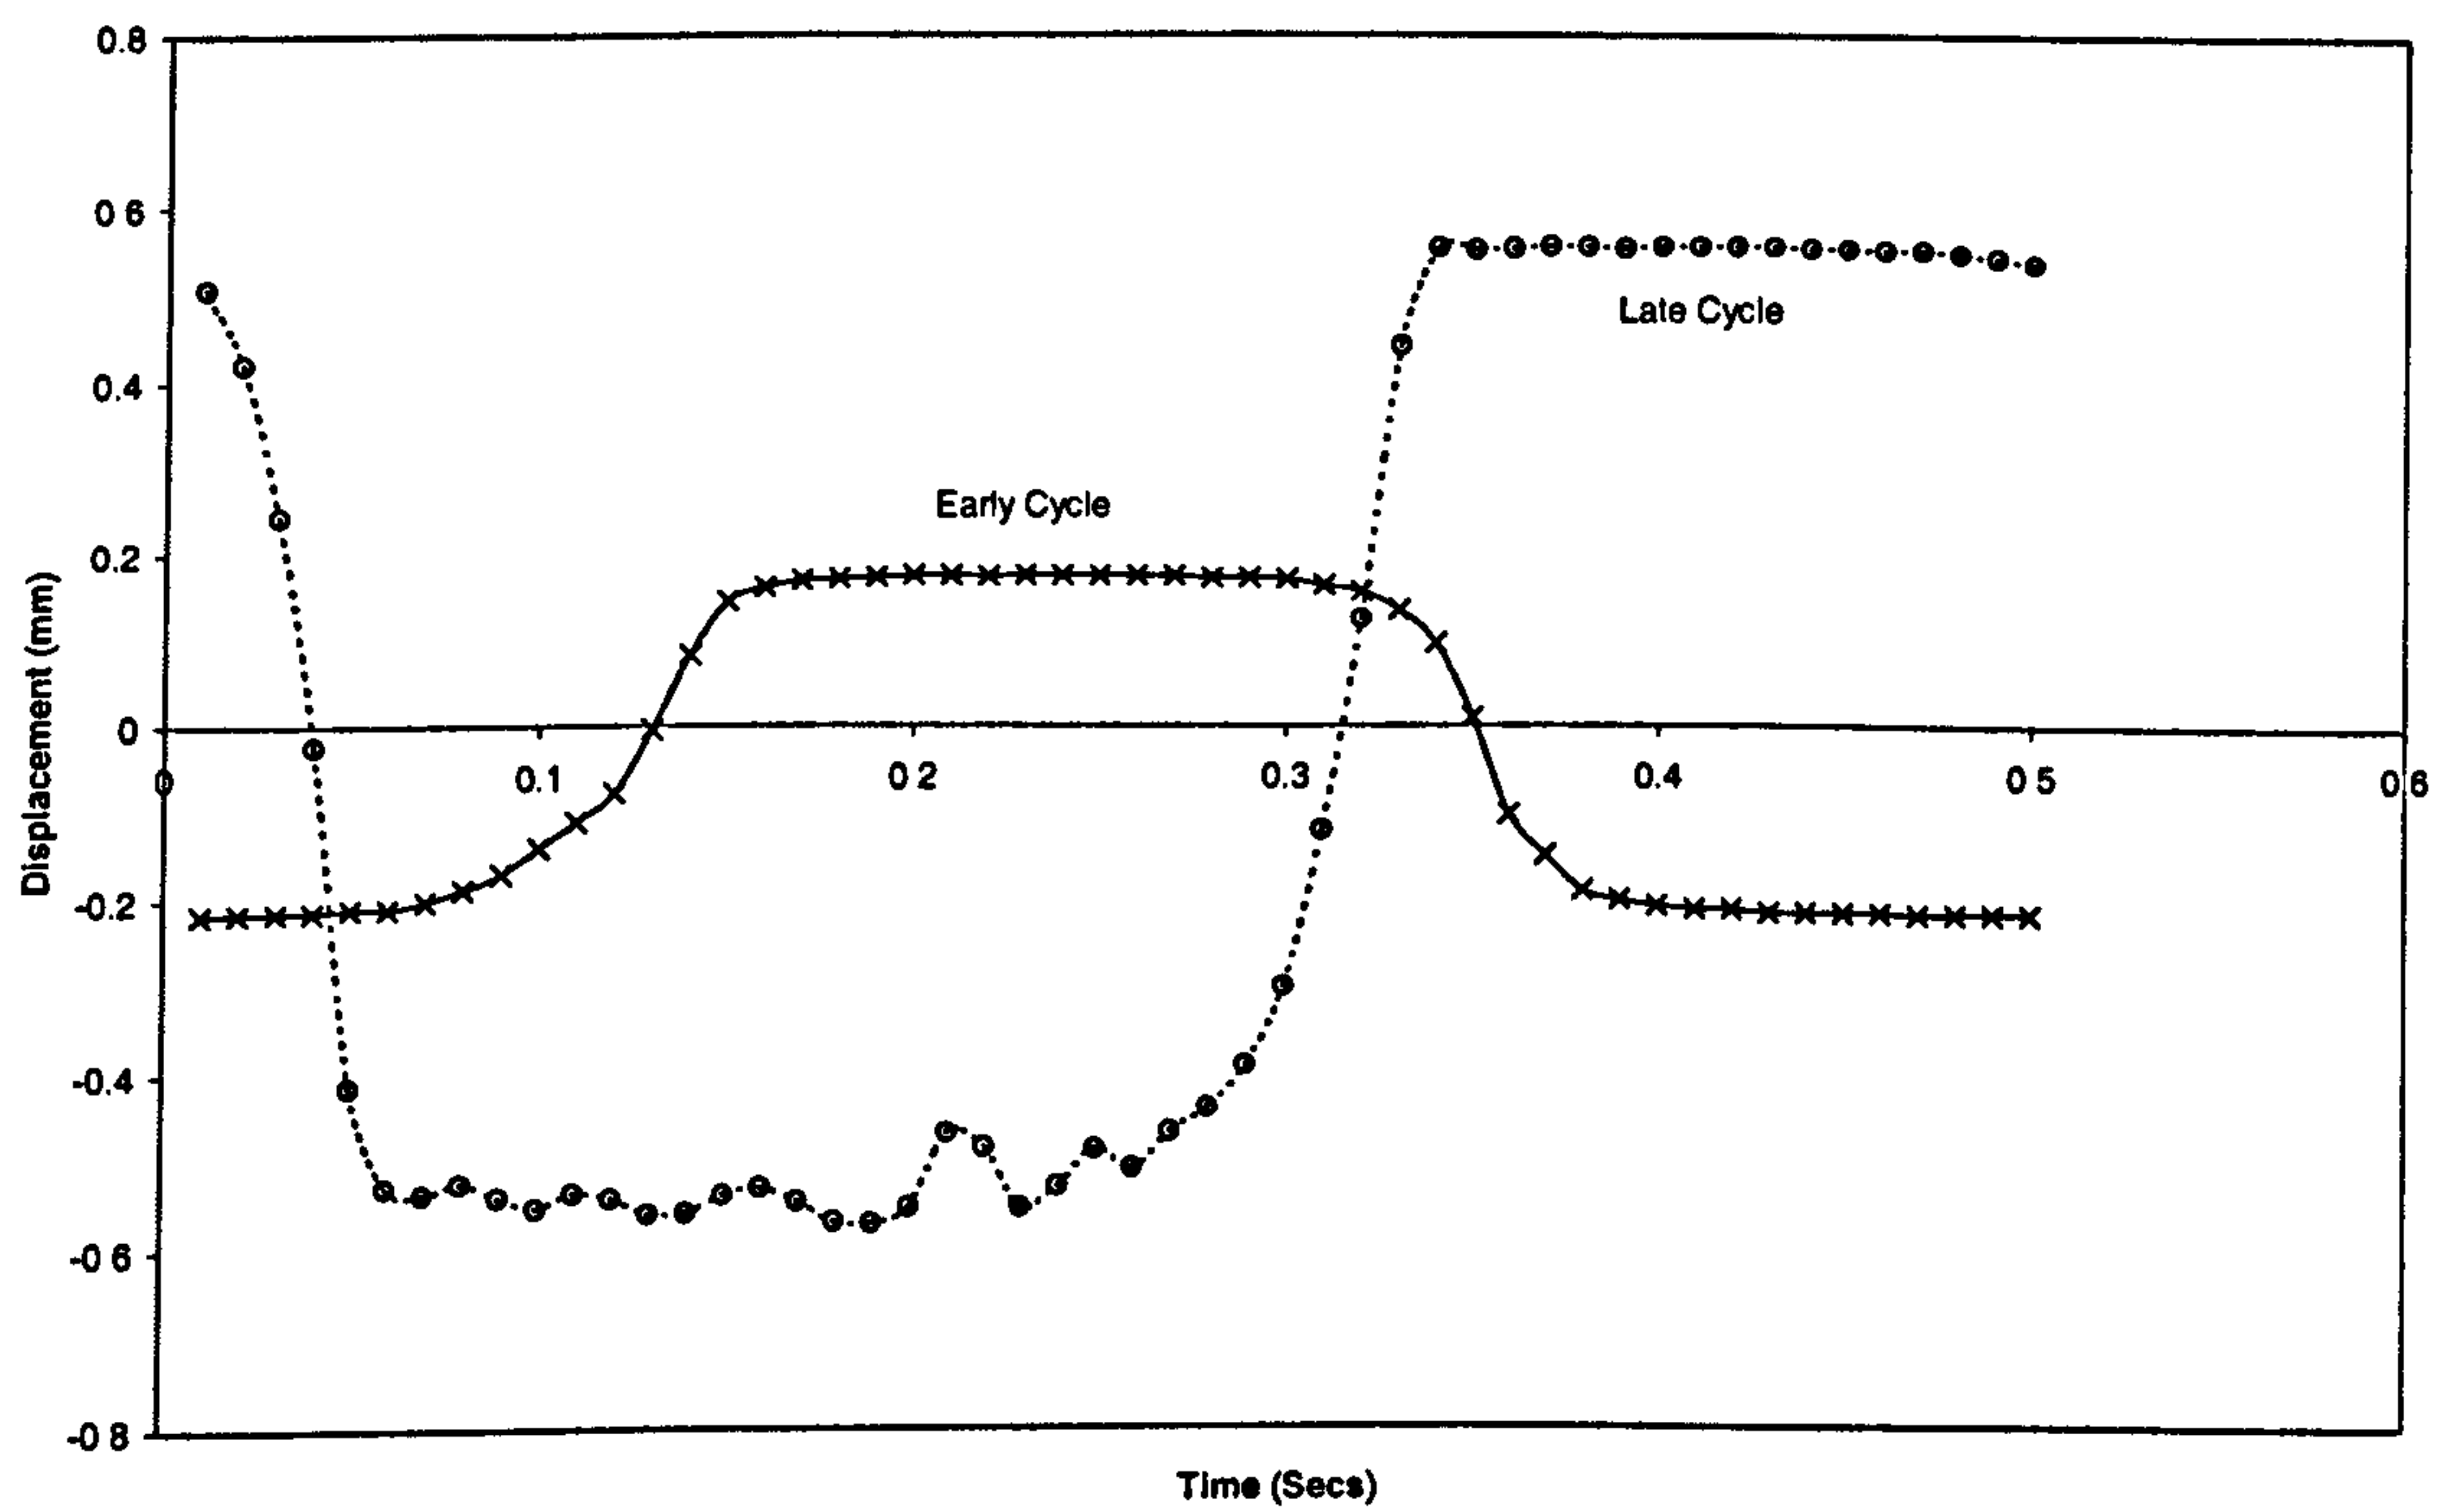
Figure 6.47b – Effect of deterioration on displacement resistance (20kg/m³ steel fibre with 4.62mm crack width)

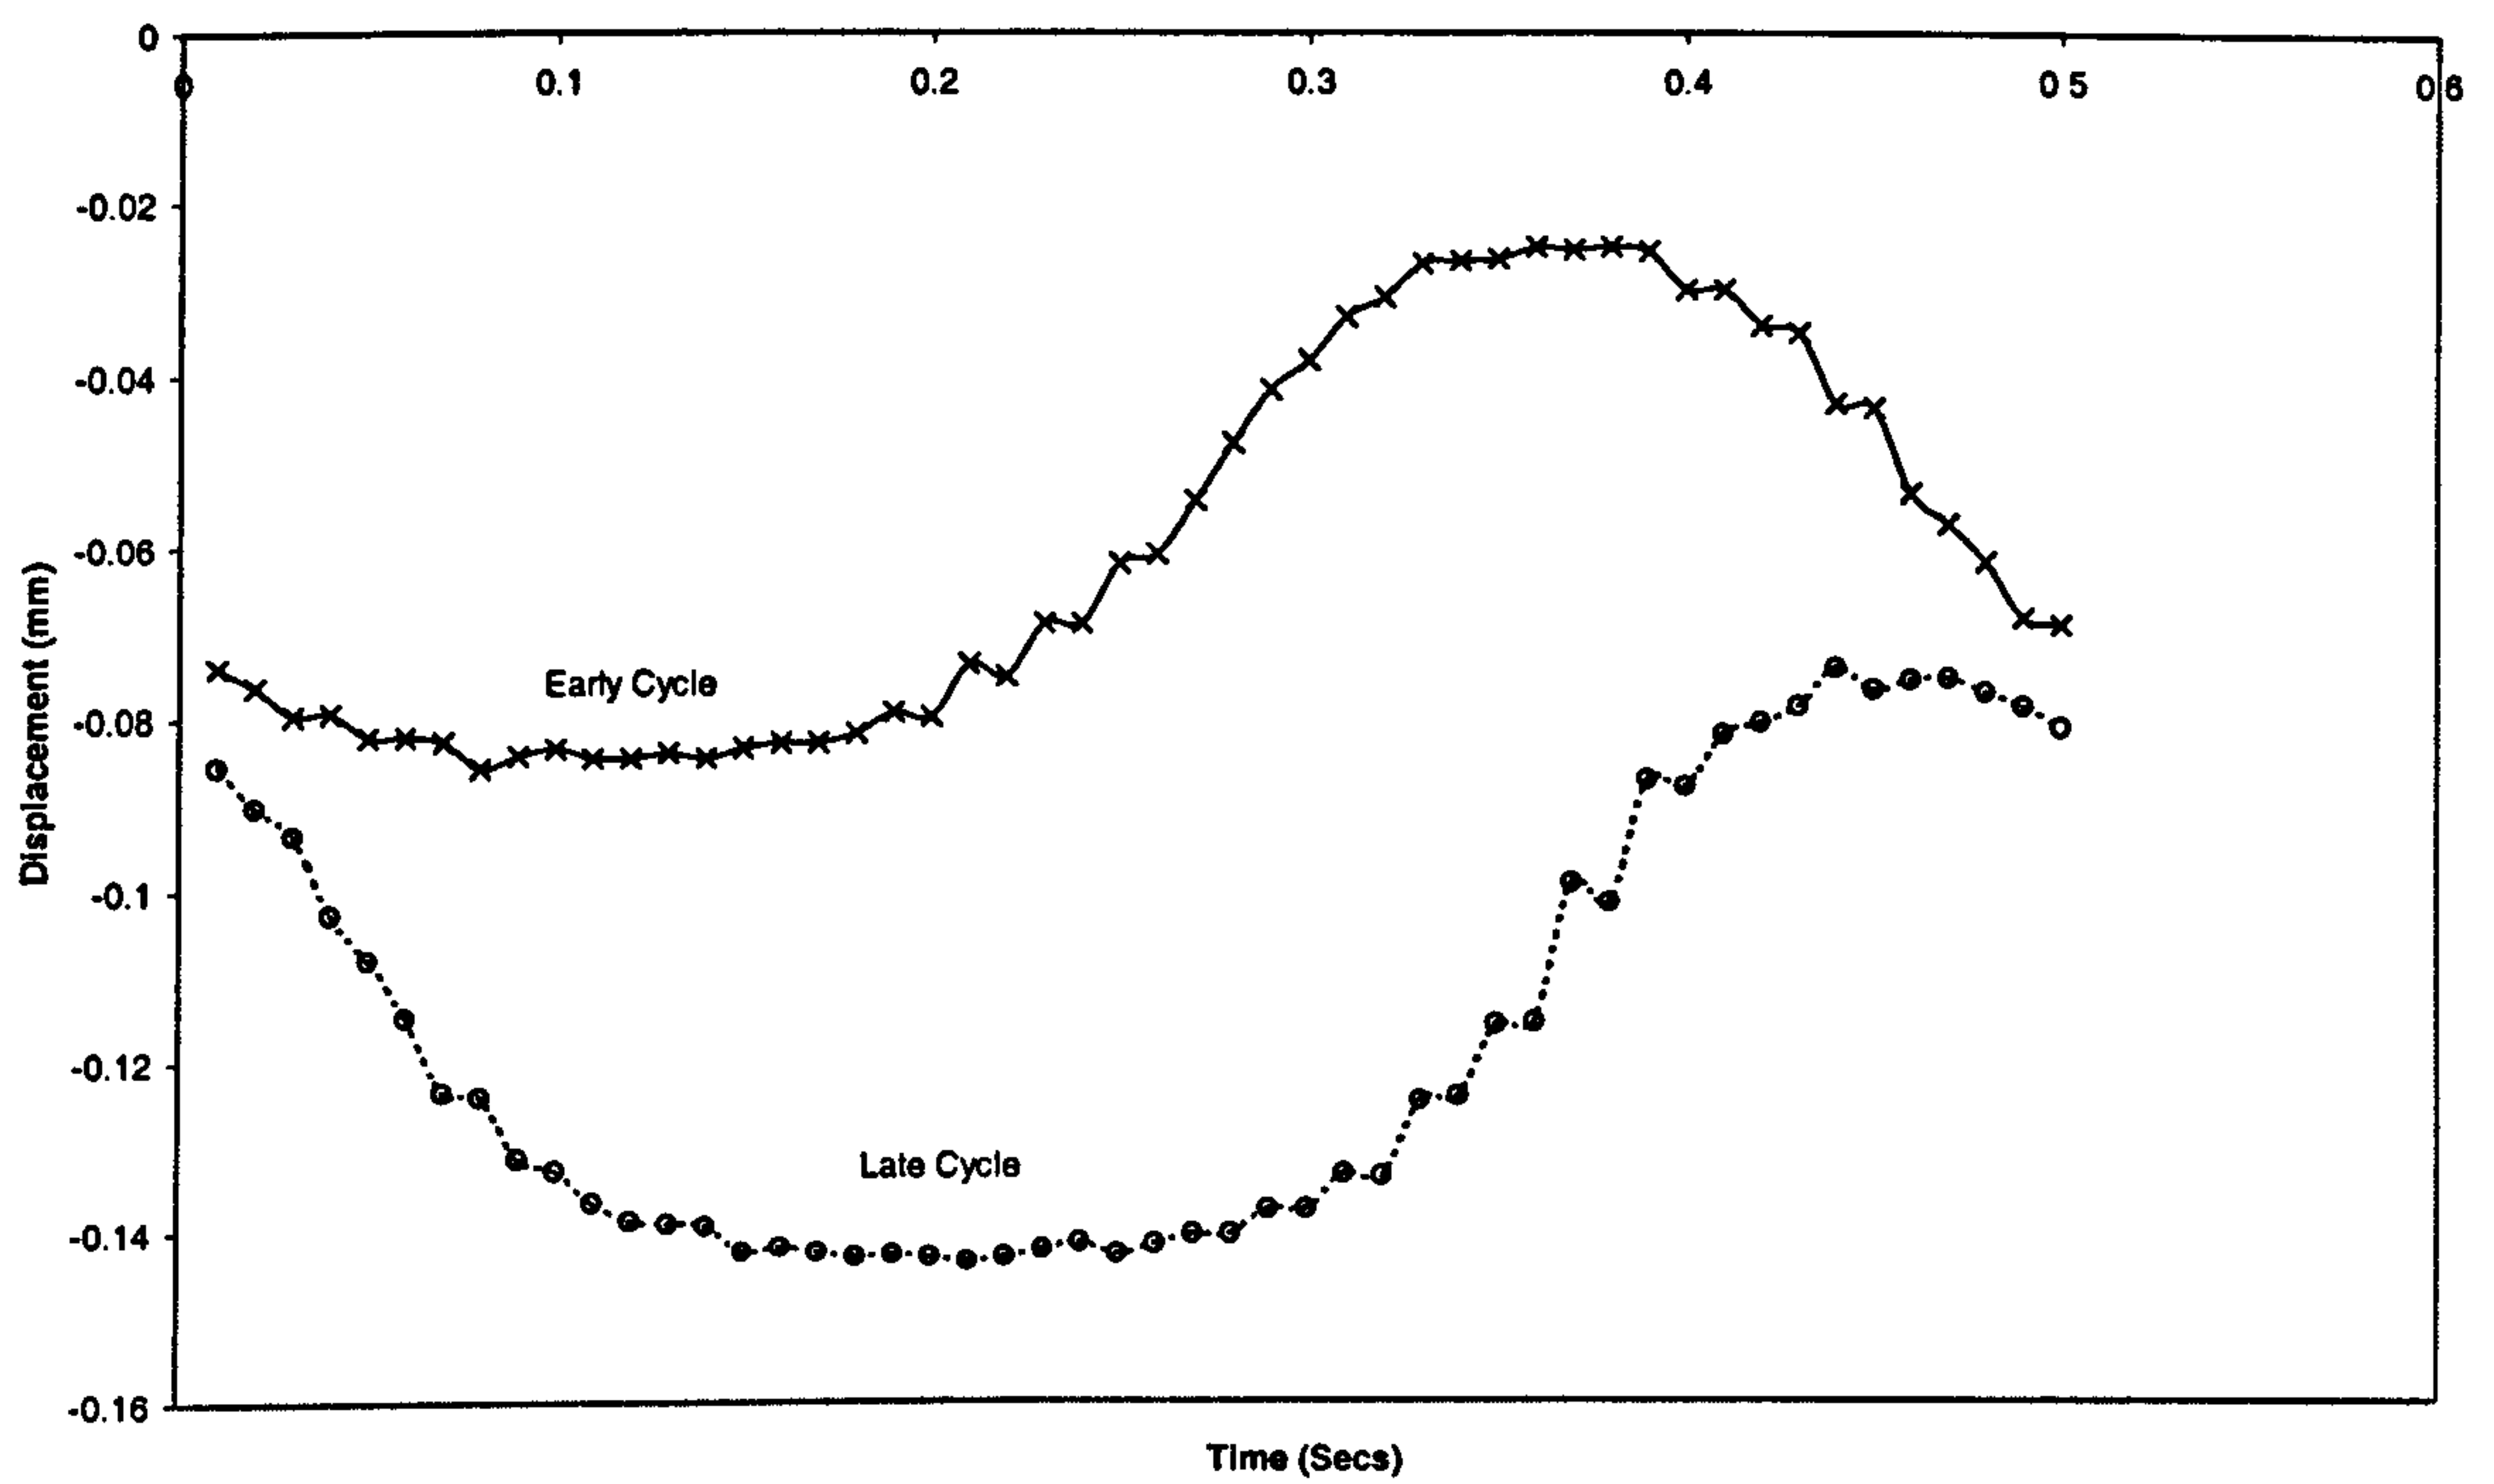
Figure 6.48a – Effect of deterioration on displacement resistance (40kg/m³ steel fibre with 1.98mm crack width)

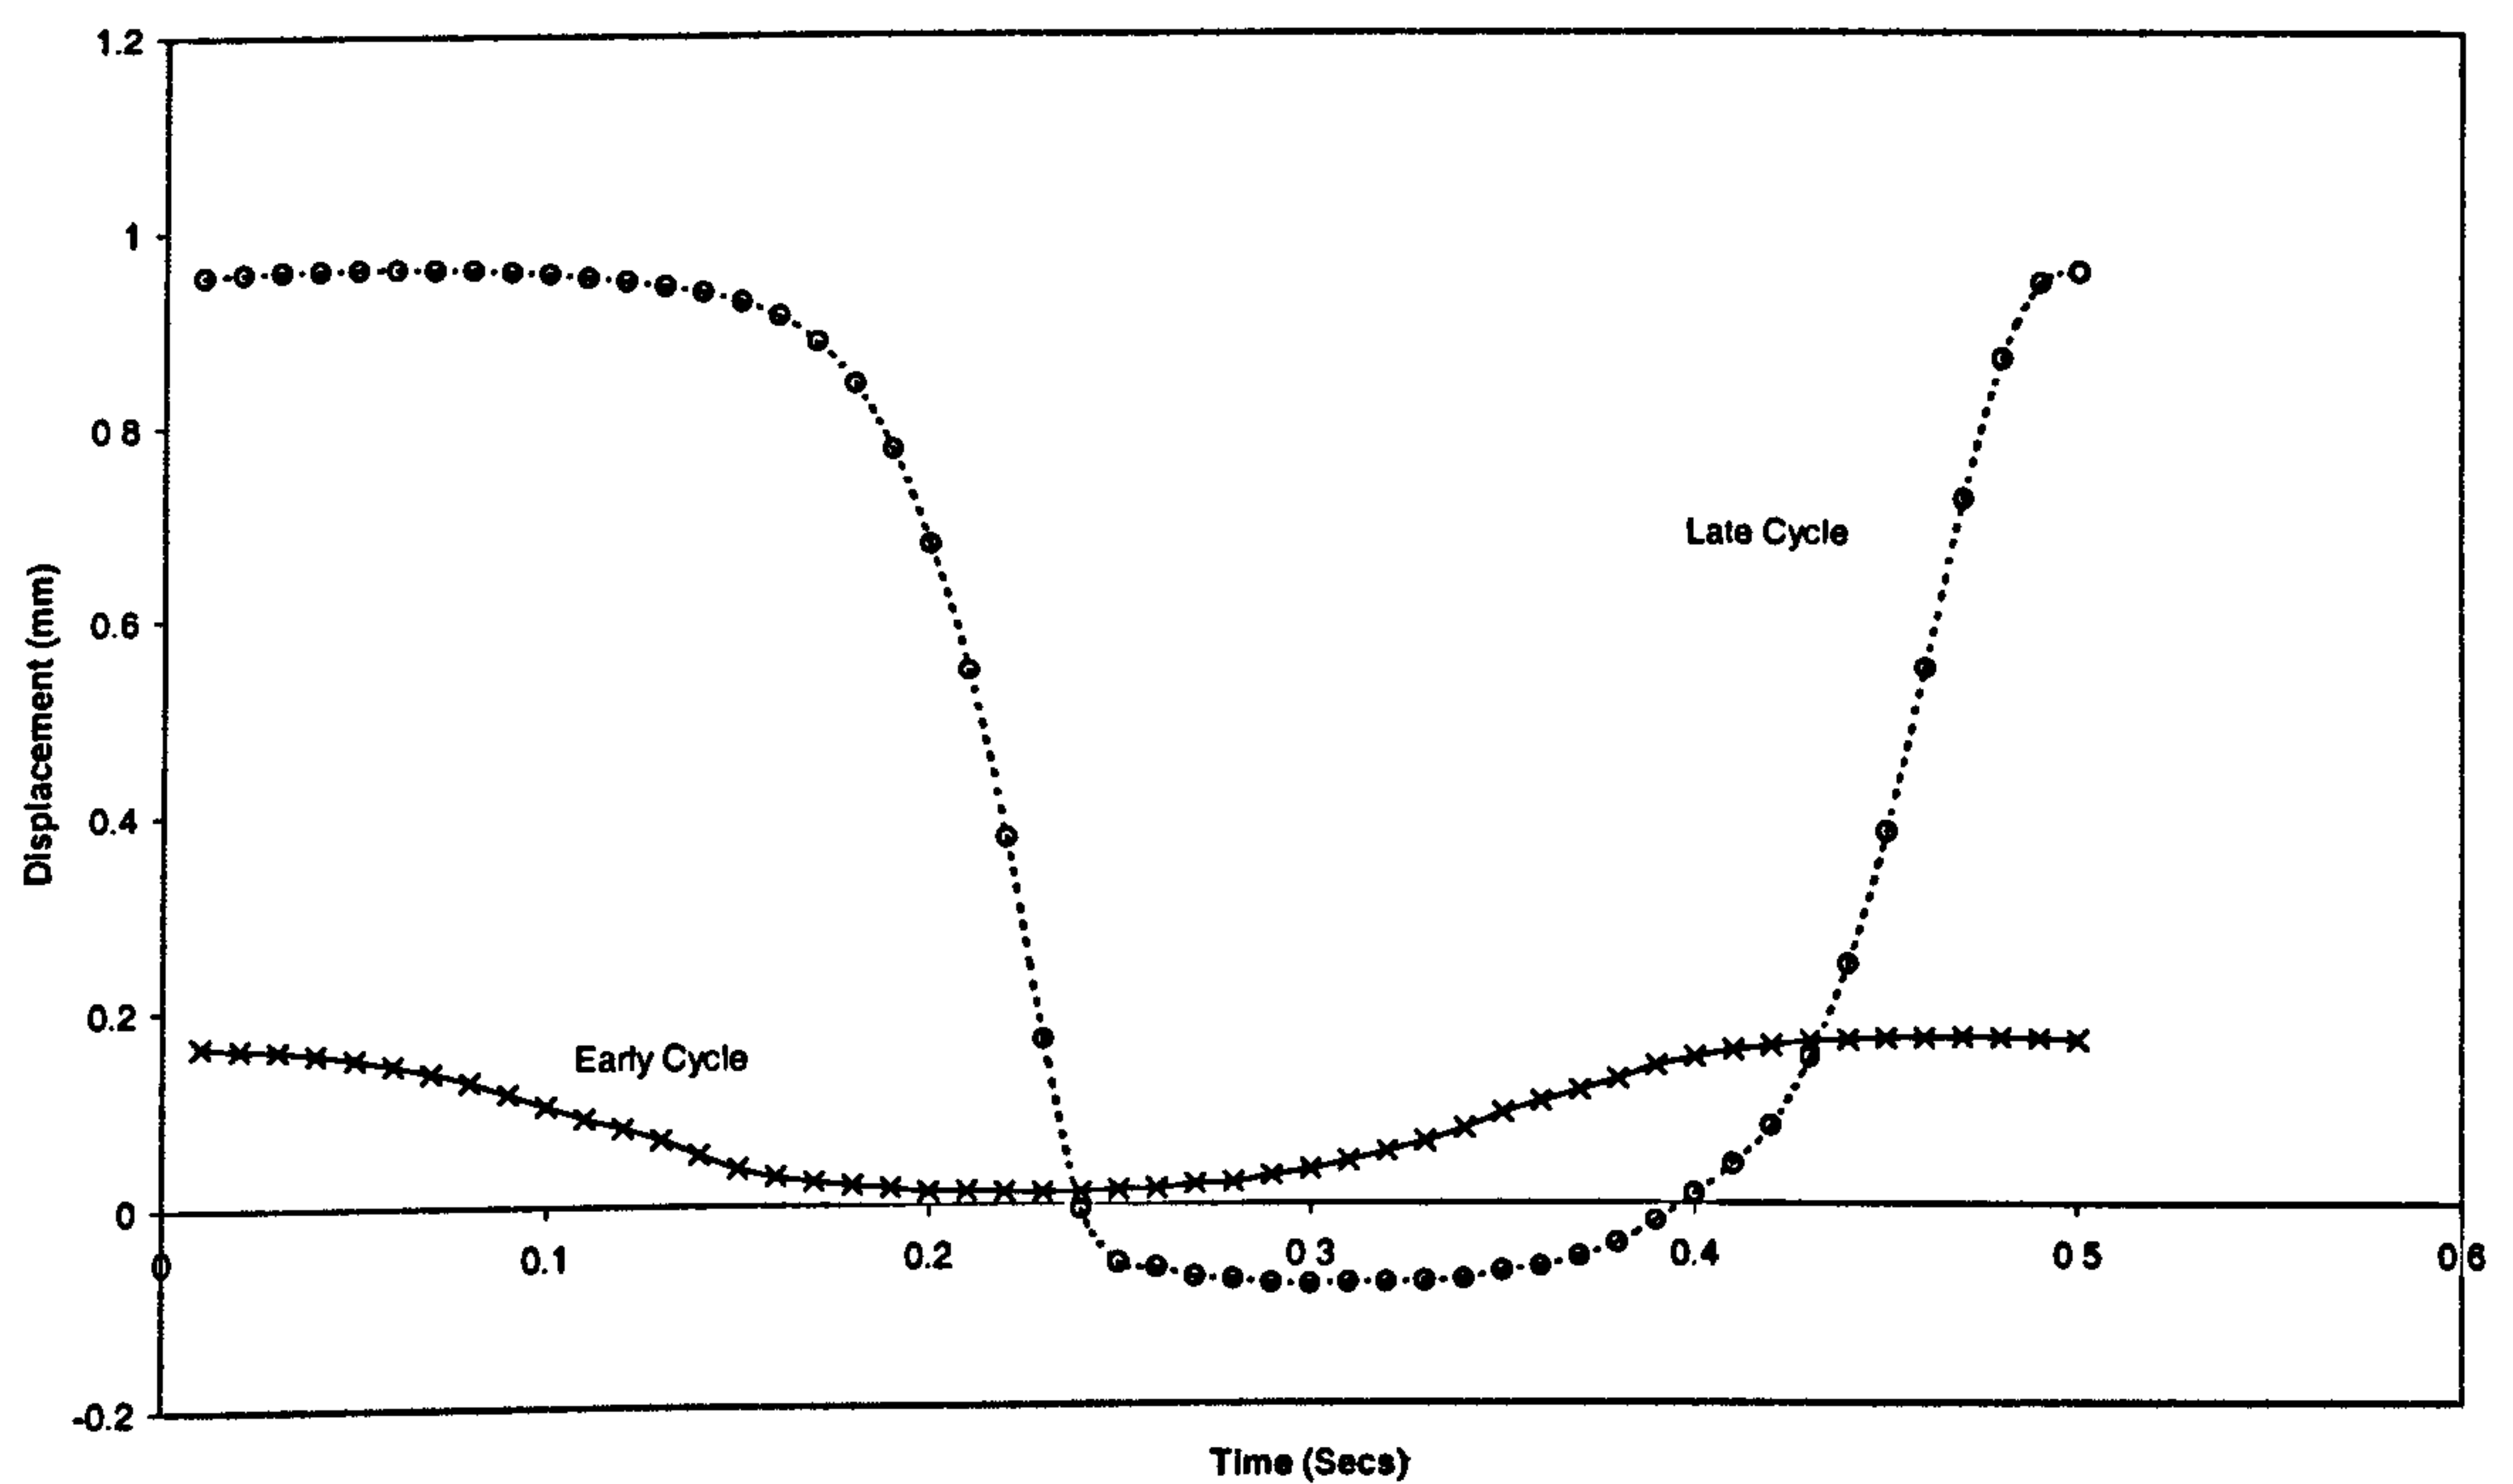
Figure 6.48b – Effect of deterioration on displacement resistance (40kg/m³ steel fibre with 5.94mm crack width)

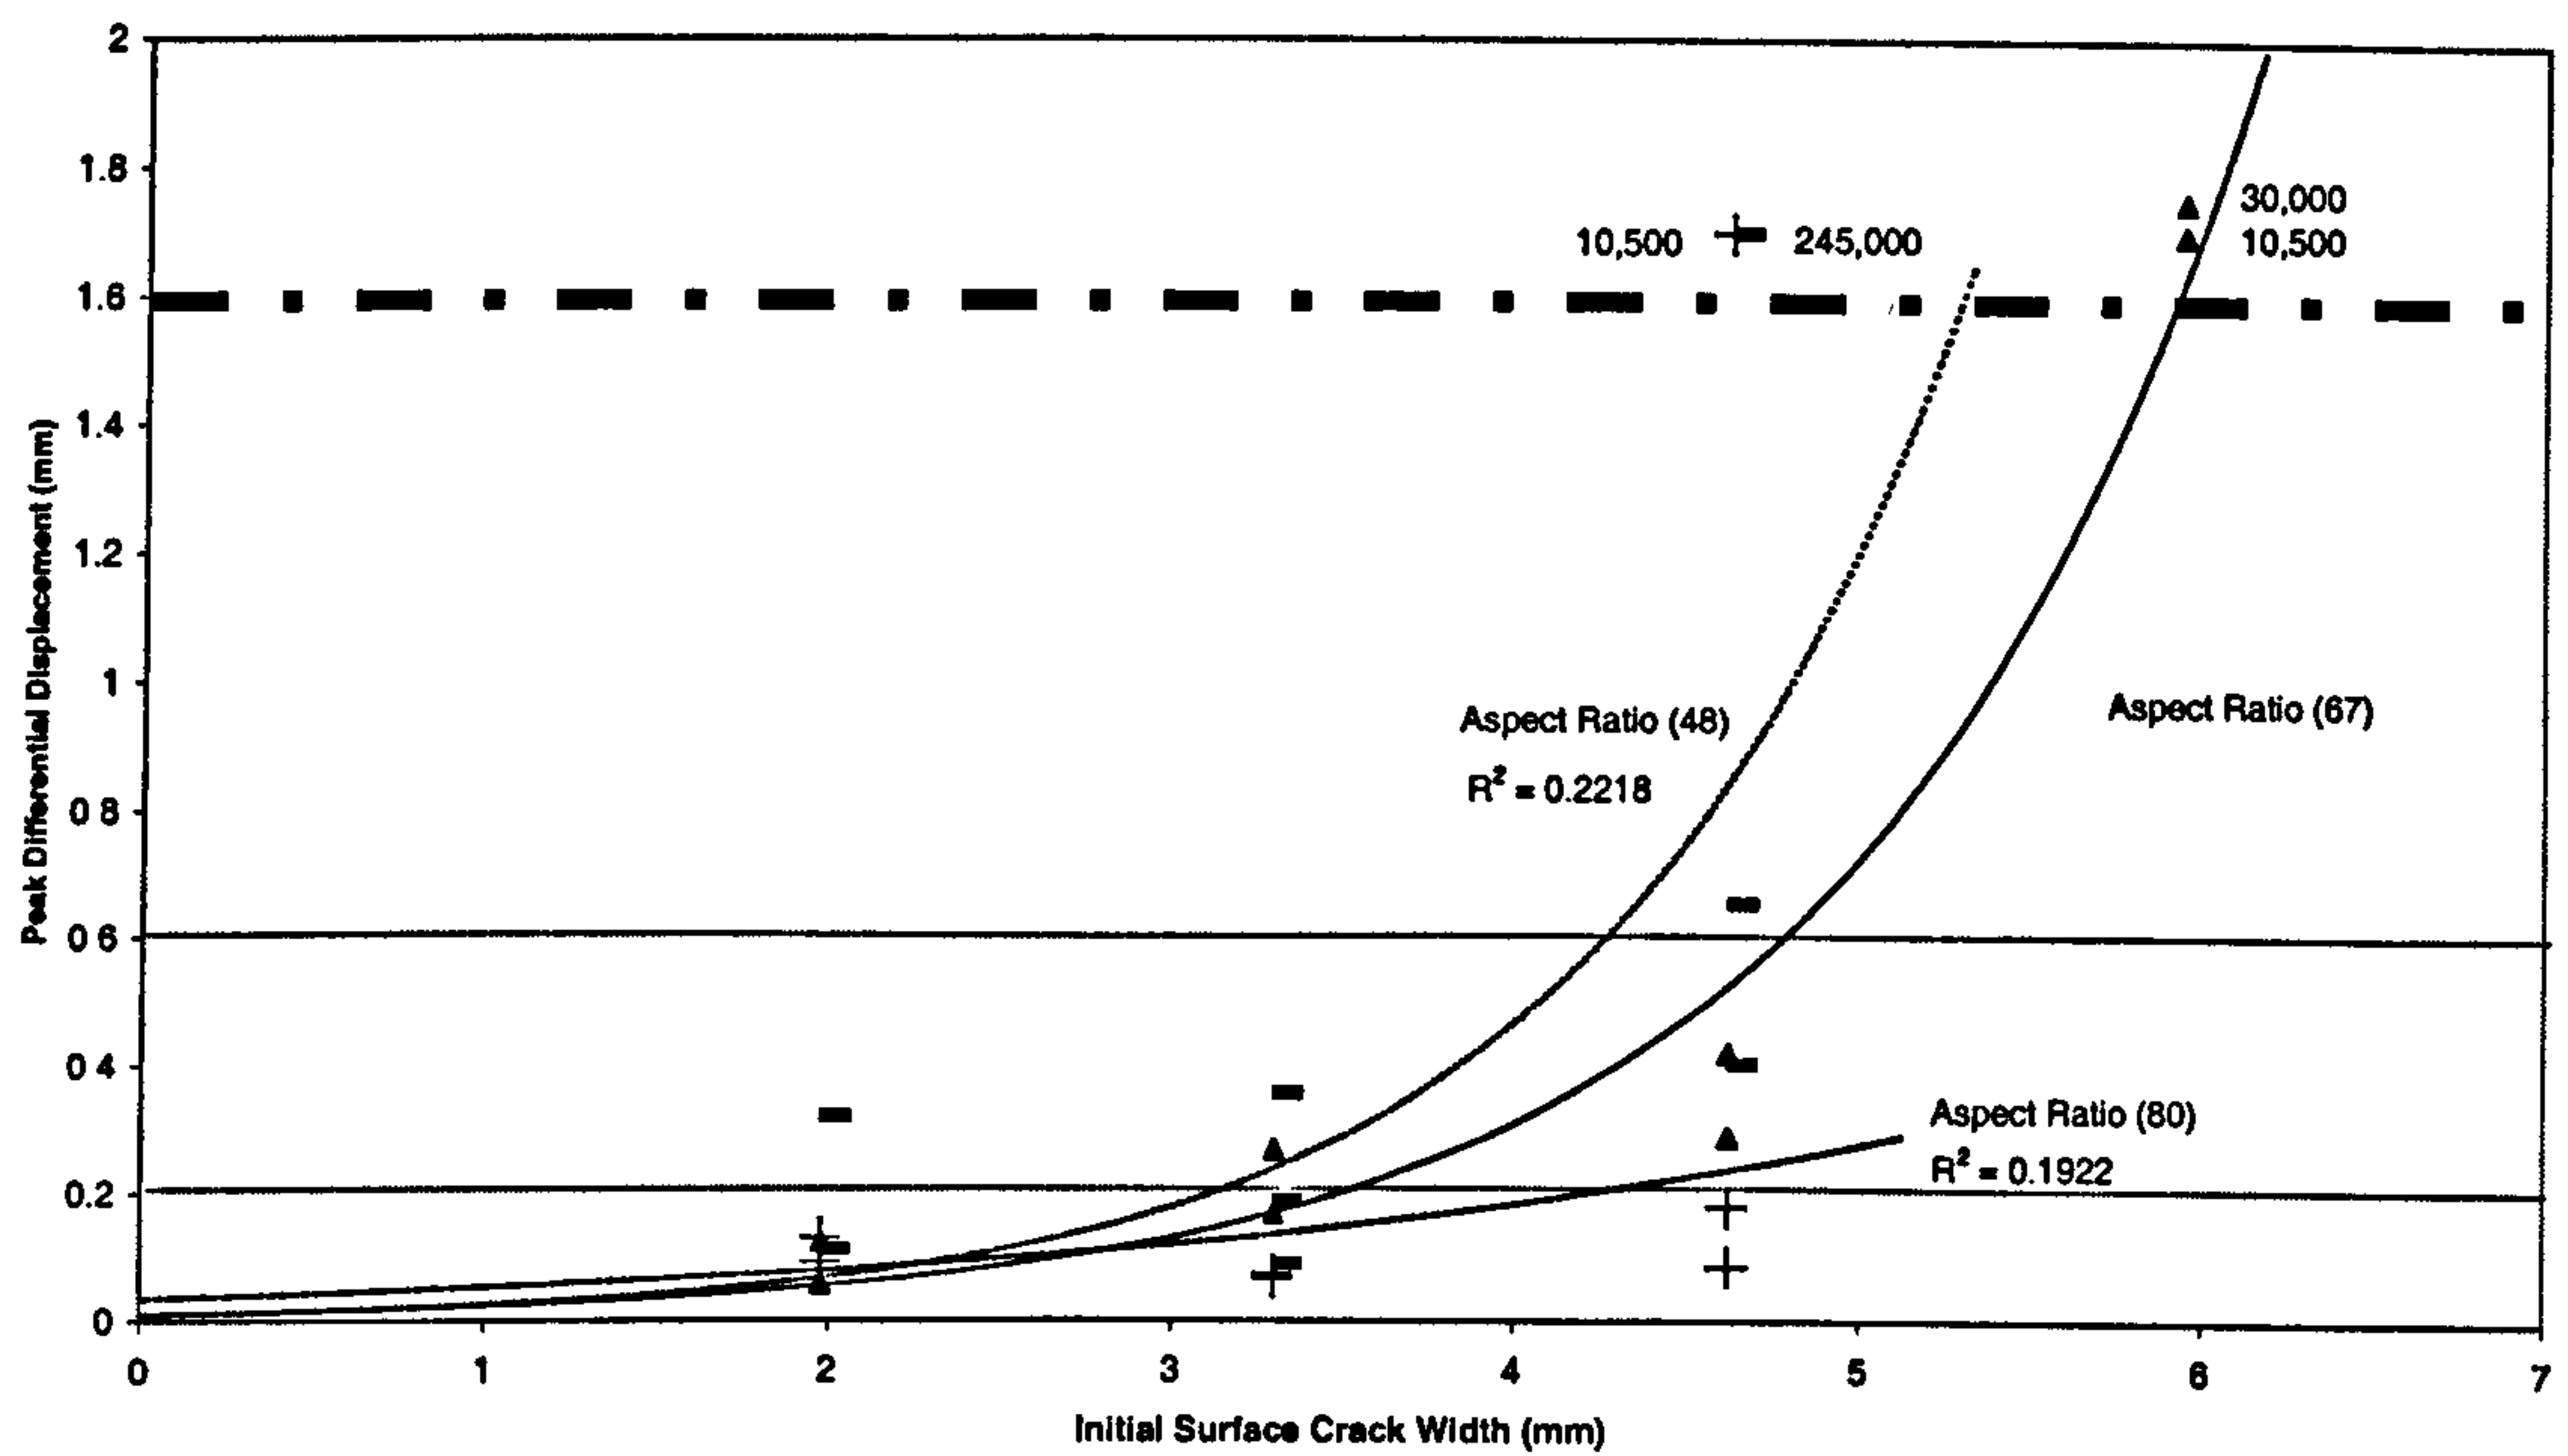
Figure 6.49 – Effect of steel fibre aspect ratio on differential displacement

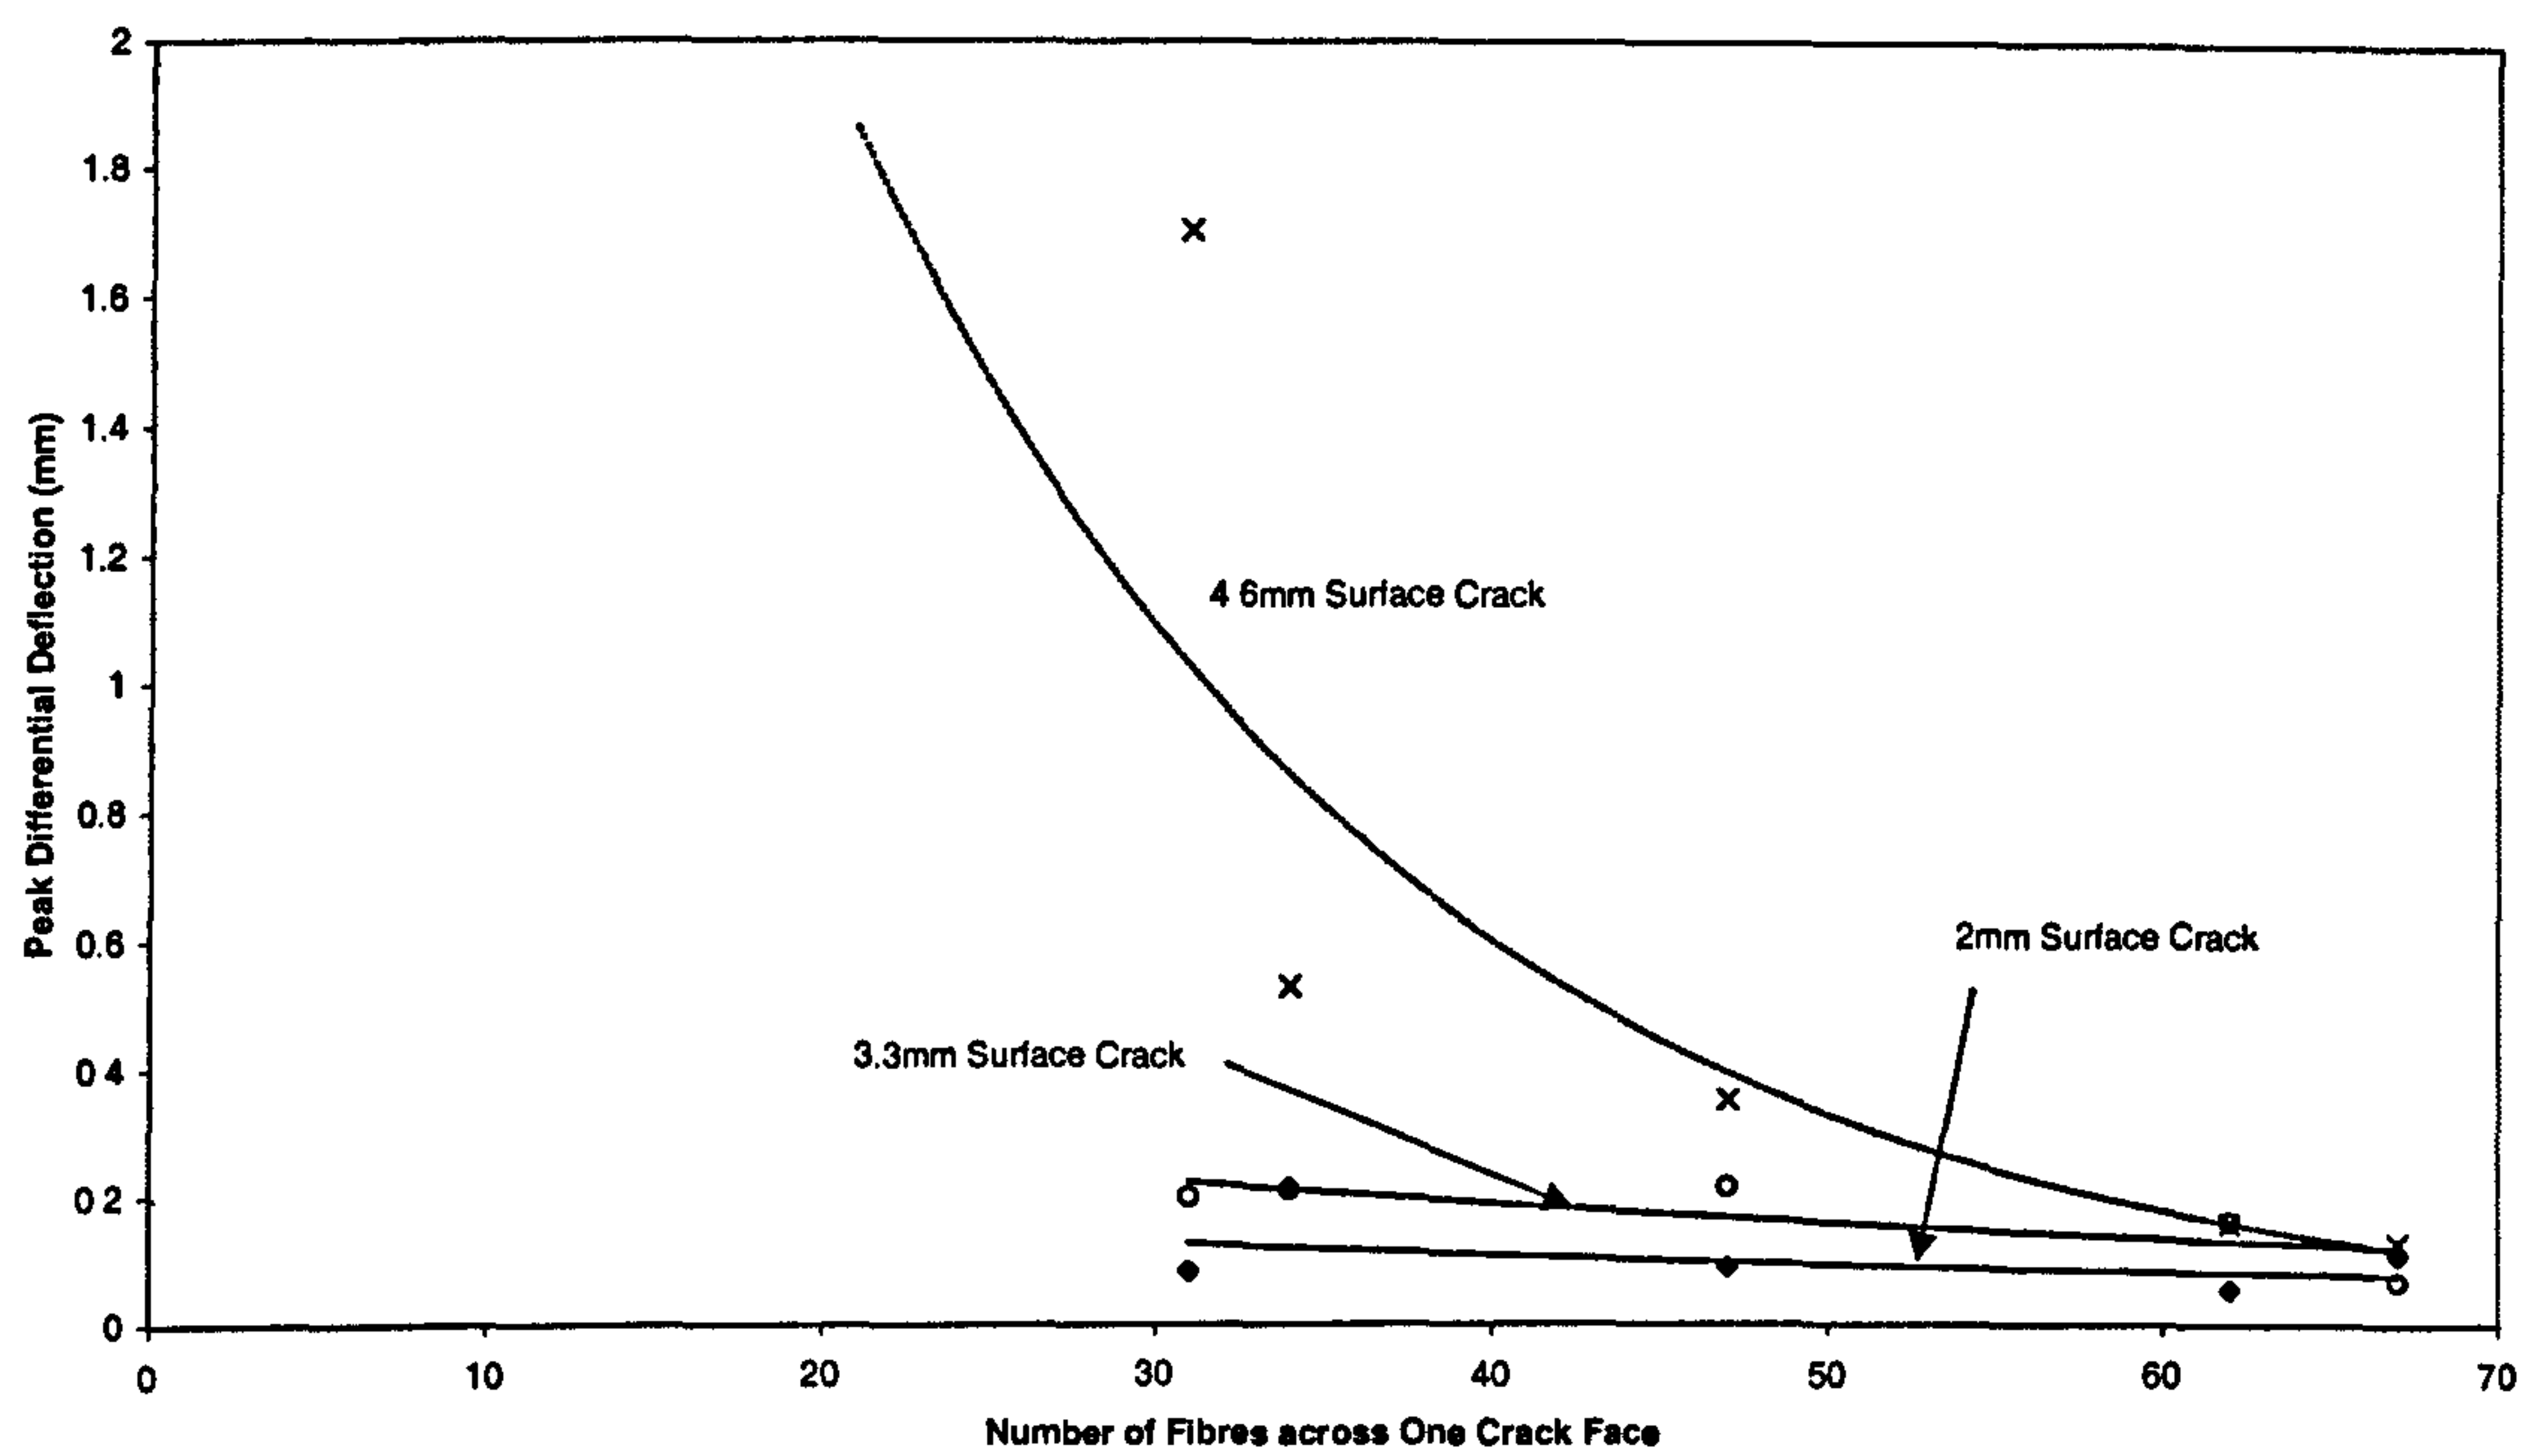
Figure 6.51 – Effect of crack face fibre count on resistance to deflection

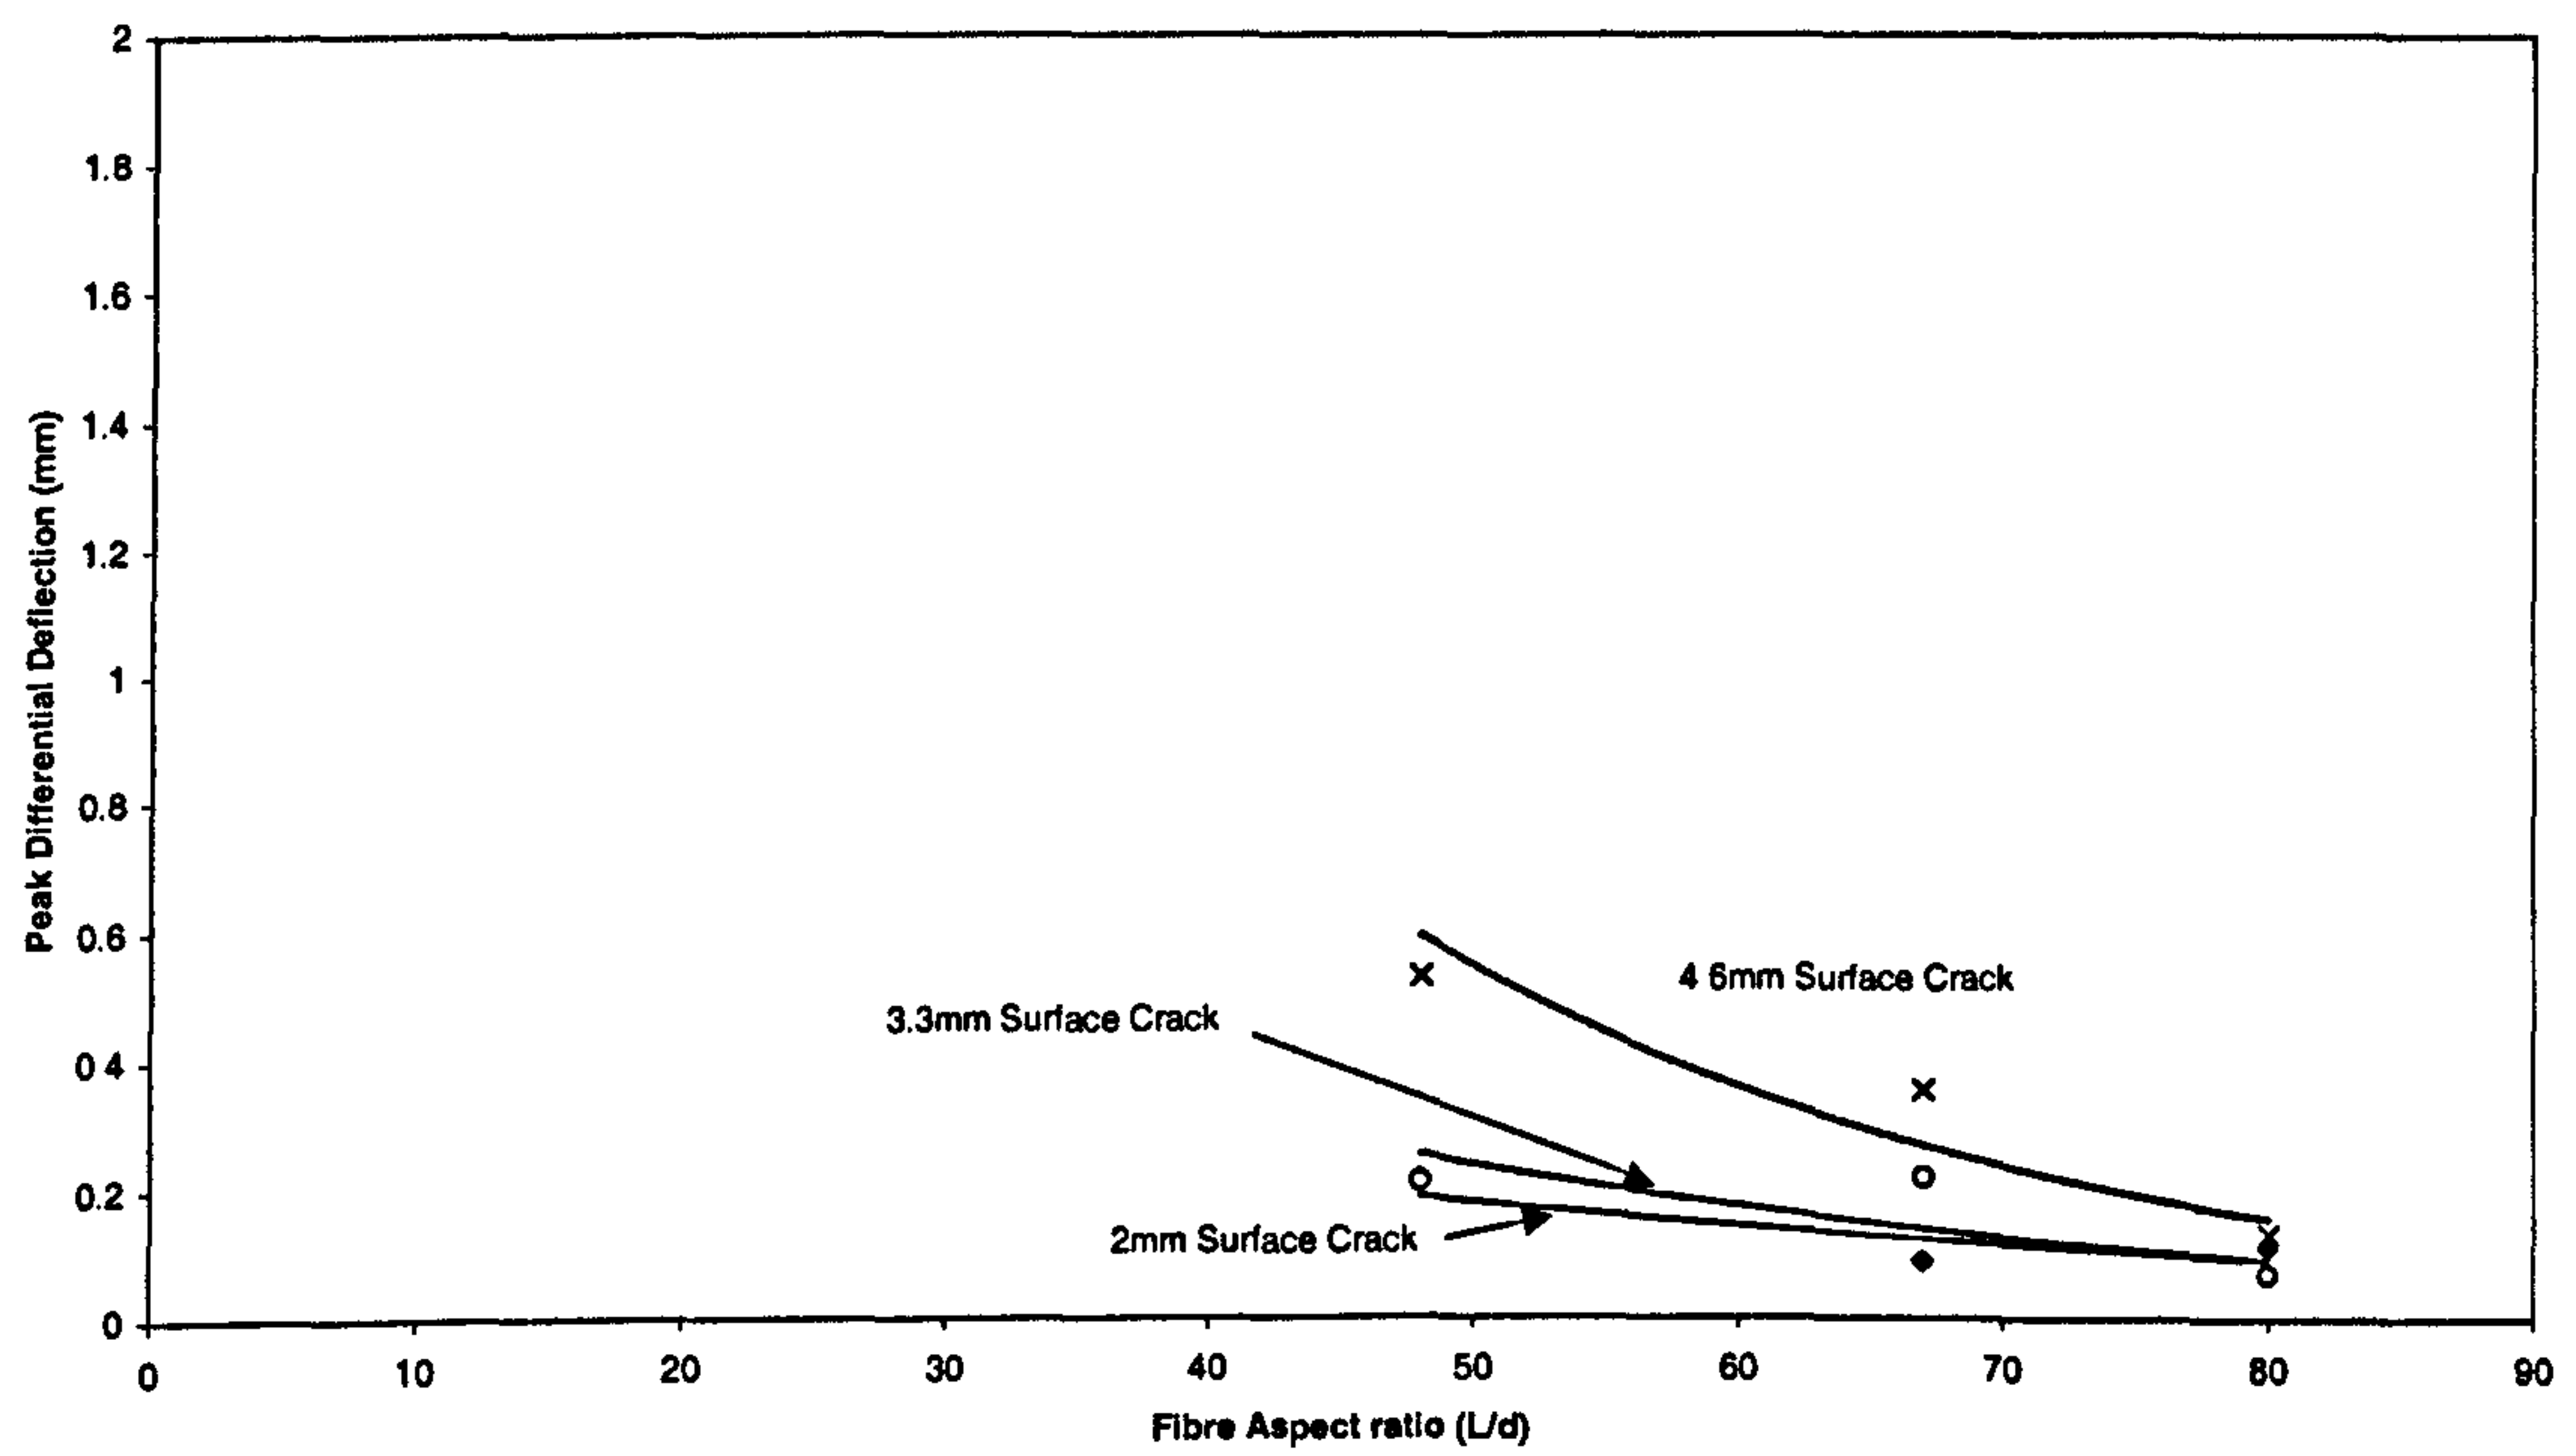
Figure 6.52 – Effectiveness of aspect ratio in resistance to displacement
