LOAD TRANSFER ACROSS CRACKS AND JOINTS IN CONCRETE SLABS ON GRADE

Stuart John Arnold

**A Doctoral Thesis Submitted in partial fulfilment of the requirements for the
award of
Doctor of Philosophy of Loughborough University**

20th February 2004

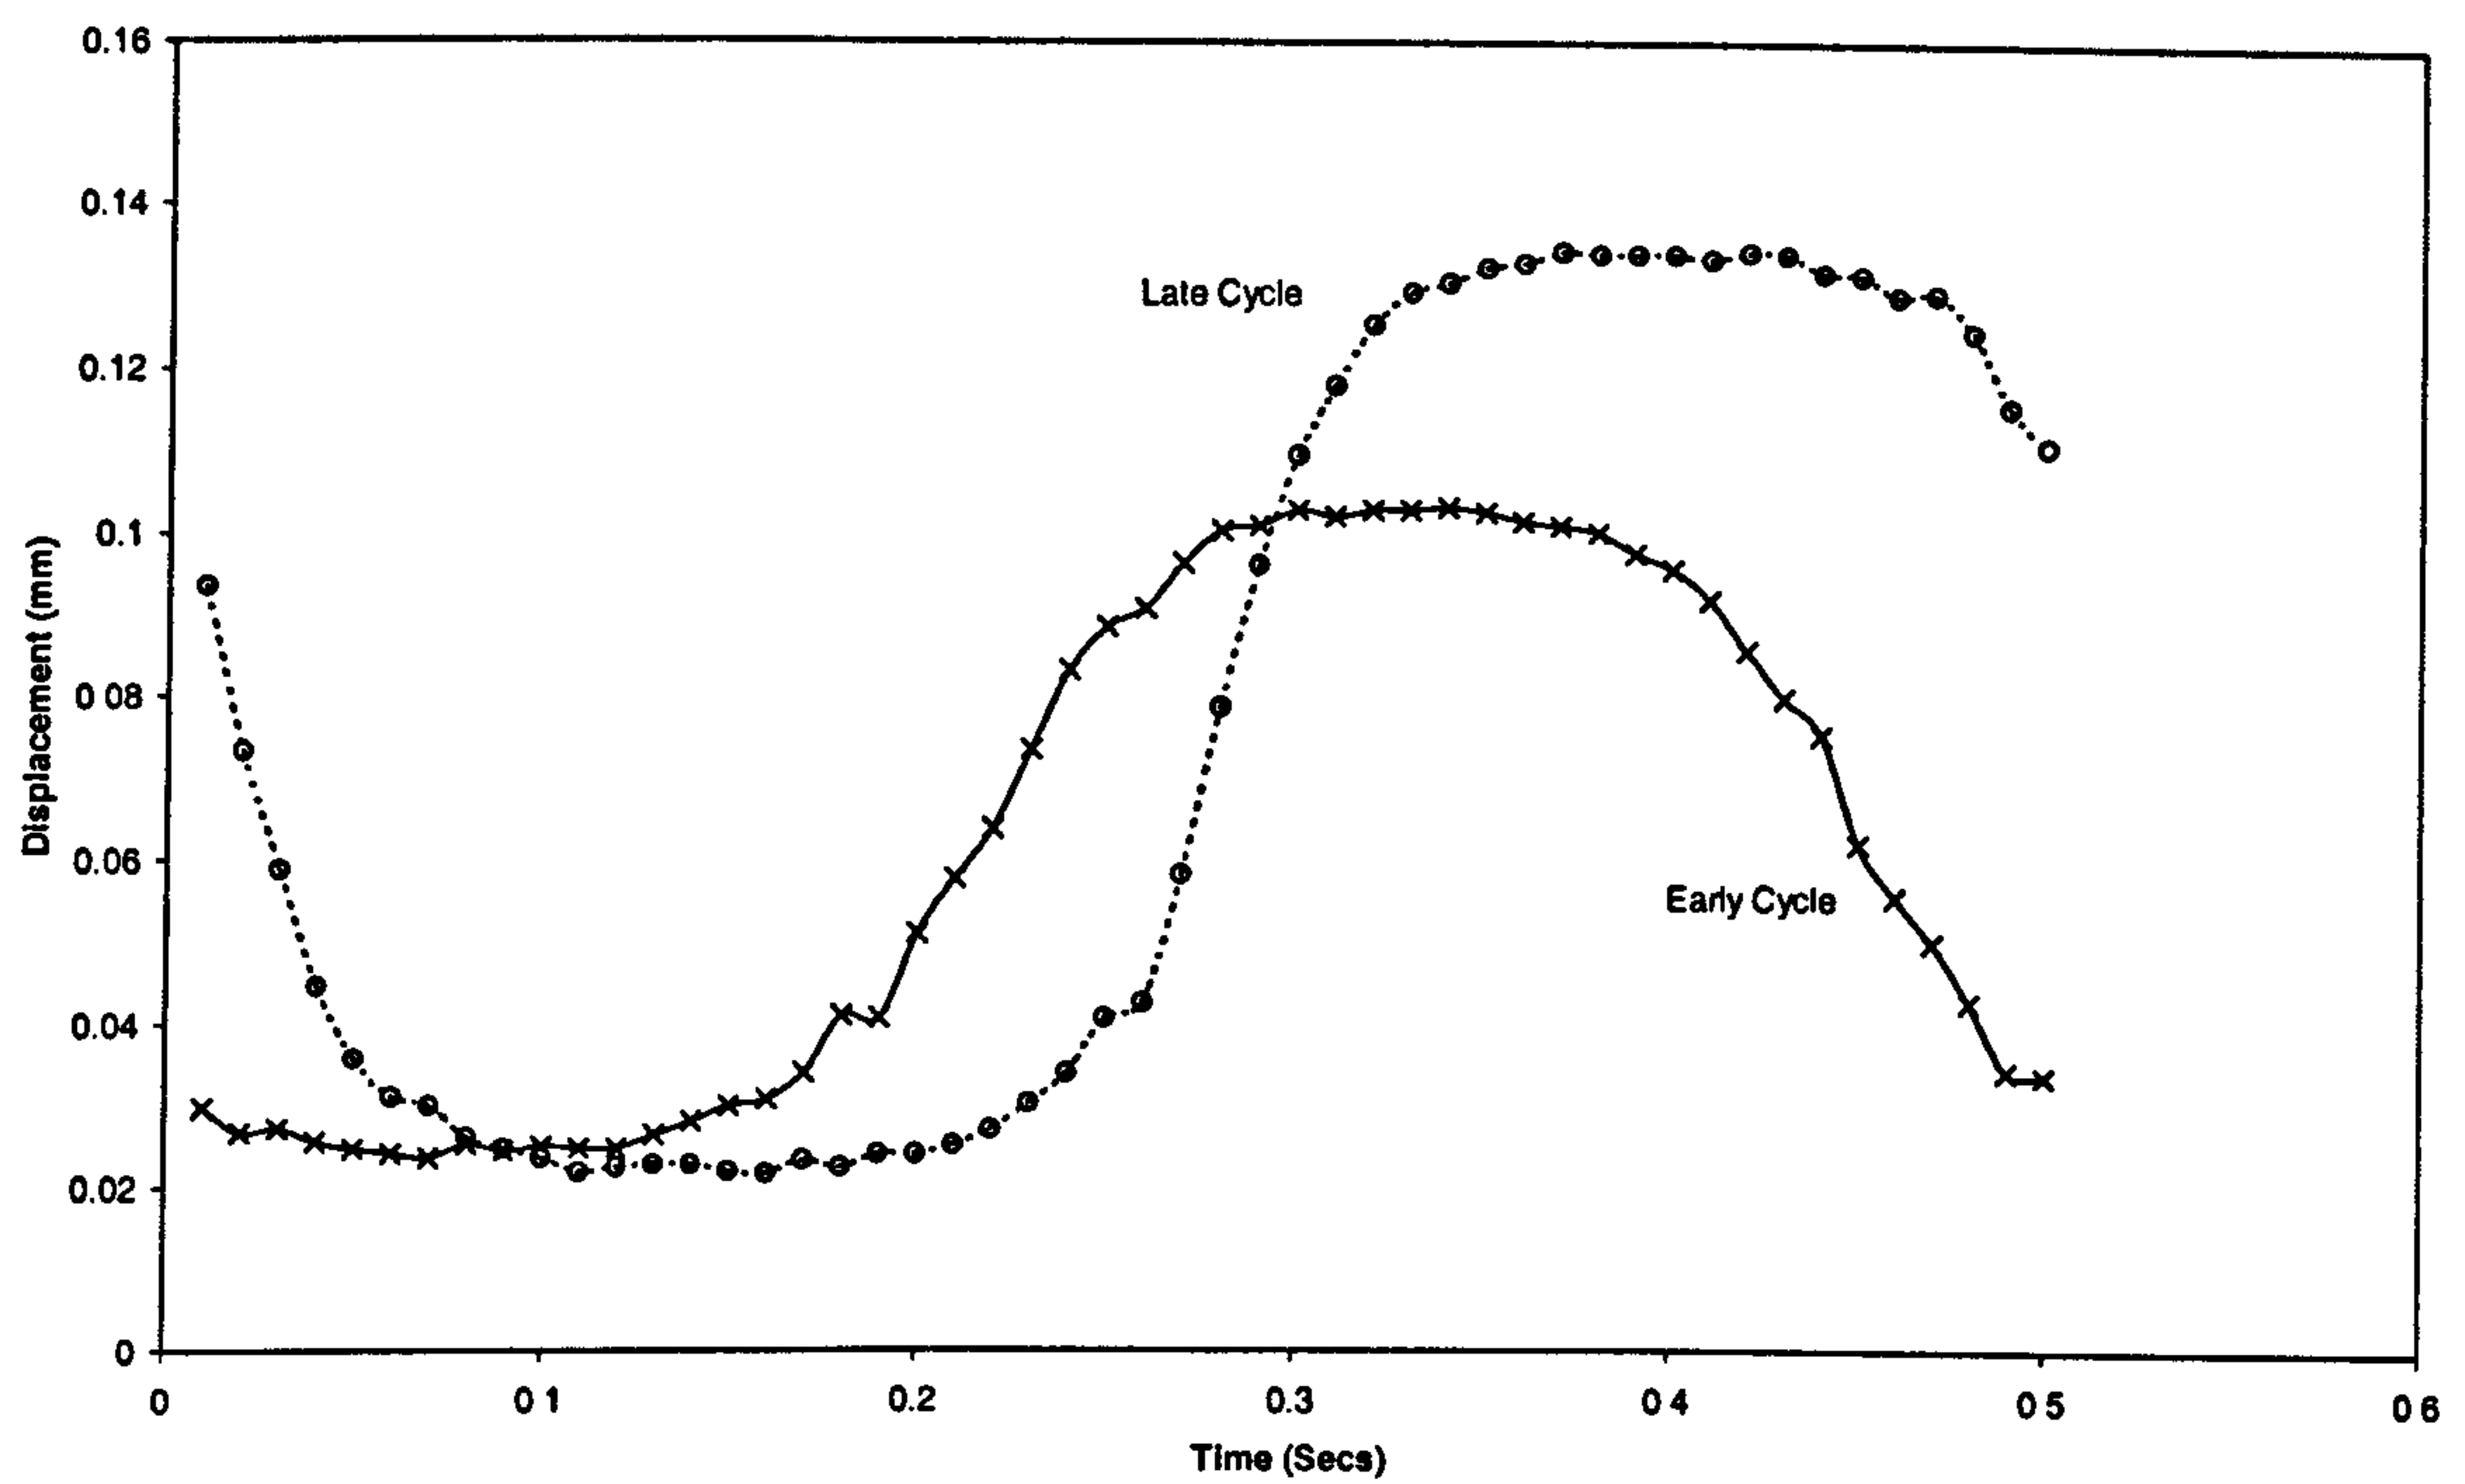
Figure 6.53a – Effect of deterioration on displacement resistance (steel fibre of aspect ratio 80 with 1.98mm crack width)

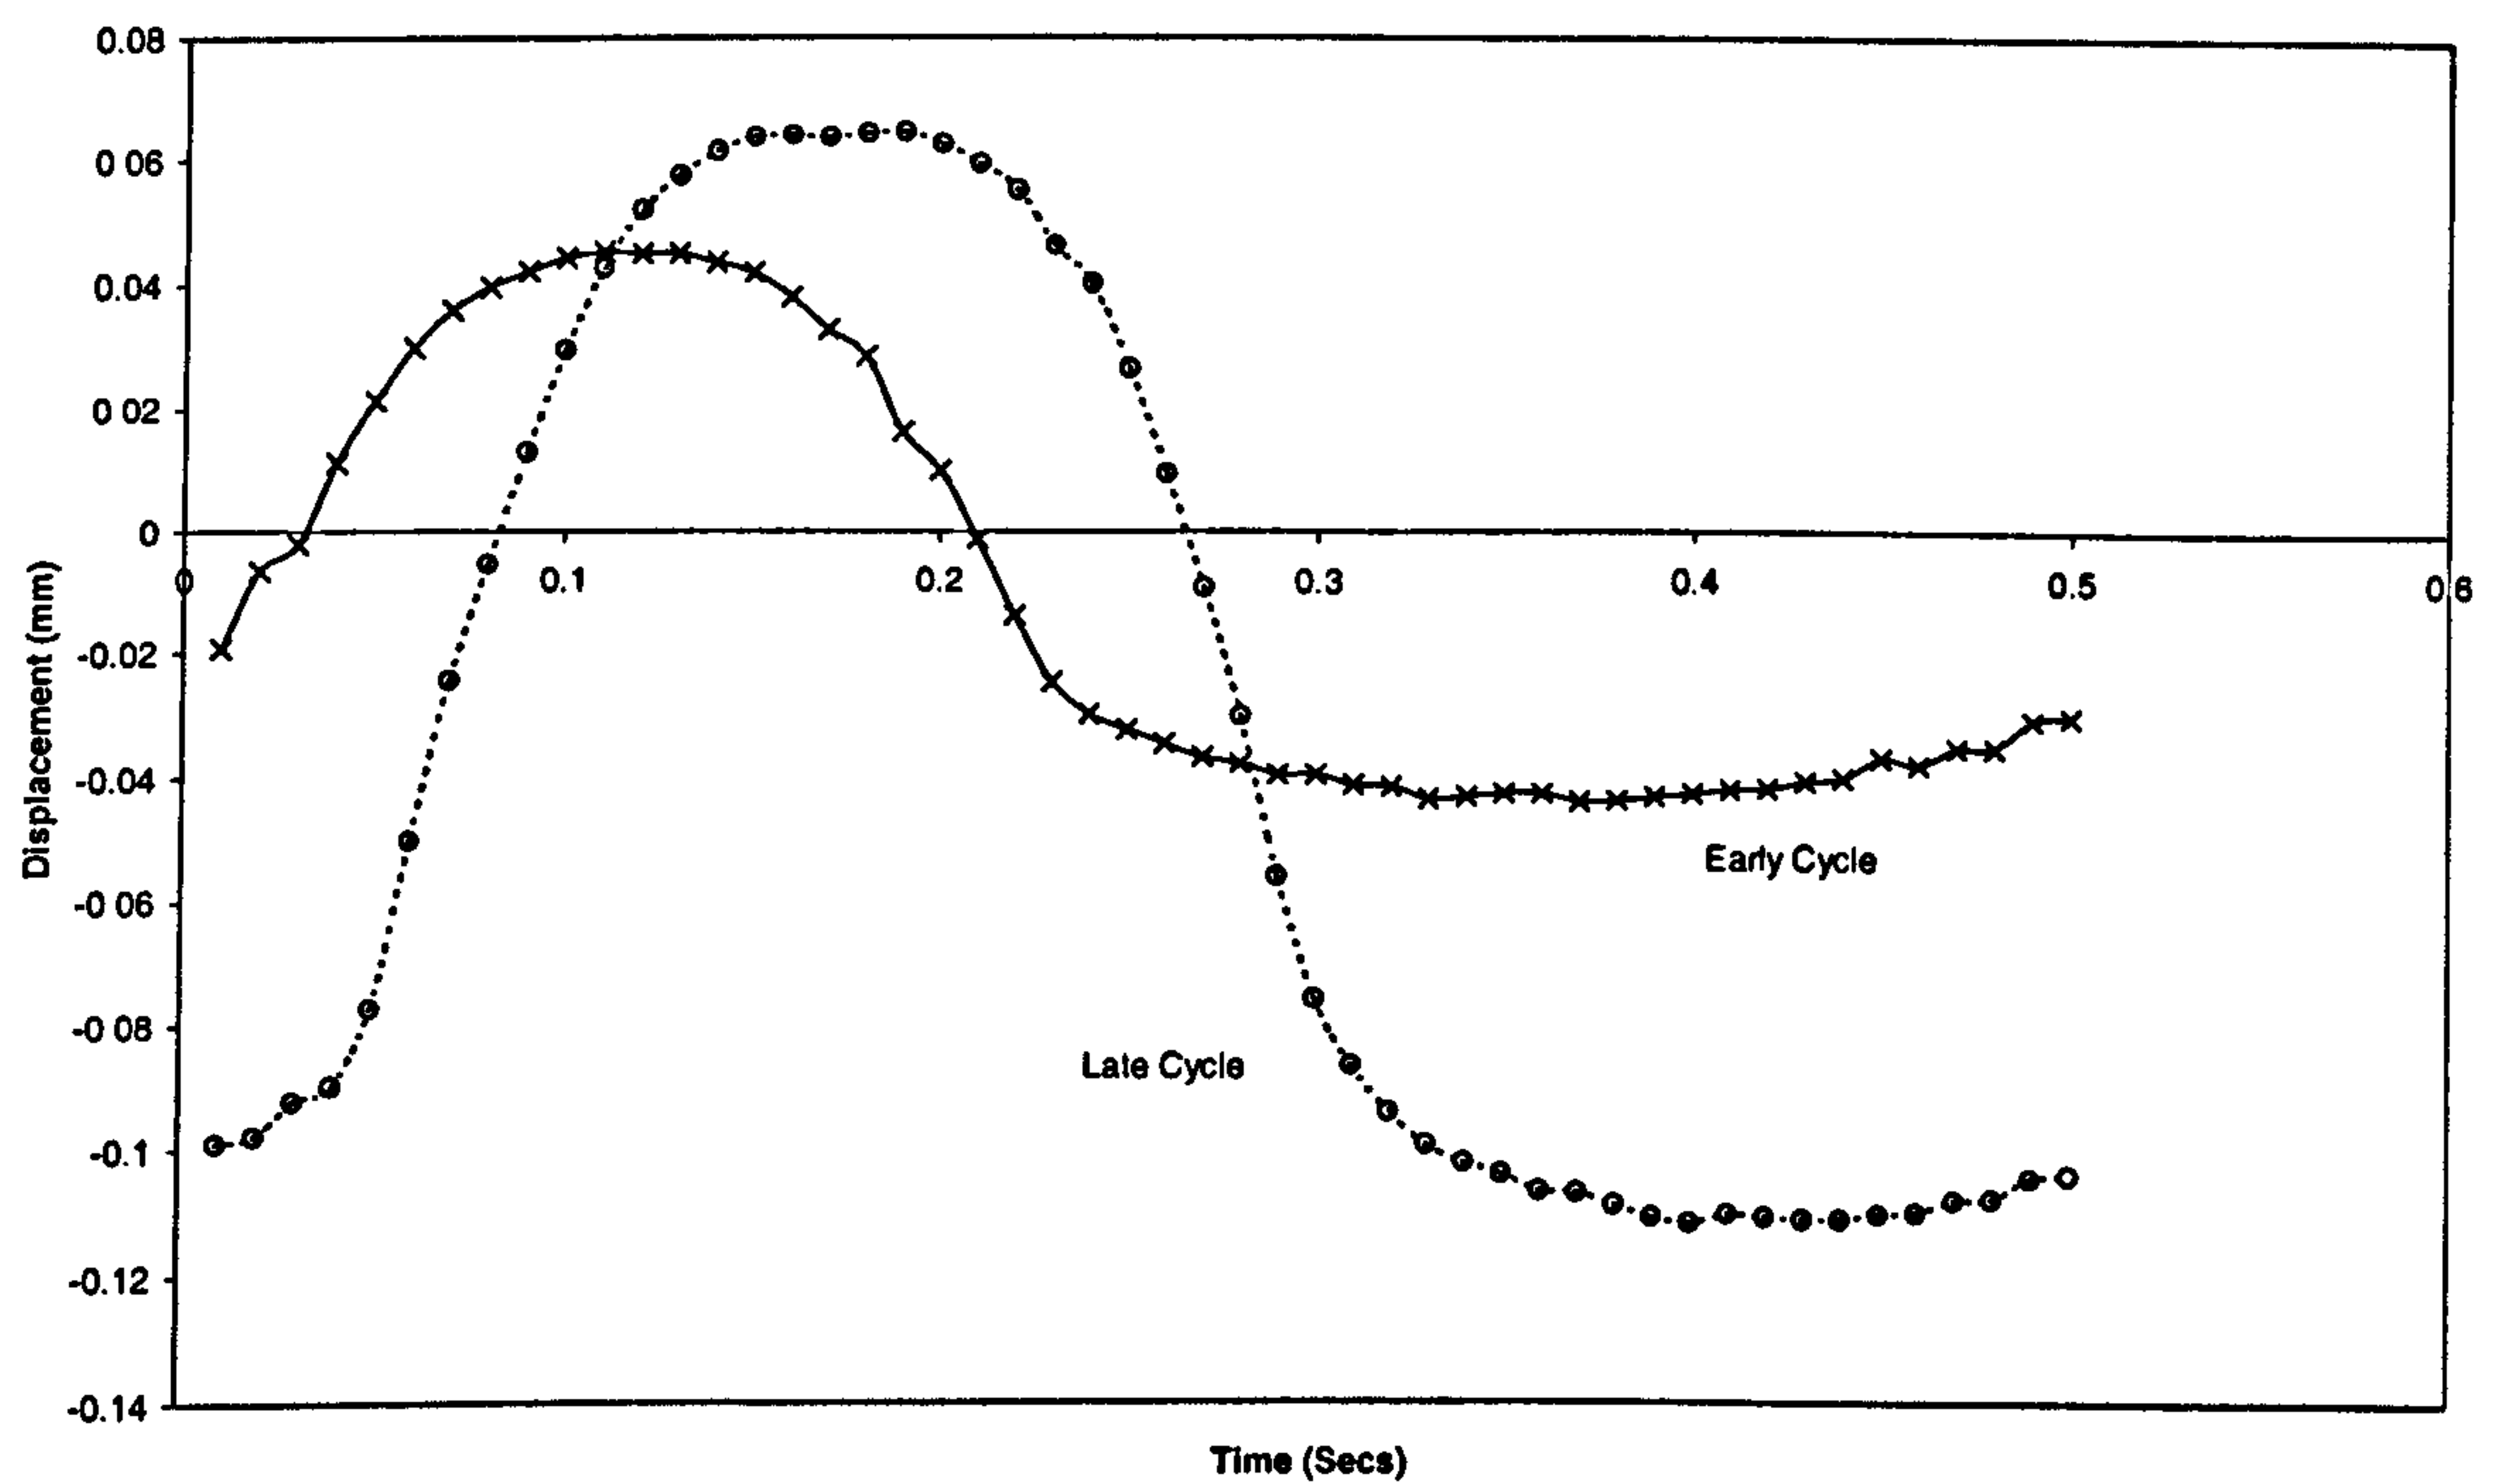
Figure 6.53b – Effect of deterioration on displacement resistance (steel fibre of aspect ratio 80 with 4.62mm crack width)

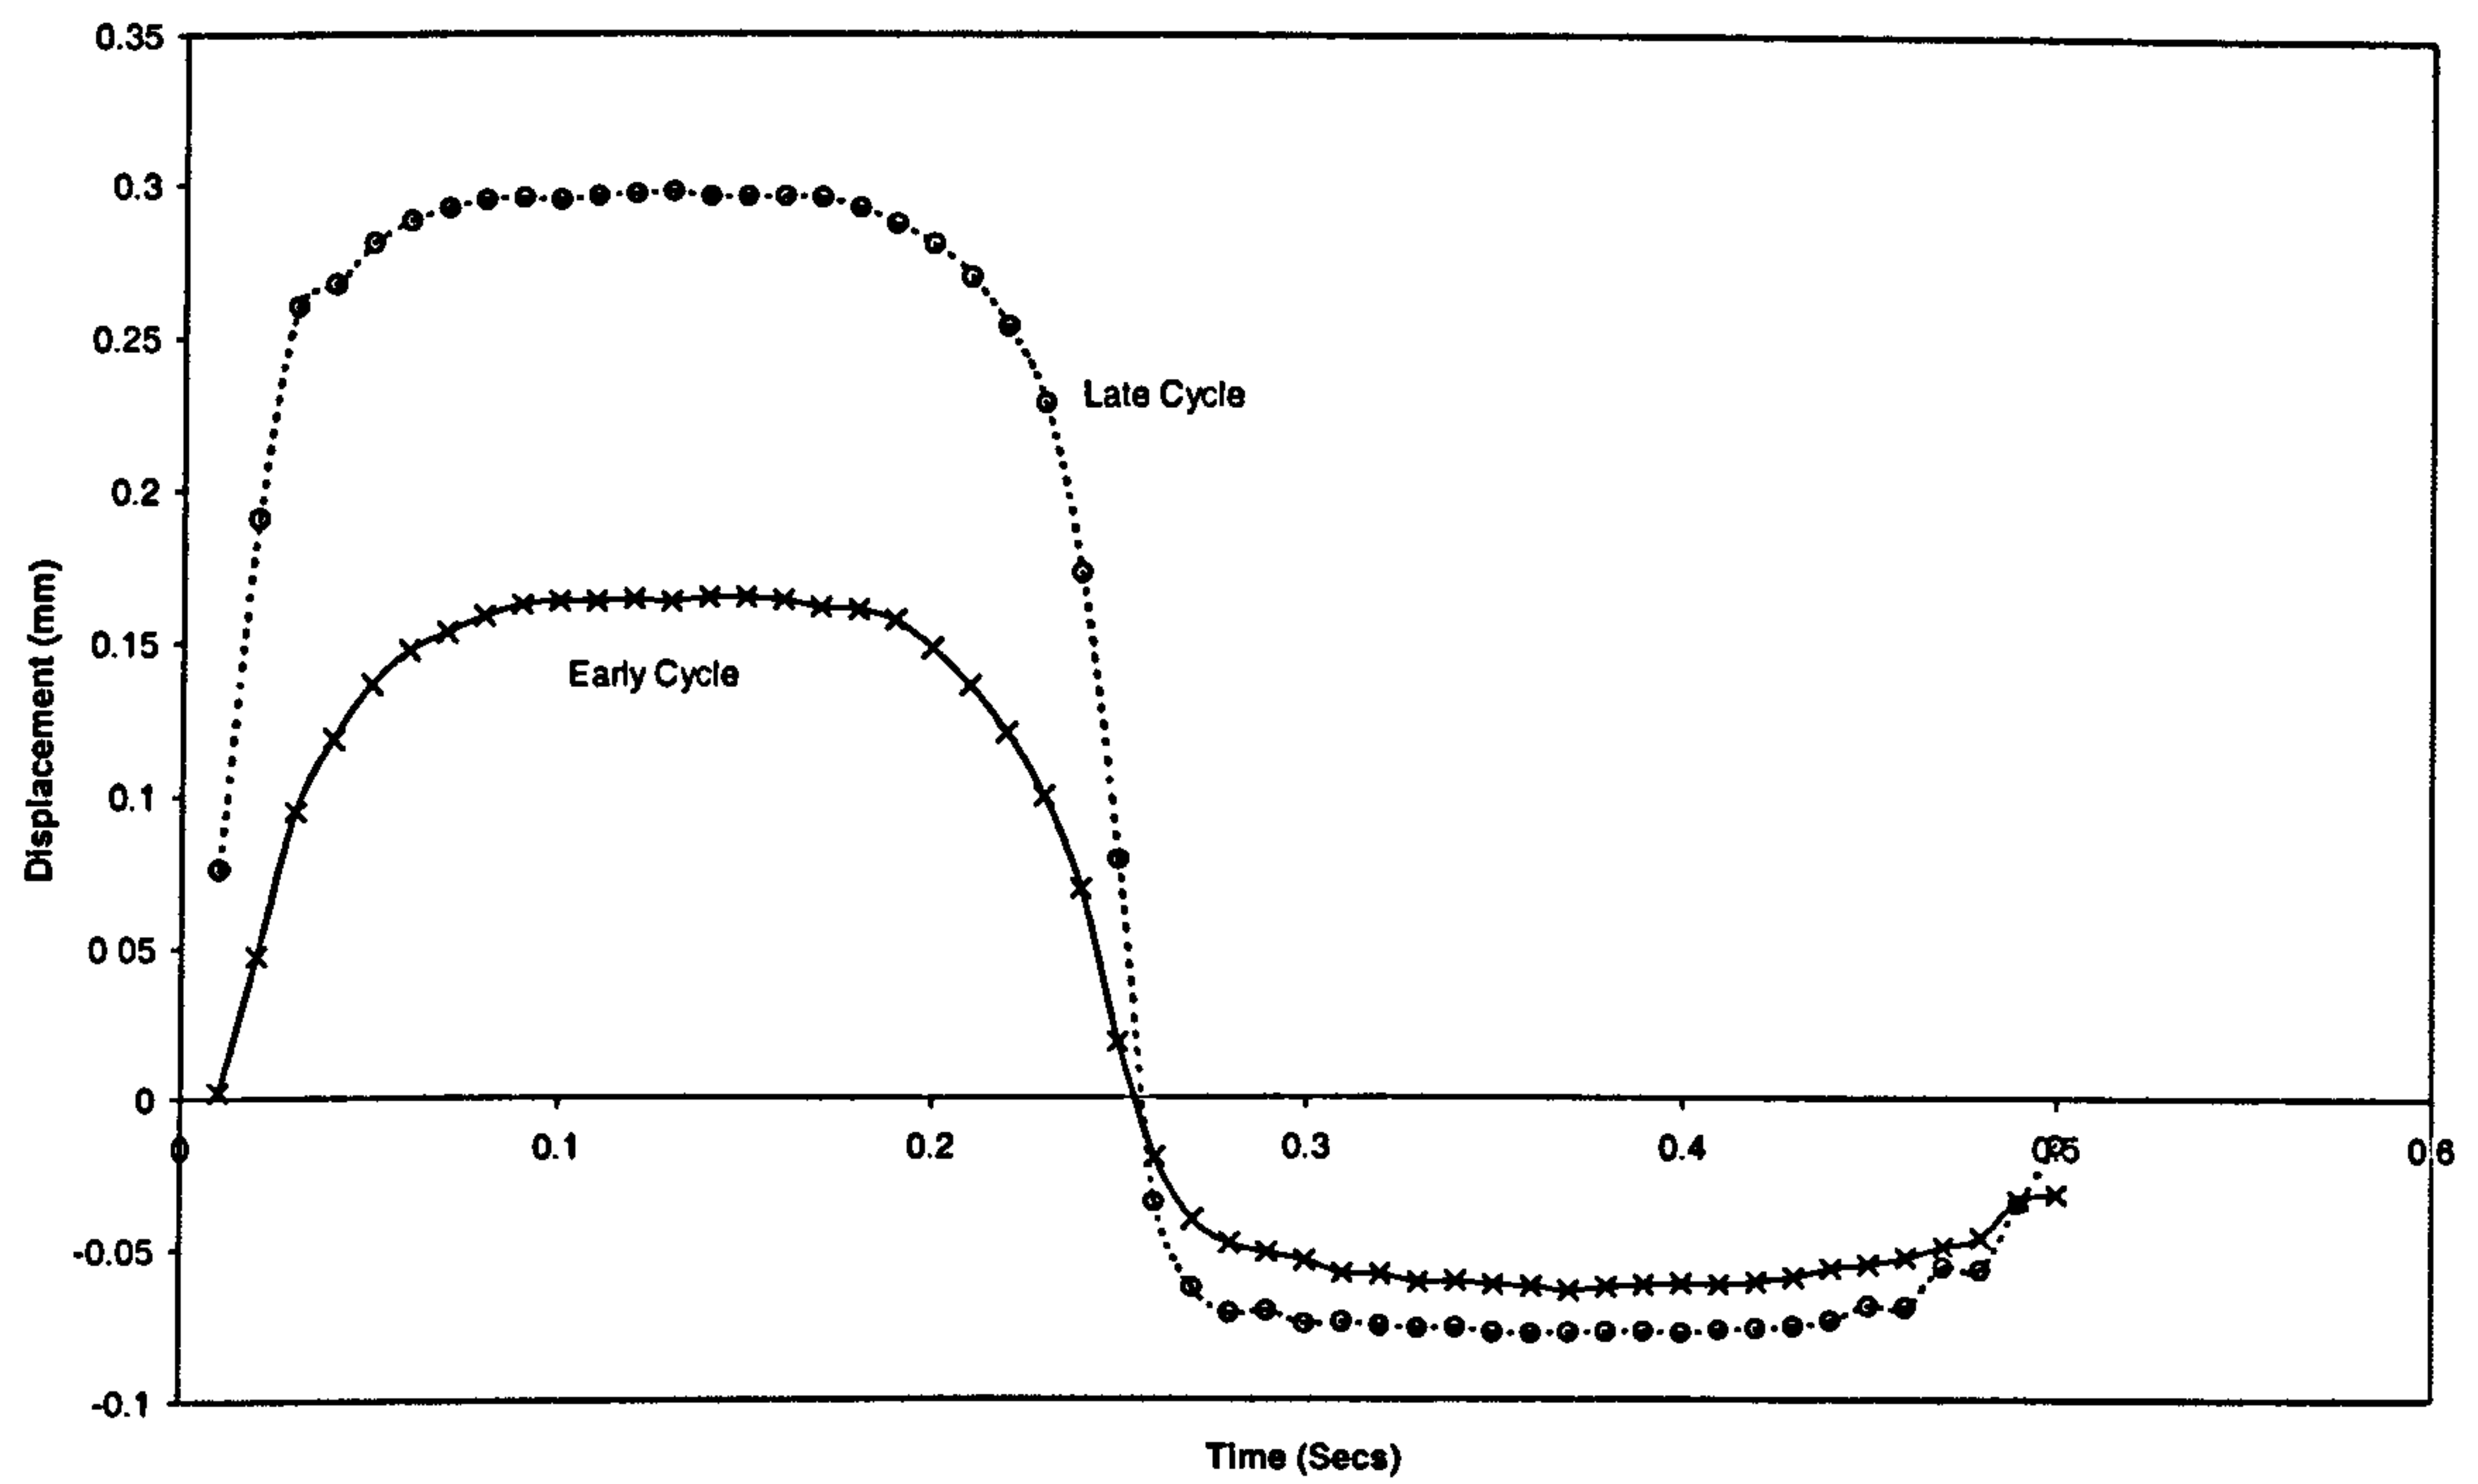
Figure 6.54a – Effect of deterioration on displacement resistance (steel fibre of aspect ratio 48 with 1.98mm crack width)

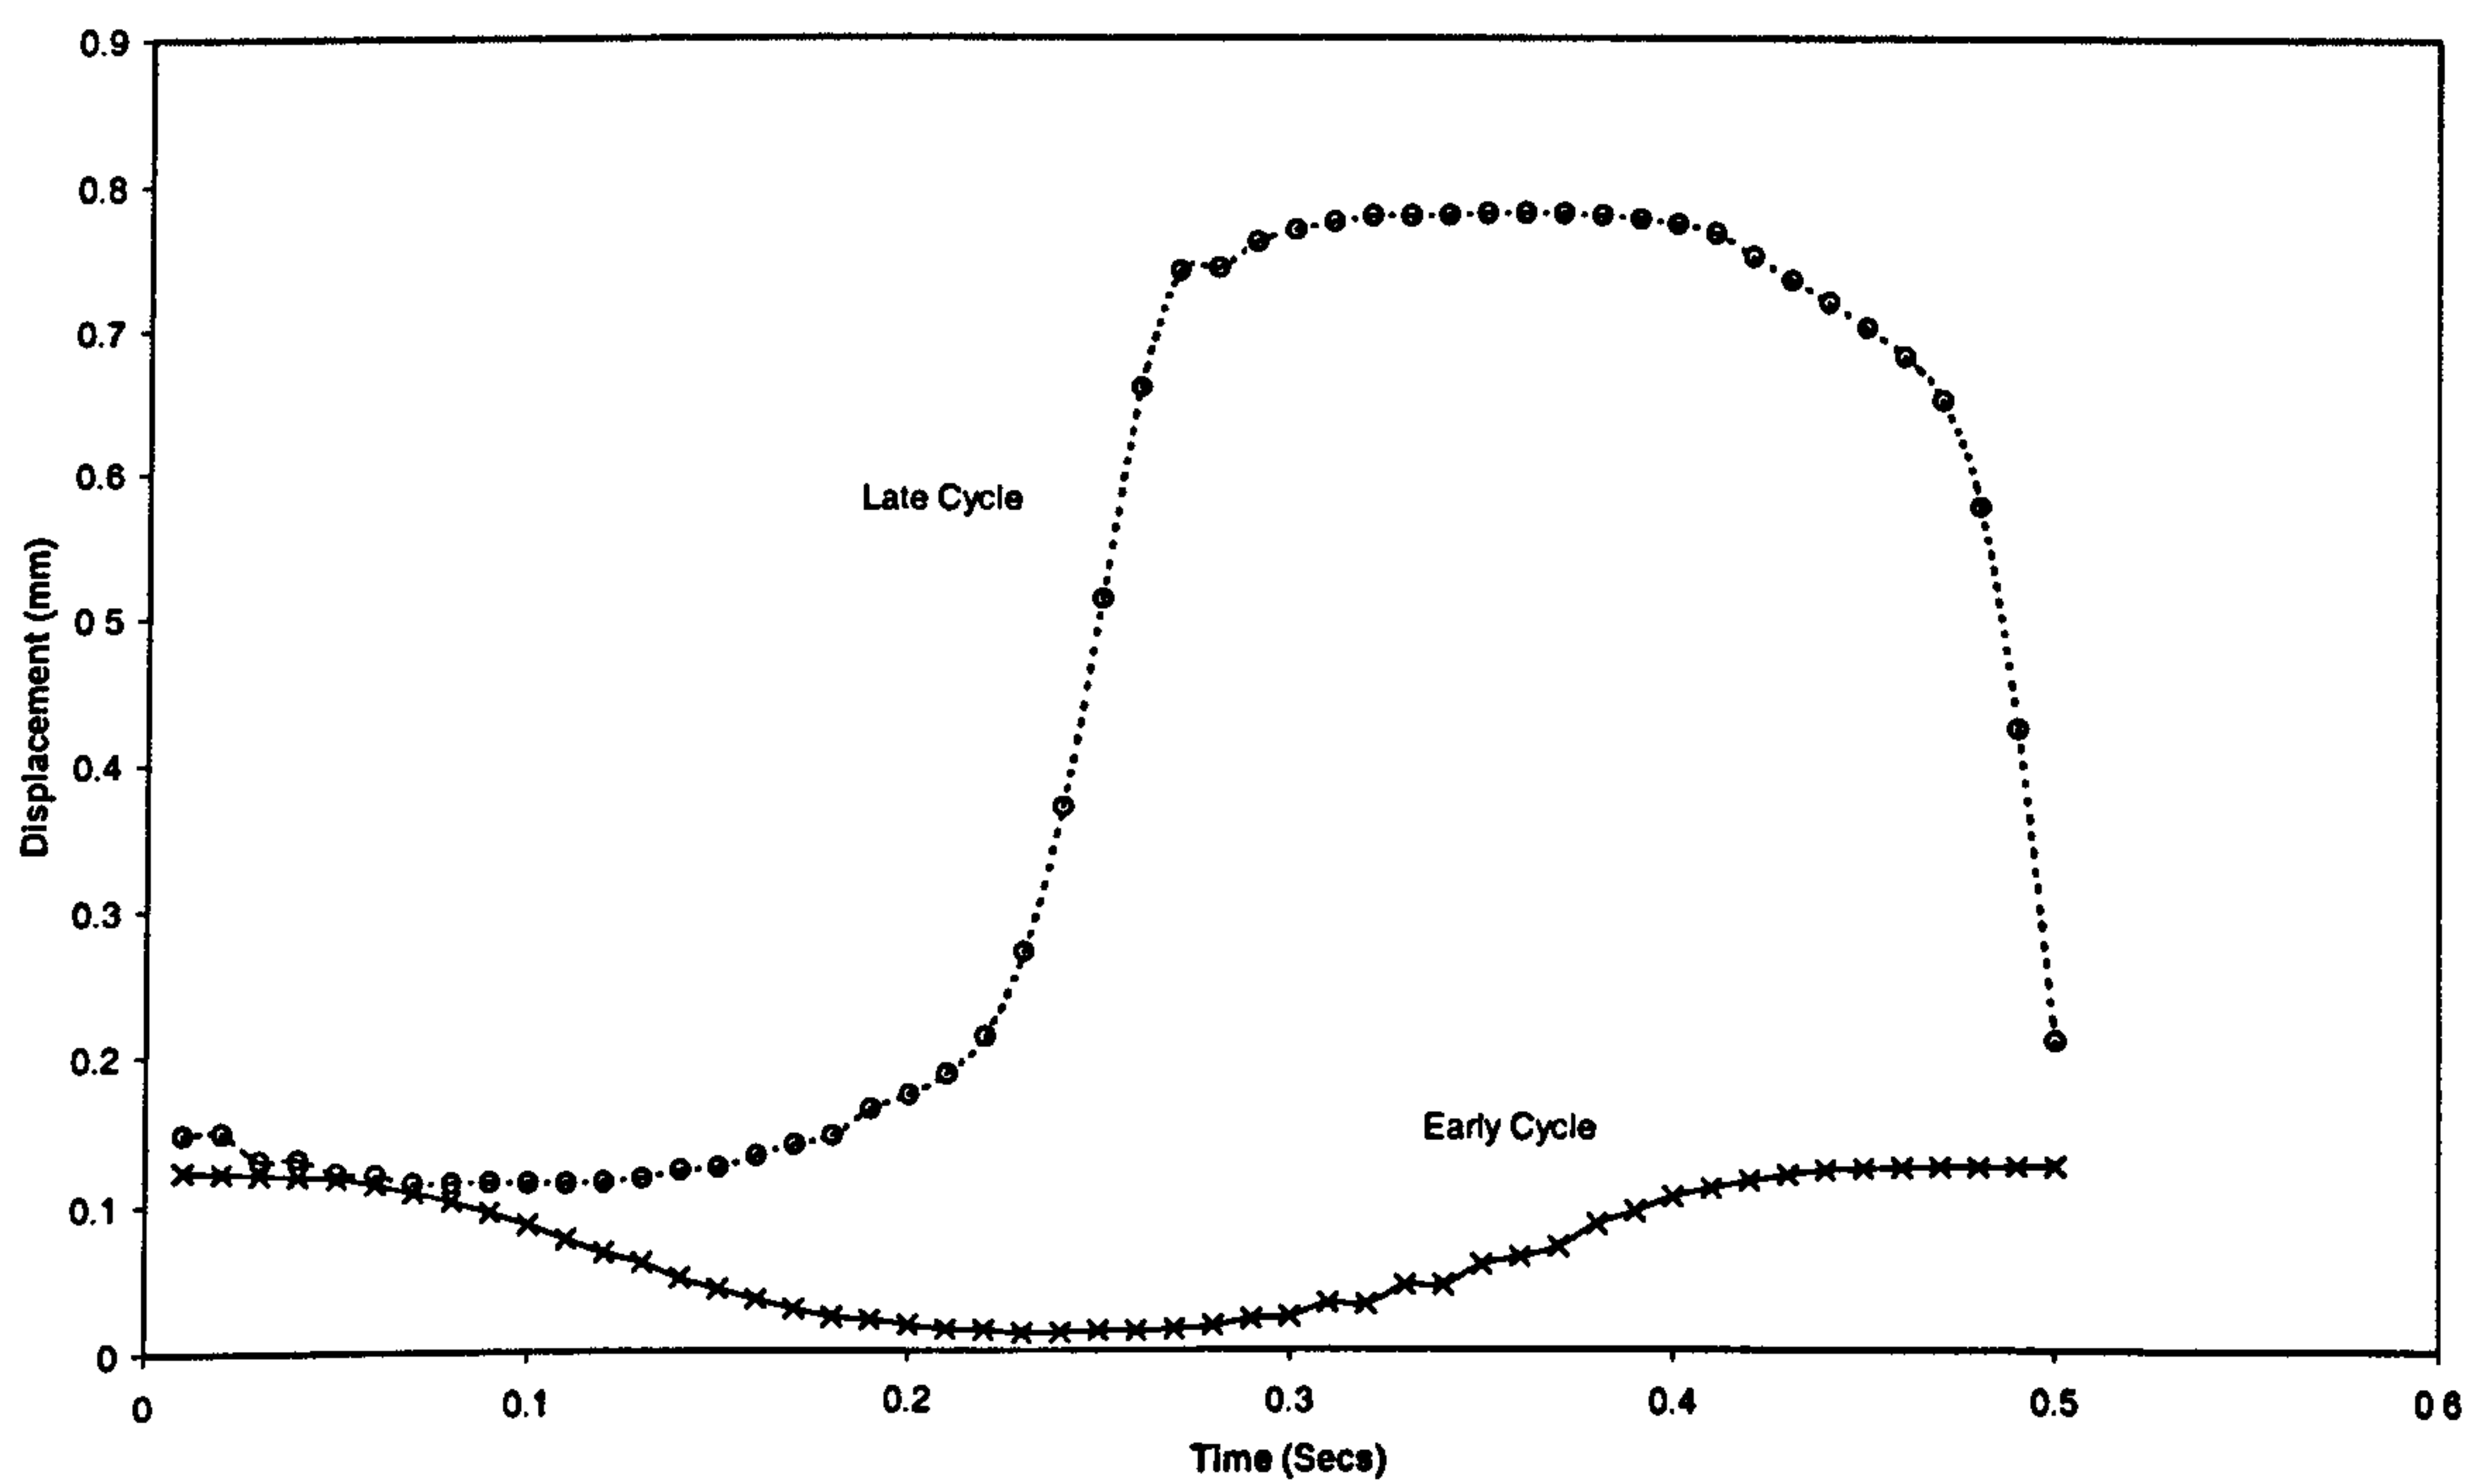
Figure 6.54b – Effect of deterioration on displacement resistance (steel fibre of aspect ratio 48 with 4.62mm crack width)

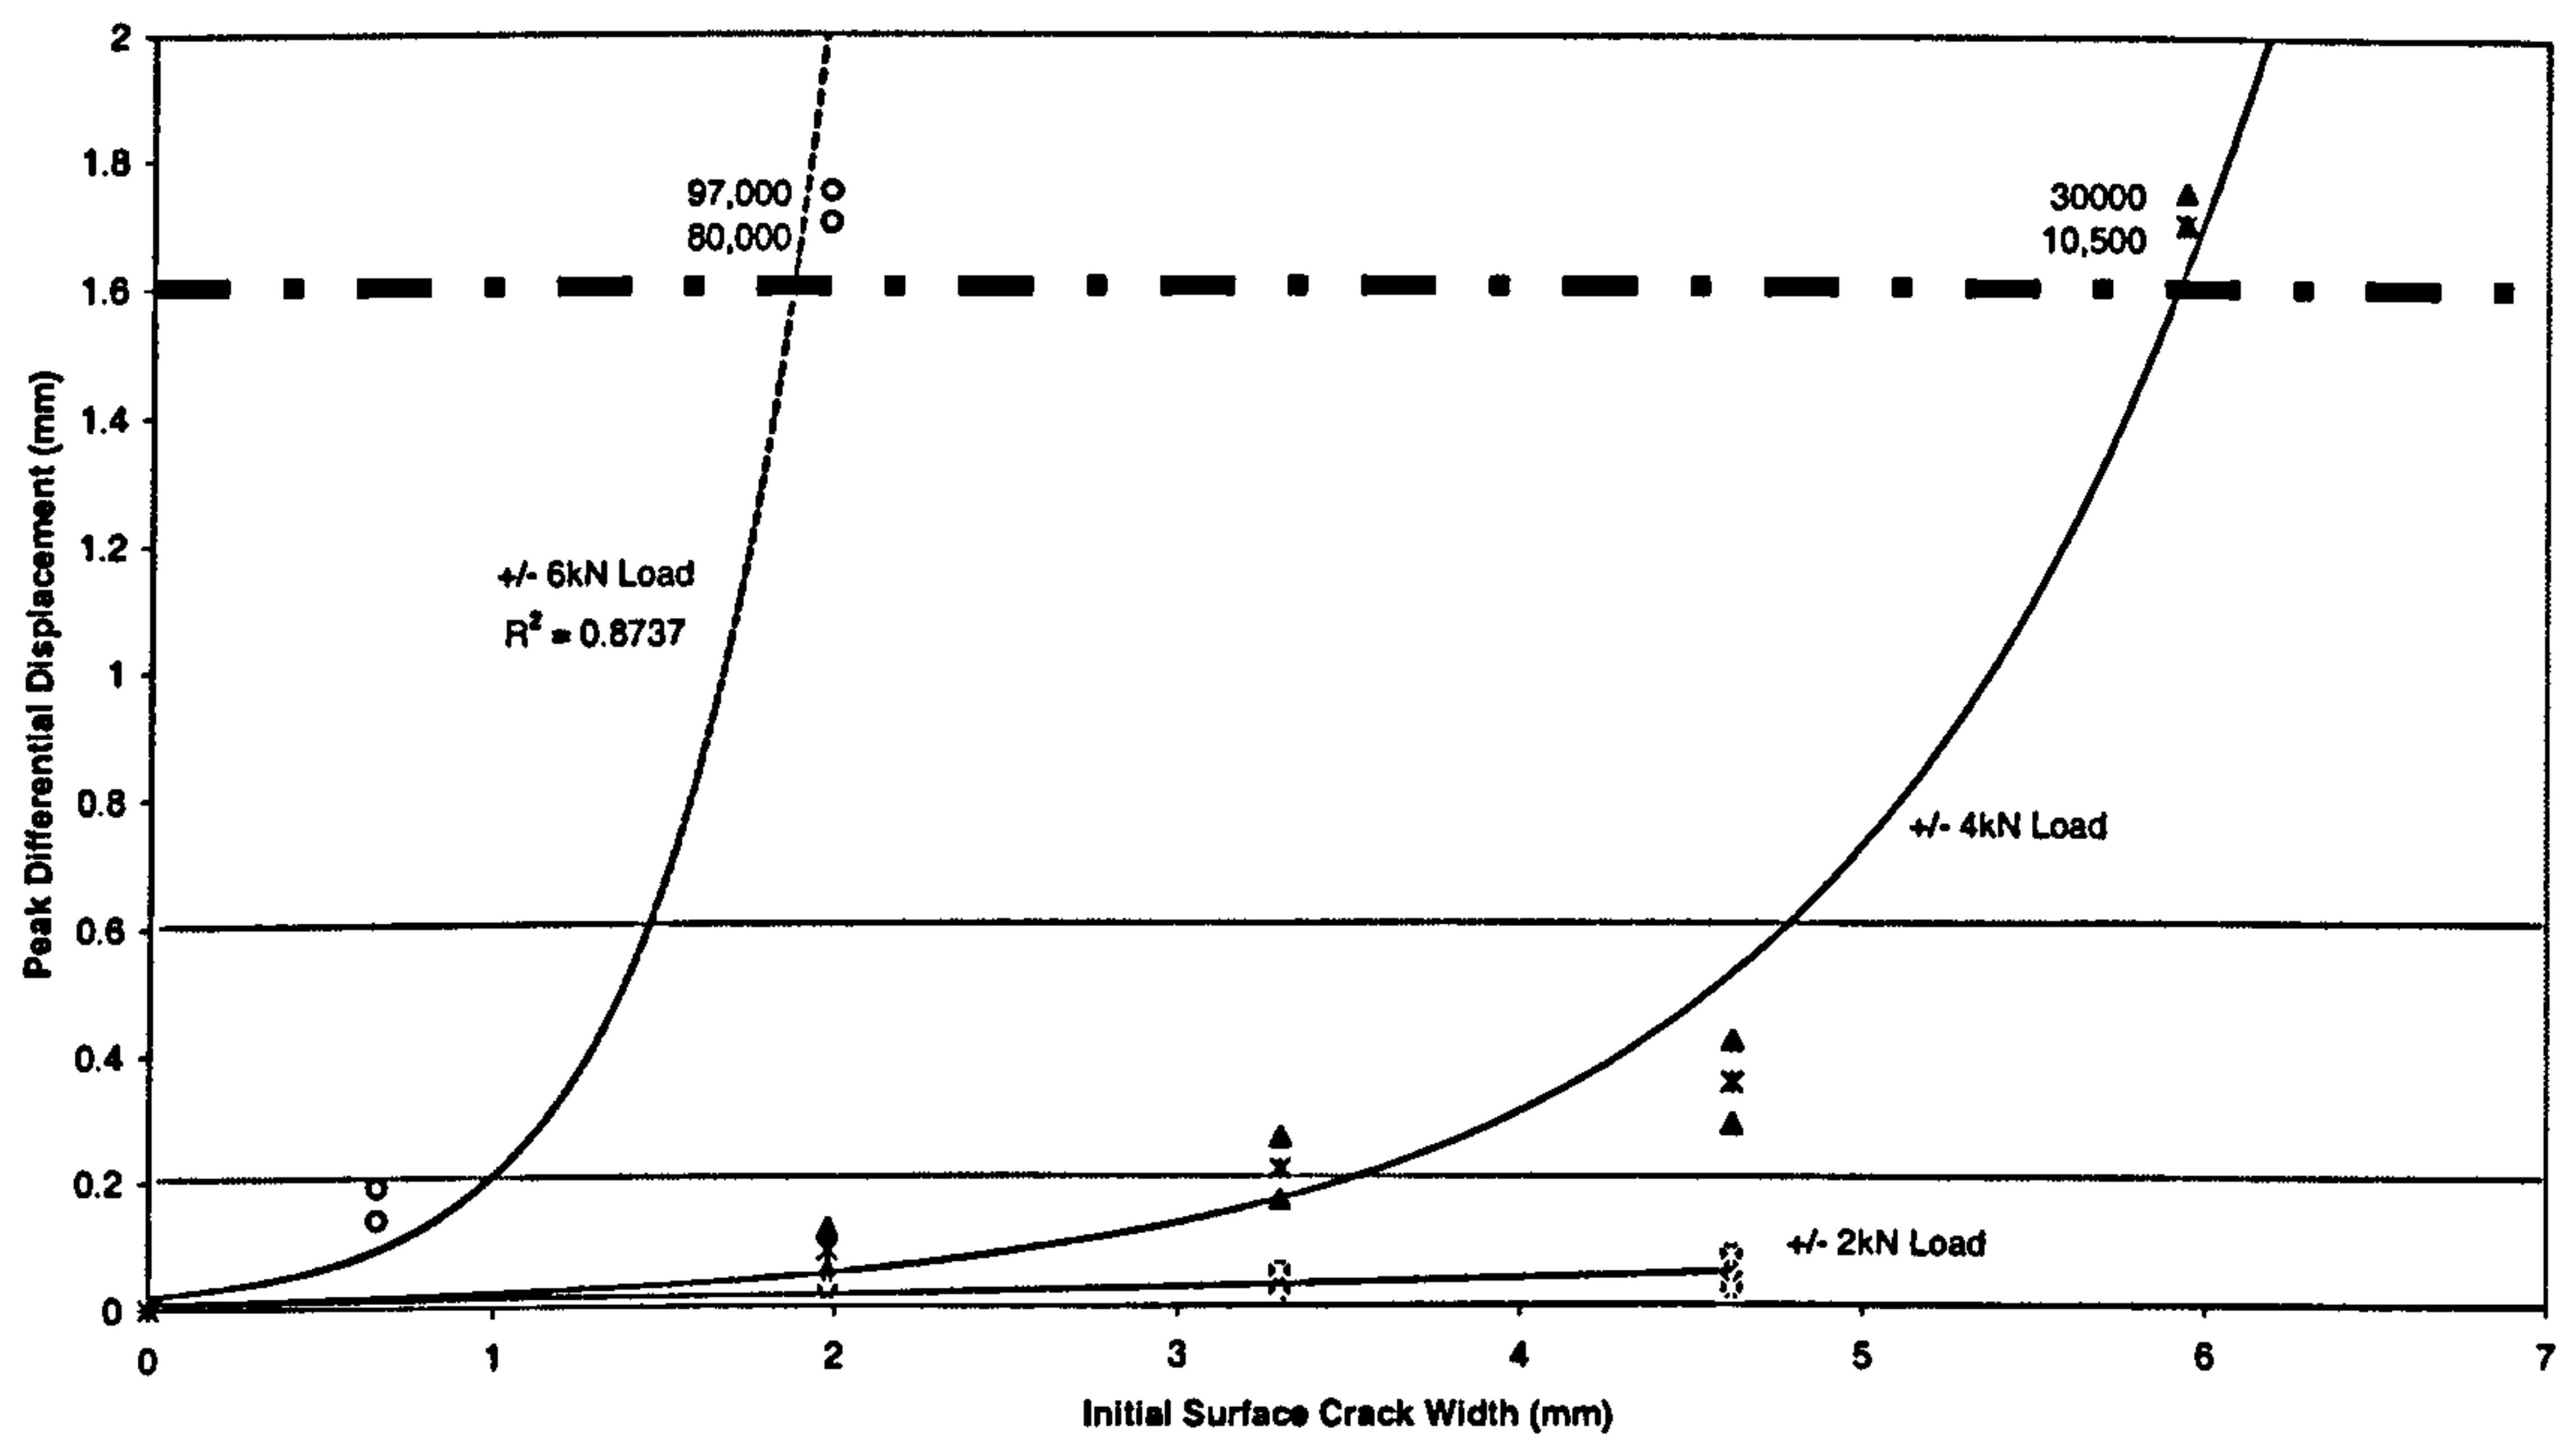
Figure 6.55 – Effect of load magnitude on differential displacement

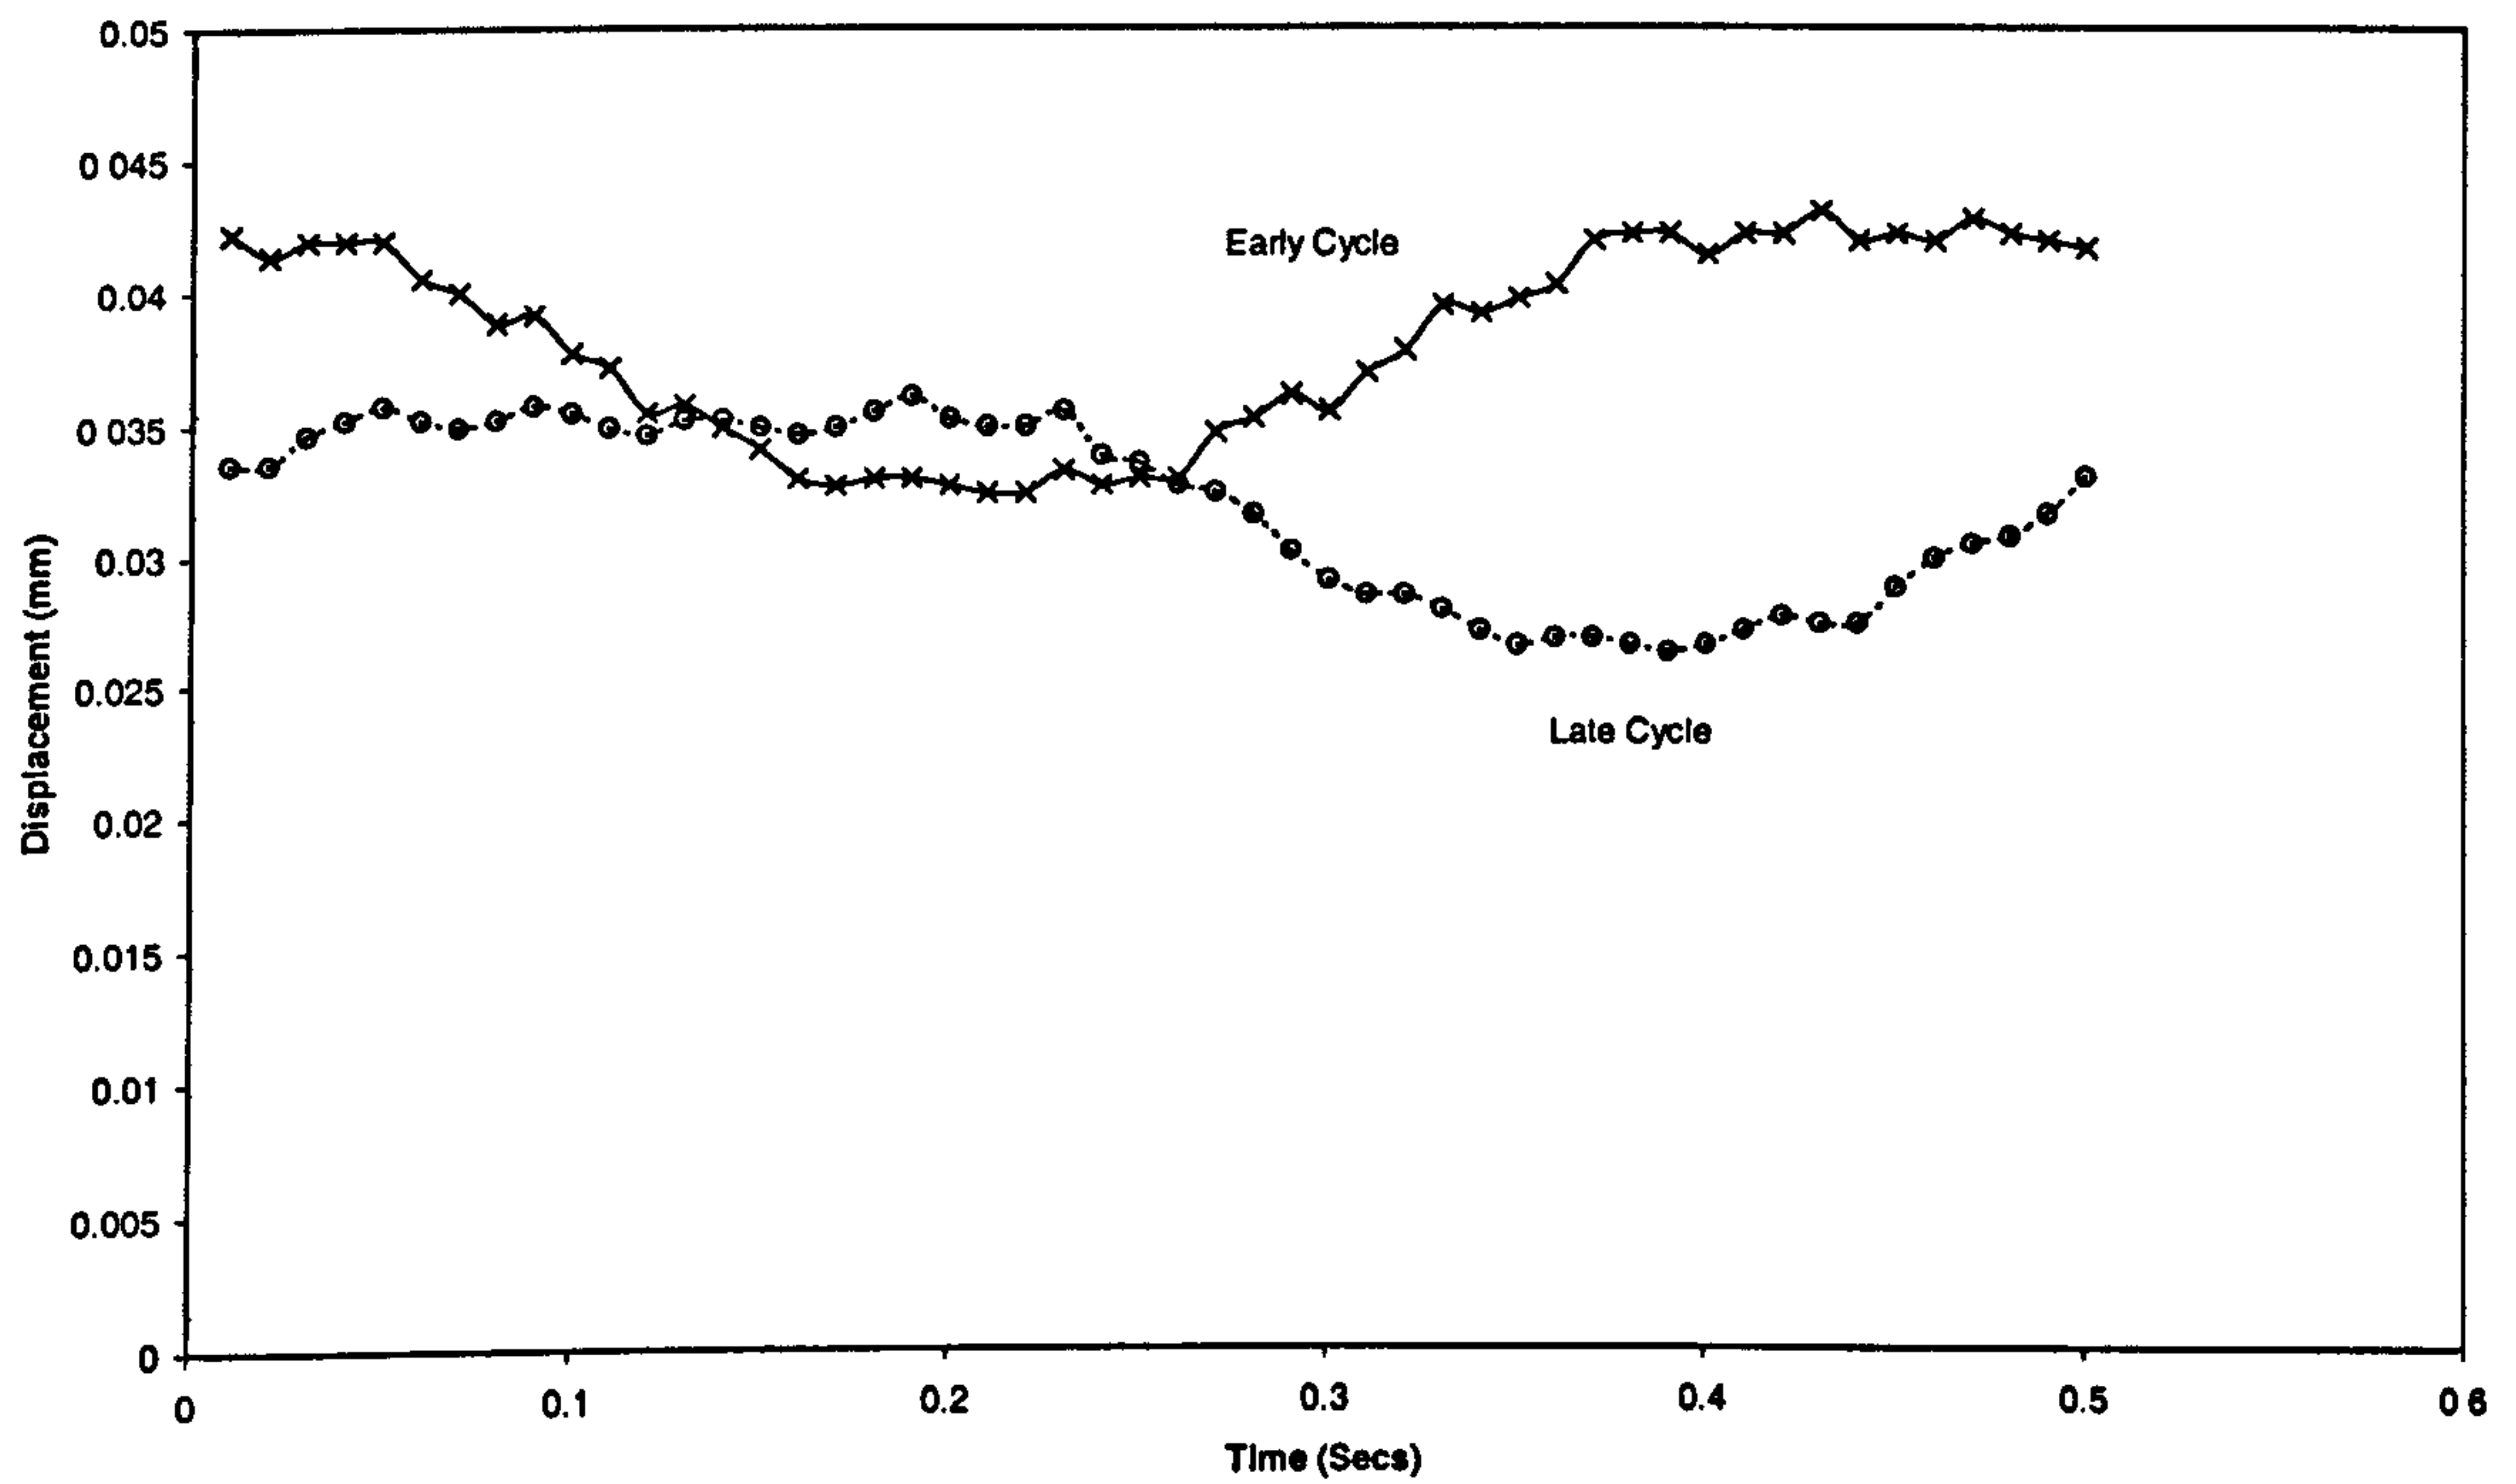
Figure 6.56a – Effect of deterioration on displacement resistance (load magnitude of 2kN with 1.98mm crack width)
