LOAD TRANSFER ACROSS CRACKS AND JOINTS IN CONCRETE SLABS ON GRADE

Stuart John Arnold

**A Doctoral Thesis Submitted in partial fulfilment of the requirements for the
award of
Doctor of Philosophy of Loughborough University**

20th February 2004

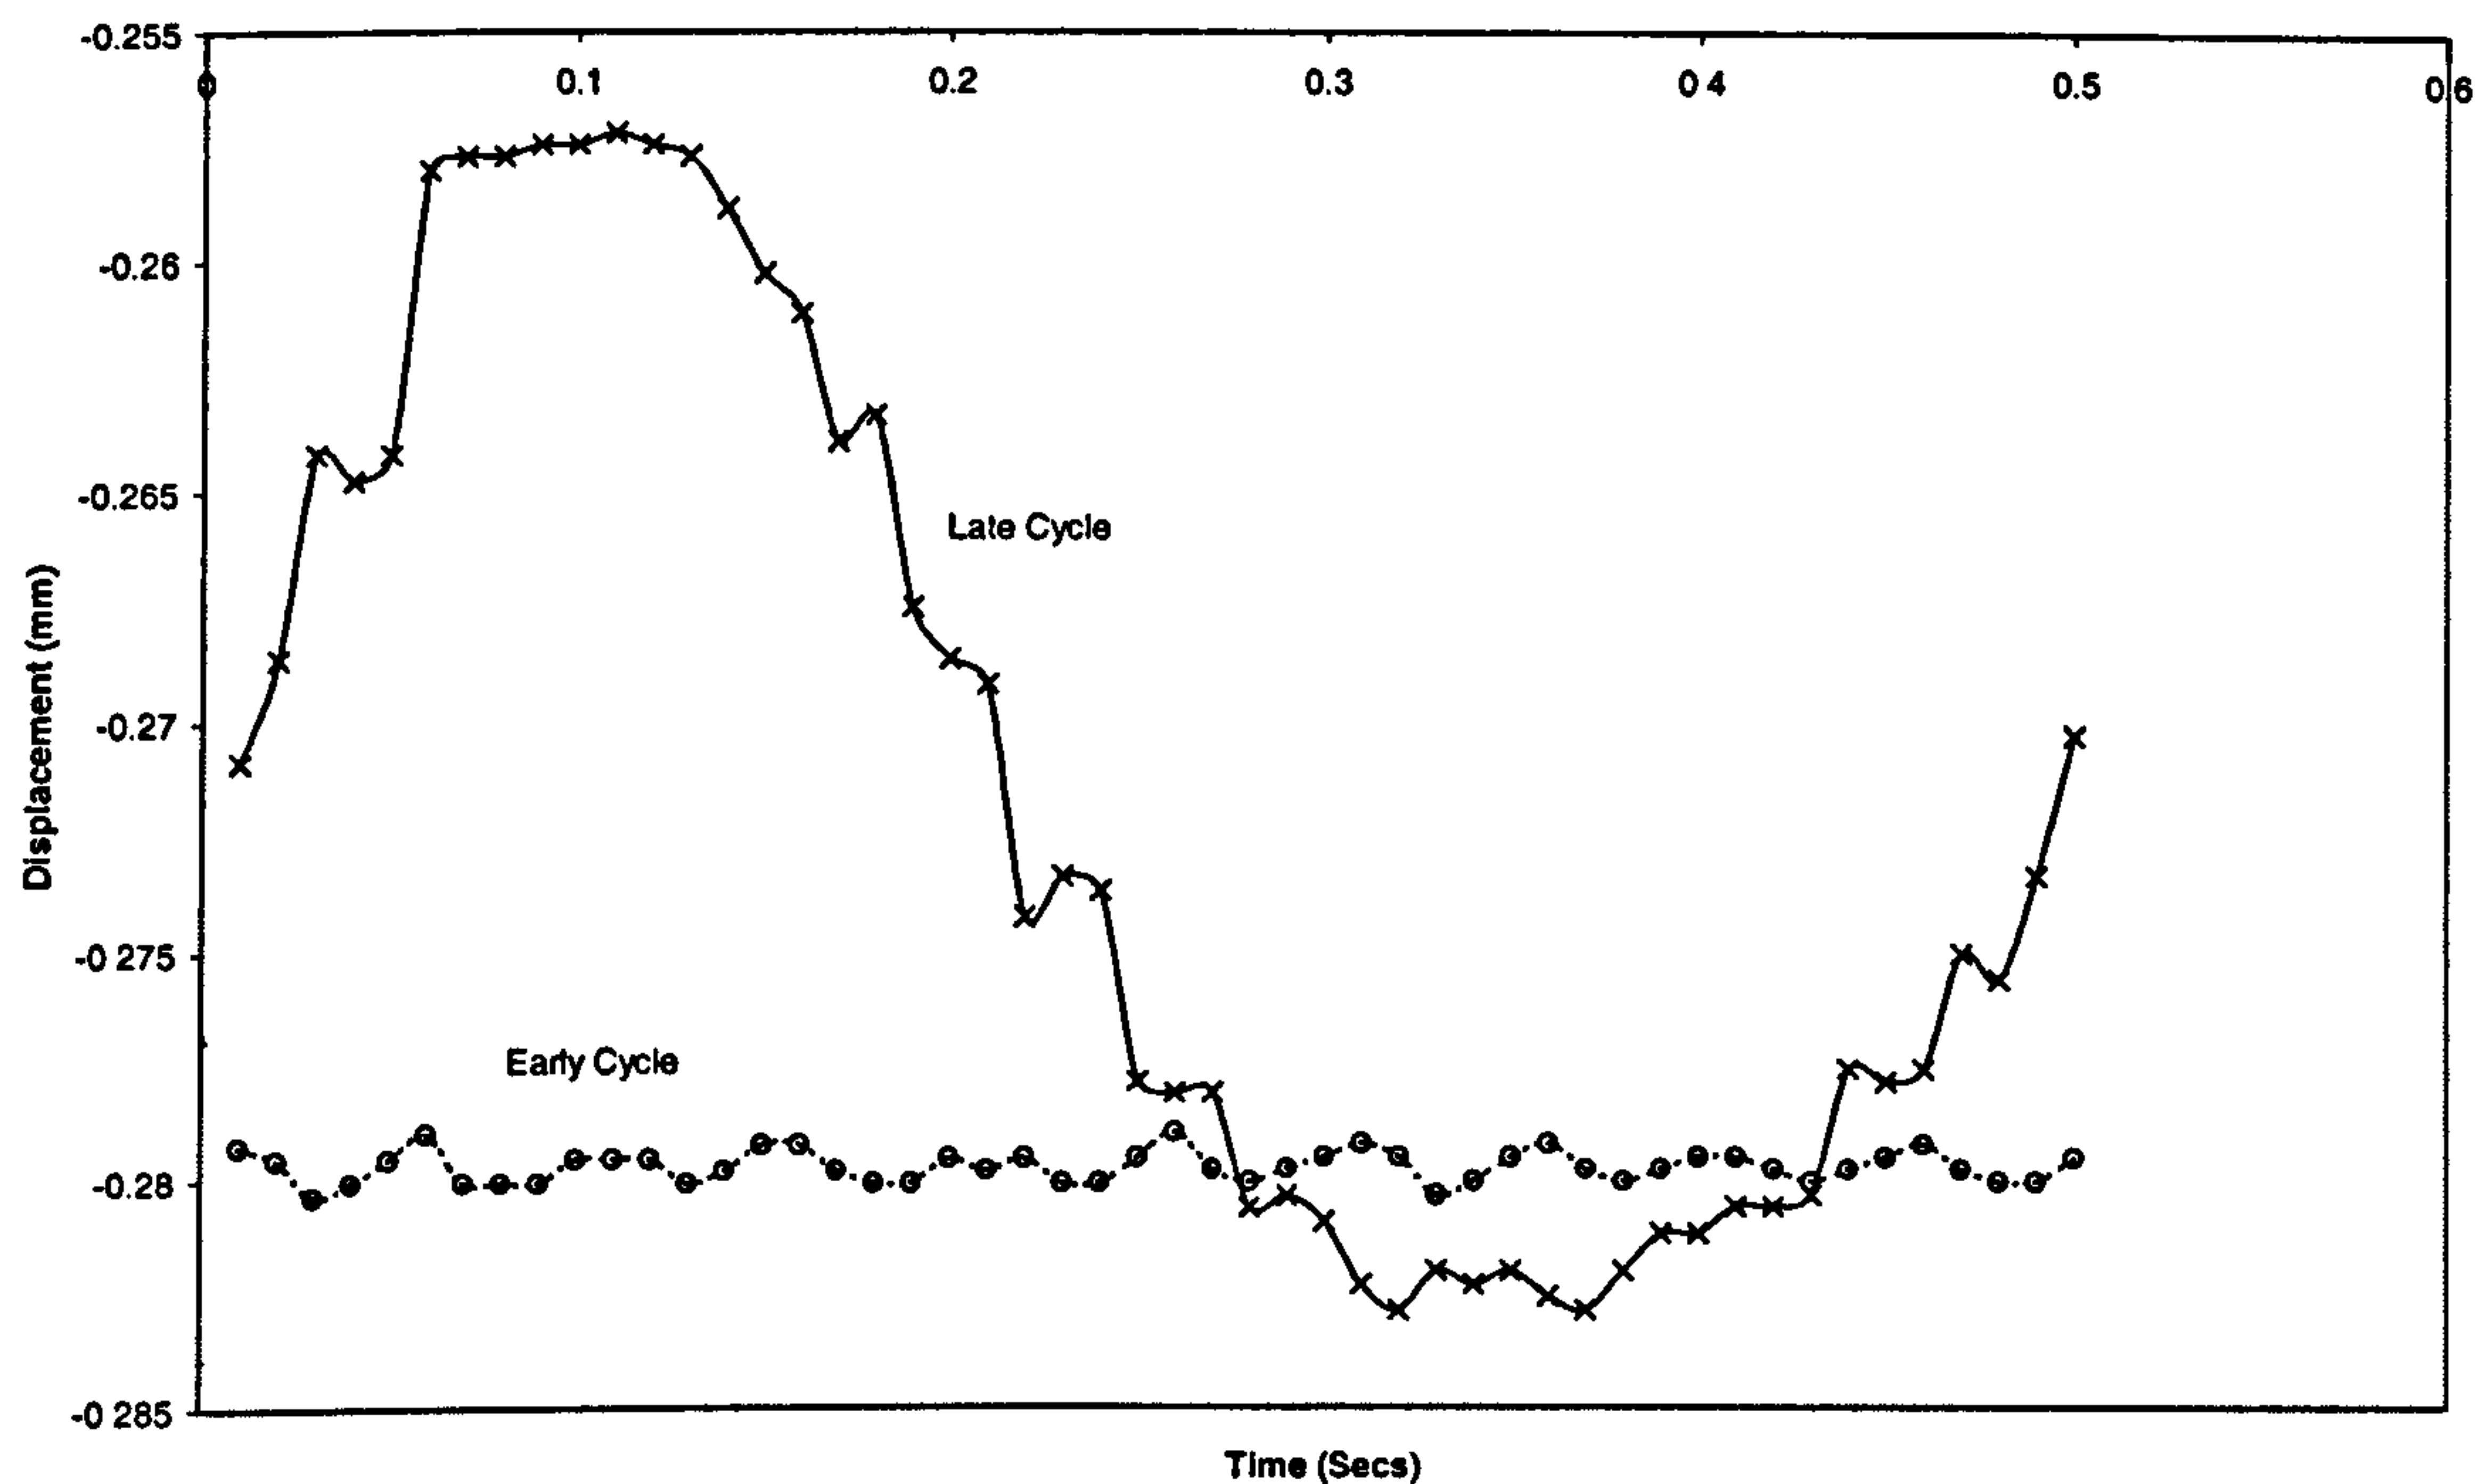
Figure 6.56b – Effect of deterioration on displacement resistance (load magnitude of 2kN with 4.62mm crack width)

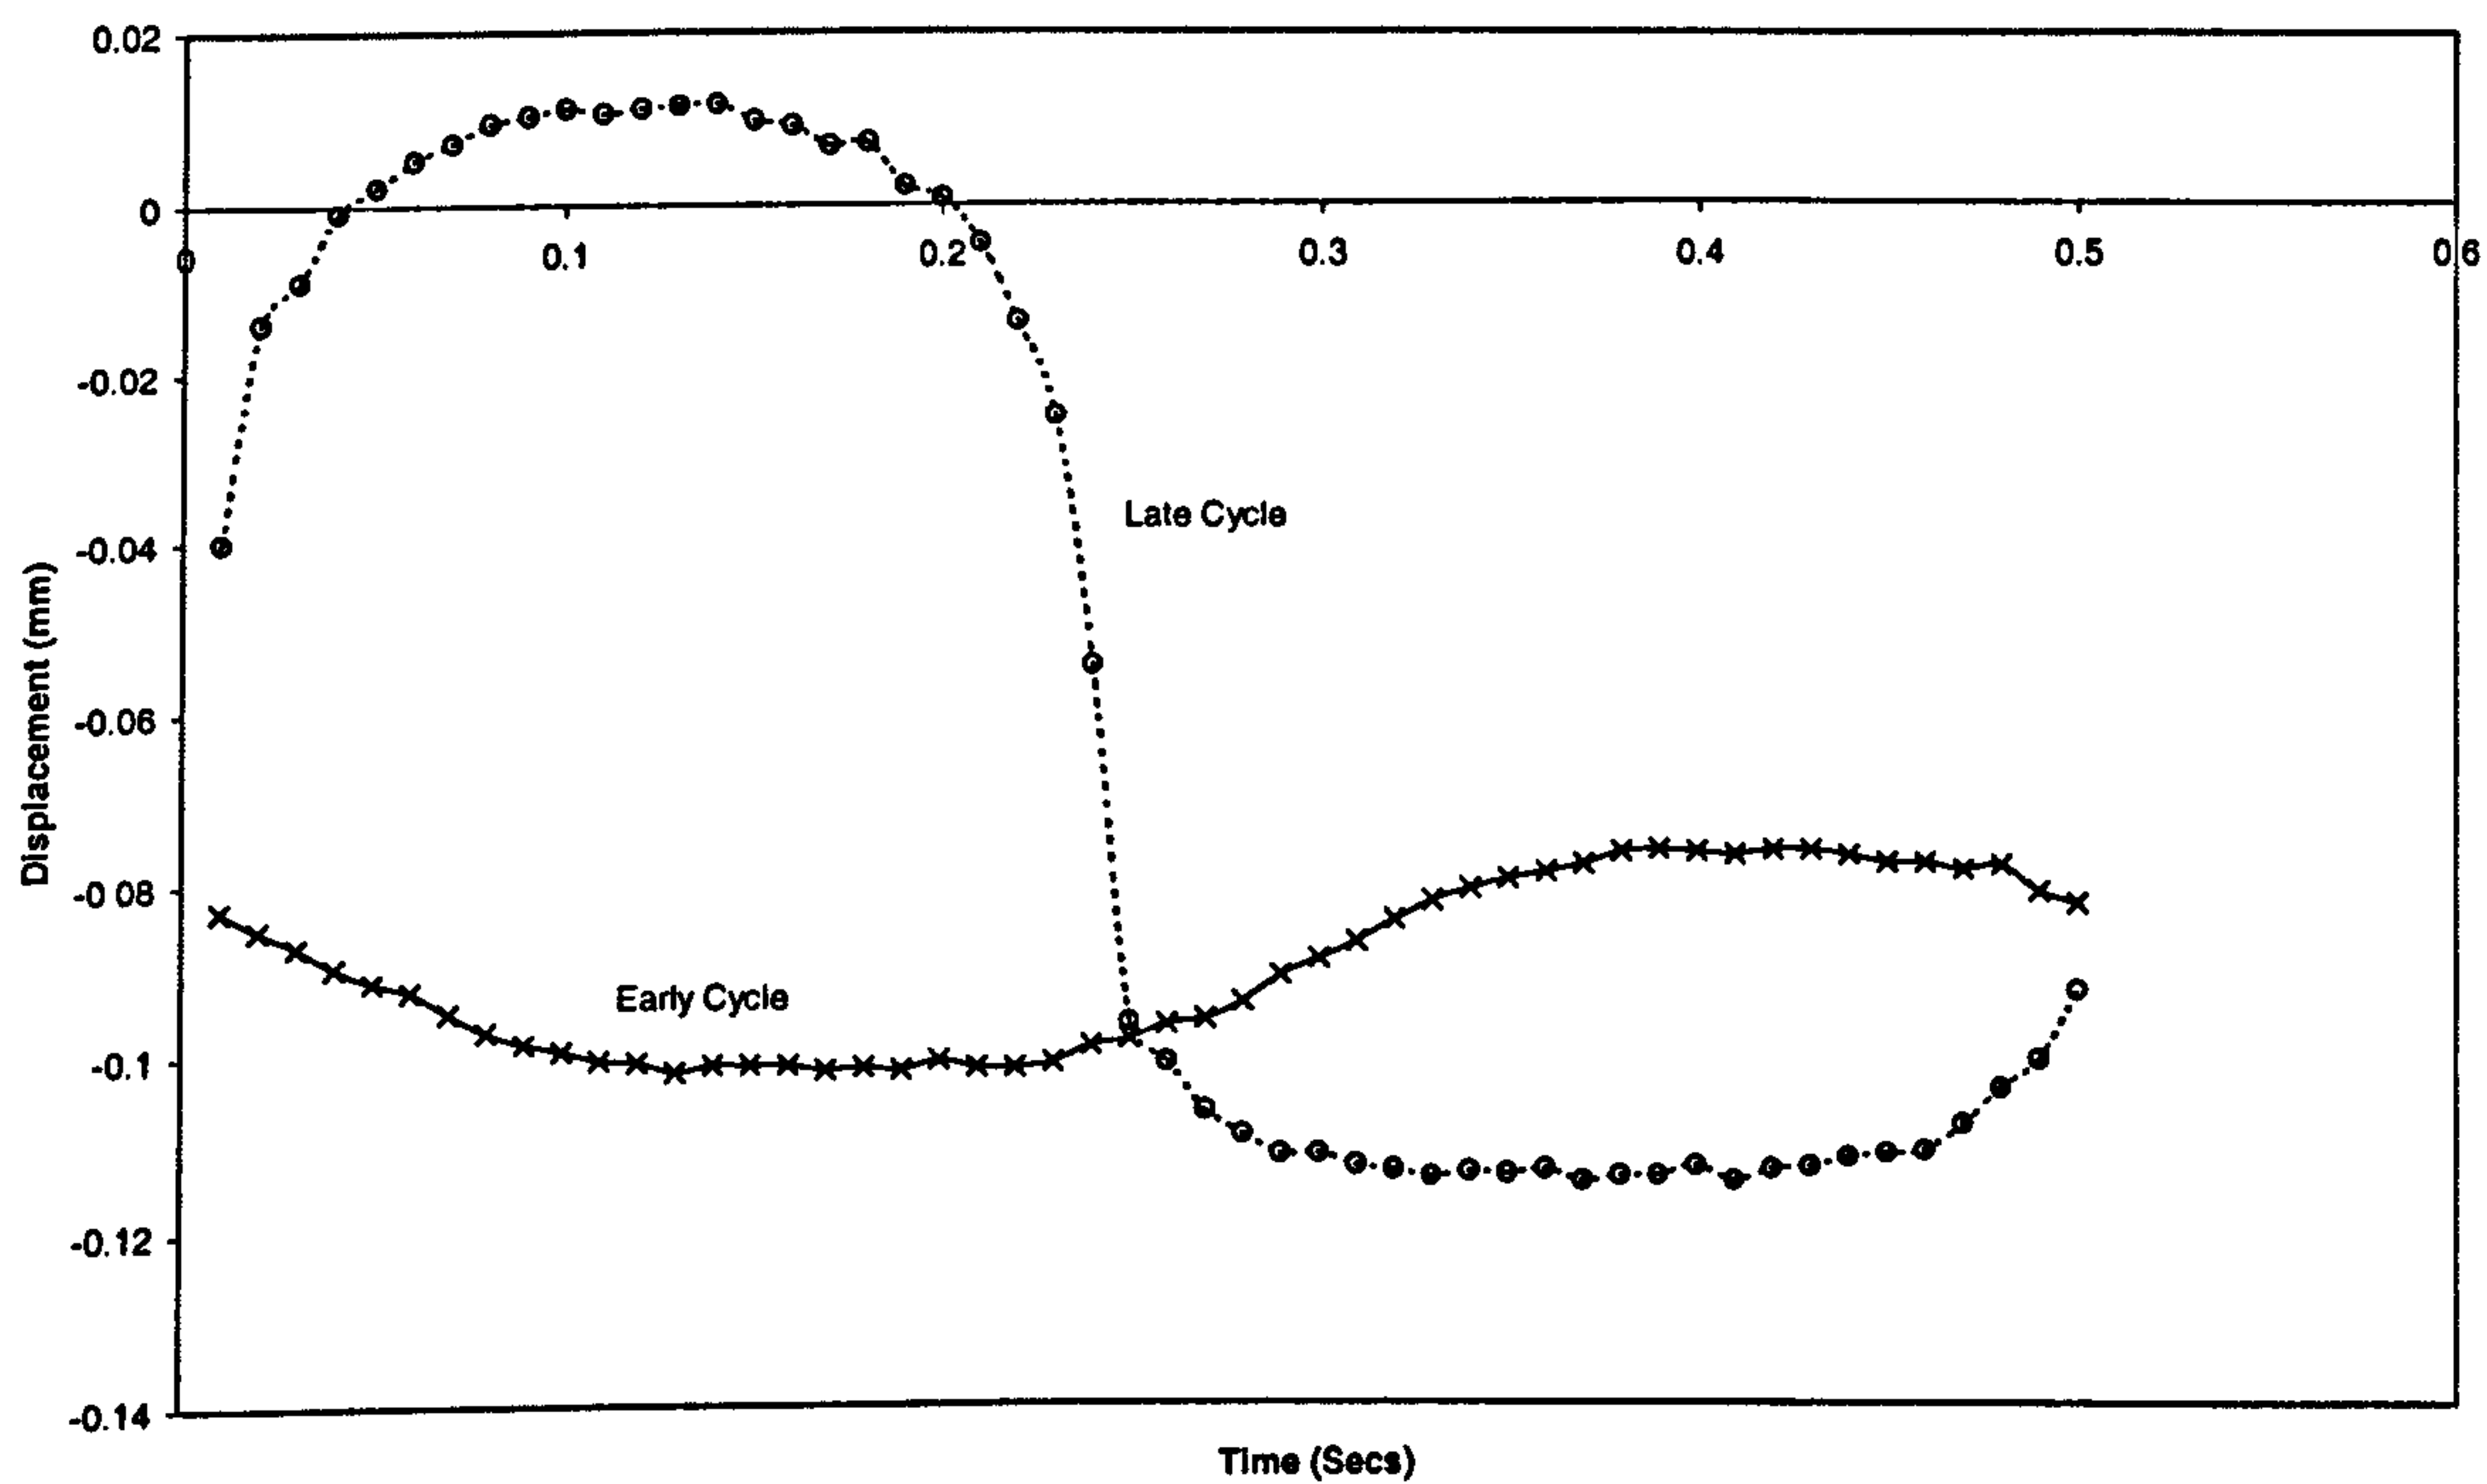
Figure 6.57a – Effect of deterioration on displacement resistance (load magnitude of 6kN with 0.66mm crack width)

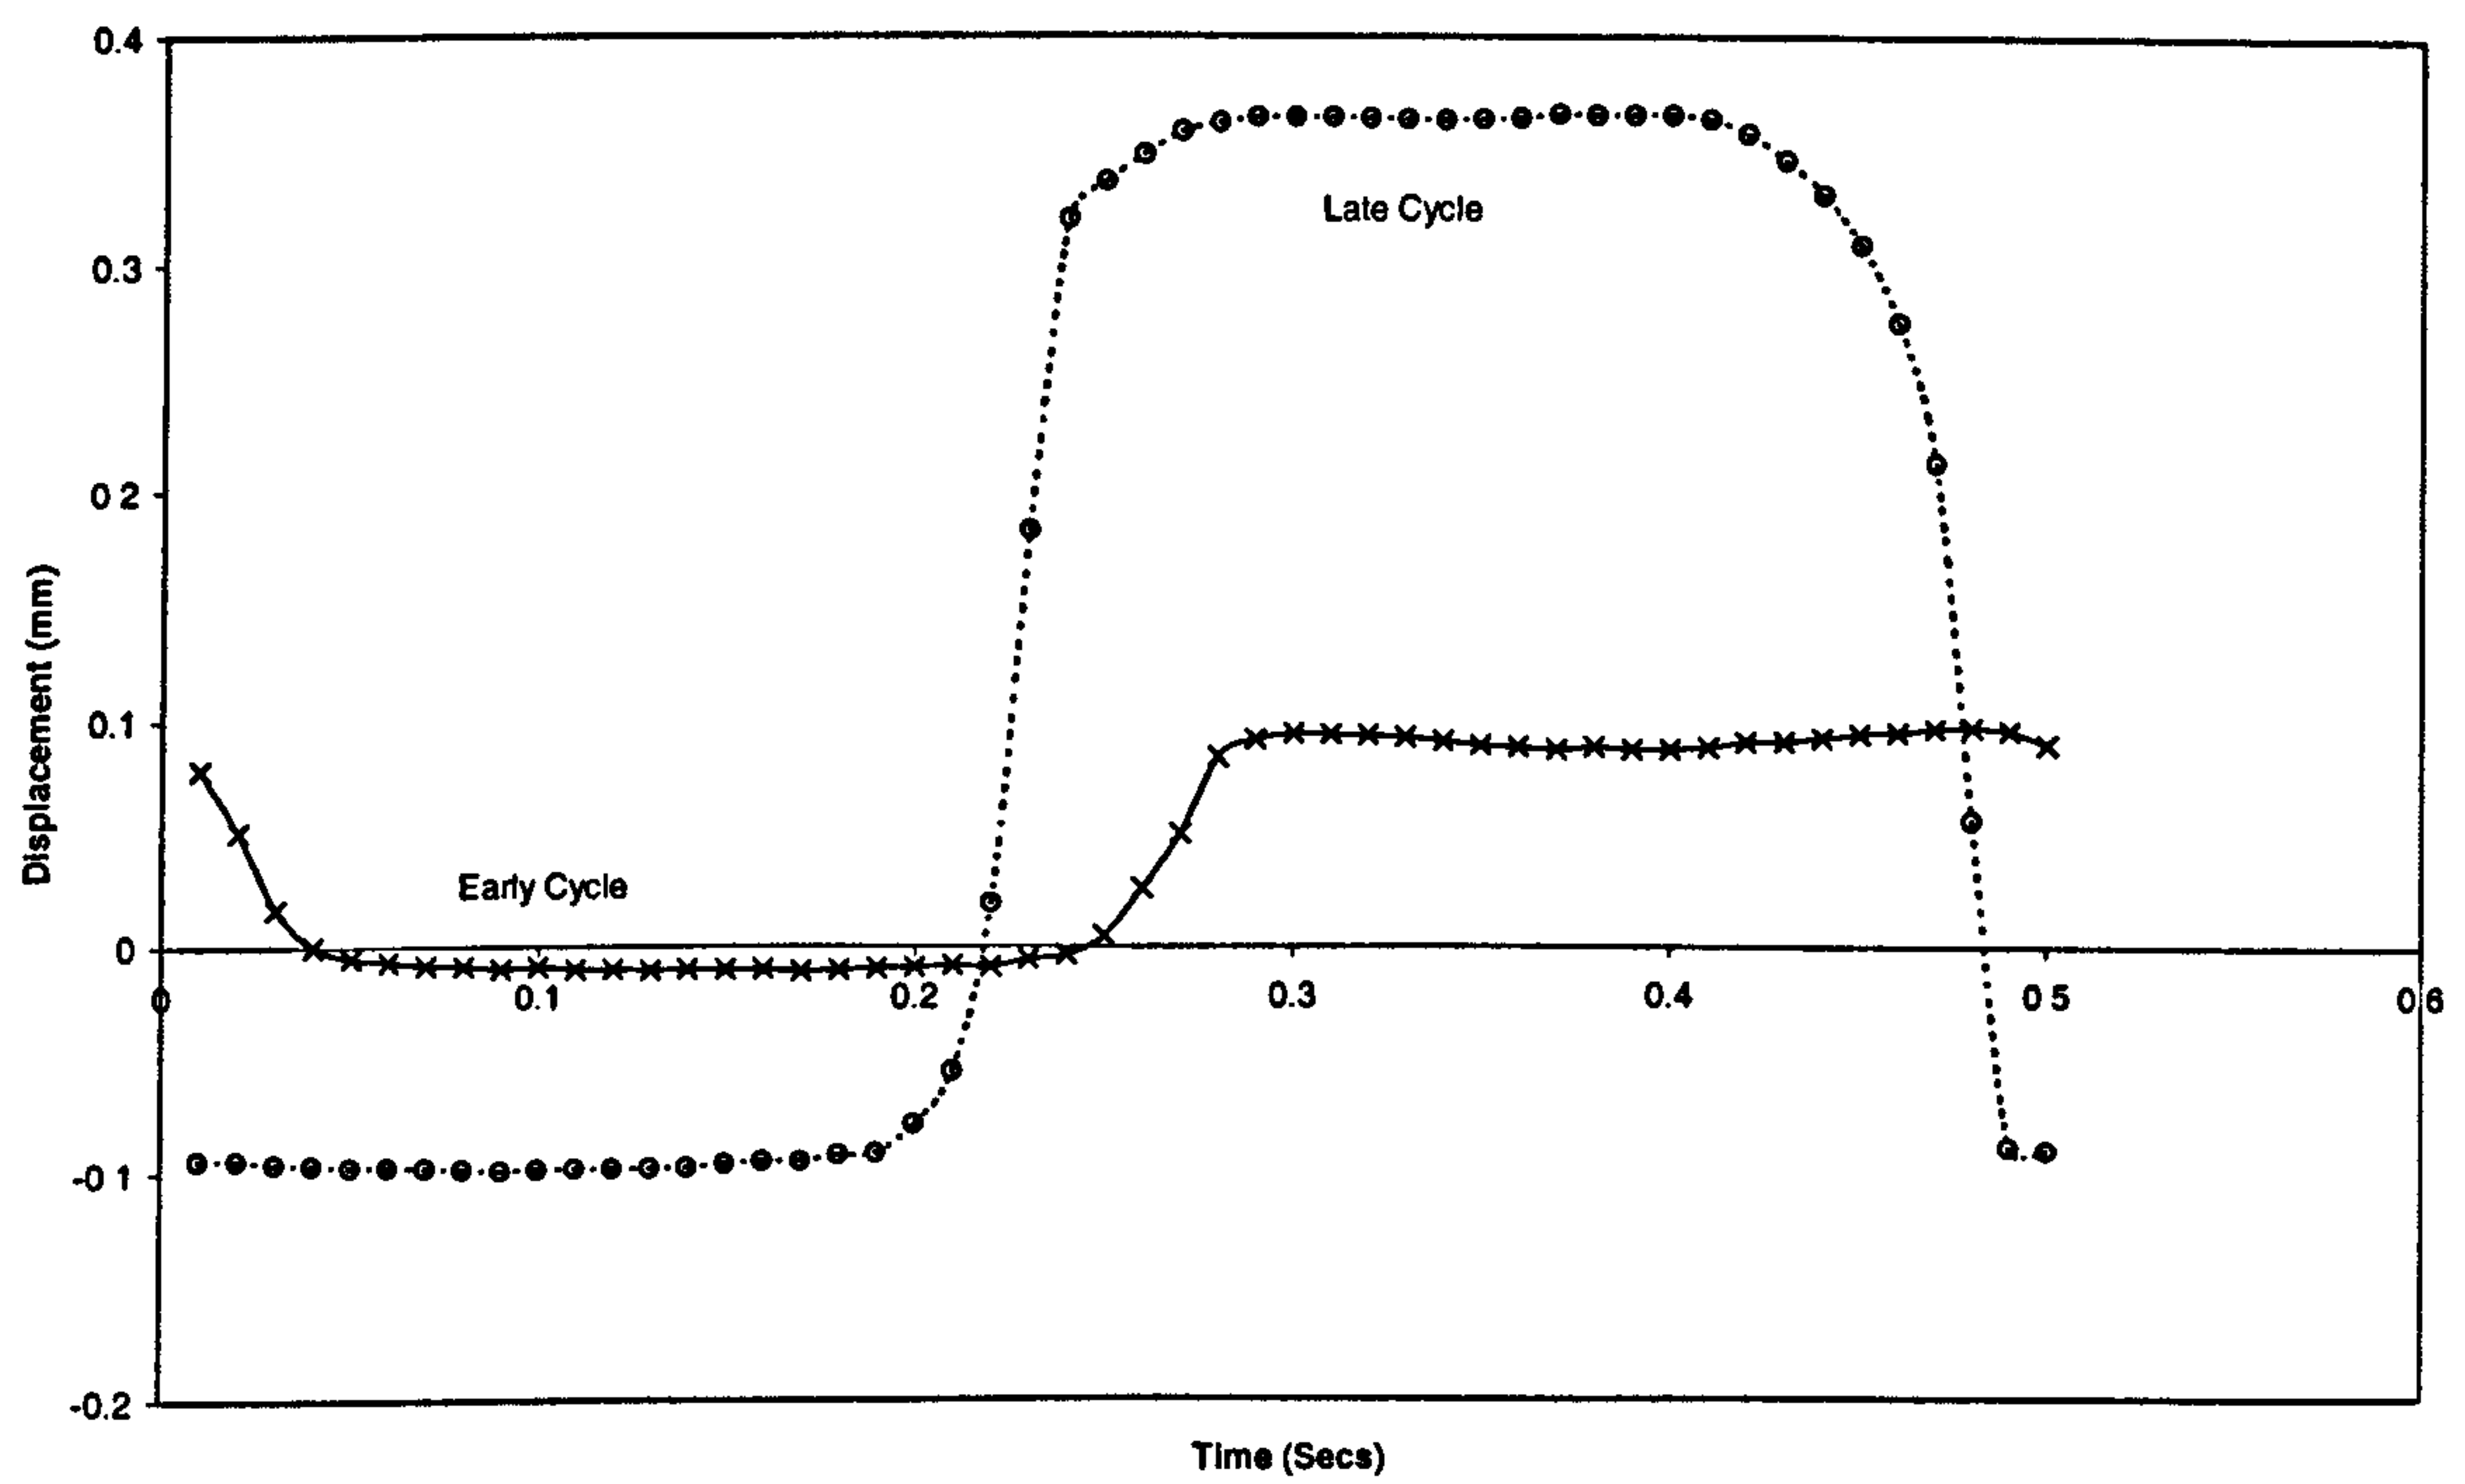
Figure 6.57b – Effect of deterioration on displacement resistance (load magnitude of 6kN with 1.98mm crack width)

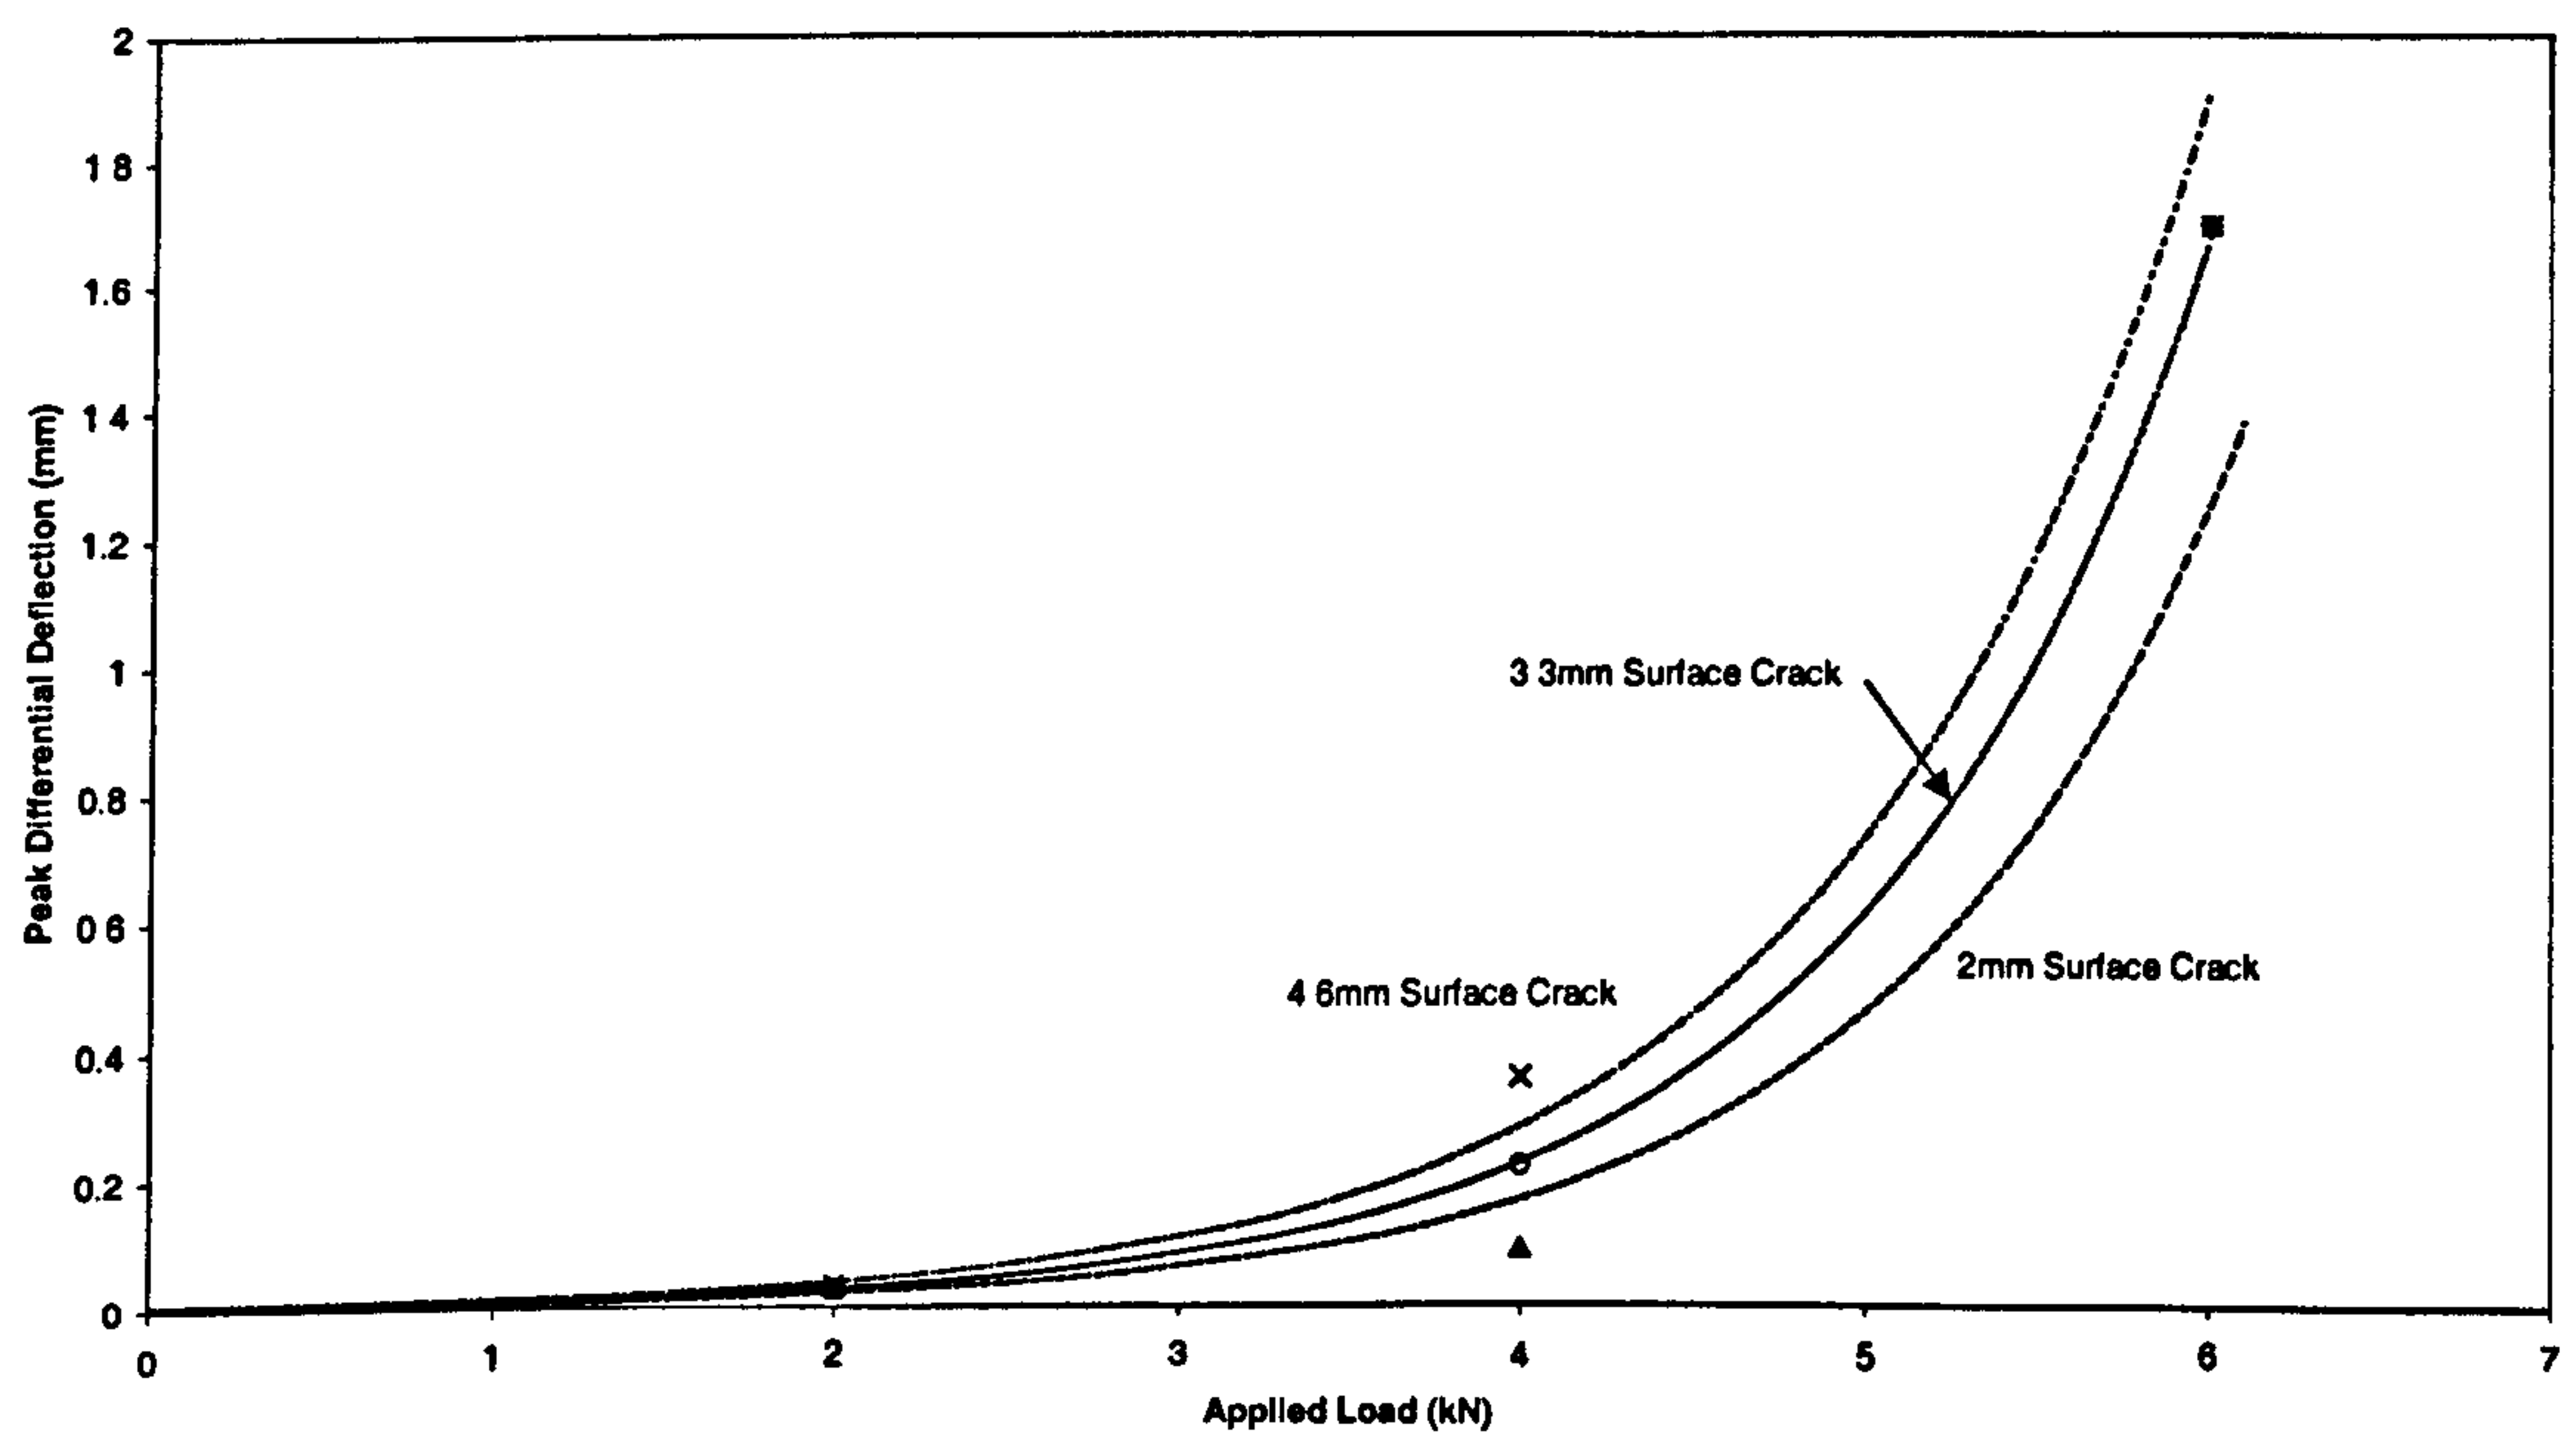
Figure 6.58 – Effect of load magnitude on displacement

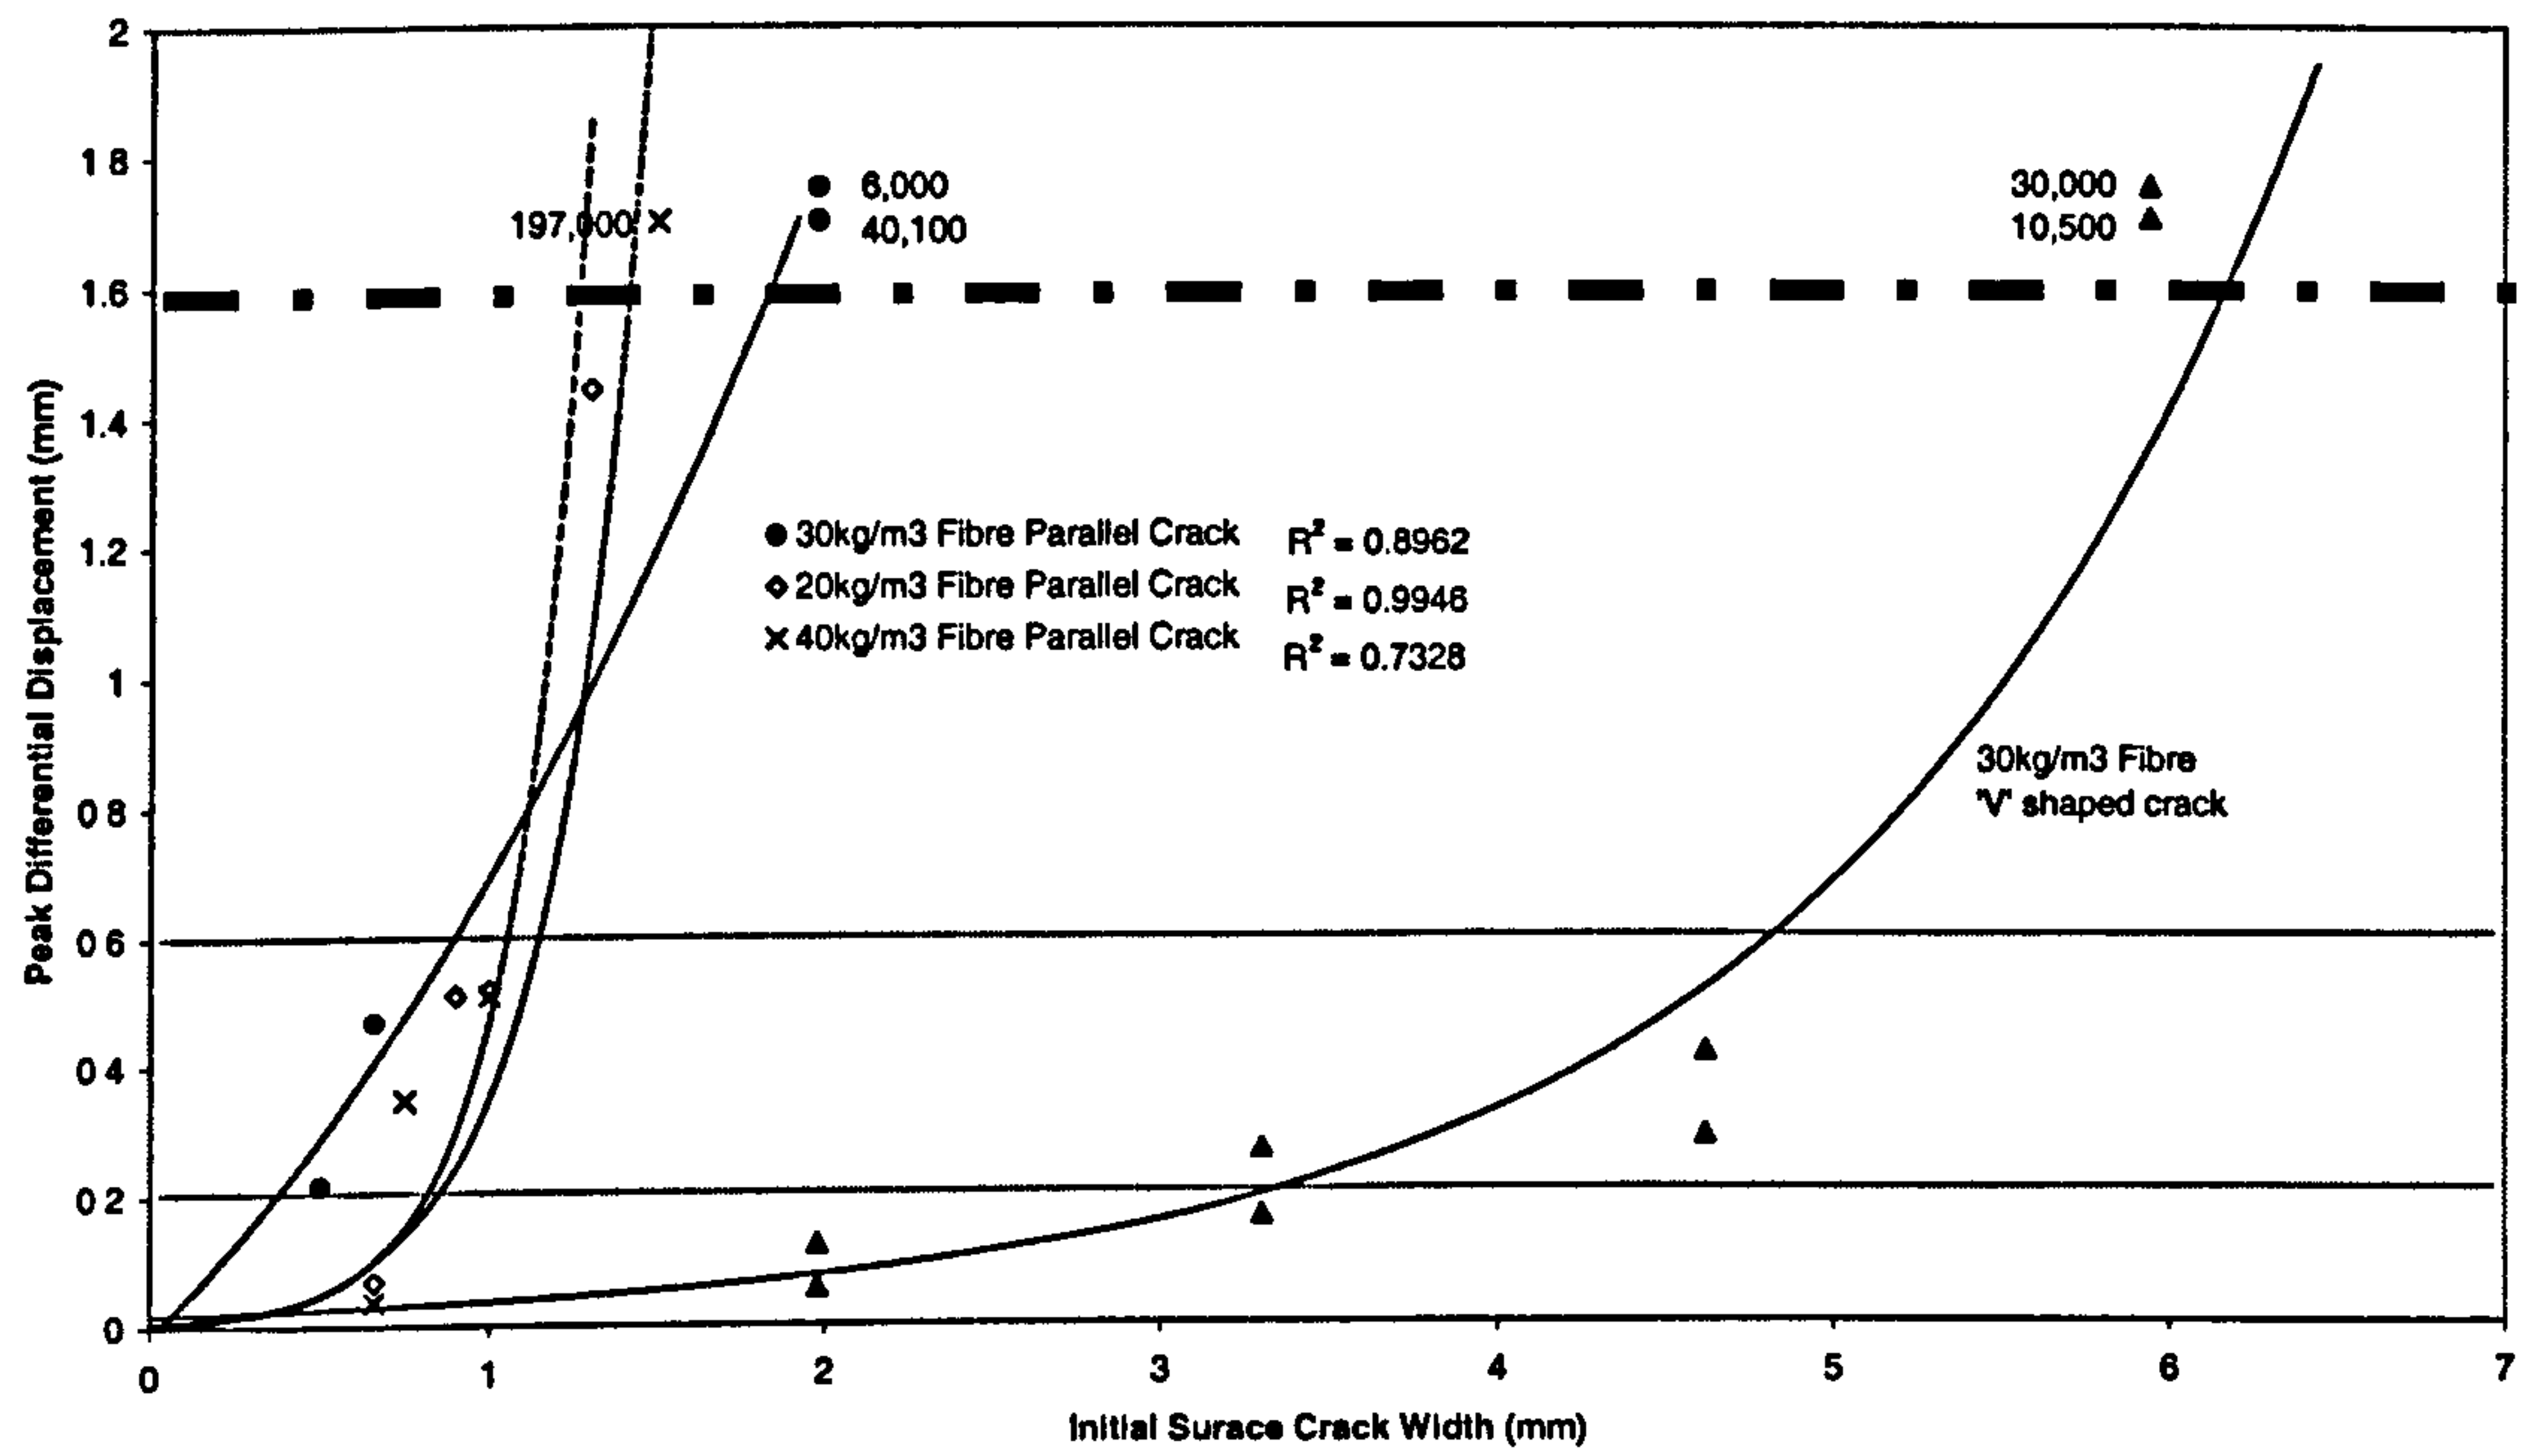
Figure 6.59 – Effect of crack profile on differential displacement

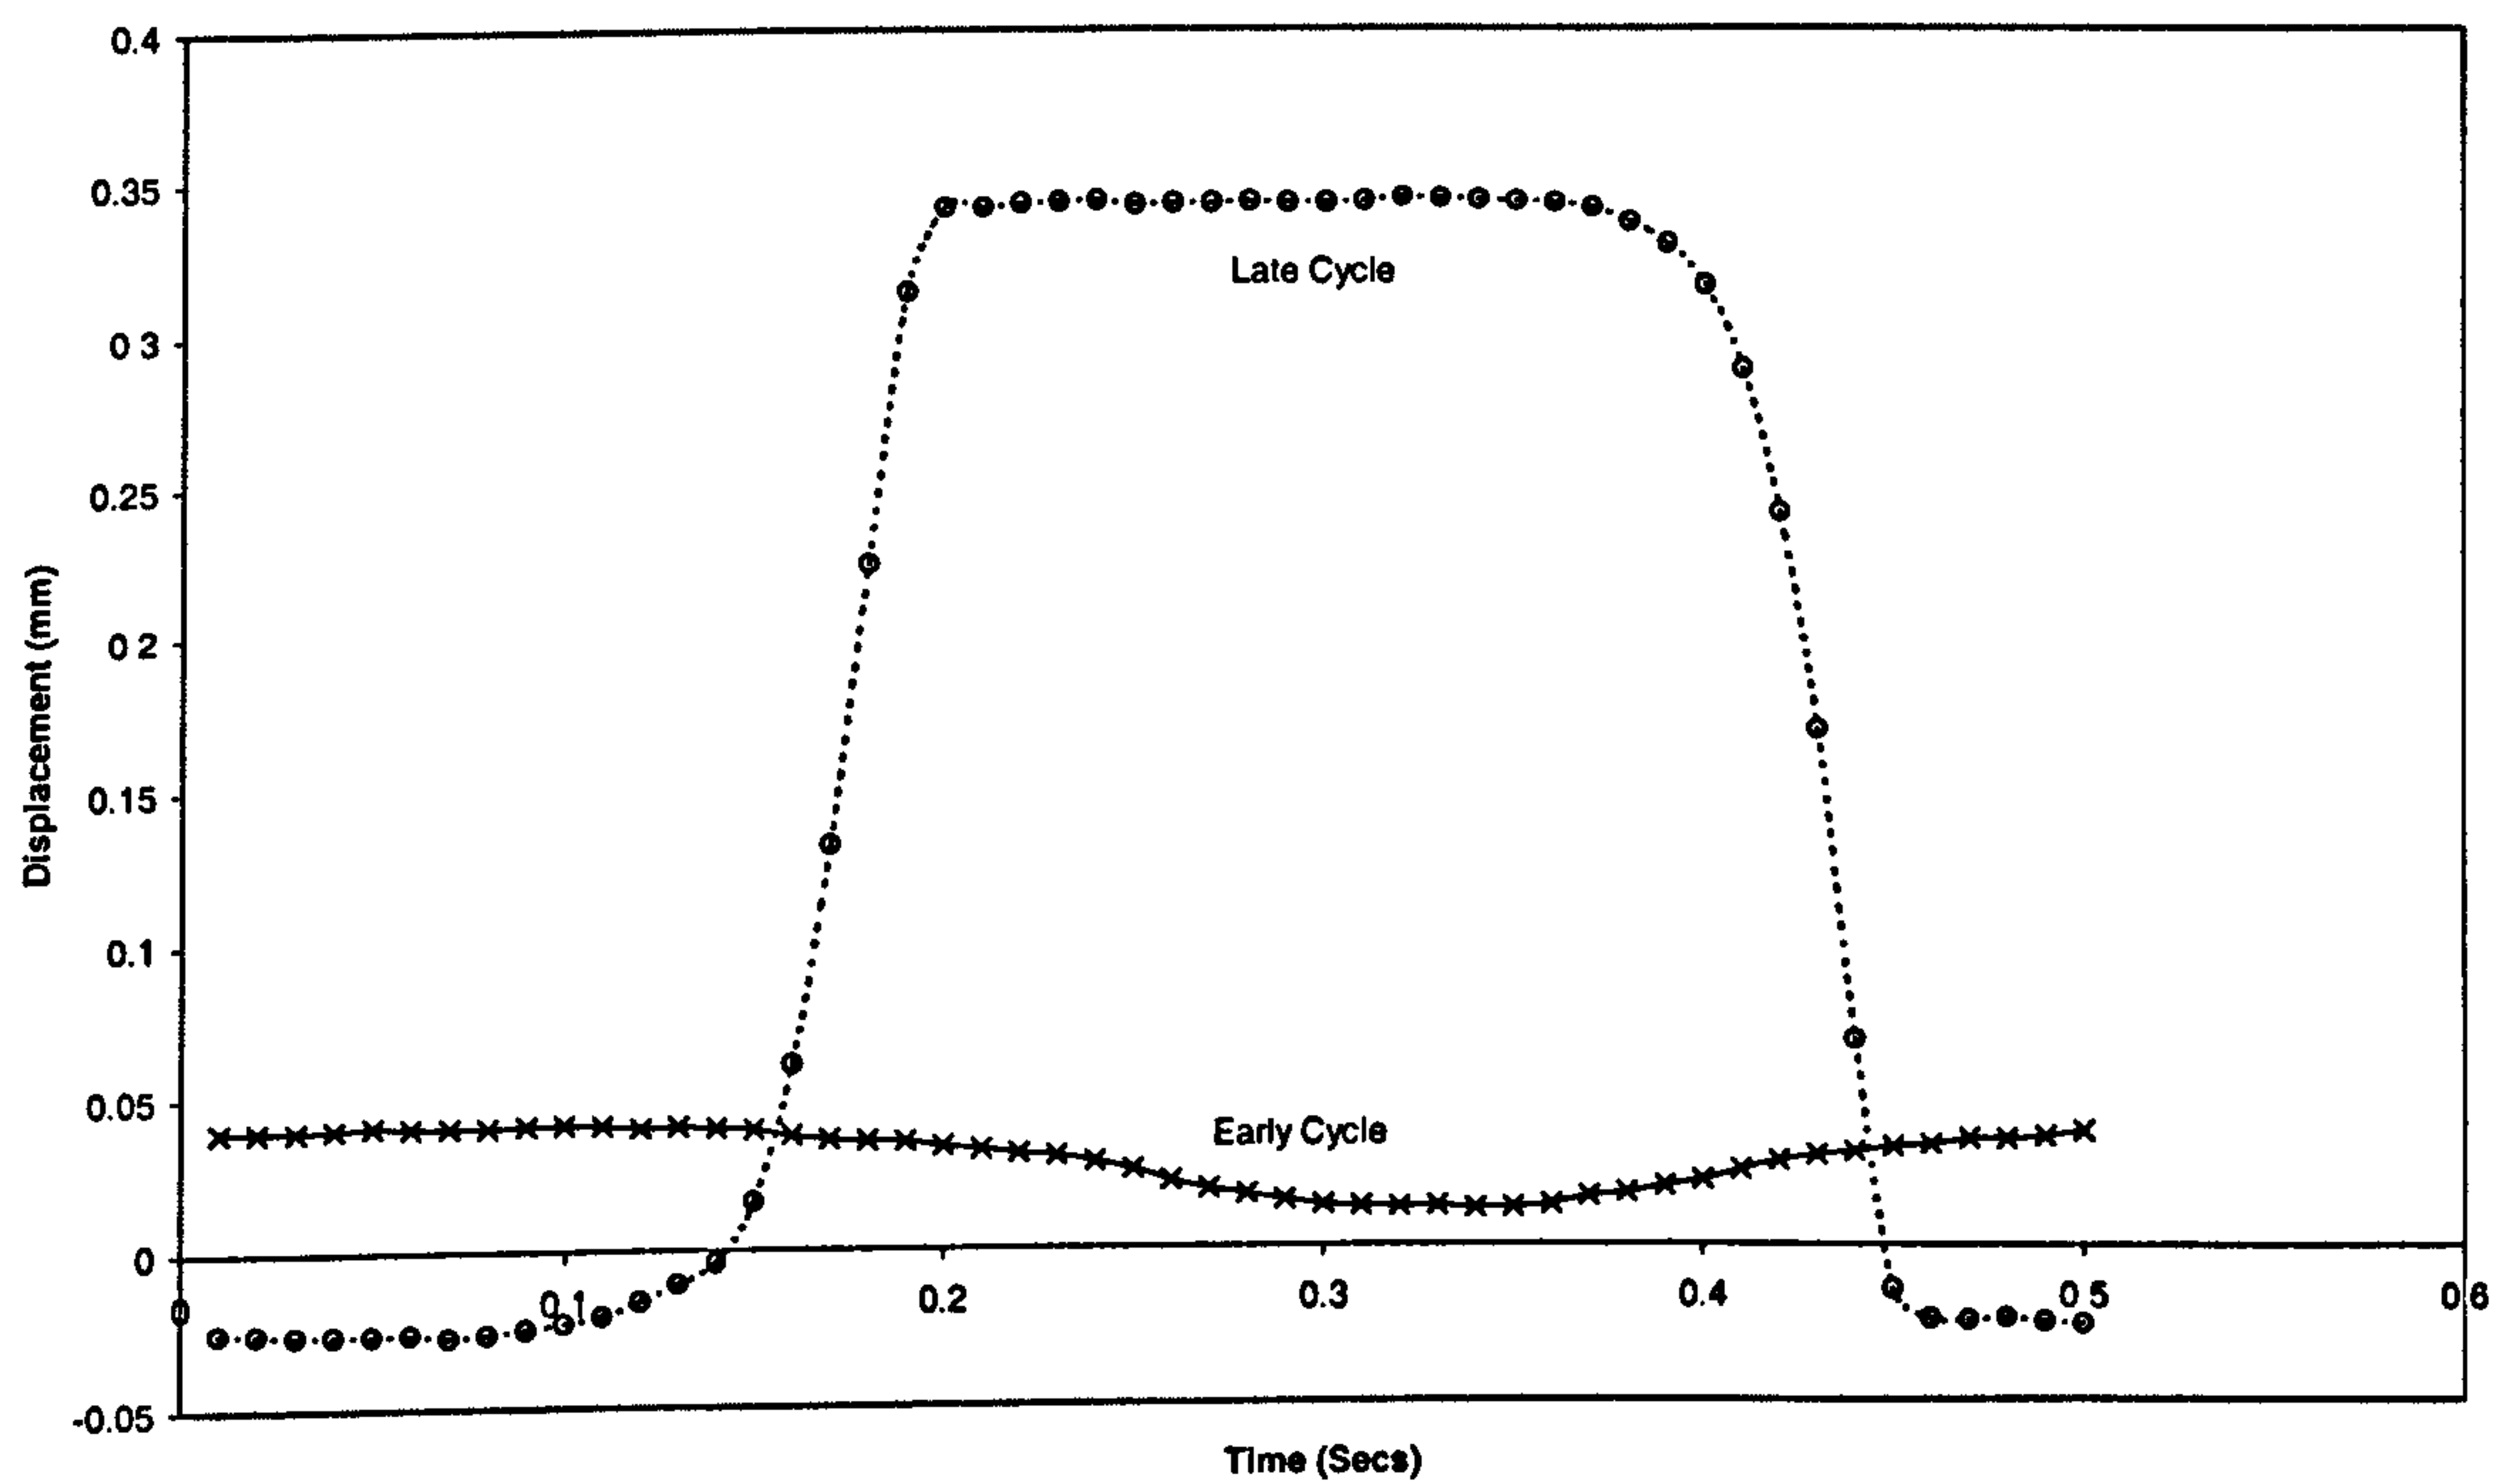
Figure 6.60a – Effect of deterioration on displacement resistance (Parallel crack of 0.66mm width)
