LOAD TRANSFER ACROSS CRACKS AND JOINTS IN CONCRETE SLABS ON GRADE

Stuart John Arnold

**A Doctoral Thesis Submitted in partial fulfilment of the requirements for the
award of
Doctor of Philosophy of Loughborough University**

20th February 2004

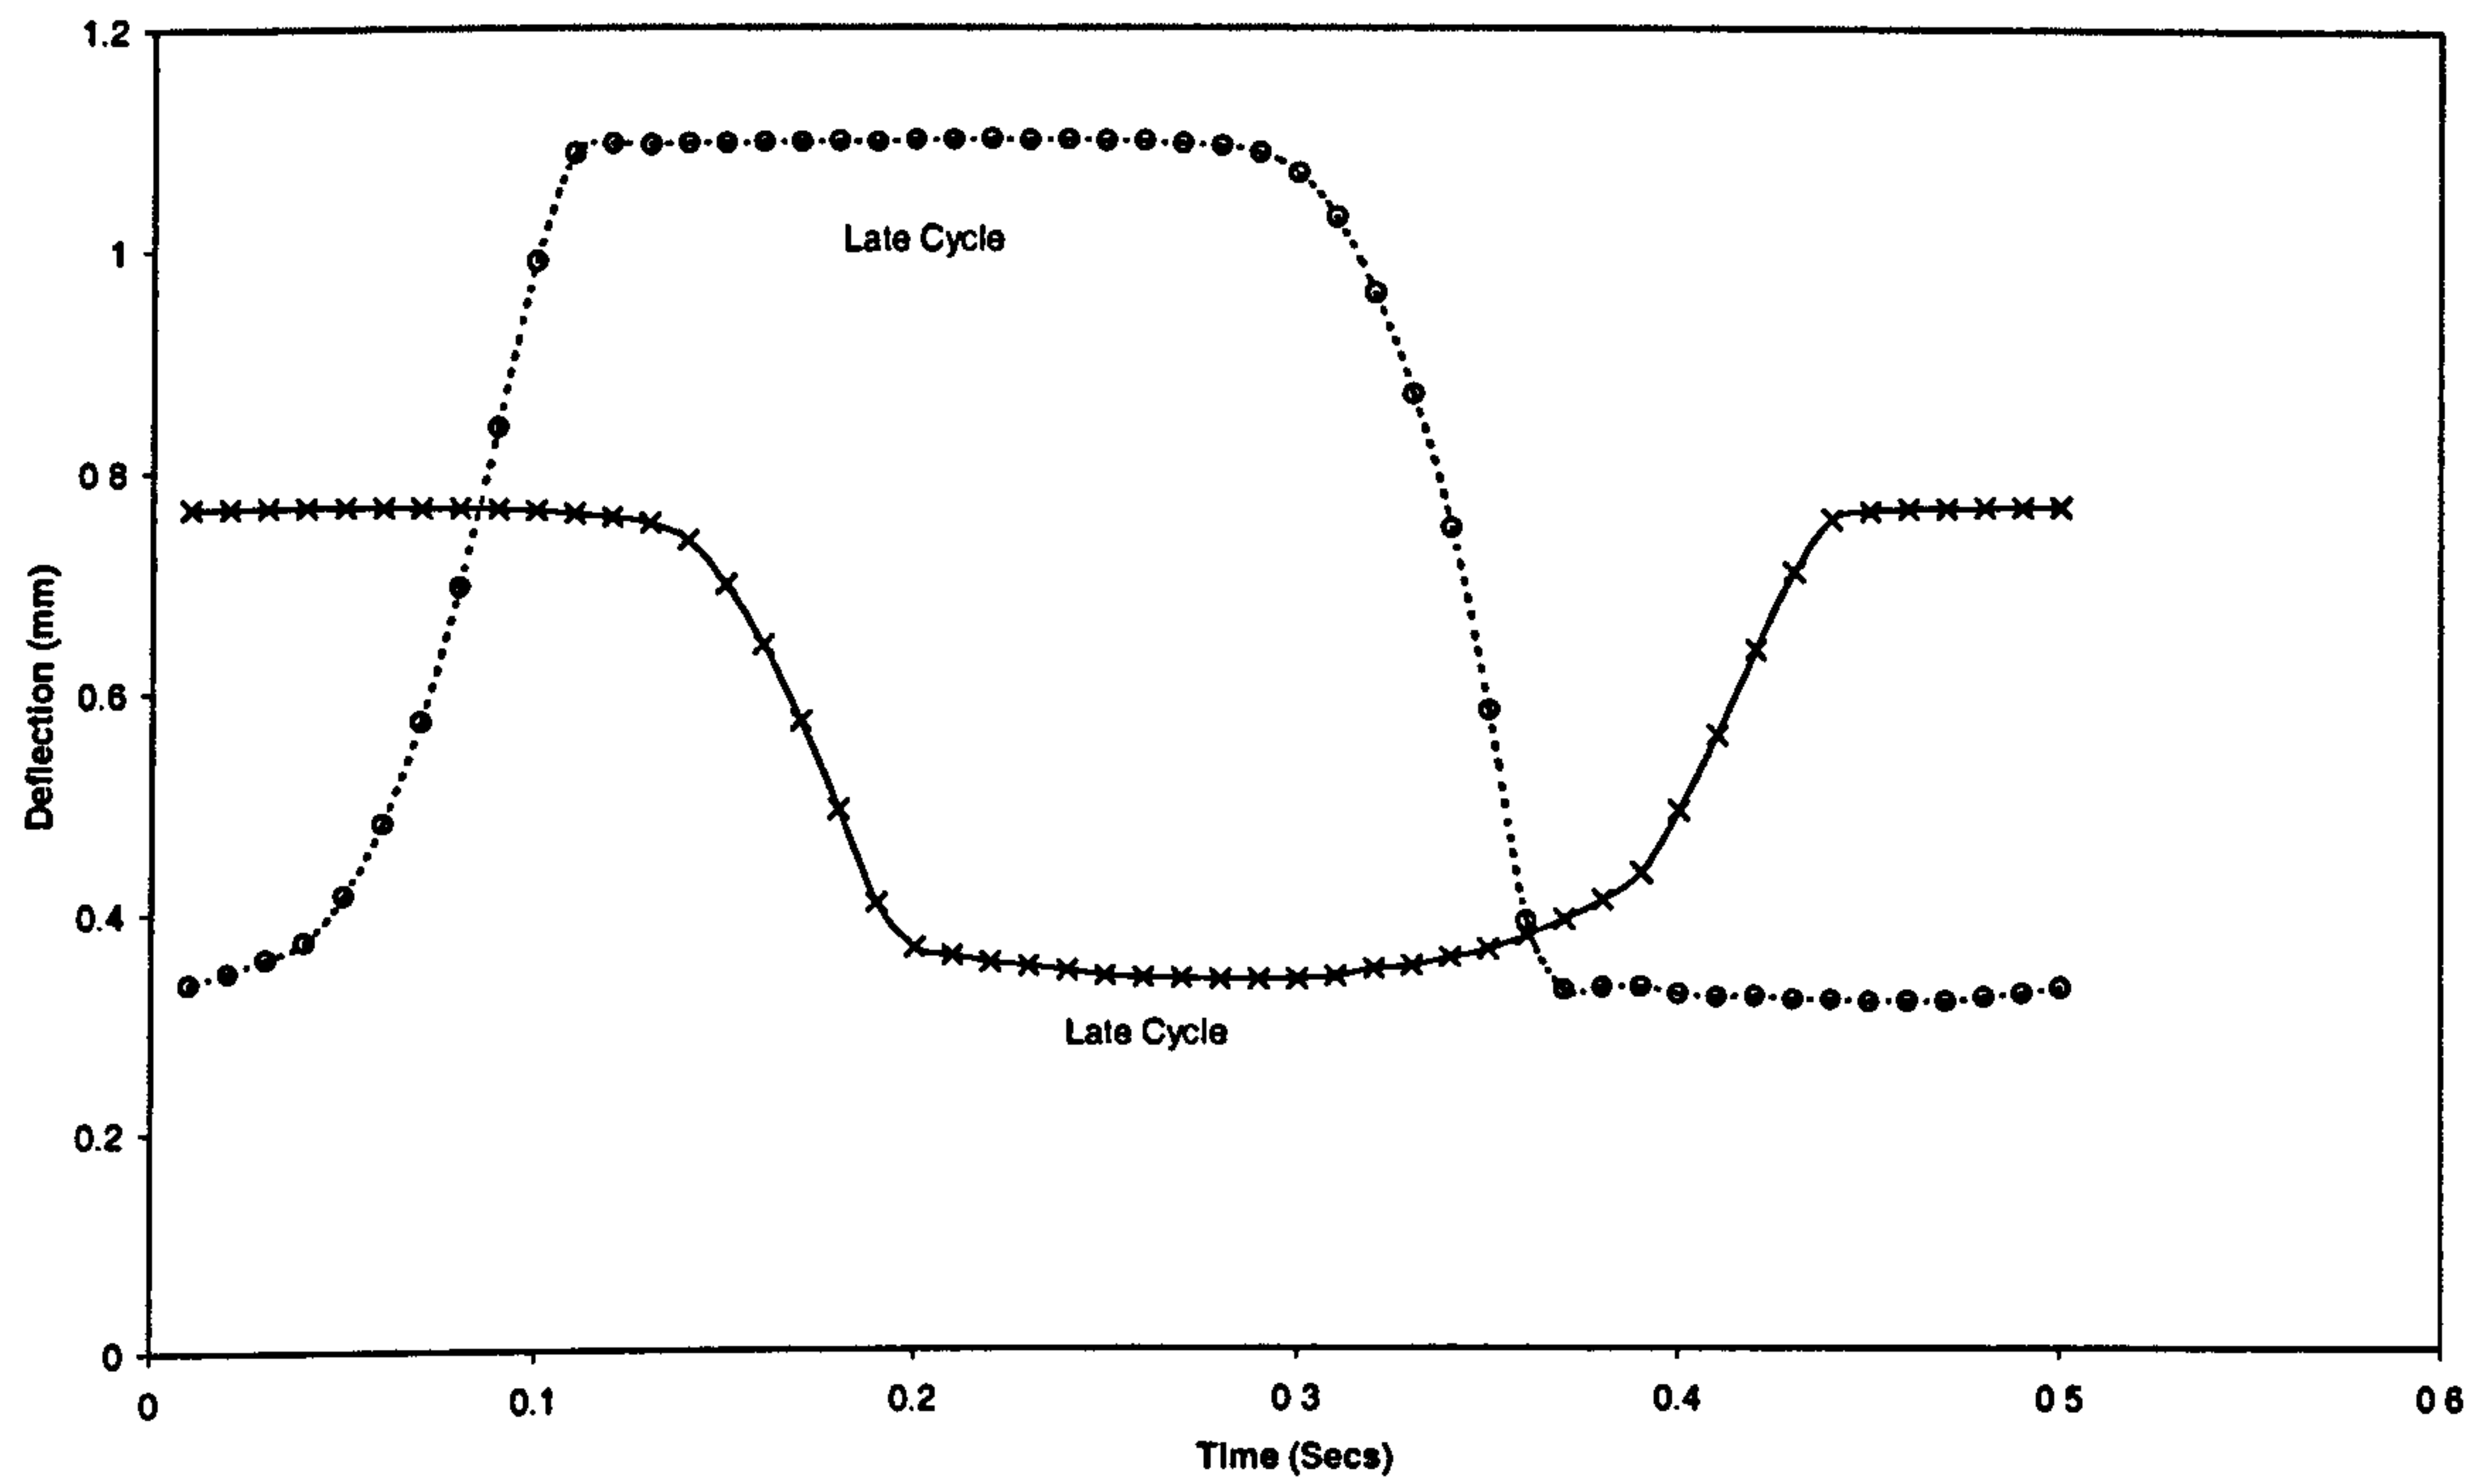
Figure 6.60b – Effect of deterioration on displacement resistance (Parallel crack of 1.98mm width)

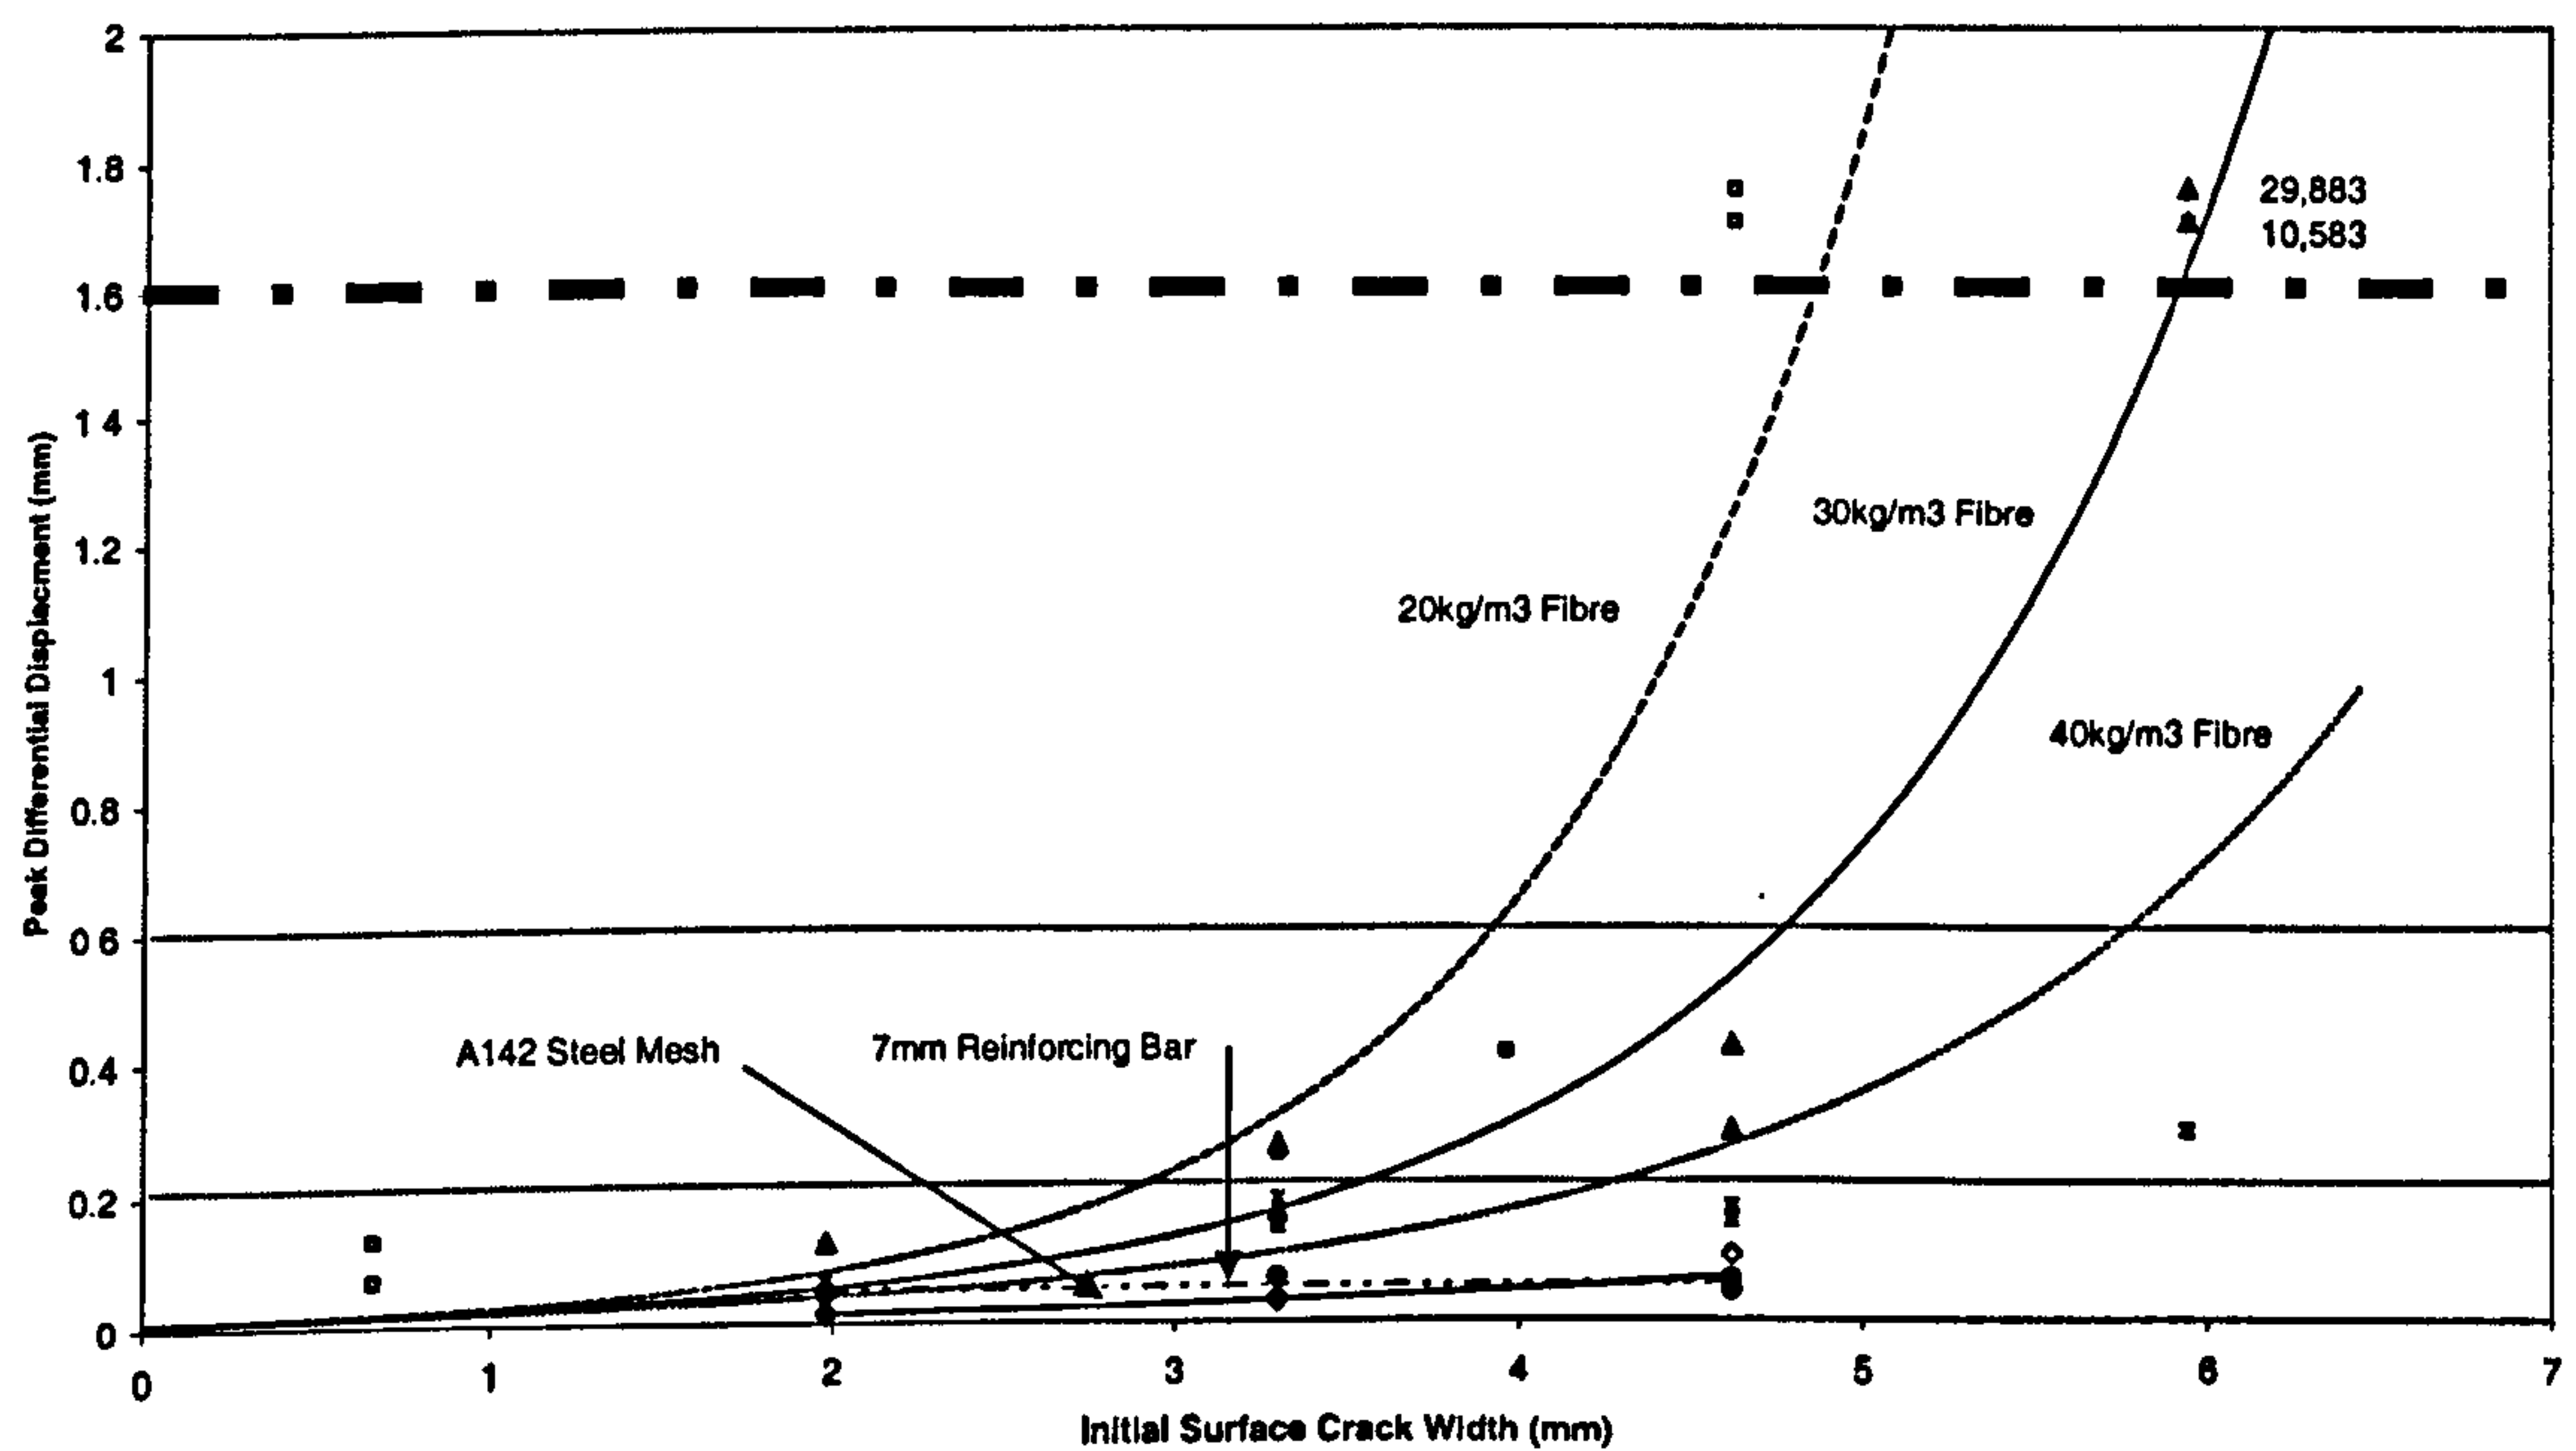
Figure 6.61 – Effect of steel fabric and reinforcing bar on displacement

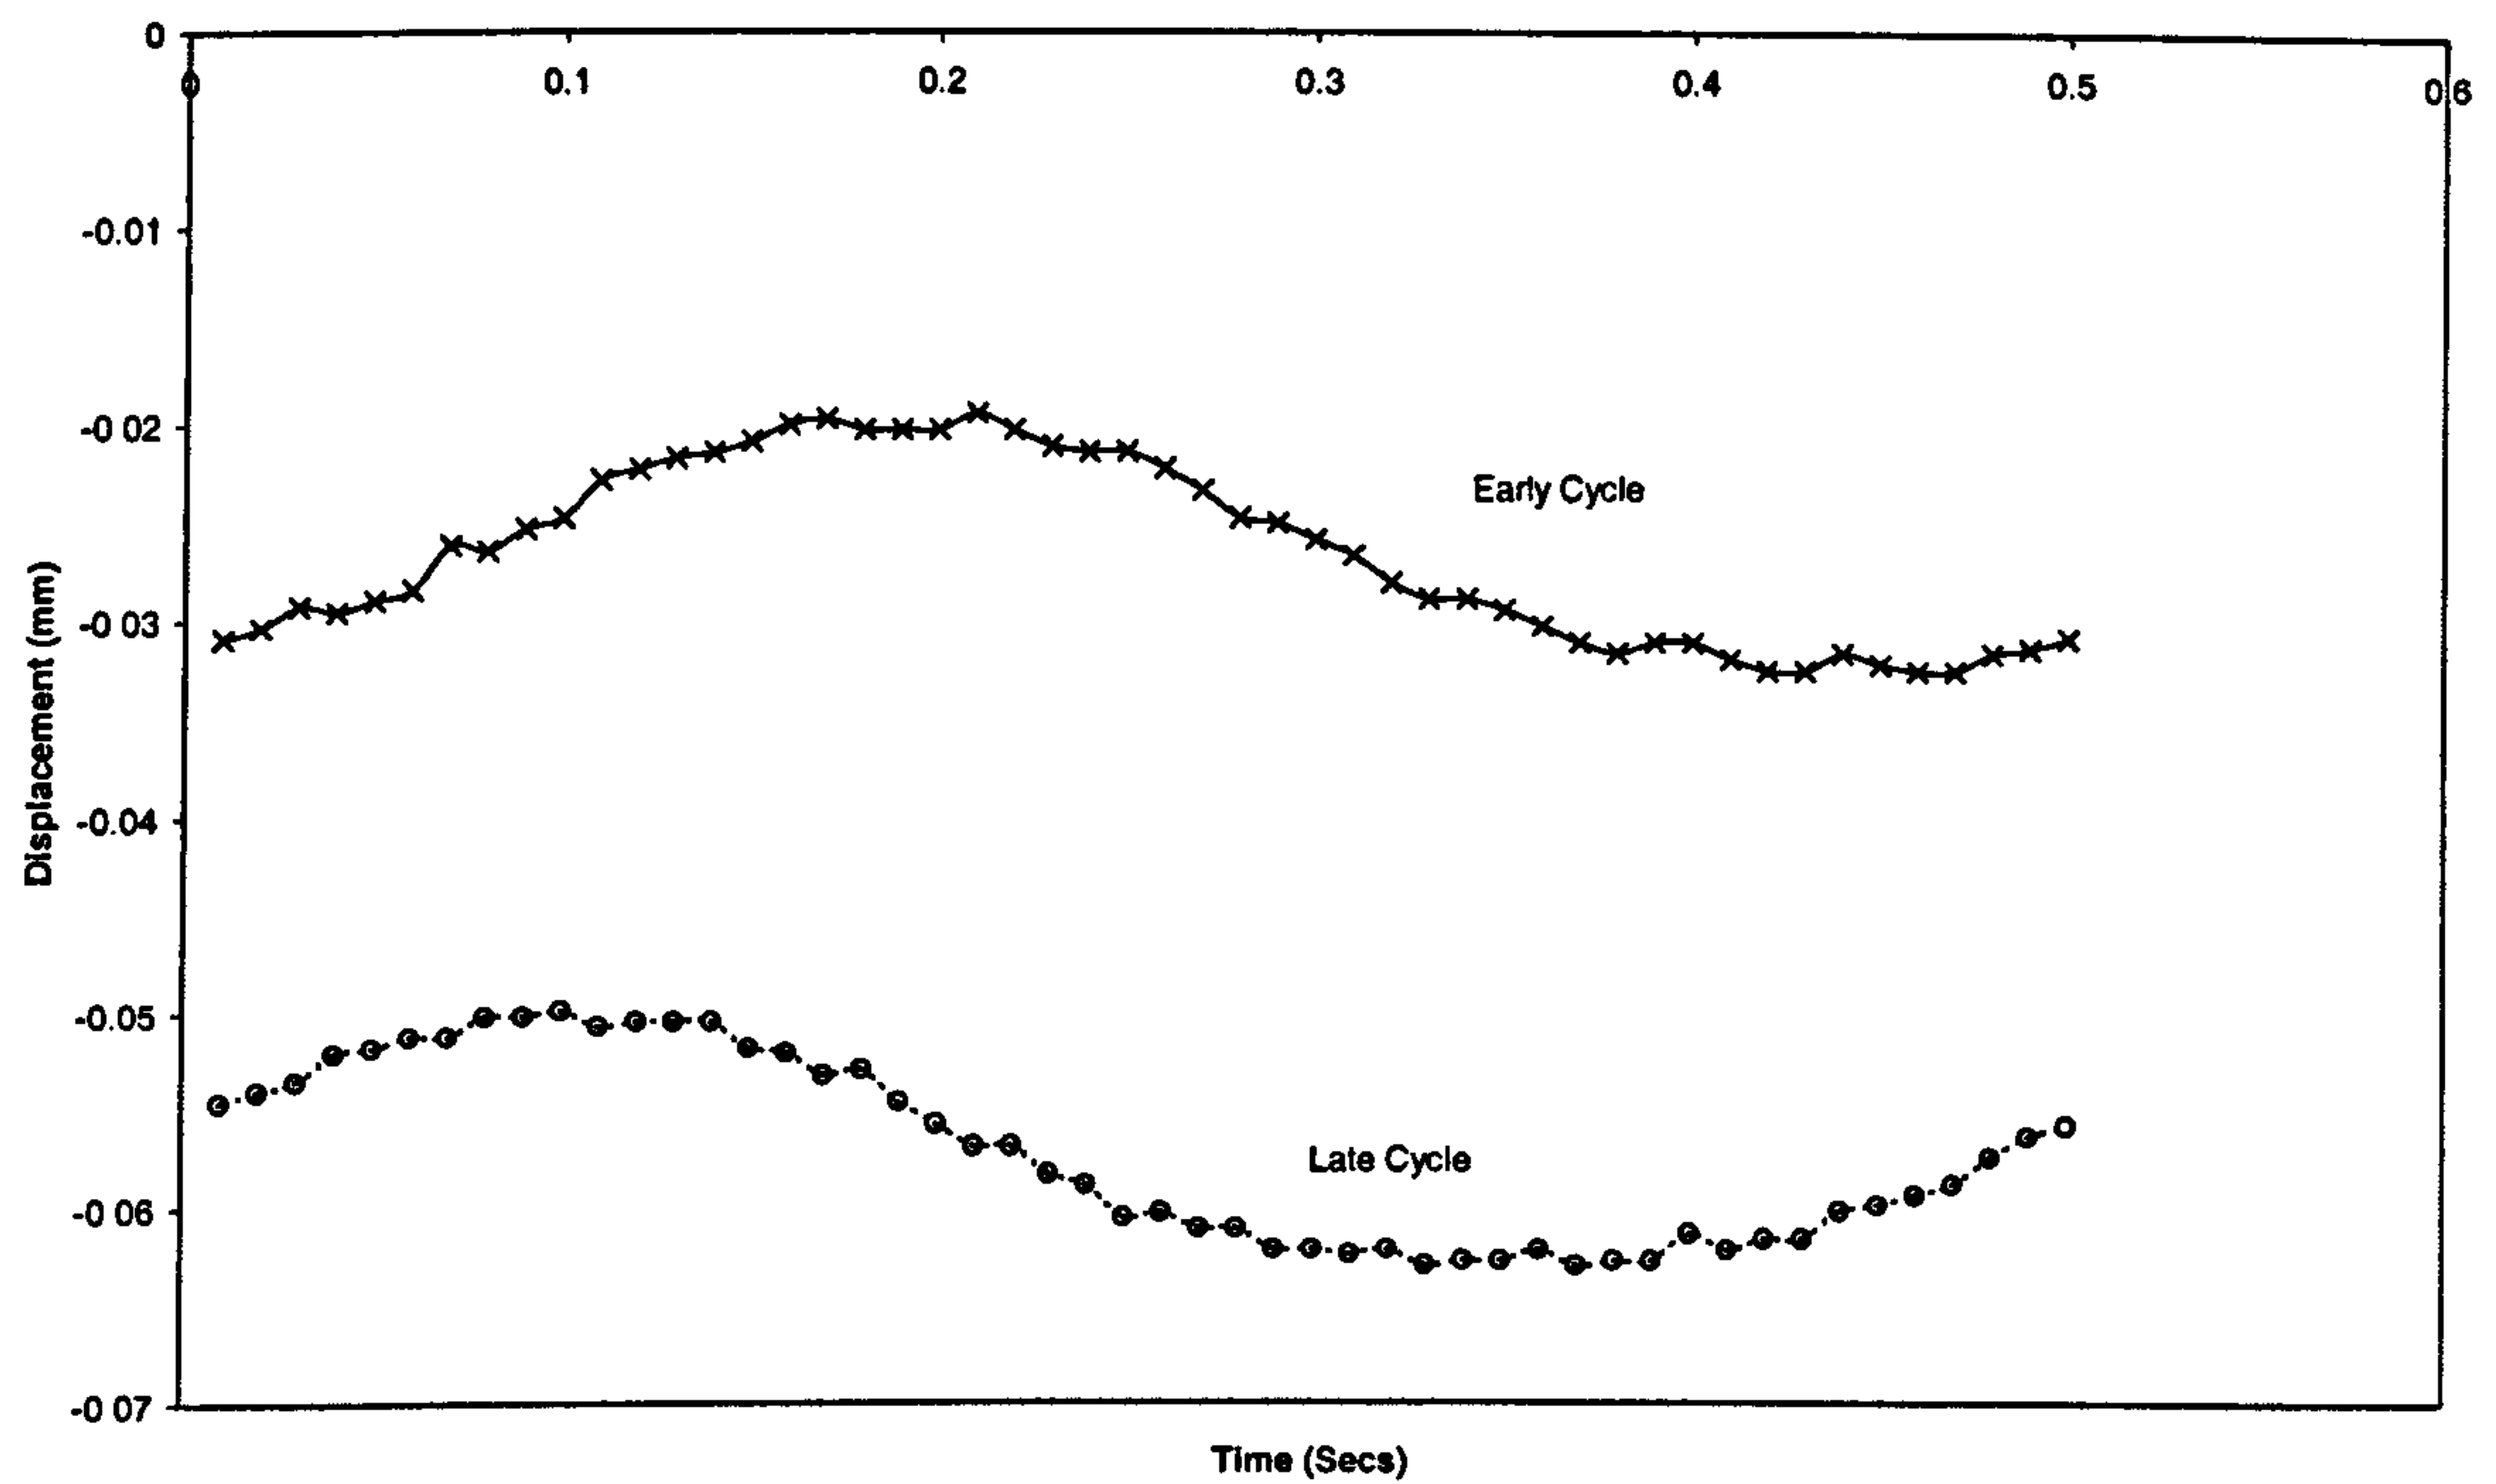
Figure 6.62a – Effect of deterioration on displacement resistance (steel fabric with 1.98mm crack width)

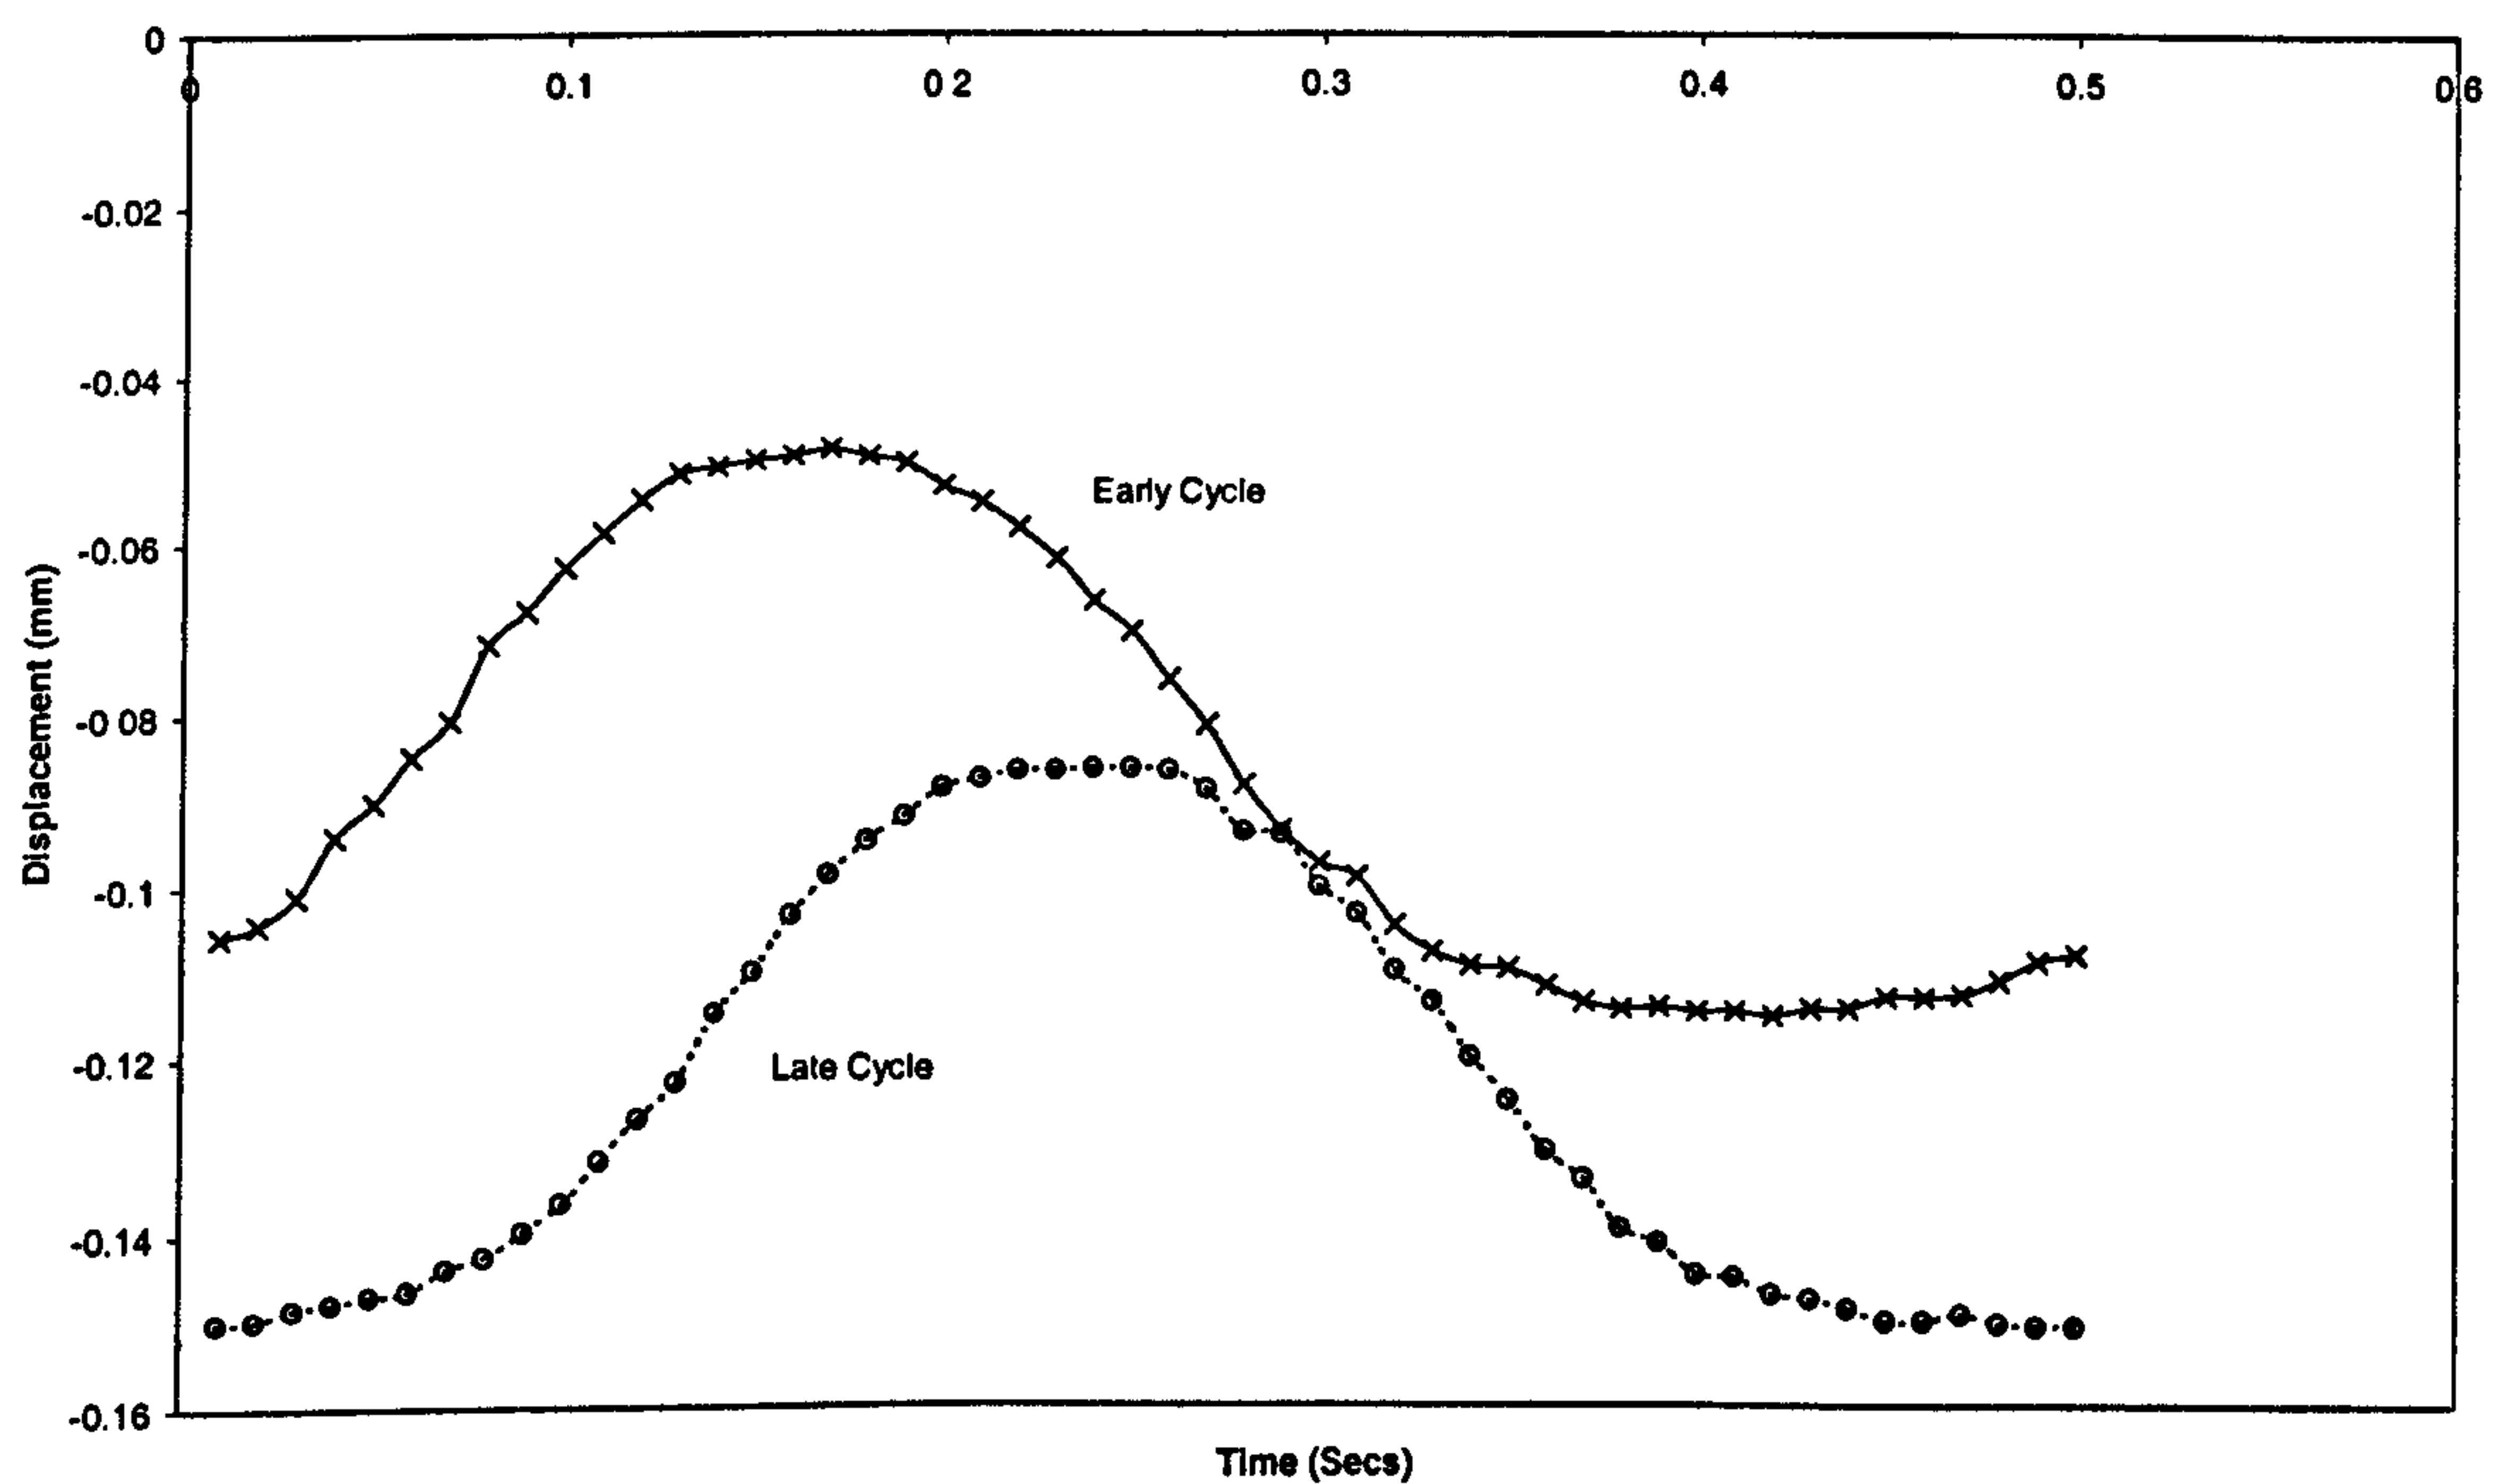
Figure 6.62b – Effect of deterioration on displacement resistance (steel fabric with 4.62mm crack width)

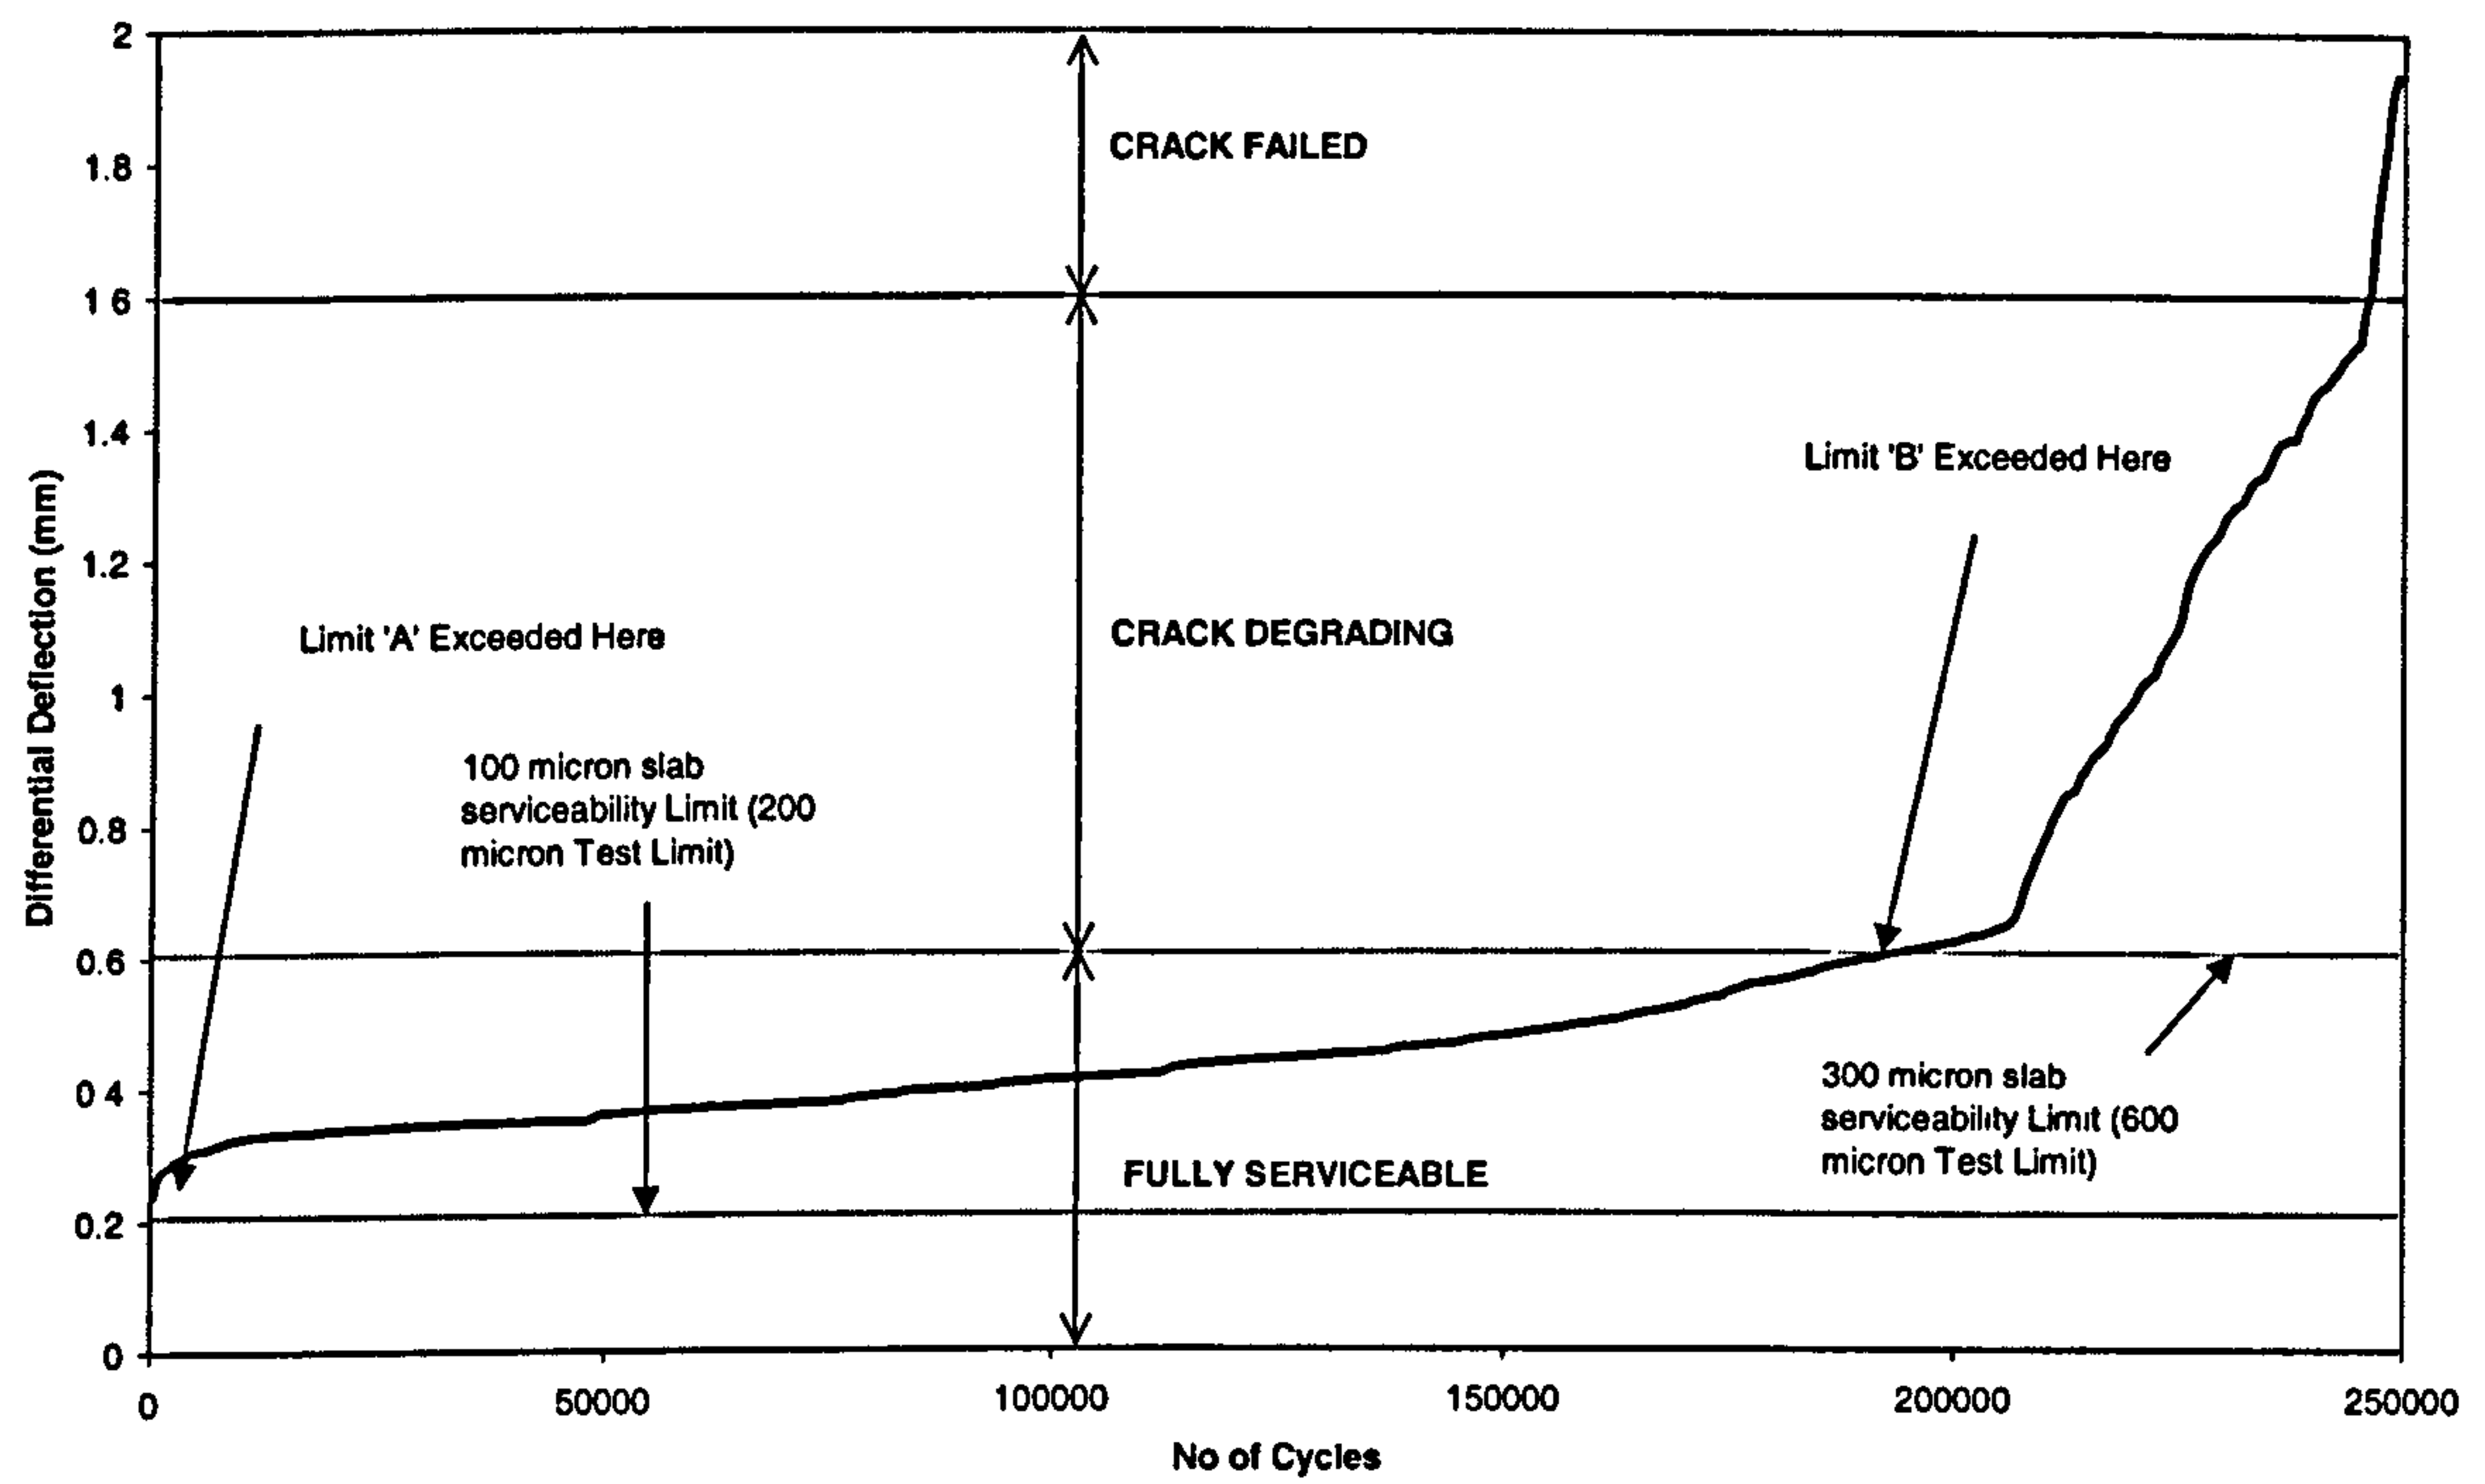
Figure 6.63 – Serviceability thresholds for crack degradation

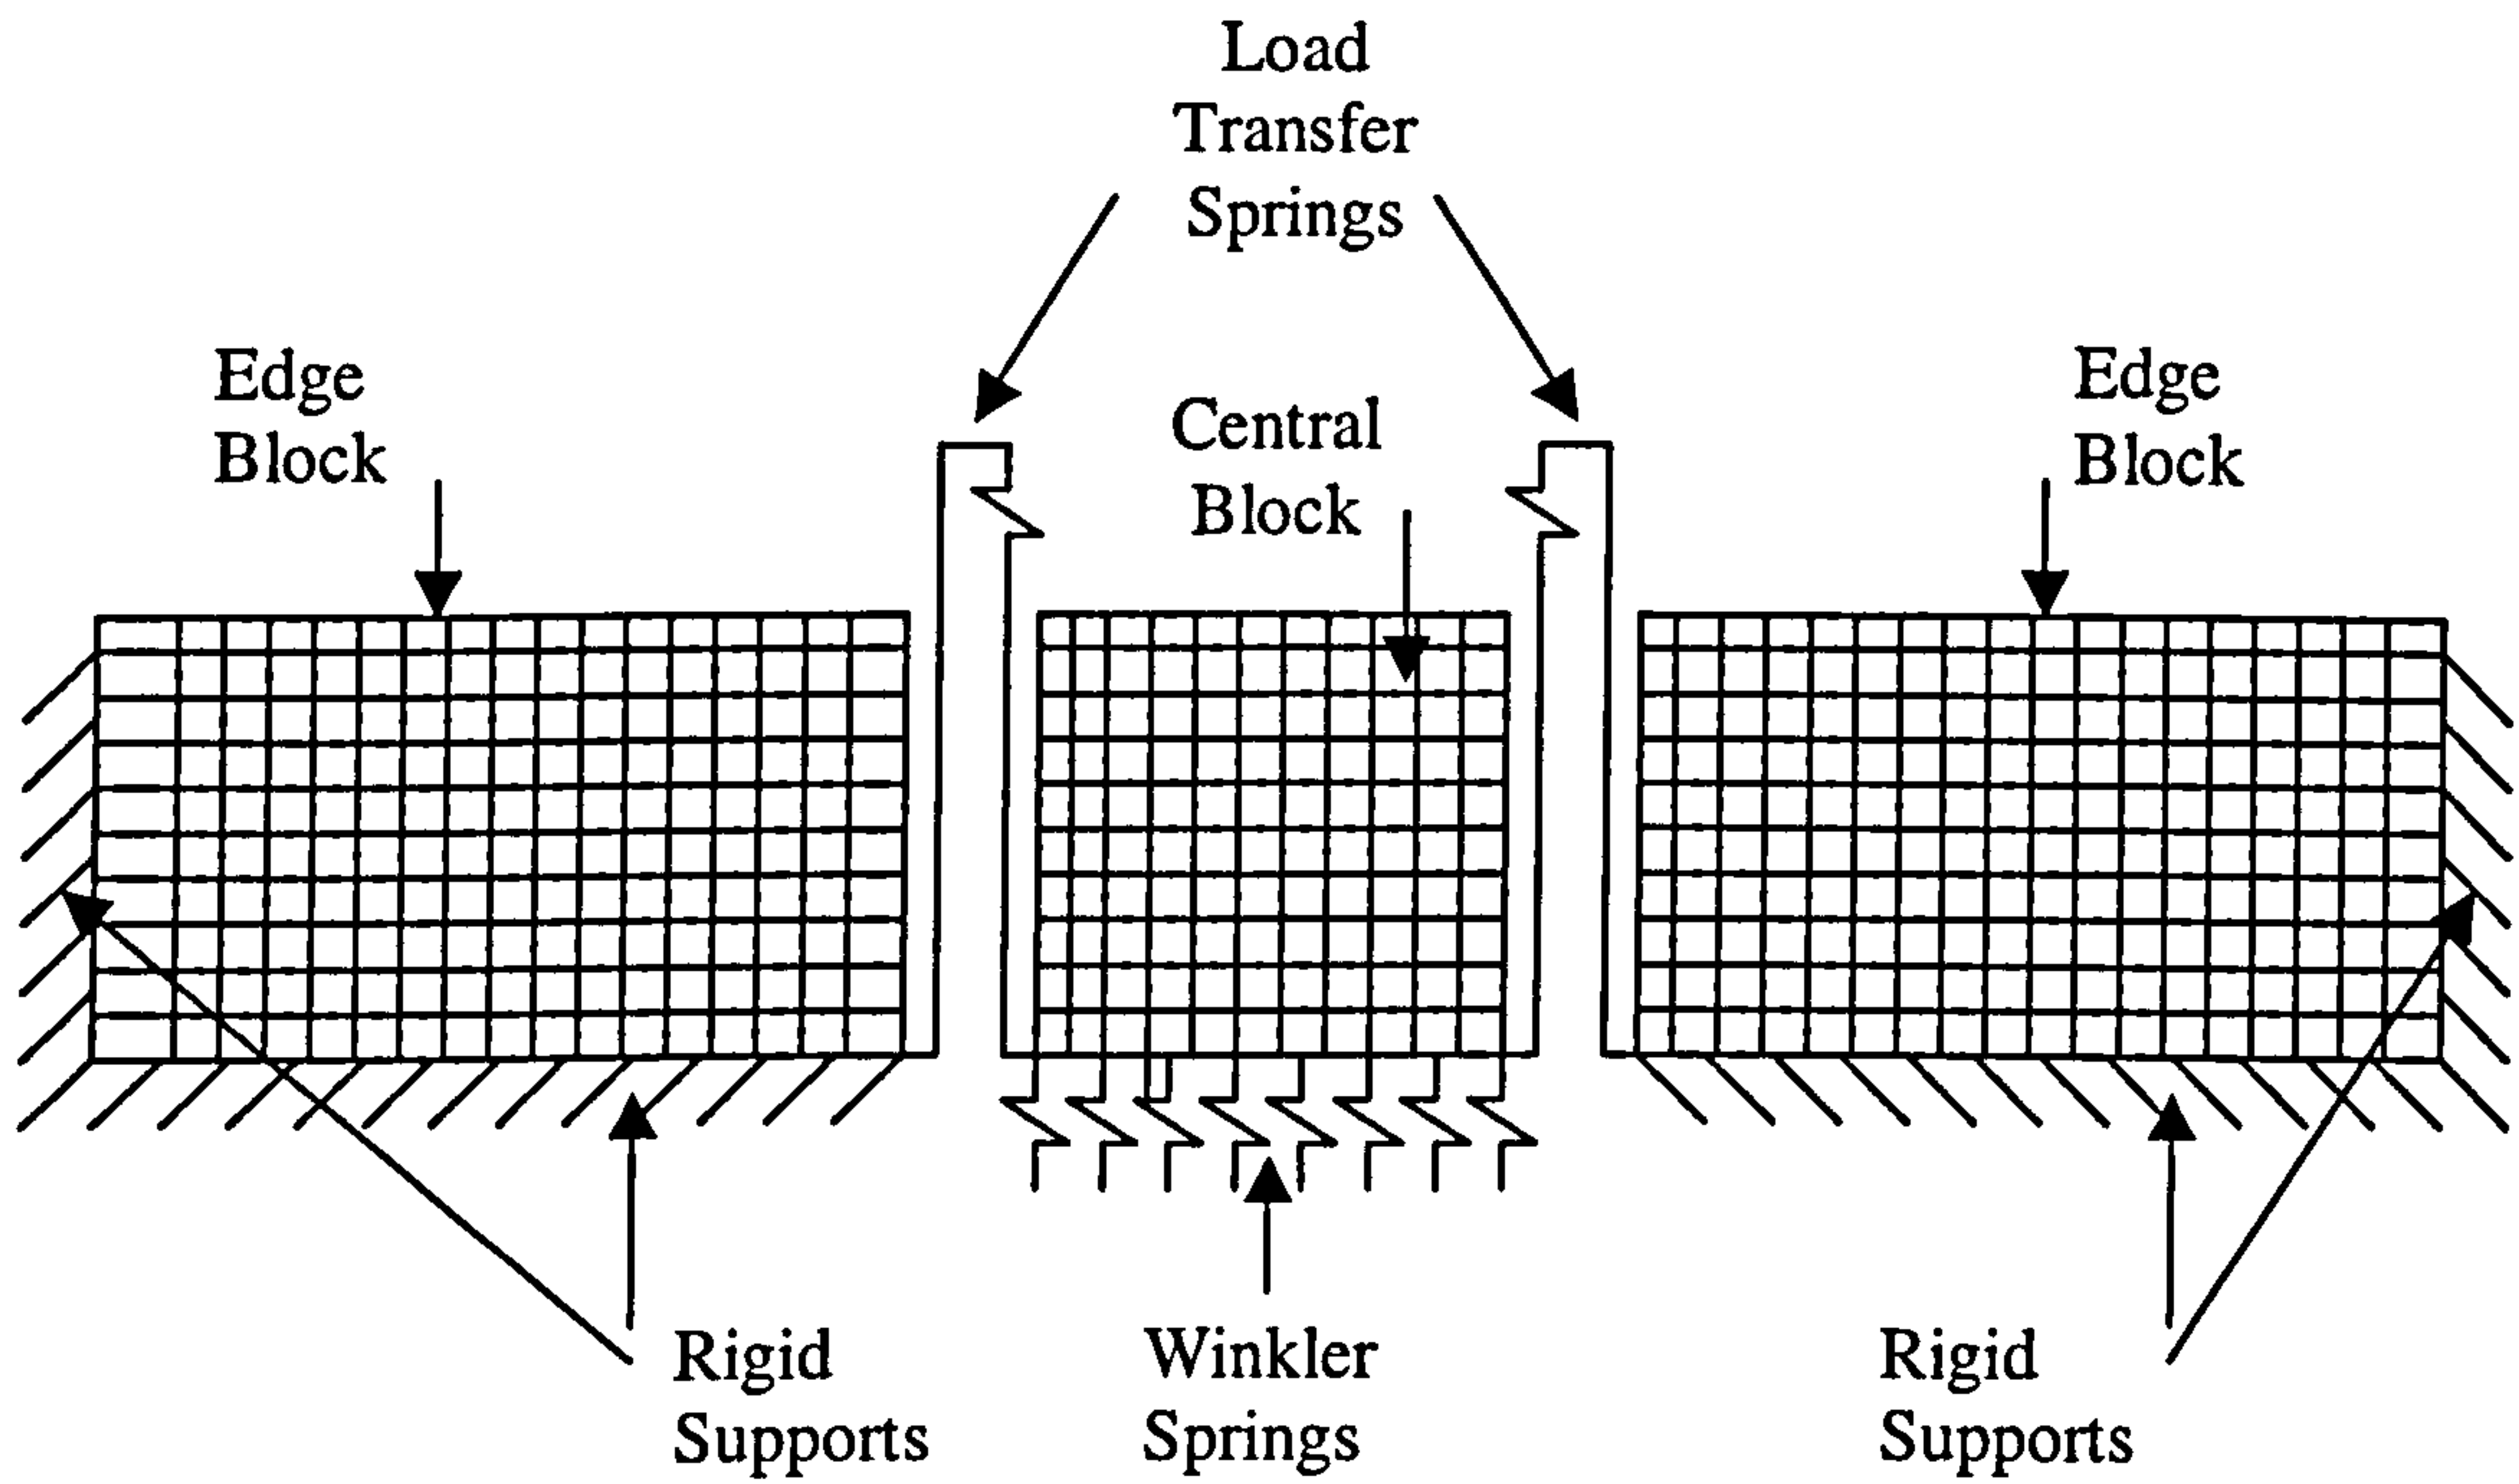
Figure 7.4 – Schematic of the Finite Element model of crack behaviour within the laboratory test rig
