LOAD TRANSFER ACROSS CRACKS AND JOINTS IN CONCRETE SLABS ON GRADE

Stuart John Arnold

**A Doctoral Thesis Submitted in partial fulfilment of the requirements for the
award of
Doctor of Philosophy of Loughborough University**

20th February 2004

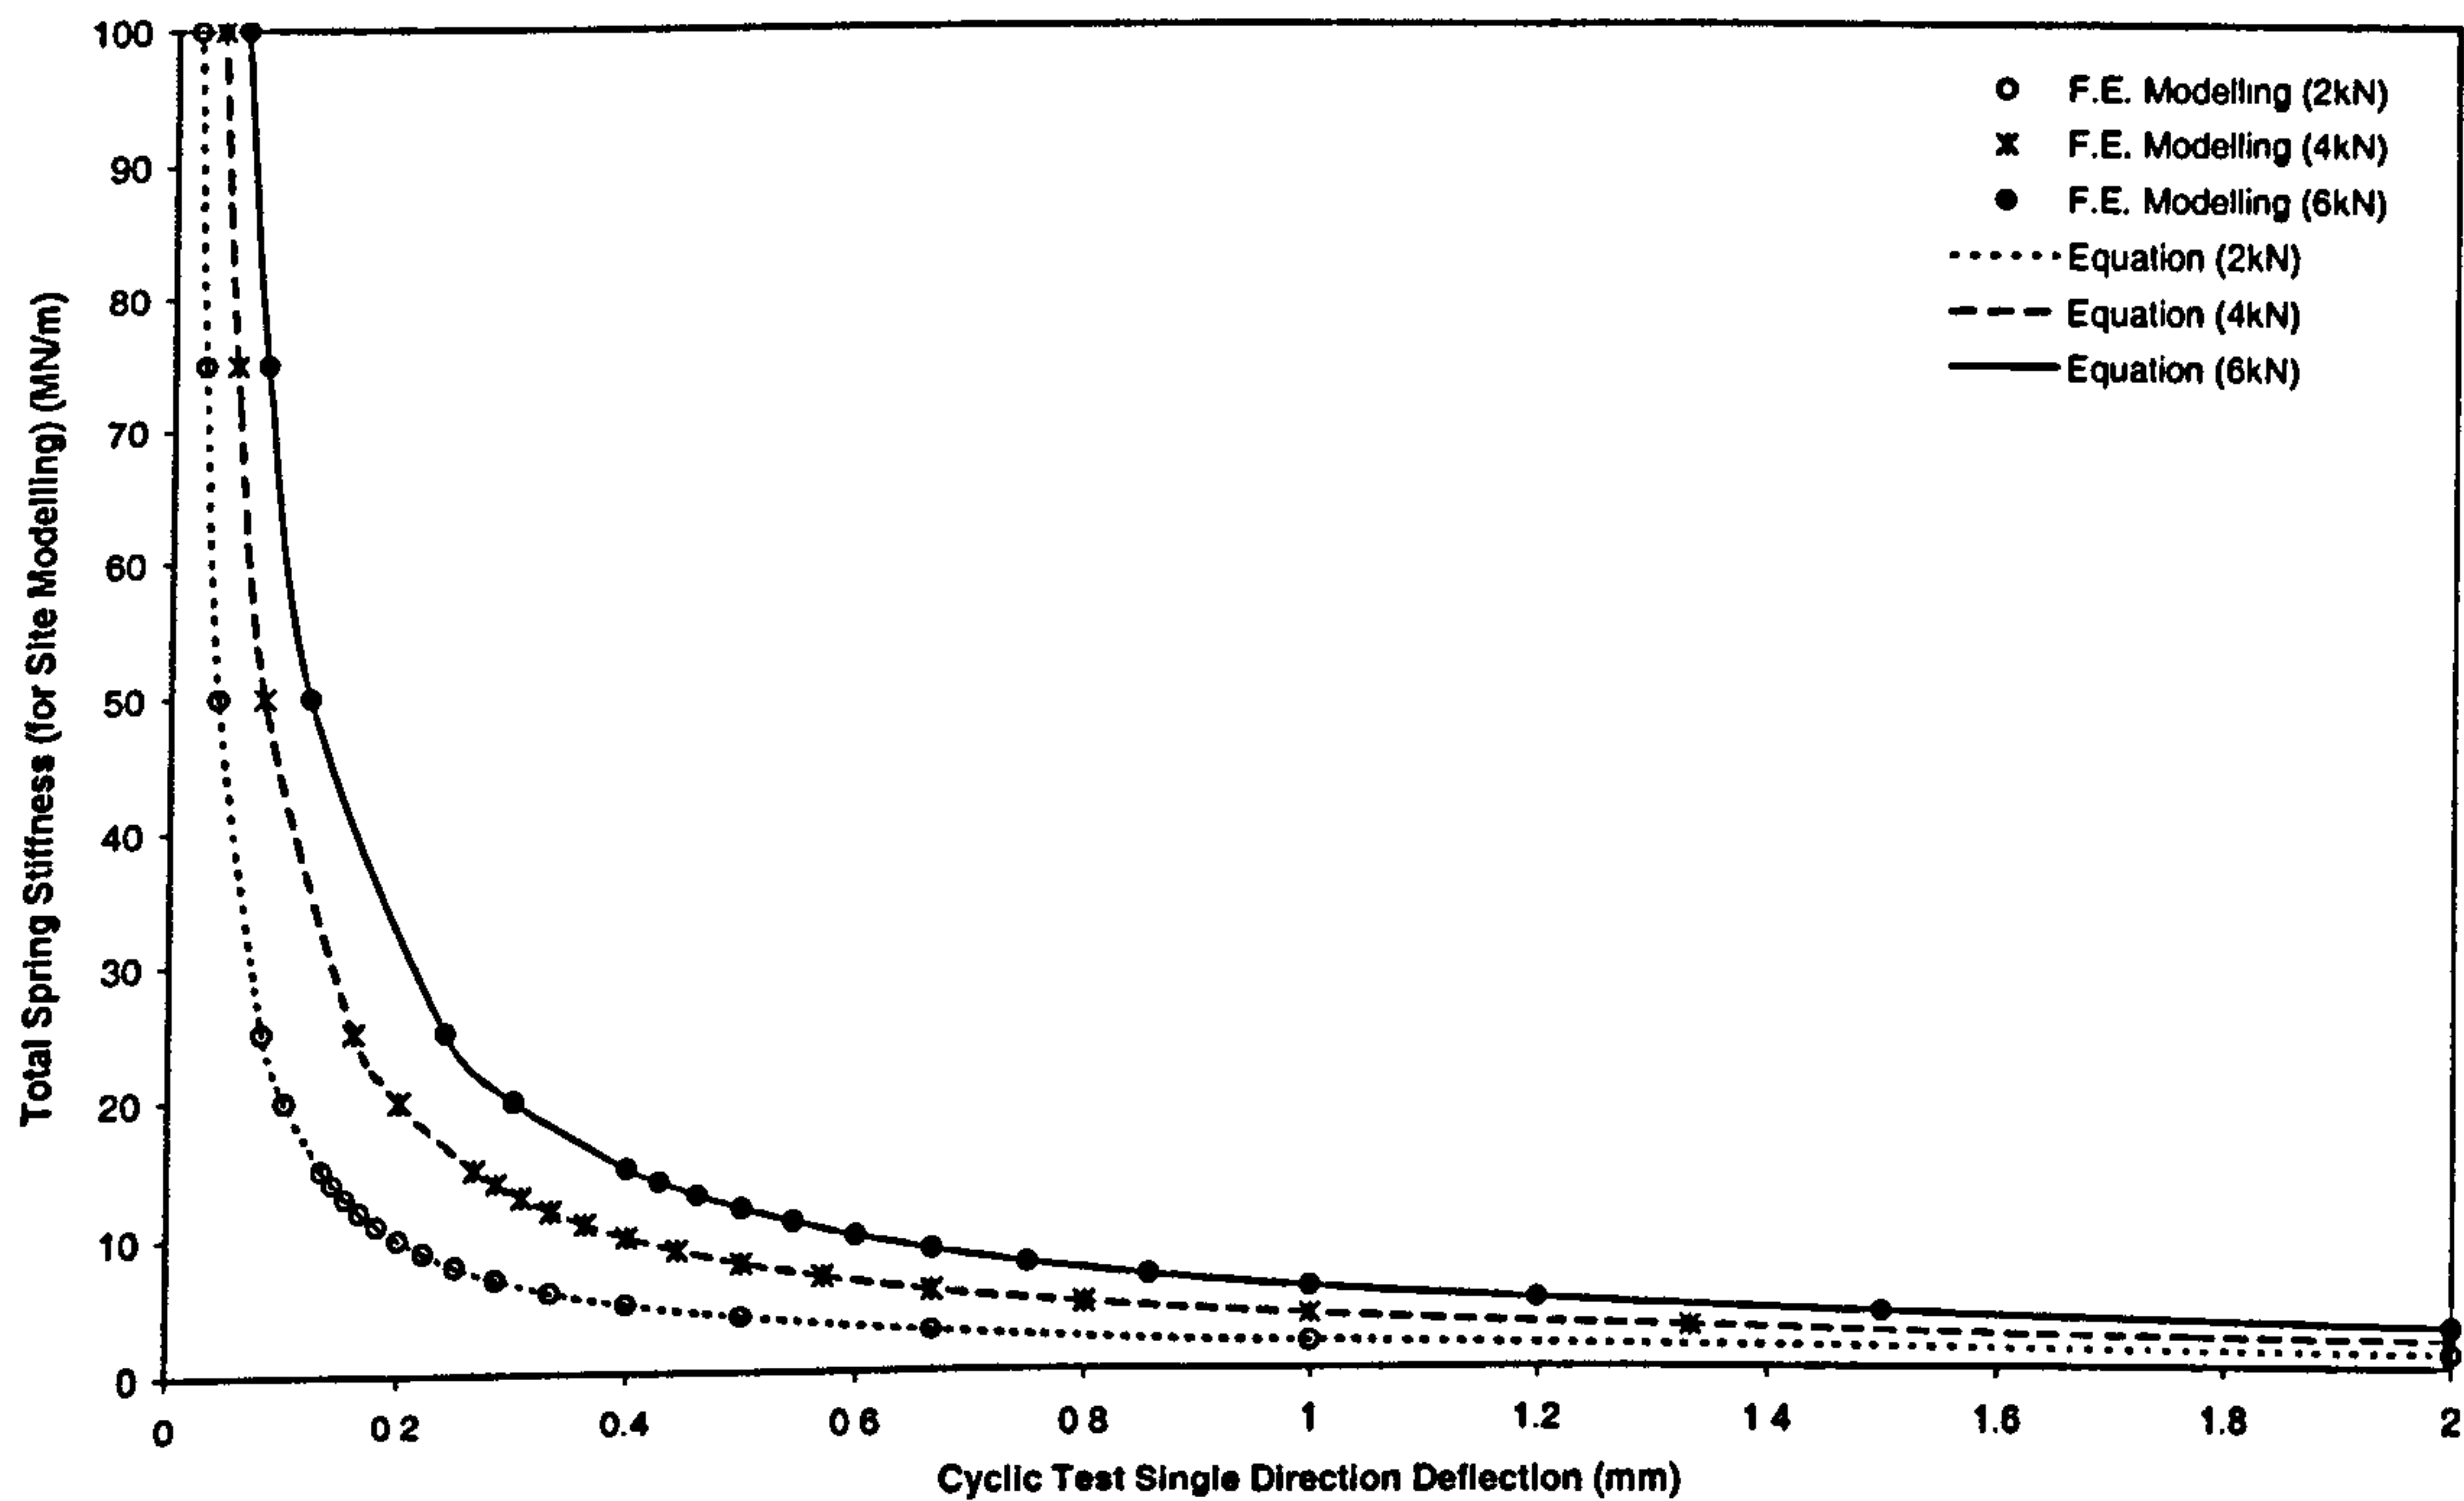
Figure 7.5 – Comparison of the laboratory Finite Element model with the standard spring equation

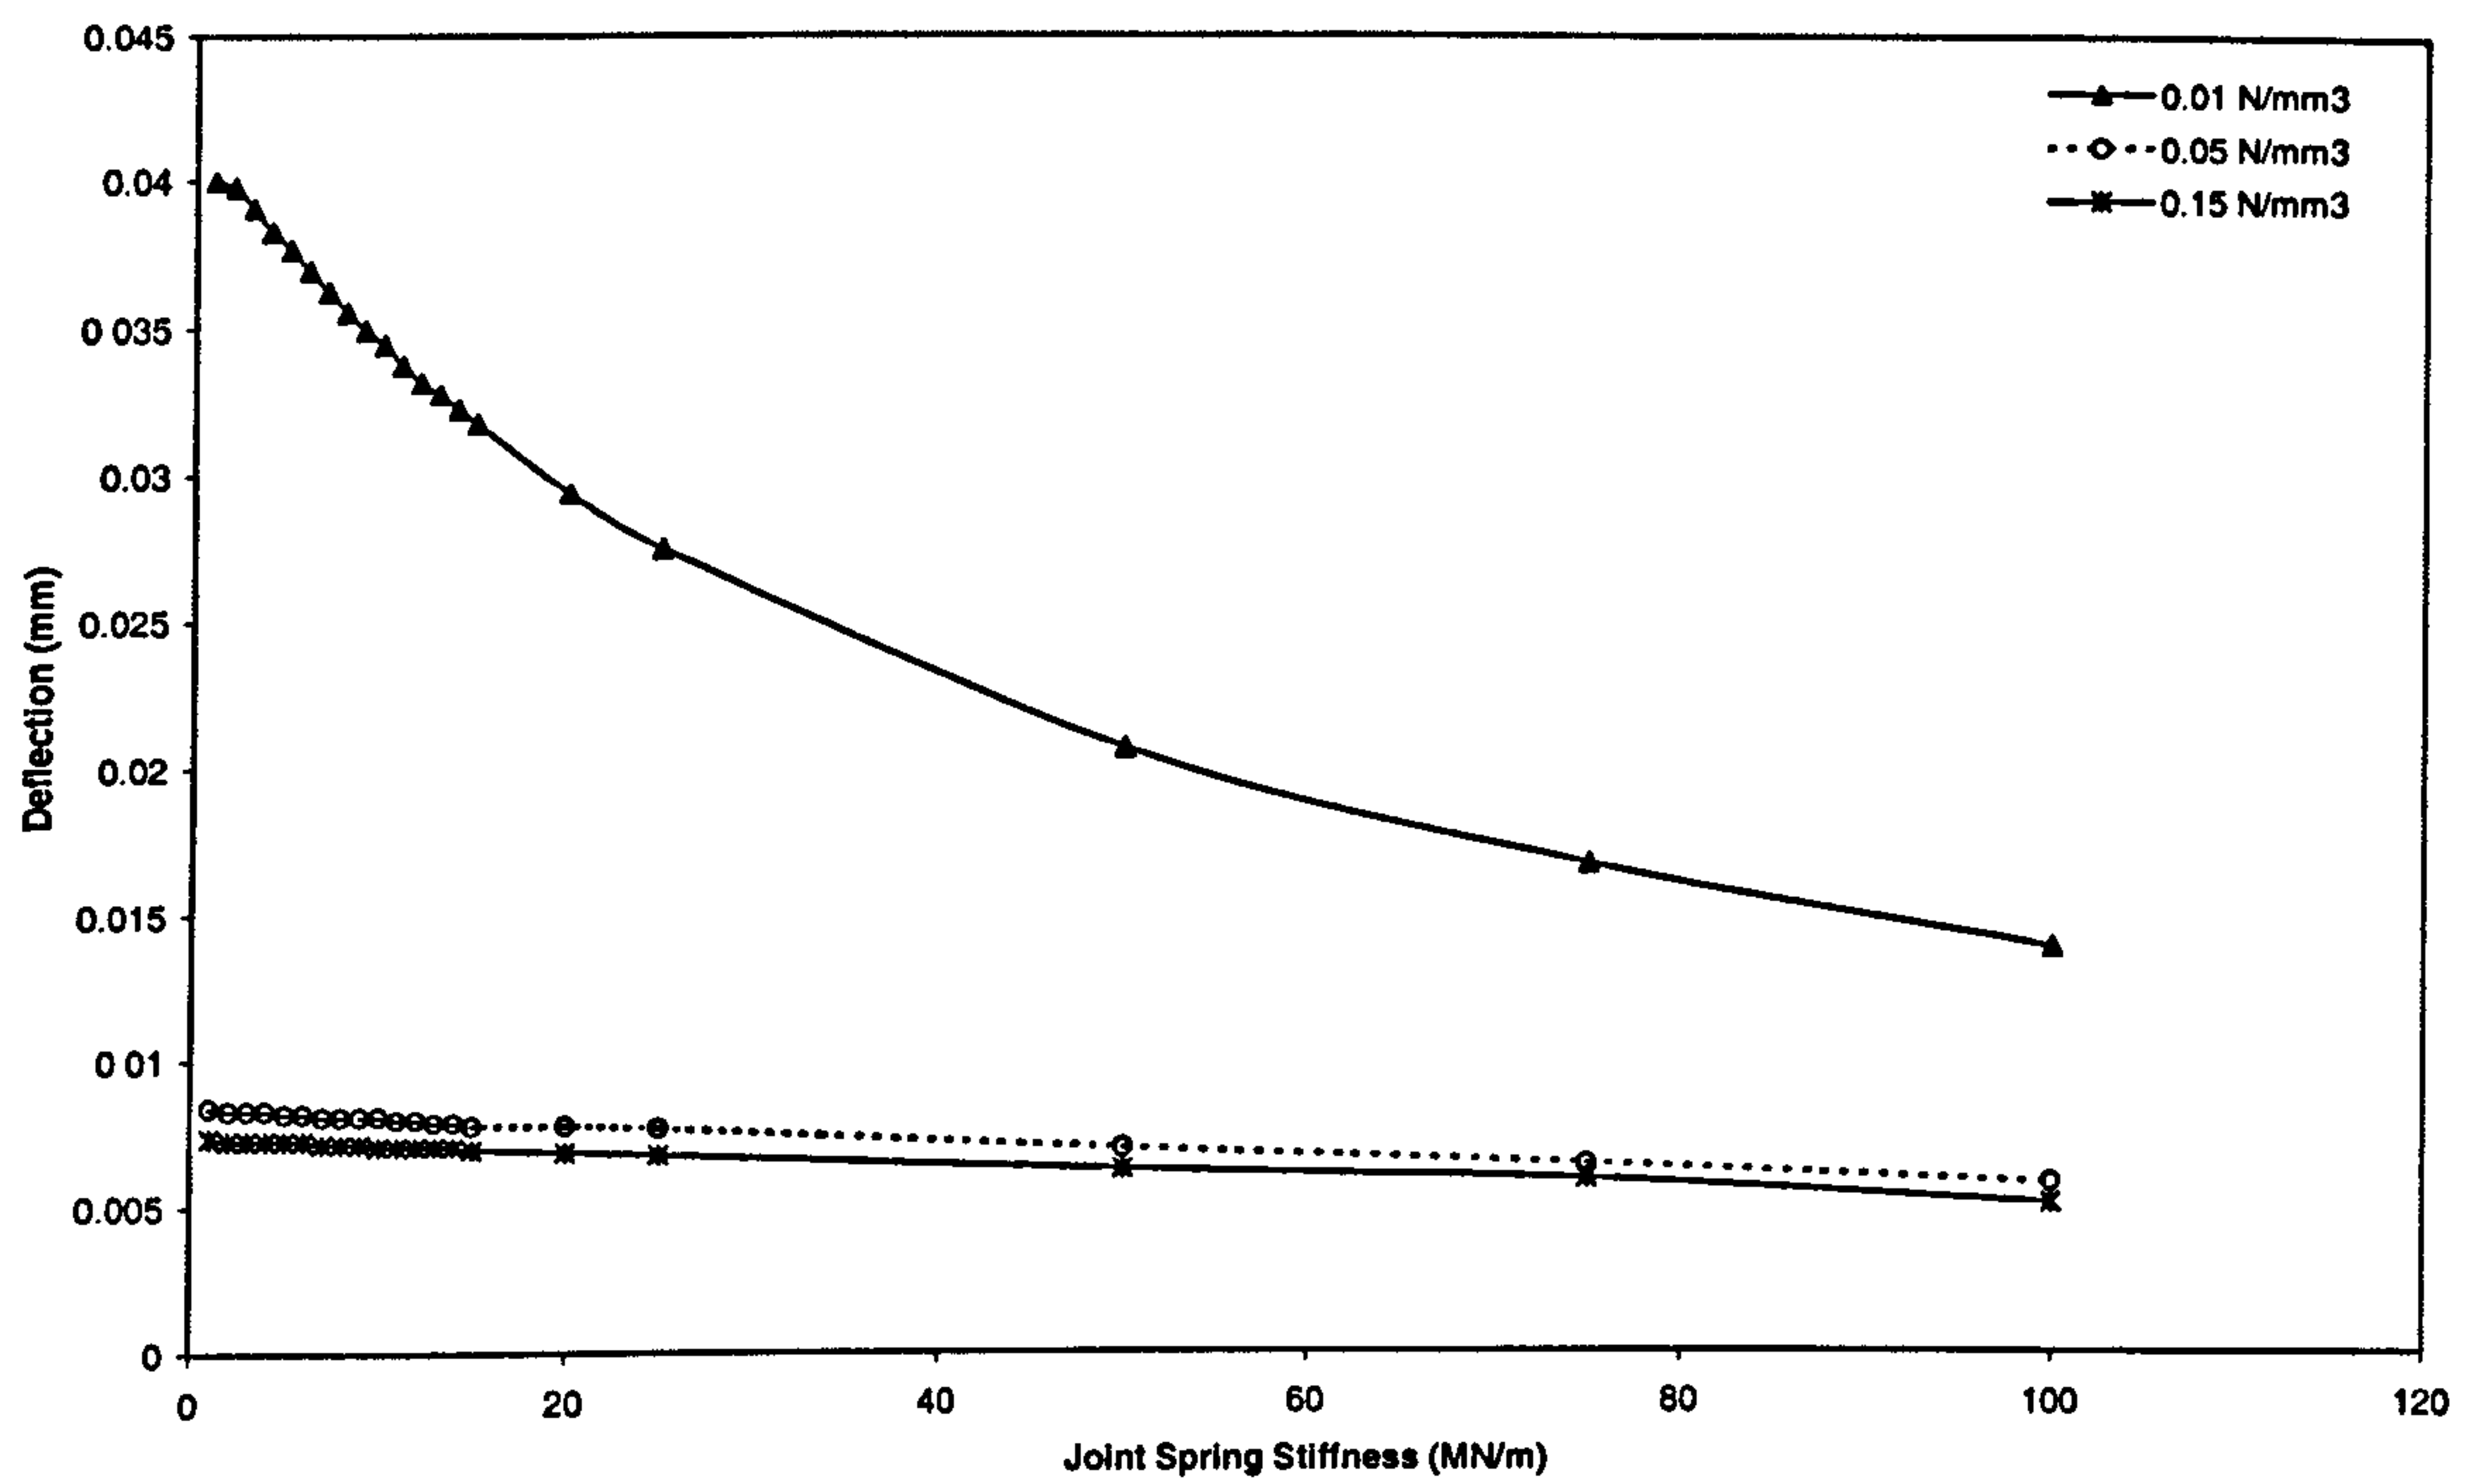
Figure 7.6 – Effect of foundation material under the crack in the laboratory Finite Element model.

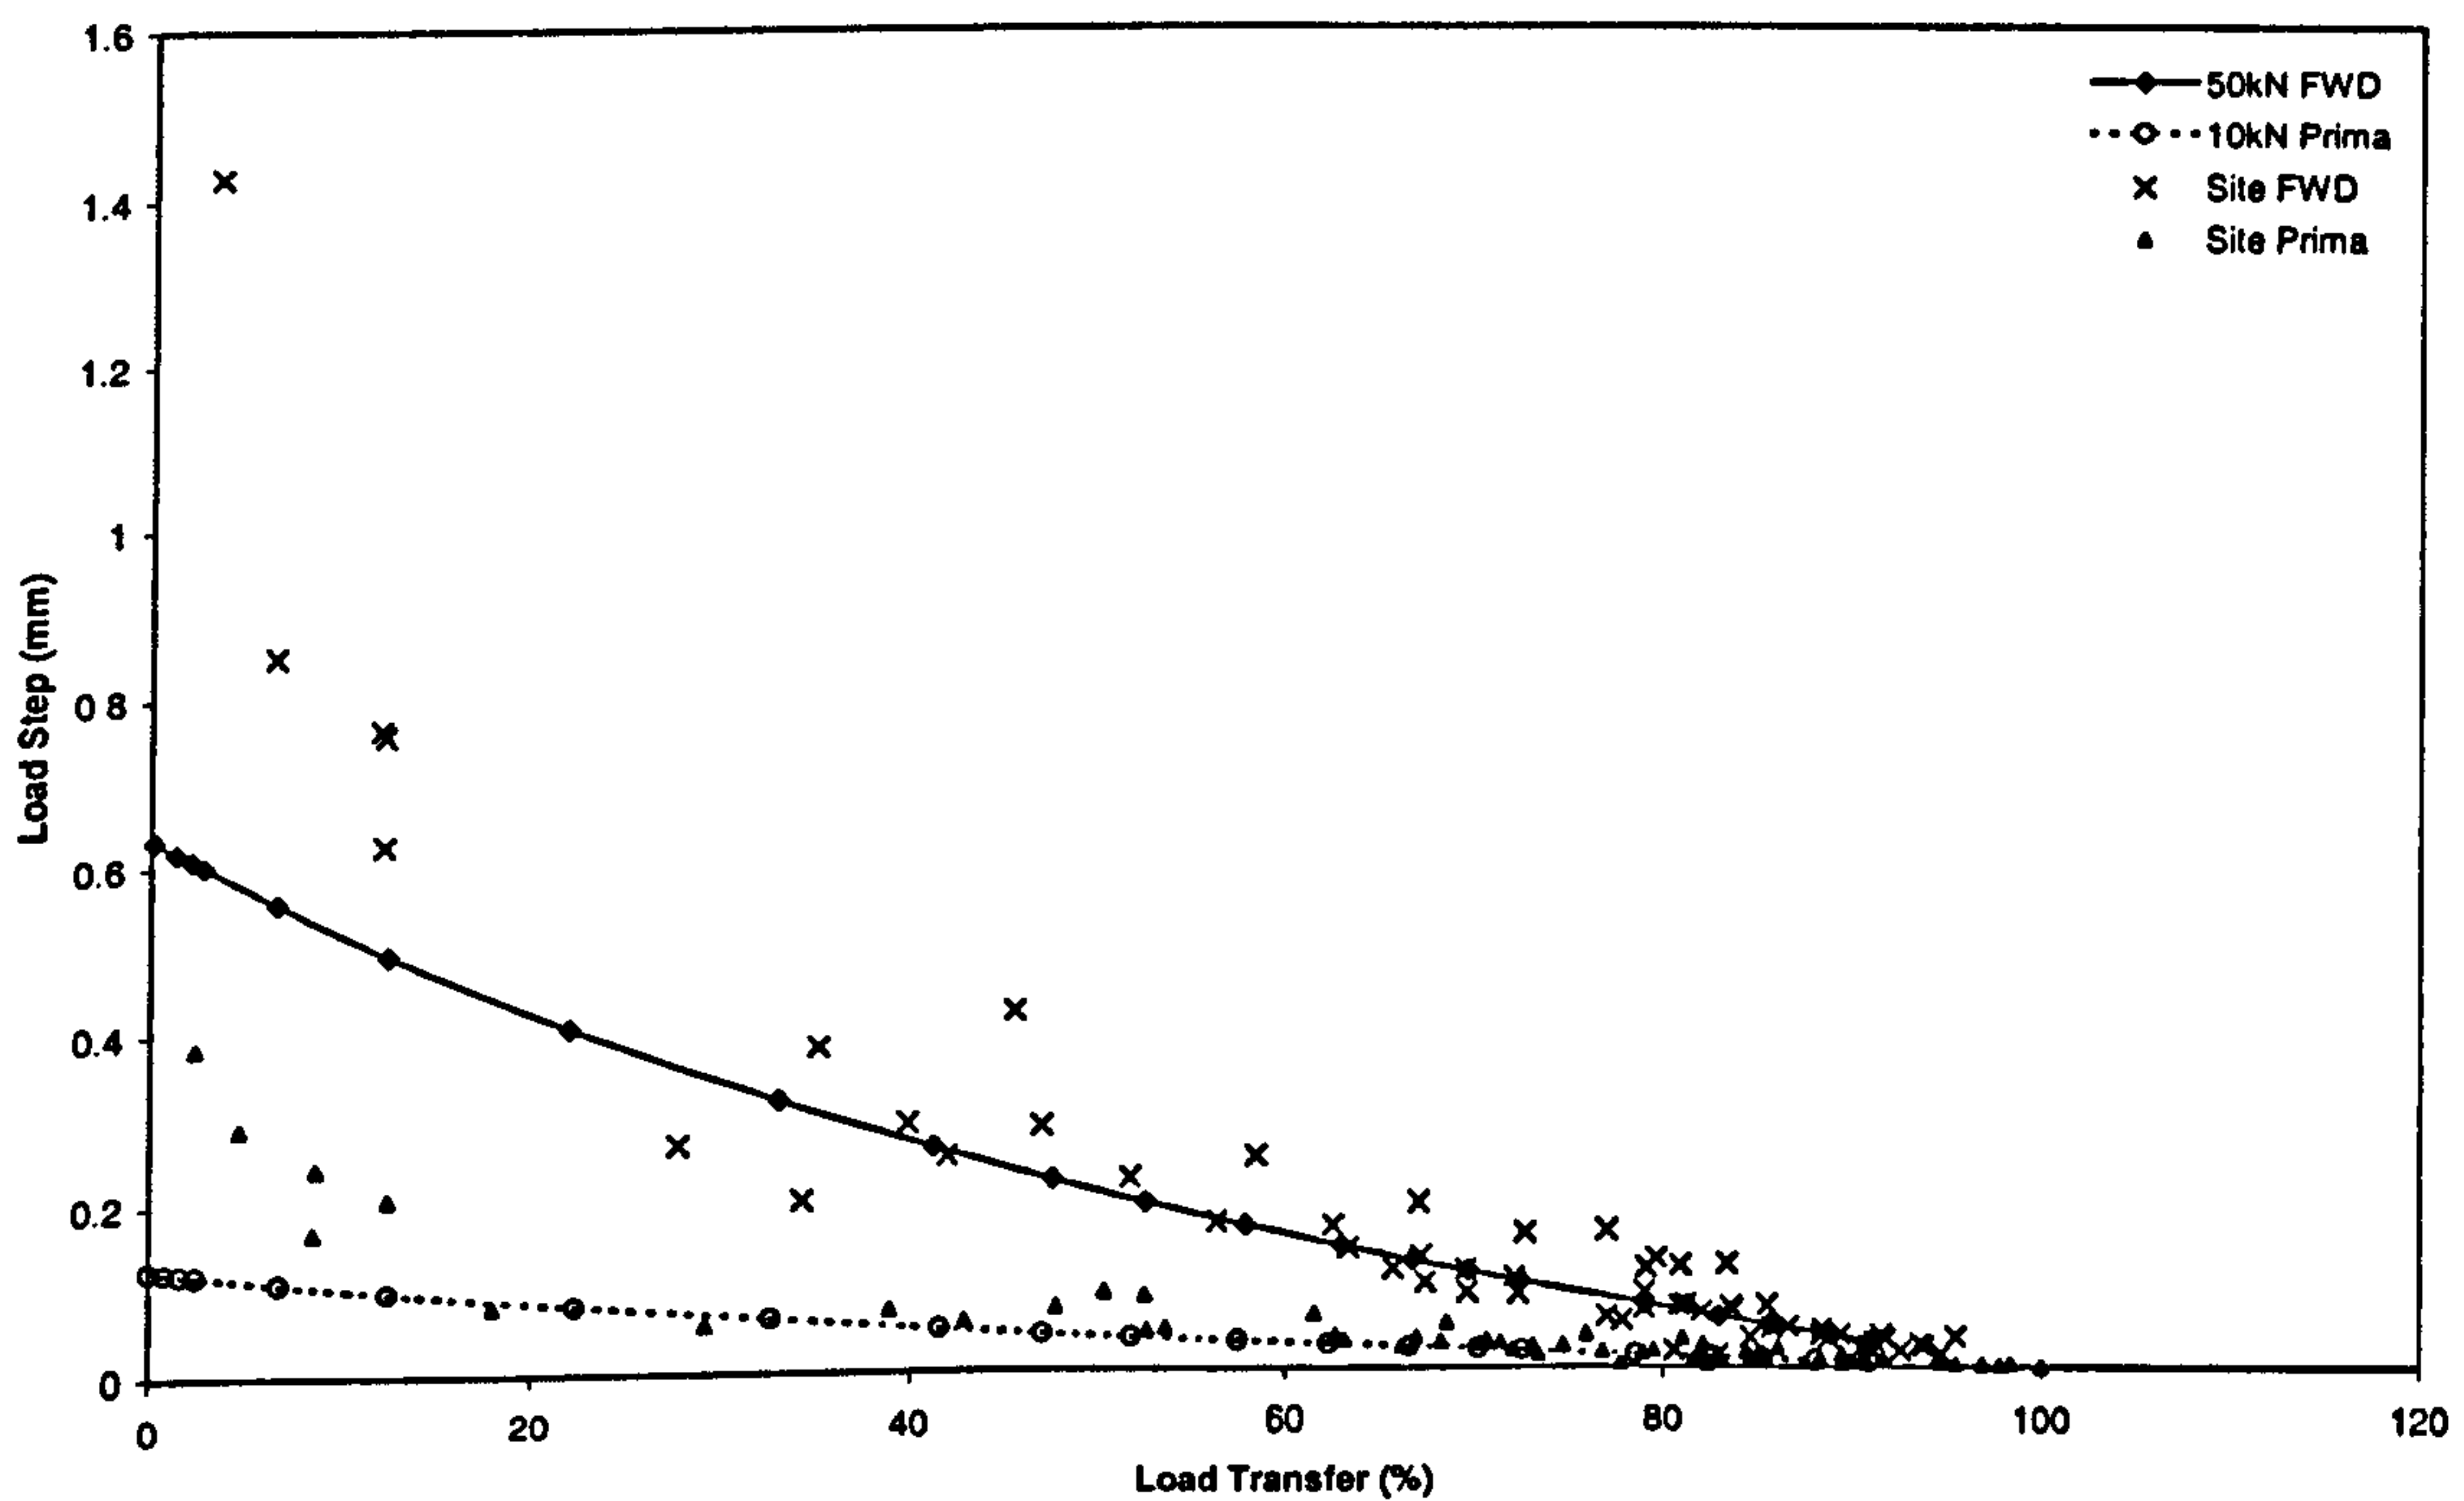
Figure 7.7a – Comparison of load transfer and load step between the Daventry Finite Element model and in-service slab response

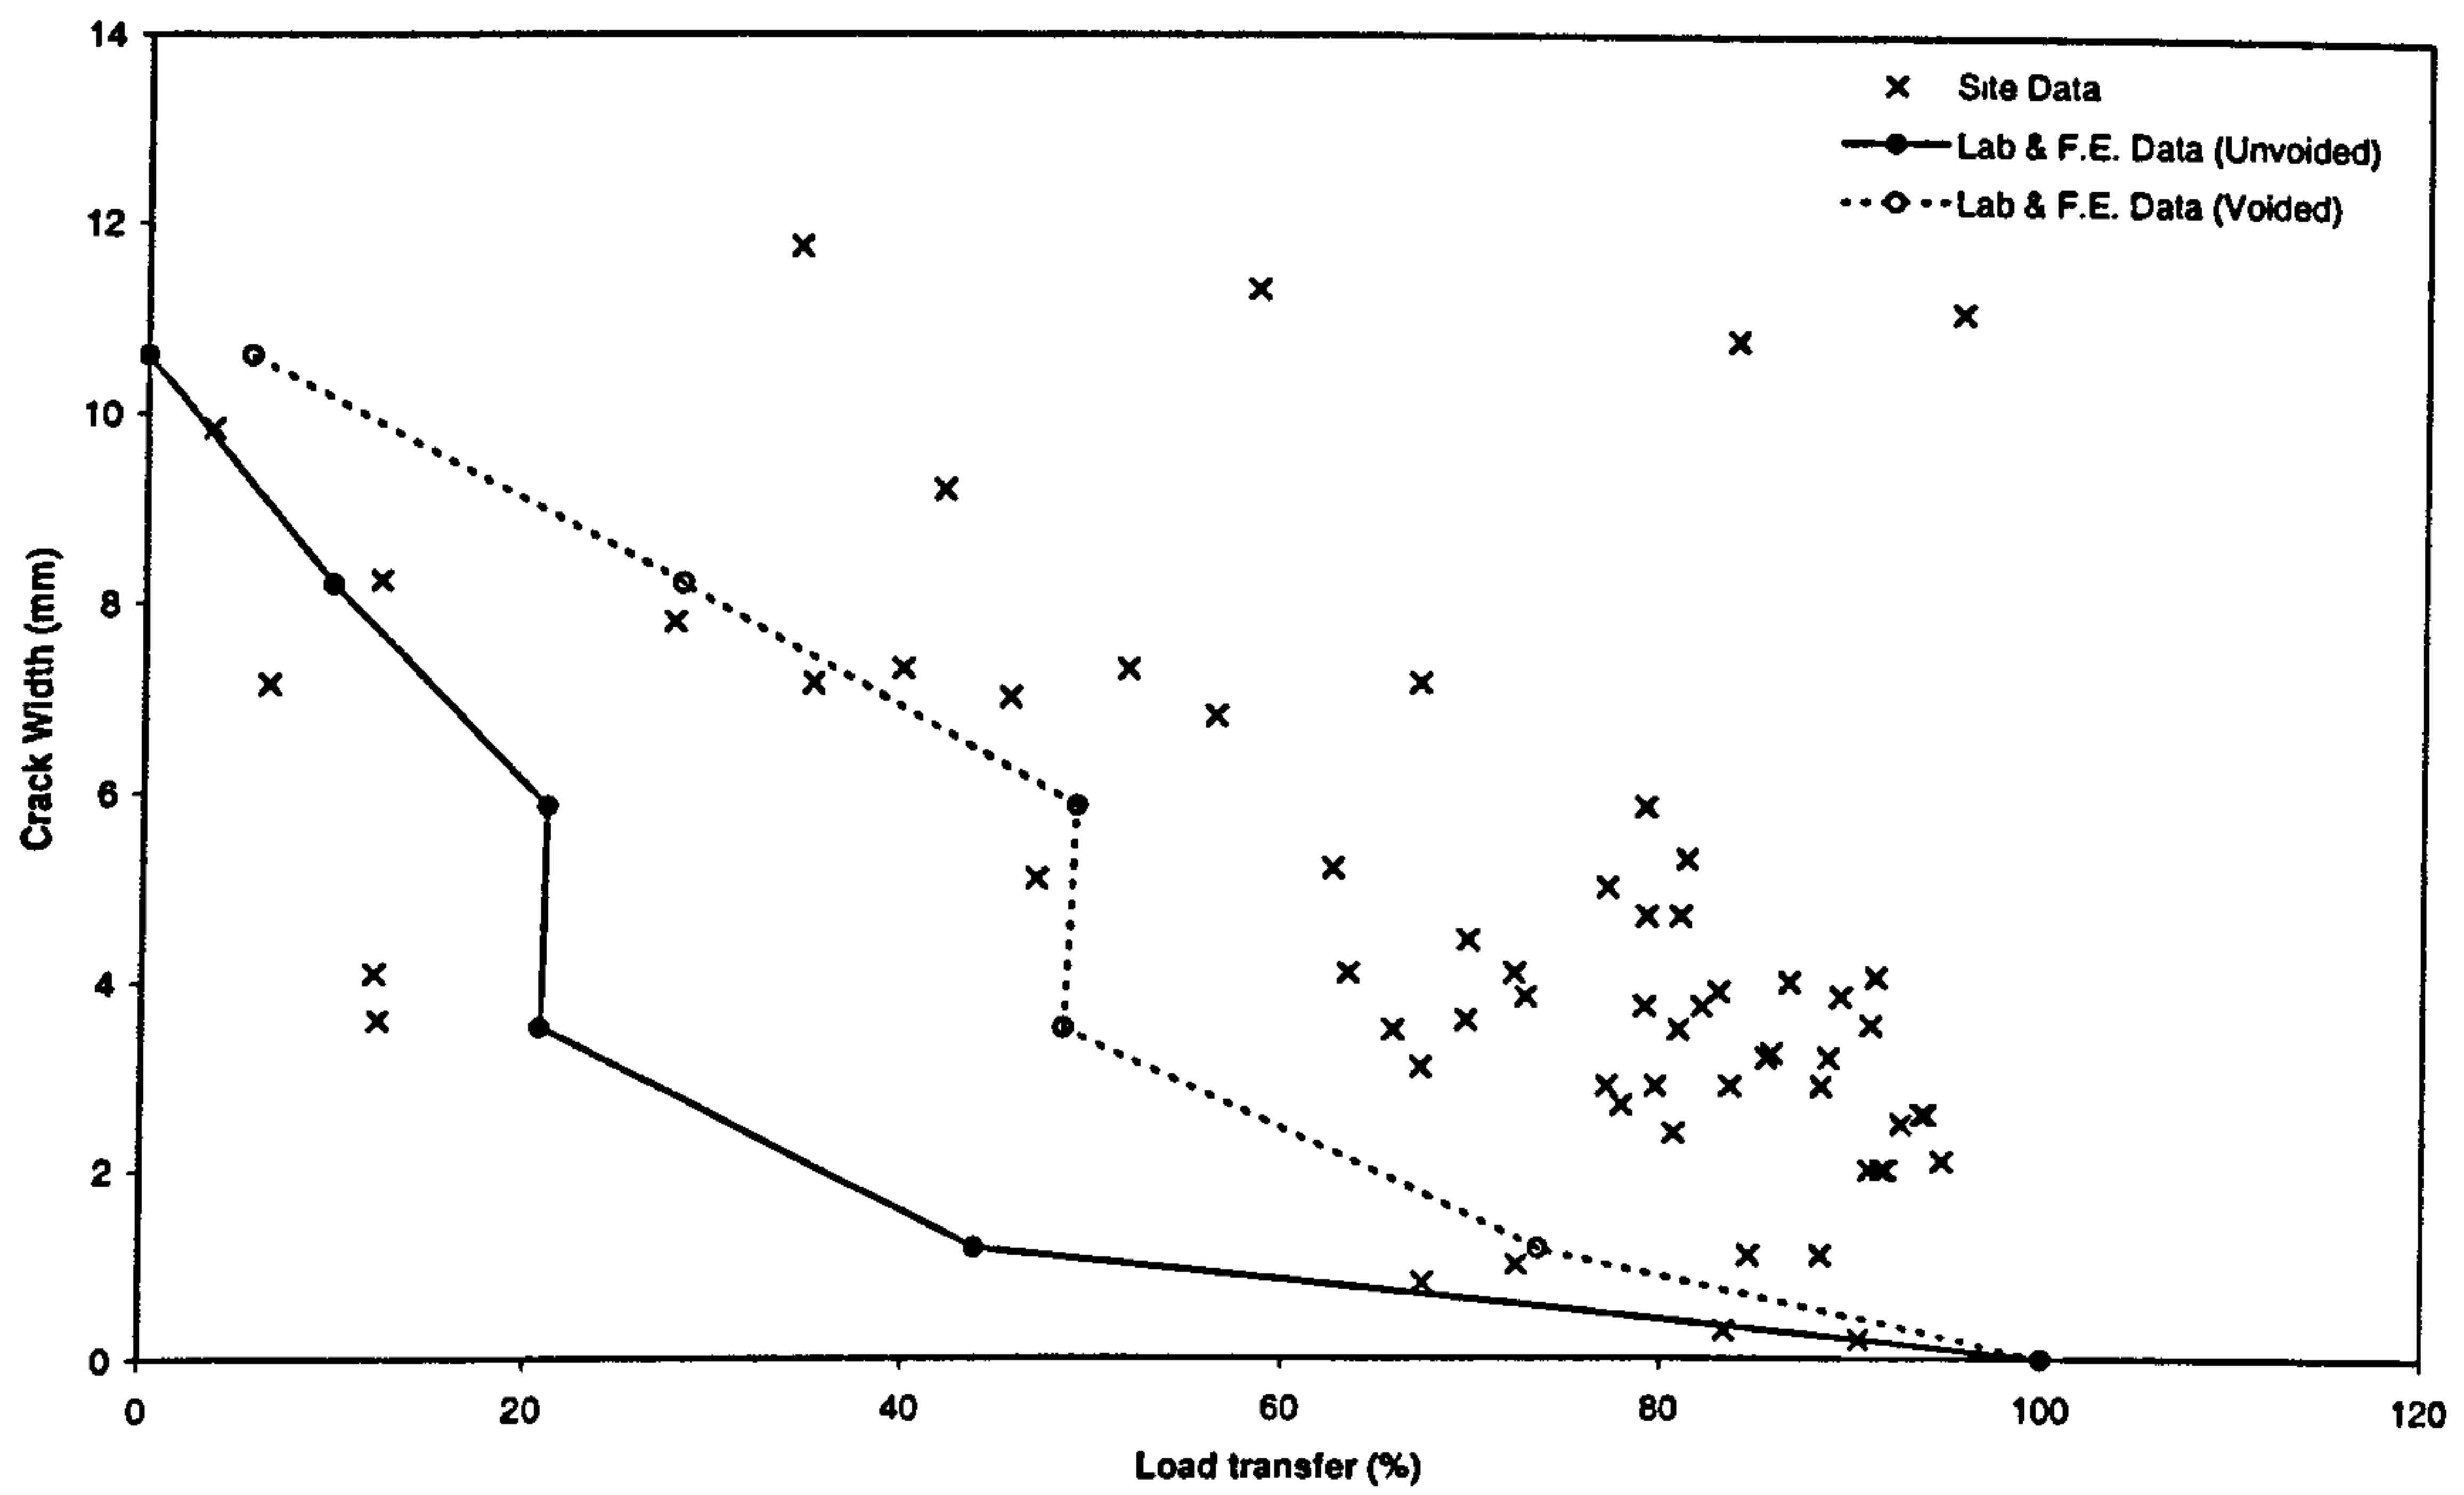
Figure 7.13 – Comparison of predicted and actual surface crack width/load transfer behaviour for Daventry

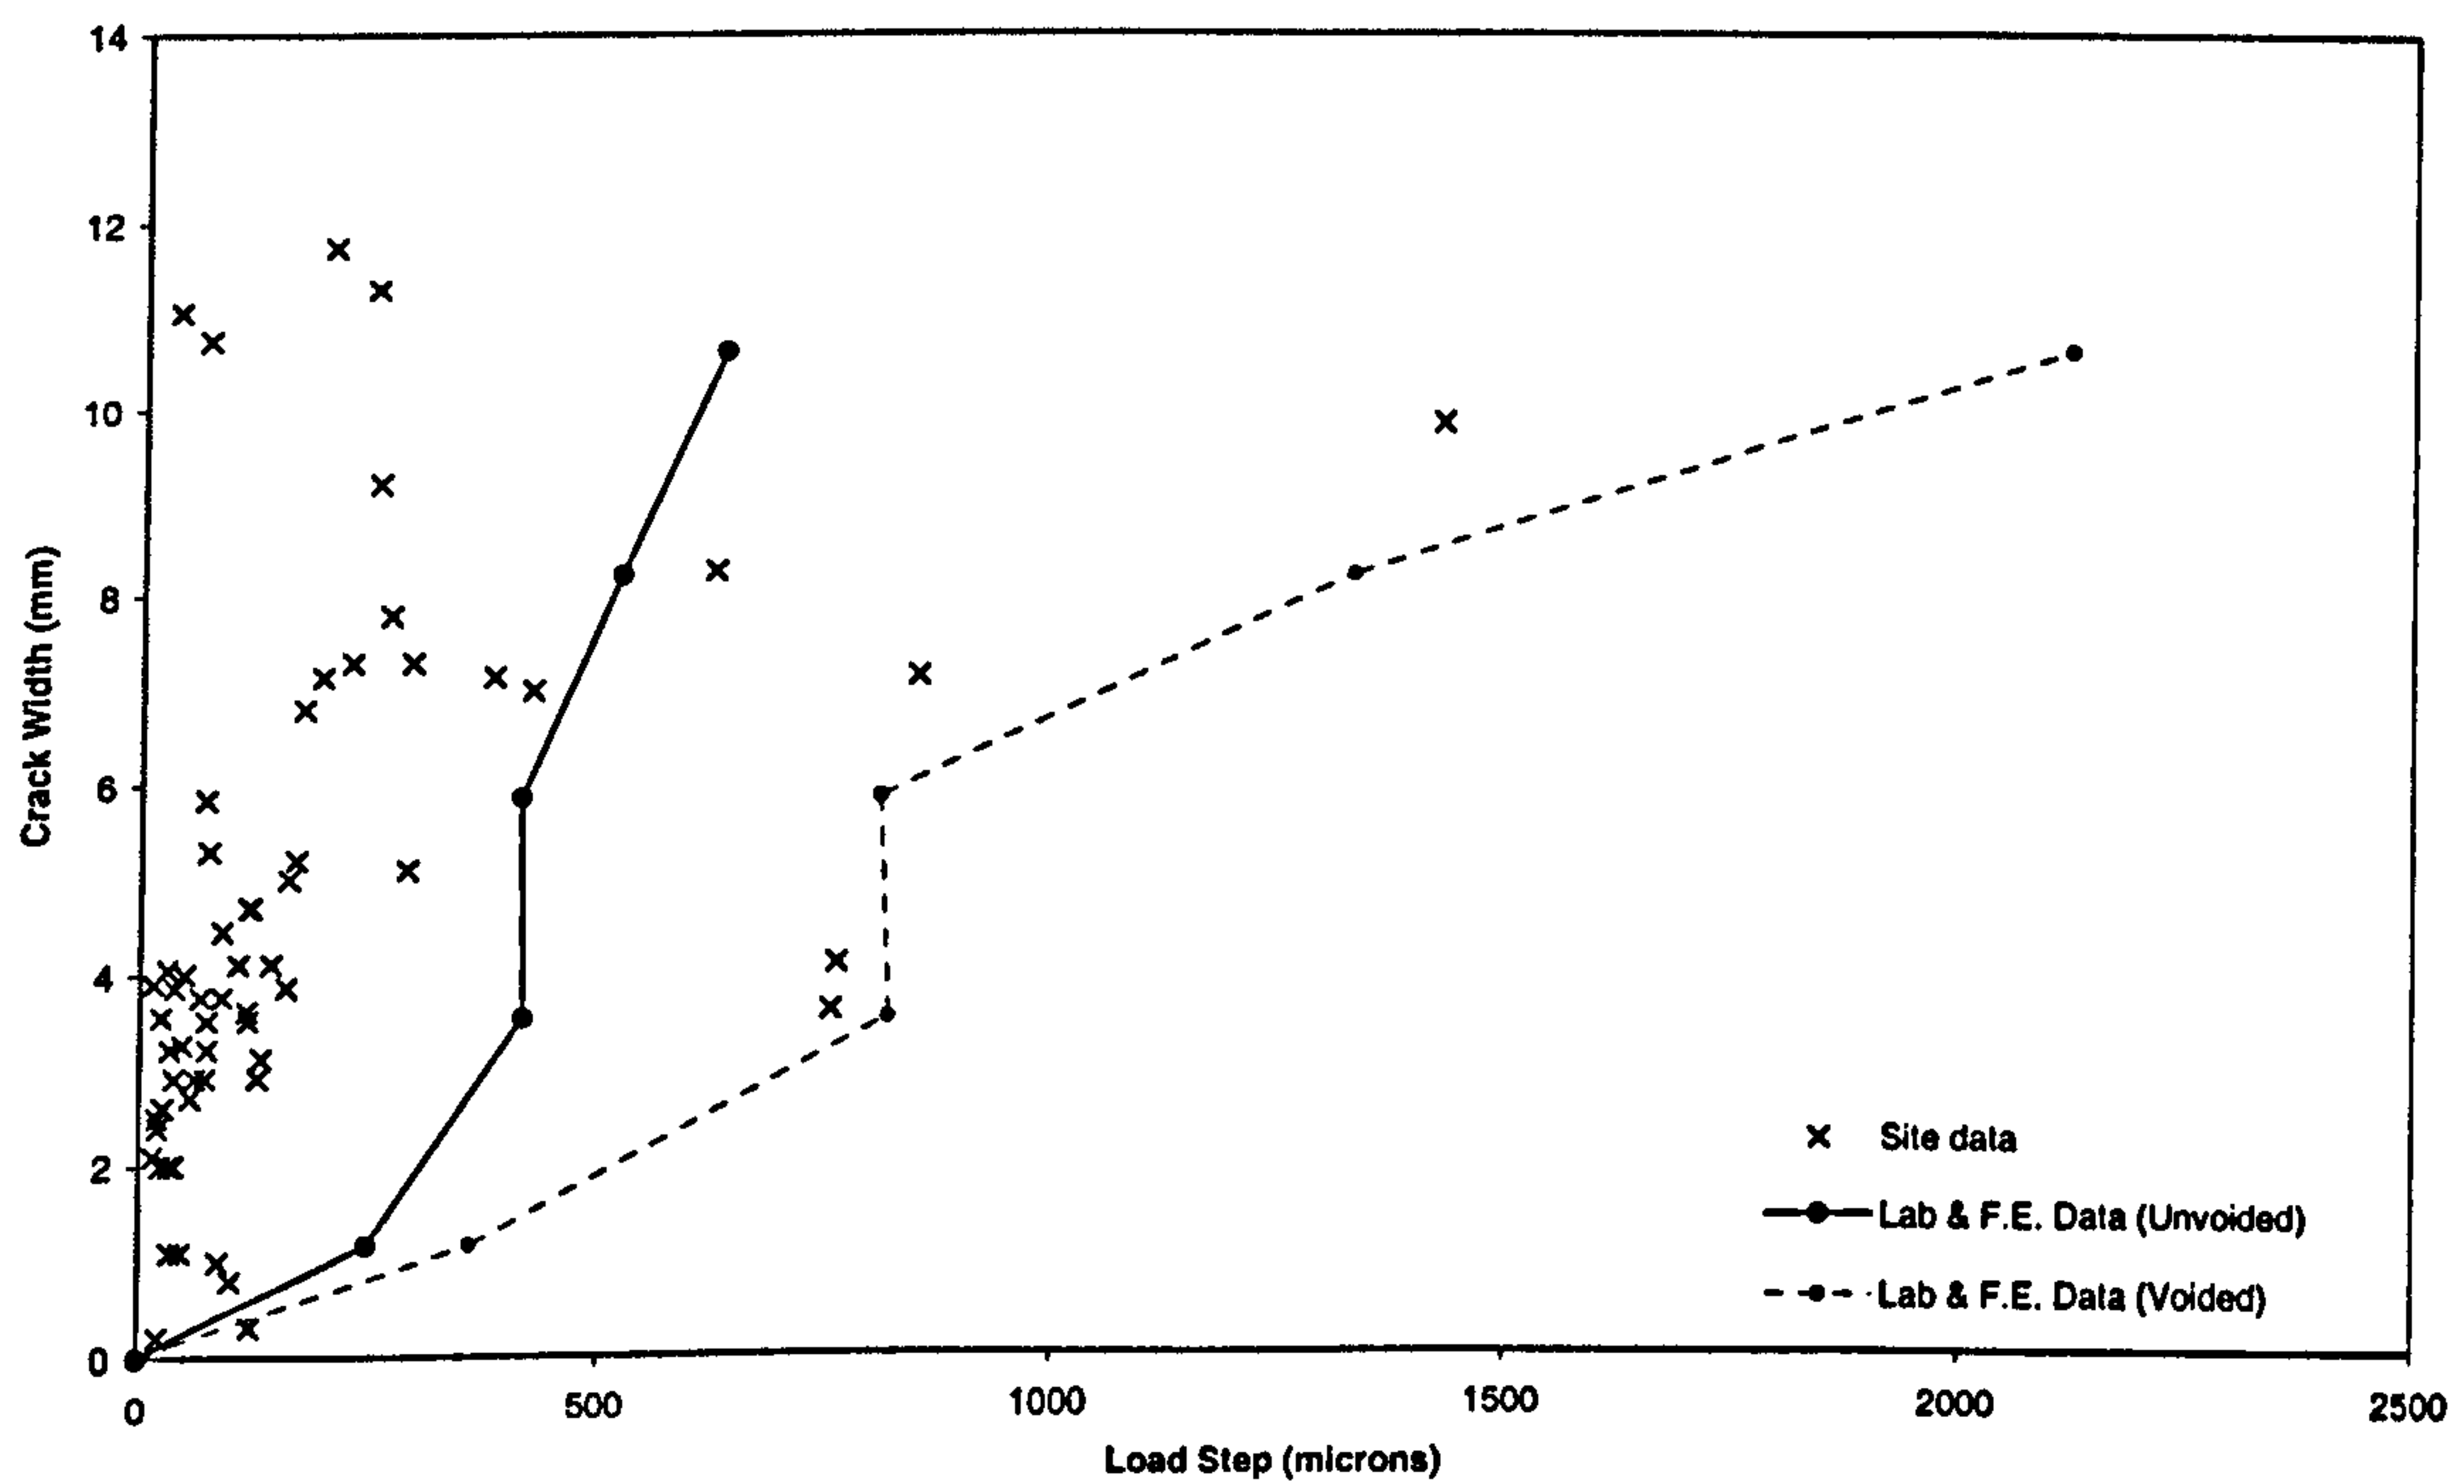
Figure 7.14 – Comparison of predicted and actual surface crack width/load step behaviour for Daventry

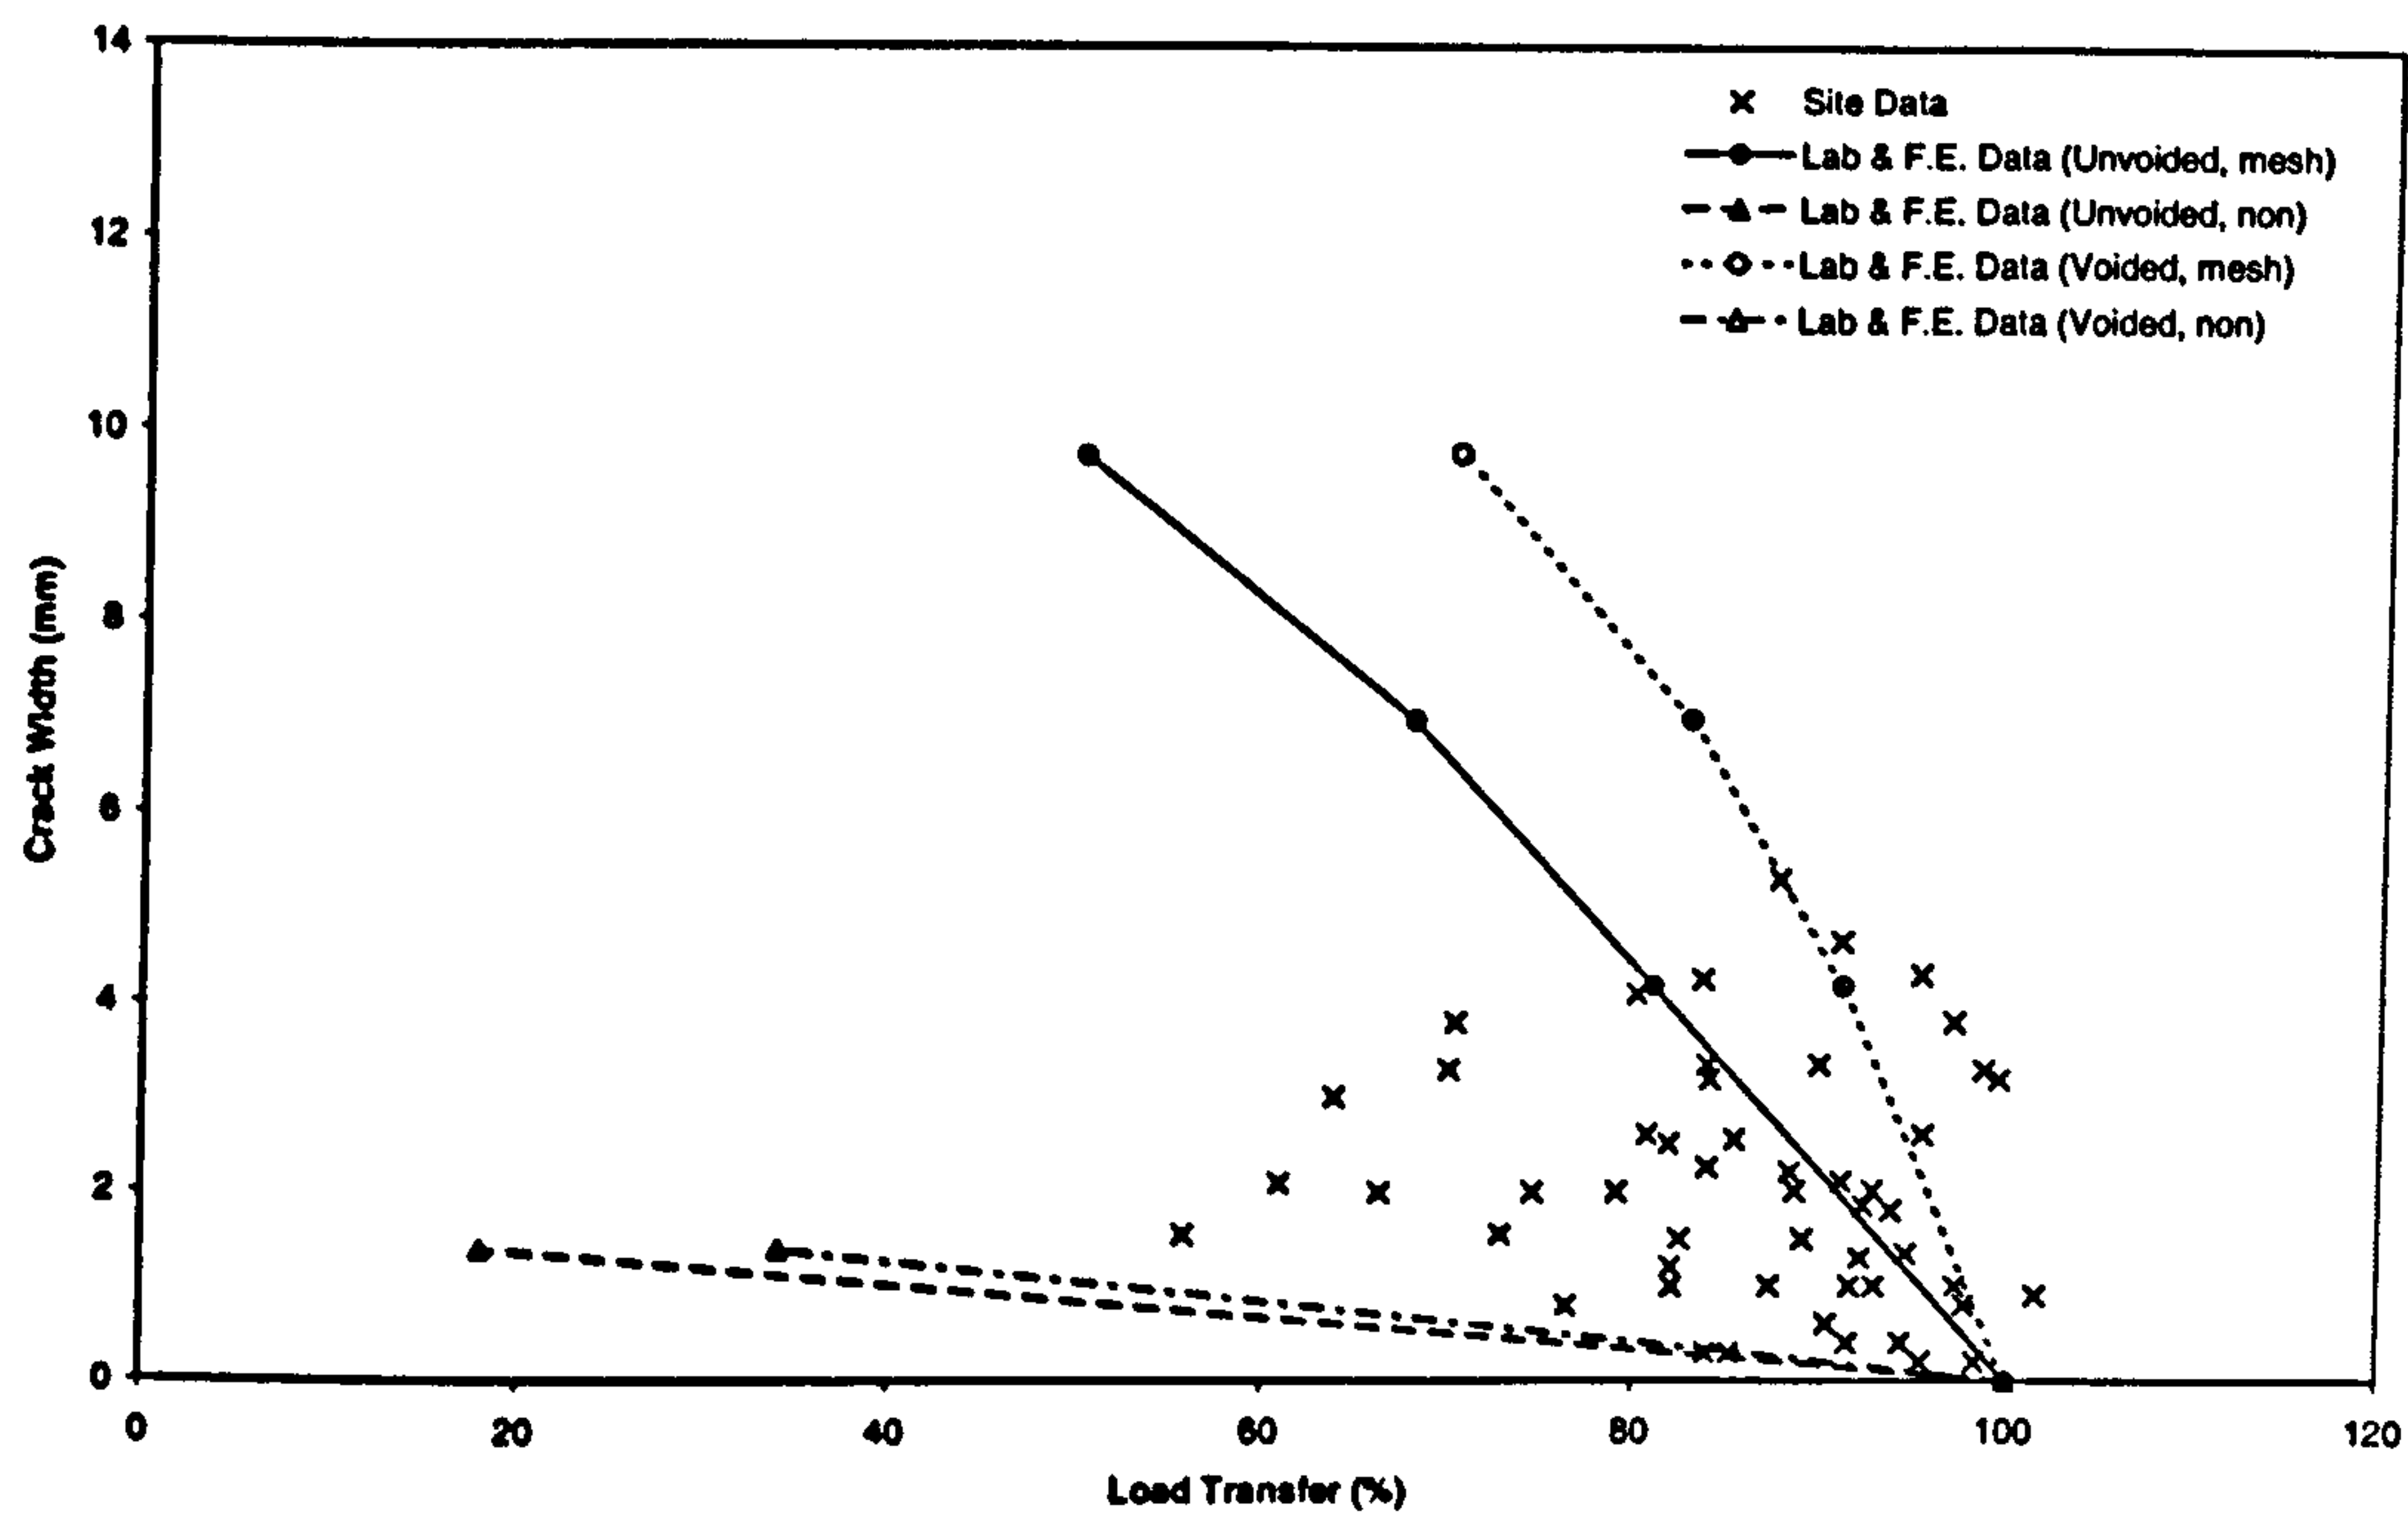
Figure 7.15 – Comparison of predicted and actual surface crack width/load transfer behaviour for Lutterworth
