LOAD TRANSFER ACROSS CRACKS AND JOINTS IN CONCRETE SLABS ON GRADE

Stuart John Arnold

**A Doctoral Thesis Submitted in partial fulfilment of the requirements for the
award of
Doctor of Philosophy of Loughborough University**

20th February 2004

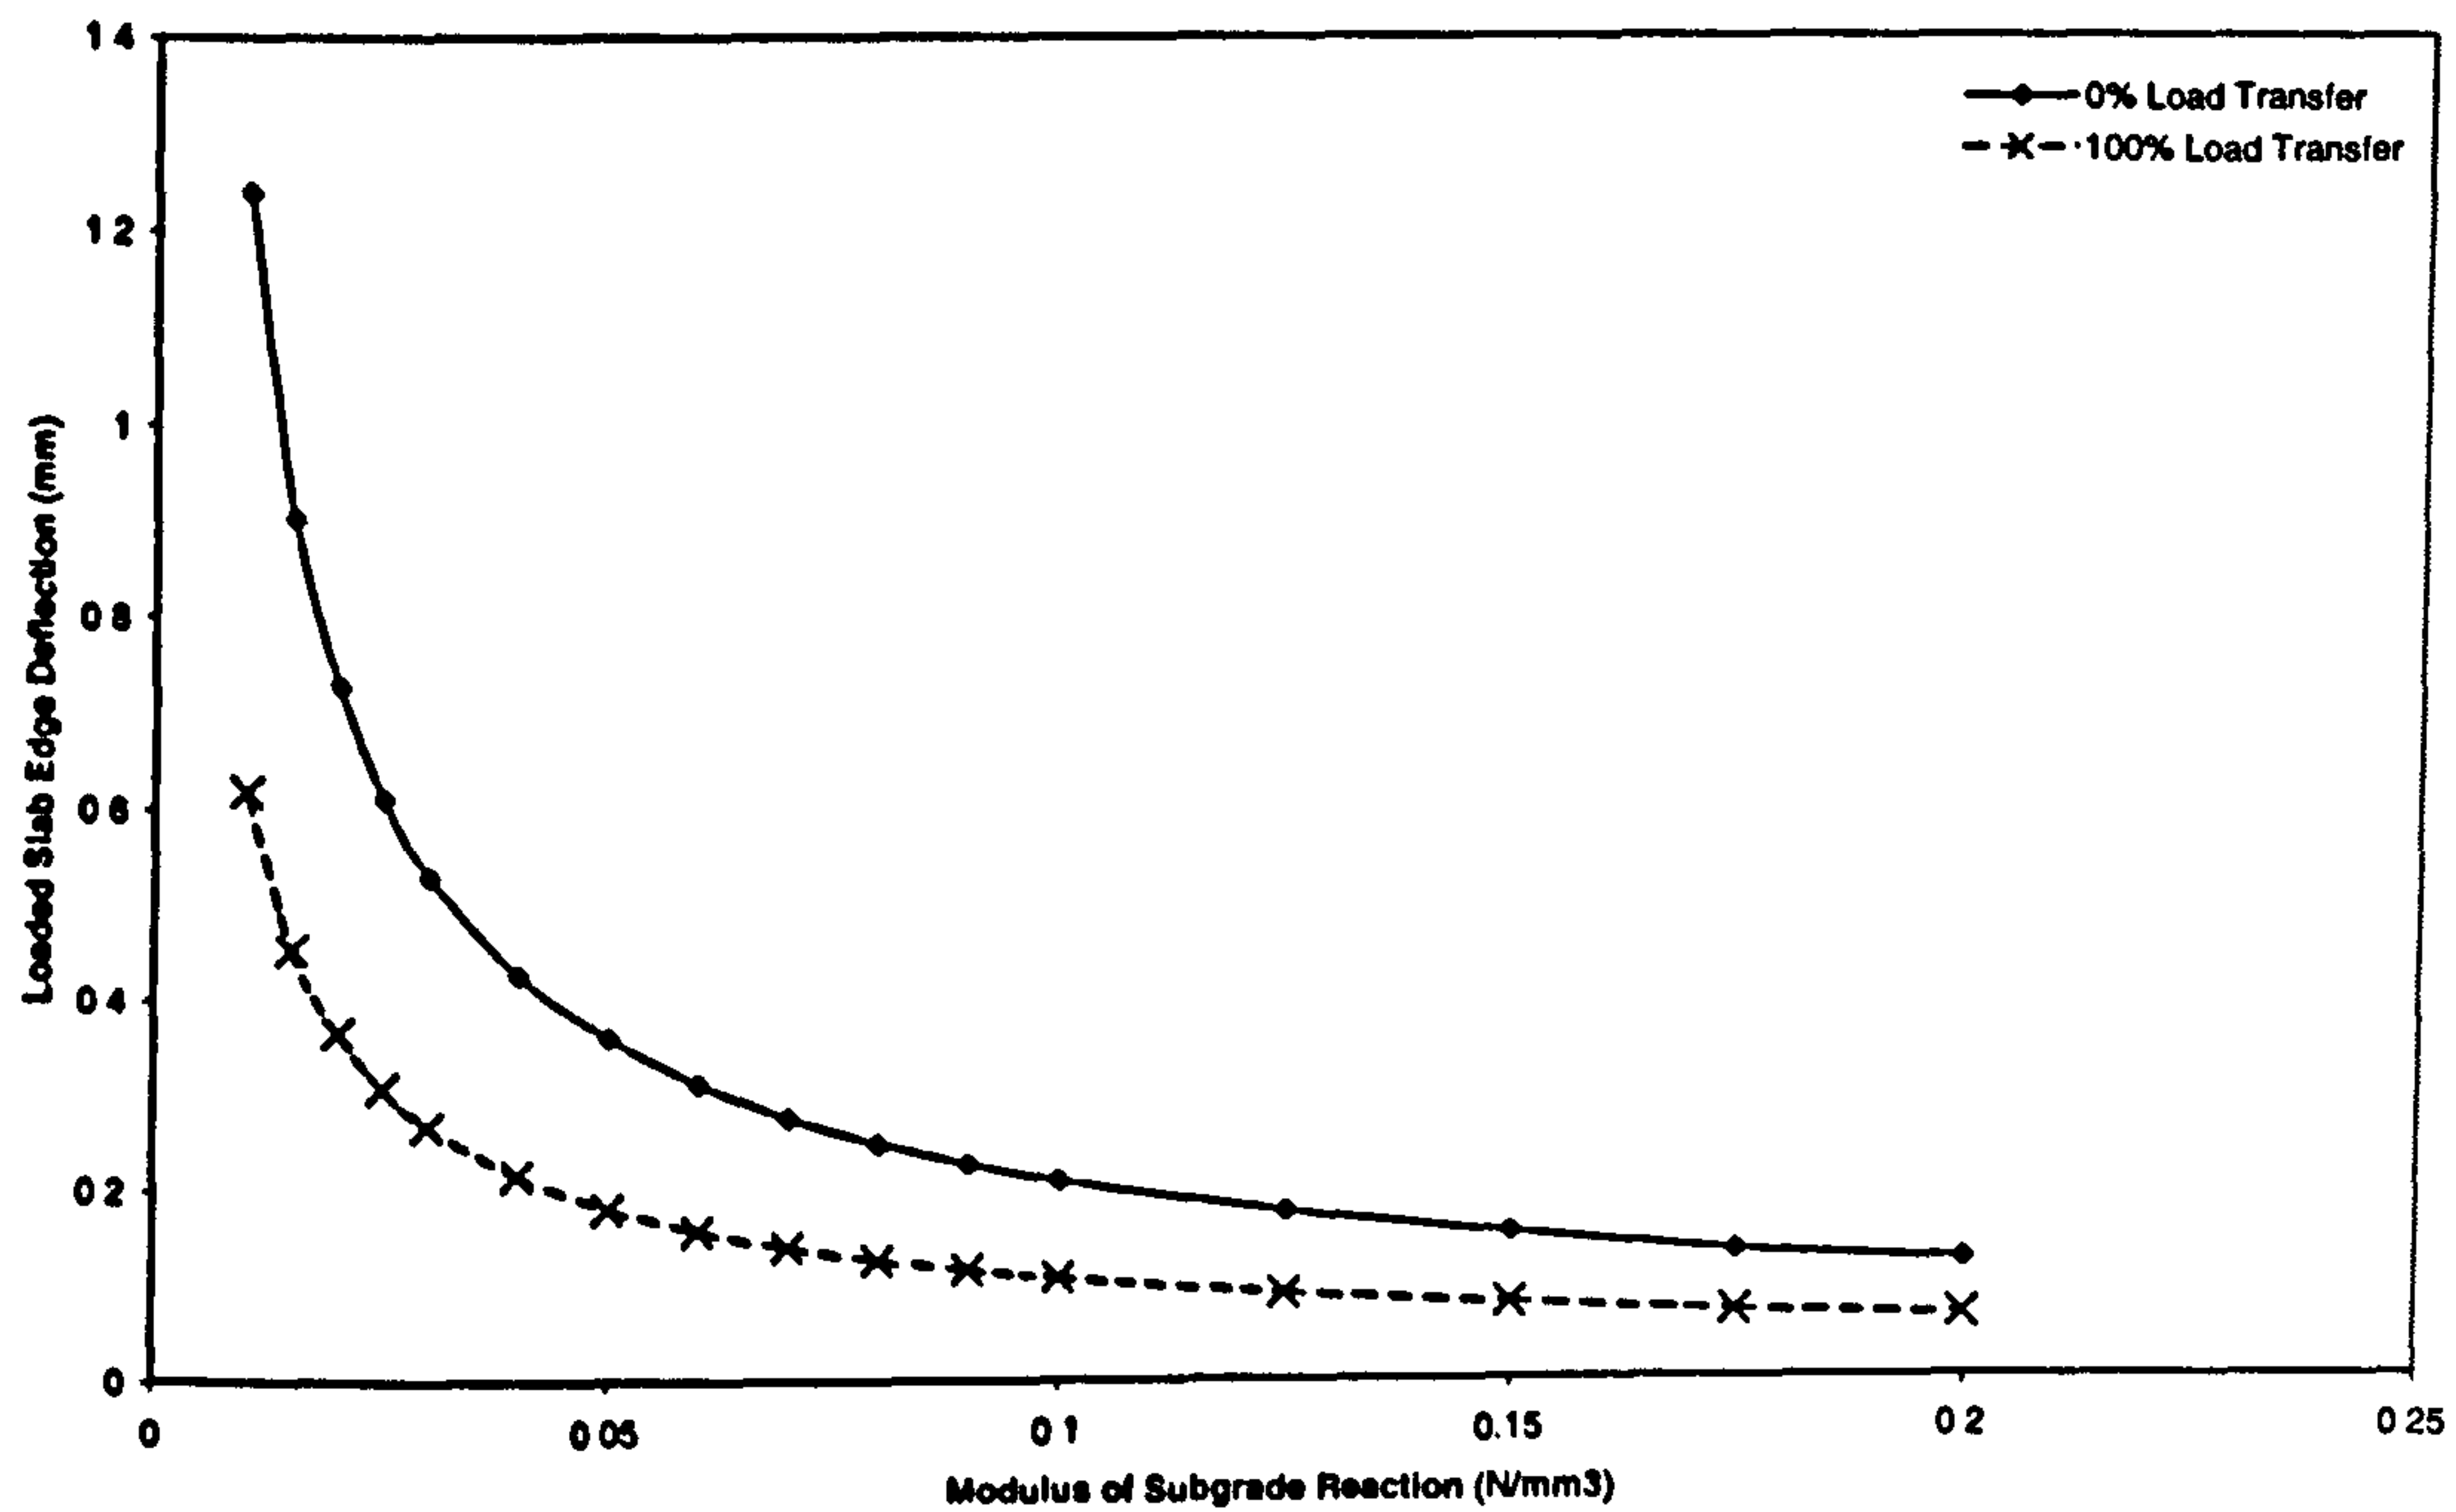
Figure 7.17 – Effect of modulus of subgrade reaction on the loaded slab edge deflection for a typical in service slab
