41st WEDC International Conference, Egerton University, Nakuru, Kenya, 2018

**Assessment of the functionality of rope pumps for
sustainable water supply in rural areas of Malawi**

A. Kamanga, J. Mhango & R. Veldman (Malawi)

PAPER 3041

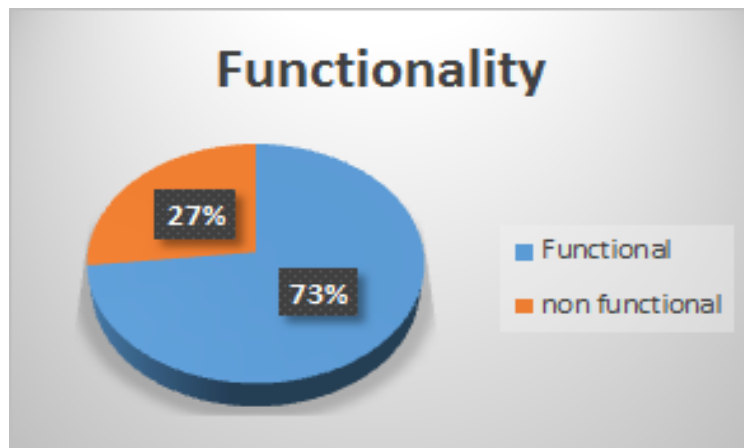
Figure 2. Functionality of the visited pumps

Functionality is one of the critical areas to look upon as far as management and sustainability of water facility is concerned. Within the research a functional pump was defined as a pump that pumps water of required volume at the time of the visit. The research examined a total of 127 Rope pumps, and it was observed that 93 pumps were functioning while 34 pumps were non-functional representing 73% and 27% respectively. It was also found that out of 127 Rope pumps 52 pumps were private owned pumps while 75 pumps were communal pumps. A total of 45 private pumps were functioning while (87%) 48 communal pumps were working during the time of visit (64%).

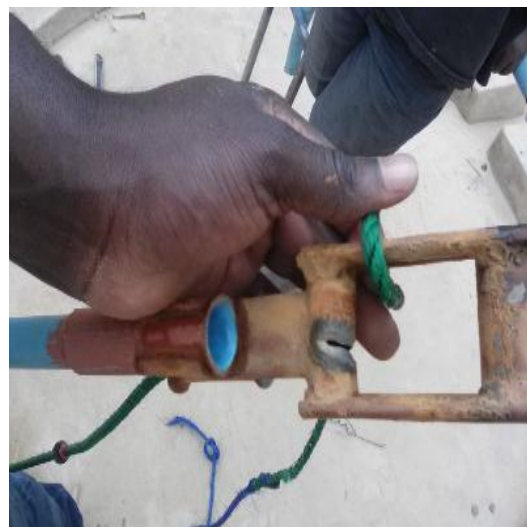
Photograph 2. Worn out guide box
