Deformation of the Zhangjiazhuang high-speed railway tunnel: an analysis of causal mechanisms using geomorphological surveys and D-InSAR monitoring

On 18 January 2016, the Zhangjiazhuang high-speed railway tunnel in Ledu, Qinghai Province, China, underwent serious deformation and structural damage. A crack formed at the top of the tunnel and the concrete on the crown peeled off. As a result, the tunnel could not be operated for three months. In order to determine the types and spatial distribution of the landslides in the region and the surface deformation characteristics associated with the tunnel deformation, we used field geological and geomorphological surveys, unmanned aerial vehicle image interpretation and differential interferometric synthetic aperture radar (D-InSAR) surface deformation monitoring. Nine ancient and old landslides were identified and analysed in the study area. Surface deformation monitoring and investigation of buildings in several villages on the slope front showed that the tunnel deformation was not related to deep-seated gravitational slope deformation. However, surface deformation monitoring revealed an active NEE–SWW fault in the area intersecting th

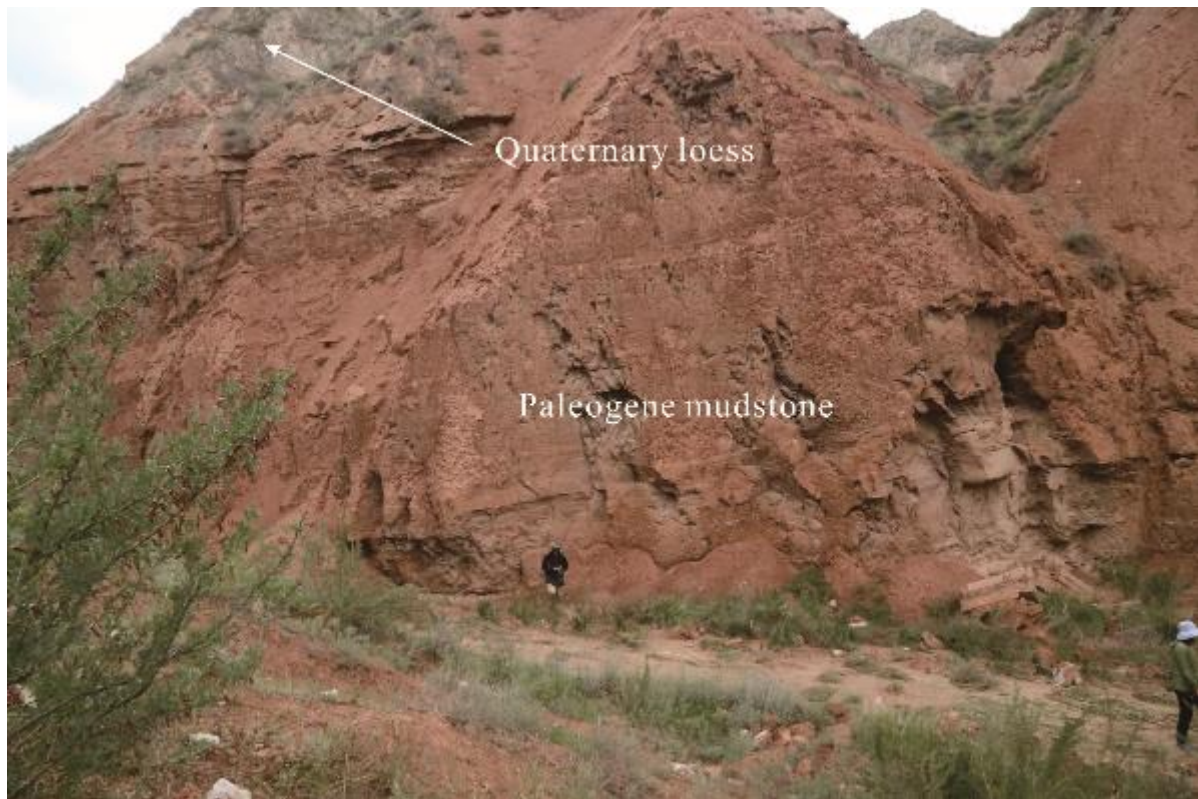
Figure 3 Typical lithologies outcropping at the Gaojiawan landslide site. The upper part is Quaternary loess and the lower part is Paleogene mudstone.

The stratigraphy of the study area consists mainly of Quaternary loose loess and Paleogene mudstone and sandy-mudstone (Figure 3). According to the results of previous studies (Song 2006), field investigations and drilling data, the strata in the study area comprise the following, from bottom to top: (i) The Paleocene Qijiachuan Formation, the lithology of which is brown-red conglomerate with intercalated sandstone (Figure 4a and 4b). (ii) The Eocene Honggou Formation, which is composed of three litho-stratigraphic units. The lower unit consists of brown-red mudstone; the middle unit consists of grey-green banded mudstone and brown-red mudstone interbedded with brick-red mudstone; and the upper unit consists of grey-green gypsum intercalated with glauberite and lime-yellow marl. Based on the method introduced by Hoek and Brown (1997) to evaluate rock mass quality, the Geological Strength Index (GSI) of these layers has the range of 70–80. The dominant strike of the units is 130°–175° and the dip angle is 3°–7°. (iii) Quaternary loess. According to borehole data, the loess in the region is up to 144 m thick. Zhou et al. (2020) determined that the friction angle and cohesion of loess and mudstone, based on a consolidated quick shear test, are 26°, 22 KPa and 35°, 28 KPa, respectively. The terraces of the Huangshui River are distributed in the northern part of the study area; the thickness of the gravel layers of terraces is up to 19 m (Fig. 4c).

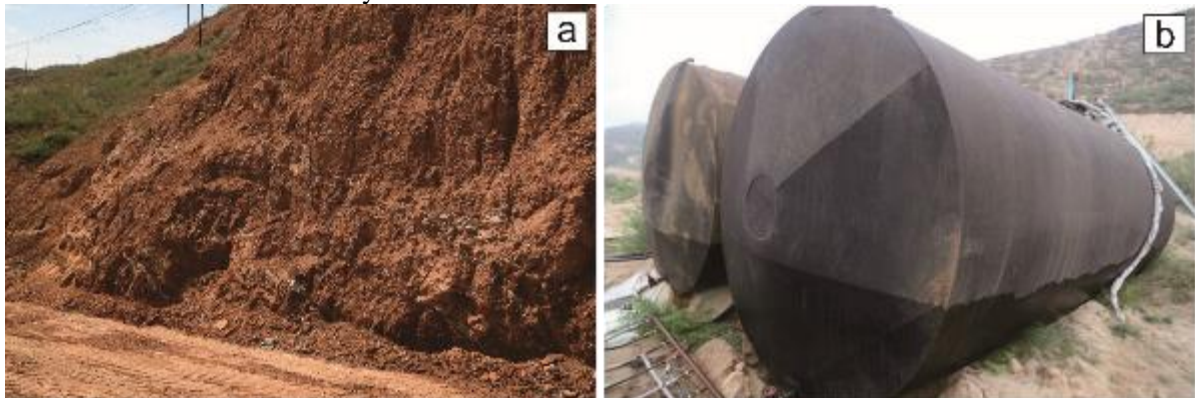
Figure 14 Photos of the study area. a Mixed accumulation of the L8 that gravel layer of the river terrace exhibiting a reverse dip phenomenon. b Water tank used for storing water for irrigation.
