**ANALYSING AND PREDICTING
FALSEWORK FAILURE IN HONG KONG**

A Doctoral Thesis submitted in partial
fulfillment of the requirements for the award of
Doctor of Philosophy of Loughborough University

February 2002

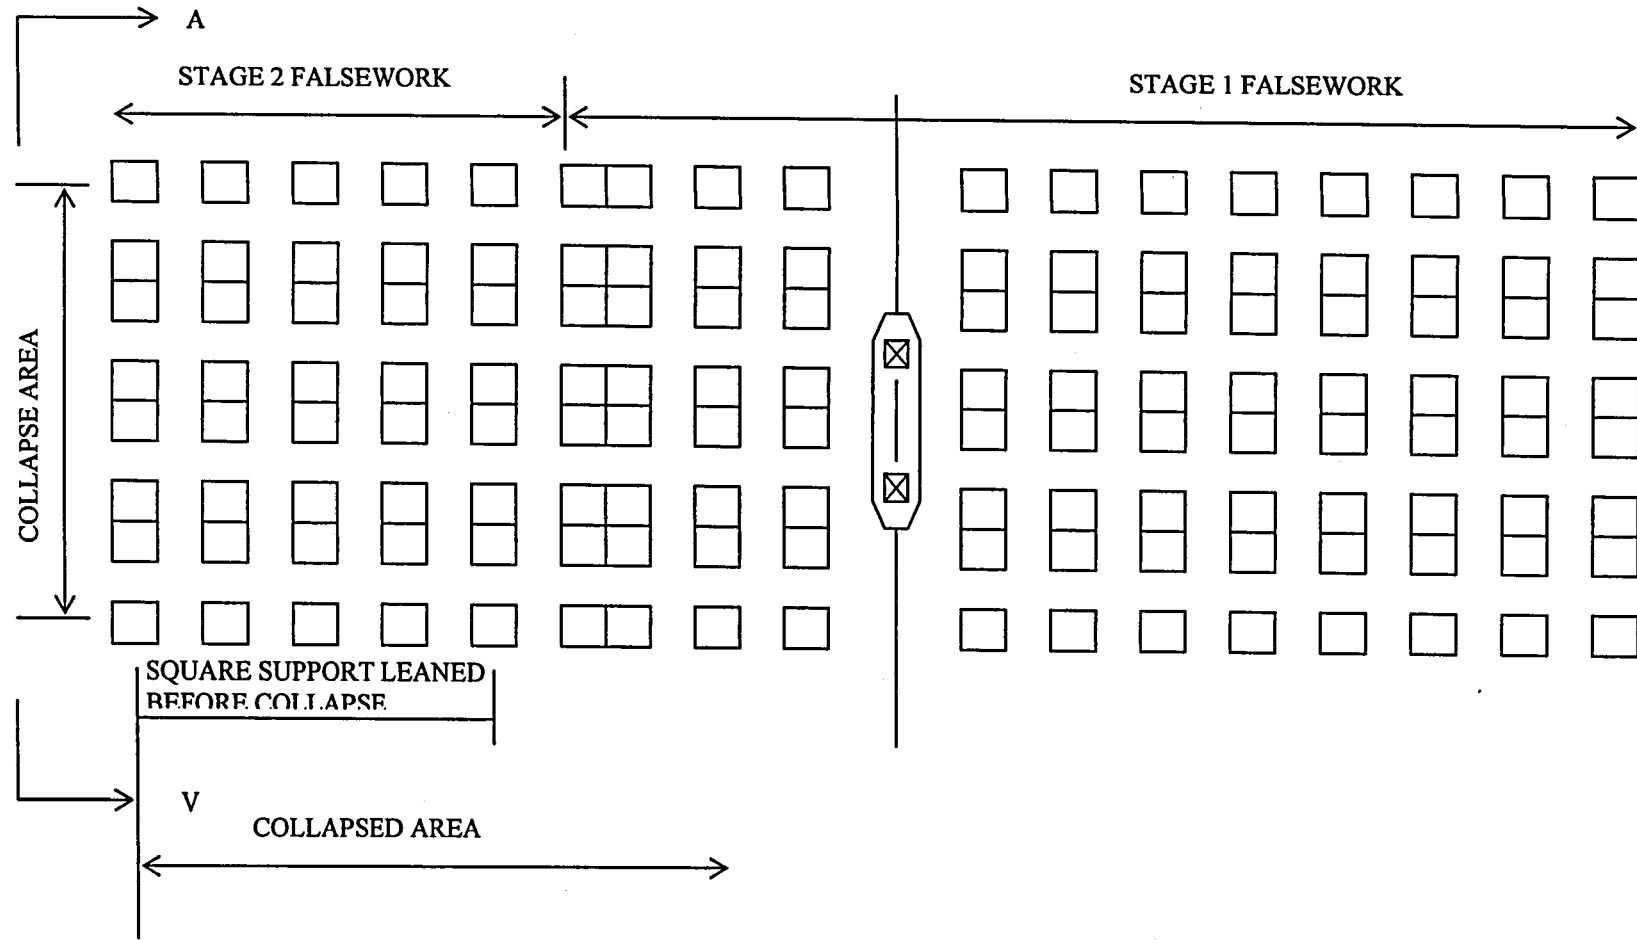
Figure 6.1: Layout plan of falsework supports, Tsing Yi, Hong Kong

Square props were used as the falsework for the concrete bridge deck between Piers E3 and E4 of the north carriageway. It consisted of four tubes, and made up of intermediate sections of various lengths (Figure 6.1). Each prop rested on a concrete slab.

The collapsed area was about 24m in length and 12m in width. A total of ten rows of props with each row consisted of eight individual props fell. The height of the props was about 14.5 m and 16 m for Stage 1 and Stage 2 props respectively.

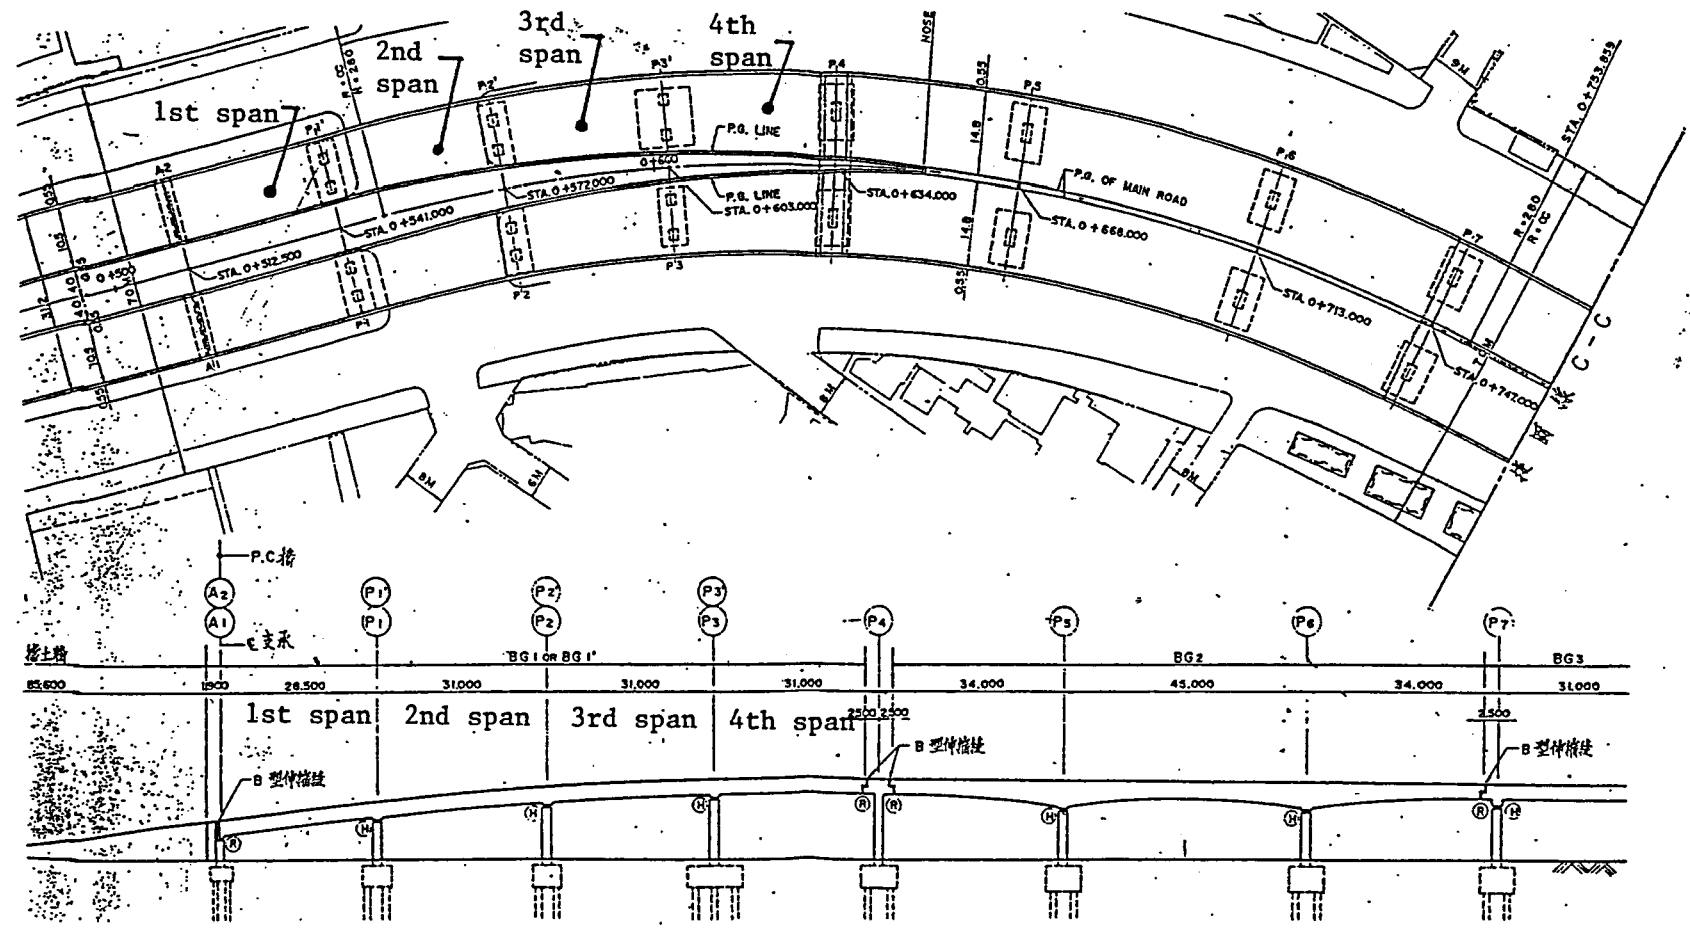
Figure 6.4: Layout plan of collapse in Taipei, Taiwan

The highway bridge was located along the central part of Hsinhai Road at the southern part of Taipei City. The bridge was designed as two parallel structures, running from East to West, connected by a tied beam or separated by an expansion joint. The collapsed portion of the bridge deck was the northern part of four continuous spans about 120m in length and was of post-tensioned concrete construction as shown in Figure 6.4. The average longitudinal fall was 3.5 per cent and the height of the soffit above ground varied with a maximum of around 6m.

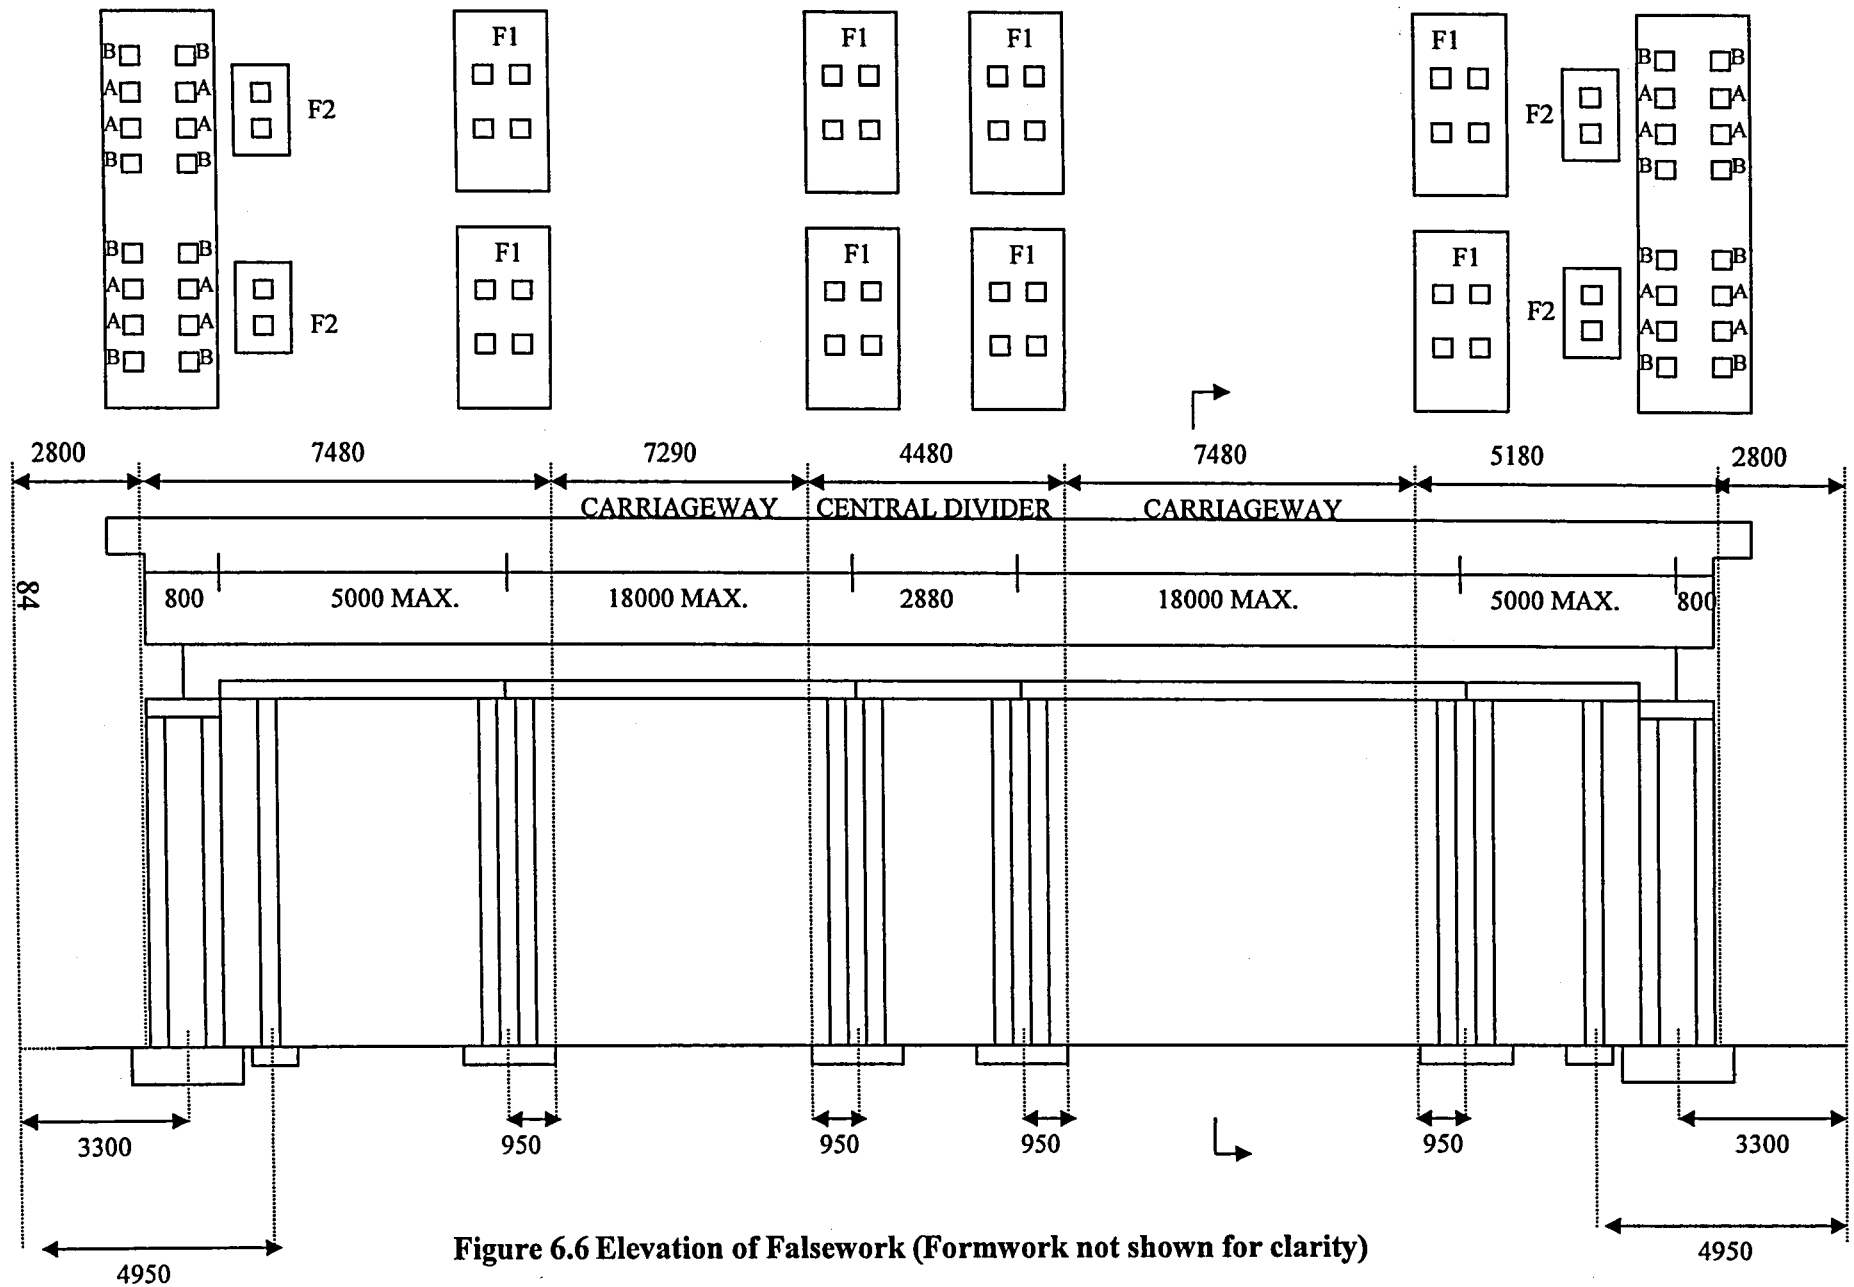
Figure 6.6 Elevation of Falsework (Formwork not shown for clarity)

In January 1996, in Hong Kong, two precast and prestressed concrete beams collapsed during construction of a footbridge. The collapsed 34m span footbridge was designed to straddle Po Ning Toad, Tseung Kwan O, Hong Kong. It was formed by first installing two concrete beams of rectangular cross section 0.65m x 1.95m. Each beam was about 110 tonnes by weight. The 3m wide deck and the roof were then built on the two beams. (Figure 6.6).

Timber formwork was used for casting the beams. Steel transverse I-beams and channels were erected to spread the concrete load onto the longitudinal steel beams. The vertical supports were quadshores consisting of four tubular steel members which were connected to the temporary concrete footings by bolts (Figure 6.6).

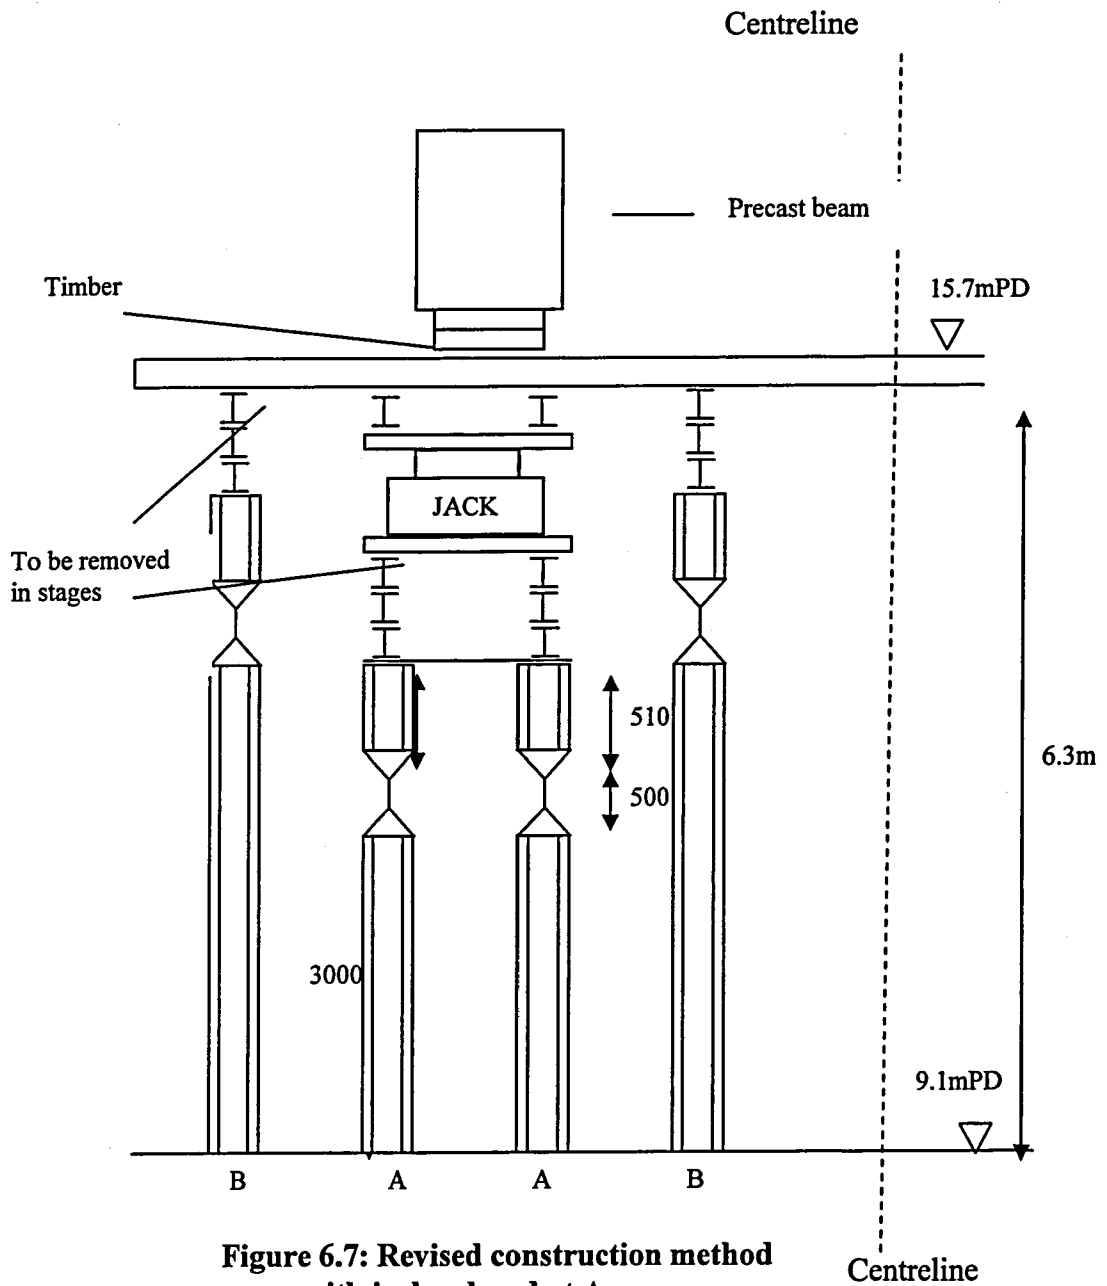
Having completed the erection of B props, the workers attempted to remove the intermediate I-beams on A props. While they were striking the last screw jack of the A props at the North end of the bridge, the two concrete beams fell, rotating about their longitudinal axis. Three workers on site were injured and a lorry driver was crushed to death by the falling beams.

When concrete was being placed for the casting of the two beams, the I-beams on the props at the North end had shifted. Due to the post-tensioning of the beams, there was a re-distribution of loads on the I-beams and the props. Unfortunately, the loads were not evenly distributed. In addition, the I-beams on A props had been stiffened whereas those on the B props were unstiffened and could not be able to support the increased loads.

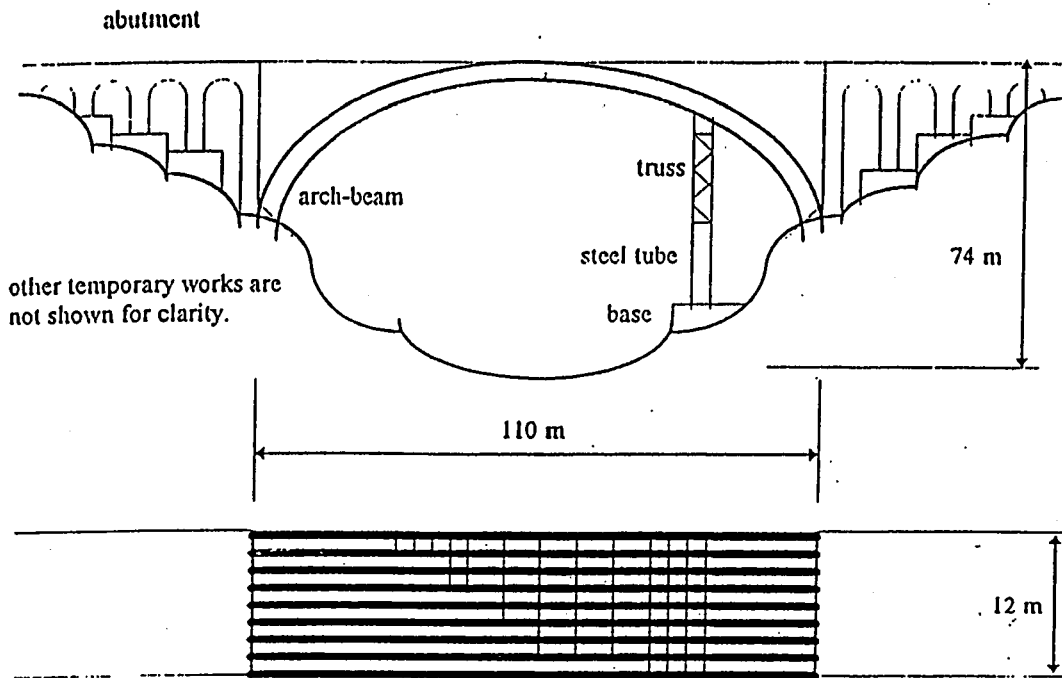
Figure 6.8 Elevation and plan of the arch bridge

This bridge was one of the two main arches in a highway joint-venture project which was scheduled to be completed by March 1997. The bridge was 12m wide and 163m long. The top part of the 110m centre span would be 74m above the valley. The height of the arch was about 17m which means the ratio of height to span was 1/6.5. Details of the bridge are shown in Figure 6.8. The bridge deck comprised nine arch beams to form eight boxes by the bottom slab, cover slab and diaphragms (Figure 6.9). The reinforced concrete arch beams were constructed in situ. The precast concrete diaphragms spaced at a certain distance were used to increase the stability and stiffness of the arch.

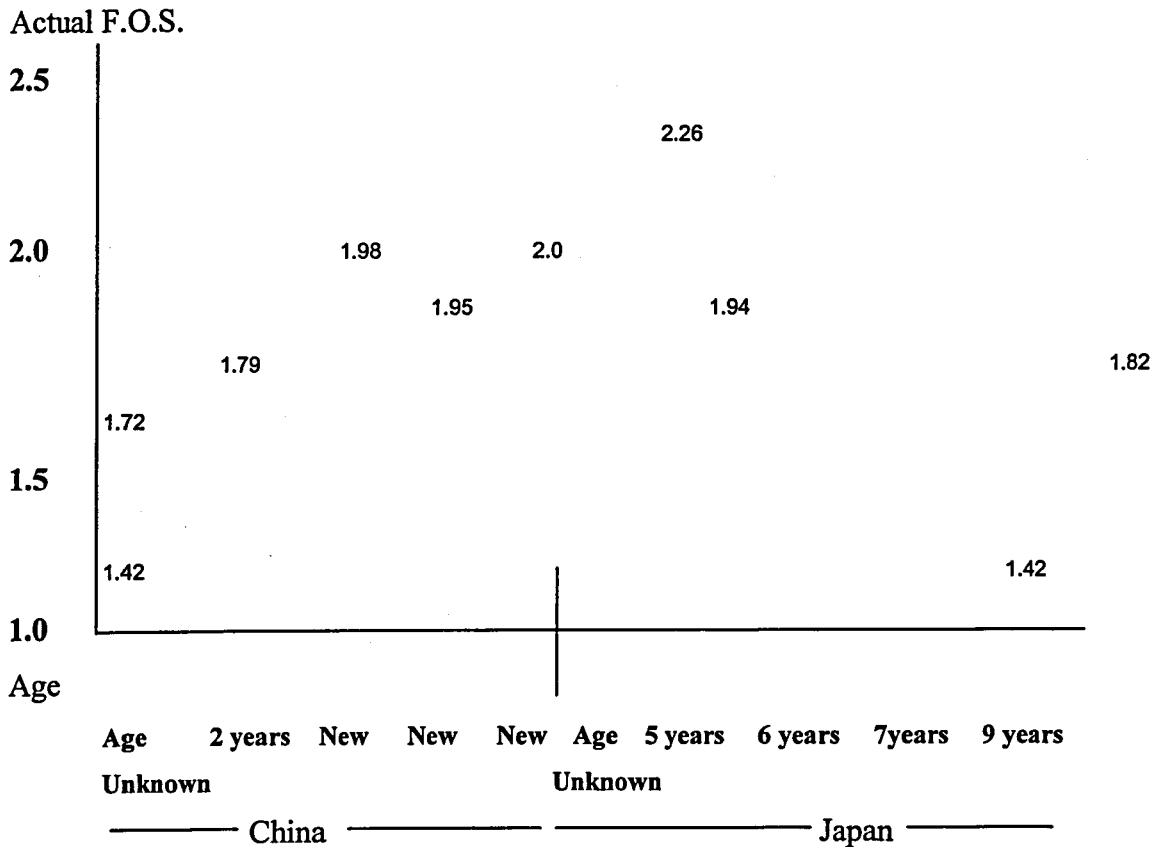
Figure 7.1: Actual factor of safety vs age of scaffold frame

The actual factor of safety of the scaffold frames was plotted against their age in Figure 7.1. The correlation was discussed with respect to their origin, i.e. either China or Japan.

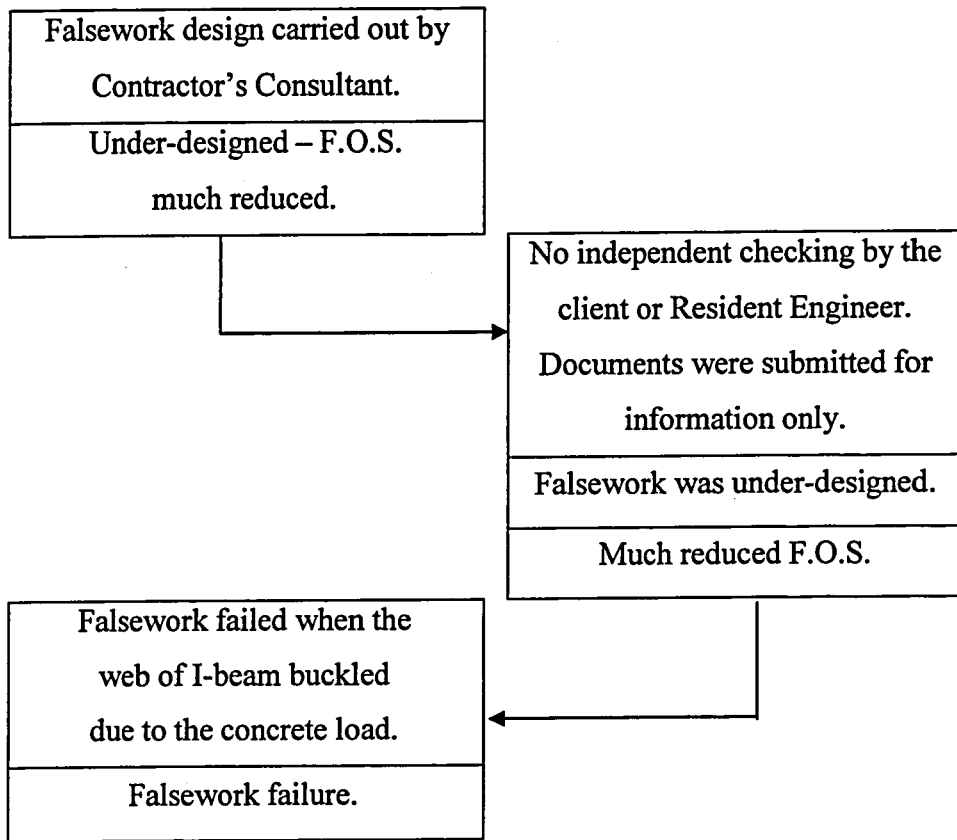
Figure 9.11 Case study 1- Event sequence diagram

- Main Contractor – McCrossan.
- Main Consultant – Rehder-wenzel designed the falsework.
- Client – MDOT - had a copy of falsework design for information only.
- It was common not to check the falsework design by the client. The contract required a Registered Engineer (not the Contractor) to carry out the temporary works design. Design was performed by the Contractor's consultant but without checking by any third party.
- Cause of failure – Web-buckling of an I-beam falsework.
- Control / Prevention – no independent third party checking of the design which was carried out by the Contractor's Consultant.
- Triggering event – concrete pouring.

- This was a typical case that the design was inadequate and there was no independent checking.

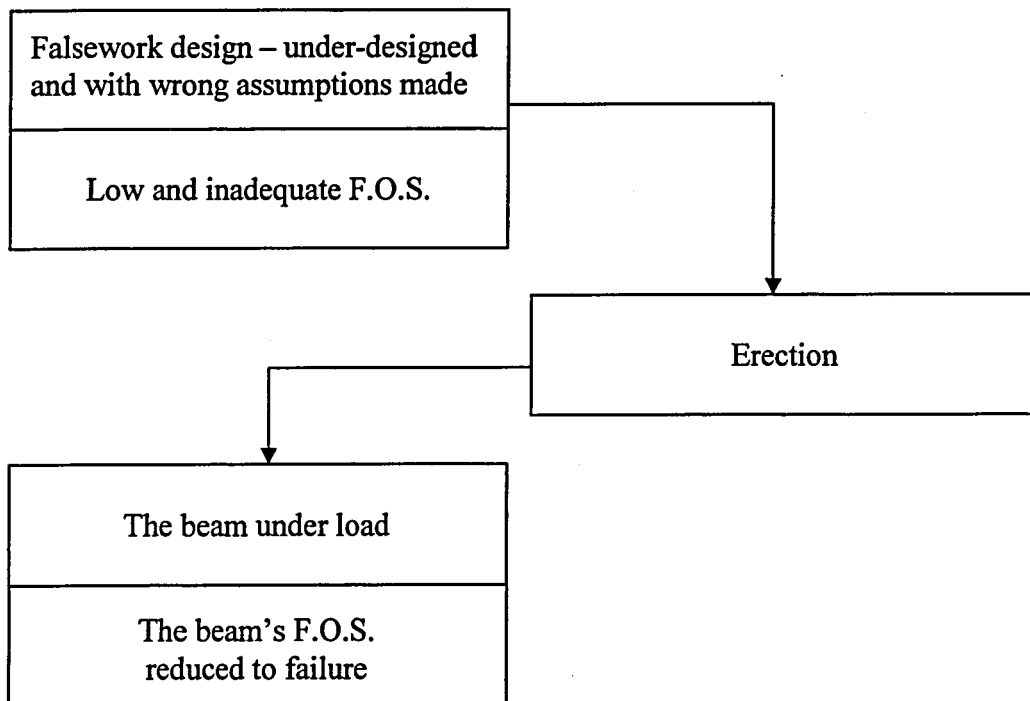
Figure 9.13: Case study 2 – Event sequence diagram

- Construction: A precast beam of 100-ton was resting on the falsework before tensioning and making connection to permanent supports.
- Client: Public Works Department.
- Contractor: Sollel Boneh.
- Client's responsibility – designed the bridge and supervised the construction work.
- Contractor's responsibility –the construction.
- The failure investigation report quoted "The load was not evenly distributed as assumed in the design."
- Cause – Falsework was overloaded due to uneven load distribution contrary to the assumption in the design.
- Procedural – No third party verification of the falsework design.
- Construction method – Concrete beam to be post tensioned.
- Triggering event – Load of the beam supported by the falsework.
- Event sequence of diagram of Procedural causes:

- This was a typical case of no checking of falsework design.

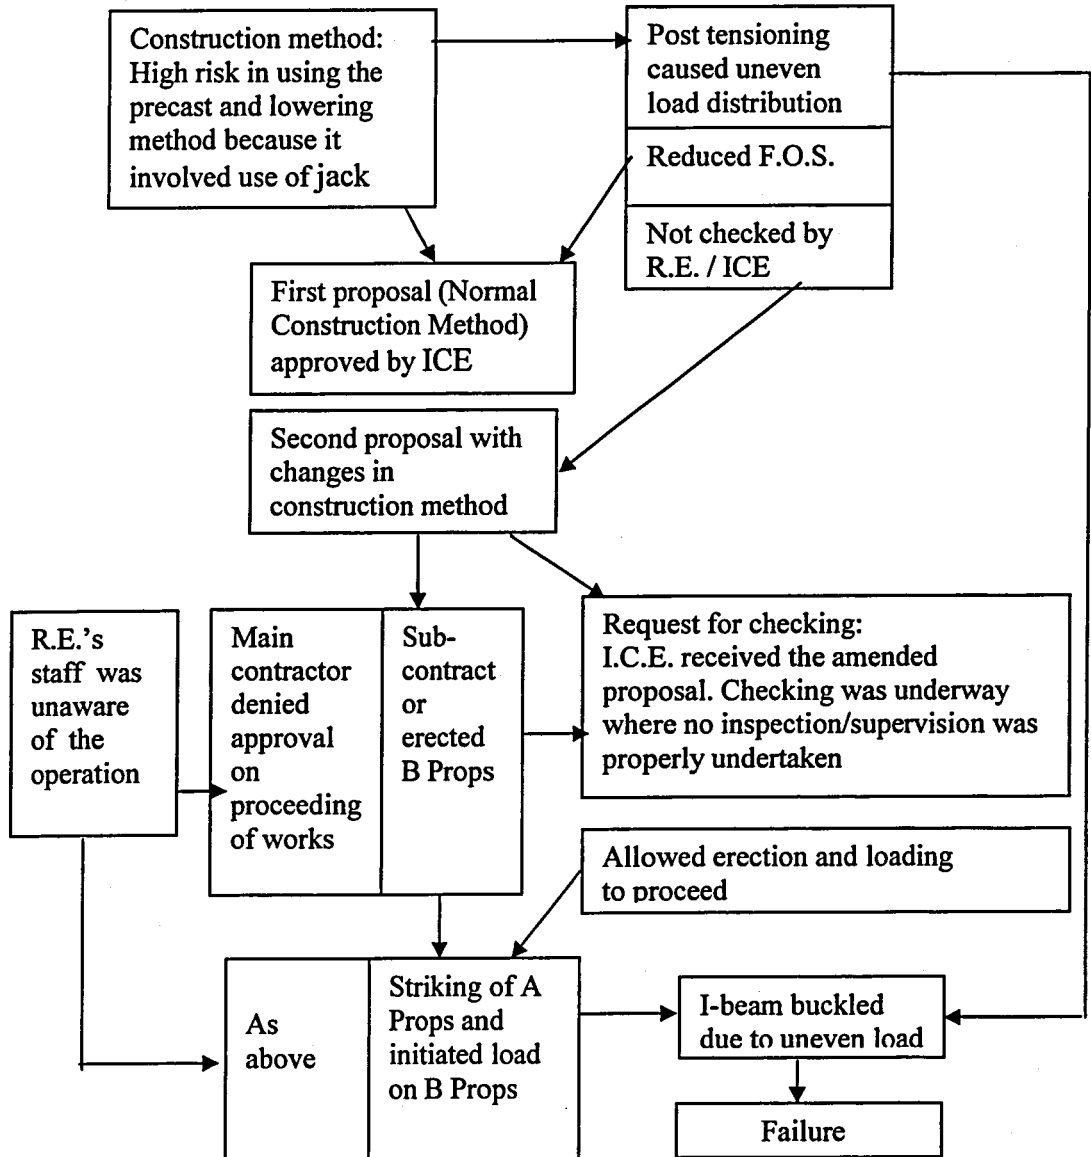
Figure 9.16: Case study 3 – Event sequence diagram

- (2) Inadequate inspection of falsework after post tensioning by ICE, Resident Engineer and Contractor.
- (3) Proceed erection and loading without Resident Engineer's and Independent Checking Engineer's inspection and approval.
- (4) Inadequate review / checking / approval of falsework due to a change in construction method.

- This was a failure case involving the employment of Independent Checking Engineer. The construction method changed and proceeded without approval of the Independent Checking Engineer.

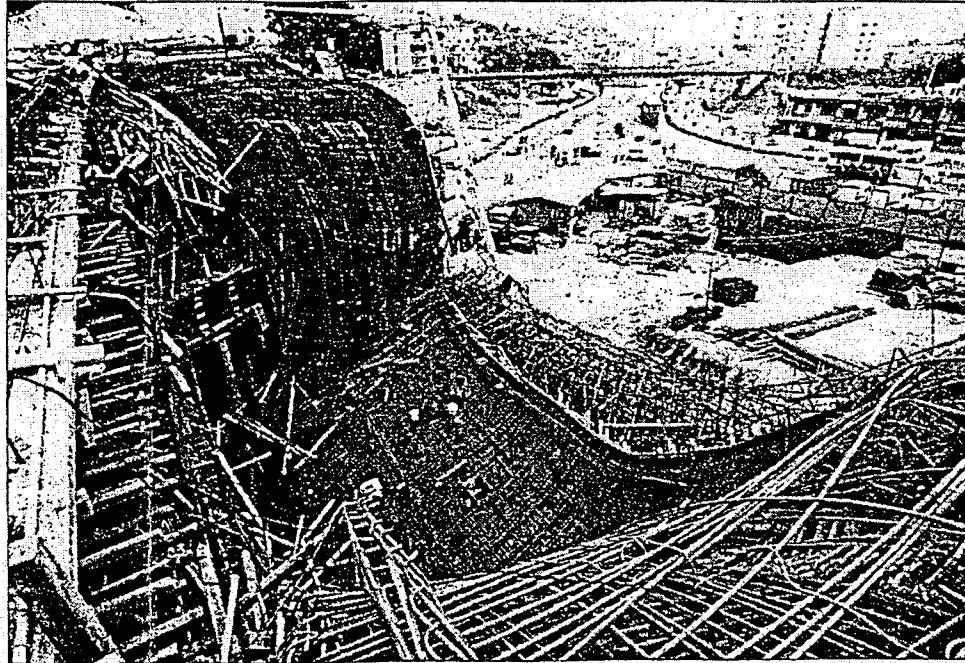
Topped structure: A bridge under construction near Yantian port in Shenzhen collapsed on Monday night, injuring 30 workers, 5 seriously.

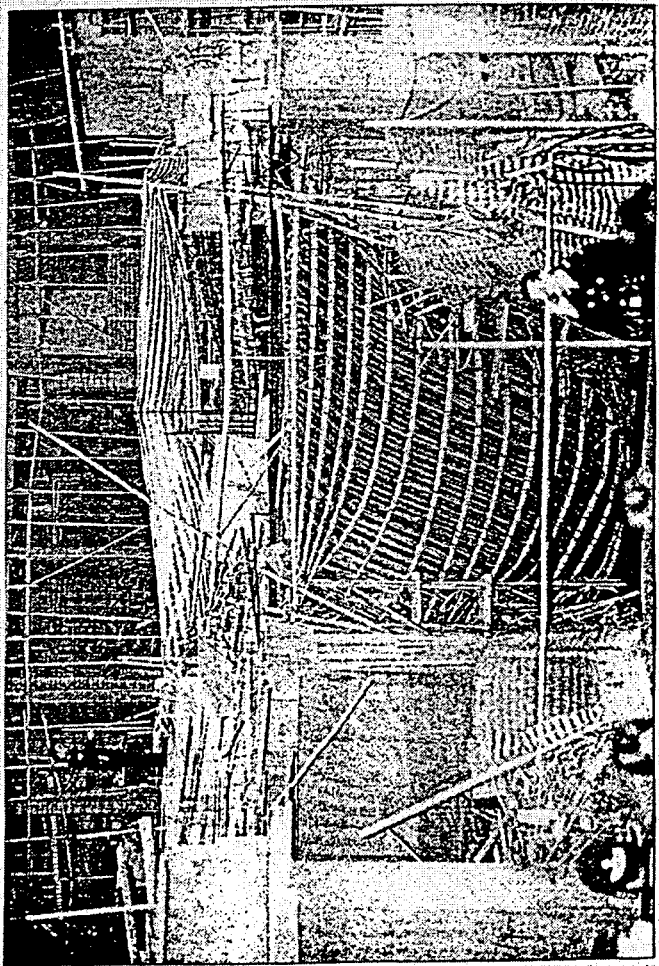
昨午五時四十分，十五名工人正在上址三層剛出半台工作，平台下則以鐵架支撐，工人當時正以一條石渠進行灌石工程，其間，疑支架不穩而下塌，引致四米乘十米範圍出現下塌，平台工人即爭相逃避，其中五名女工人即光顧不及，墮向平台下四米地面，幸各人未有被因瓦礫中，其知工友曾狀，立即上前救護及報警。警方及消防員接報到場，立即將五名傷者救出送院。警員據報現場封鎖調查。稍後，勞工處及屋宇署亦到場了解情況。

青山公路帝鴻灣建築地盤工業意外發生後，警方封鎖現場進行調查。

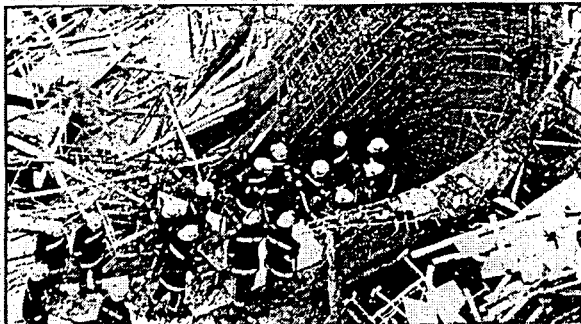
Firemen search the wreckage of the collapsed canopy.

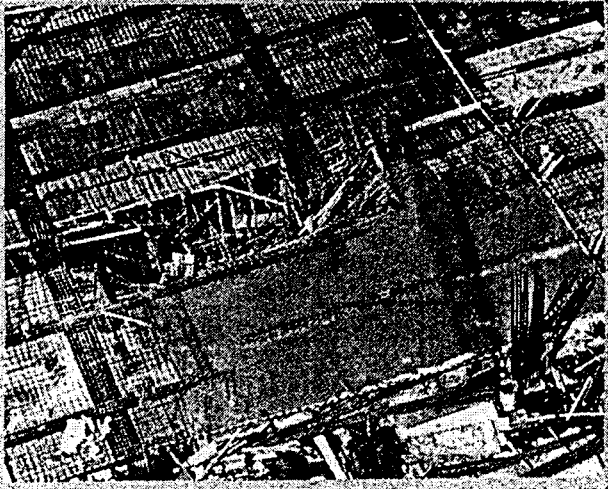
■塌地台的電影資料館地盤出現一個大洞。 蕭錦文攝

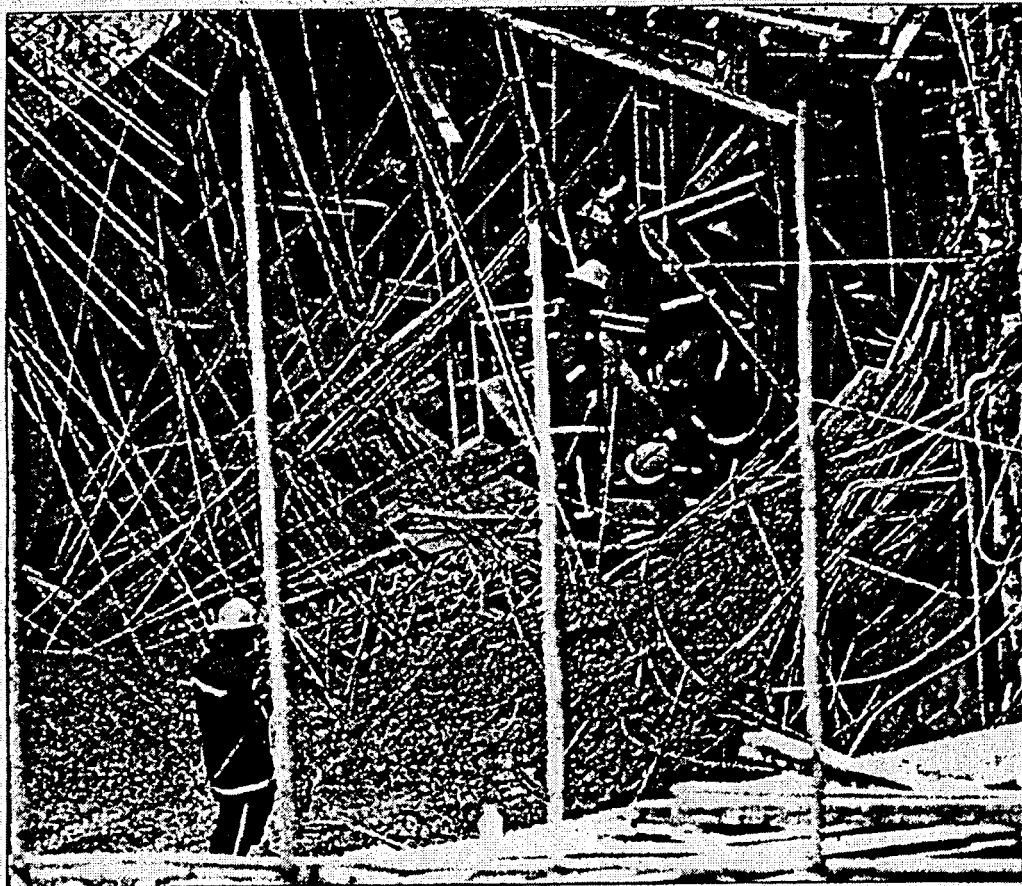
數噸水泥壓塌鐵架傷三人

消防員在已塌下的地盤內，使用生命探測器，找尋還有沒有被困的地盤工友。

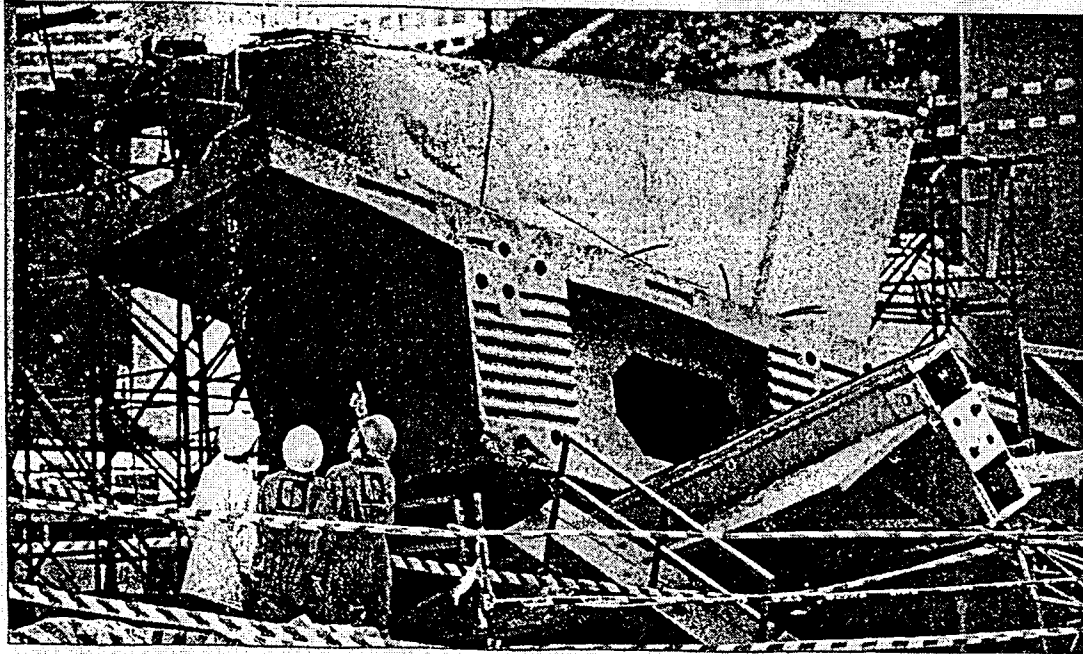
Case Ref. No. 10 Tseung Kwan O, HK

Two workers killed as flyover collapses

Bridge of death... inspectors examine the collapsed concrete section that killed two Thai workers at the troubled Kwai Chung viaduct project.

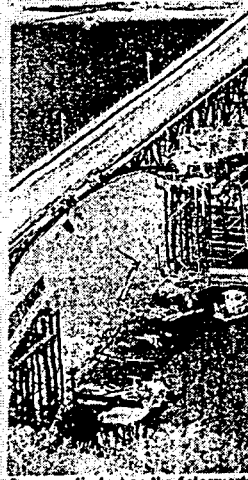
One man died when the falsework of the bridge collapsed.

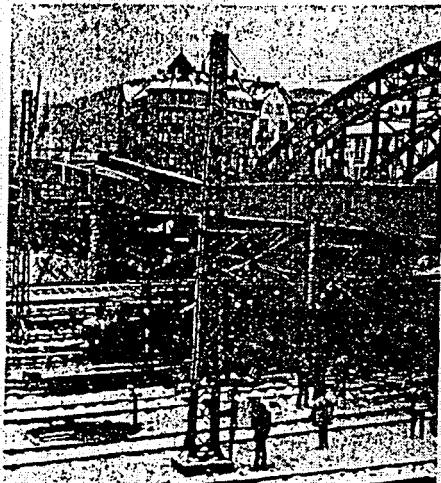
Ruined bridge channel lays across single pier and abutment.

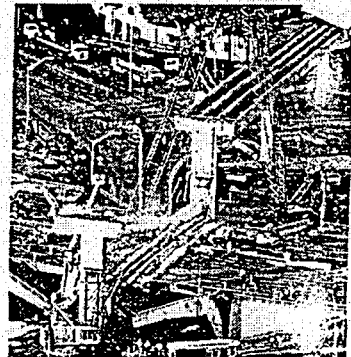
A spokesman for Eby Construction says the contractor believes it "acted properly under the supervision, review, inspection and direction of the Colorado DOH." The report notes the contractor's field personnel "disregarded" state regulations on the removal of falsework supporting the pier cap.

Girders collapsed onto Denver's Interstate 25.

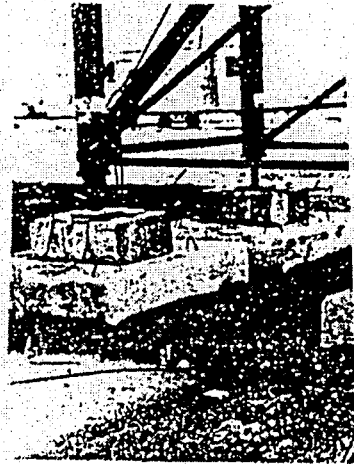
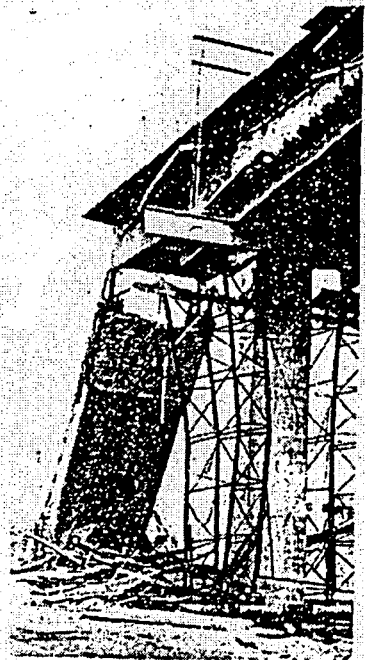
TOP: High-Capacity shoring towers should have been based on sand jacks, timber blocks and precast concrete pads. ABOVE: Engineers are still struggling for a safe and effective method of lowering hanging debris.

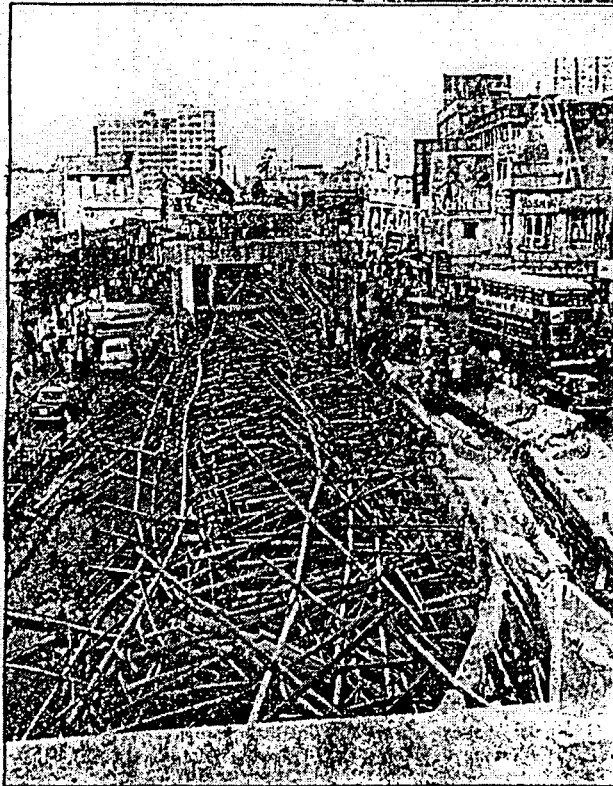
New Civil Engineer, 25 June 1981

Box outs probable cause of Singapore flyover failure

Collapse last February of the 65m long central section of a six lane flyover under construction in Singapore may have been caused by larger than planned temporary box outs in the deck of the concrete box superstructure.

But suggestions of low strength in situ concrete or inadequate prestressing have now been firmly ruled out. And the only questions left unanswered are should the design still have been adequate to accommodate the large box outs, or alternatively why were they not partially filled in prior to the falsework being stripped?

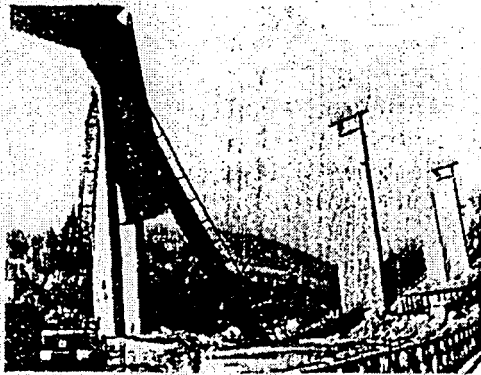
Austrian span fell as launching truss went

when falsework gave way. The curved, superelevated 891-ft-long ramp, under construction in downtown Auckland, had a single-cell, prestressed concrete box girder superstructure consisting of six spans, ranging from 96 to 212 ft.

According to the public works ministry, "At the time of the failure the concrete in the superstructure had been prestressed for about a day. The prestressing operations resulted in a change of weight distribution over the length of the temporary supporting structure. This resulted in a substantial increase in the load at the end of the concrete girder."

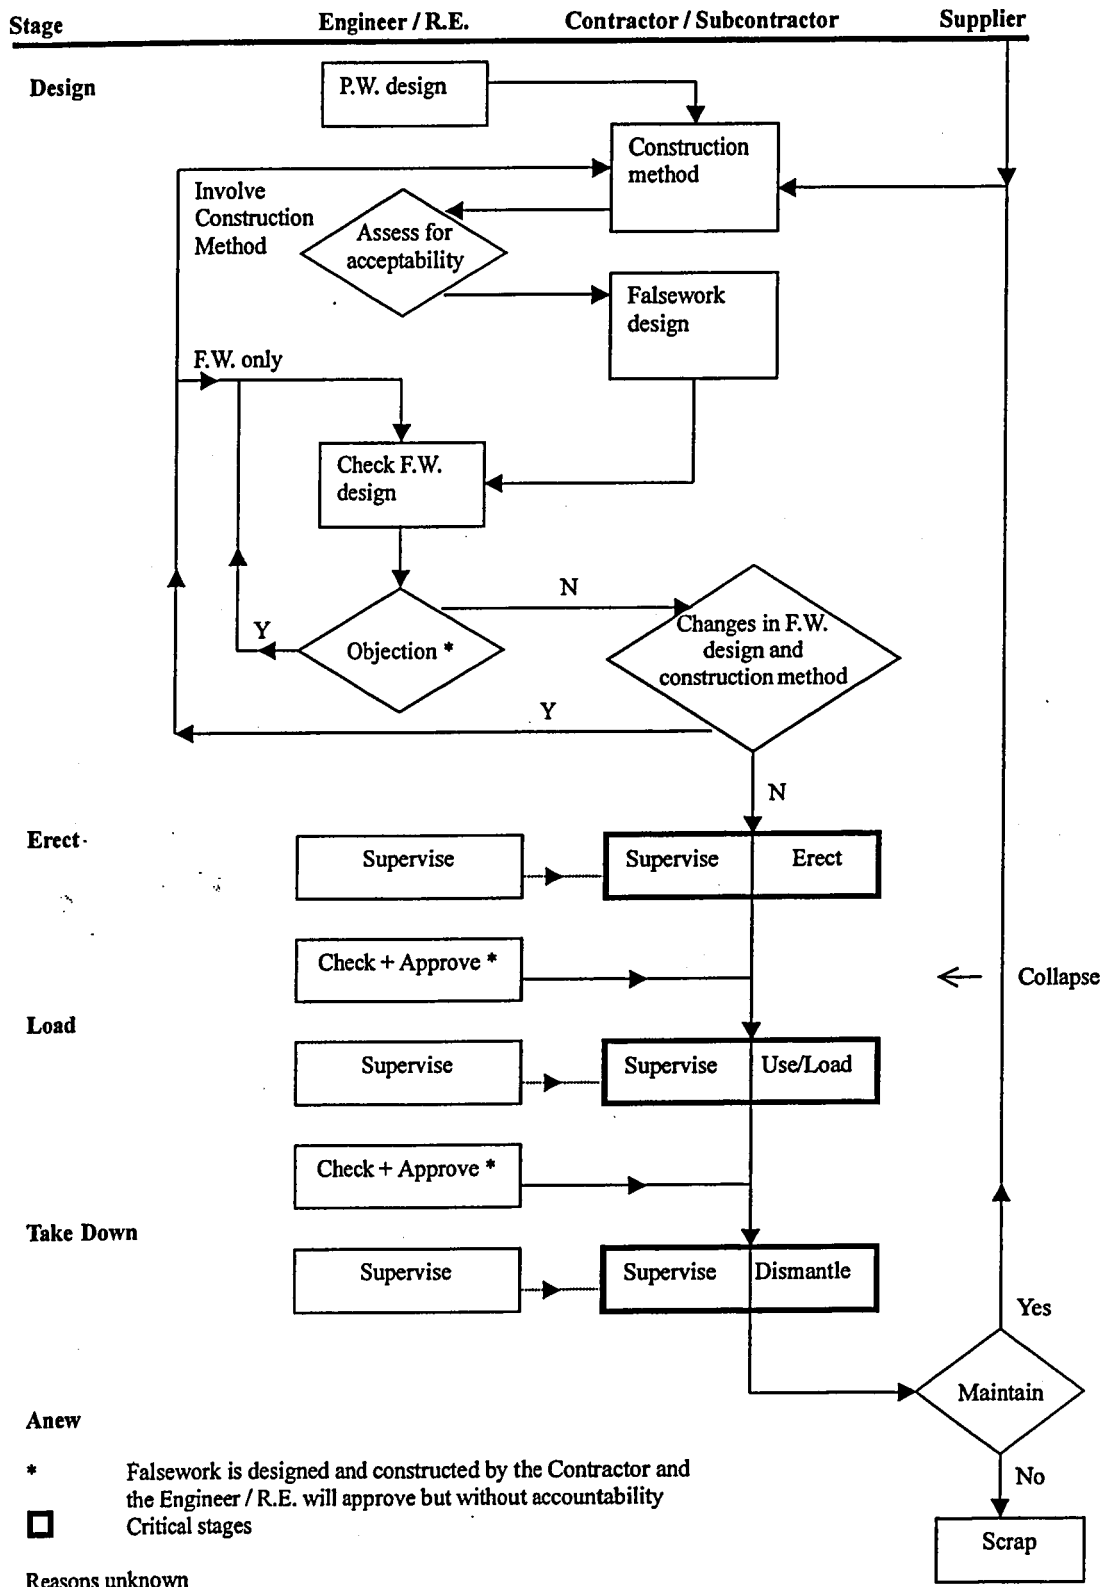
Figure C.41: Case Ref. No. 41 Elgin, Ill, USA [C]

A small concrete arch bridge in which scrap plastic replaced fine aggregate collapsed during construction but will be rebuilt in Elgin, Ill. (ENR 12/16/71 p.3). The 100-ft span for pedestrians and maintenance vehicles fell as forms were stripped. It will be re-erected, again using ground up plastic bottles to replace 30% sand by volume, after modifications by the original designer, Elgin architect Robert Layer.

The report says the center joint was designed primarily to resist compression and recommends that it should take tensile stress as well. Also, forms should be removed from the center first instead of last, as was done the first time. The new structure will be a two-hinged arch instead of three-hinged.

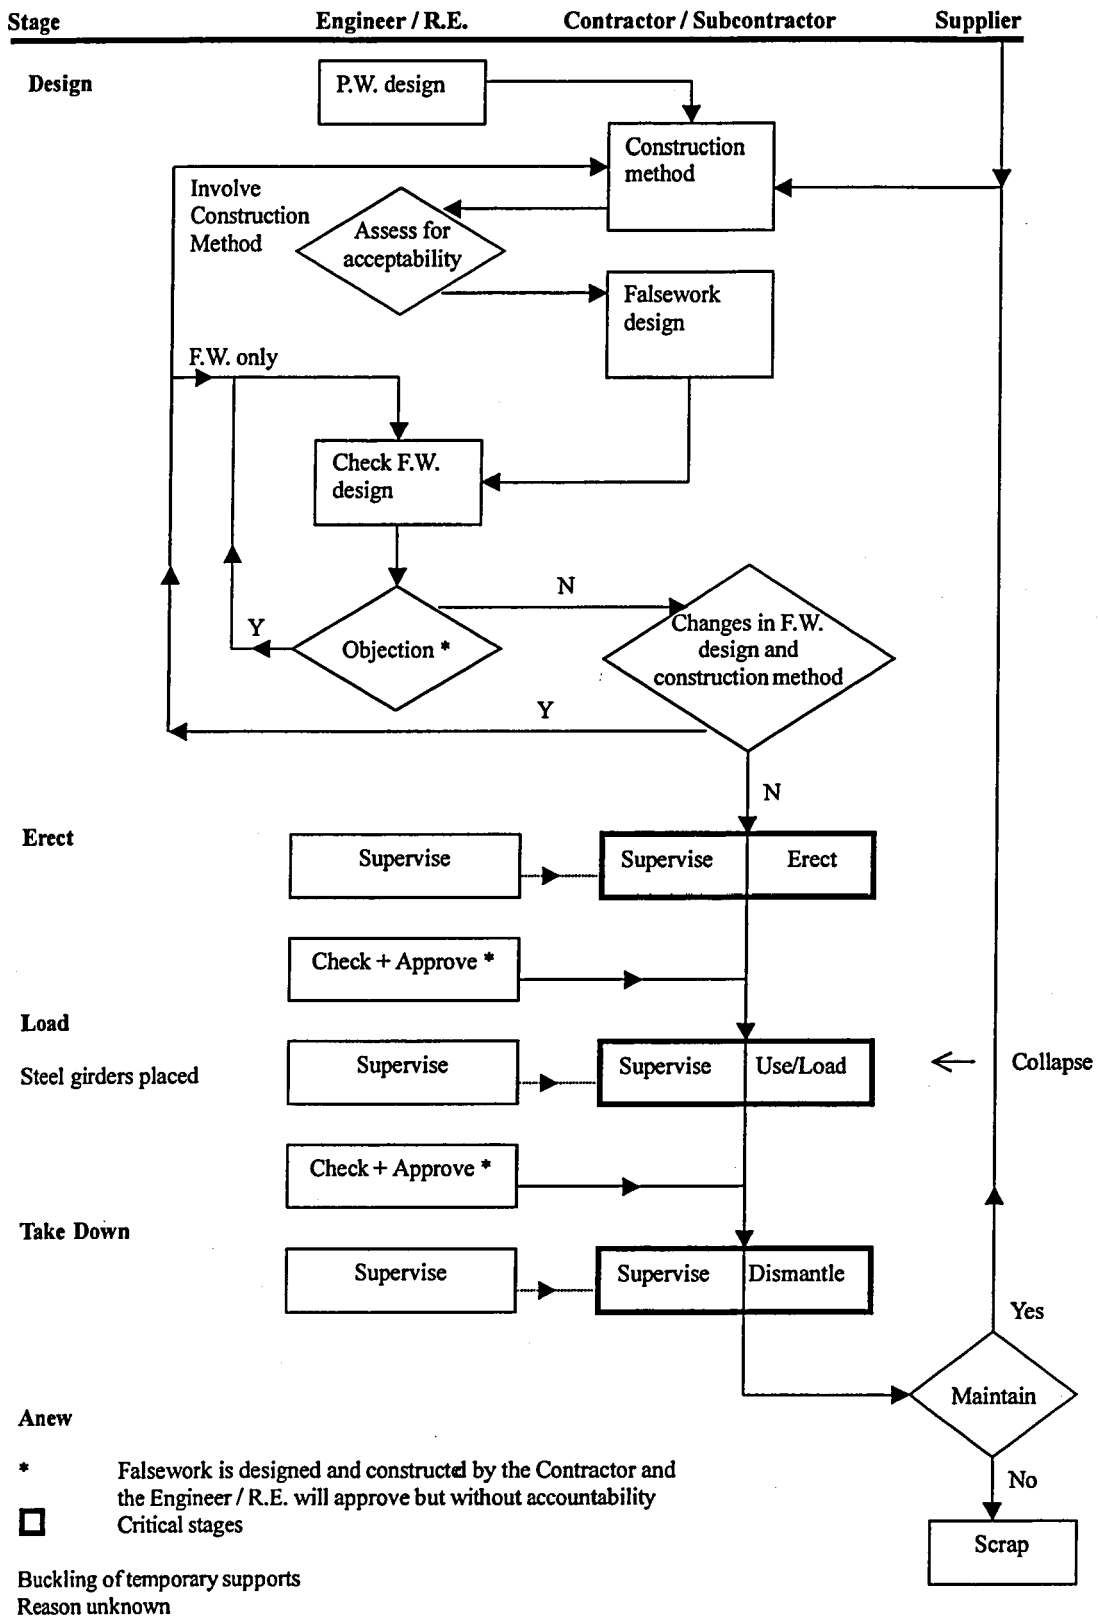
Figure C.48: Case Ref. No. 48 Fife, UK [C]

Fife ⁹	Superstructure of road overbridge collapsed due to buckling of temporary supports after concrete they were supporting had set	22 June, 1962 ✓	3 killed ← 45
Calder, Yorks ¹⁰	76 m concrete span collapsed due to low strength and inadequate bracing of steel beams in temporary supports	23 Aug., 1967 ✓	4 killed ← 45
Willemstad, Curaçao ¹¹	Steel bridge collapsed due to brittle fracture of anchor bars at unauthorized(?) welds	Nov. 1967 ✓	20 killed
Fourth Danube, Vienna ¹²	210 m centre span of steel box girder bridge buckled without collapse due to temperature contraction of top flange	6 Nov., 1969 ✓	
Seebucke, Brennerautobahn ¹³	Concrete superstructure severely deformed by 1.7 m differential movement of foundations near lake side	Nov. 1969	
Milford Haven ¹⁴	Steel box girder collapsed during cantilever erection due to buckling of support diaphragm	2 June, 1970	4 killed
Soboth, Austria ¹⁵	192 m length of concrete box girder collapsed, possibly due to fracture of temporary stay by crane	July 1970	3 killed
