Dynamic bending behaviour of woven composites for sports products: Experiments and damage analysis

HIMAYAT ULLAH¹, ANDY R. HARLAND, VADIM V. SILBERSCHMIDT*

Wolfson School of Mechanical and Manufacturing Engineering, Loughborough University, Leicestershire, LE11

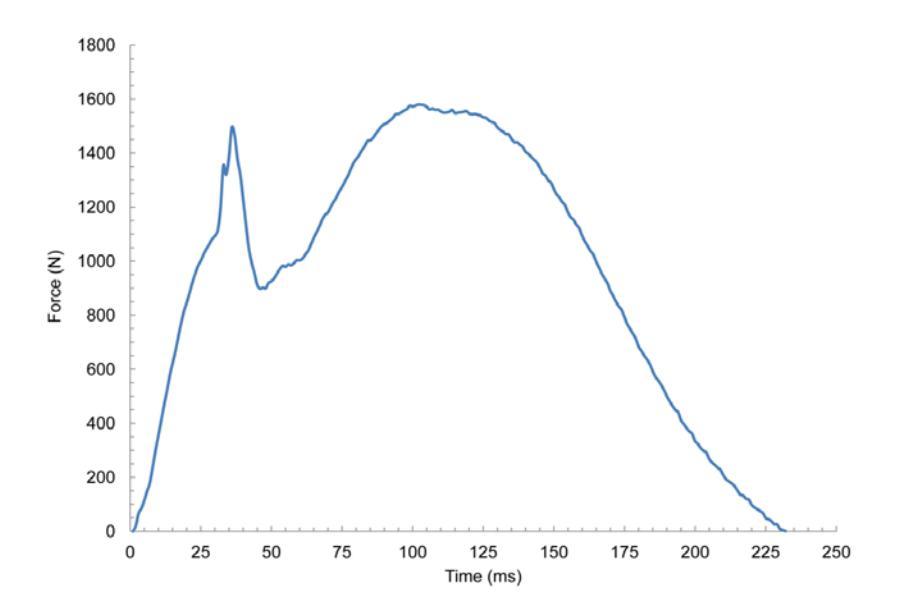
Fig. 1. Vertical ground reaction force during running

Footwear is subjected to repeated impacts as the heel strikes the ground during running. As shown in Fig. 1, a typical vertical reaction force with two peaks is generated in heel-strike during running. The first peak known as the *passive load* cannot be cushioned by human movement as its duration is too short for a human to make a cushioning movement. Hence, since this impact load is considered as the source of injuries, it needs to be cushioned by a shoe material [4]. Further, the peak forces generated during a heel strike are 2-3 times the runner's body weight, and the number of impacts is around 1500 per mile, varying between subjects [5]. Due to repetitive impacts and high loading rates in running, it is more likely that injuries occur to the bones and tissues of human legs. Therefore, among the main design requirements for athletic footwear are impact and shock resistance, better damping and energy absorption, higher strains to failure and strain rates, higher stiffness and light weight for better comfort of runners. Nowadays, sports industry focuses on innovations in sports shoes in areas of materials, motion control of foot, mass and athletics design. Carbon fabric together with the embedding thermoplastic polyurethane matrix offers these unique properties to footwear insoles. Thin strips of CFRP laminates are sandwiched in the midsole between EVA foam or polyurethane, especially at the heel's region subjected to higher impact loads.

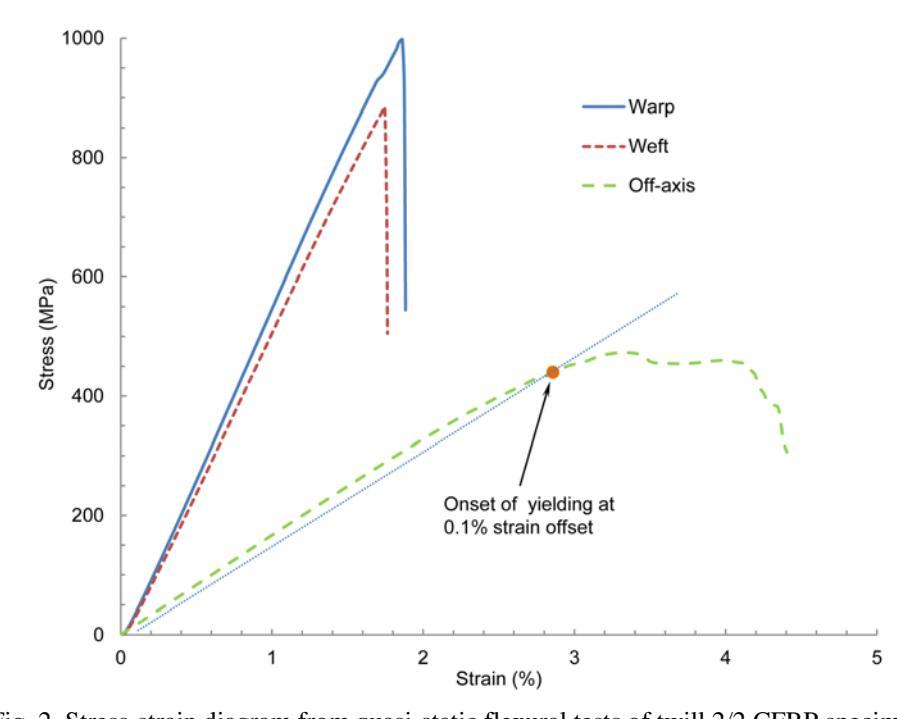
Fig. 2. Stress-strain diagram from quasi-static flexural tests of twill 2/2 CFRP specimens As shown in Fig. 2, the off-axis specimens demonstrated a large-deformation nonlinear behaviour before their ultimate failure as compared to their on-axis counterparts. This ductile behaviour is due to matrix plasticity as well as cracking and alignment of tows along the loading directions called *fibre trellising*. The latter is the result of fibres reorientation towards the loading direction, with the angle between warp and weft fibres changing from 90° with increasing the load level. This behaviour is more pronounced in off-axis specimens tested under uniaxial tensile loads resulting in strains to failure up to 30% as studied in [19]. Such ductile, or yielding behaviour of composites is more desirable for energy-absorption purposes and is termed *pseudo-ductility* in recent research works such as [20]. Recently, various approaches, such as partially discontinuous ply architecture [21], hybrid laminates with higher ductile fibres, intermingled cuts, single-polymer composites [22] and offaxis/angle-ply laminates have been proposed to improve the yielding behaviour of composites. In this work, this pseudo-ductility in angle-ply laminates is studied for sports applications for the first time. Thanks to such behaviour, the off-axis laminates are still capable to bear a load after the damage initiated at the yield point (Fig. 2). Here, the yield point refers to the knee where the stress-strain curve deviates from the initial elastic line and does not necessarily indicate the presence of plastic deformation as observed in metals. Further, the off-axis specimens exhibited higher levels of strain to failure - 4.5% - than the on-axis specimens. The specific energy absorption, calculated from the area under the stress-strain curve divided by the material density (1450 kg/m³), was 8.5 kJ/kg, which is some 60% higher than that of the on-axis specimens (Table 1). However, the increase in energy-absorption capability is accompanied by a reduction in stiffness and strength properties of the tested offaxis specimens. These properties can be improved by selecting ply angles in the range from 20° to 30° depending on various applications. Still, it is evident that off-axis laminates are capable to plastically deform and absorb energy like metals before their ultimate failure. Further, it was reported in [18] that thermoplastic PEEKbased composites demonstrated in 10% higher specific energy absorption than epoxy-based composites tested under similar conditions.

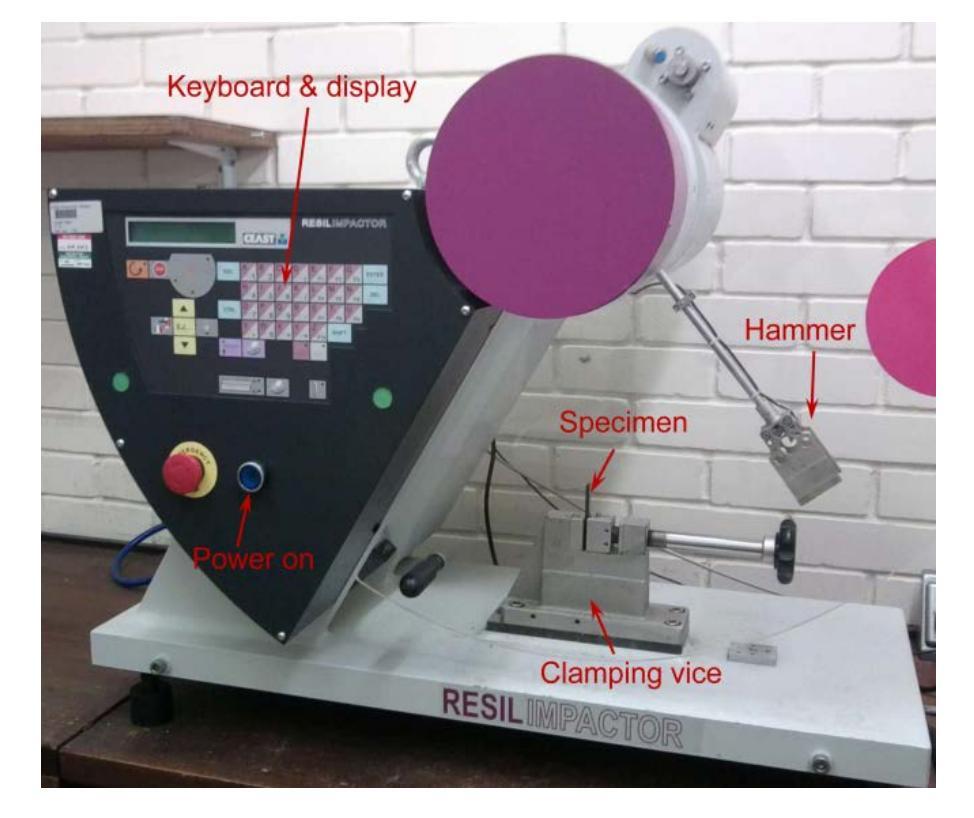
Fig. 3. Resil test set-up for impact bending

Dynamic tests were performed to characterise the bending behaviour of composite laminates under low-velocity impact regimes characteristic of the sports products in their service. Dynamic bending tests in an impact energy range from 0.1 J to 1.2 J were carried out according to the ASTM D4812 standard using a pendulum-type CEAST Resil impactor as shown in Fig. 3. In these tests, the bottom of the specimen was held in a clamping vice, whereas its upper part (30 mm) was struck by the impactor with specified impact energy, resulting in dynamic large-deflection flexure. With the same mass of impactor, the impact energy levels were varied by changing the initial angle of the hammer. A piezoelectric force sensor was fixed to the hammer's striker to measure the impact load. The data acquisition was achieved using DAS 8000 system at 227 kHz frequency. The force-time history of the dynamic event was recorded. The rest of the dynamic test parameters can be calculated using the equations given below, with the assumption of perfectly rigid impactor. The hammer's initial velocity at the moment just before the contact takes place can be determined from the potential energy using the following equation:

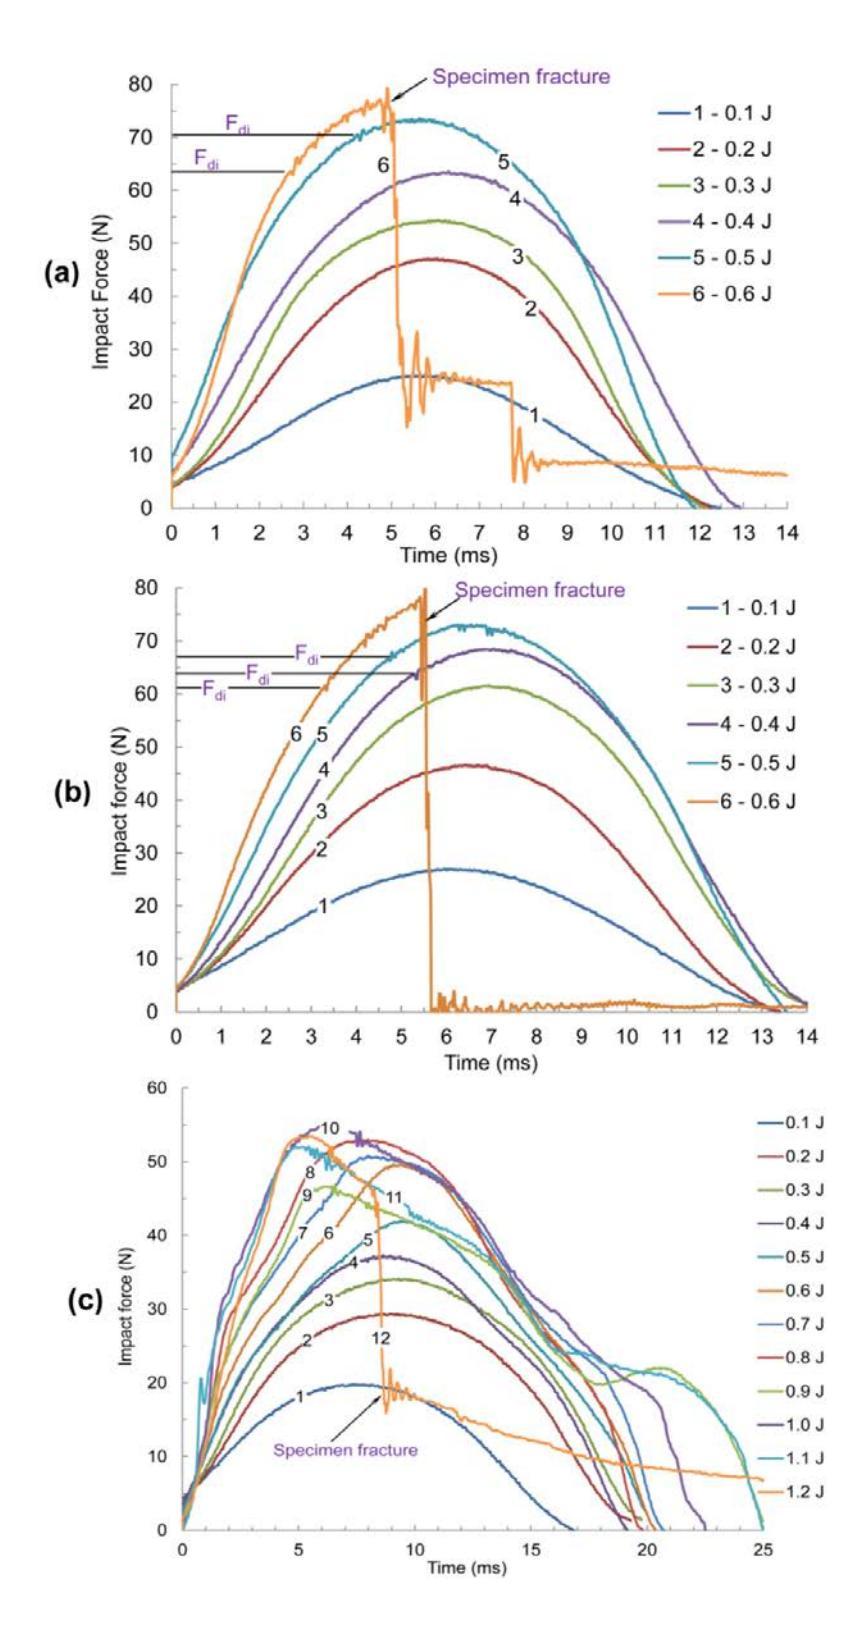
Fig. 4. Force-time responses of CFRP warp (a), weft (b) and off-axis (c) laminates at various impact energies

The impact force-time responses of CFRP warp, weft and off-axis specimens tested at different energy levels are illustrated in Fig. 4. It can be observed that both the slope and maximum peak force of the curves increased with impact energy. At lower impact energies, the force increased linearly with time at the beginning of impact, indicating the behaviour of undamaged specimen. After the maximum load peaks, the hammer bounced back and the load reduced to zero. The loading and unloading portions of the curves for both the warp and weft specimens up to 0.4 J and off-axis specimens up to 0.3 J had a nearly symmetric parabolic shape; indicating the occurrence of little damage in the form of a dent or matrix cracking at the impact point. In these impact tests, the energy was rather stored elastically in the specimens like a spring. As the impact energy was increased to 0.5 J and 0.4 J for warp and weft specimens, respectively, oscillations in the force-time plots can be observed before the load peaks. These fluctuations associated with load drops are designated as F_{di} in Figs. 4a and b, representing the onset of damage such as delamination and matrix cracking linked with reduction in the laminate stiffness [23, 24]. The curves became non-symmetric with regard to their peaks at 0.5 J as can be seen in Figs. 4a and b. In these tests, at 0.6 J impact energy, fabric fracture occurred in both types of specimens denoted by an abrupt drop in impact force indicating a loss of contact between the hammer and laminate. This was caused by brittle fracture of the fabric in tension in the front face of the specimen as a result of bending. The force did not reduce to zero in the warp specimens, as the back-face plies under compression were not fractured, causing a residual load of about 20 N. However, in the weft specimen, the load dropped to zero representing the laminate's complete fracture.

In both types of warp and weft specimens, the impact force increased with the impact energy, however, with a little effect on the contact durations (Fig. 4). The reason is that higher impact velocities induced larger deformations and, therefore, larger impact forces.

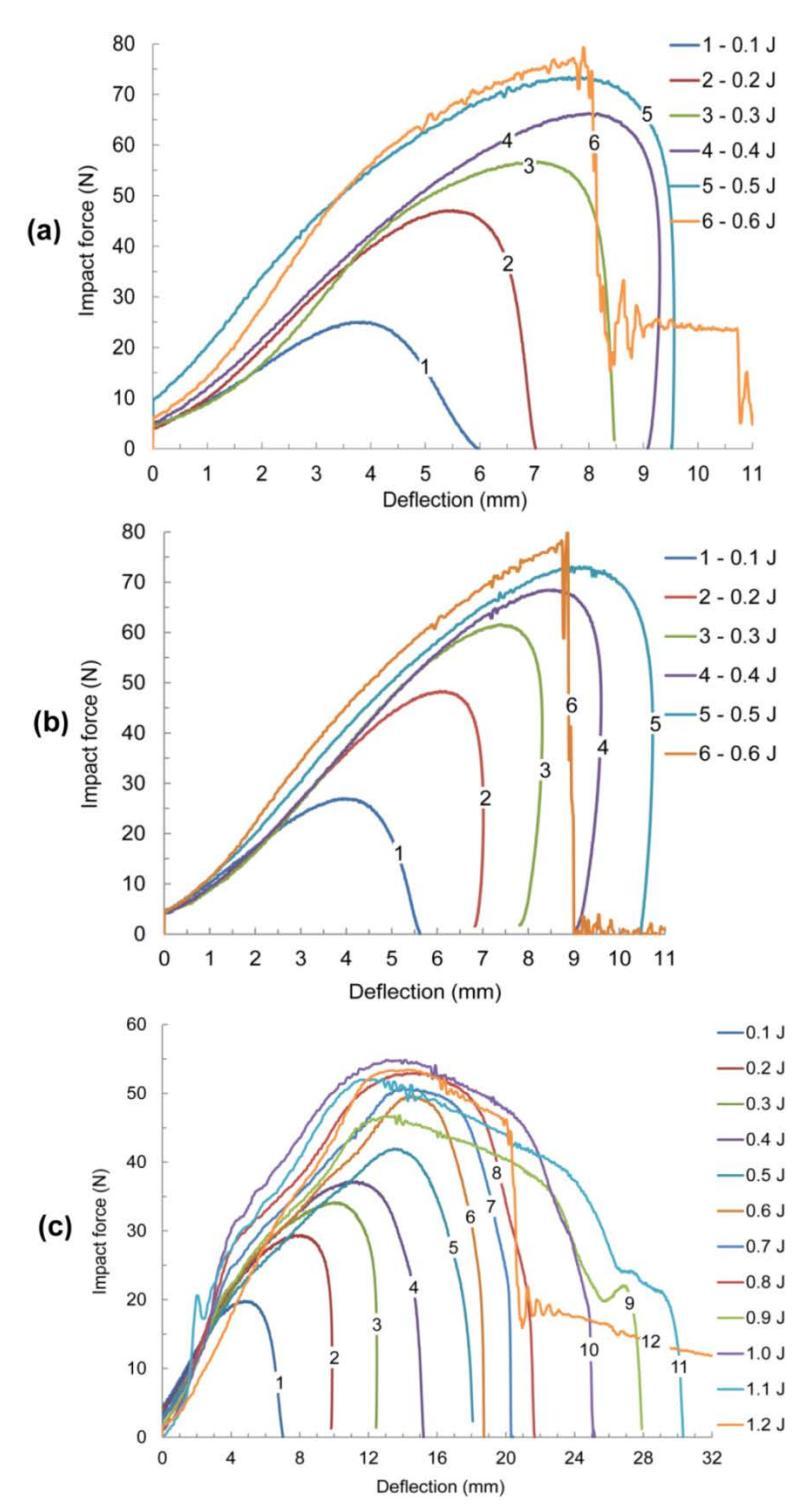
Fig. 5. Force-deflection responses of CFRP warp (a), weft (b) and off-axis (c) laminates at various impact energies

The force-deflection (F-d) responses for the warp, weft and off-axis configurations of CFRP samples at different impact energy levels are given in Fig. 5. Actually, all the curves started from the origin but due to higher Hertzian stiffness between the hammer and the specimen at the start, the load seemed to start from non-zero values. In cases without impact damage, a peak load relates to the maximum resistance provided by the specimen as an indication of its flexural stiffness [24]. The slope of F-d curves indicates the contact stiffness, while the area under the curve is the energy absorbed, which is increased with impact energy. It is worth mentioning that a membrane stiffening effect also occurred in thin laminates as the maximum deflection was several times greater than the specimen's thickness.

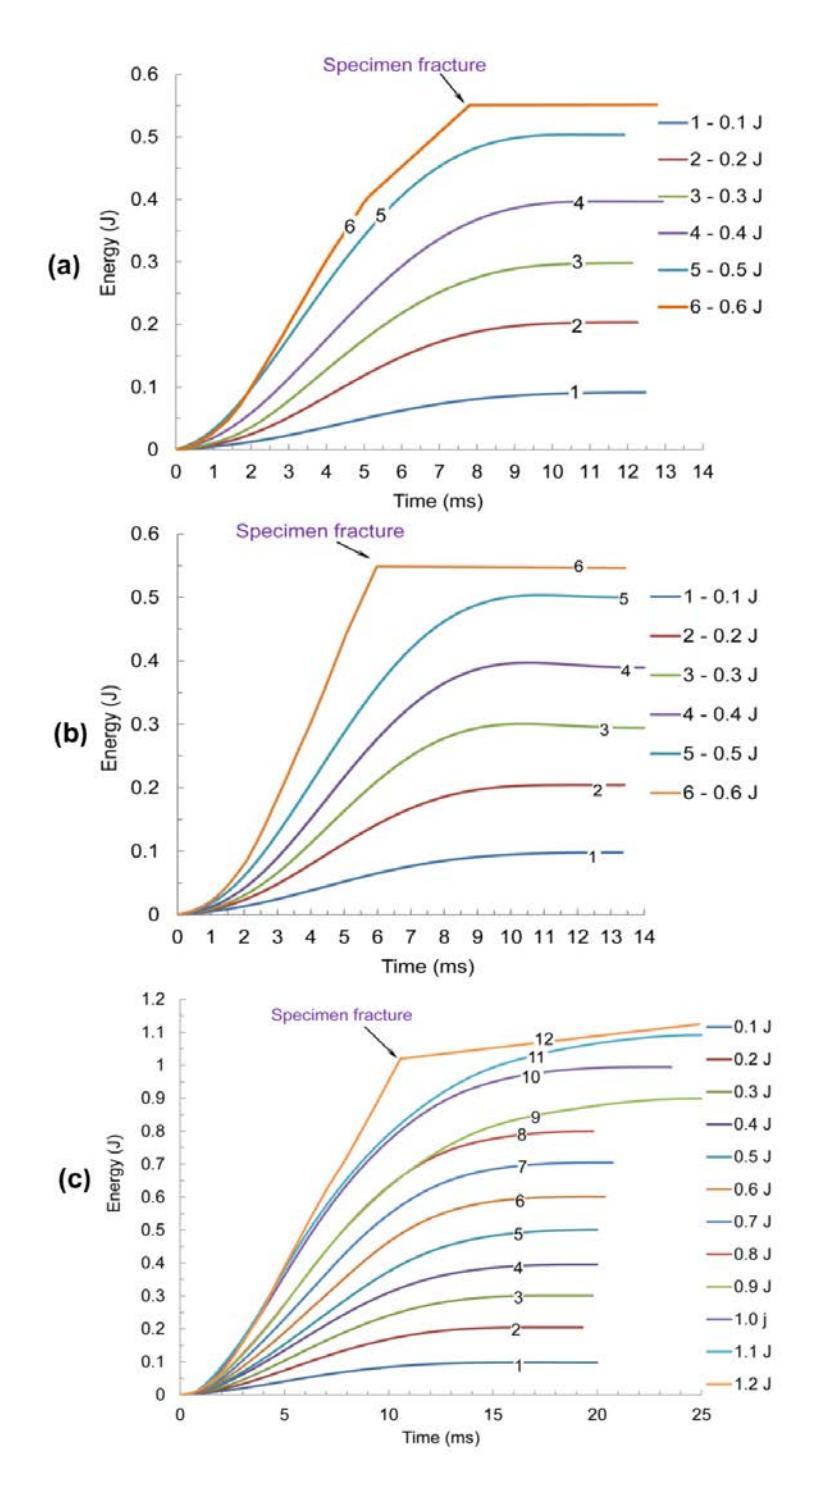
Fig. 6. Energy-time responses of CFRP warp (a), weft (b) and off-axis (c) laminates at various impact energies

Variation of energy with time for the warp, weft and off-axis CFRP specimens at different impact energies is shown in Fig. 6. As the impactor hit the specimen, the latter started absorbing the impactor's kinetic energy. The energy increased during loading until a maximum value and then decreased during a rebound and ultimately remained horizontal. This constant value gives the total energy absorbed by the specimen at the end of an impact event. Energy absorption in composites is mainly through elastic strain energy, plastic deformation and formation of various damage mechanisms [26].

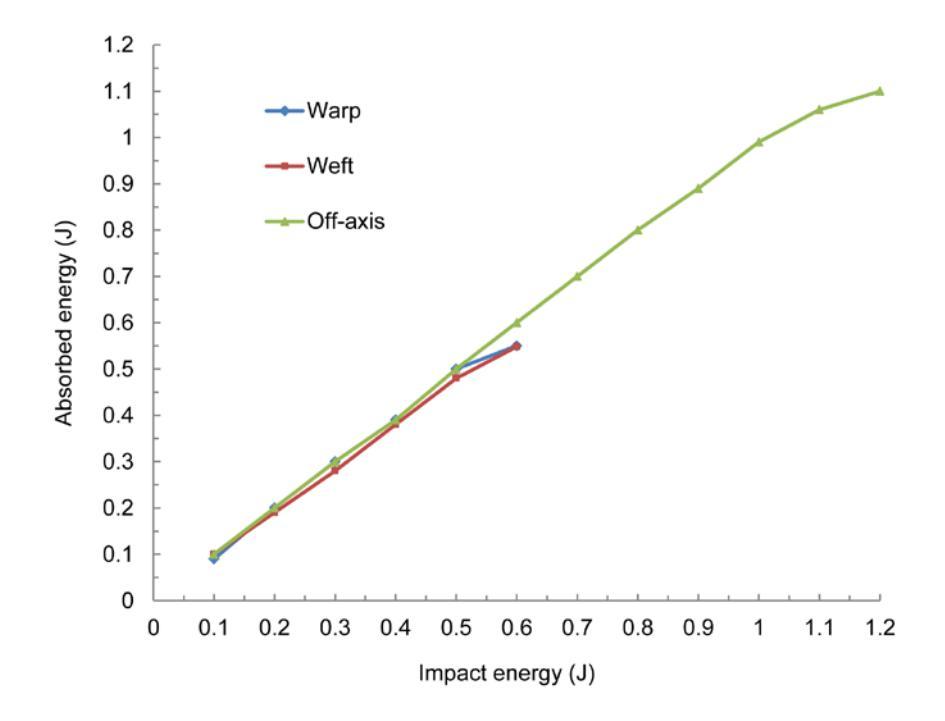
Fig. 7. Variation of absorbed energy with impact energy of CFRP warp, weft and off-axis specimens

Variation of the absorbed energy with impact energy, i.e. energy profile diagram is plotted for the warp, weft and off-axis specimens in Fig. 7. Here, the points below the equal energy line (a bisector) show the remaining energy retained by the impactor and used to rebound it from the specimen at the end of impact [27]. Here, too, the rebounding phenomena were exhibited more by the on-axis specimens than the off-axis. The energy profile diagram also showed that the off-axis specimens absorbed more energy without any rebound represented by an

almost straight line than the on-axis specimens. At impact energy of 0.6 J, both types of warp and weft specimens showed fracture after absorbing lower amounts of energy. This also implied that the hammer did not result in further damage in the laminates even if the impact energy increased. However, the off-axis laminates showed greater energy-absorbing capability up to impact energy of 1.2 J prior to their ultimate fracture.

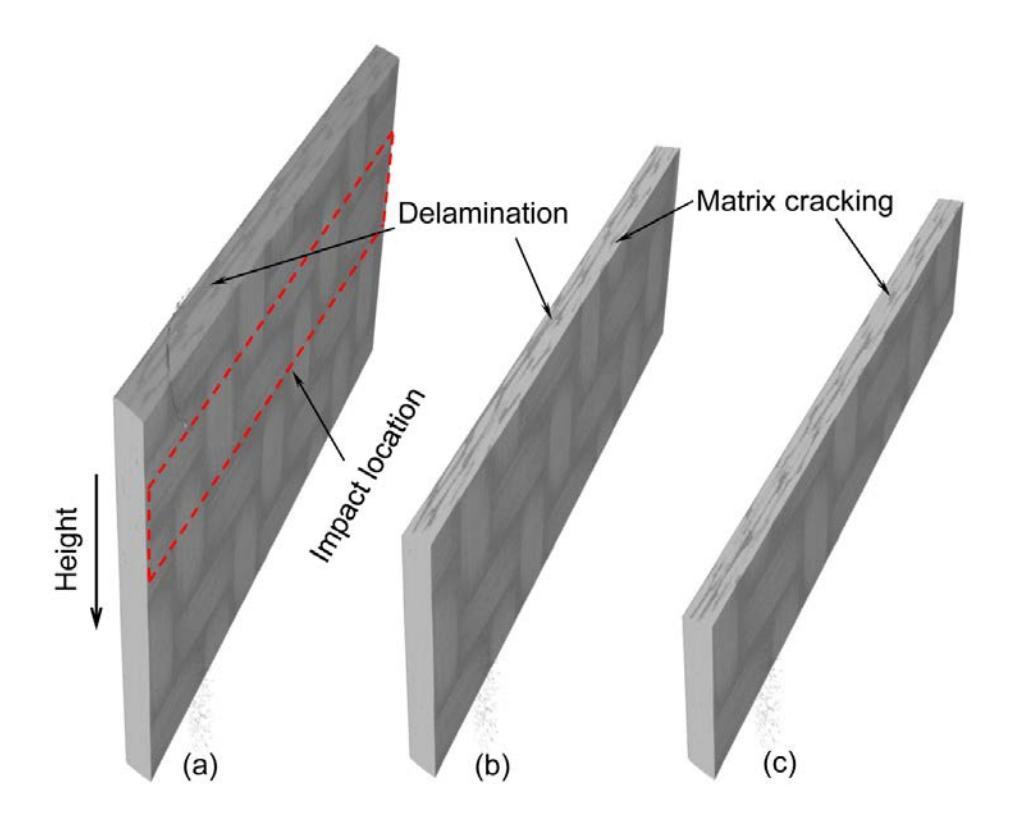
Fig. 8. Tomographic 3D images of warp specimen at impact location along the height of sample: (a) full; (b) half; (c) one-third of hight

CFRP warp specimen impacted at 0.5 J was prepared for 3D scanning. The sample was exposed to X-rays generated at 75 kV and 80 μ A. Radiographic images were obtained from 3600 rotation views over 360° of rotation (0.1° rotation step) during 3D reconstruction. The tomographs thus reconstructed, had a resolution of 14.7 μ m for the impact specimen, and are illustrated in Fig. 8. These tomographs demonstrate cracks in the TPU matrix and delamination at the impact point along the sample's height. Matrix cracks developed in weak resin dominated regions around the yarns and initiated inter-ply delamination. Micro-CT analysis showed that matrix cracking and interlaminar delamination were the significant damage modes underneath the impactor contact zone.

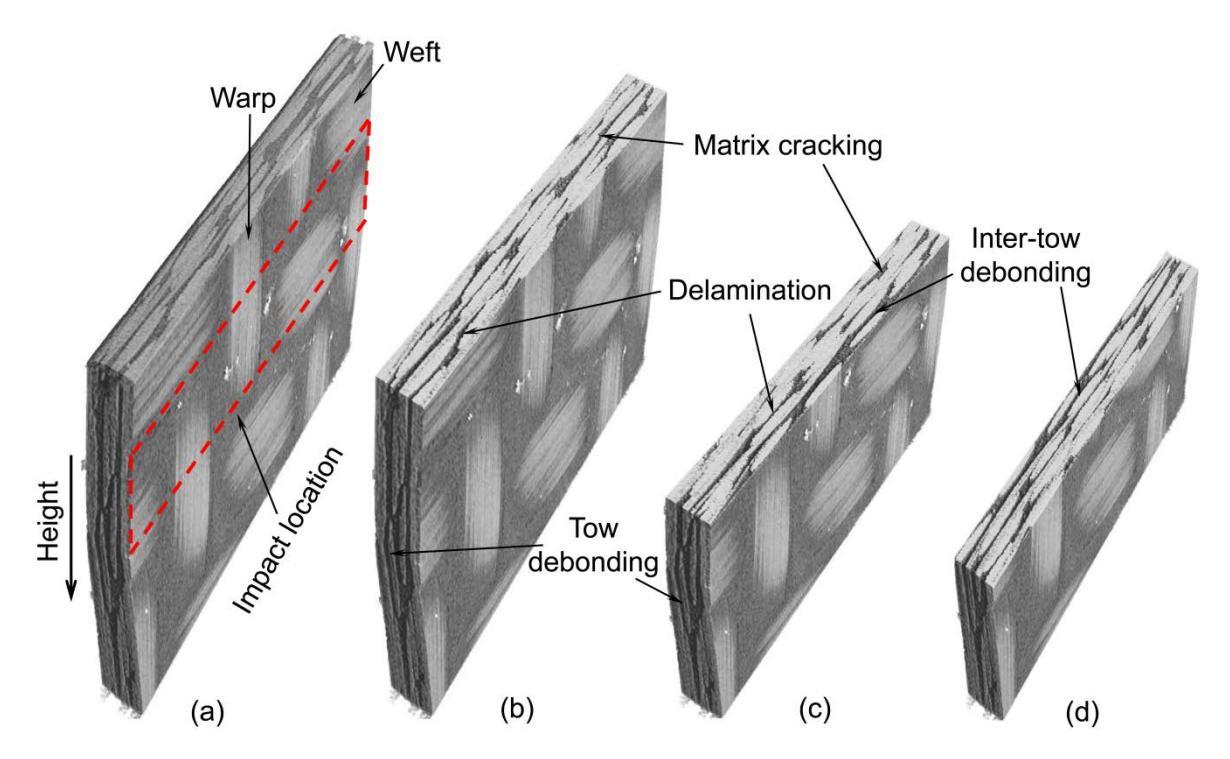
Fig. 9. Tomographic 3D images of warp specimen at impact location along the height of sample: (a) full; (b) three-quarter (1 mm above impact centre line) (c) half (at impact centre); (d) one-quarter (below impact centre line) of height

The tomographs of the fractured specimen at the impact location are shown in Fig. 9. Matrix cracking, delamination and tow debonding at the hammer's impact location along the specimen's height are evident. It can also be observed that the inter-tow cracks propagated into the resin pockets. At the impact location (Fig. 9c), the interface on the impact side (specimen's front) was more damaged than the back. Dents in the tows below the striker are also visible. All the resin-rich interfaces underwent inter-ply delamination below the impactor. The

back face, and only minor dents below the striker were observed on the impacted face as shown in Fig. 9. The impact location experienced matrix cracking and delamination as shown in Figs. 9c and d. Here, the fabric fracture was observed only at the bending location.

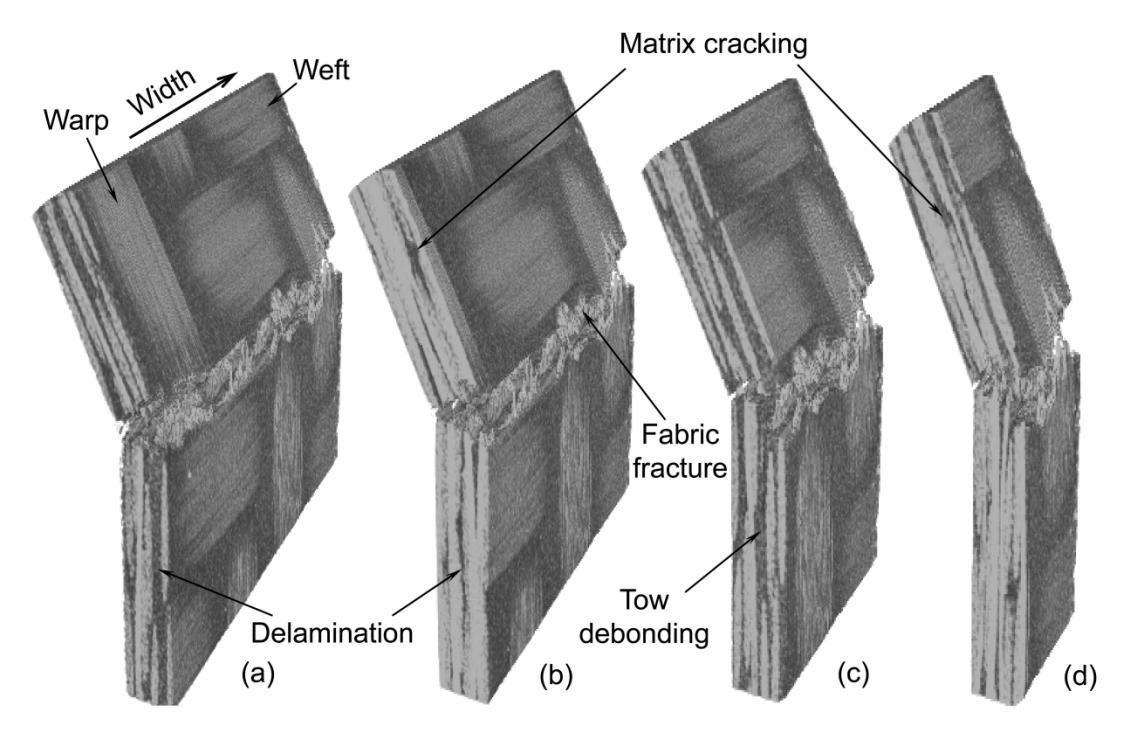
Fig. 10. Tomographic 3D images of warp specimen at bending (fracture) location along the height of sample: (a) Full; (b) three-quarter; (c) half; (d) one-quarter of width

tomographs of the CFRP specimen at the fractured location presented in Fig. 10 demonstrate interlaminar and intralaminar damage mechanisms at various positions along the sample's width. It is evident that the specimen exhibited progressively matrix cracking and then delaminations and tow debondings until its ultimate fracture. Matrix cracking was dominant in the resin-rich regions surrounding the tows. Interlaminar delamination, i.e. separation between adjacent fabric plies, and intralaminar delamination such as tow debonding, which is separation between tows within a single ply, can also be observed. In the fibre-rich regions, the apparent damage mode was debonding at the tow/matrix interface. The analysis of internal structure showed that at the time of fabric fracture, triggered by tensile fibre failure, almost every ply was delaminated. This delamination is more pronounced in Figs. 10a and c than in 10b and d. The reason is that warp tows, which are aligned along the specimen's axis, bear a higher load than transverse weft tows in bending of the specimen under impact. All the tomographs demonstrate that matrix cracking, delamination and tow debonding were the significant damage modes at the specimen's impact location, whereas at the bending location, apart from these modes, fabric fracture was also observed.

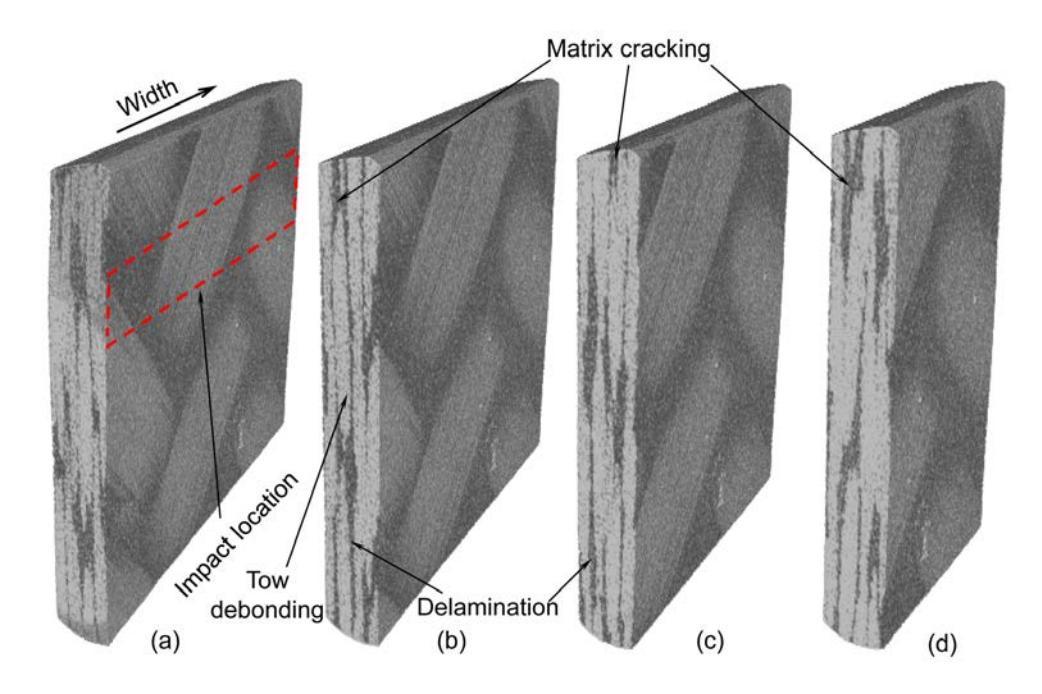
Fig. 11. Tomographic 3D images of off-axis CFRP specimen at impact location along the width of sample: (a) full; (b) three-quarter; (c) half; (d) one-quarter of width

Here, two samples of the off-axis CFRP laminates, one with dimensions of 6.42 mm x 6.0 mm x 1.0 mm from the impact region, and second with dimensions of 21.4 mm x 14.1 mm x 1.0 mm from the bending/fractured region were prepared. The tomographs with resolution of 4.5 µm and 15.4 µm for the impact and fractured specimens, respectively, were obtained from the reconstruction process. These tomographs of the off-axis fractured specimen at the impact and the bending locations are presented in Figs. 11 and 12, respectively. In Fig. 11, the sample shows similar damage modes of matrix cracking, delamination and debonding as in the on-axis specimens. However, the extent of damage is less than in the on-axis specimens. In the off-axis laminates, thicker interlaminar and intralaminar resin-rich regions are present than in the on-axis ones. In these laminates, the elasto-plastic TPU matrix sharing almost 50% of load with fibres in $\pm 45^{\circ}$ orientation was yielded ahead of the crack tip during cracking and delamination; thus enhancing fracture toughness of the woven composites and suppressing damage. The sample at the bending location in Fig. 12 also highlighted similar damage modes with additional fabric fracture on the tension (impact side) of the specimen. However, due to plasticity, this fracture was not as catastrophic as occurred in the on-axis specimens, pierced in two pieces as shown in Fig. 10. Here, the specimen was intact even after the fracture of fabric on its tension side, as shown in Fig. 12, thanks to intact tows/fibres on the compression side. Therefore, it is evident that pseudo-ductility in the off-axis specimens resulted in damage suppression under dynamic loading.

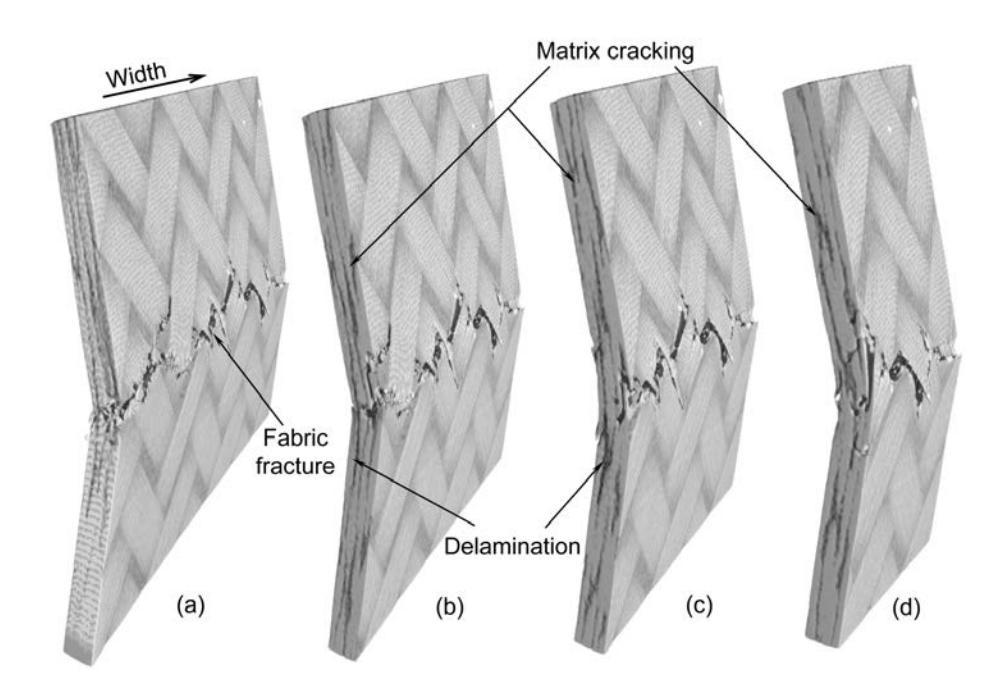
Fig. 12. Tomographic 3D images of off-axis CFRP specimen at bending (fracture) location along the width of sample: (a) full; (b) three-quarter; (c) half; and (d) one-quarter of width

In the off-axis specimens, as the impact energy increased up to 0.4 J, the loading and unloading parts showed nonlinear behaviour instead of oscillations, demonstrating that plasticity of the laminates resulted in a lower level of damage in them than in on-axis specimens. The specimens impacted at energies between 0.8 J - 1.1 J also showed a permanent bending-like deflection after tests (Fig. 4c), which might be due to pseudo-plasticity of the off-axis laminates. The plasticization of matrix in the resin-rich regions also played an important role by leading to local permanent deformations due to ductility of the TPU matrix, apart from fibre trellising. At higher energy levels, the specimens exhibited more pronounced yielding, implying the onset of plastic deformation indicated by the plateau at the top of the curves (Fig. 4c). The specimens also exhibited a snap-back during the rebound, shown by the depths and kinks in Fig. 4c. Unlike the on-axis specimens, the peak loads remained almost the same, with an appreciable increase in the deformation of the off-axis specimens at higher impact energy of 1.2 J than the on-axis specimens, but the failure was not sudden and catastrophic, giving a warning in the form of load reduction (Fig. 4c). Here, a residual load remained after failure, and the specimens were still intact as can be seen from micro-CT images in Fig. 12.
