PEOPLE-CENTRED APPROACHES TO WATER AND ENVIRONMENTAL SANITATION

Performance of Arsenic and Iron removal plants in Bangladesh

M. H. Rahman and M. Z. Rahman, Bangladesh

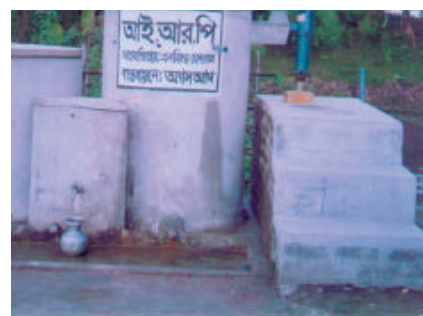
Figure 2. Typical Community AIRP

The conventional community type iron removal plants (Figs. 1 and 2) operate on the principles of aeration of ferrous iron to convert it to ferric iron which co-precipitates with arsenic. Groundwater drawn by hand pump from a tube-well drops into the aeration/ sedimentation chamber (around 1m diameter and 1m height, with cascades on top of this chamber for better aeration). This promotes oxidation of iron and arsenic by the air. The aeration/ sedimentation chamber is provided with air vent pipes for better circulation of air (Fig.1). Water from this aeration/sedimentation chamber passes through the up-flow roughing filtration chamber (around 1m diameter and 0.8m height) due to the pressure head from the water level in the aeration/sedimentation chamber. The water is subsequently collected into a storage tank (around 0.5m diameter and 0.8m height) fitted with water tap for public uses. Filtration media comprises brick chips, charcoal and sands. Filtration media is back-washed twice or thrice in a week depending on the rate of discharge through the filter media, and sludge is collected in a holding pond. Back-washing is carried out using the following procedure. First the plant (both sedimentation and filtration chambers) is filled up with water from the tube-well, then drainage valves of both sedimentation and filtration chambers are opened simultaneously to rapidly drain out sludge from both chambers. Then the filtration media is washed with around 25 litres of water by pouring this water from a bucket onto the top of filter media to remove the impurities within the interstices of the filter media. The operation and maintenance of this system is very simple. A group (at least two persons from the user community are selected as caretakers) are trained during the time of the construction of plants to be responsible for operation and maintenance of the system. No proper methods for the disposal of arsenic contaminated sludge have been developed yet. Presently the sludge from the holding ponds of AIRPs is discharged
